**Historic Landmark Commission  
October 24, 2011  
Permits in National Register Historic Districts  
NRD-2011-0080  
Pease Park  
1100 Kingsbury Street**

**SUBJECT: Update: Back-up Information for National Register Permit:  
Pease Park Improvements**

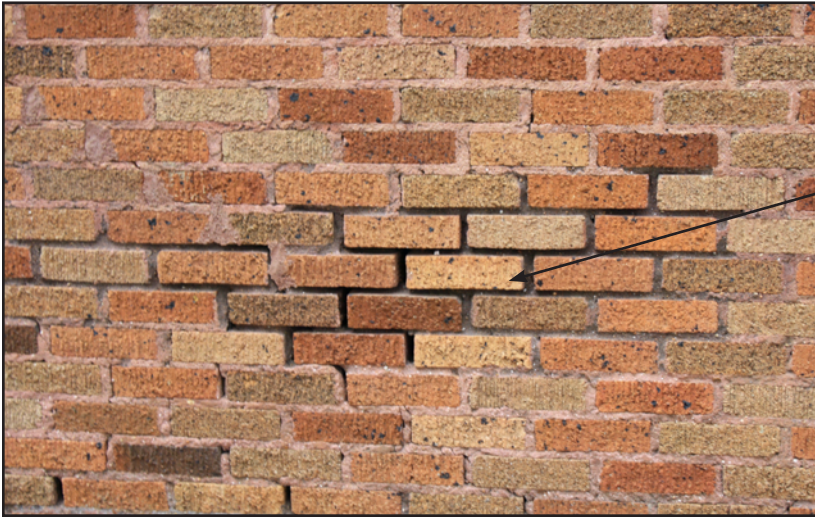
- b. Repair and restoration of historic concrete tables, benches, and bench legs at Pease Park (Fig. 12)
- c. Repointing of specific areas of the Historic Tutor Cottage Restrooms. The original pink limestone mortar has washed out and eroded from natural causes on different elevations of the cottage (Fig. 2). As a part of the repair process, the mason will prepare mock-up samples to be approved, using similar aggregate, color, and lime to match the historic mortar. Upon approval, the areas of missing mortar will be repointed and mortar joints will be finished and tooled to match the original design.

Figure 2: Missing mortar necessitates repointing the Tudor Cottage restrooms.

1. Tudor Cottage Restrooms:
  - a. Repoint missing and deteriorated mortar as needed with a mortar mix that matches original material in color, texture, and other properties. Mason will prepare a mock-up for approval by City staff.

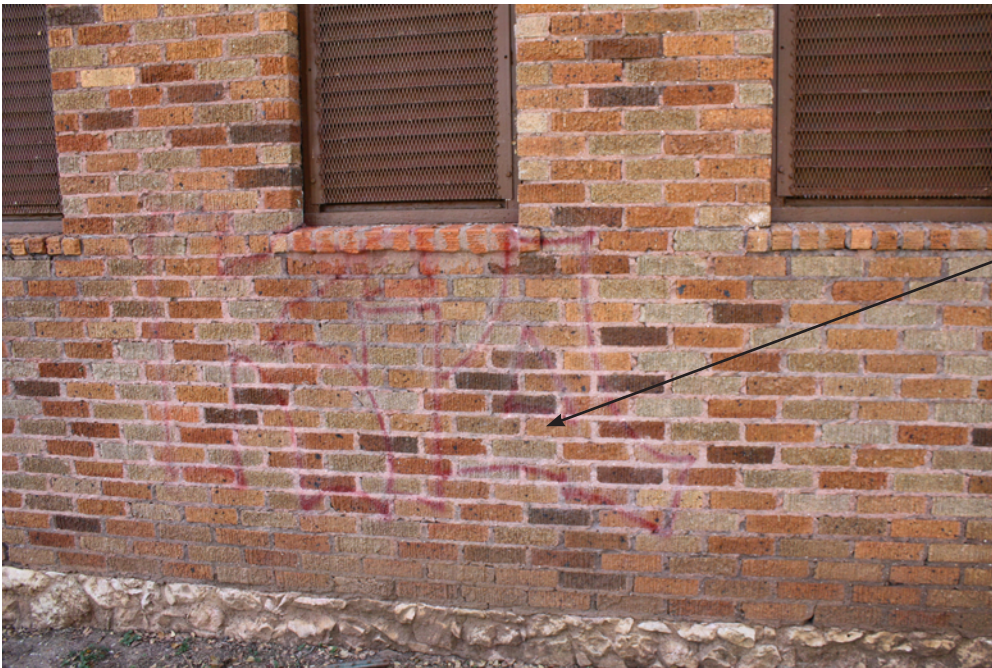
Figure 3: Graffiti on the brick masonry Tudor Cottage Restrooms.

- b. Remove graffiti from masonry using an appropriate product.
2. Memorial Gates
  - a. Repoint mortar as needed with a mortar mix that matches original material in color, texture, and other properties.

- a. Removal of graffiti must be done carefully and no products can be used that are deleterious to the integrity of the brick and mortar (Fig. 3). An excellent reference, *NPS Preservation Brief 38: Removing Graffiti from Historic Masonry*, is attached. (Appendix D).

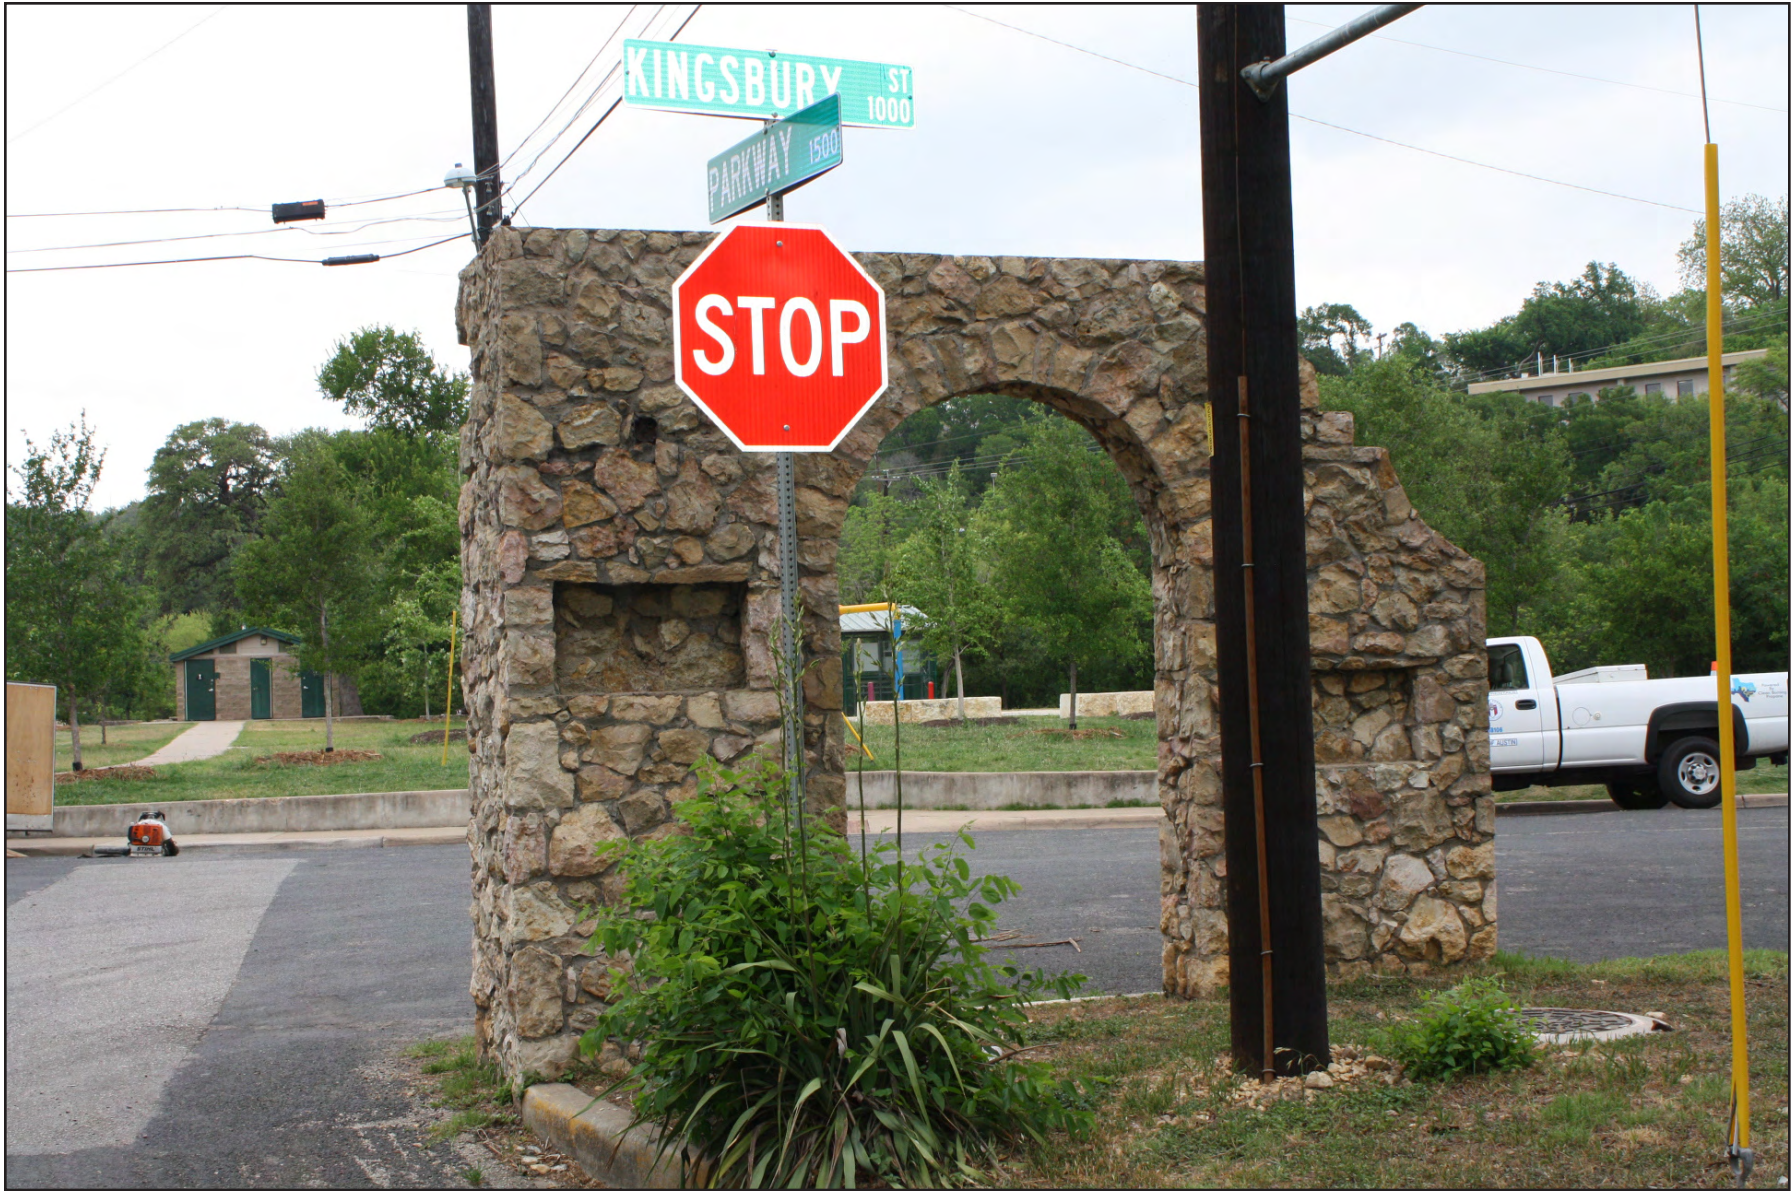
Figure 4: Pease Park Memorial Gates (east archway), designed by Giesecke & Harris, 1926-27: In addition to restoring the lighting, signage, and wrought iron detailing on the archway, long-term plans might also include the relocation of the stop sign and utility pole.

- a. The grant proposal calls for 3 (three) hand carved signed, two depicting “Pease Park” and one stating establishment dates. The material specified is native limestone (Niches can be seen in Figs. 4 & 5).

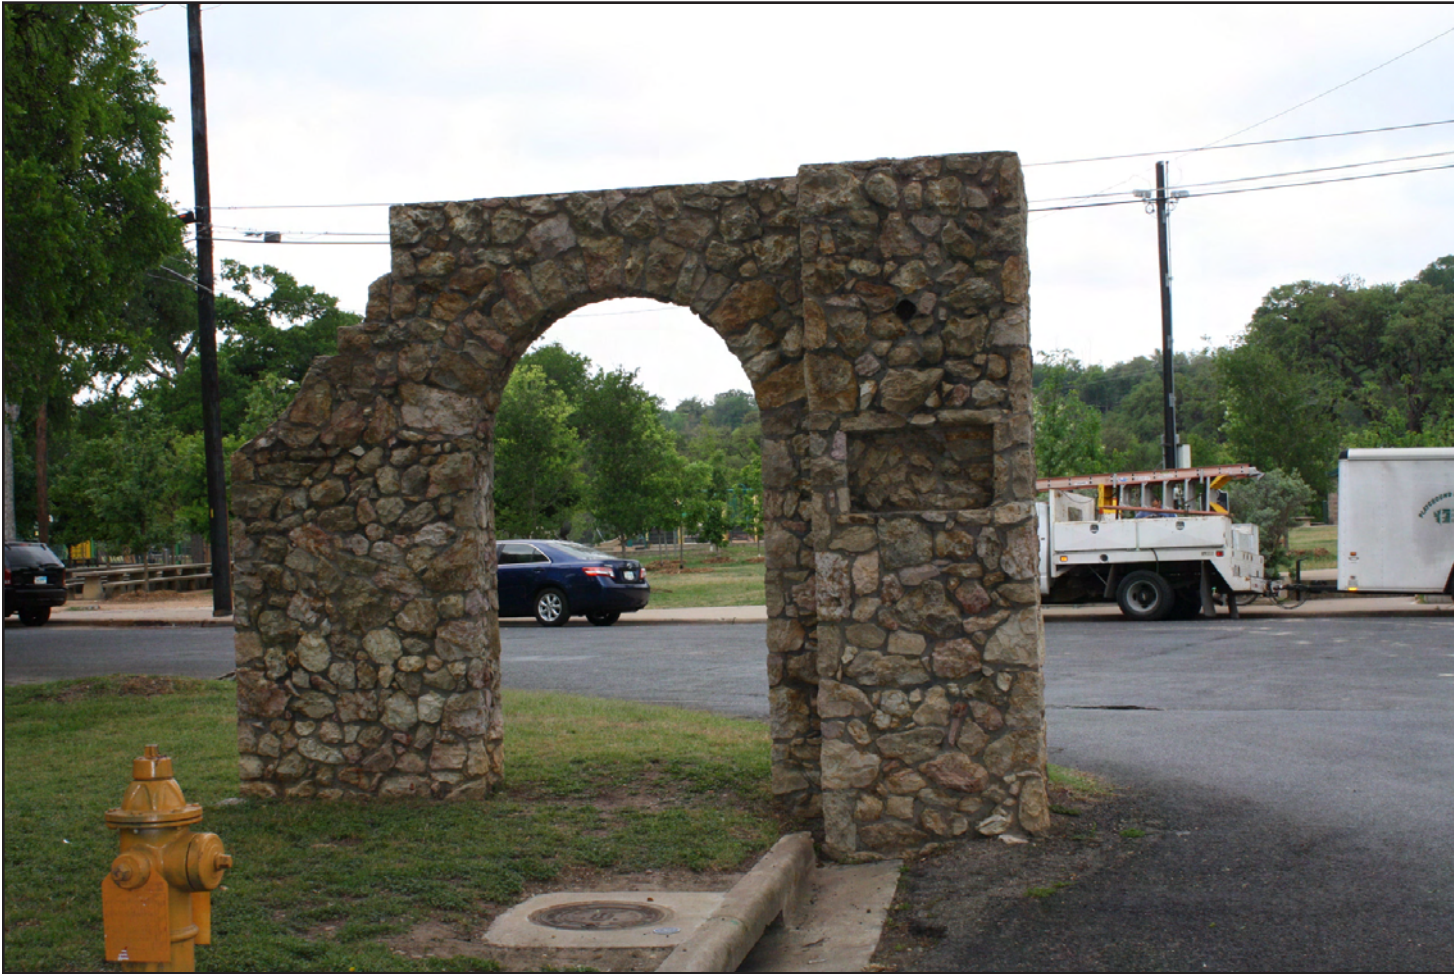
Figure 5: Pease Park Memorial Gates (west archway), designed by Giesecke & Harris, 1926-27: The grant proposal calls for installation of signage in the niche of the archway. Landscaping around the archways will also enhance the overall appearance of the entrance to Pease Park.

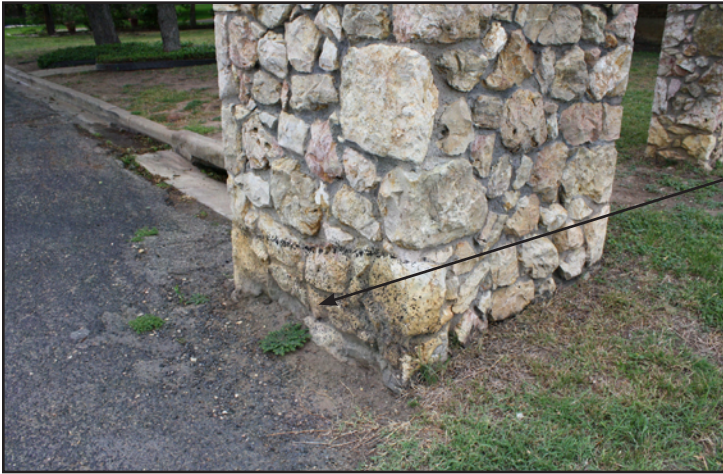
Figure 6: Tar has splashed up from the road on to the entry archway.

- iii. It is recommended that a thoroughly cleaning be undertaken (Fig. 6).
  - iv. For the repair of the concrete picnic area, PARD and the HPO request that a diagram be provided that shows what type of intervention is proposed for each area of repair. For example, certain areas of damage will require re-casting of concrete.

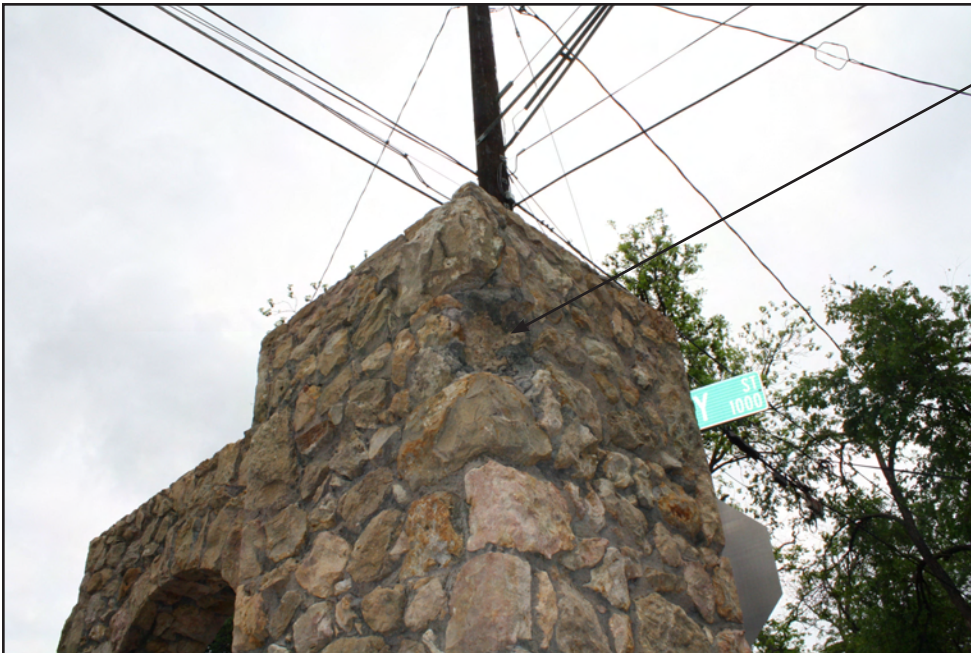
- a. The repair and repointing of missing mortar, a cornerstone, and mortar cap from the historic archways at the main entrance to Pease Park. The eastern-most arch exhibits damage from vehicular impact, which is causing cracking and movement at the center of the arch and right side of the column. The repair of the cracked arch is an immediate priority to prevent the collapse of the stone (missing limestone shown in Fig. 7).

Figure 7: Missing limestone from the entry archway.

- b. Replace missing stone at corner and stone cap with matching material.
  - c. Replace missing plaques with sandstone plaques. Font to be block lettering similar to that used on the Aldredge Place entrance columns. Date on plaques will be "1926" - the date gates were constructed.

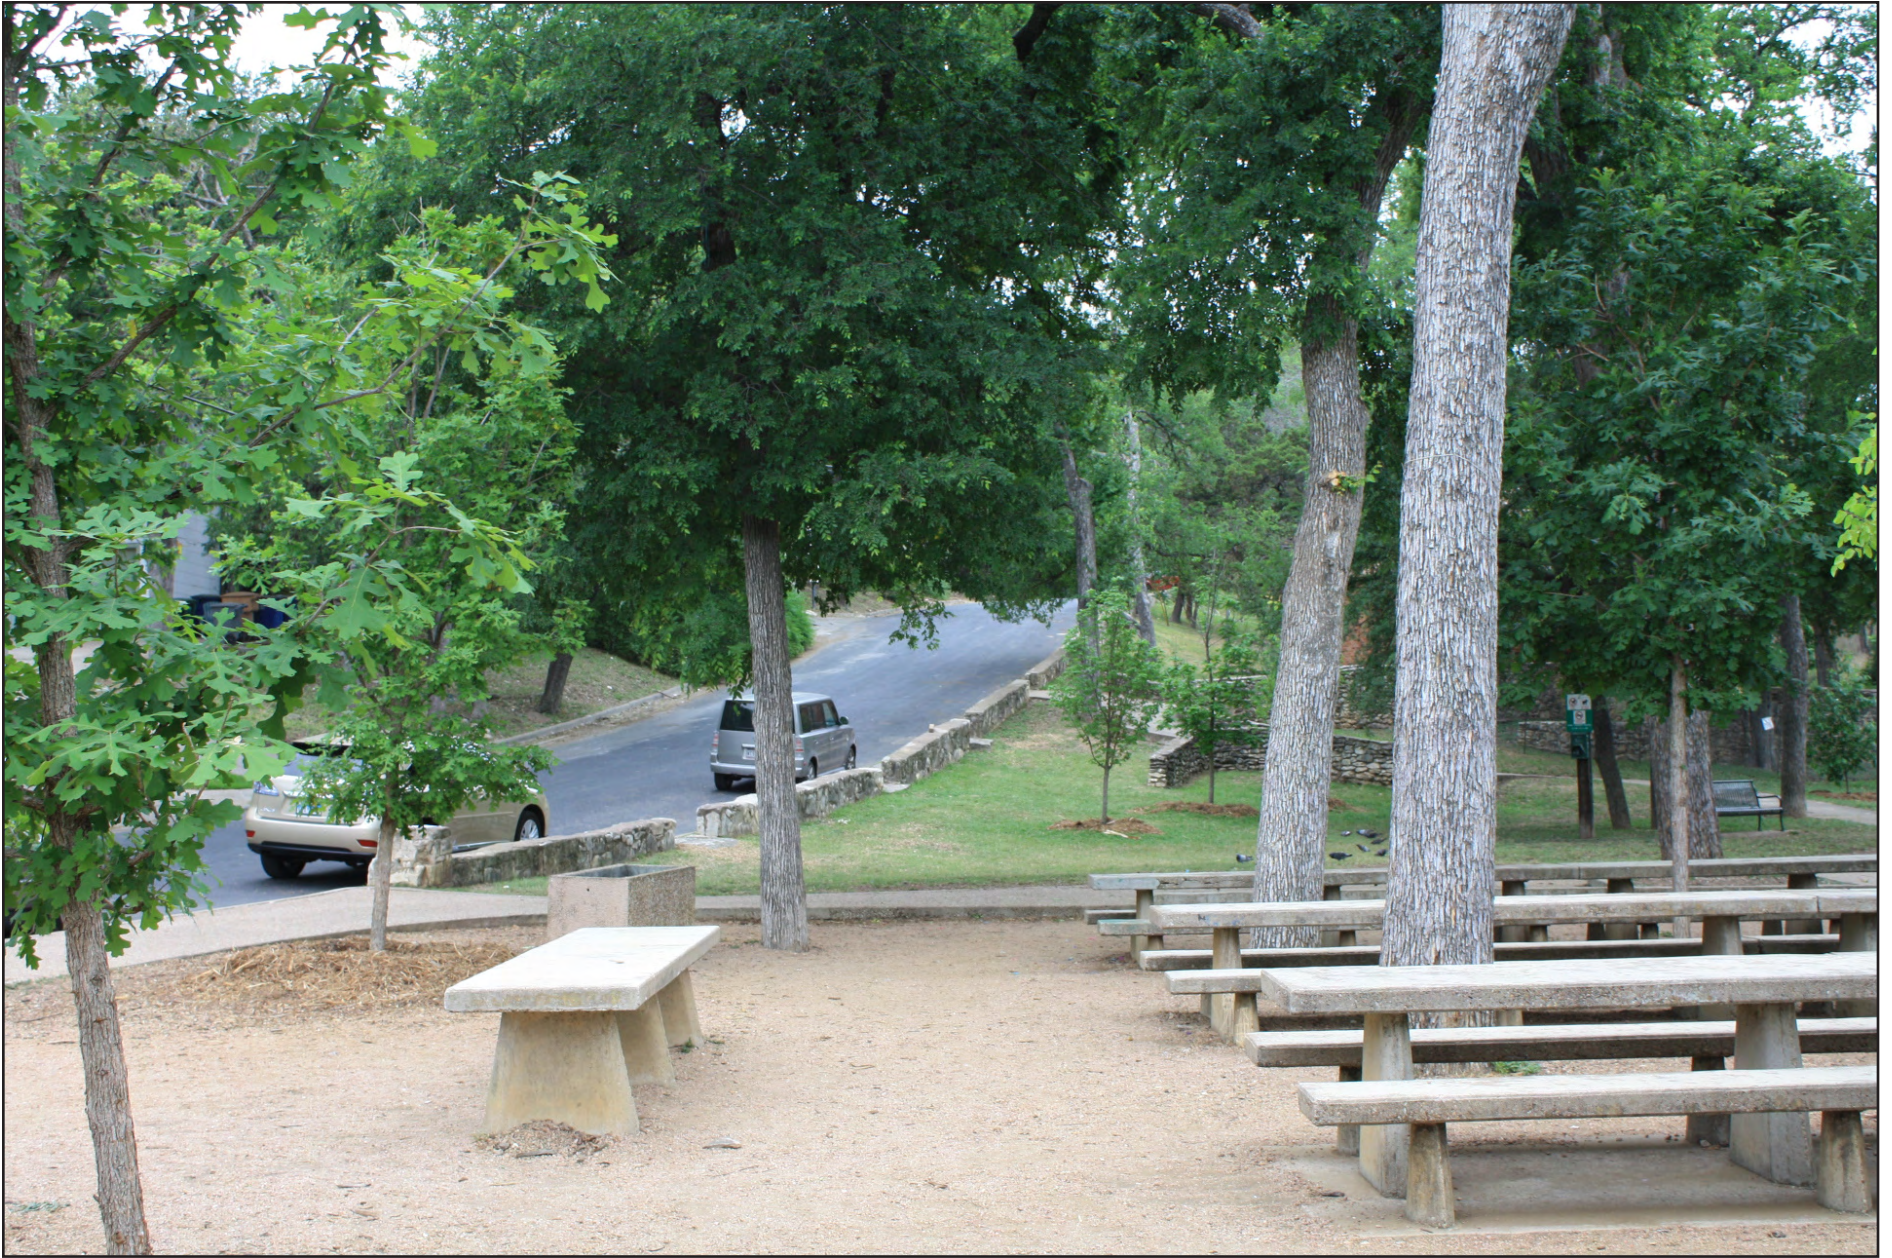
Figure 12: Pease Park concrete picnic tables and benches with an estimated construction date in the mid-1930s.

3. Concrete Picnic Tables and Benches
  - a. Repair historic concrete tables, benches and bench legs. Contractor will develop detailed documentation of damaged/deteriorated areas and recommendations for repair treatments, which will be reviewed by City staff.
