Address of Property: 1101 E 10th Street

Building Name or LHD: Metropolitan AME Church

# PROPERTY INSPECTION REPORT

**Concerning:** 1101 E. 10th Street, Austin, TX 78703

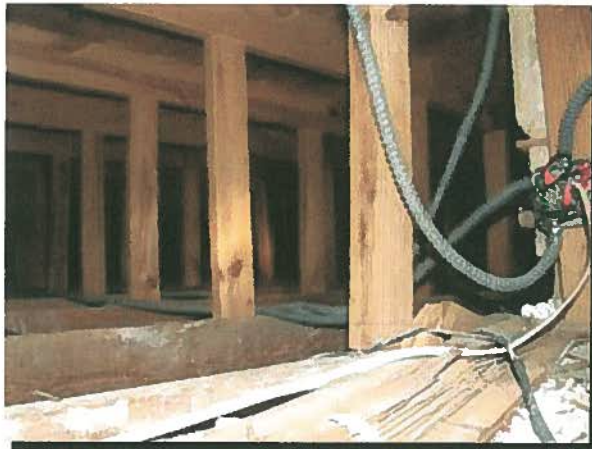
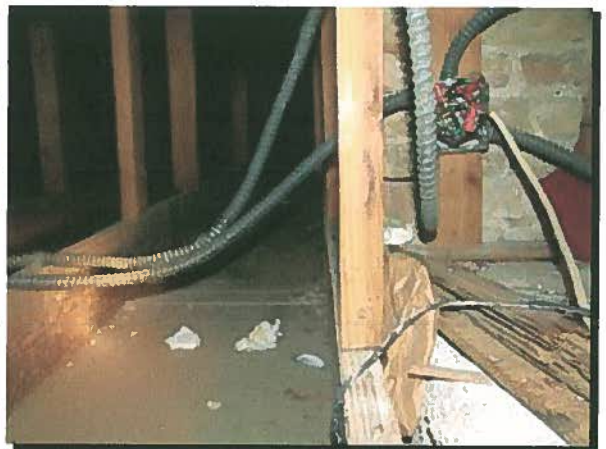
☒ Floor/ceiling space between basement and second story: 2x4 vertical supports have been put in place with very little attachment and some appear to be loose. There is no diagonal or horizontal bracing as required by current standards. Lower, basement posts are bowed in areas. Live load expectancy of structure is unknown. A qualified foundation contractor or engineer should evaluate structure for need of upgrades or modifications per its intended use, as this structure is intended to bear a large capacity load (over 200 people) and may be exceeding structure's capability. Additional lower supports (posts) and interior cross bracing may be recommended, but should be evaluated by licensed engineer..

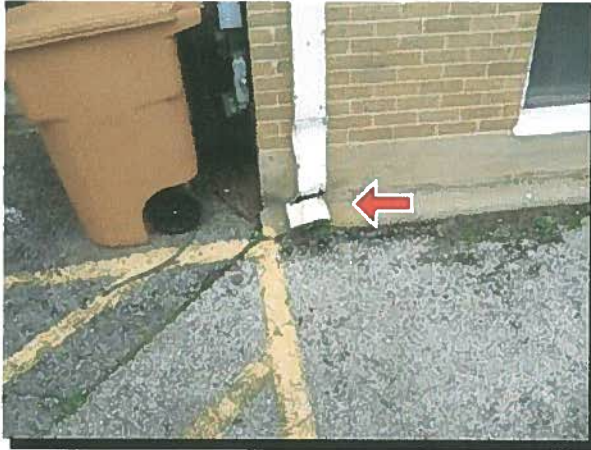
☒ Drainage is deficient. Gutters and downspouts are damaged in multiple areas. Gutters do not appear to be capable of handling runoff, and may require replacement with larger/deeper capacity. There is notable areas of moisture incursion surrounding the structure that require the enhancement of the capacity drainage system. Subterranean drains exiting towards the perimeter of the property may be advisable.

B. Picture 1 Damaged.

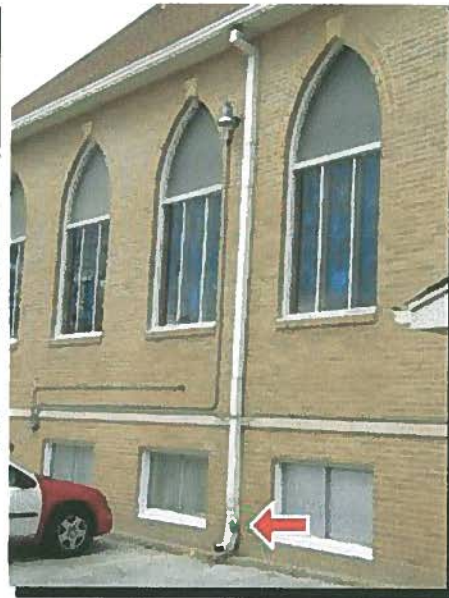
B. Picture 2 Damaged, not functional.

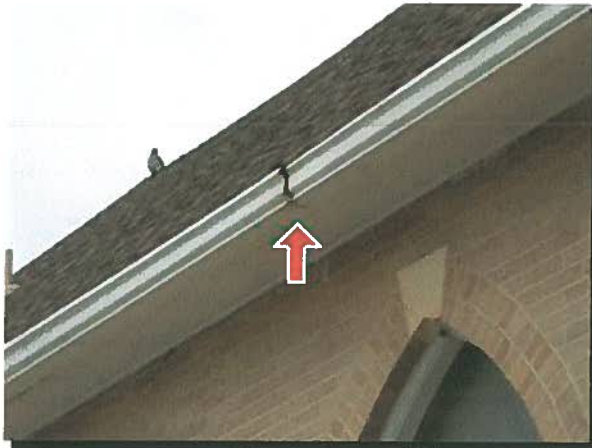
B. Picture 3 Gutter rail separated.

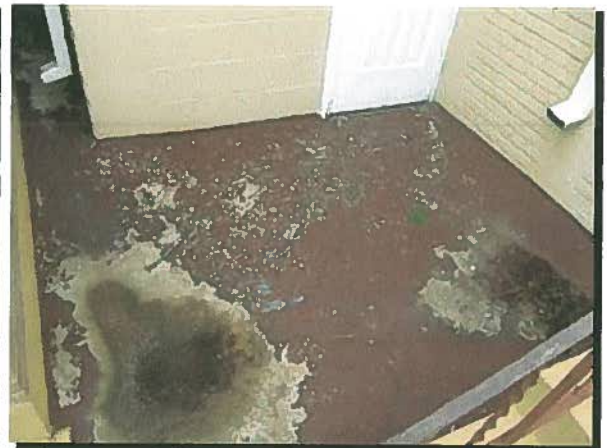
B. Picture 4 Standing water. Deficient slope away from structure.

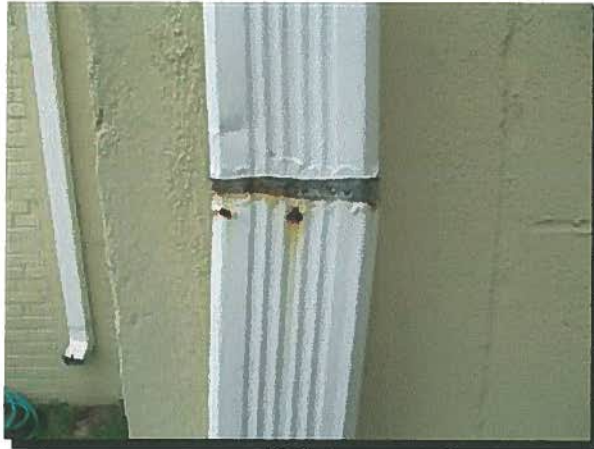
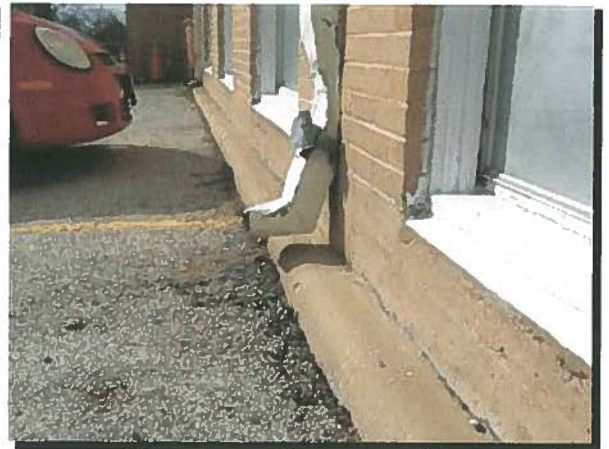
B. Picture 5 Downspouts damaged in several areas. B. Picture 6

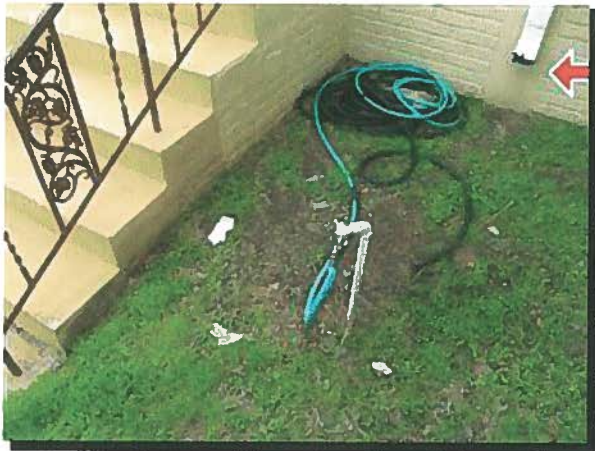
☒ Downspouts deposit large amounts of runoff near the base of the structure, and appear to be contributing to the moisture content in the basement. Gutter downspouts that terminate at or near foundation should be extended away from foundation to reduce/prevent moisture intrusion.

B. Picture 10 Extend away from foundation.

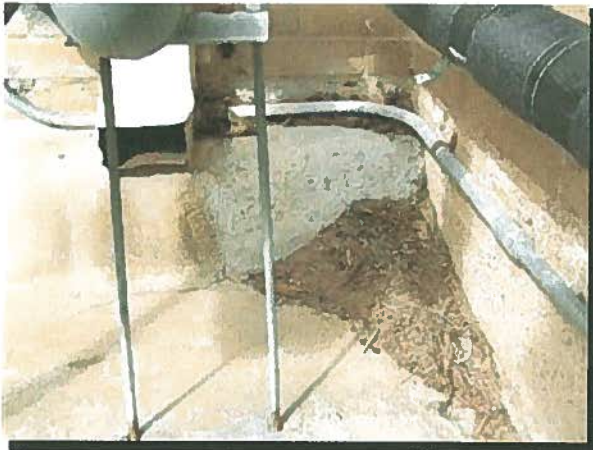
B. Picture 11 Even concrete areas are absorbing the excess runoff.

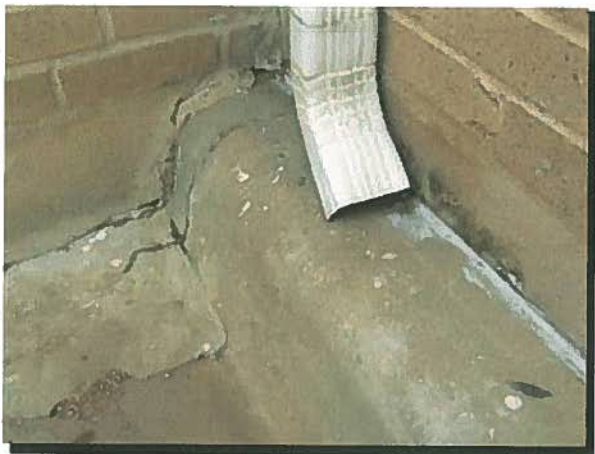
☒ Cement barrier at base of structure, adjoining basement walls is sloped towards structure. This barrier should slope away from the structure.

B. Picture 13 Several repairs to pooling area. Drain and slope of barrier should be away from structure.

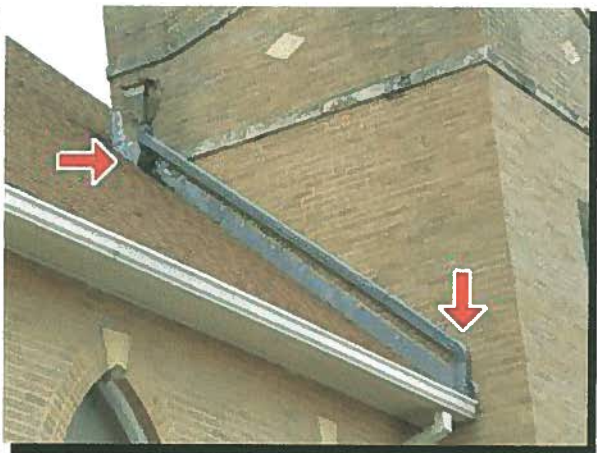
B. Picture 16 Here we see damage to wall and roof from a leaking scupper.

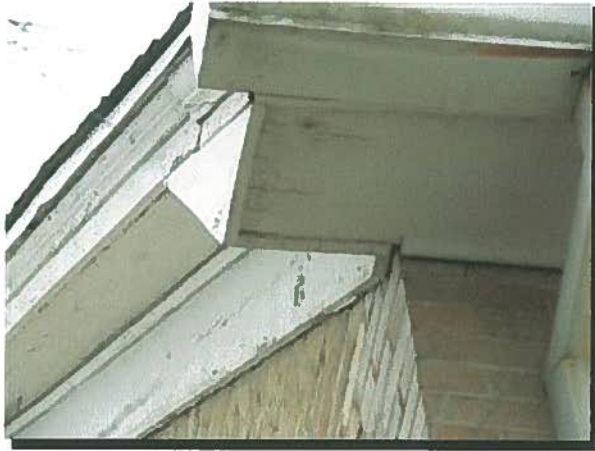
B. Picture 17 Damage to eaves from poor drainage.

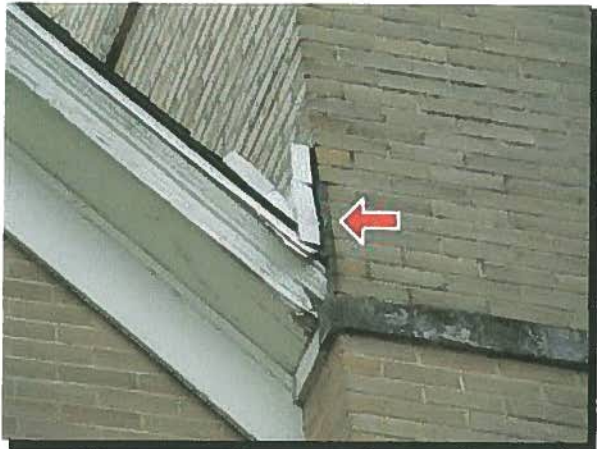
☒ Flashing at valleys, counter flashing to be increased. Makeshift repairs to be removed, improved.

C. Picture 1 Makeshift diverter flashing appears to be making drainage worse as it is retaining water at valley.

The builder intends to rehab this structure per historic landmark committee guidelines, and may not be at liberty to change the outer structure or appearance. At the two towers there should be crickets installed from roof to tower walls to deflect and direct runoff away from the walls. Since these may not be allowed as they could alter the appearance, additional counter and valley flashing will be recommended to prevent water incursion into structure. An impermeable membrane extending outwards from the center of these valleys and corners may also be an alternative. Whatever the application, the intent is to prevent the incursion of runoff from roof during rains from entering into any parts of the roof or structure walls.

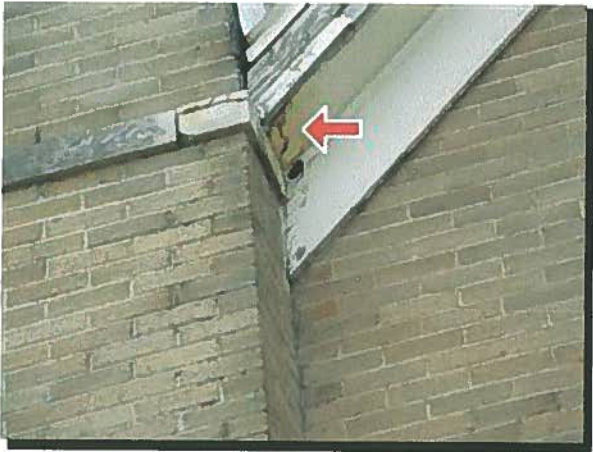
C. Picture 2 Damage from improper drainage.

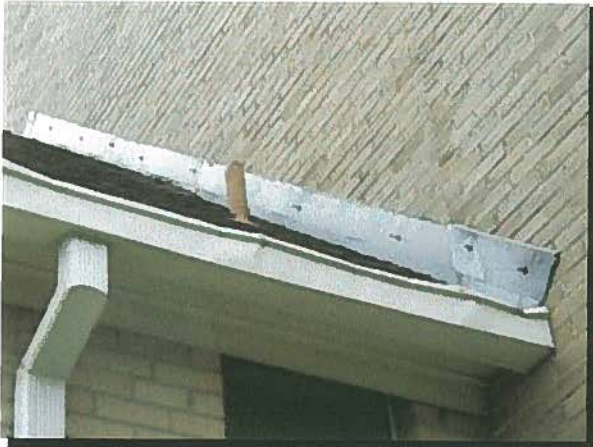
C. Picture 3 Some counter flashings have deteriorated seals at walls.

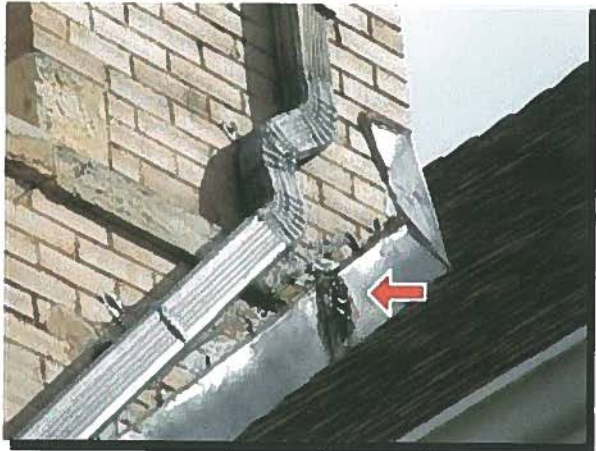
C. Picture 4 Leaking.

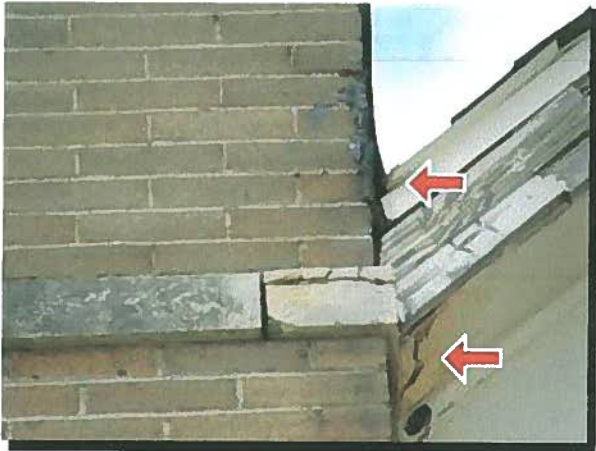
C. Picture 5 Water intrusion, subsequent damage.

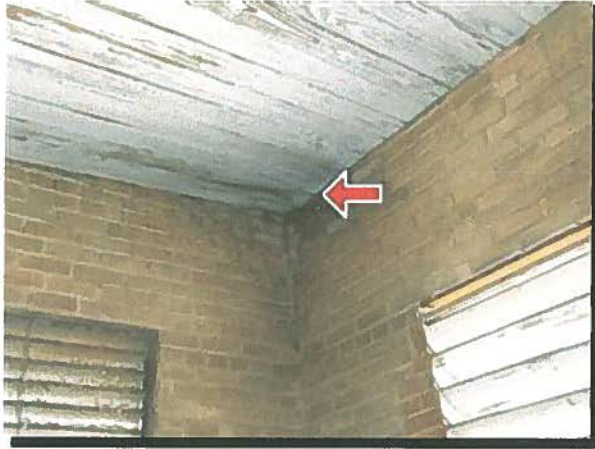
C. Picture 6

☒ Roofs above bell towers not accessible, but inspection of interior in west tower shows water damage from leaks. These roof will require repairs.

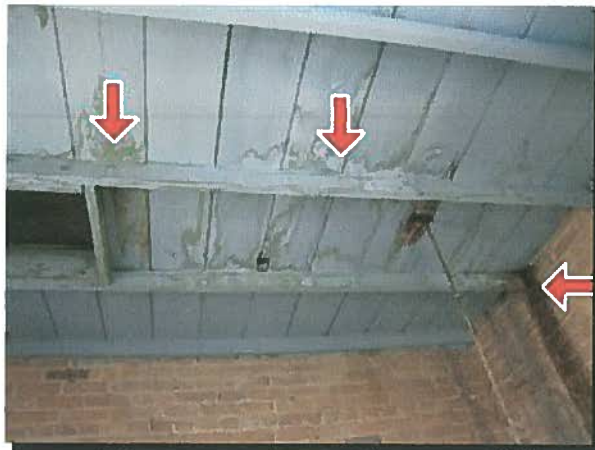
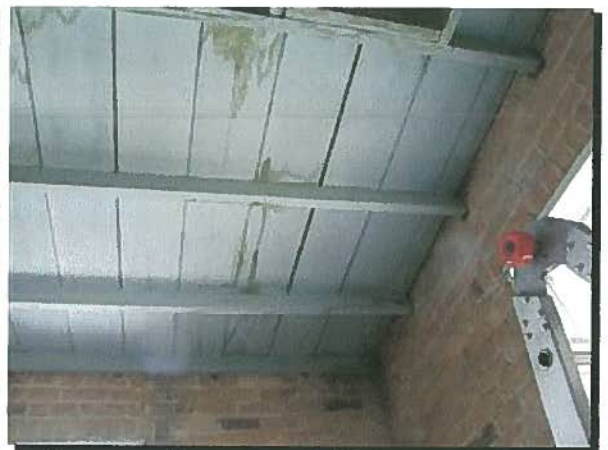
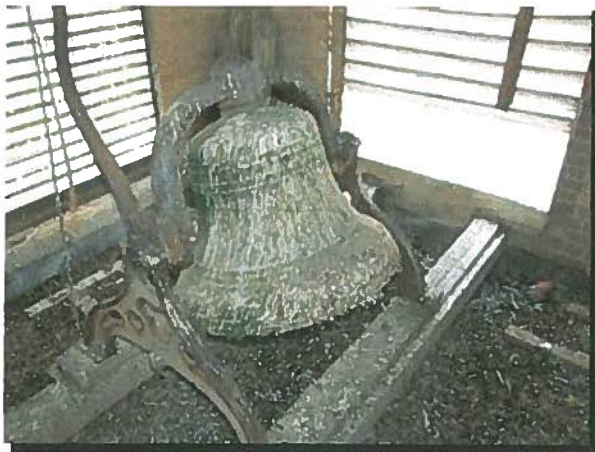
☒ The roof structure in the west bell tower is damaged from water incursion. The horizontal structural supports are rotted in several locations. The load capacity and structural integrity of the top floor, and its ability to safely support the bell housed within is suspect. It is recommended that this area not be used as an entry until an engineer can evaluate for its safe use.

The roof above should be repaired or replaced, and made to be leak free.

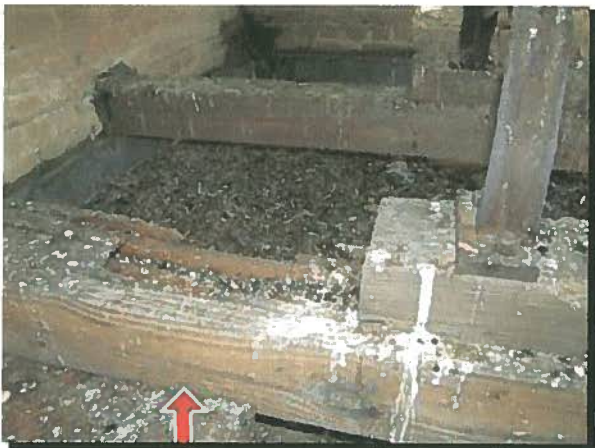
D. Picture 5 A 2x6 board has been nailed into place where rot is occurring.

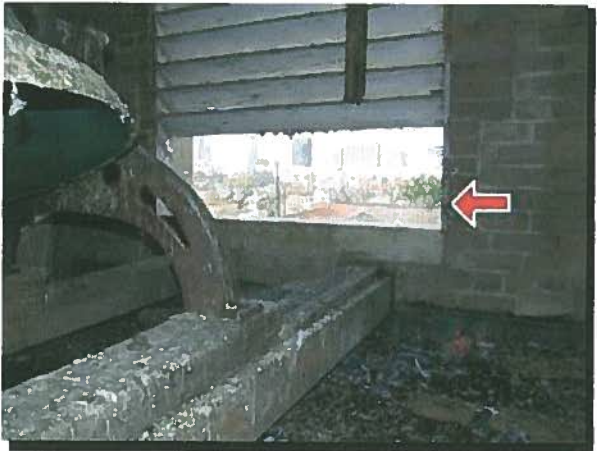
D. Picture 6 Missing lovers, open to rain intrusion.

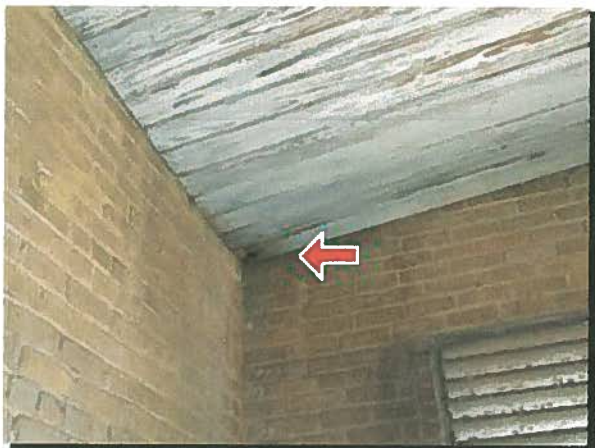
D. Picture 7 Leaks from roof.

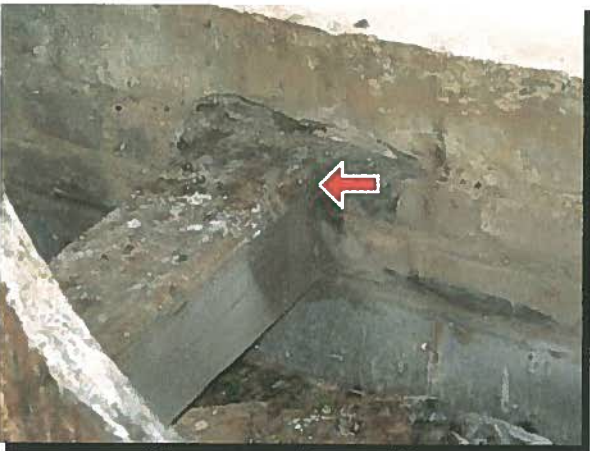
D. Picture 8 Support rotting at wall.

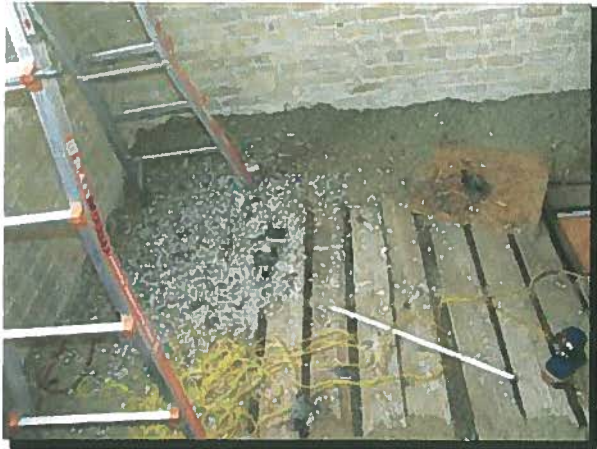
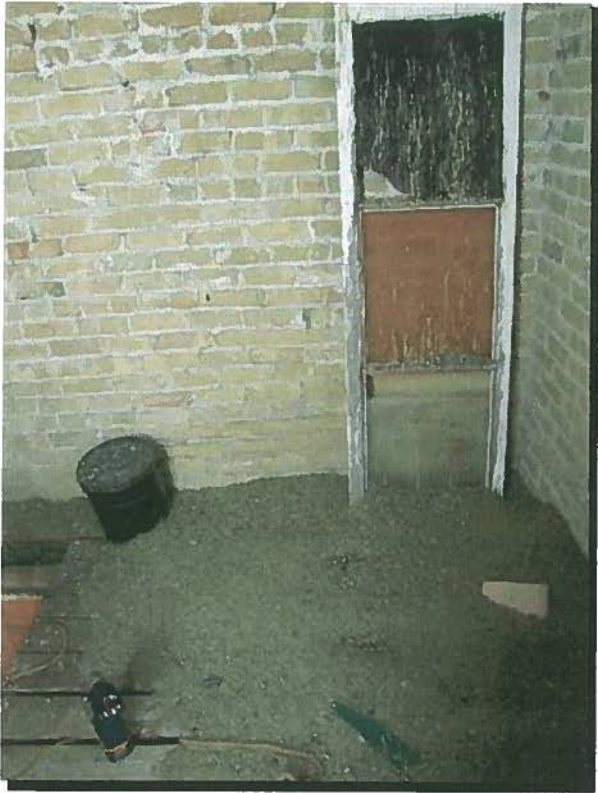
the lower loft of the west bell tower has water damage. There are rotted boards near perimeter walls. Moisture appears to be entering through damaged windows, and being allowed to stay in the insulation. This is helping to promote rot, decay. Area should be sealed and made to be weather proof. Damaged structures repaired, and insulated.

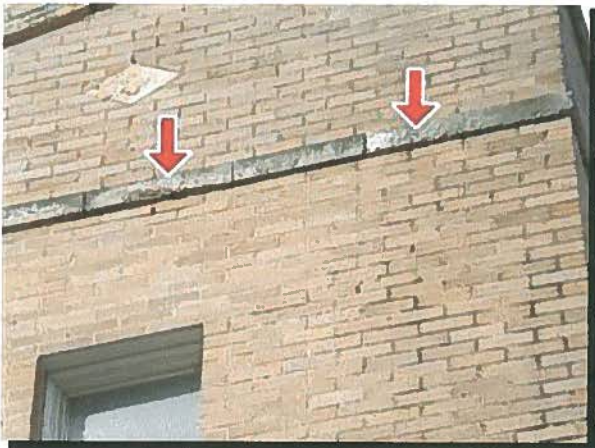
E. Picture 7 Decay and separation.

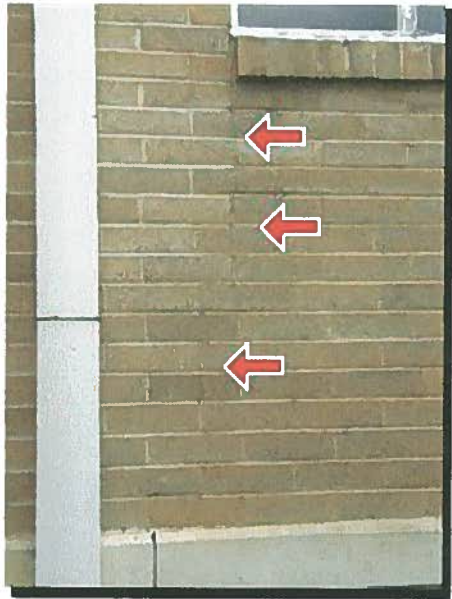
E. Picture 14 Cracks from shifting, settling.

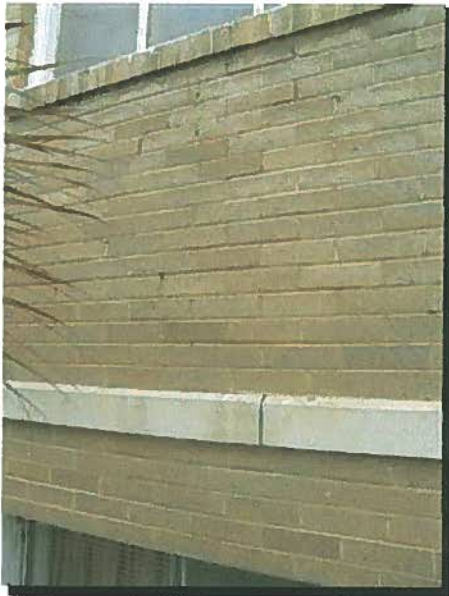
E. Picture 15 Mortar repair.

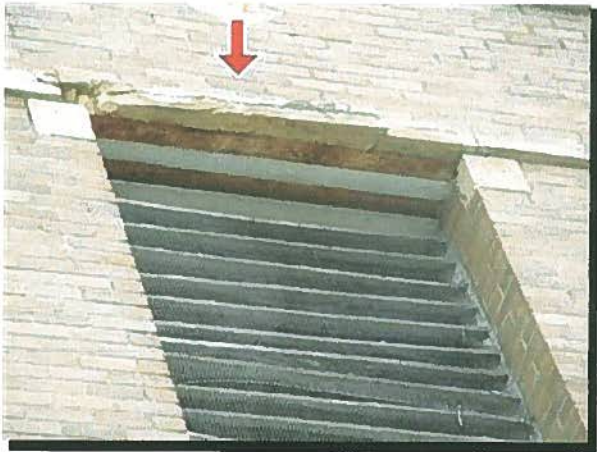
☒ Lintels are deteriorating and shifting outwards from wall applications. Some of the stonework is protruding and near falling out of wall, creating a safety hazard. The stonework in these areas will require replacement, and structural enhancements to these areas is recommended. A qualified mason should repair.

E. Picture 17 Stone protruding, ready to fall out of wall structure.

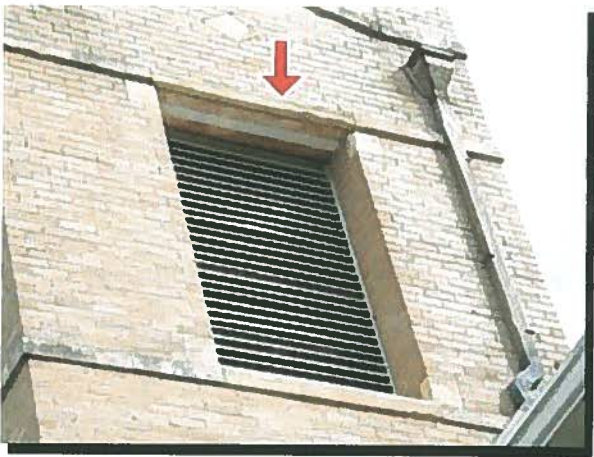
E. Picture 18 Stone falling outward.

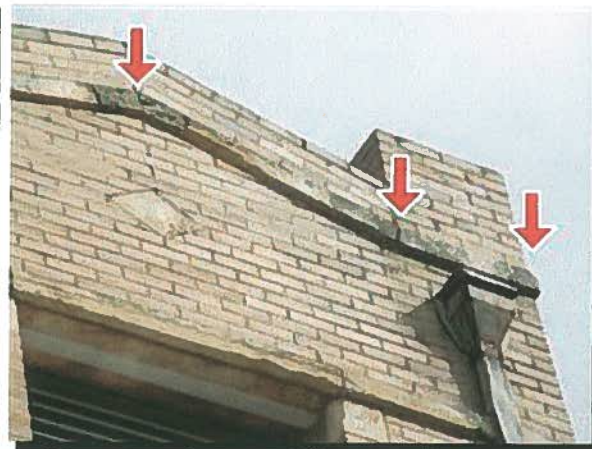
E. Picture 20 Deteriorated.

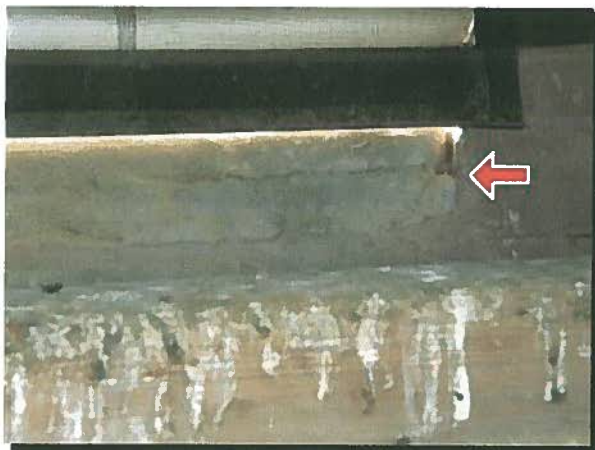
E. Picture 21 Deterioration is all way to interior.

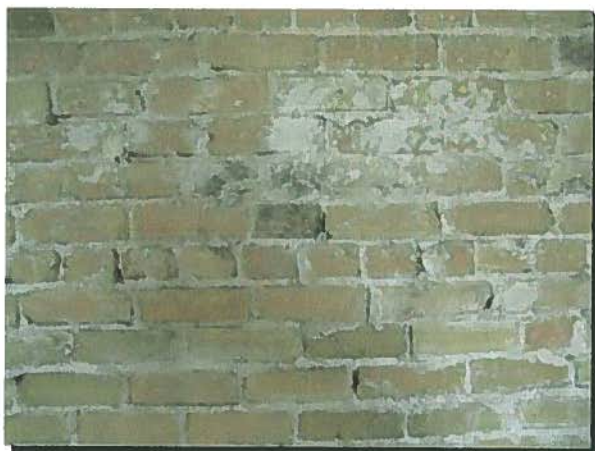
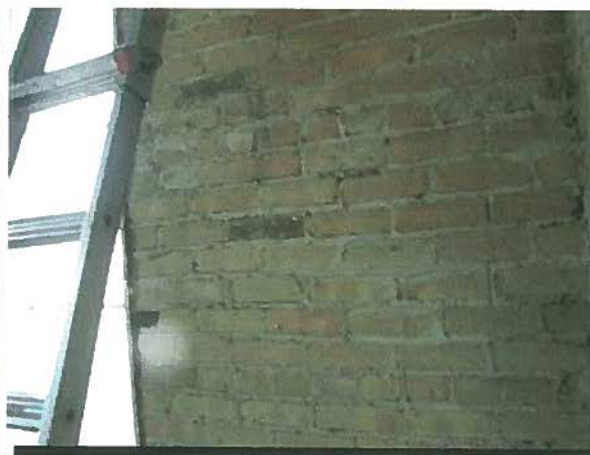
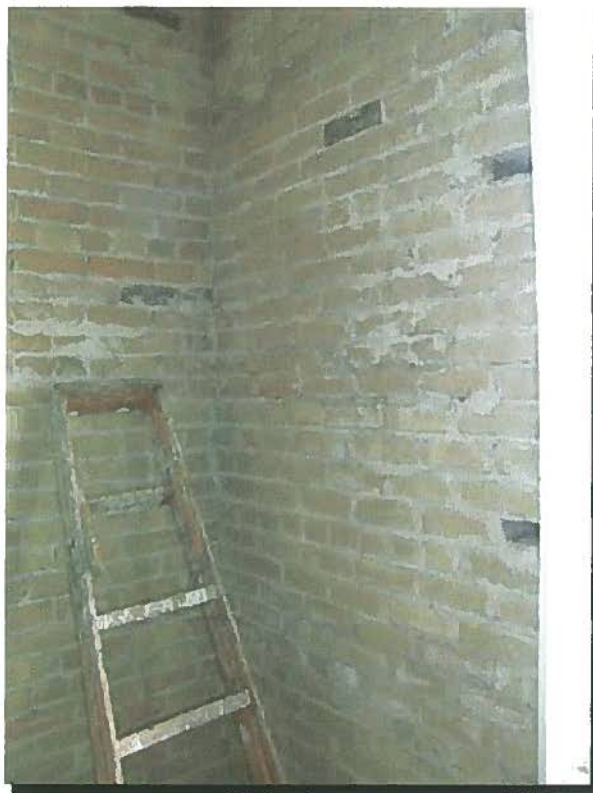
☒ Interior walls of towers have decaying brick mortar, there are signs of structural shift and there is no horizontal support present. An licensed structural engineer should evaluate these towers for structural integrity, and determine if structural upgrades are necessary. Internal wood or steel truss systems and/or lattice work may be recommended, but cannot be determined by an inspector.

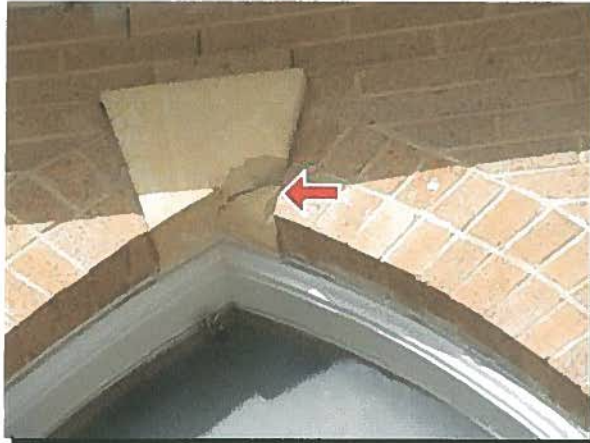
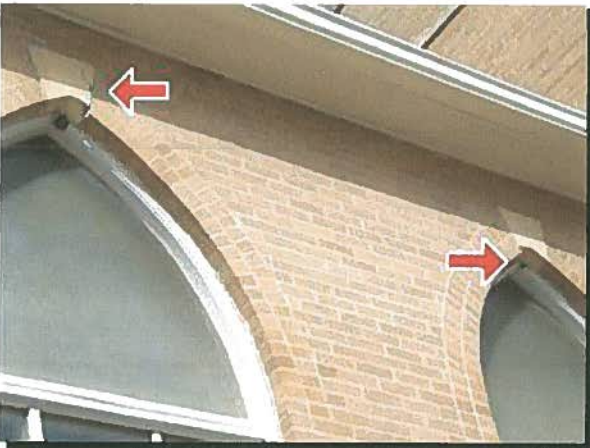
☒ Keystones above windows are damaged, with a few showing evidence of structural shift. Repair needed.

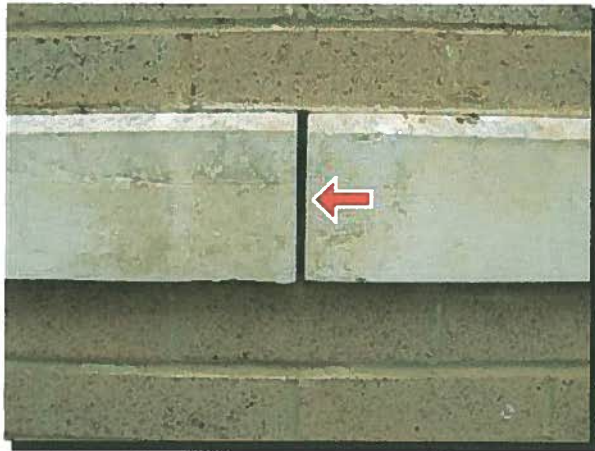
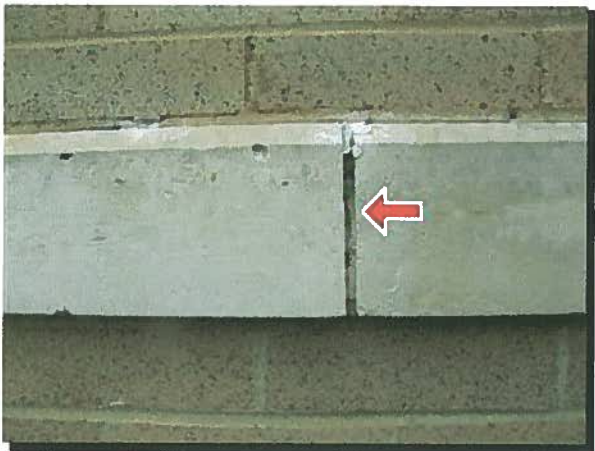
☒ All exterior siding butt & transitional joints that have separated more than 1/8" should be re-sealed (caulk and paint) to prevent moisture incursion

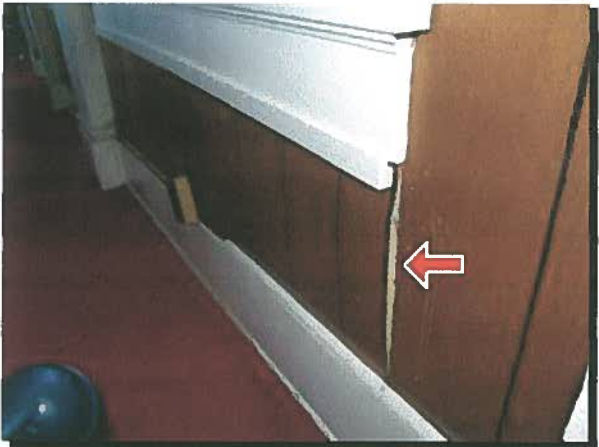
E. Picture 39

☒ Interior basement and congregation walls exhibit signs of water incursion. See drainage and roofing section for recommended upgrades to prevent further incursion, damage.

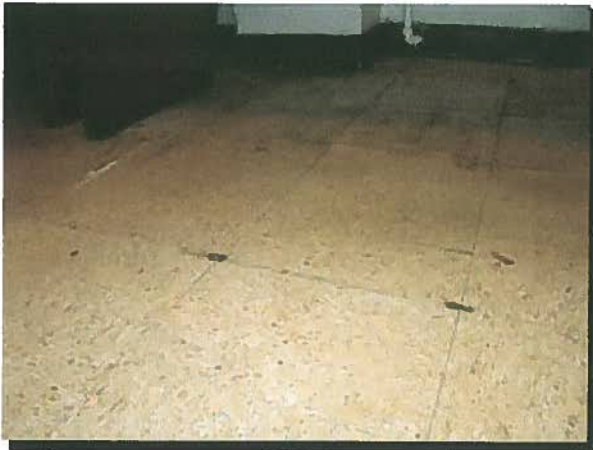
F. Picture 1 Lifted tiles.

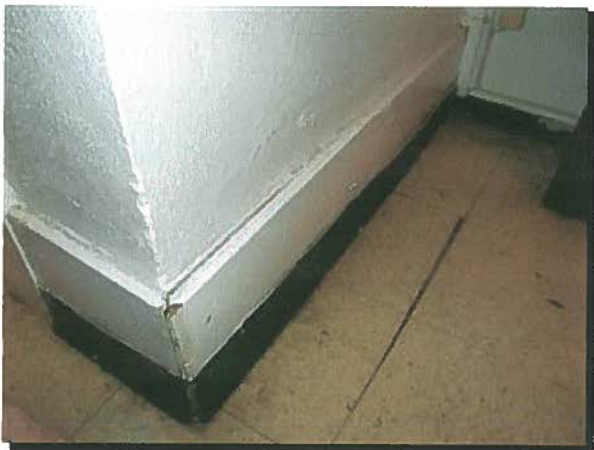
F. Picture 2 Loose tiles.

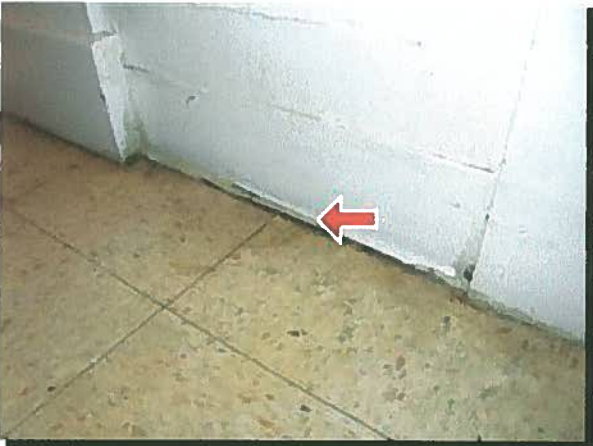
F. Picture 3 Water damage at basement walls.
