# **JOLLYVILLE TRANSMISSION MAIN: Environmental Commissioning Monthly Report**

Presented to the Austin Environmental Board  
April 4, 2012

# Jollyville Transmission Main Project Status

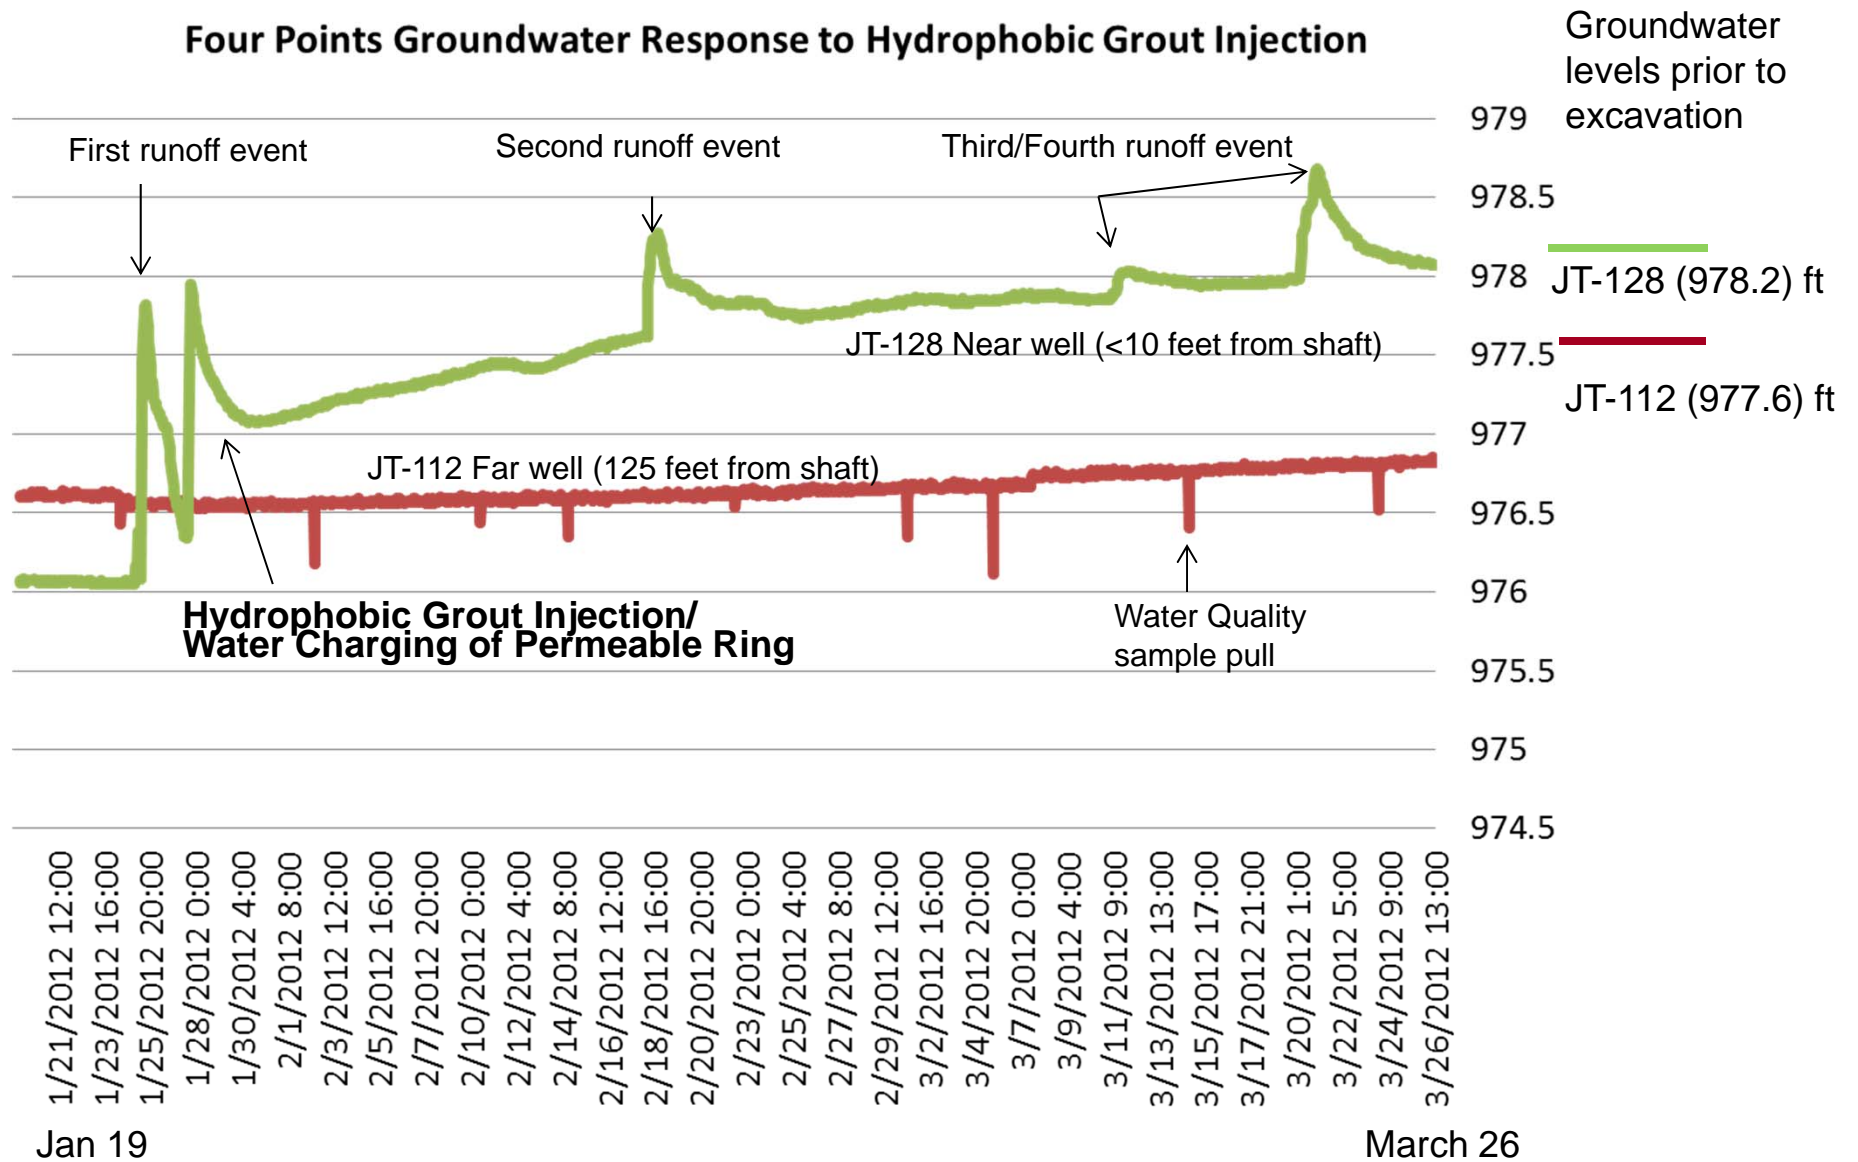
## Four Points Groundwater Response to Hydrophobic Grout Injection

Near well (JT-128) shows recovery to 978.1 ft MSL (within 0.1 ft of pre-excavation level); Far well (JT-112) to 976.8 ft MSL (within 0.8 ft of pre-excavation level)

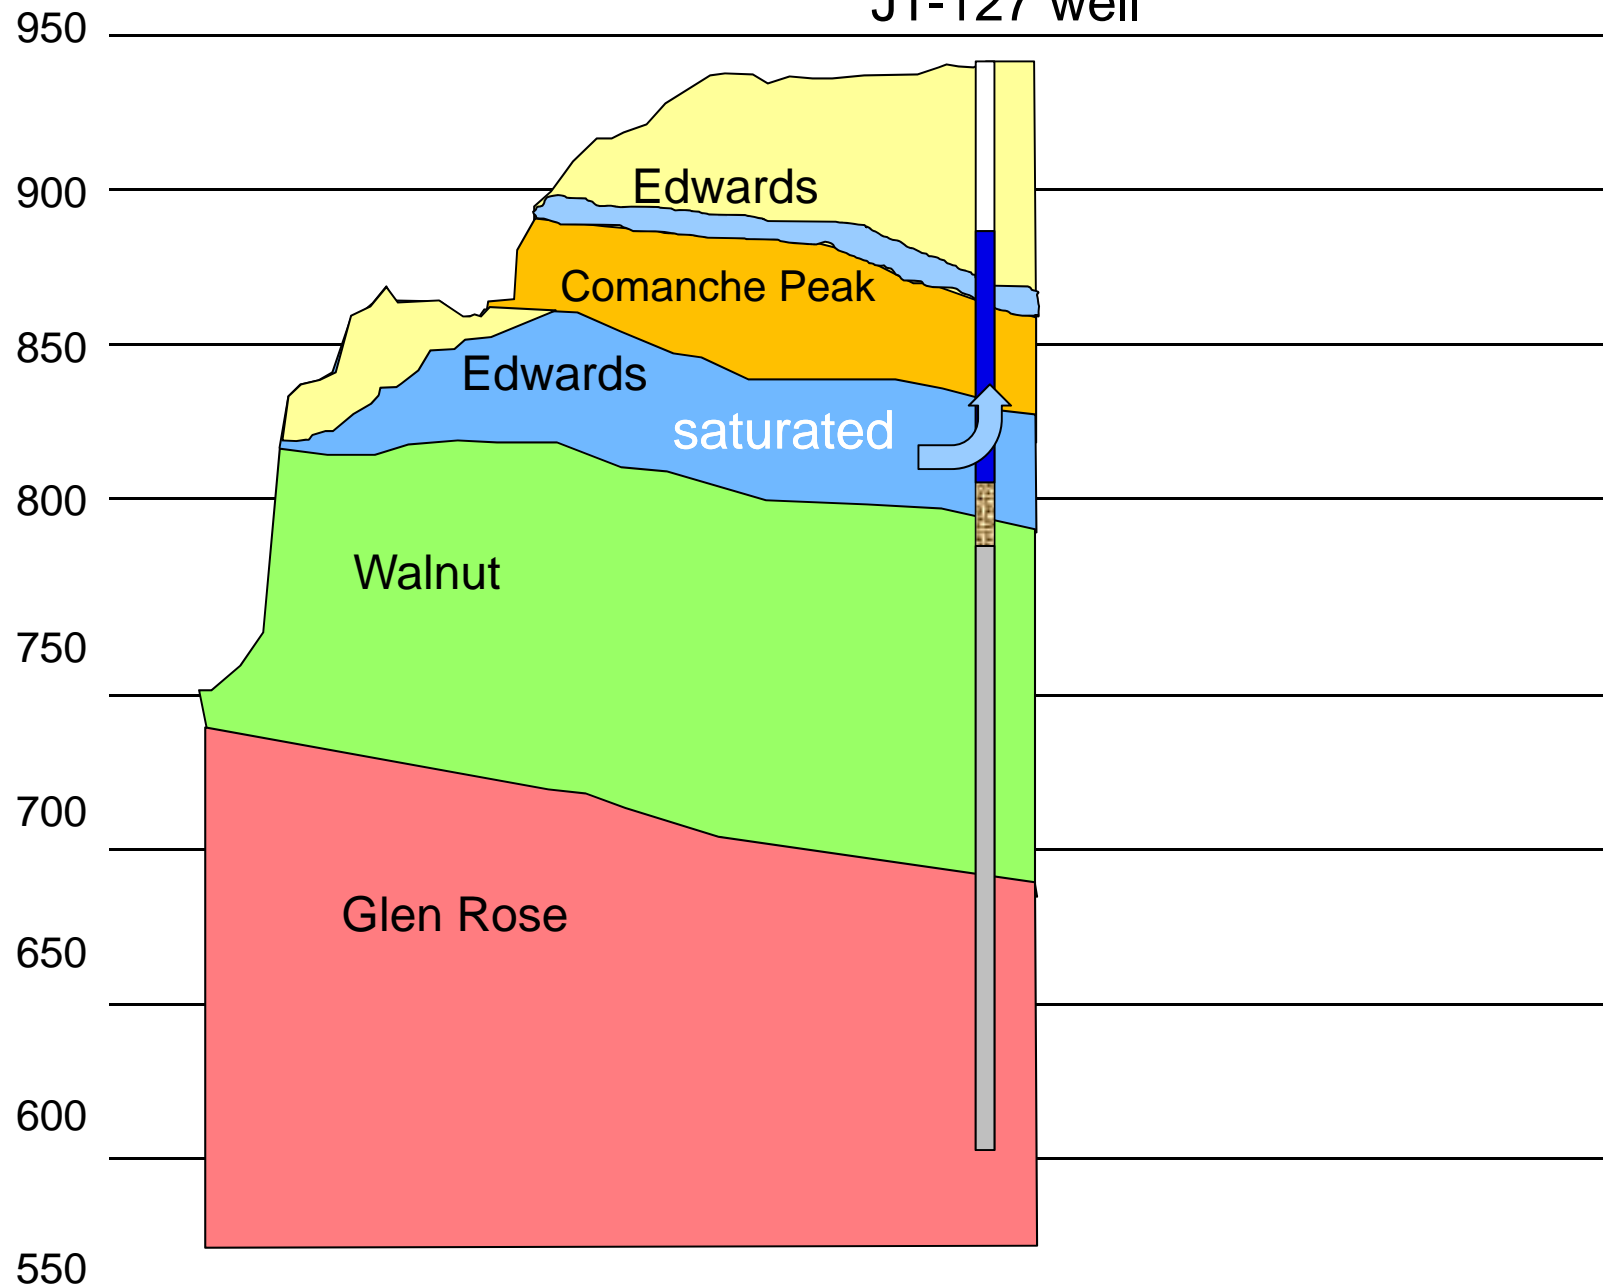
# JT-127 well

Issue	Resolution
Rapid drop in JT-127 groundwater level	Analysis underway. Possible explanations include Comanche Peak formation operating as a confining layer, resulting in pressure drop when Comanche-Edwards contact mined through.

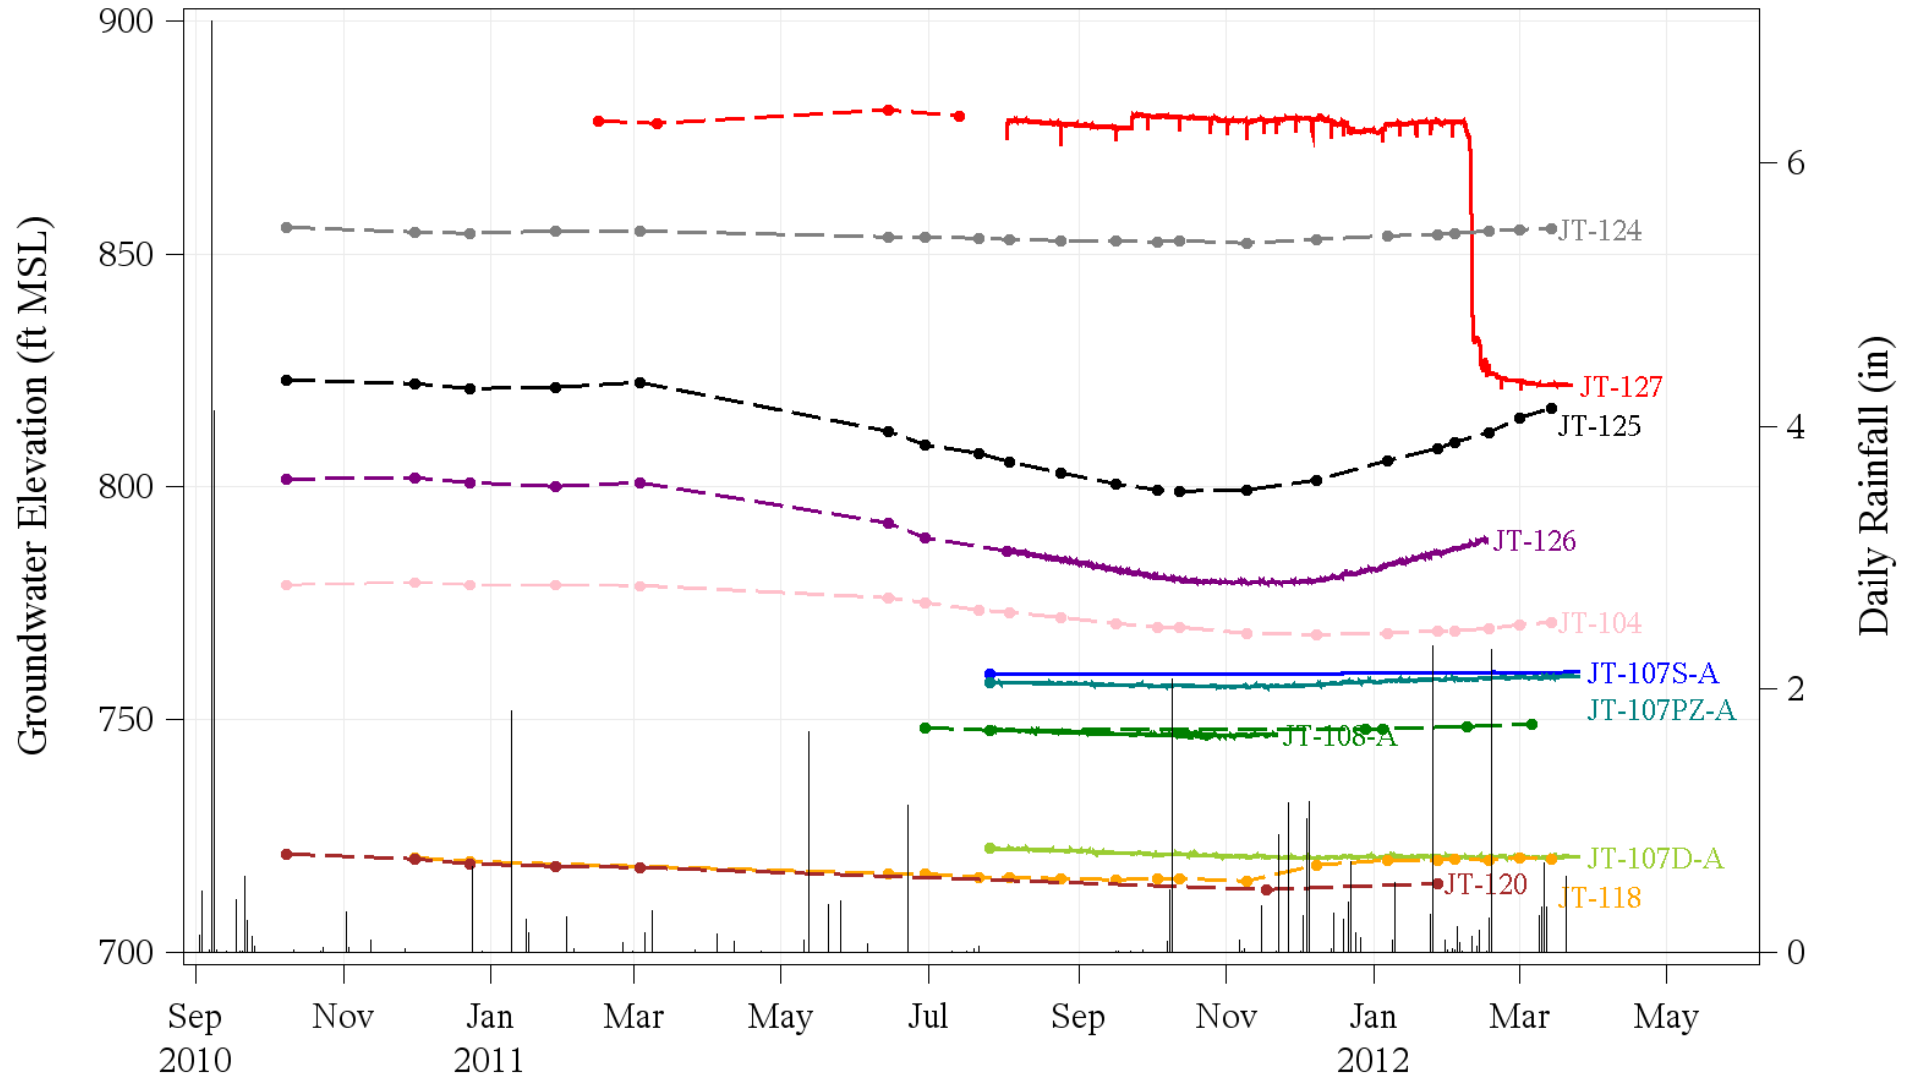
# Hydrographs for Eastern Area

- The water-level recoveries observed in Glen Rose wells JT-125A and JT-126 are not a result of recharge from precipitation events in late 2011 and early 2012 through the Edwards.

- The water-level changes of several feet observed in Glen Rose wells within and immediately east of the BCP could not have transmitted through the Glen Rose to produce the much larger (greater than 20 ft) water-level changes observed in Glen Rose wells JT-125A and JT-126.

- The water-level declines and recoveries observed in Glen Rose wells JT-125A and JT-126 do not indicate greater hydraulic conductivity in the Glen Rose than was measured using packer tests.

- The observed differences in water-level elevation and magnitude of change during 2011 and early 2012 between the Edwards and Glen Rose wells indicate relatively poor hydrologic connection between the Edwards and the Glen Rose.

- The pumping of irrigation wells at golf courses in the vicinity of the eastern end of JVTM appears to be a plausible cause for the water-level declines observed in Glen Rose wells JT-125A and JT-126 in summer 2011 and the subsequent recoveries after pumping cessation.

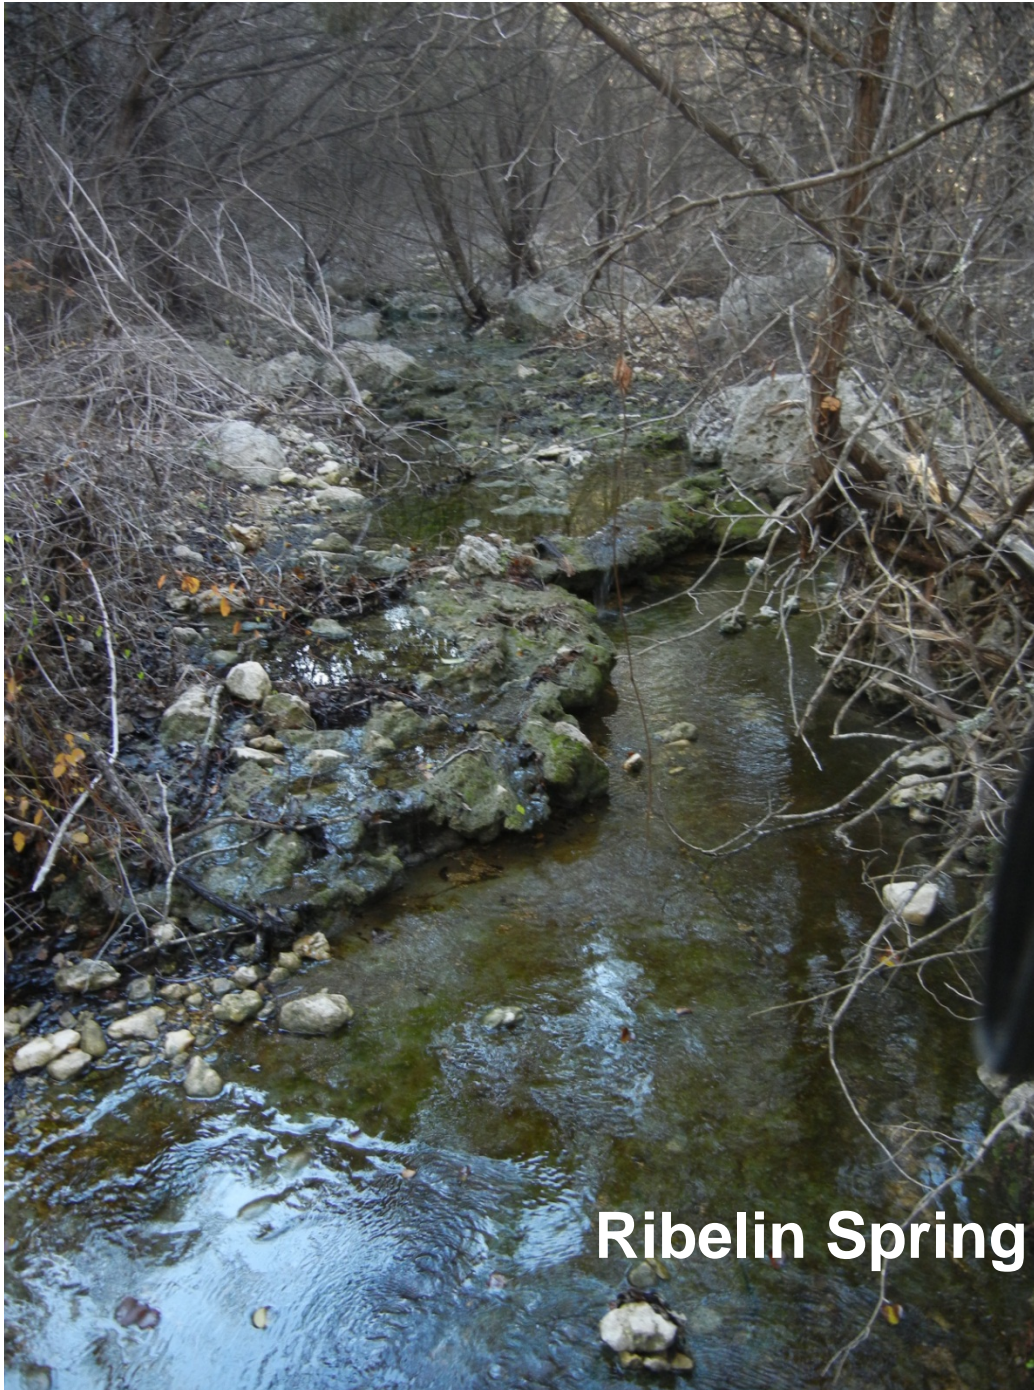
**Ribelin Spring**

- All springs and stream reaches flowing
- Water quality parameters within expected range
- Nondetects for indicators of mining, vehicular operation, and drilling (TPH, Cu, Cr, Zn)
- Background Screening for phthalates from hydrophobic grout injection at Four Points (JT-112 and Gaas Spring) negative. Will continue screening on weekly basis.
