**PARKS & RECREATION DEPT.**  
**URBAN FORESTRY PROGRAM**  
**TREE EVALUATION FORM**

Location: ROW / COA property / Parkland Property address: 2100 Barton Springs Rd  
 Date: 6-13-12 Inspector: Lara Schuman

DBH: 53.5" Species: Pecan

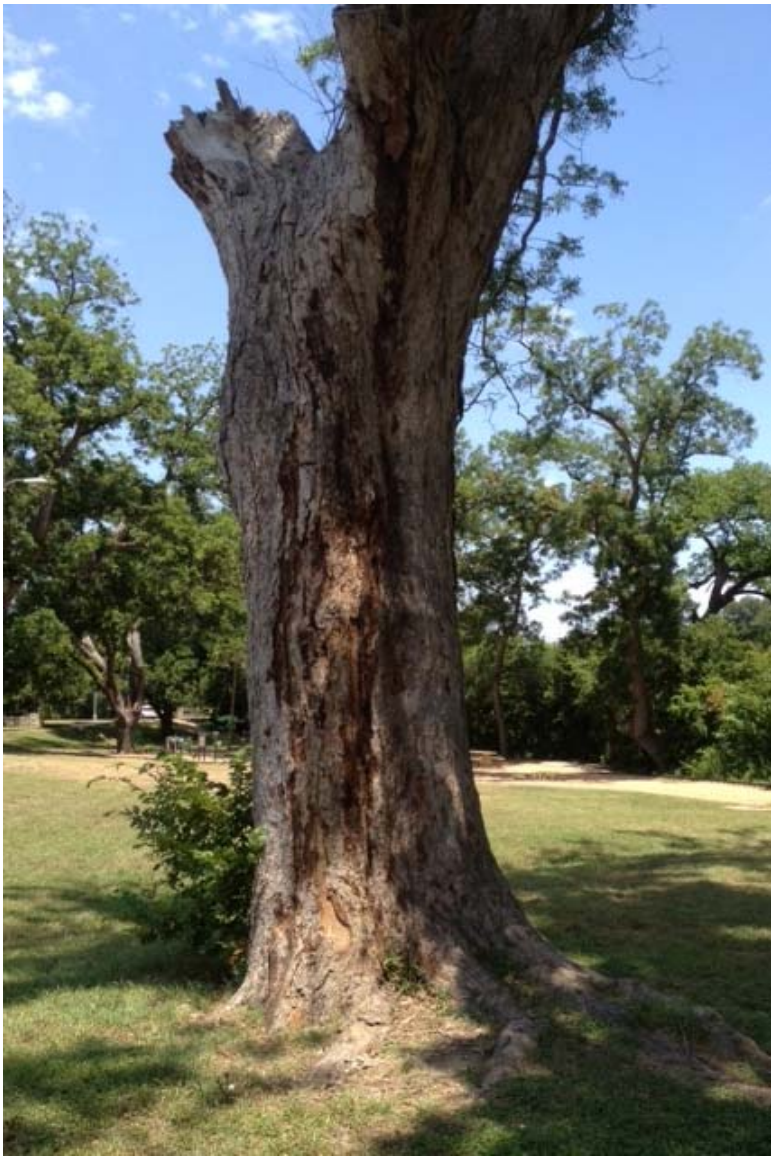
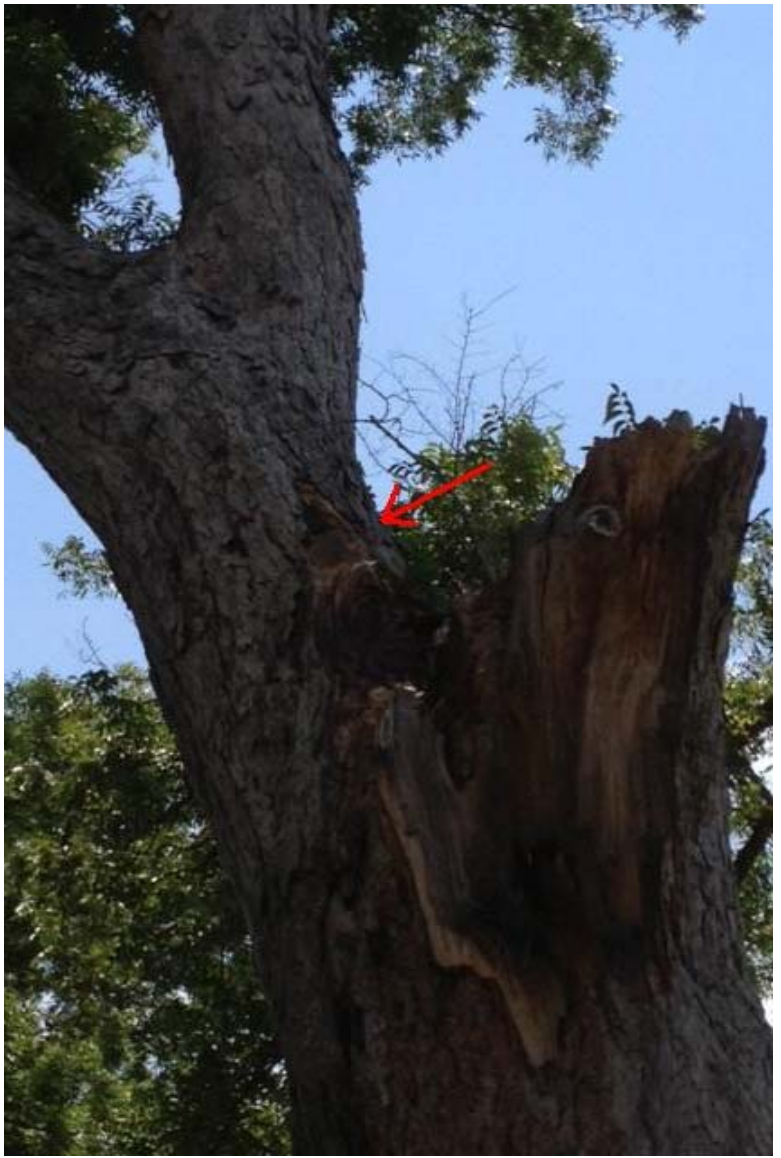
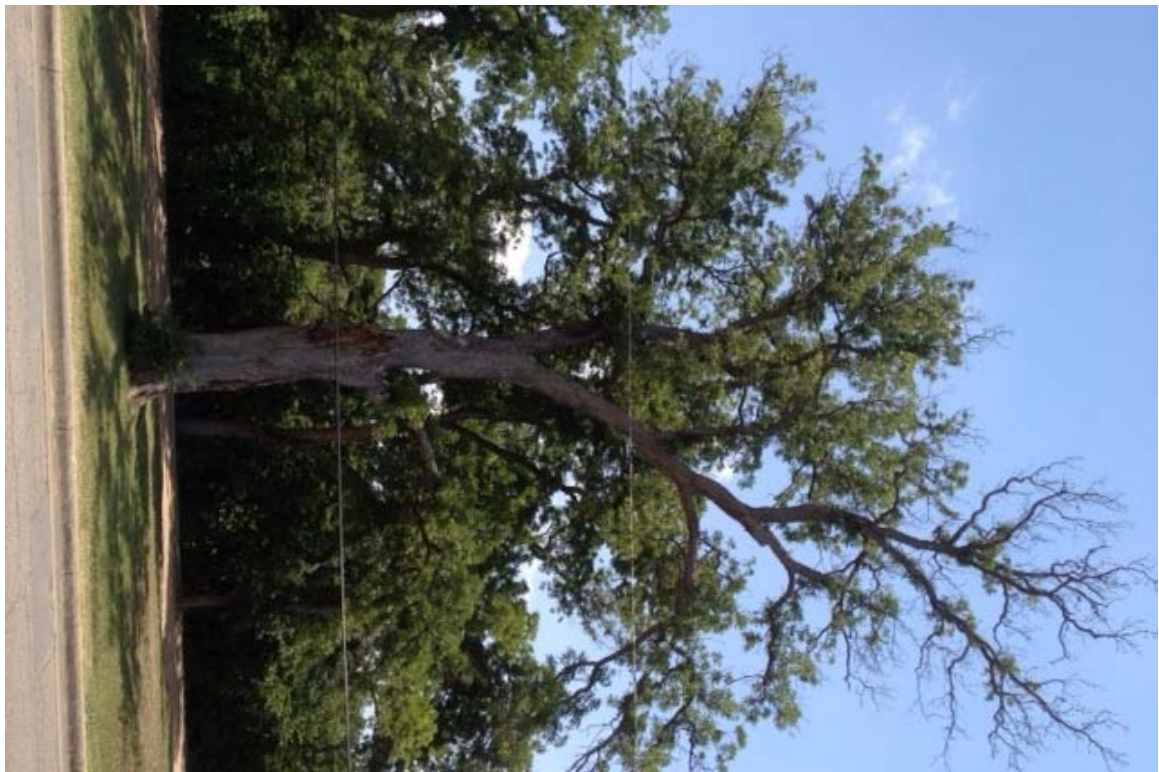
| Defect | Root crown | Trunk | Scaffolds | Branches | Other notes |
|---|---|---|---|---|---|
| Codominants/forks | | | ✓ | | <u>This co-dominant scaffold has already failed</u> |
| Cracks/splits | ✓ | ✓ | ✓ | | <u>There is a horizontal crack at the base of the main scaffold</u> |
| Cankers/galls | ✓ | ✓ | ✓ | ✓ | <u>Hypoxylon throughout tree<br/>Failed right at trunk/scaffold crotch</u> |

Comments: The majority of the remaining live growth of this tree is on the scaffold with a horizontal crack at its base and is over the zilker train

Action: prune / remove
