Re: City of Austin Urban Forestry Board Recommendations for Locating  
Art in Public Places (AIPP) and Related Structures near Trees

RE: Brush square Oak, by o Henry and suzanna Dickinson museum

The purpose of this report is to evaluate the health and vigor of the live oak and overall impact of the site changes 2 years prior over the critical root zone. These include the installation of 2 historic buildings infringing on the critical root zone and an art patio work infringing in half the critical root zone.

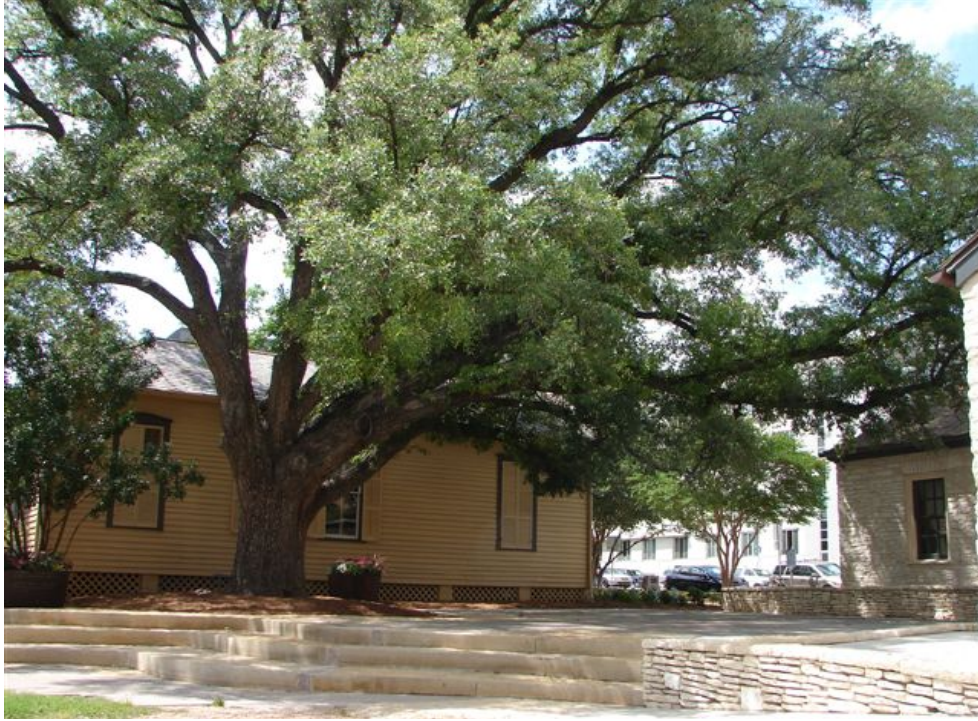
The Brush Square heritage live oak was impacted by the installation of the AIPP Stone Courtyard built in 2010. In the attached tree permit the City Arborist described the general condition of the tree as good; now the tree is declining and needs remedial work to prevent the additional decline that is expected to occur if corrective measures are not implemented in the near future. Please refer to the attached Tree Assessment Report from certified arborist Vincent Debrock, Heritage Tree Care. Mr. Debrock explains that the 44-inch-diameter live oak shows pale leaves and a thin canopy (70% of original density), but no signs of problems caused by insects or other tree-related diseases. The stone courtyard (the AIPP artwork) extends over a large portion of the root zone of the tree, reducing water availability to the roots with the significant impervious cover from the concrete, stones, and grade changes.

Site visit performed on Monday May 7<sup>th</sup>. *Quercus fusiformis*. DBH of 44". Half of critical root zone has a radius of 22 ft. Foliage is smaller and paler than nearby trees. Top half of the canopy is showing thinning estimated at 70% of its original density. No significant insect or disease impacts were observed.

Brush Square Heritage Live Oak Showing Thinning Canopy and Pale Leaves

The extensive site changes since 2009 are impacting the overall health of the tree. We expect more gradual decline in the coming years if corrective measures are not implemented. These measures should strive to provide a healthier root system. These can include a combination of several elements:

- Root wells through the changed grade and stone patio area
- Soil improvement with compost and mulch
- Compaction remediation and prevention with airspade and incorporation of 1' layer of sand and 1" layer of compost through the available critical root zone.

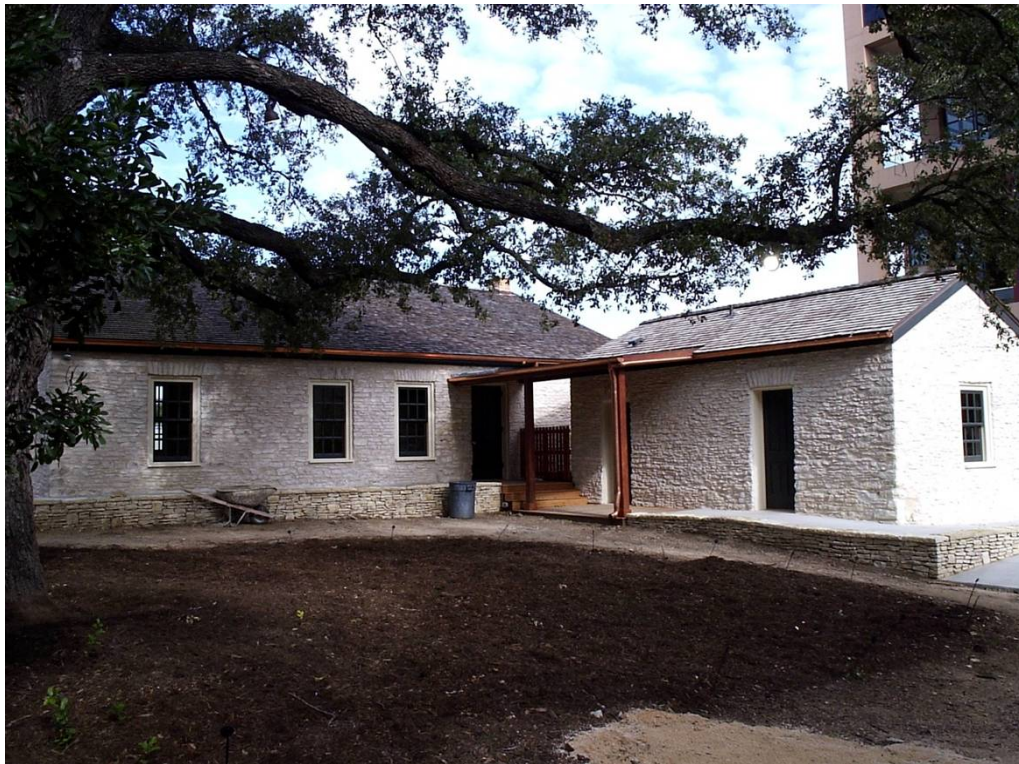
Original Grade before Courtyard Installation

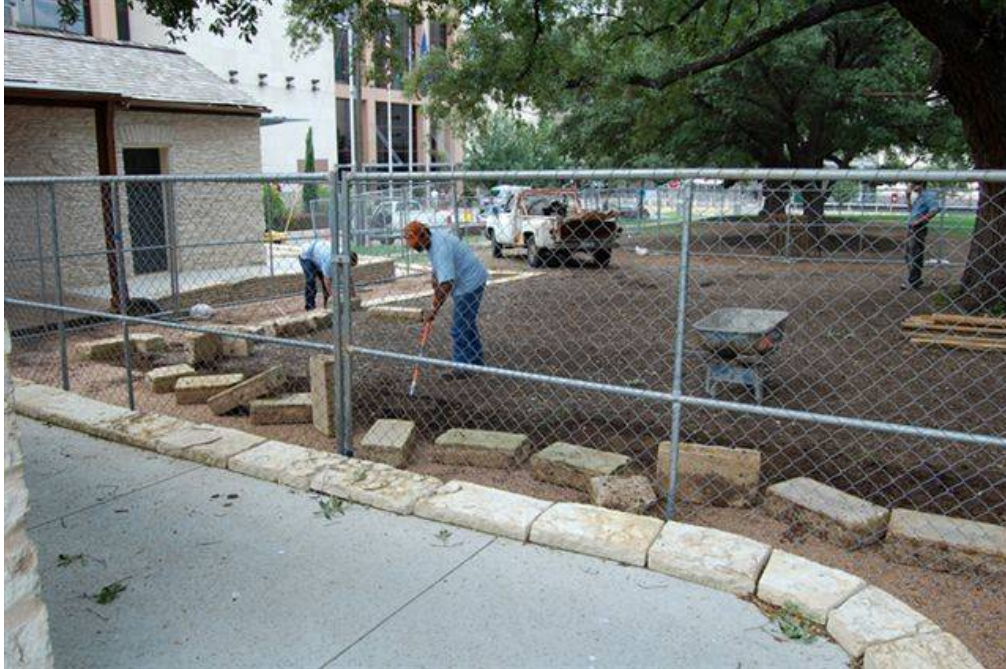
8 photographs provided by the museum curator showing the construction process. Grade changes are larger than 8 inches through a significant area of the CRZ. The patio coverage is made up of thick limestone slabs tightly juxtaposed with marble slabs. Joints are approximately 1/8 ". No information has been provided regarding root zone impact and mitigation actions during the project other than these photos.

Grade Was Raised Significantly in 2010 over CRZ of Brush Square Tree

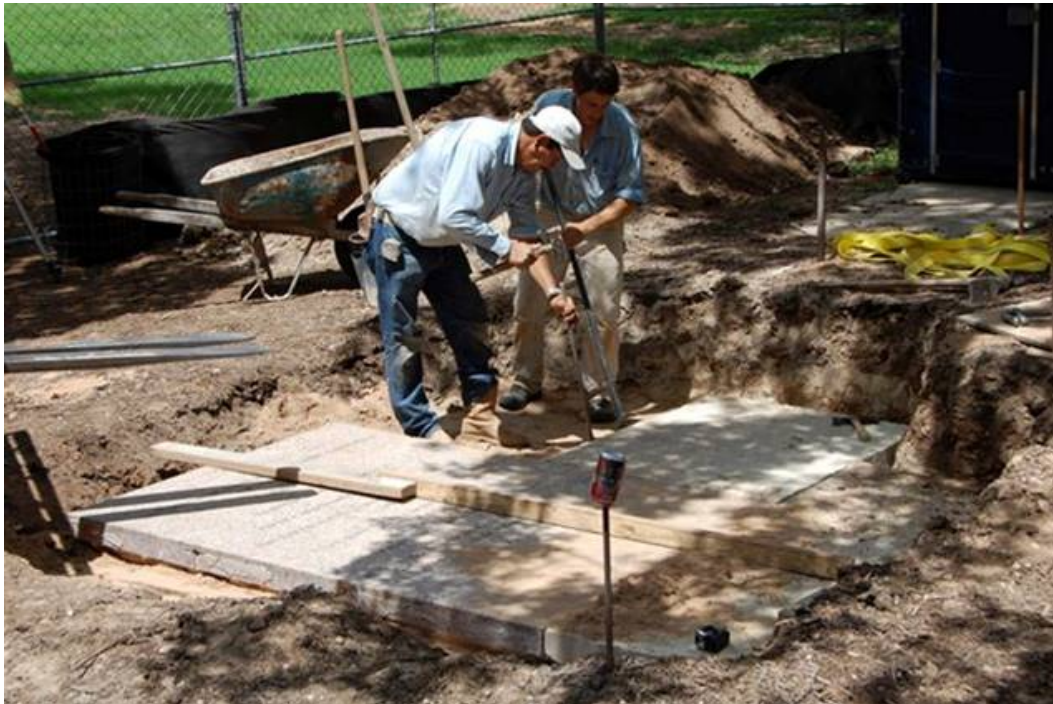
The tree permit that was approved by the City Arborist (attached) for this work required that no cut or fill work be done within the inner one-half of the CRZ. It was intended that the root zone be protected from machinery and trucks to avoid soil compaction. The City Arborist and the Parks and Recreation Department (PARD) recall that the artist, as well as the AIPP-overseeing staff, agreed not to dig within that inside half of the CRZ and that no roots would be cut. However, photographs show that there was significant digging (more than 2 ft. deep) within that area. In addition, the grade was raised by several inches through a significant portion of the CRZ. A large amount of fill was added over the compacted soil, and a significant part of the root zone was covered with impermeable heavy stone; making it very difficult, if not impossible, for the roots to get water. The resulting 1/8-inch spacing between the stones is too small to allow the passage of sufficient water. The decline of this tree demonstrates that these roots

Large Deep Hole Dug within  $\frac{1}{2}$  CRZ of Brush Square Tree  
(7 ft. From The Trunk. Tree Is To The Right)

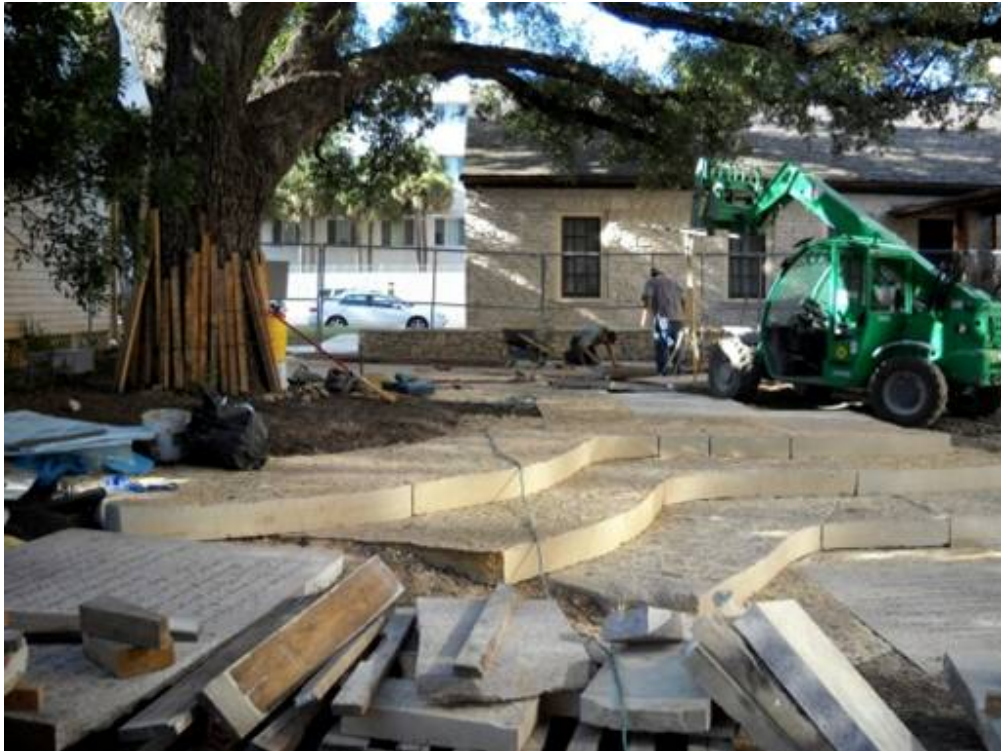
have been affected by all of this work. While the record breaking drought and heat of 2011 affected many trees, the adjacent live oaks are not showing signs of stress, which suggests that the impact of construction, which violated the terms of the tree permit and best practices in tree care, is the primary cause of the leaf yellowing and thinning canopy. Photographs are attached, and you will note that machinery and trucks are shown working within the root zone of the tree.

## Machine within CRZ of Tree Compacting Soil

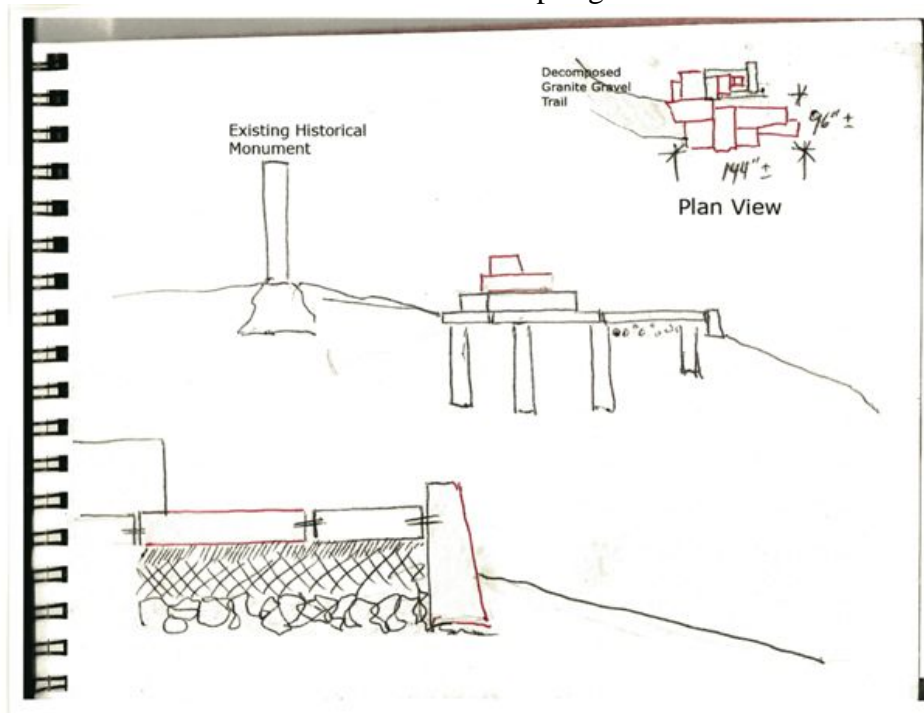
The second case brought to our attention is the heritage pecan on the south lawn of Barton Springs Pool. Artwork was to be installed within the CRZ of this tree in spite of PARD recommending numerous times over several months that it not be done. The installation of an overlook to serve as a base for the artwork required digging within the CRZ of this tree over a large area, but no certified arborists, landscape architects, or engineers were involved in the design. The artist submitted several sketches of the installation (attached). Acting PARD Forestry Manager Angela Hanson explained during a public review meeting that heritage trees are already stressed by drought and does not recommend having artwork installed within their CRZ if that artwork or its installation may cause a permanent impact to the CRZ and she recommends that AIPP projects conform to applicable tree protection rules. It was not until more than 40 concerned citizens protested against this artwork at a public meeting, that it was moved from underneath the tree canopy and located outside the pool fence.

Artist's Sketches for Overlook Construction within CRZ of Heritage Pecan Tree  
In South Lawn of Barton Springs Pool

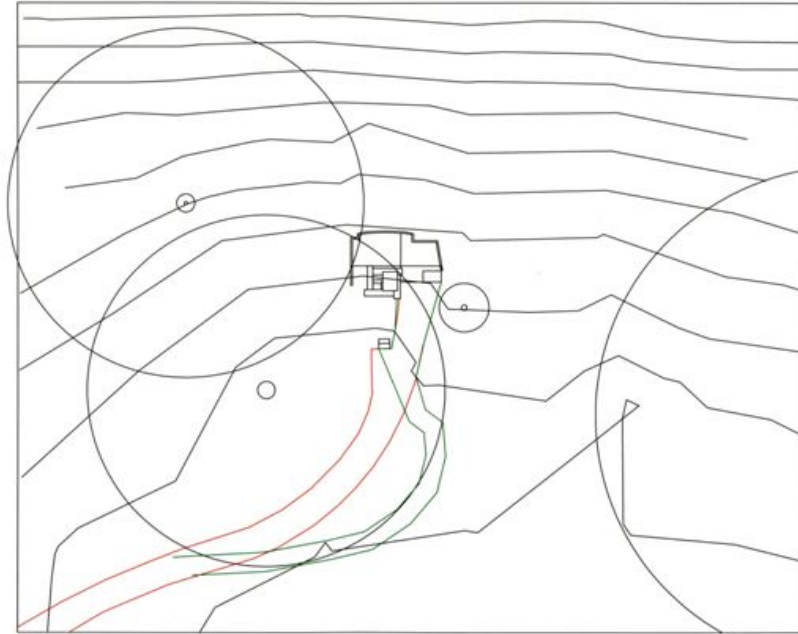
Artist's Plans to Install Overlook, Artwork and Path within CRZ of BSP Tree

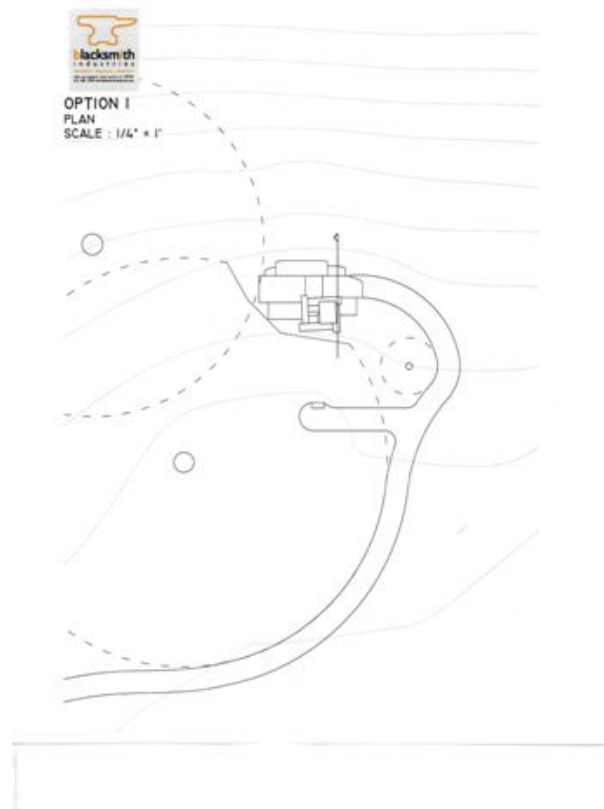
Another Version to Install Overlook, Artwork and Path within CRZ of BSP Tree
