HISTORIC LANDMARK COMMISSION
APRIL 22, 2013
CERTIFICATE OF APPROPRIATENESS
LHD-2013-0004
3805 Avenue H
Hyde Park Local Historic District

PROPOSAL

Reroof a contributing house using asphalt dimensional shingles.

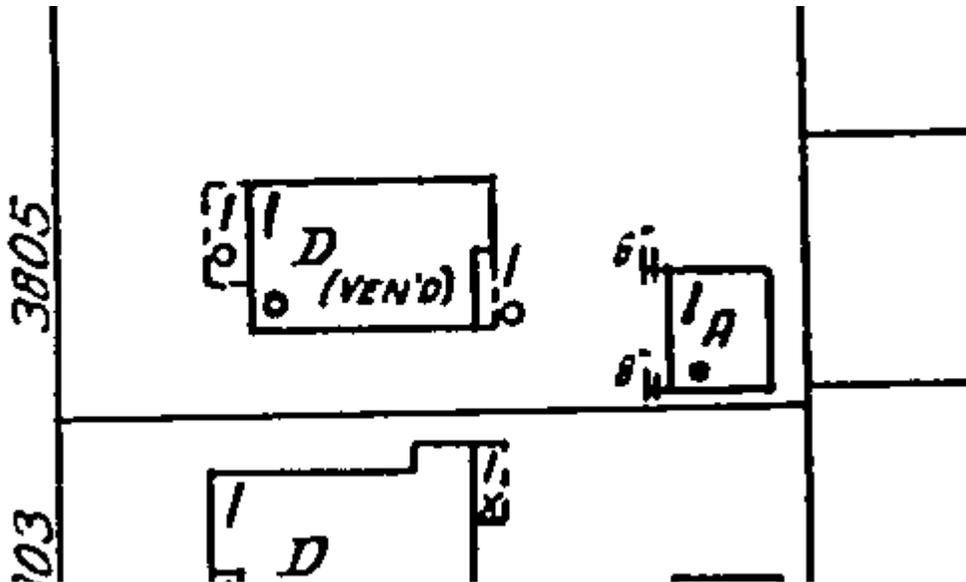
1935 Sanborn Map

Indicates a one story, brick veneered dwelling with non-combustible roof covering of metal, slate, tile or asbestos shingles.

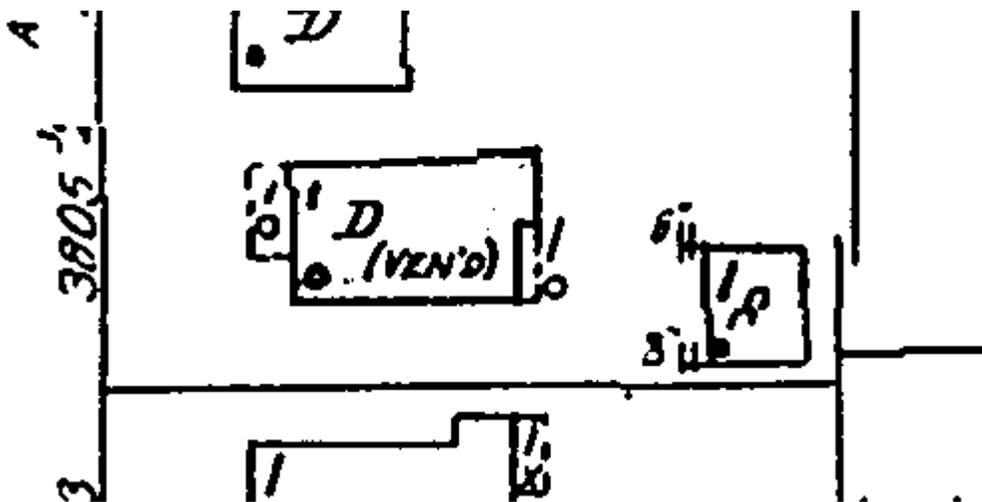
1961 Updated Sanborn Map

Indicates a one story, brick veneered dwelling with non-combustible roof covering of metal, slate, tile or asbestos shingles.

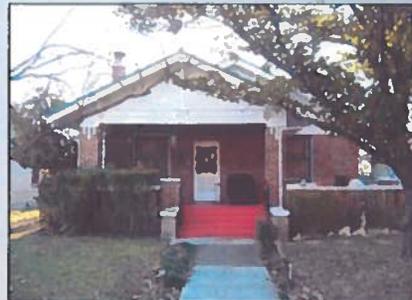
Existing Roof

- **Petrographic analysis**
 - Roof is a concrete tile system with a polymer-modified coating on the exterior surface (green color)
 - Unconsumed cement materials were observed within the concrete tiles

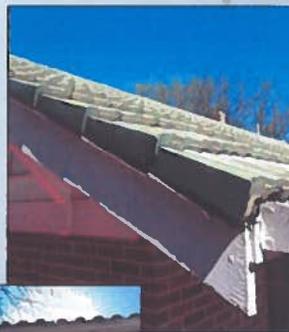
Existing Roof

- **Inspection and structural review**
 - Damaged and missing tiles
 - Lack of integration between tiles and vertical surfaces
 - Significant damage to interior gypsum wallboard at roof and walls caused by roof leakage
 - Deteriorated wood structure within attic space
 - Multiple applications of sealing materials at exterior of roof

- **Roof replacement and wood fascia repairs**
 - Currently causing structural damage and deterioration of original interior finishes
 - Homeowner's insurance requires replacement within 30 days after purchase
 - Must be completed before installation of new finishes to prevent water damage
- **Complete kitchen and bathroom renovation**
 - Currently not in a serviceable state
 - Must be completed before move-in on March 1, 2013
