# **JOLLYVILLE TRANSMISSION MAIN: Environmental Commissioning Monthly Report**

Presented to the Austin Environmental Board  
May 7, 2014

## JTM Current Status as of 4/9/14

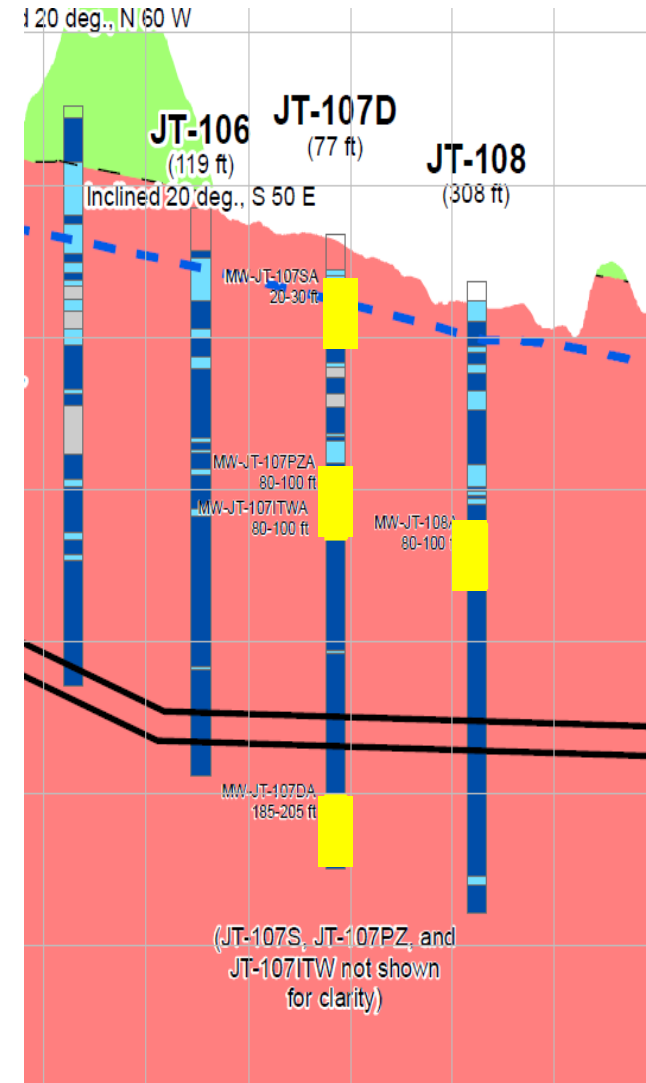
- decline (~8 feet) in deepest well as tunnel passes with stabilization after rain
- small decline in PZ-A (~3 ft) with some recovery after rain
- no decline in 107S-A.

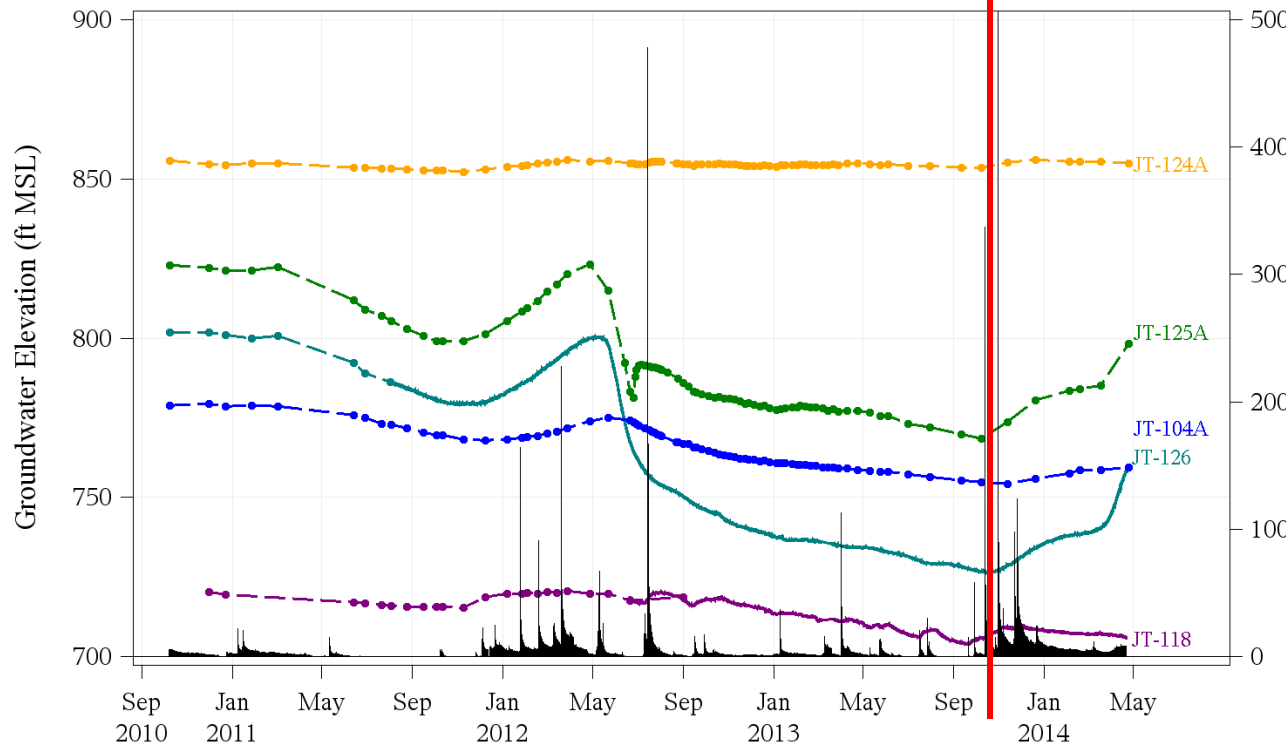
Hydrographs for Wells JT-104A, JT-118, JT-124A, JT-125A and JT-126

- Reach 3 excavation complete, pipe laid, and grouted.
- Most wells saw an uptick after October rain events (excluding 127, not pictured), but grouting also occurred at this time, so the two events are confounded.
- Groundwater levels in JT-125A and JT-126 appear to be recovering as CLSM is being poured in the JR shaft.

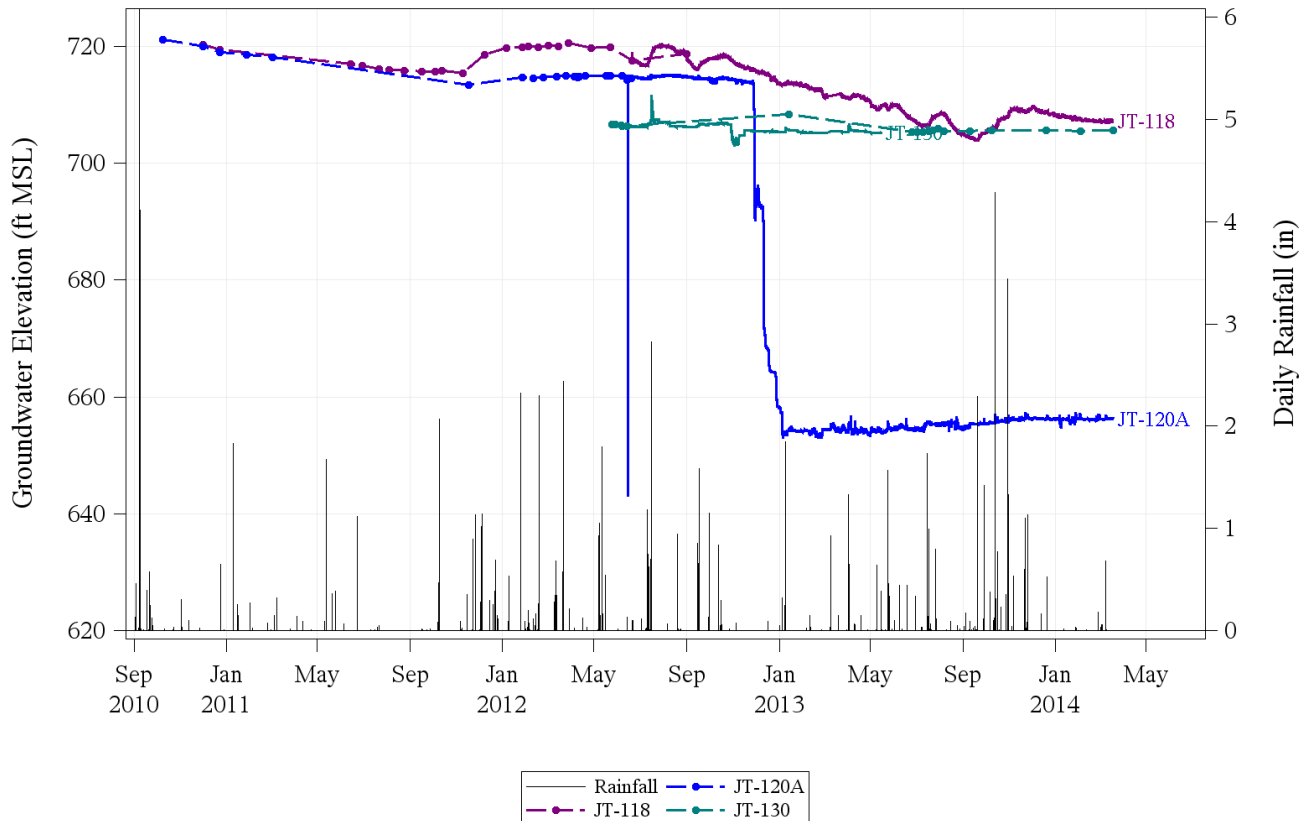
Hydrographs for Wells JT-118, JT-120A and JT-130

- JT-120 (adjacent to shaft) water level at bottom of screen
- JT-118 declines influenced by shaft and responsive to rainfall
- JT-130 relatively flat

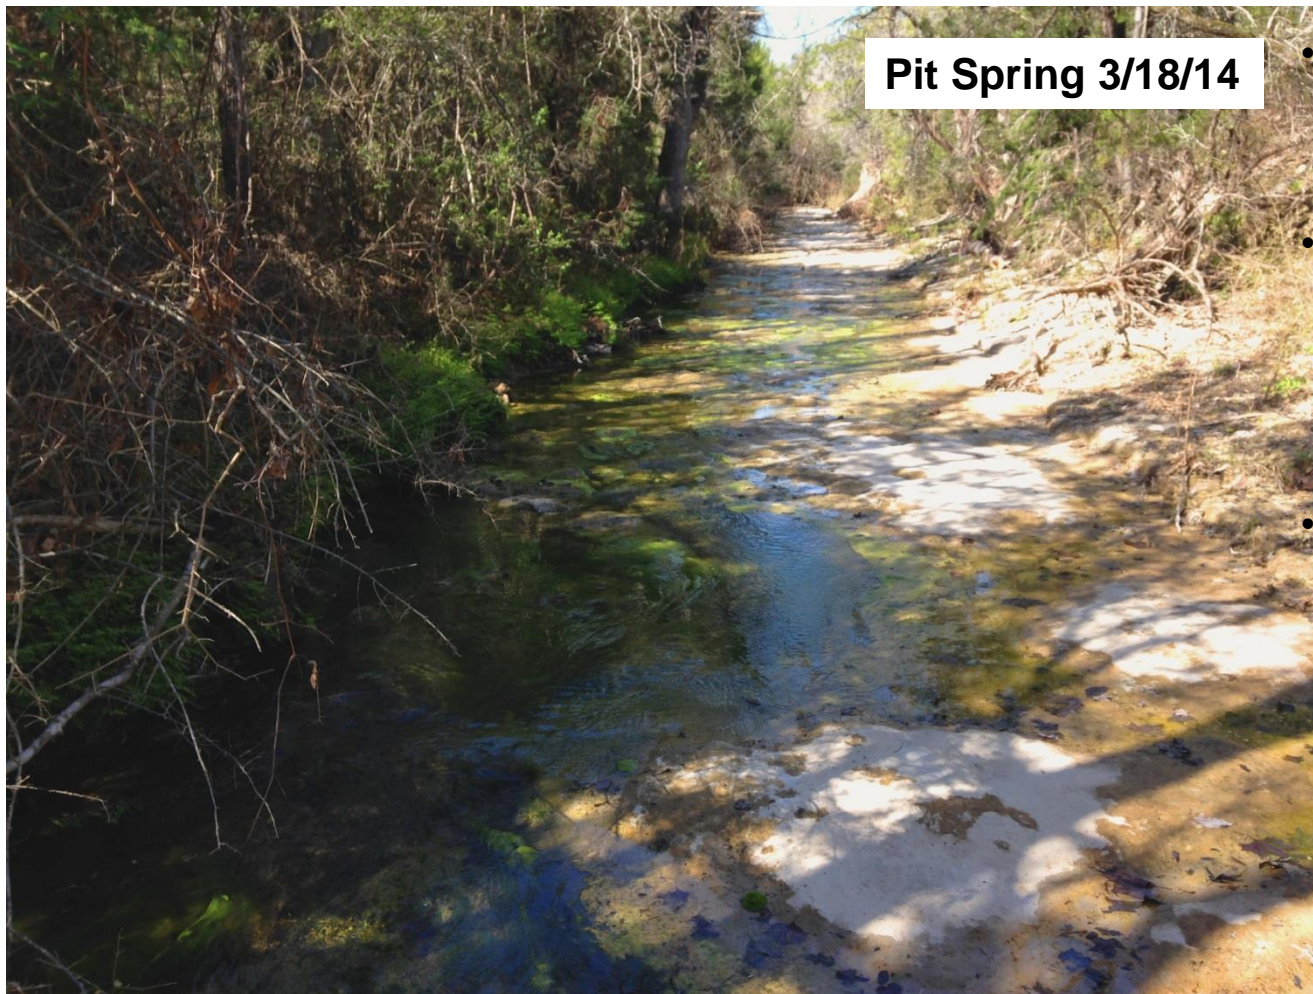
**Pit Spring 3/18/14**

- Main stem of Bull Creek and all springs flowing at normal levels
- Nondetects for indicators of mining, vehicular operation, and drilling (TPH, Cu, Cr, Zn)
- Nondetects for di-n-butyl grout compounds in JT-112, Gaas spring

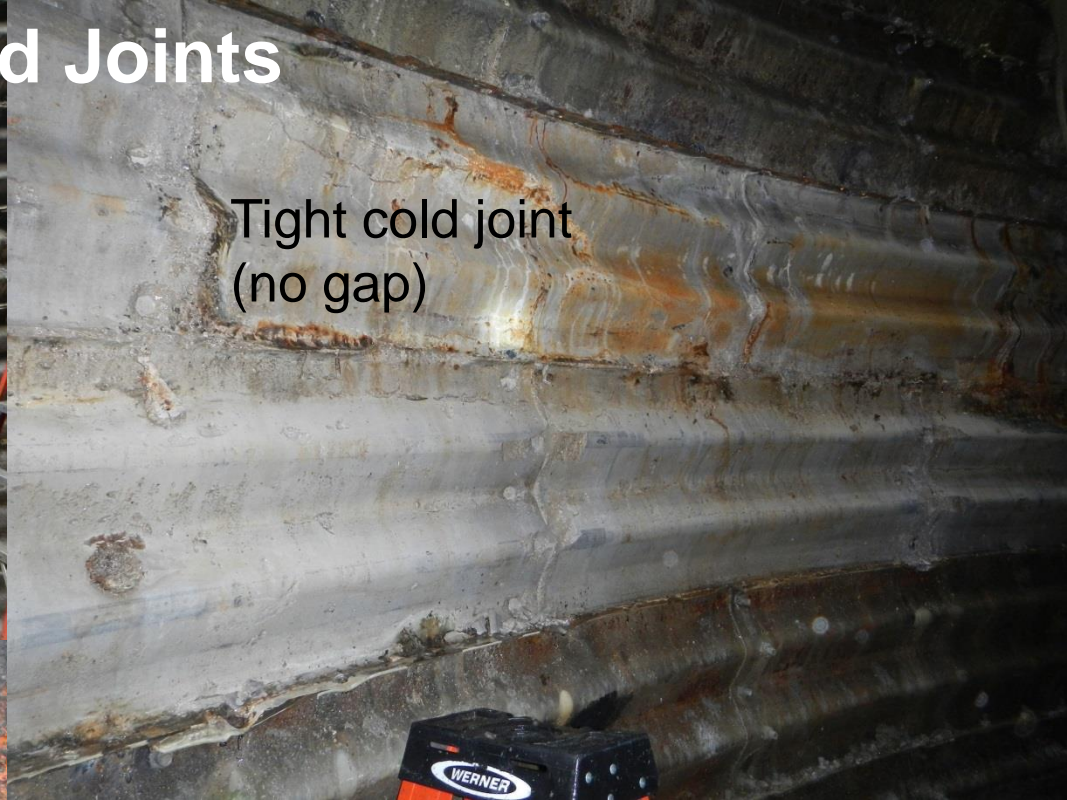
Tight cold joint  
(no gap)

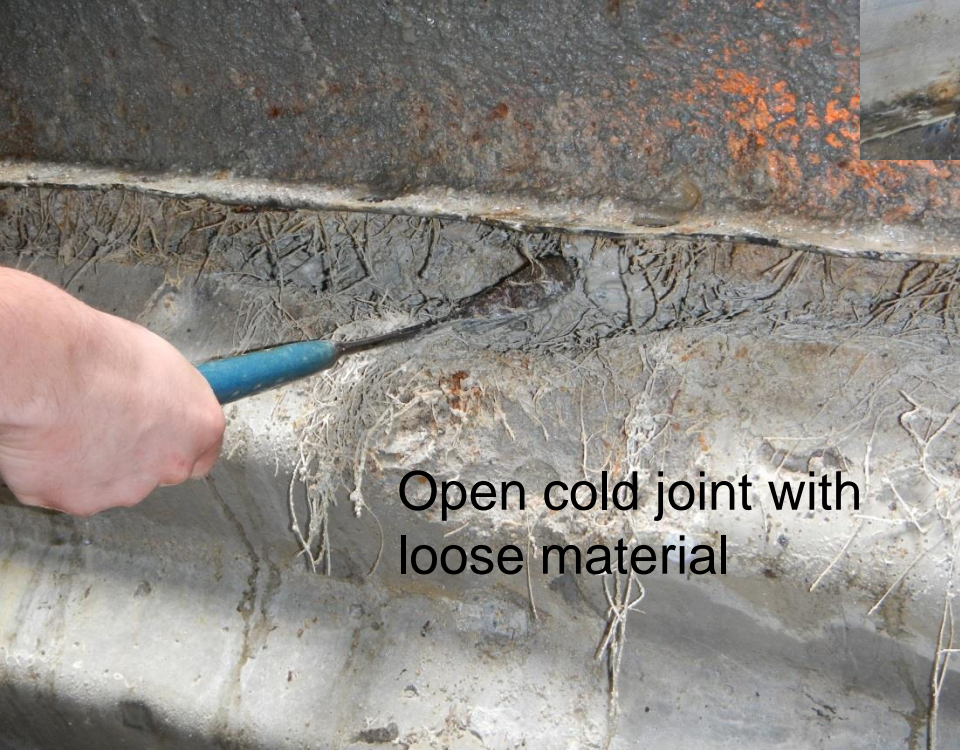
Open cold joint with  
loose material

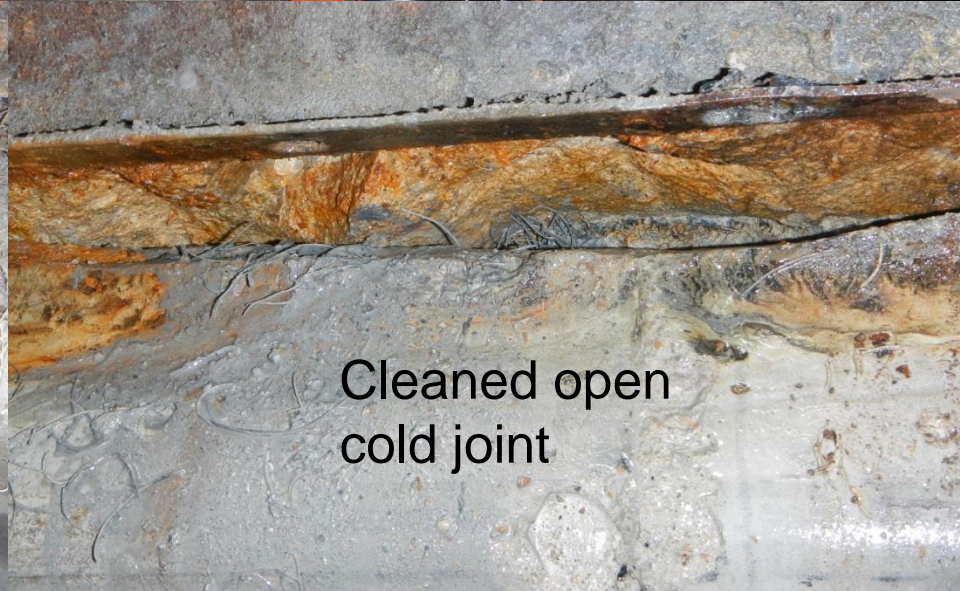
Cleaned open  
cold joint
