Late Backup
SPARKS ENGINEERING, INC.
STRUCTURAL EVALUATION, DESIGN AND TESTING

**SUBJECT: Initial Structural Assessment
3805 Red River**

RE: 3805 Red River; Case C14H-2014-0007

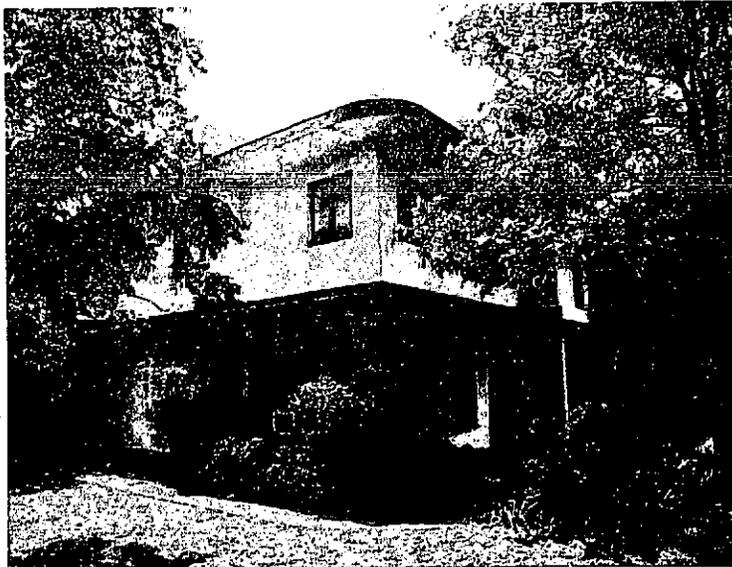
Figure 1 House at 3805 Red River.

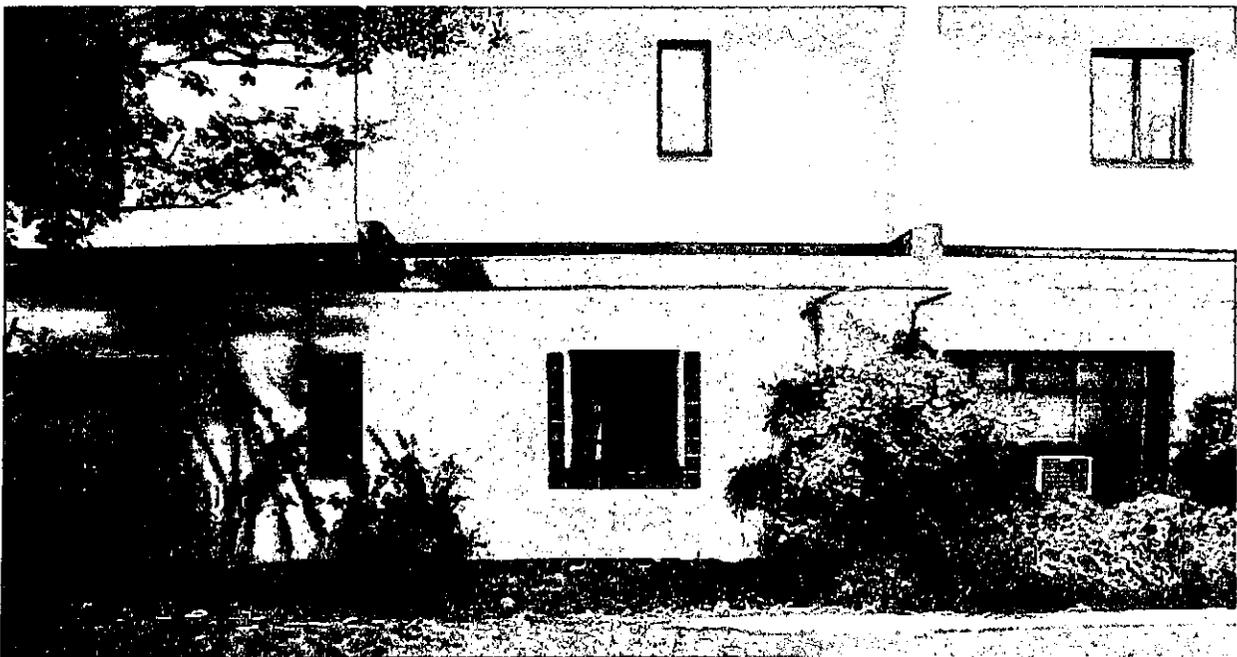
Figure 3 North elevation view of the house. There are no structurally significant cracks in the exterior load-bearing walls.

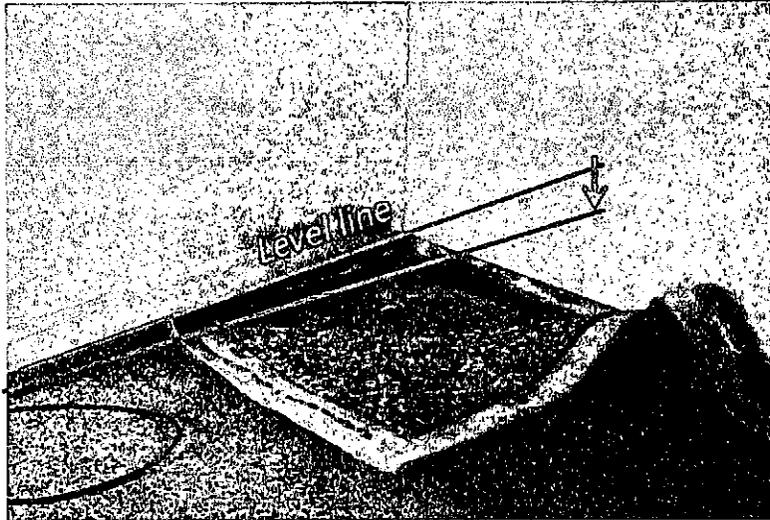
In my opinion, the structural foundation is not damaged, nor is the house unsafe as asserted in the report by Mirza Tahir Baig, P.E. of Professional StruCIVIL Engineers, Inc. dated May 19, 2014. Contrary to Mr. Baig's conclusions, the house is structurally stable. The exterior walls do not need to be underpinned. The interior floor slab can be replaced without disturbing the load-bearing exterior walls.

Figure 4 The interior floor slab is not supporting the exterior load-bearing walls, as seen here where the floor slab has settled independent of the walls.

4. Replace all first floor concrete slabs, sidewalks and drives with engineered concrete.
5. Replace the wood treads, risers, and bent plywood cap at the exterior stairs to the second floor in the back yard – this is a standard maintenance item. More durable alternative materials could be considered for this work without significantly compromising the architectural integrity of the property.
