Cottonwood Tree Removal at Barton Springs Pool

Joint Committee Notification Ar

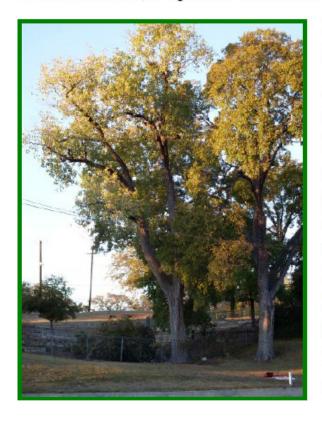
Cottonwood, Populus deltoides

Risk Rating: 8

Size: 48" DBH, 45-60' Height

Age Class: Over-mature

Crown Class: Co-dominant

Notes: codom at 30 ft near drainage large shallow roots beyond

Site Summary: cement drainage and turf

Root Summary: good ratio near trunk, fair@dripline, bigger roots near dripline

Soil/Foliage Summary: sandy & clay; minor dieback in crown

Radar Summary: Lowest percent average solid wood: 49% at 1 foot,

overall average Mattheck score: 0.638

Maintenance Recommendation: Prune – Crown Clean, possible removal.
