PROPERTY INSPECTION REPORT

Concerning: 1901 EXPOSITION BLVD, AUSTIN, TX
(Address or Other Identification of Inspected Property)

By: Nev Nicholson, Lic #272 03/24/2015
(Name and License Number of Inspector) (Date)

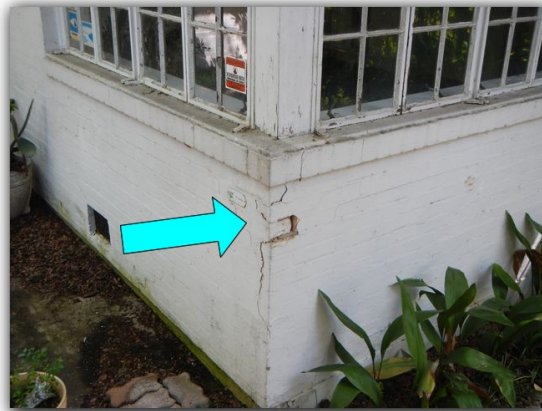
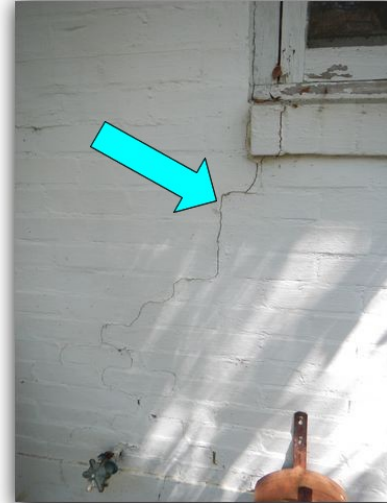
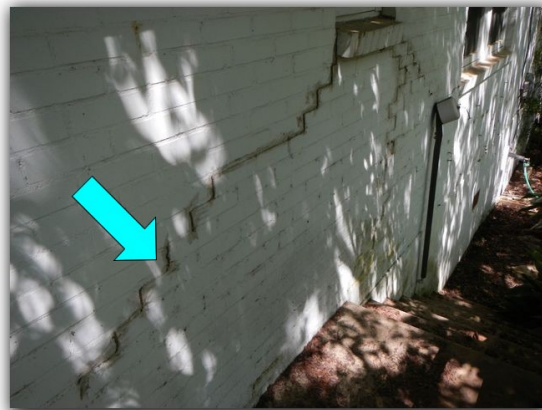
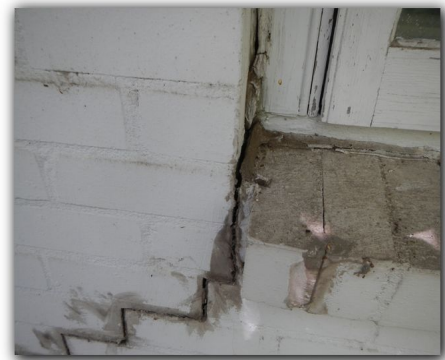
- **Cracks in exterior brick** at all sides of the Home are evidence of structural movement.

- **Repairs to cracked masonry** to be made following Foundation repairs.

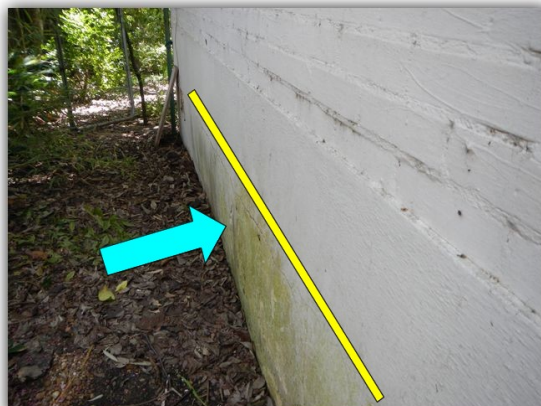
- **The Grade Beam** at the north side of the Home (below left) near the rear corner bulges outward and has a horizontal crack due to movement.

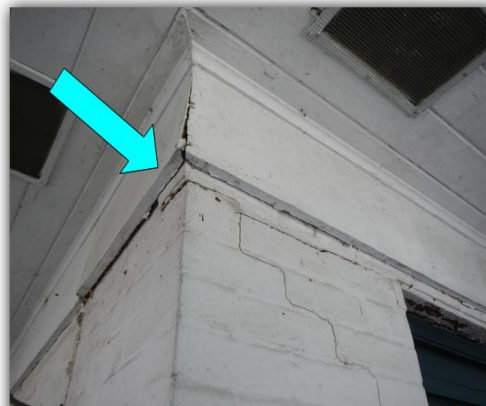
- **Separation of Frieze Board trim** at the corners of the Home (above right) is also indicative of Foundation deflection.

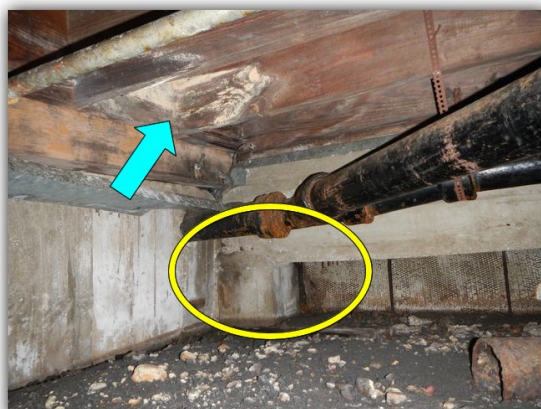
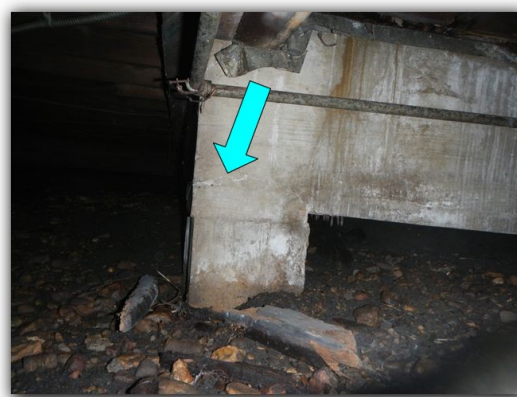
- **Cracks can be seen between Beams and Piers** in the Crawlspace (ringed in left photo, and arrow in right below)

- **Rotting Joists at the front wall of the north Bedroom** (arrow in left photo above) are a result of leaking plumbing at the laundry hook-ups in the rear of the adjoining Breakfast Room.

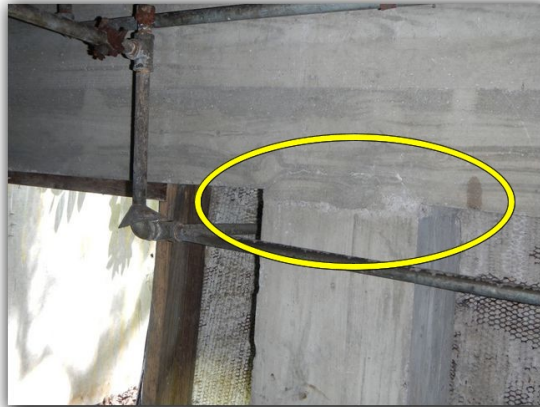
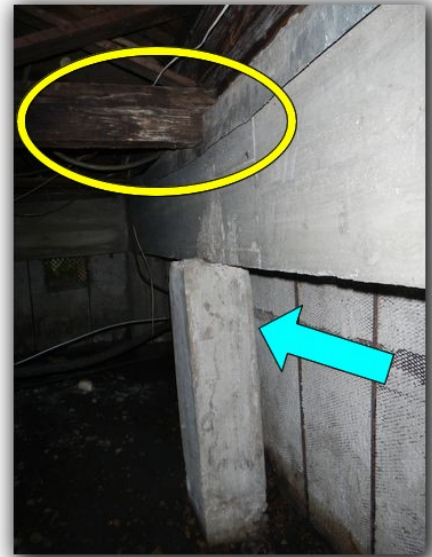
- **Shear crack at a Pier** to the right of the Crawlspace Entry at the rear east wall (left photo above).
- **Another Pier** to the right of the Crawlspace Entry (right) has separated from the underside of the Beam and is almost completely rotated out from under it!
- **Joist ends above** (ringed in same photo) are rotted.
- **A Structural Engineer** should be hired to carefully assess the viability of the Foundation and determine what repair options are needed.
- **The high moisture levels in the Crawlspace** have resulted in organic growth on the Joists. This is a pre-cursor to dry-rot in the Floor Structure.
- **Junked Heating parts** in the Crawlspace (below) need to be carefully, and responsibly, removed. Some of these contain Asbestos Insulation.

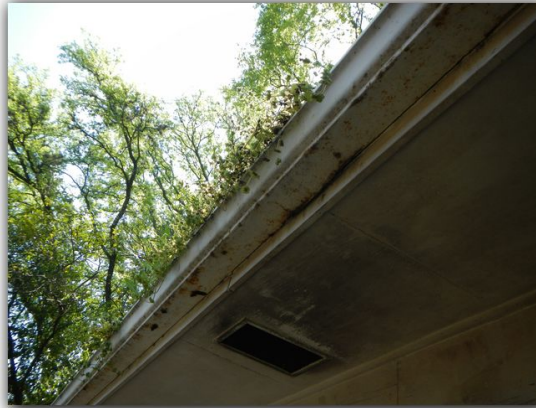
- **Negative Sloping of Lot** toward the front of the Home has resulted in Foundation Movement and a saturated grade in the Crawlspace.
- **A Sub-Surface Drainage System** will need to be installed across the front of the Home. This will involve a Pump device to push fluid from run-off and ground water to daylight and a suitable location.
- **Guttering at the Carport** is rotted (photo). it will need to be removed for the reconstruction of the spoiled Eaves here.

- **New Guttering** to be flashed to Eaves.
- **Spouts to extend clear** of the Carport Slab.
- **No Guttering currently on Home's** Eaves. Recommend this be done as part of Drainage corrections here.
- **Front Spouts may flow onto** Sub-Surface Drain system, but not connect directly to it!
- **Rear Spouts** to be extended clear of Foundation with flexible Hoses.

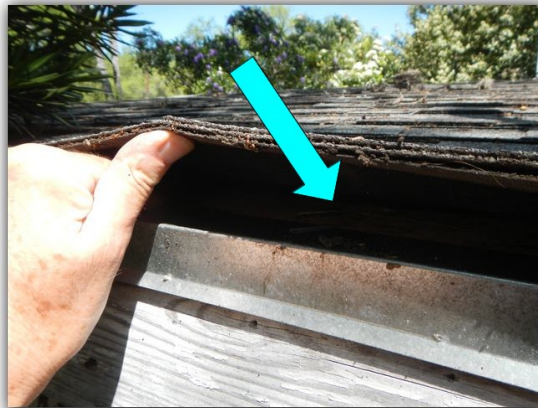
- **The installation of the Roof Covering is sub-standard** and the Roof is Leaking as a result.

- **Low-Sloped Roof like this requires 2 Layers of Felt** Underlayment, or similar product. This Roof has but one layer of Felt that does not reach the Eaves. This has resulted in decayed Eaves.
- **The Copula on the Kitchen Roof** (below right) has been heavily sealed at its edges with asphalt cement in an attempt to stop leaks here. As has the Copula at the main roof (left)

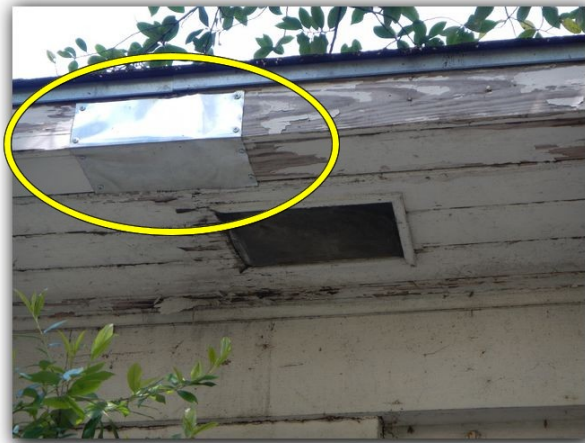
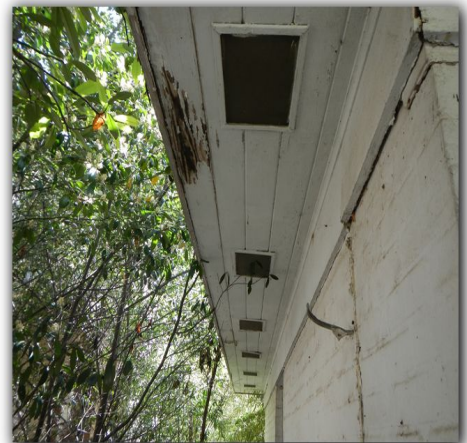
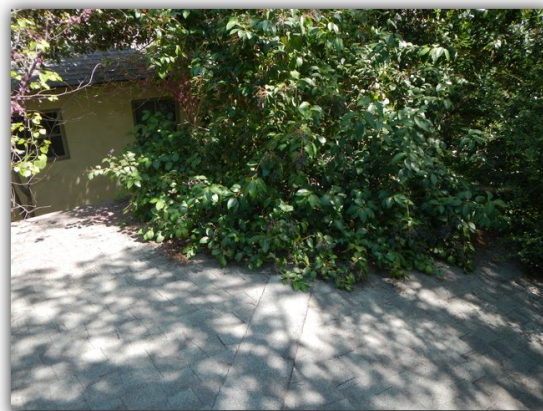
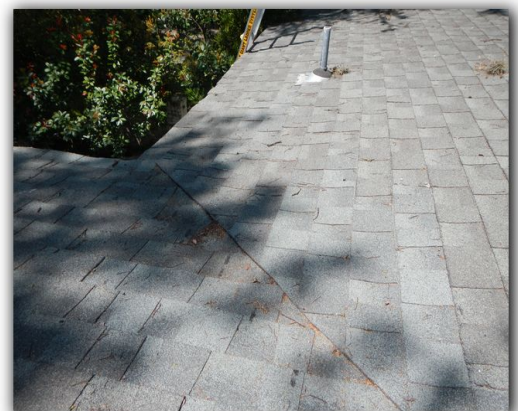
- **'California' style Shingling at the Front Porch Valley** (above right) is not a good idea on low-slopes like these.
- **Professional cutting back of all vegetation** from roof and eaves needed prior to any roof work, in addition to removal of all diseased and deadwood in tree branches above the roof.
- **Roof will need to be stripped**, spoiled Decking and Eaves replaced, New Flashings installed at all penetrations and attachments to the roof, and Valley.
- **Apply suitable Underlayment** for low-slope.
- **Install new Roofing** of choice.
- **New Roof to include** Ridge Venting.
- **Carport Roof** to be included in this work.

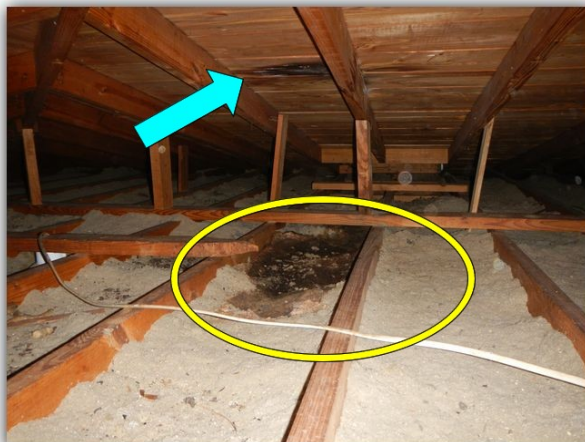
- **The undersized Hatch in the top of the Pink Bedroom Closet** is not accessible due to built-in cabinetry here. A new Hatch in the Passageway between rooms is needed.
- **Roof Leak Damage** evident in Roof Decking (arrow) and molded Insulation on Ceilings below (ringed).

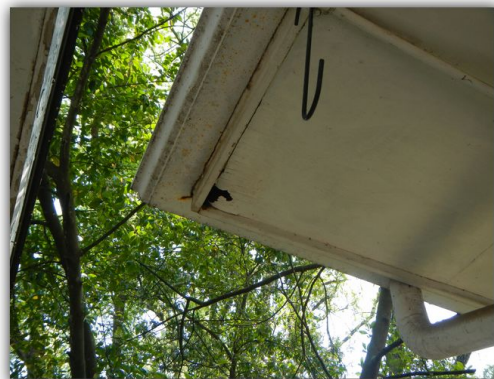
- **Rebuild spoiled Eaves** here.

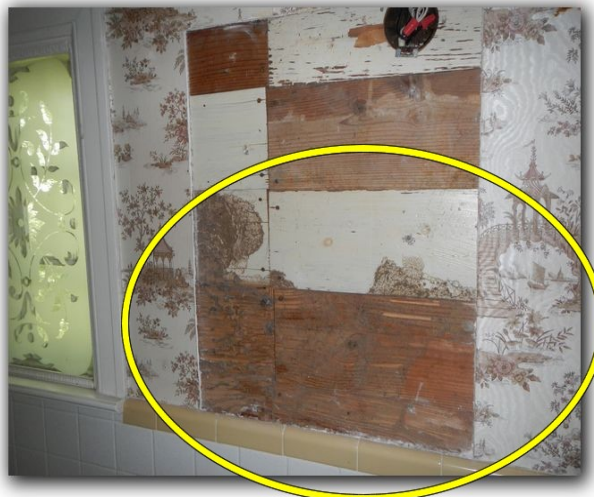
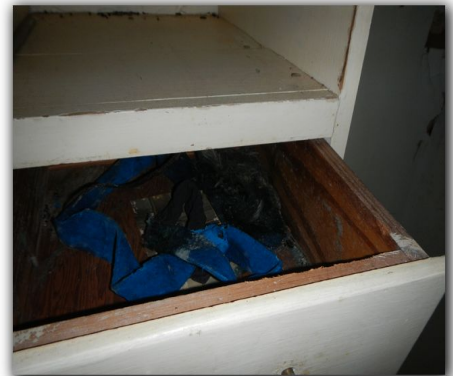
- **Evidence of extensive *Termite Activity** observed in original Plank Walls (left) at south east Bathroom where Vanity Mirror once was.
- **It is likely that other walls in the Home** have been similarly weakened and damaged by Termite activity (whether active or not).
- **My recommendation** is to strip all interior walls to the Studs to expose Wall Framing.
- **Only then** can the full extent of decay, pest damage be addressed.

- **Rodents have overrun the Home.** bait and traps found throughout. Including the remains of a poisoned one in the Pink Bedroom Closet drawer (right)
- **Cabinets are spoiled with urine and droppings** (left below). Soiled cabinetry should be replaced. (Urine is a marker for continued rodent activity. Cleaning will not remove the scent for rodents to follow).

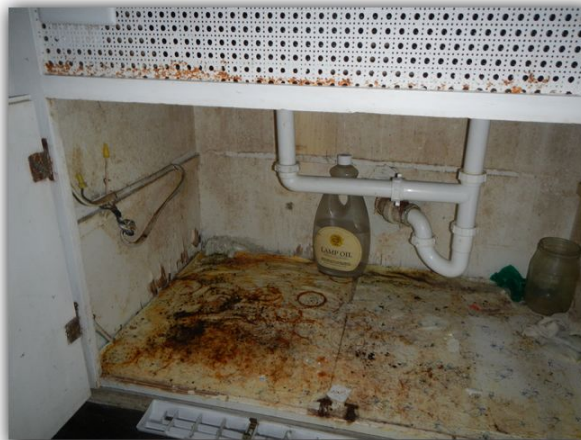
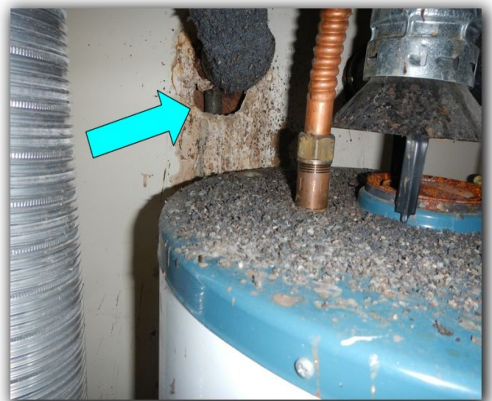
- **Rodents use not only the Roof** for access, but also the Crawlspace. gnawed opening in wall behind Water Heater (right) is from Crawlspace access.
- **All Floor Openings in Crawlspace** will need to be Foam and hardware Cloth Sealed.

- **The Home will need a complete gutting** of all interior finish including wallboard.
- **Partition Wall between Kitchen and Breakfast/Utility Room** has rotted Sill plate.

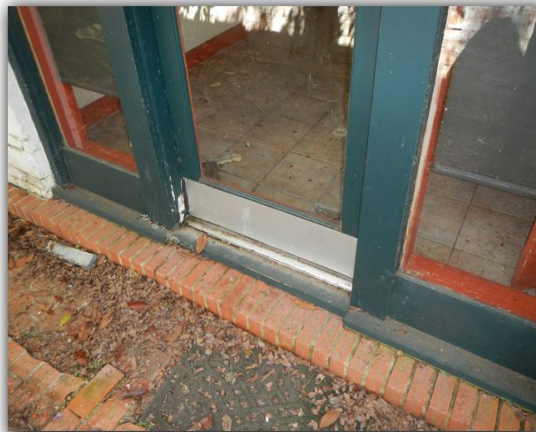
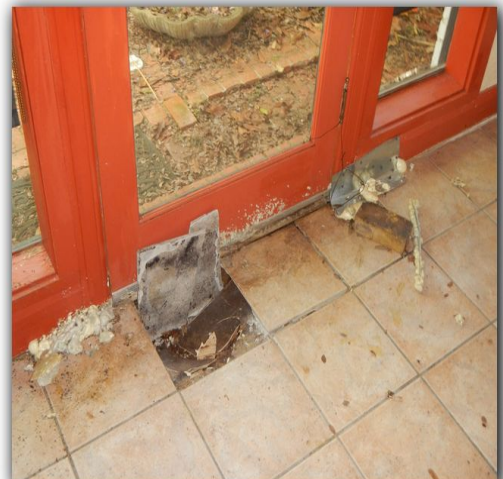
- **The lack of a Threshold Flashing** and Negative Drainage to the Front of the Home has resulted in the rotting and collapse of the Subflooring at the Breakfast Room Floor inside the Doorway (right).

- **The Door will need to be removed** to repair, and the Sill and Flash correctly.
- **The Subflooring in the Breakfast Room** will need to be taken up to exposed Joists and repair as needed.

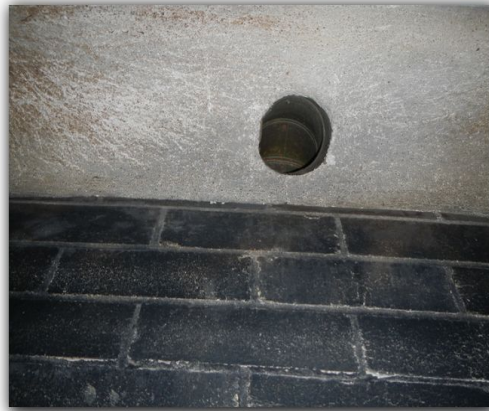
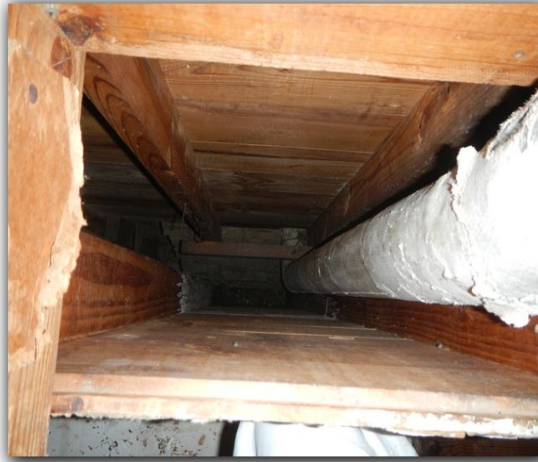
- **The Living Fireplace** is a decorative gas appliance only space.
- **The Vent in the top of the Fireplace (left)** extends up through the wall cavity (right) through the Attic to the Copula where it stops!

- **This Asbestos Insulated Vent stack** needs to be carefully sleeved with Tape, or responsibly disposed of and replaced with a Type B Vent.
- **A Firestop Collar** needs to be at the top of the Wall Cavity on the Vent (right photo).
- **Firestop the remainder of the Wall Opening** to the Collar with Drywall.
- **The Vent must extend through** and above the Copula.

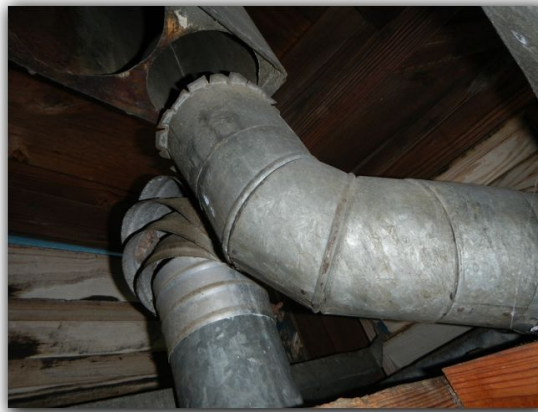
- **It stops here! The Furnace Vent also terminates inside the Copula** next to it (photo).
- **Poisonous Gases from either spill back** into the Attic, and down each others vents into the Home!
- **Mechanical Contractor** to repair and extend both these Vents out and above the Copula.
- **Install a Wall-Receptacle type Monoxide Detector** into a receptacle in the room with the Fireplace.
- **Plumbing Contractor** to repair and check all Gas Tubing and fixture outlets in the Home and crawlspace.
- **Crawlspace Tubing** to be properly supported to Joists. Remove all junked gas tubing from Crawlspace.

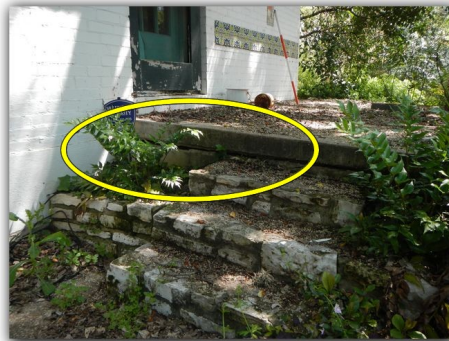
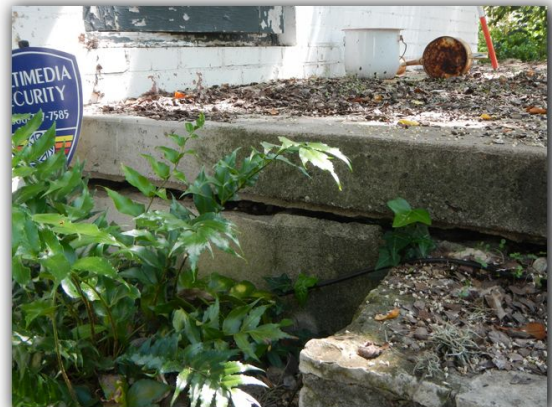
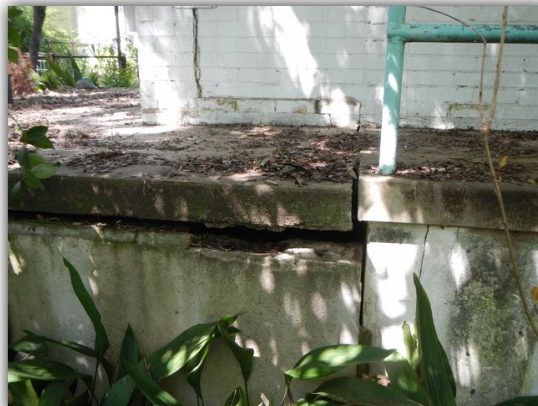
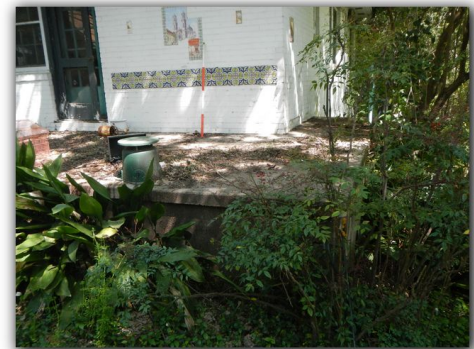
- **Collapsing Supporting Walls** at the perimeter of the South Porch (photos) need to be rebuilt, and the Porch Surface leveled to meet the Steps (below left)

- **The edges of this Porch (above right)** need a Guardrail installed.
- **The Privacy Wall** at the Breakfast west Porch is tilting outward due to poor drainage here. The Mountain Laurel it is now leaning against on its front side is likely all that is keeping it from collapsing!

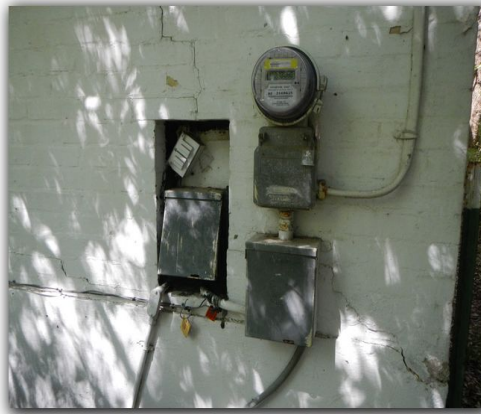
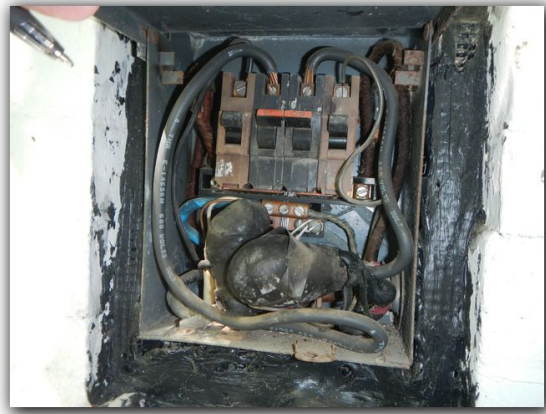
- **Outdated and undersized Breaker Boxes** to be replaced with new 200 amp (or larger) Breaker Box

- **Re-Wiring of entire Home** needed during stripping of all Interior Walls.

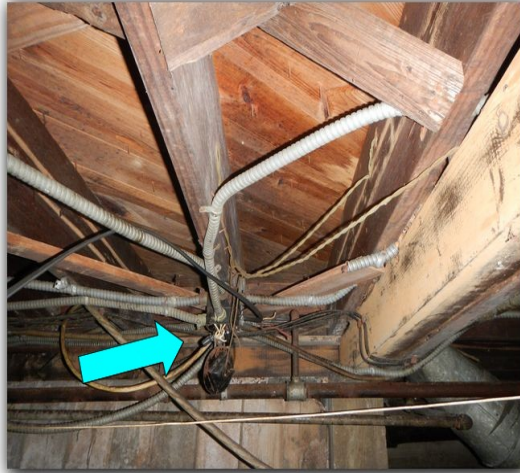
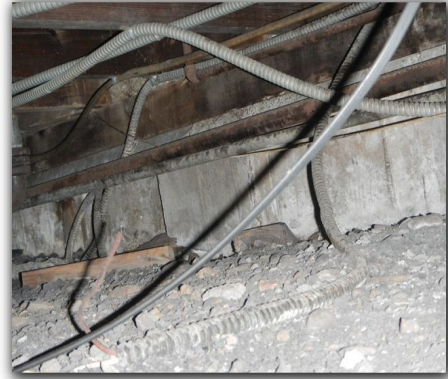
- **Repair/Rewire Crawlspace Wiring.** All splices to be in Covered Junction Boxes.
- **All Wiring to be stapled** up to Joists.

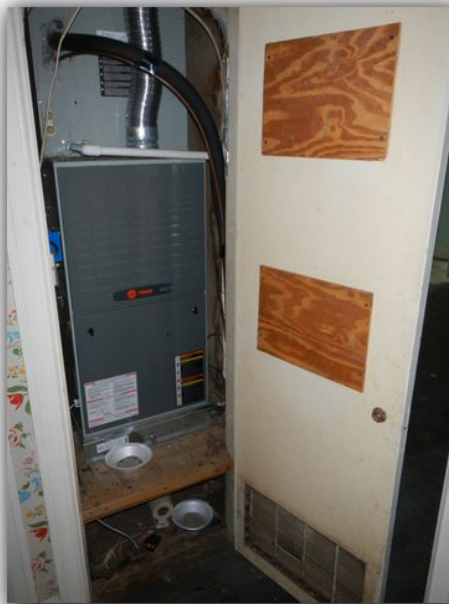
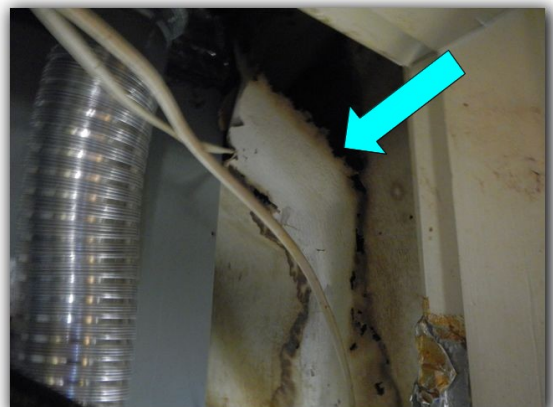
- **One of the Return Air inlets to the Air Handler** is the bottom of the Closet Door (left). Remodel front of platform to be drywall.
- **Install Return Air through Crawlspace** to floors of each Room.

- **Cloth/Paper wall covering** in the Closet (above right) to be stripped and walls Drywalled. (This will require removal of the Air handler).
- **Return Air Plenum** under Air Handler platform to be cleaned and floor openings sealed (below). Line all walls and floor with Ductboard.

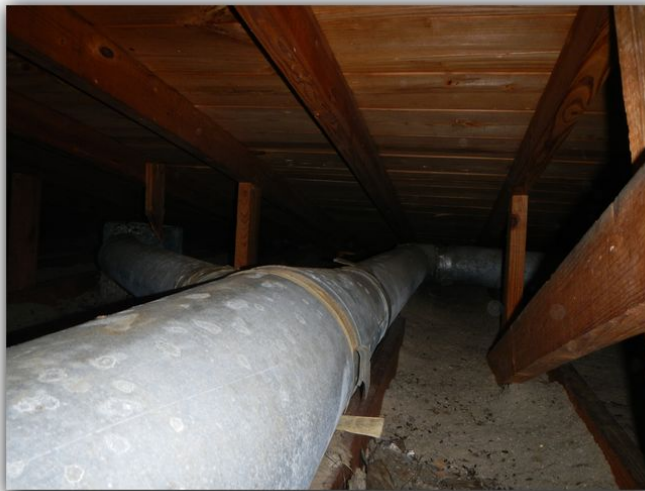
- **Rodents have stripped Attic Ductwork** of Insulation Jacket!

- **Remove all existing Ducts** during replacement and repair of Ceiling Joists. Replace all AC Ducts in Attic.

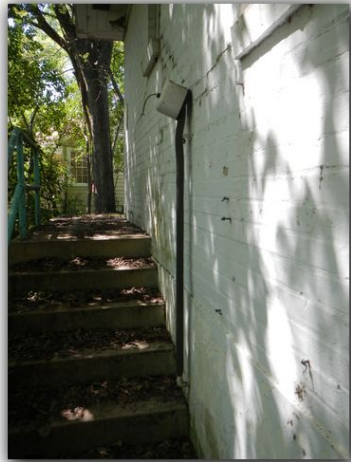
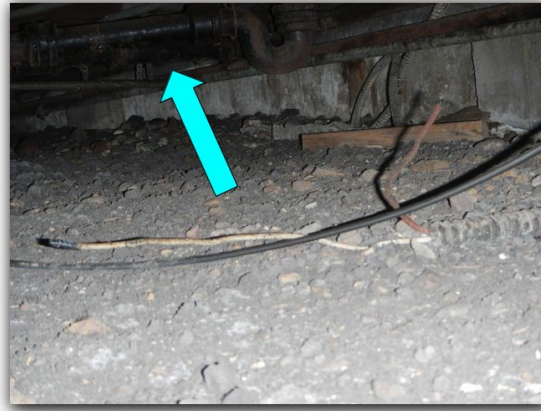
- **All Supply Plumbing** including exterior Bibbs (left) and Crawlspace to be replaced.

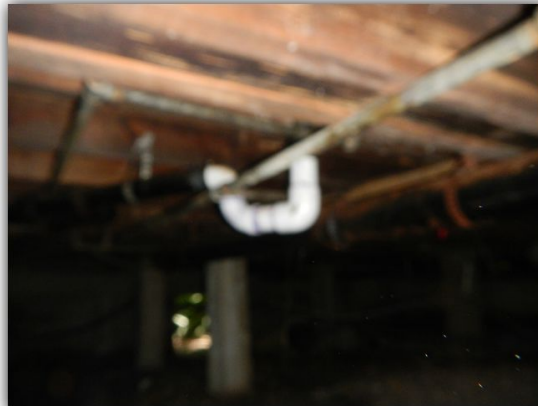
- **All Crawlspace** iron drain piping to be replaced.
- **Waste Drain** through front yard to street Tap to be scoped for condition. It is likely to need replacement.
- **Improper PVC parts** making up Tub Trap under north hall bath (photo).

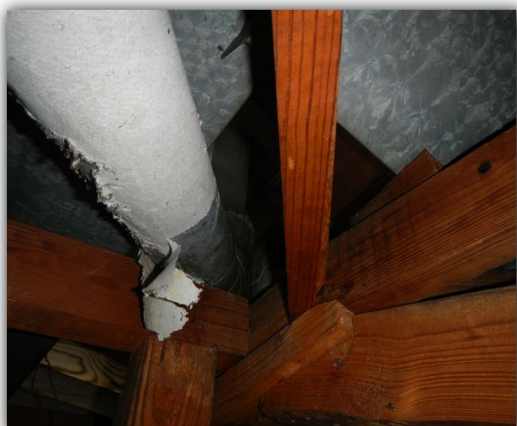
- **Repair Venting** for Water Heater.

- **Water Heater Closet lacks a Leak Pan** to protect the Home from Tank Leak damage.
- **Install a Pan** with Drain to exterior.
- **Install a Sediment Tee** on the Gas Supply at the Tank.
- **Add a Flood-Stop Valve** on the Cold Supply to the Tank to protect the Home from catastrophic leak damage in the event of a Tank failure.

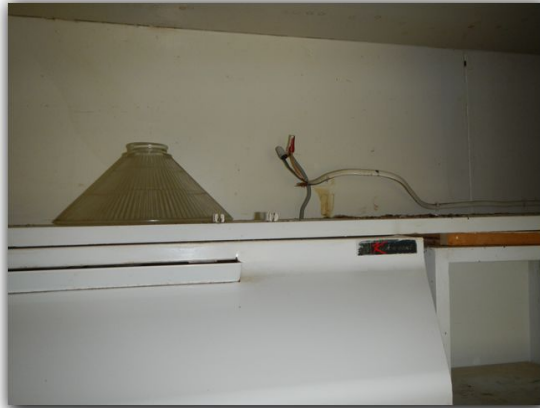
- **Re-Wire** Vent Hood.

Note: This is a Recirculatory Vent
