MEMORANDUM

RE: Seepage Along Idelwild Road

SUBJECT: Ridgelea Storm Drain Project - Groundwater Issues

DATE: February 13, 2015

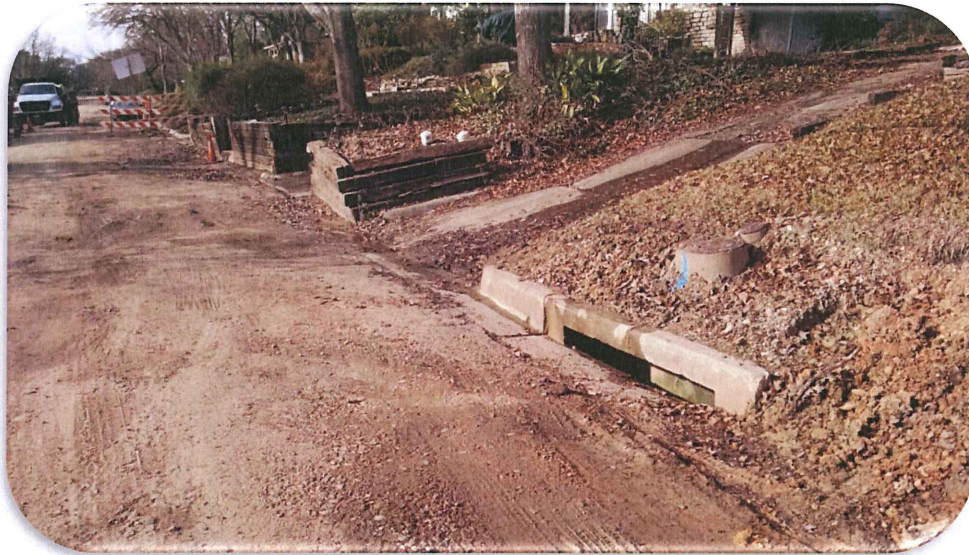
Figure 2 – Groundwater Condition on Idlewild Road

Historically the neighborhood has experienced high groundwater as evidenced by the numerous underdrain outfalls within driveways, retaining walls with weepholes, and weepholes cut into existing curb and gutter. Many of these “seeps” from private driveway joints and pipe outfalls are six-feet higher (or greater) than the existing street grade.

A picture showing an example of the existing groundwater condition can be found below in Figure 2. There are groundwater seeps in the driveway from private property upslope of the storm drain project.

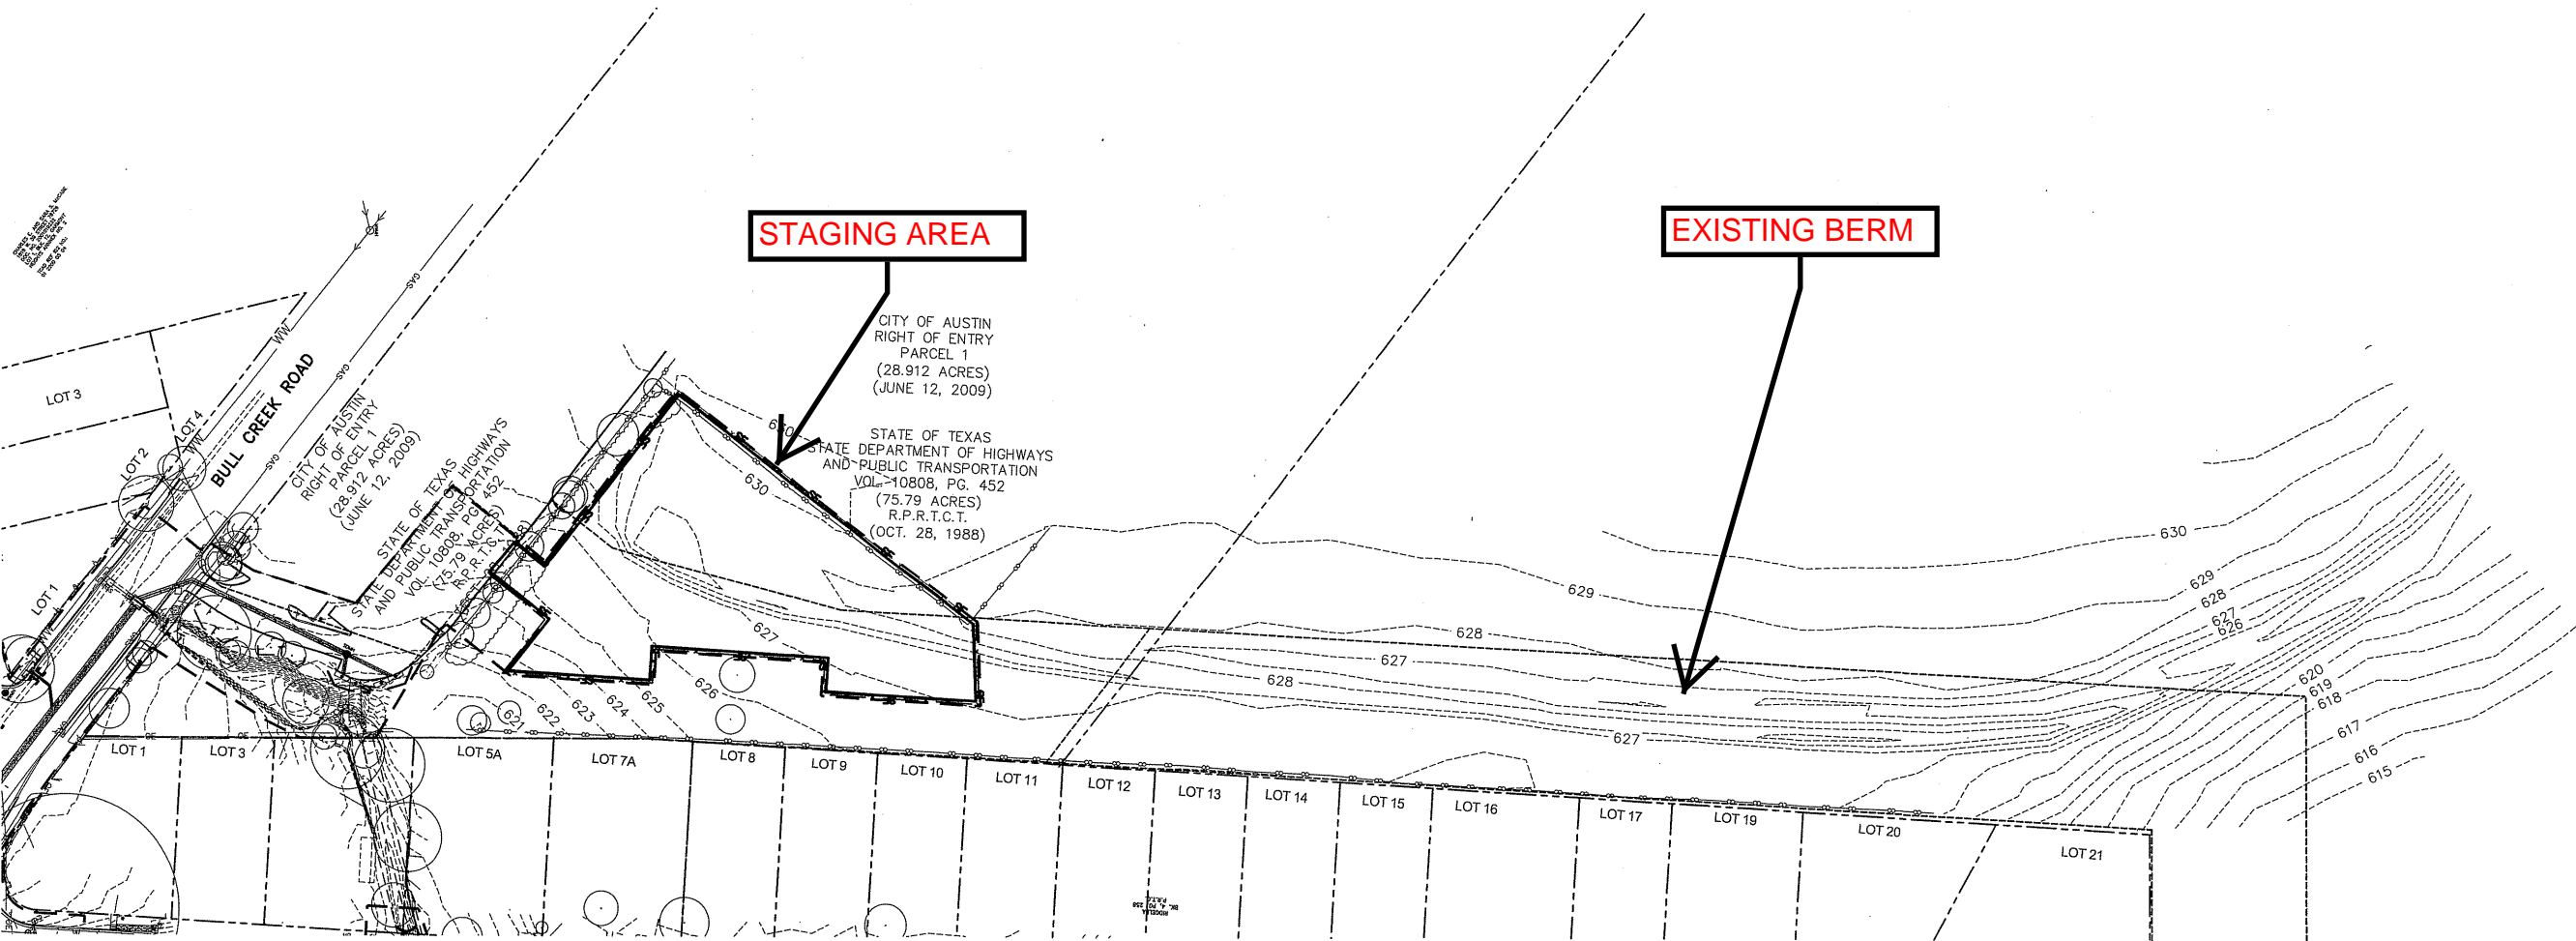
ATTACHMENT 1

The Project conducted a design phase topographic survey in the area behind the lots in question all the way to Bull Creek Road to assess existing drainage patterns. Please find a copy of Plan Sheet 16 included as Attachment 1 with callouts provided for clarification.

During the design phase, the project team established a staging area and small channel modification near Bull Creek Road (and the southern TXDOT parking lot). Both the staging area and small channel modification were thoroughly analyzed and subsequently certified to create no adverse impact from increased surface runoff directed at private residences.

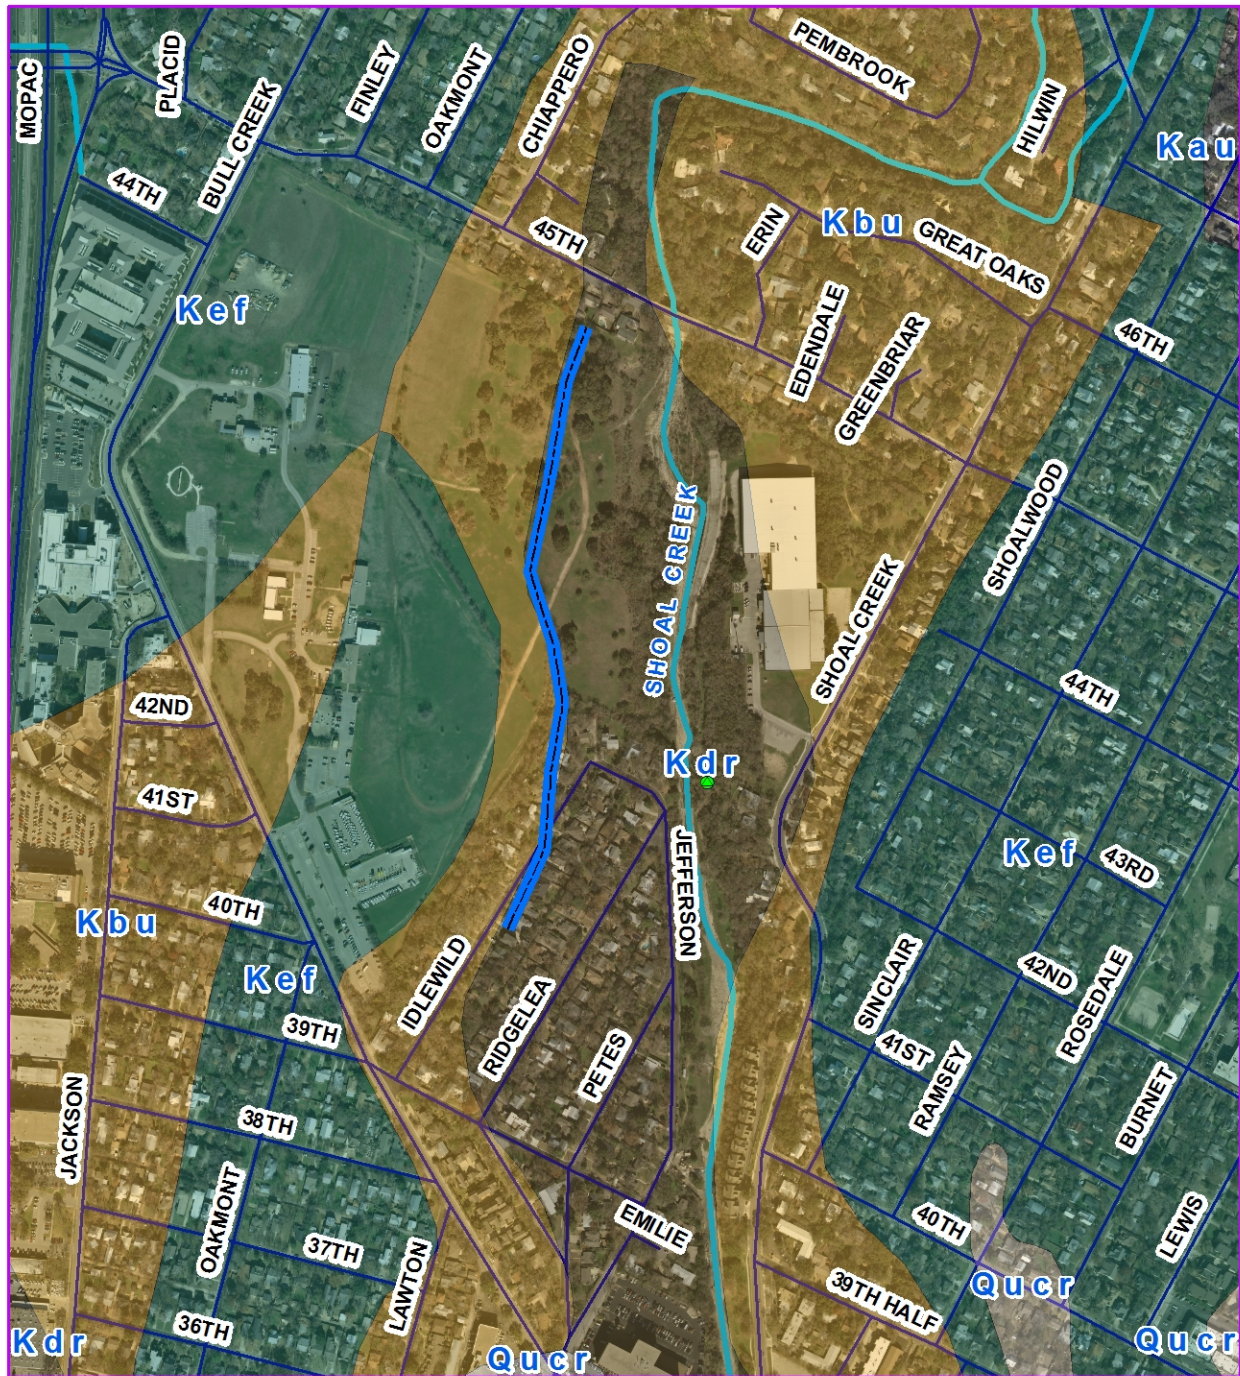
Geology and groundwater seep horizon Ridgelea neighborhood

The blue line represents the geologic contact between the overlying Buda limestone with the underlying Del Rio clay. Seepage is common at this geologic contact; in the Ridgelea neighborhood and other locations within the region.
