**HISTORIC LANDMARK COMMISSION  
JANUARY 25, 2016  
DEMOLITION AND RELOCATION PERMITS  
HDP-2015-1037  
3108 GRANDVIEW STREET**

Re: 3108 Grandview / TK # 15215

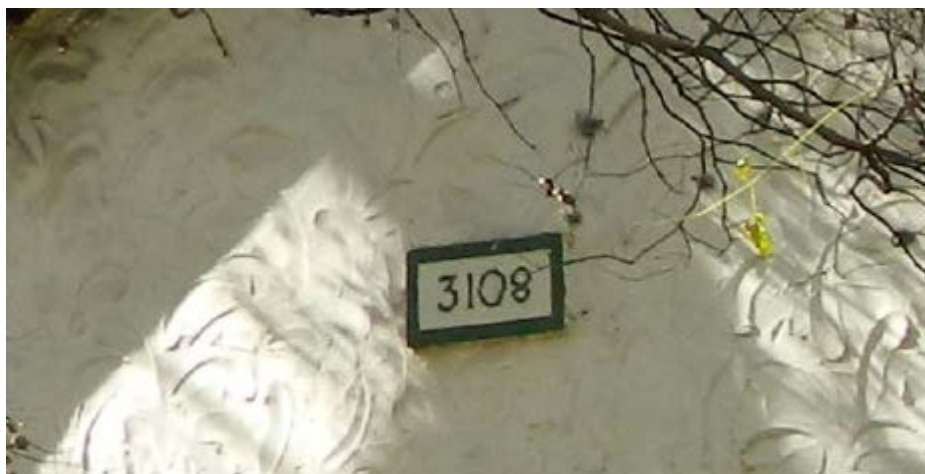
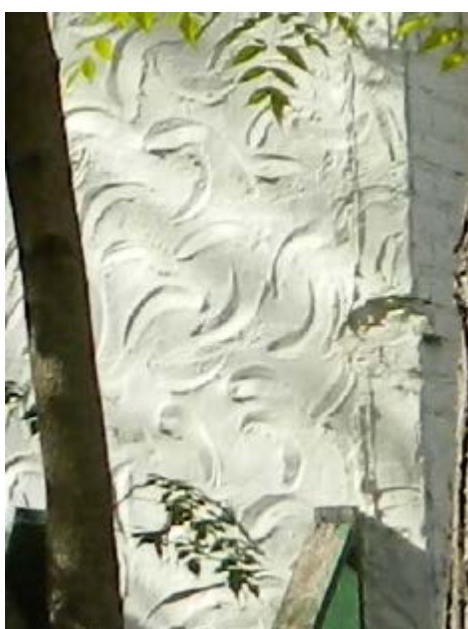
Details of the palm-plastered exterior of the house

It is our understanding that some design features of the Exterior stucco have historical interest. It will not be possible to save any of the existing installation however, the style / desirable features can be easily be replicated in any replacement building.

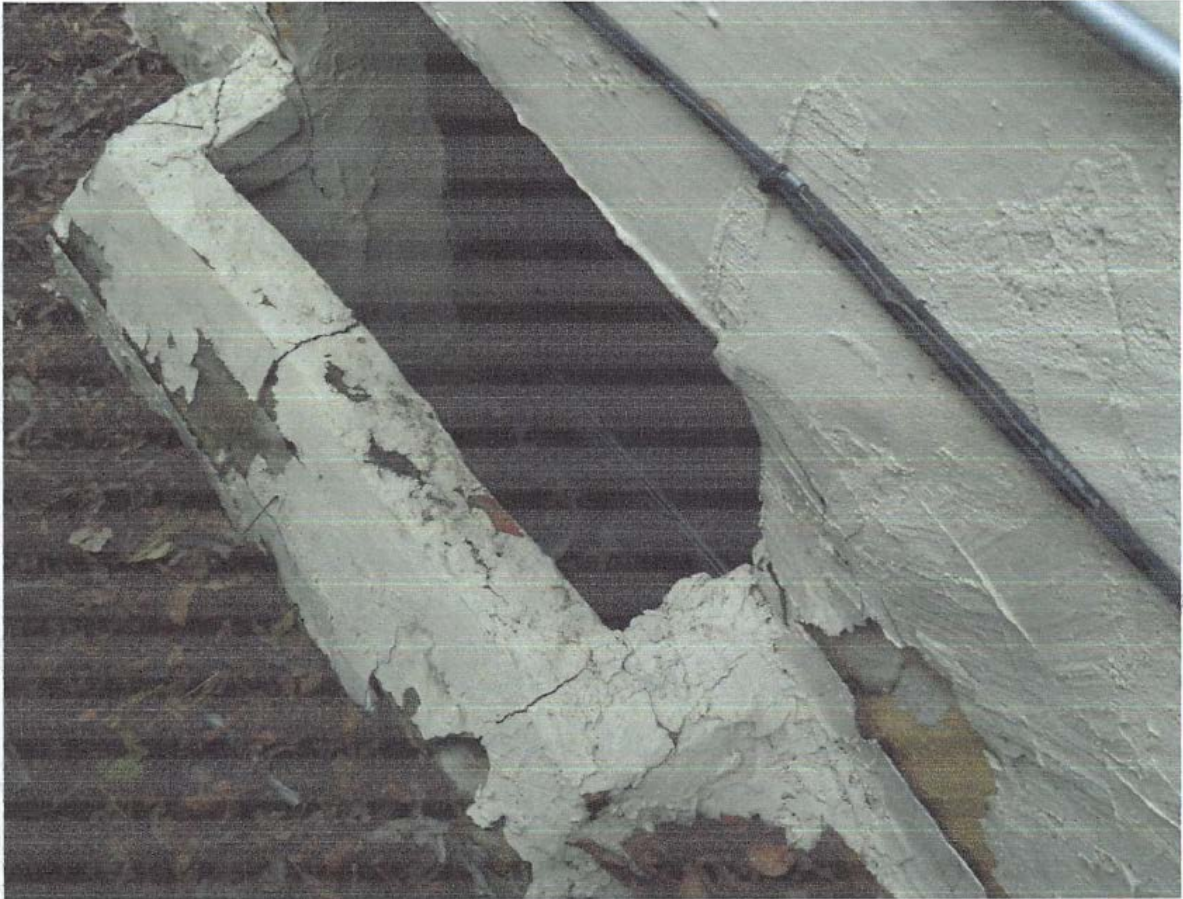
P3 / LOWER LEVEL WINDOW AT SOUTH WALL

2] Windows: Most of the wood windows are severely deteriorated, are single pane, and do not meet current code requirements.

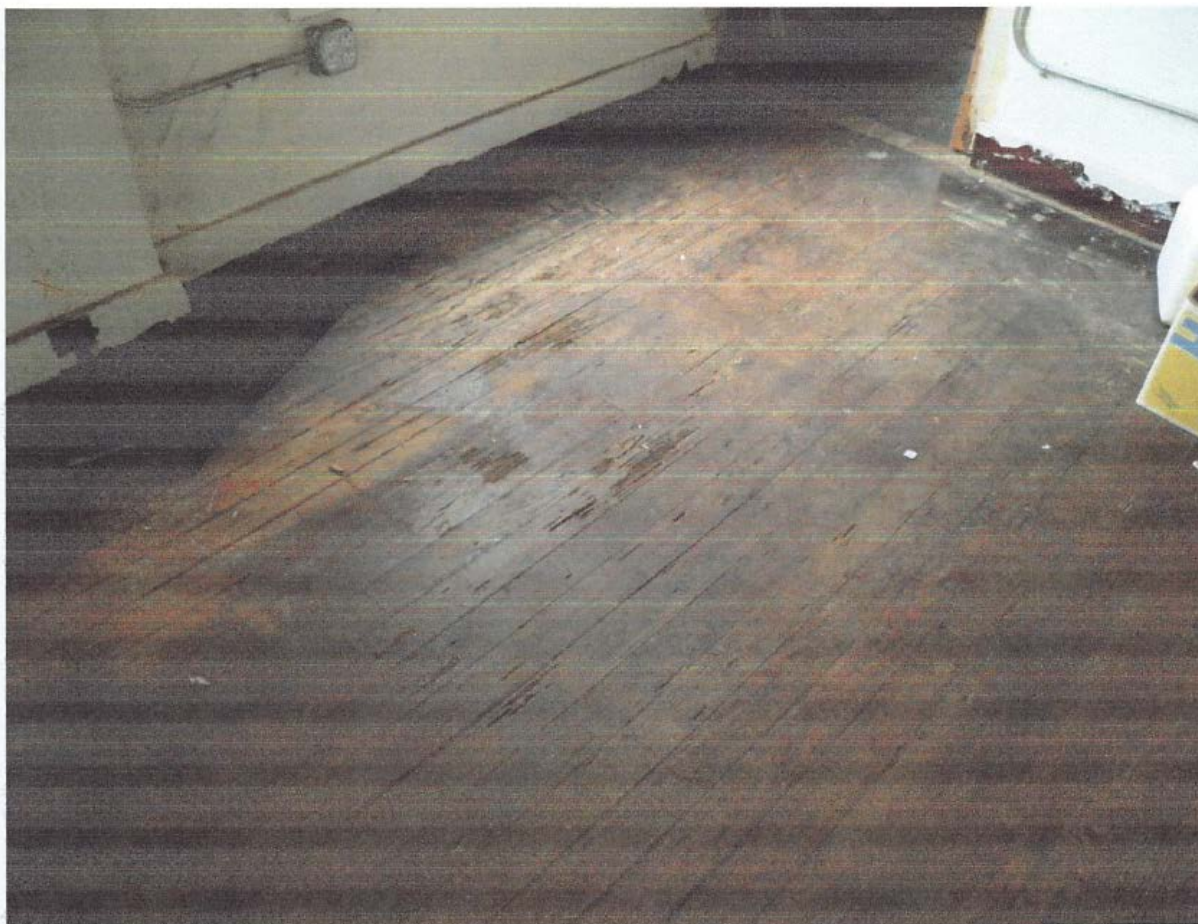
3] Moisture Infiltration: There is a perceptible pungent odor in the building indicating the presence of mold. The perimeter exterior walls are constructed of solid brick masonry with no steel reinforcing, no moisture membrane or gap between the interior and exterior finishes. Moisture is being transmitted and trapped within the walls. Deterioration of the embedded wood framing and wood flooring from insect infiltration and "rot" was observed at multiple locations. All wood needs to be replaced.

P8 / EVIDENCE OF TERMITE  
INFESTATION IN THE INTERIOR WOOD

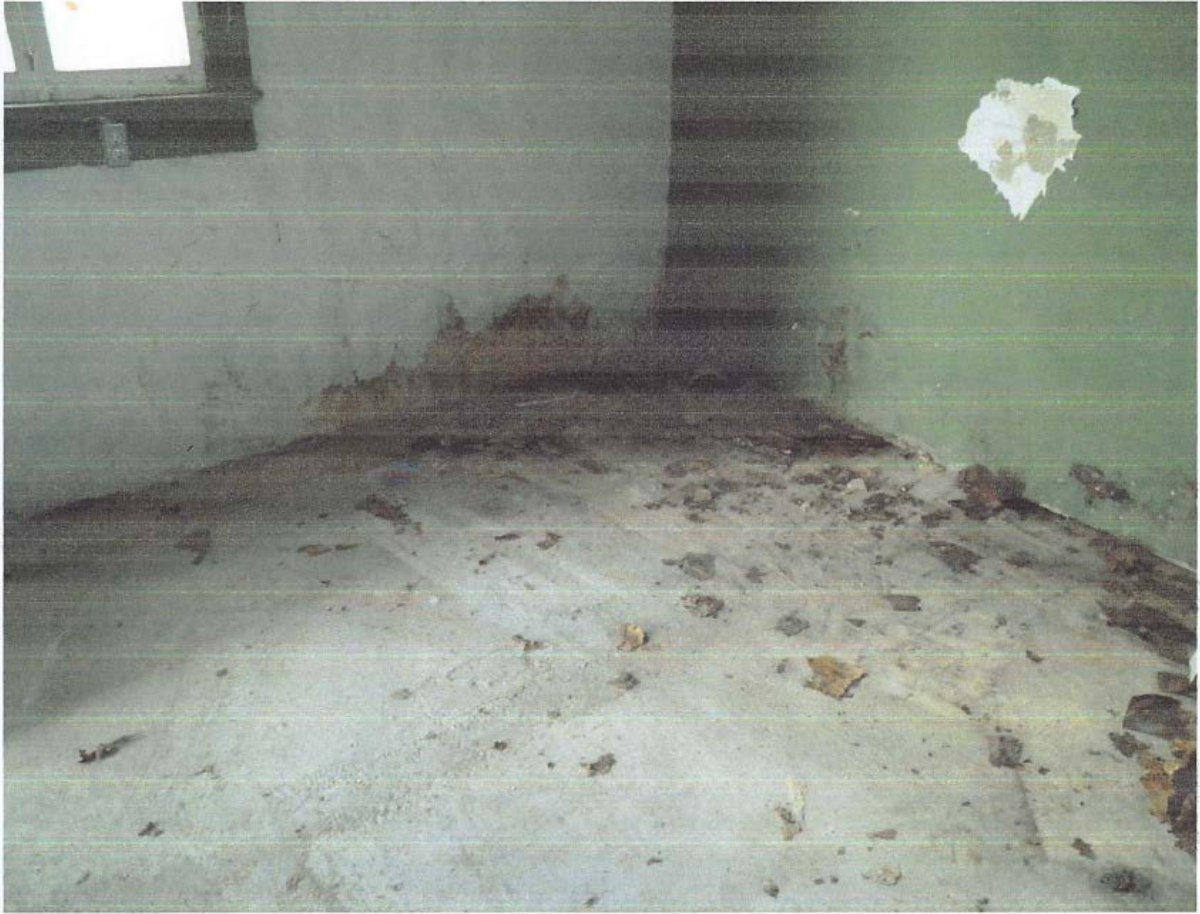
2] Drainage: The grade at the front / east end of the building is at the upper level and the grade at the west end is at the lower level. Evidence of moisture infiltration was observed in the floor and walls at the lower level.

P9 / WATER INFILTRATION AT THE  
GROUND LEVEL FLOOR

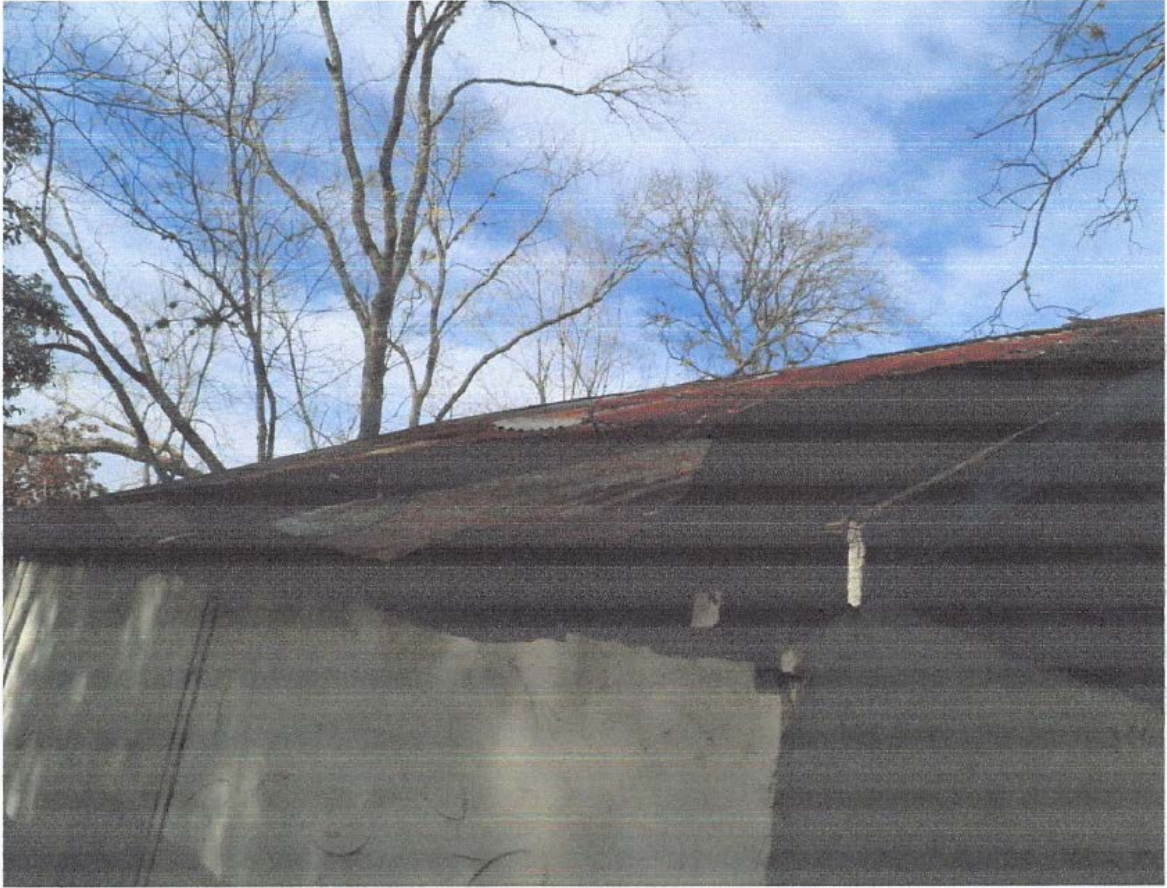
P10 / SOUTHEAST CORNER OF THE GARAGE ROOF

1] Roof: The metal roof has curled up at many locations. Several roof rafter on the south side of the roof have failed. With continued exposure to weather I anticipate that the entire roof will collapse with a short period of time [months]

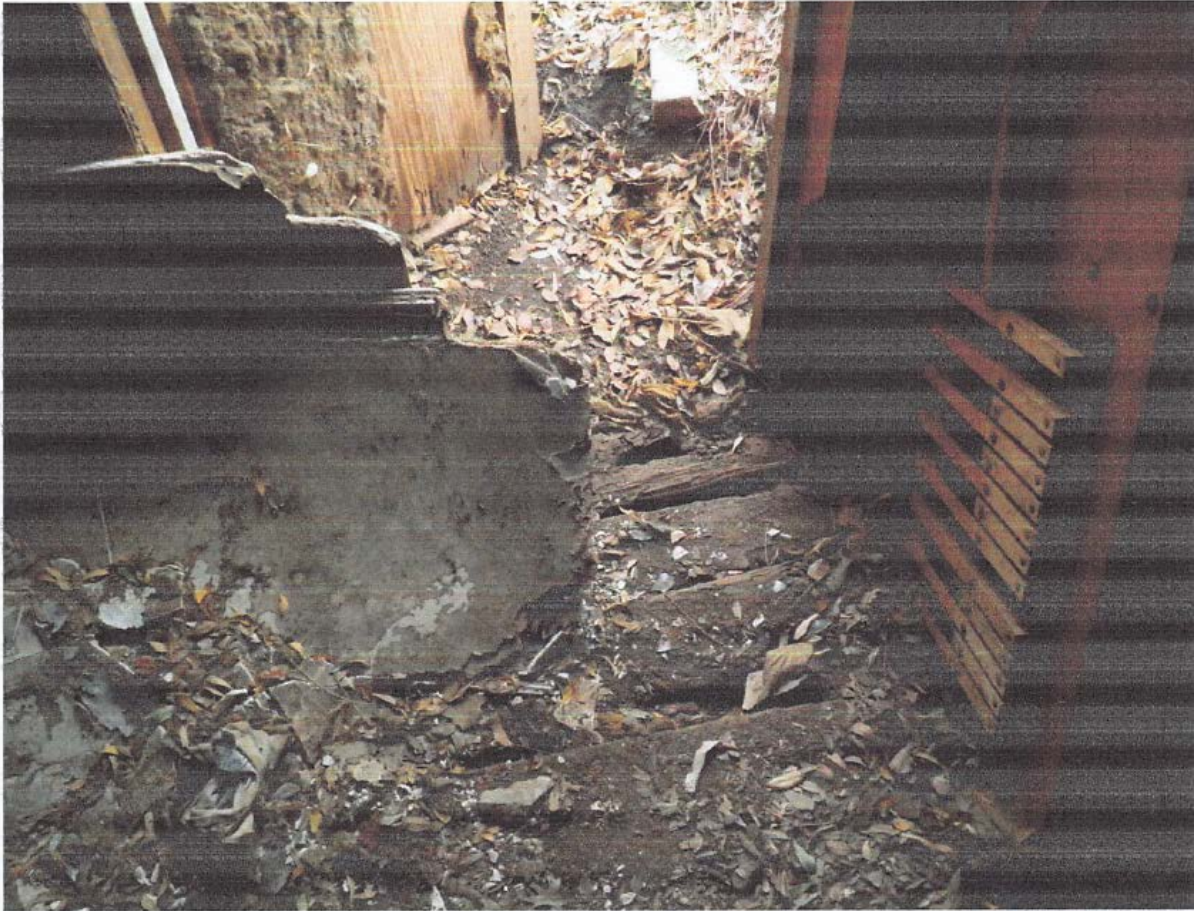
P12 / GARAGE FLOOR AT EAST ENTRY

2] Floor: Portions of the floor are constructed of wood framing and have experienced significant deterioration. Complete replacement will be required.

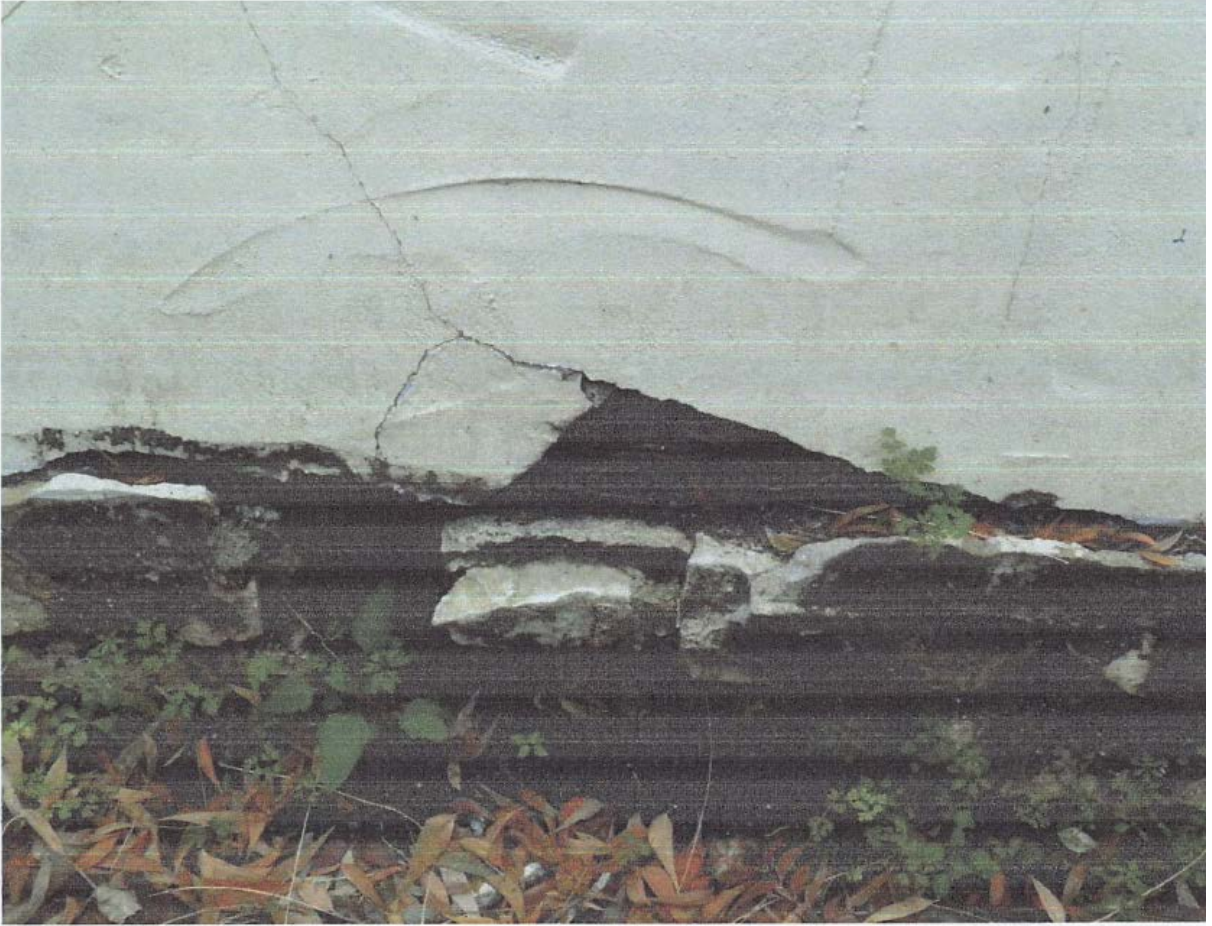
P13 / LOWER SECTION OF NORTH GARAGE WALL

3] Walls The lower sections of the perimeter walls are exposed and are severely deteriorated from water intrusion. A significant portion of the exterior walls, including the stucco, will have to be removed and replaced. The east wall is acting as a retaining wall with the high grade. A retaining wall shall be installed across the east side of the Garage.

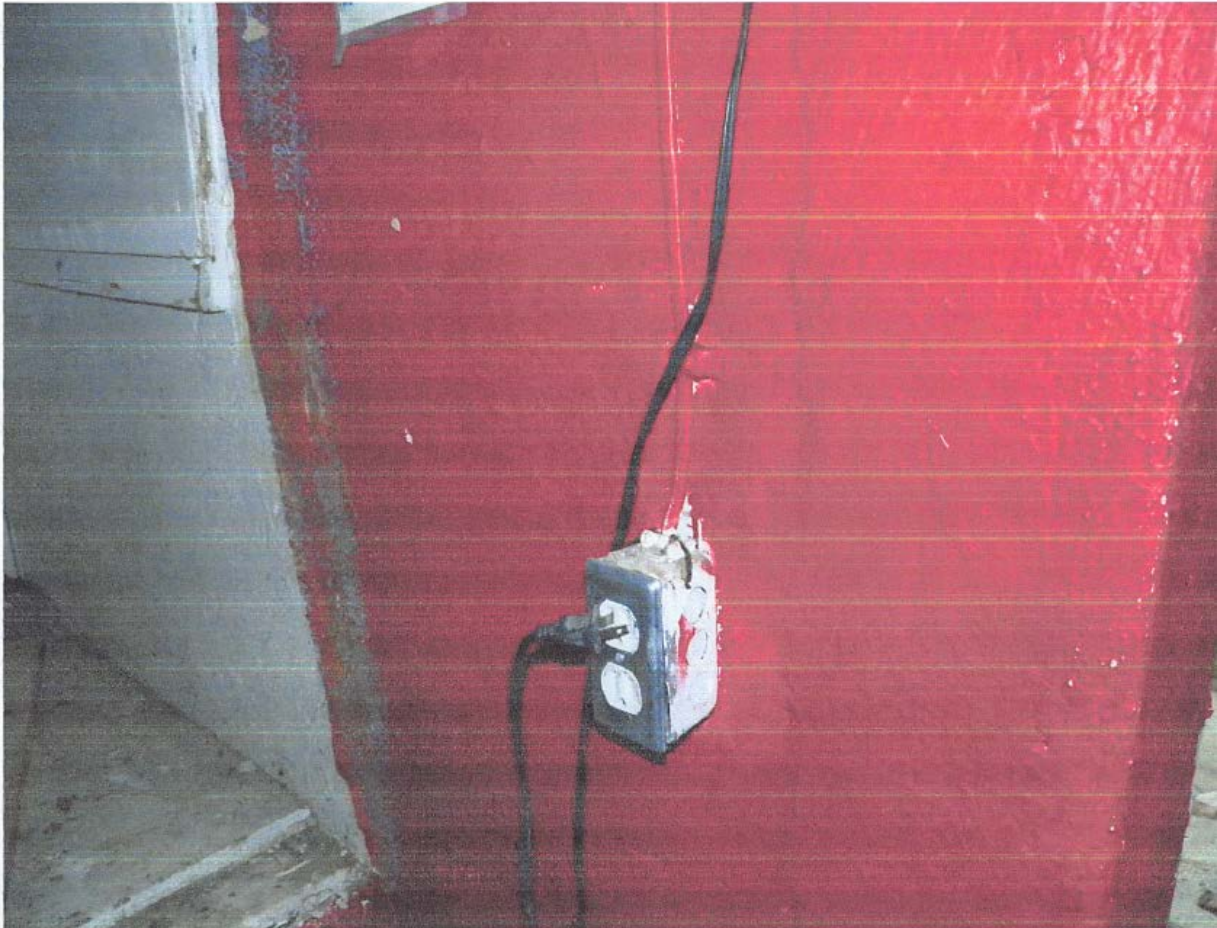
3] Electrical and Plumbing: Almost all of the visible interior Electrical, Water Supply, and Wastewater lines are improper and / or severely deteriorated and need complete replacement:

P14 / IMPROPER ELECTRICAL INSTALLATION
