ZONING CHANGE REVIEW SHEET**CASE NUMBER:** HDP-2015-1037**HLC DATE:**

PC DATE:**APPLICANT:** Historic Landmark Commission**HISTORIC NAME:** Ben and Maude Leifeste House**WATERSHED:** Shoal Creek**ADDRESS OF PROPOSED ZONING CHANGE:** 3108 Grandview Street**ZONING FROM:** SF-3-CO-NP to SF-3-H-CO-NP

Re: 3108 Grandview / TK # 15215

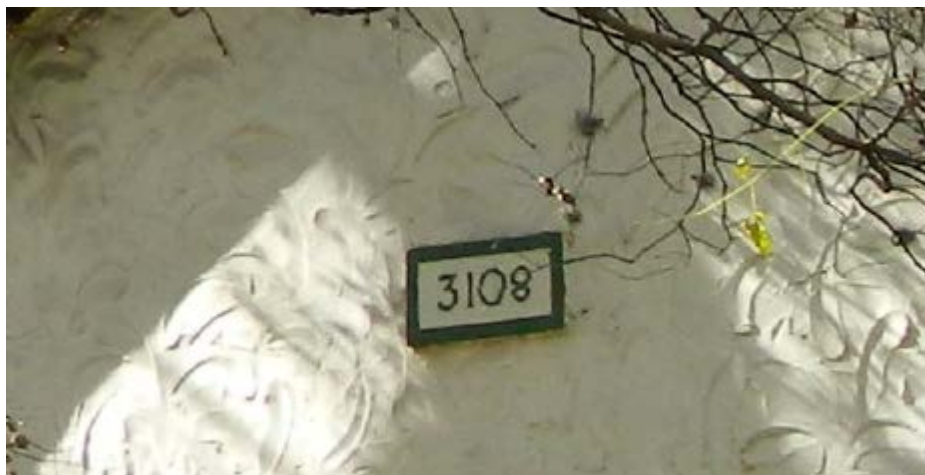
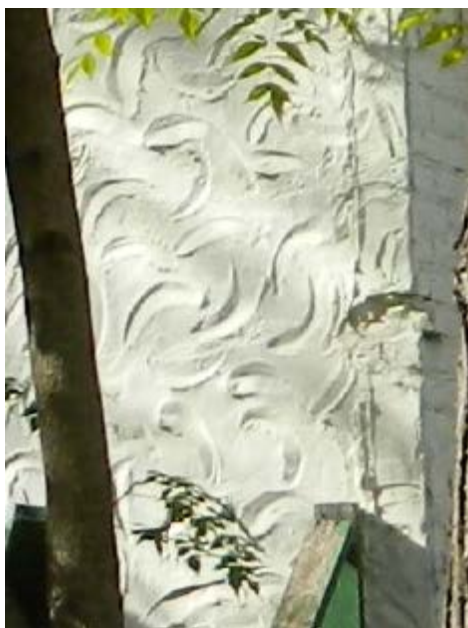
Details of the palm-plastered exterior of the house

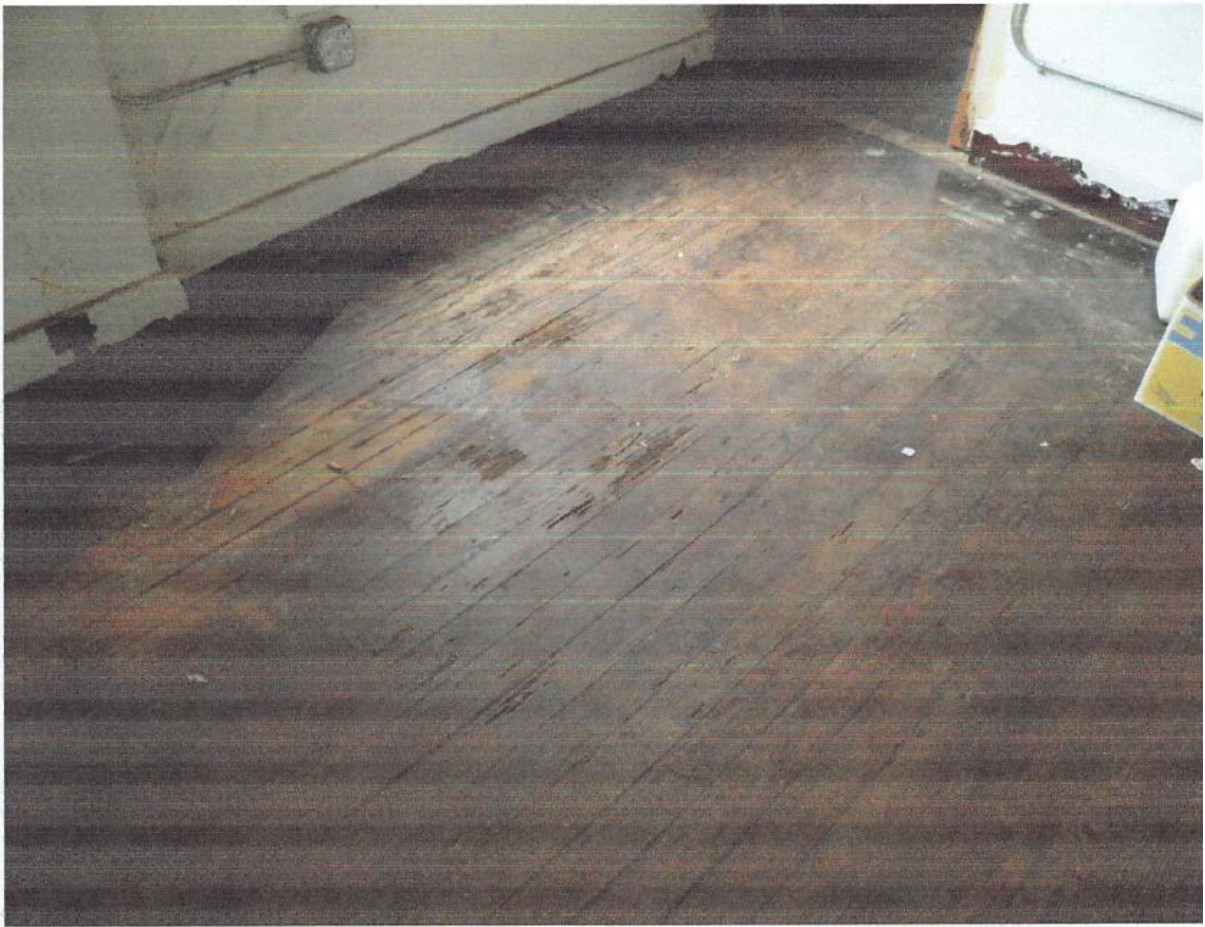
3] Moisture Infiltration: There is a perceptible pungent odor in the building indicating the presence of mold. The perimeter exterior walls are constructed of solid brick masonry with no steel reinforcing, no moisture membrane or gap between the interior and exterior finishes. Moisture is being transmitted and trapped within the walls. Deterioration of the embedded wood framing and wood flooring from insect infiltration and "rot" was observed at multiple locations. All wood needs to be replaced.

P8 / EVIDENCE OF TERMITE
INFESTATION IN THE INTERIOR WOOD

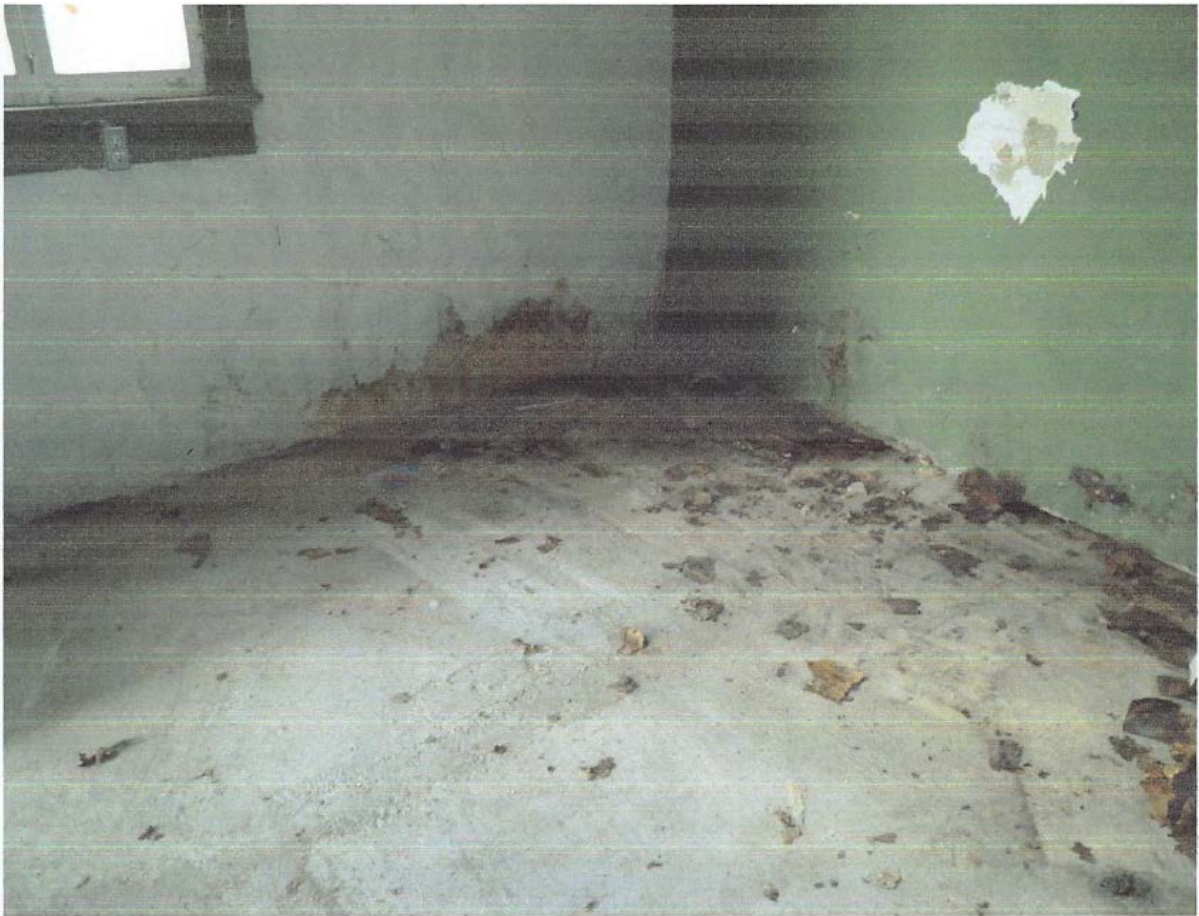
2] Drainage: The grade at the front / east end of the building is at the upper level and the grade at the west end is at the lower level. Evidence of moisture infiltration was observed in the floor and walls at the lower level.

P9 / WATER INFILTRATION AT THE
GROUND LEVEL FLOOR

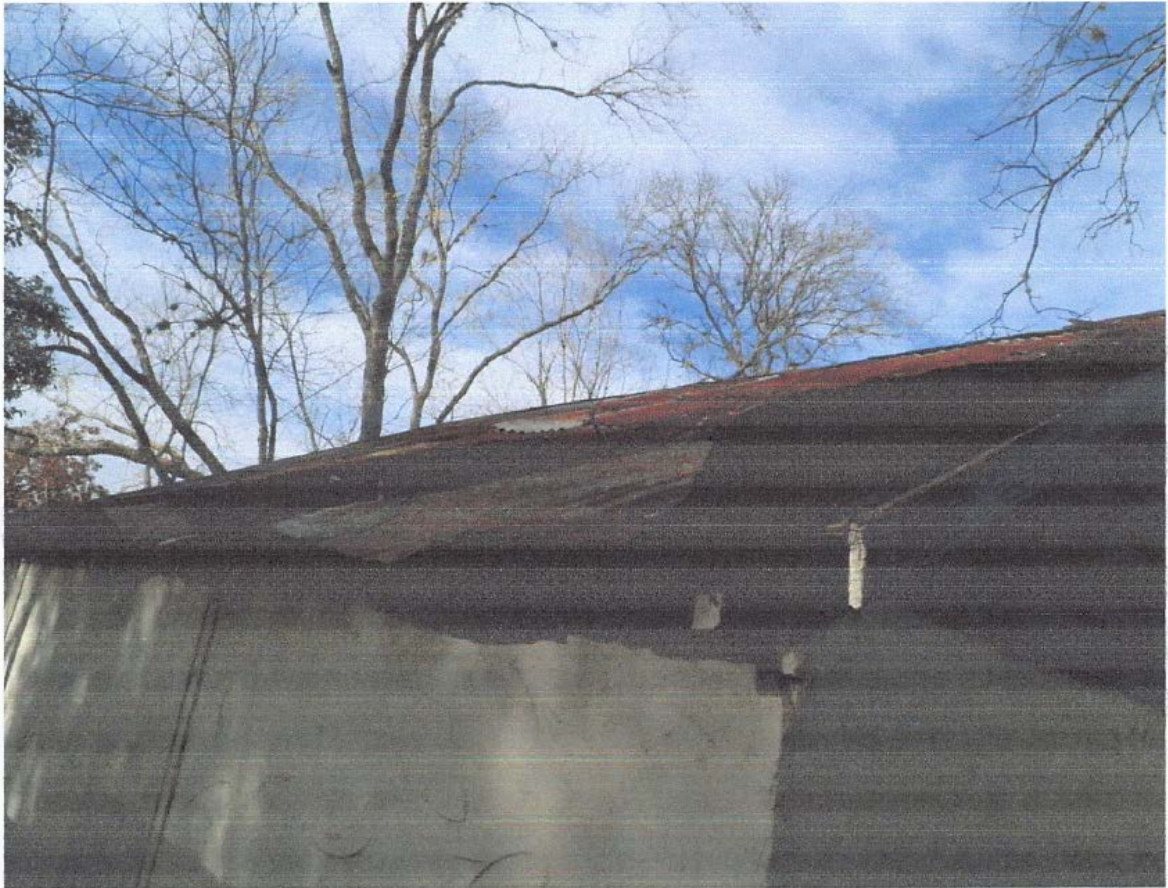
P10 / SOUTHEAST CORNER OF THE GARAGE ROOF

1] Roof: The metal roof has curled up at many locations. Several roof rafter on the south side of the roof have failed. With continued exposure to weather I anticipate that the entire roof will collapse with a short period of time [months]

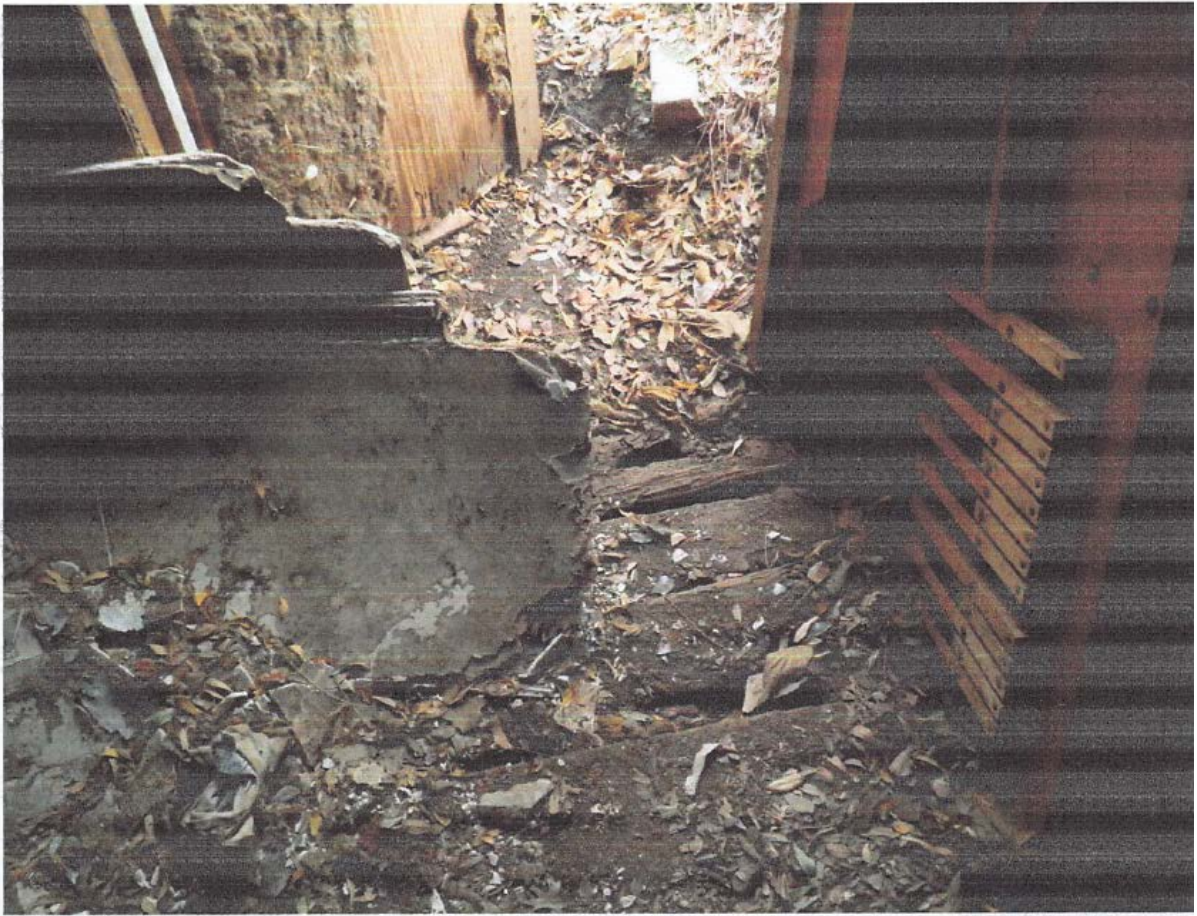
P12 / GARAGE FLOOR AT EAST ENTRY

2] Floor: Portions of the floor are constructed of wood framing and have experienced significant deterioration. Complete replacement will be required.

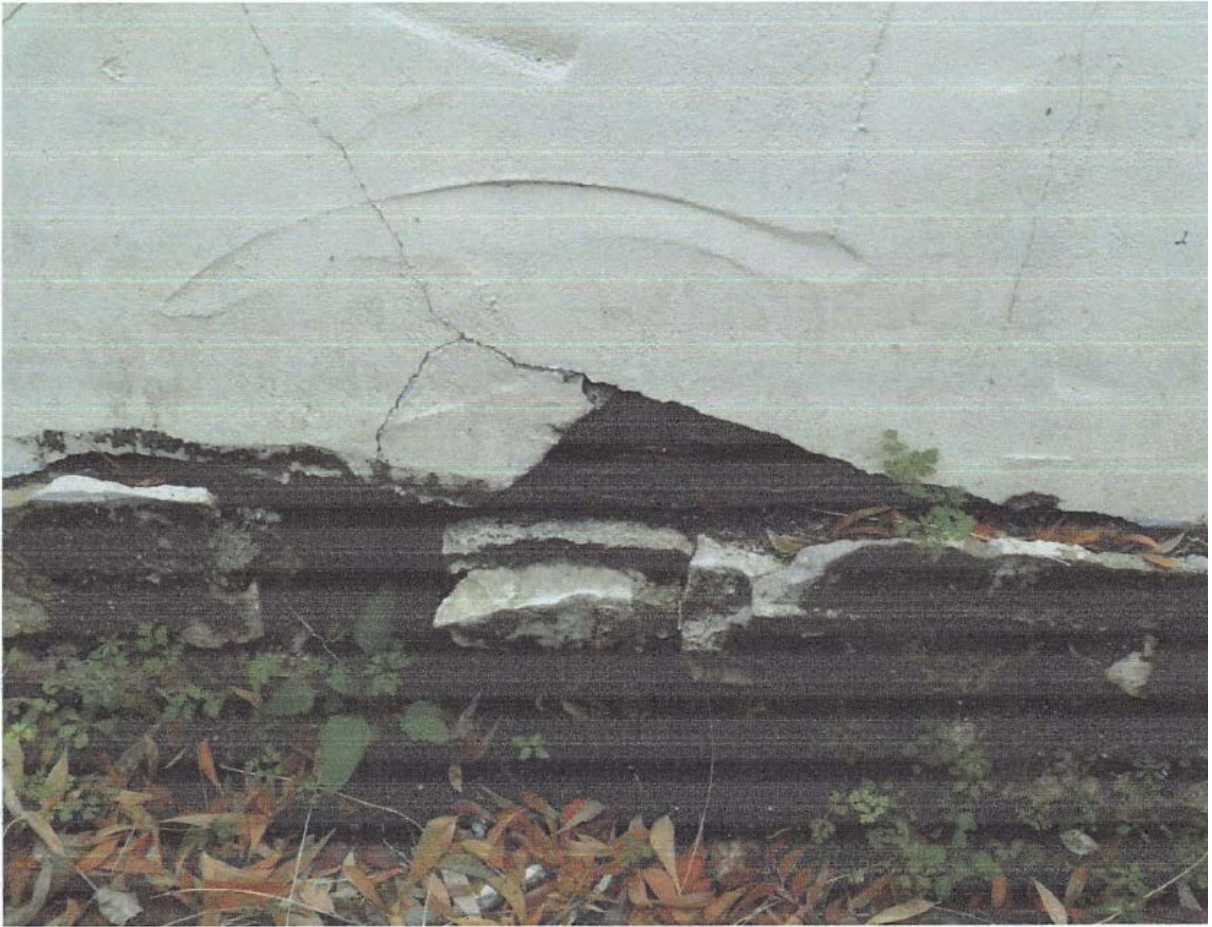
P13 / LOWER SECTION OF NORTH GARAGE WALL

3] Walls The lower sections of the perimeter walls are exposed and are severely deteriorated from water intrusion. A significant portion of the exterior walls, including the stucco, will have to be removed and replaced. The east wall is acting as a retaining wall with the high grade. A retaining wall shall be installed across the east side of the Garage.

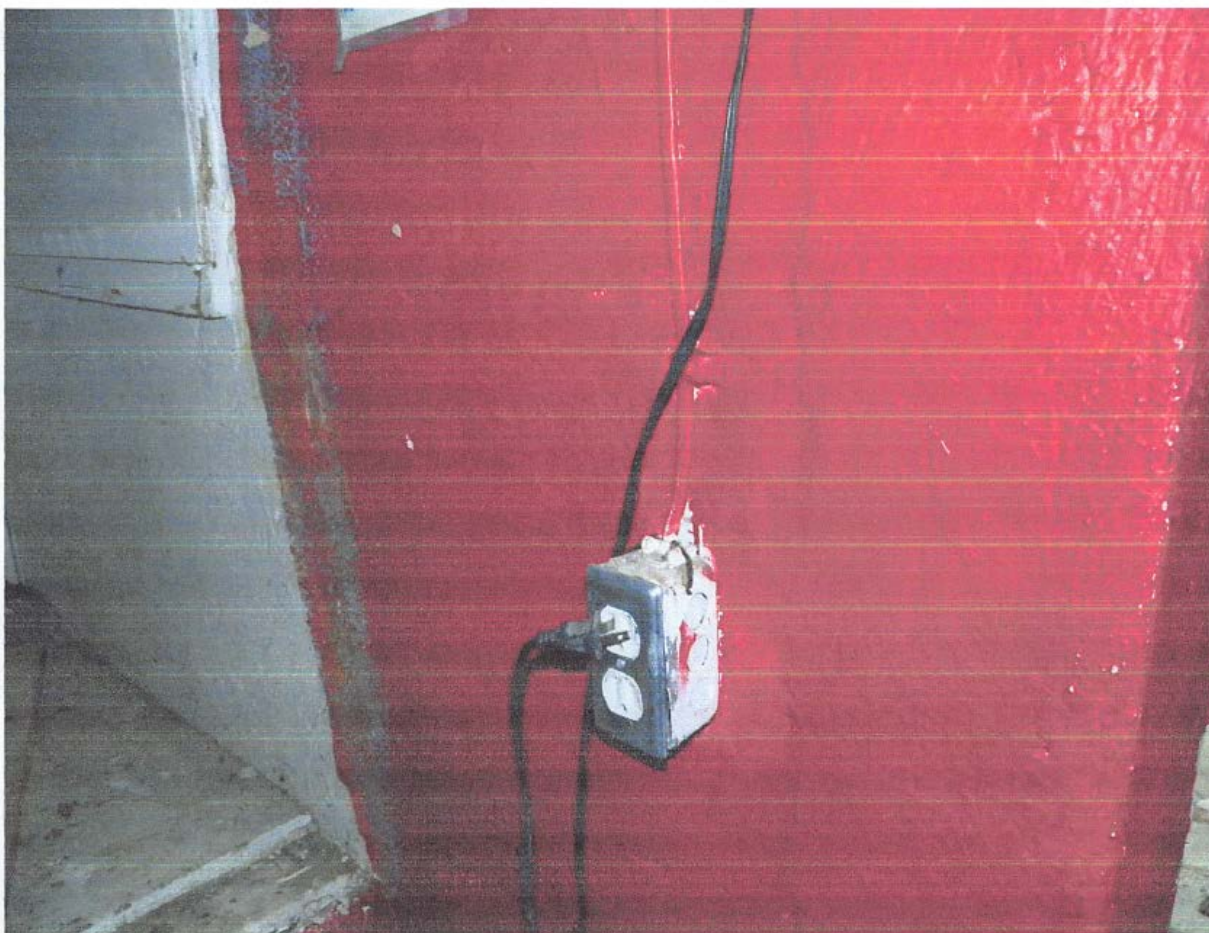
3] Electrical and Plumbing: Almost all of the visible interior Electrical, Water Supply, and Wastewater lines are improper and / or severely deteriorated and need complete replacement:

P14 / IMPROPER ELECTRICAL INSTALLATION
