# PROPERTY INSPECTION REPORT

Concerning: **2100 Rio Grande (Dormitory property)**

By: **Kenneth L. Larson / TREC # 5702**

**February 15, 2016**

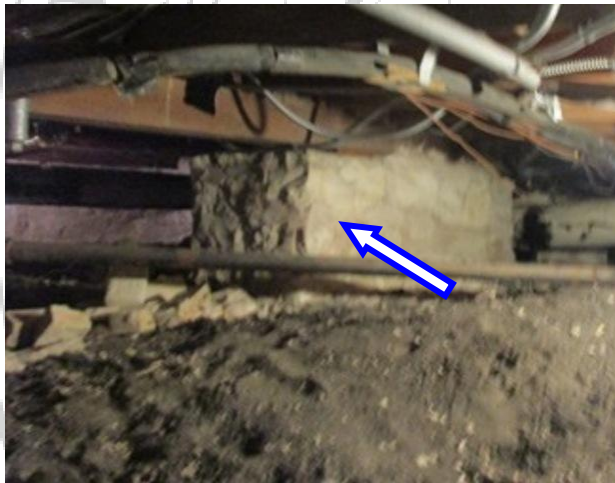
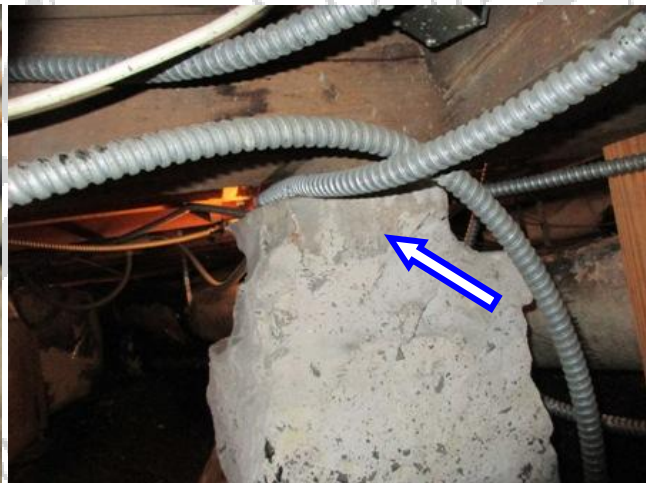
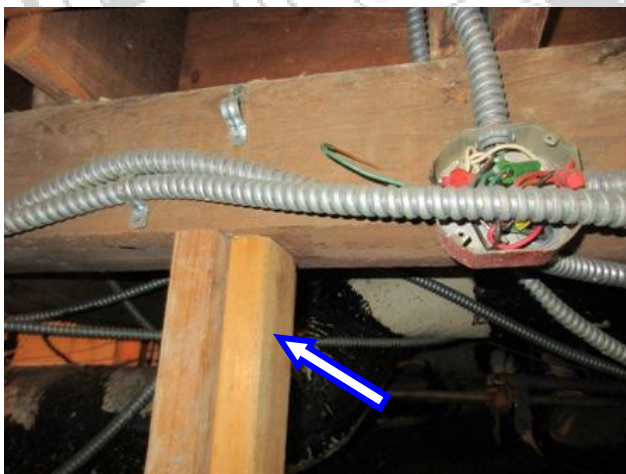
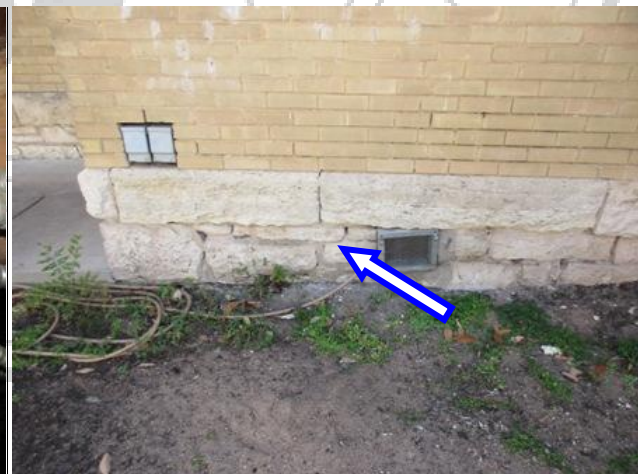
- This home uses a concrete and block perimeter beam with unevenly spaced block and wood supports under the home. Due to the age of this home being over 35 yrs, the type of concrete used is highly suspect due to pitting and deterioration.

- This foundation shows to be in need of significant repair. Floors are not deemed level throughout the structure. Under home supports were in need of additional supports. Current pier and beam supports under the home are aged and beginning to crumble. Full pier replacement is highly recommended.

- Strong musty odors were noted throughout the home. Ventilation is missing at all sides of the foundation skirting. Cross ventilation is required to allow naturally occurring moisture under the home to escape.

- It is highly recommended this foundation support structure be fully replaced by a qualified foundation repair contractor.
- Sampling of photos noted below.

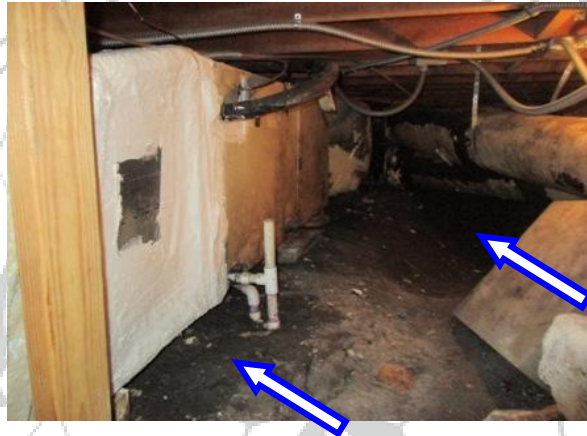
- Grading under the home is not deemed level. There are many depressions, holes, and uneven areas under the home that tend to hold water after heavy rain storms. Standing water contributes to the musty odors present in this home. Soils should be filled level and adjusted to drain out from under the home to prevent stagnant water conditions.

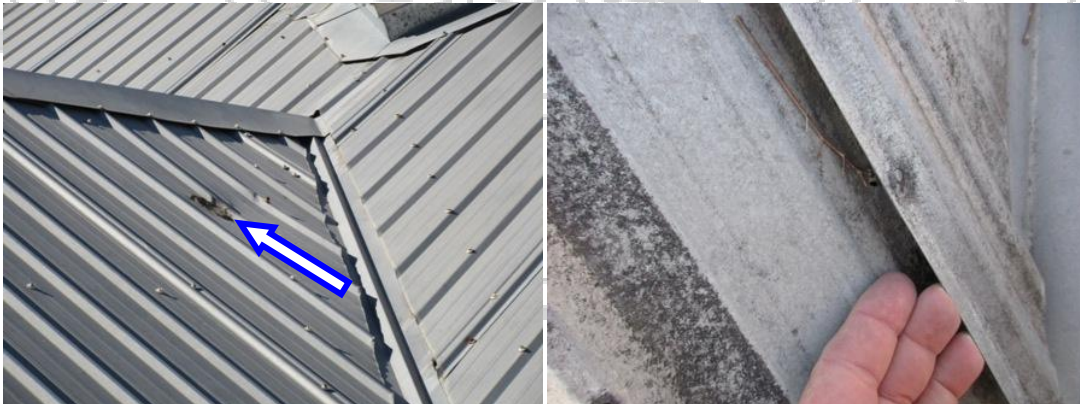
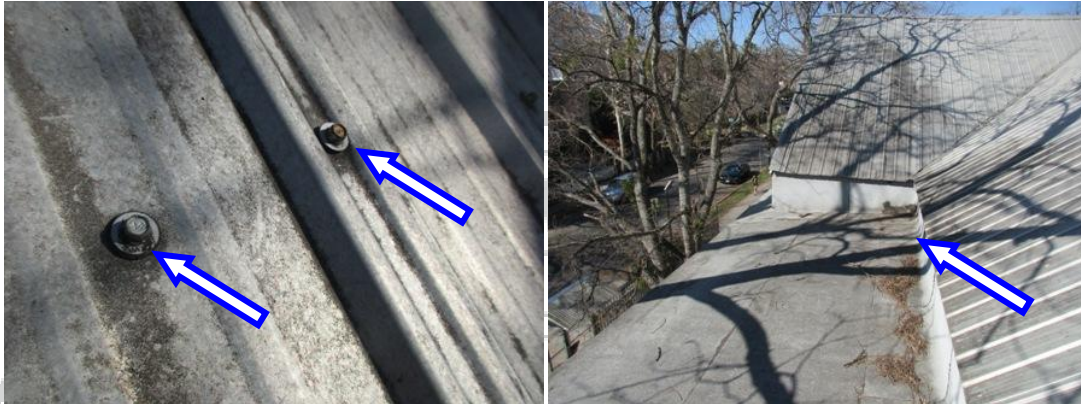
- Metal roofing on this home was noted to be damaged, corroded, having loose fasteners, and is NOT deemed to be water tight. Numerous points of moisture penetration were noted at the time of this inspection.
- Full replacement is highly recommended as this roofing is at the end of its serviceable life expectancy.
- Sampling of photos noted below.

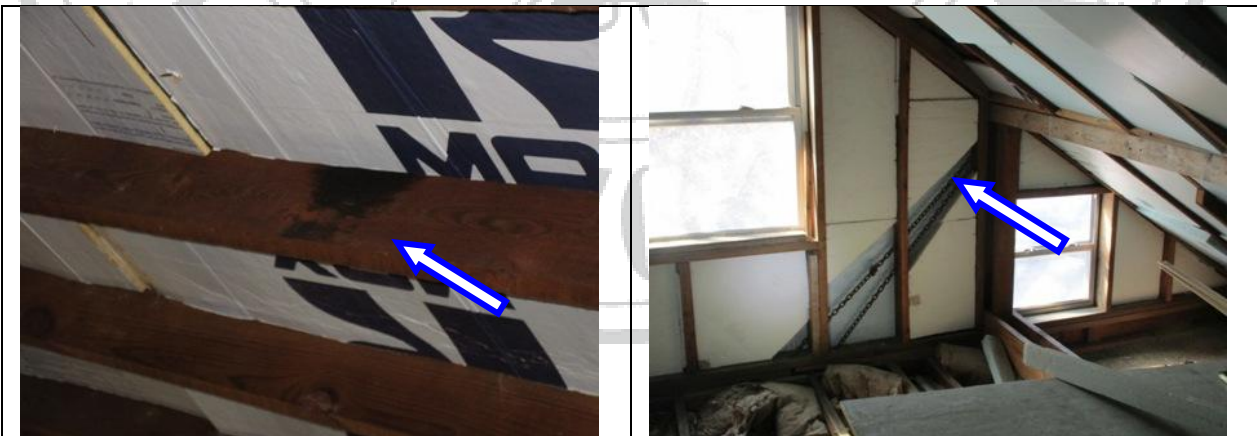
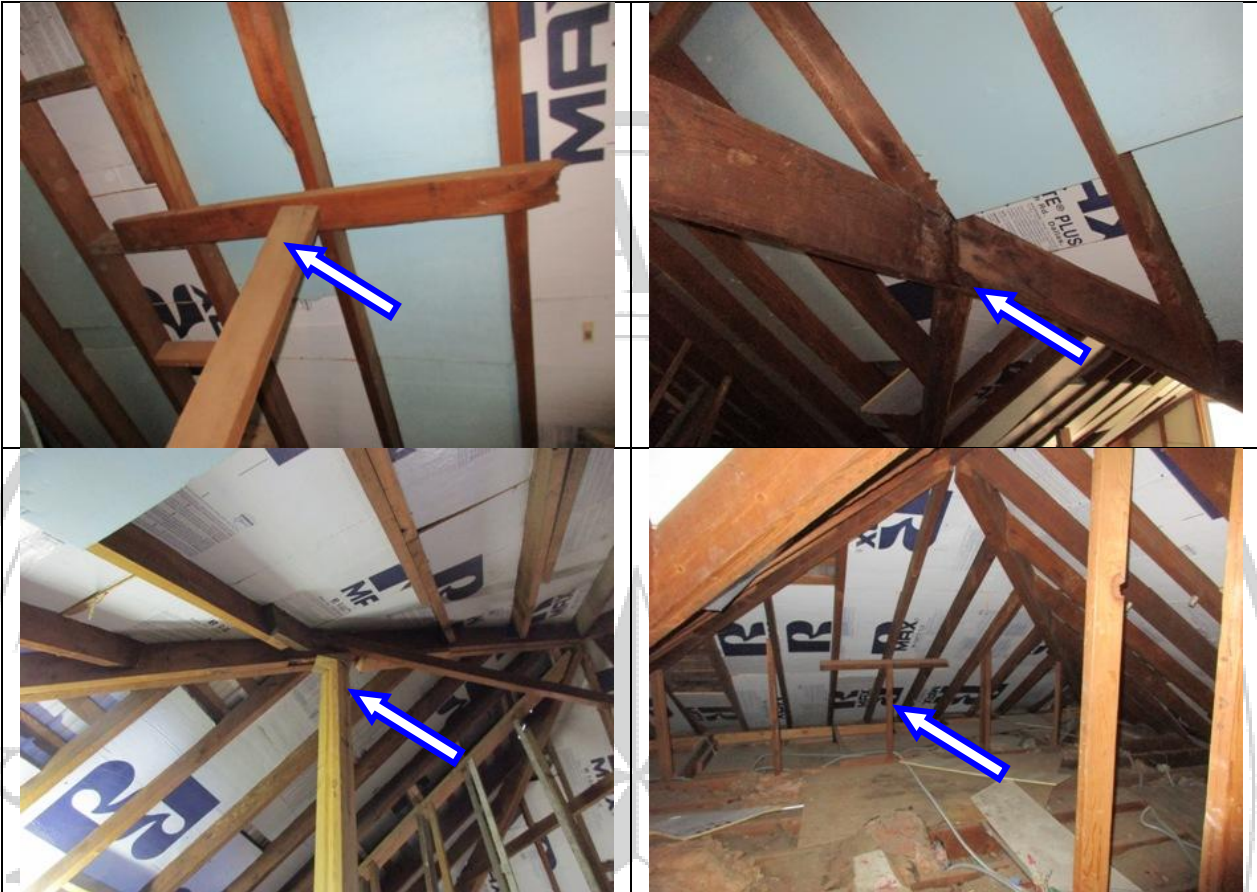
- Many portions of the attic framing are original to the home. Current framing has been patched and pieced together and is not deemed structurally sound due to sagging rafters and loose connections.

- Attic bracing needs to be updated before this roof structure fails. Bracing is needed at all over spanned rafters and where rafters were spliced together.

- Right side framing for the room addition is not properly supported. The use of chains to support the roof structure is deemed unsafe and needs to be corrected.

- Framing throughout the attic areas is water stained due to numerous roof leaks.
- Second story support beams are beginning to pull away from the home.

- Attic insulation is deemed to be non- existent, sparsely placed, and should be brought up to minimum the building standards of at least R-30 for increased energy efficiency. Air leaks and drafts were noted throughout the attic areas.

- A qualified Professional Engineer should be consulted to provide a full plan of replacement / repair for this attic structure.
- Sampling of photos noted below.

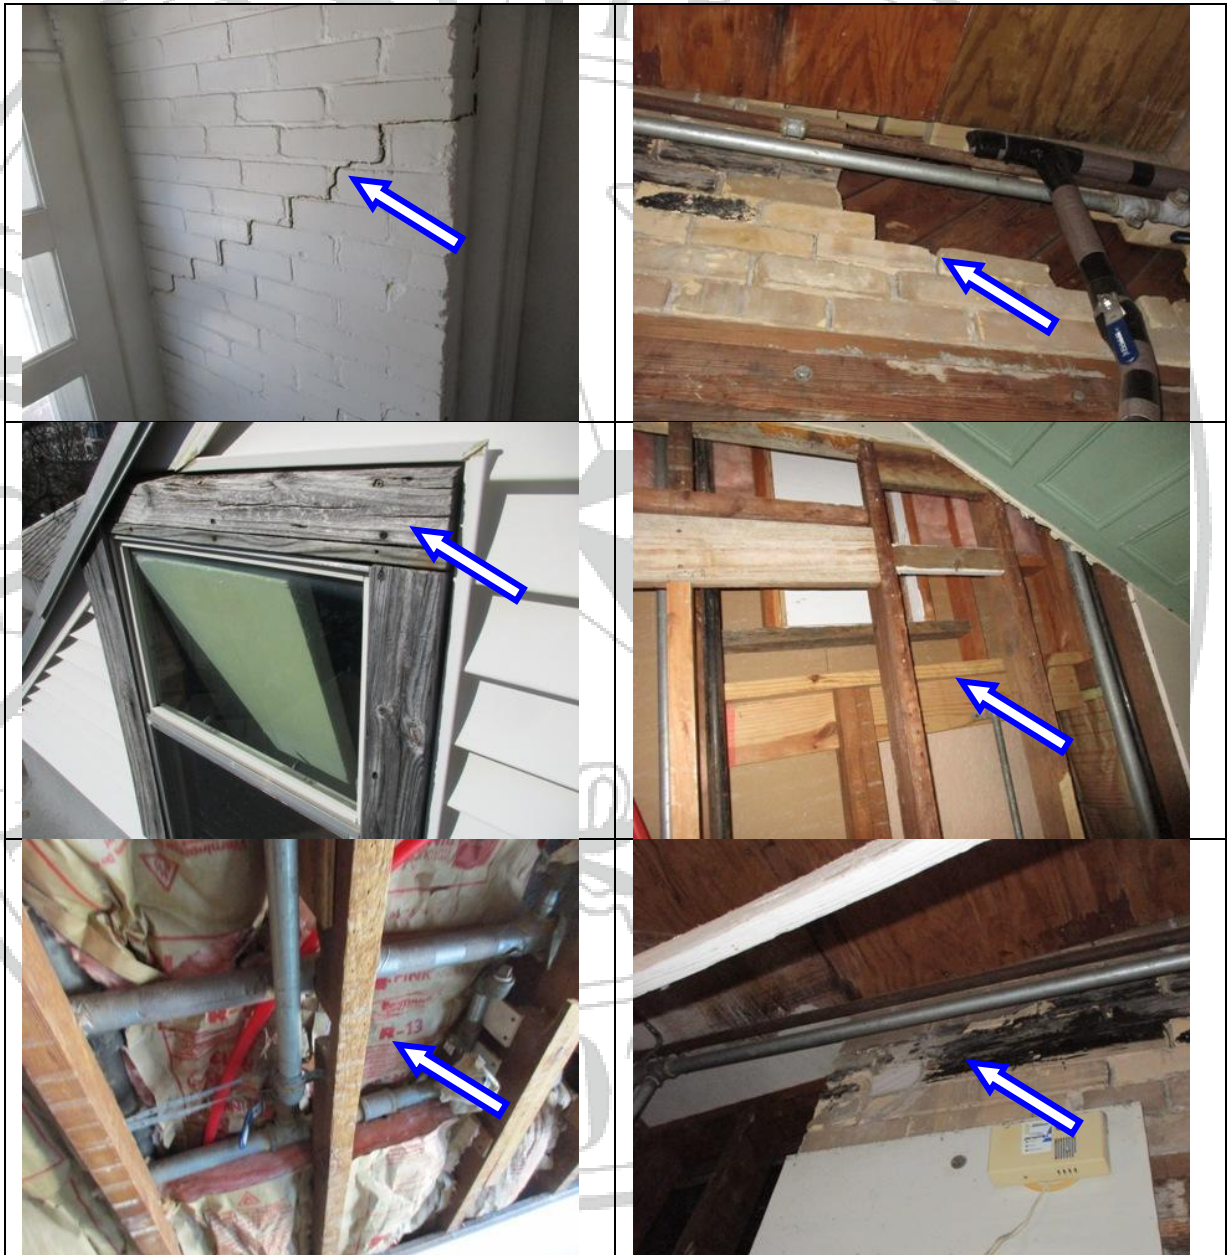
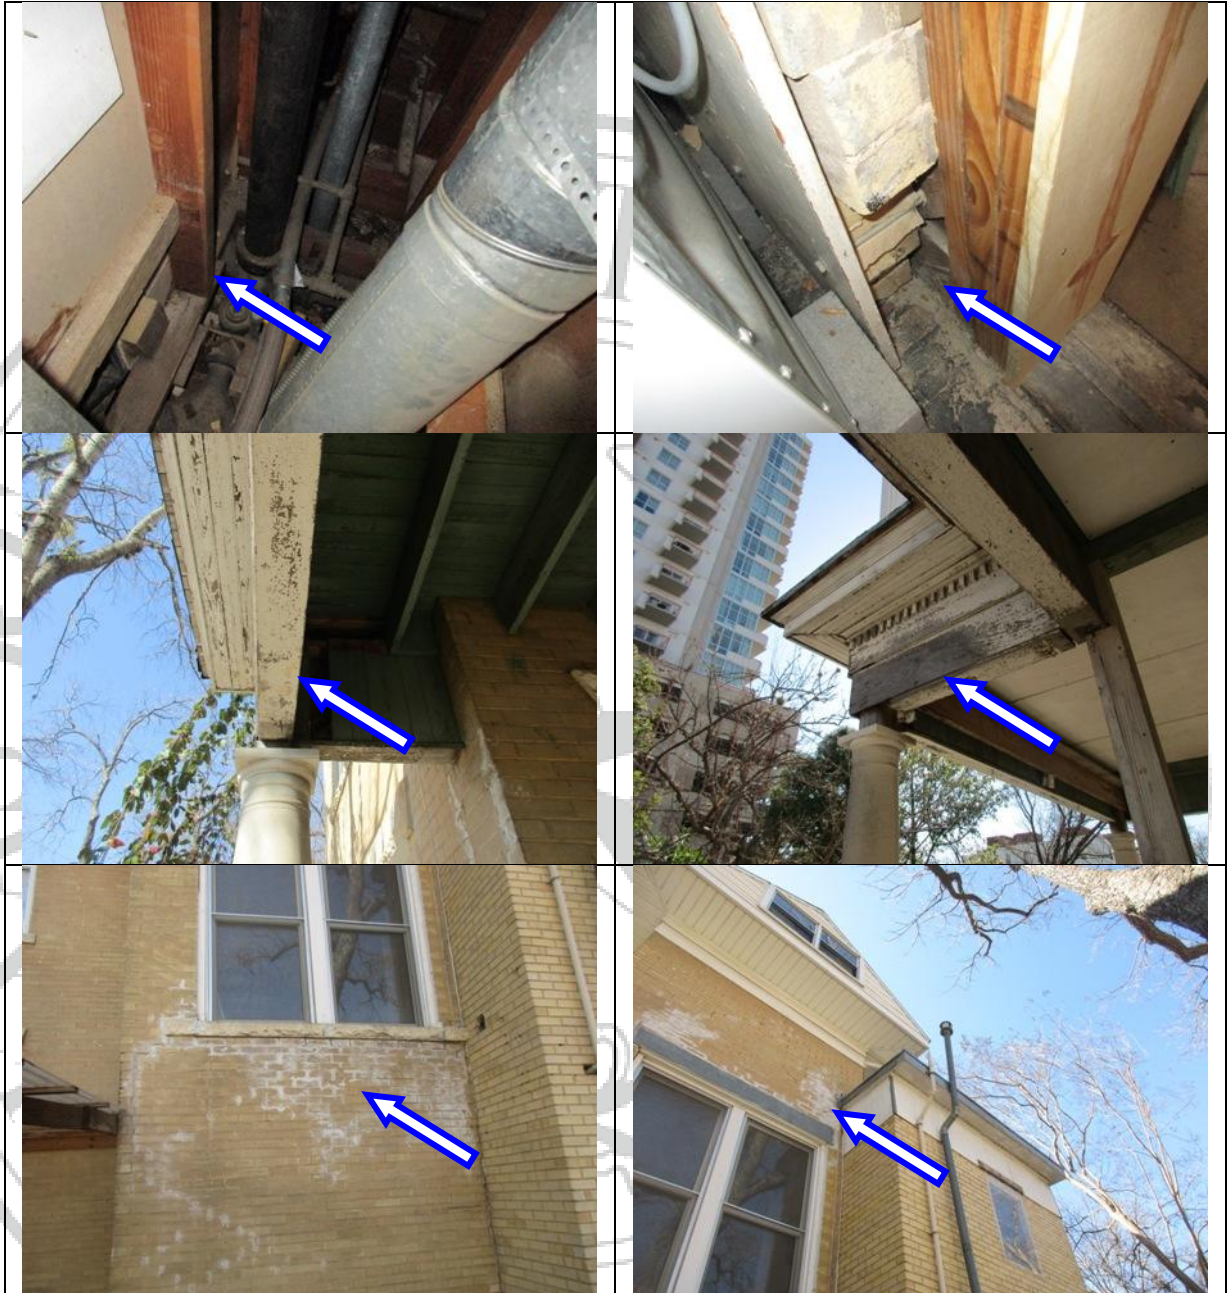
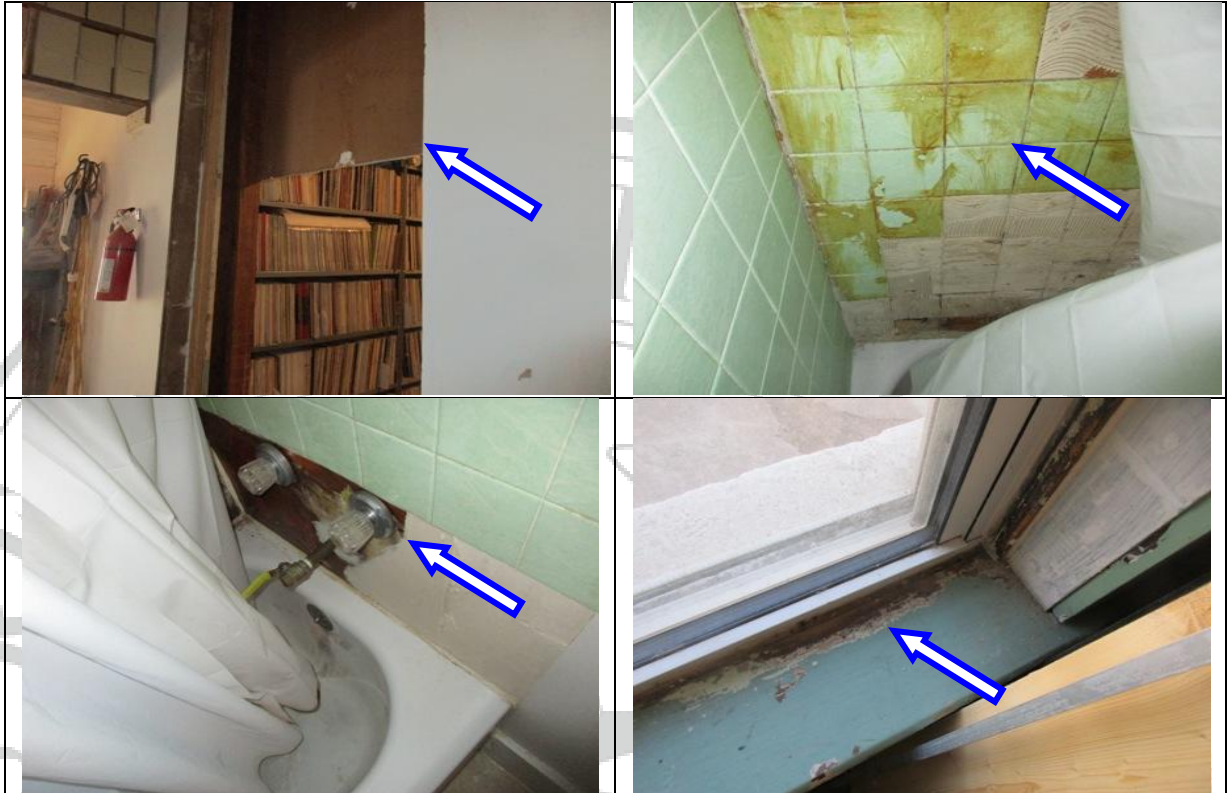
- Interior and exterior walls were noted to be cracked / damaged due to structural movement and moisture intrusions. Significant repair will be needed to correct these issues. Many interior walls have been cut open to access behind the wall plumbing and electrical components and were never repaired.

- Exterior brickwork has cracked at numerous areas and will need significant repairs.
- Nearly all exterior wood trim and fascia boards were noted to be heavily weathered, damaged, or missing.

- Interior masonry around many windows and doors was noted to be damaged, crumbling, or missing.
- Insulation was noted to be missing at all areas where the walls have been opened for plumbing or electrical repairs.

- Water damaged / leaks were noted around numerous window frames throughout the home. This has damaged the framing and window sills.

- All bathrooms were noted to have at least some serious wall / moisture damaged with many areas missing substantial sections of wall tiles. Bathroom areas are NOT deemed to be water tight around the tub and shower assemblies.
- Walls at the lower level kitchen have shifted and pulled away from the flooring.
- Brick mortar at the exterior brickwork has eroded and is missing in many areas.
- A qualified Professional Engineer should be consulted to provide a full plan of replacement / repair for all framing.
- Sampling of photos noted below.

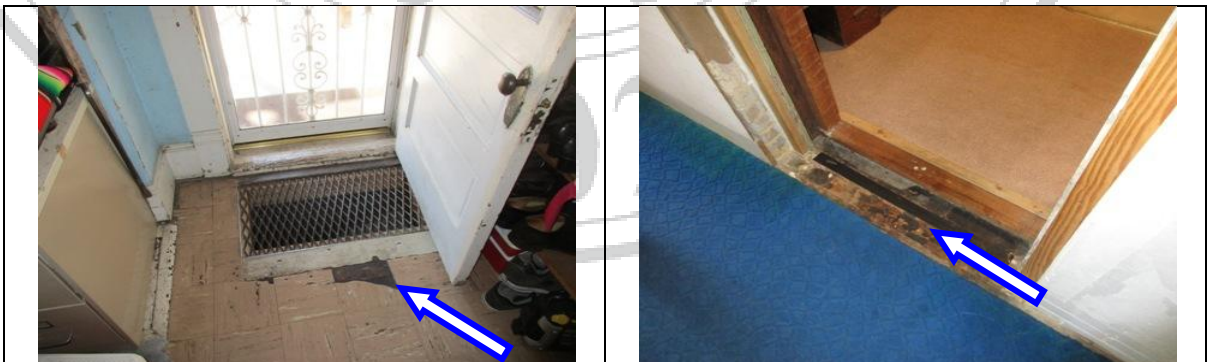
- Significant water damaged was noted throughout the home at the floors and ceilings.
- Floor tiles were noted to be missing at many of the rooms. The majority of flooring was noted to be beyond their serviceable life and should be replaced.
- Cracks at the ceilings in most rooms should be patched or repaired.
- Sampling of photos noted below.

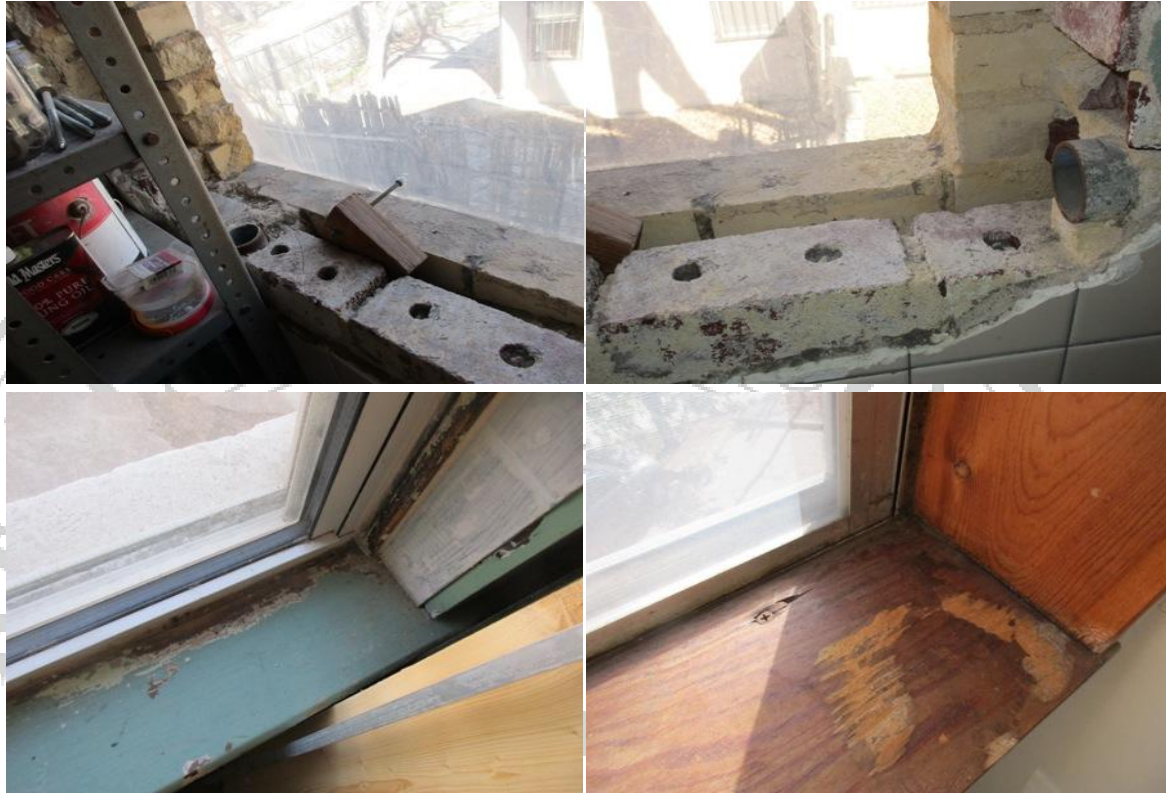
- **Windows did not all have a proper moisture flashing installed. All exterior windows must be properly flashed and caulked to prevent moisture penetration.**
- **No safety glass installed in required locations. While not required when this home was originally constructed. Safety glass is now required at all window locations within 24" of any exterior door.**
- **Windows throughout this home are an older style single pane wood framed window. These windows are aged and rotted at most locations and should all be replaced with a more energy efficient type of double pane window.**
- **Significant repair costs for windows should be expected due to age of the windows, moisture leakage, and lack of energy efficiency.**

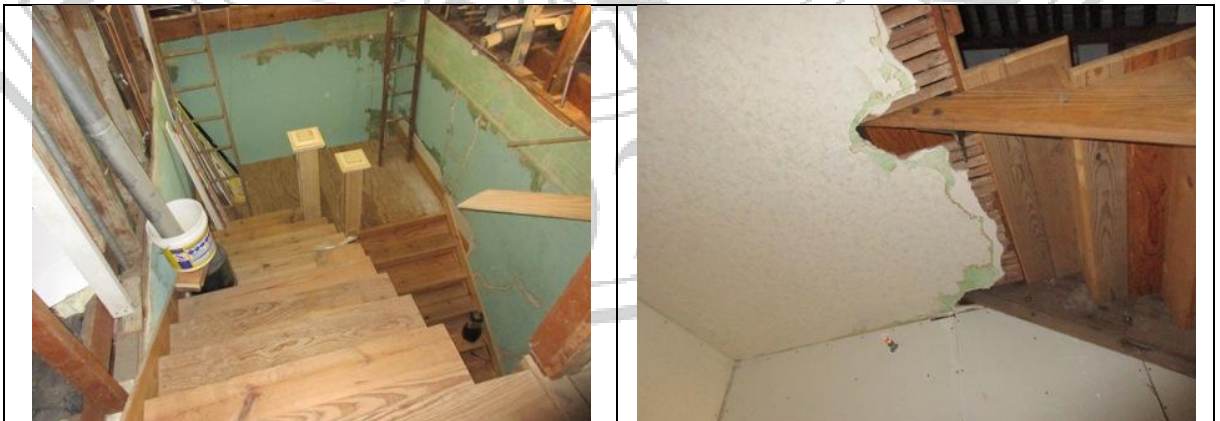
- Stairs at all levels are NOT deemed safe for use. Handrails are missing and unevenly spaced stairs were noted. Stairs are the most frequent location of injury accidents in the home. A consistent rise and run is important for safety. The tallest riser can be no more 3/8<sup>th</sup> inch higher than the shortest and the deepest tread can be no more 3/8<sup>th</sup> inch greater than the shallowest. Proper handrails and landings are also critical.
- Stair stringers are poorly connected to the surrounding framing and need repair.
- Sampling of photos noted below.

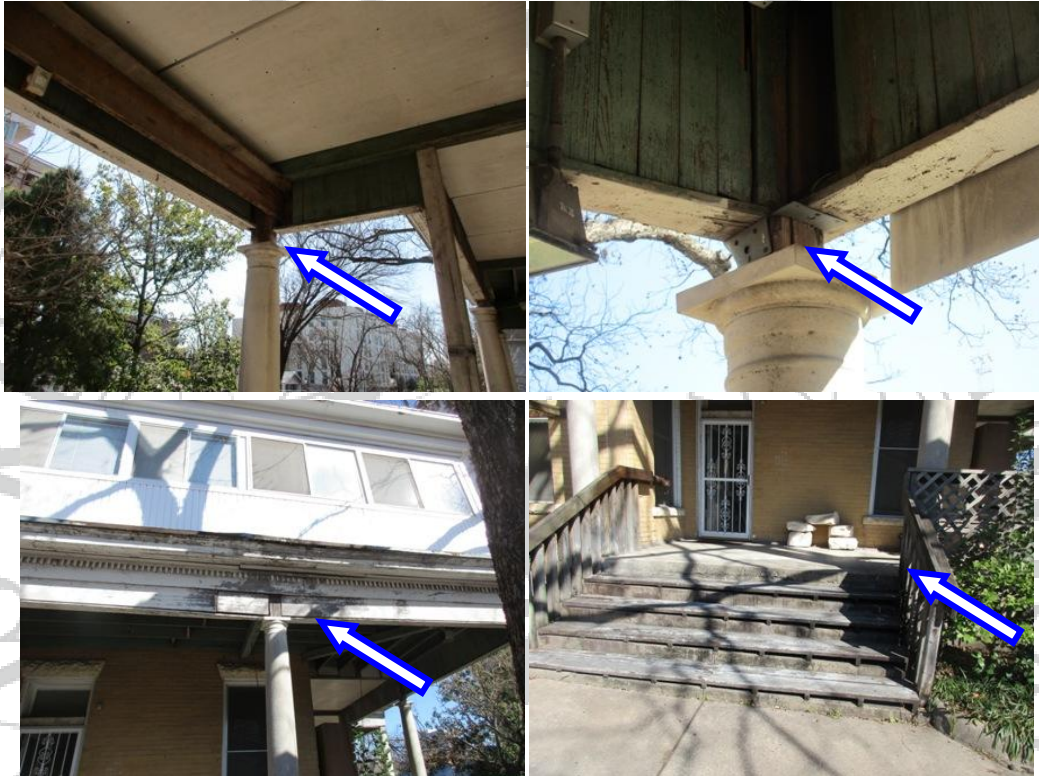
- Porches are in overall poor repair. Significant repair is required where the support beams were noted to be sagging, no graspable handrails are installed, and all open post and overhand connections are open.

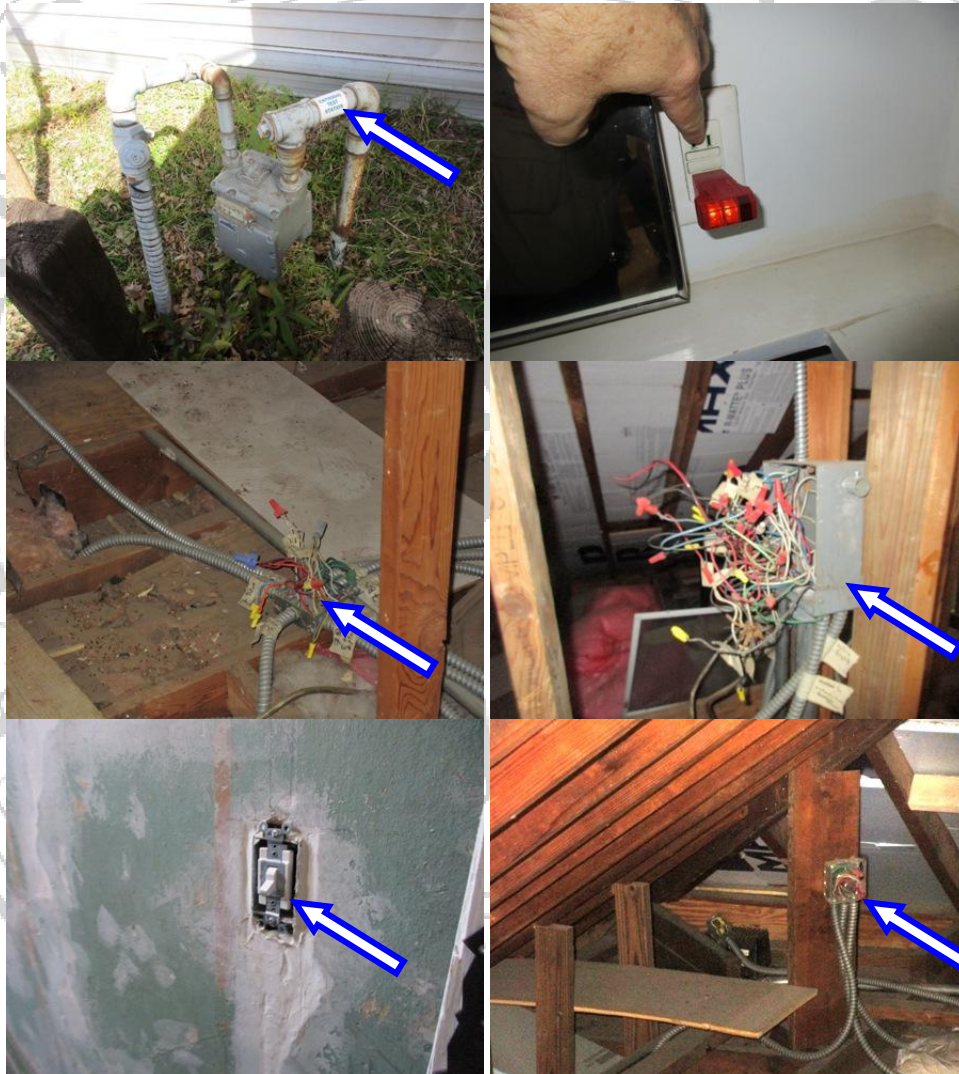
- Numerous open electrical panels and connections were noted in most attic, hallways, and open wall areas.
- Permits for electrical may not have been pulled from the City. Repairs appear to have been made by non-licensed individuals and are not deemed safe. A full electrical evaluation should be made by a State Licensed Electrician with a full plan of repair and cost estimates.

- No working GFCI protected outlets present at required areas. While this was the building standard when this home was constructed, today's building standards now require GFCI protection. Ground Fault Circuit Interrupter (GFCI) protection should be located at all bathroom, exterior, and at all kitchen counter outlets.

- Insufficient receptacles at the kitchen counter areas. 2ft/4ft rule applies for countertop spaces. Receptacles are required at least 24" from the wall of a counter and at least 48" between all other outlets so that no point is ever more than 24" from a receptacle.
- Smoke detectors are needed in all bedroom areas.
- Carbon monoxide detectors are needed in all hallway areas outside of bedrooms.
- Grounding / bonding is missing at the exterior gas meter as required per current building standards.
- Not all breakers are marked. All breakers at the service panels need to be fully identified as to their intended purpose.
- Sampling of photos noted below.

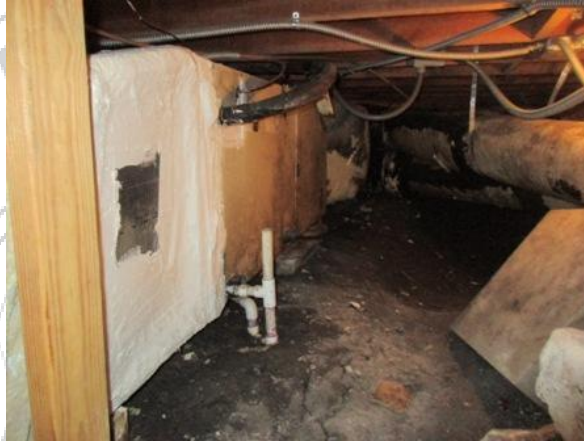
- The current crawl space furnace is deemed to aged and should be replaced.
- The furnace needs to be raised off the ground.

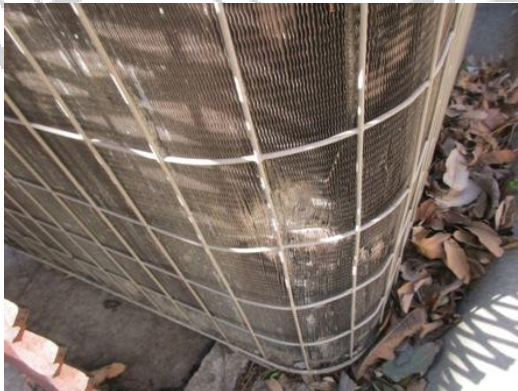
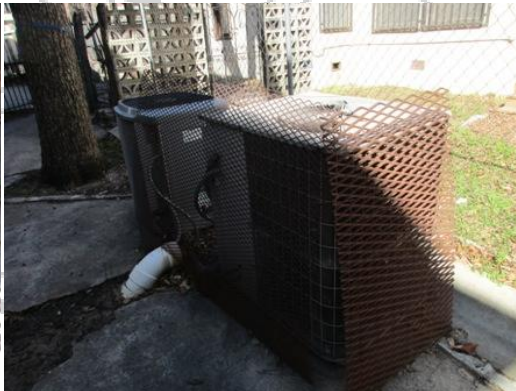
- The main home unit is over 20 yrs old and needs to be replaced.
- The Delta T differential temperature between the supply and service vents was noted to be low (10 degrees). This indicates the system may not be performing correctly or should be cleaned / serviced by a licensed technician. A properly functioning system should produce a temperature differential between supply & return air of 15 - 20 degrees F. Usually, this condition indicates a loss of refrigerant or postponed maintenance. The numerous connections between fittings on the refrigerant pipes can loosen or develop cracks that allow refrigerant gas to escape. I recommend that you ask an HVAC repairman to reappraise the system prior to purchase and to provide estimates or repairs needed to restore proper temperature differentials.

- Cooling fins at the exterior compressor are bent / damaged and should be repaired by a qualified A/C technician.

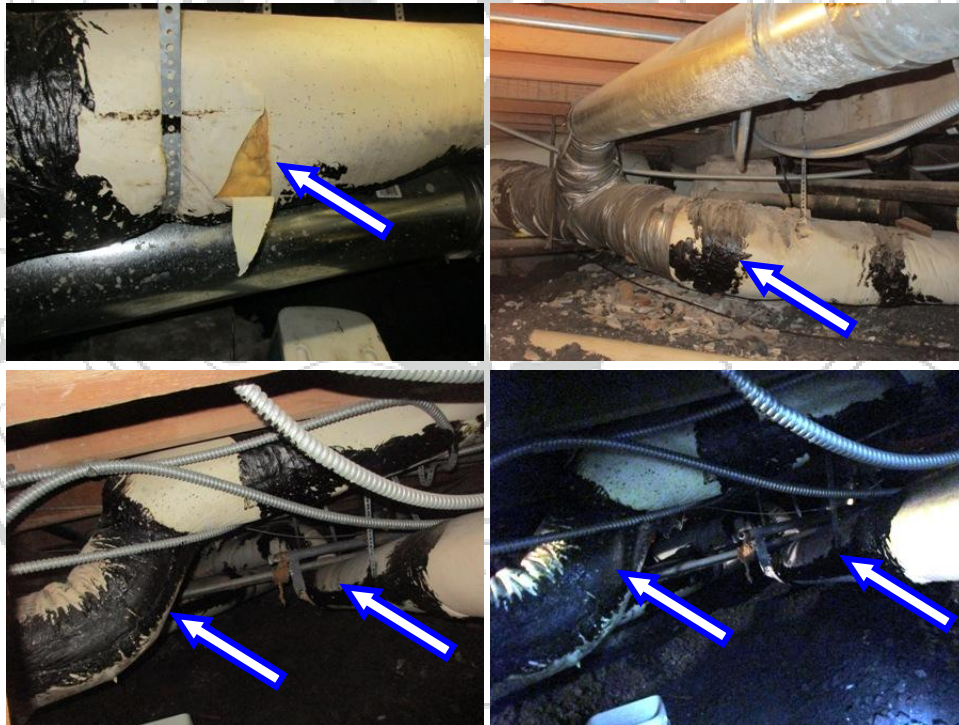
- **No central duct system installed. Ducts are limited and do not service all rooms. Ducts currently in place are deemed to be aged, damaged, and in need of repair.**

- FYI: A white colored mineral insulation was observed on HVAC ducts in the *readily accessible* portions of the attic and unfinished crawl spaces.
- **DISCLAIMER: THE IDENTIFICATION OF ASBESTOS IS EXCLUDED FROM THIS REPORT PER CONTRACT, AS IT REQUIRES MICROSCOPIC EXAMINATION THAT IS BEYOND THE SCOPE OF THIS LIMITED VISUAL HOME INSPECTION.** If the material is asbestos and is damaged, the fibers can be released and can mix with the dust and remain in the basement area for an indefinite period of time. In most cases the type of material observed on heating pipes such as these is identified as containing asbestos. The Environmental Protection Agency (E.P.A.) reports that asbestos represents a health hazard if "friable" (damaged, crumbling, or in any state that allows the release of fibers). Further guidance is available from the Environmental Protection Agency (E.P.A.). Due to the age of construction, there may be other materials within the home that contain asbestos but are not identified by this inspection report. If asbestos fibers are inhaled or swallowed, they can have serious effects on your health, which may not appear until 15 or more years later. Asbestos can cause asbestosis, a scarring of the lungs that leads to breathing problems and heart failure. It can also cause cancer of the lungs and mesothelioma, a rare cancer of the chest or abdomen lining. Special regulations exist for the removal and disposal of asbestos.

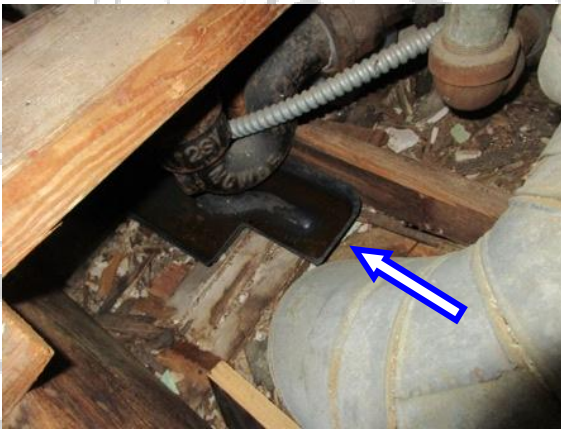
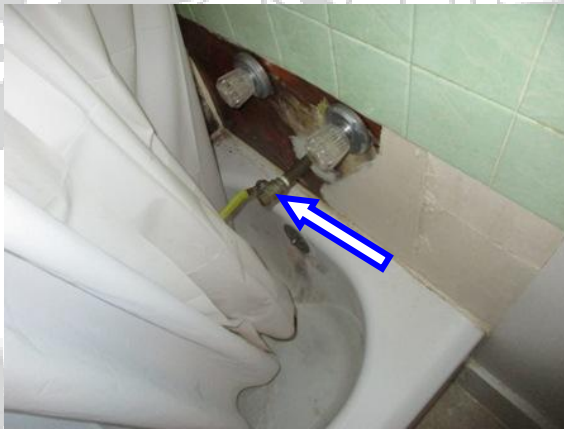
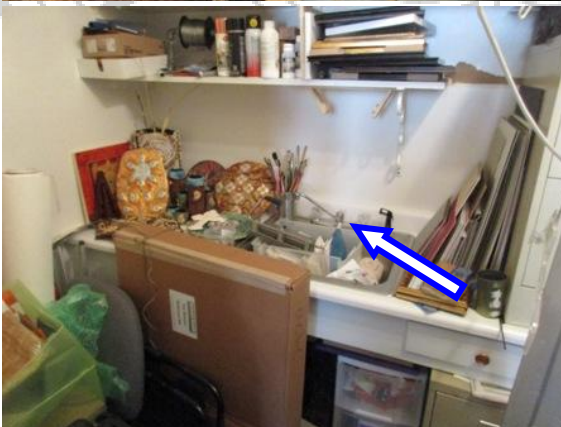
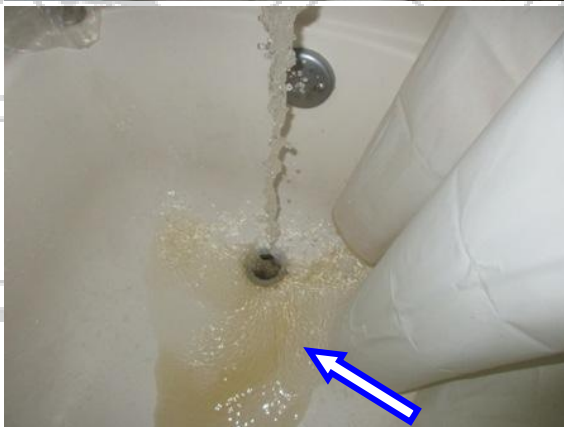
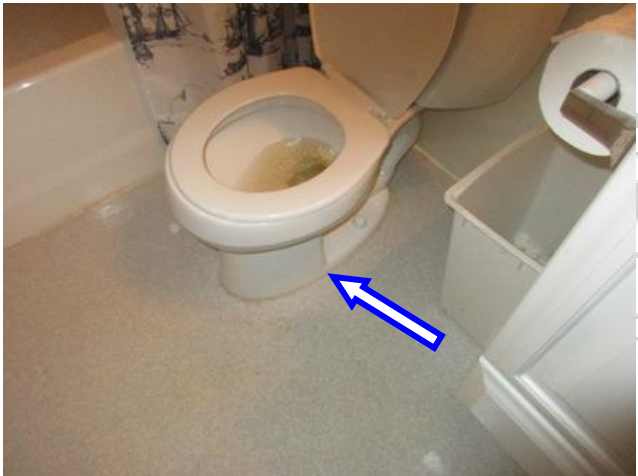
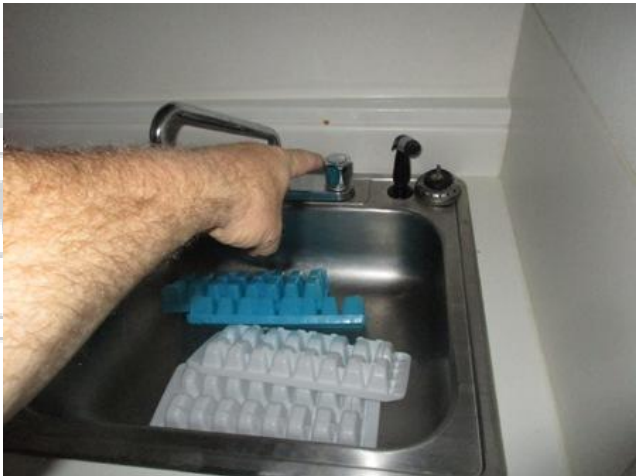
- No expansion tank installed at the top of the water heaters.
- The upstairs on demand water heater is NOT functional.
- The downstairs 40 gallon water heater is missing a drain pan and the connected gas line valve needs to be capped off where it is not being used.

- Anti siphon devices are not installed at all exterior faucets.
- Upstairs tub was noted to be leaking behind the wall area.
- Upstairs tub was noted to be missing at faucet nozzle.

- All loose toilets need to be fully secured to the floors and caulked and sealed.
- Faucets at the kitchens and bathrooms were noted to leak and should be repaired.

- Upstairs toilet was installed too close to the wall. A minimum 15" between wall & center of the bowl is required. Larger persons may find it difficult sitting on toilet.

- When tub faucets were turned on there was a heavy brown sediment that was evident in the water. The old galvanized / steel water pipes are fully depreciated and are beginning to show evidence of corrosion. While the old water pipes may be serviceable the client should be aware that repairs may be costly, for security I advise that you ask a plumber to provide estimates for the replacement of the old pipes with modern copper or PEX lines.
