# PROPERTY INSPECTION REPORT

Concerning: **2102 Rio Grande (Dormitory property)**

By: **Kenneth L. Larson / TREC # 5702**

**February 15, 2016**

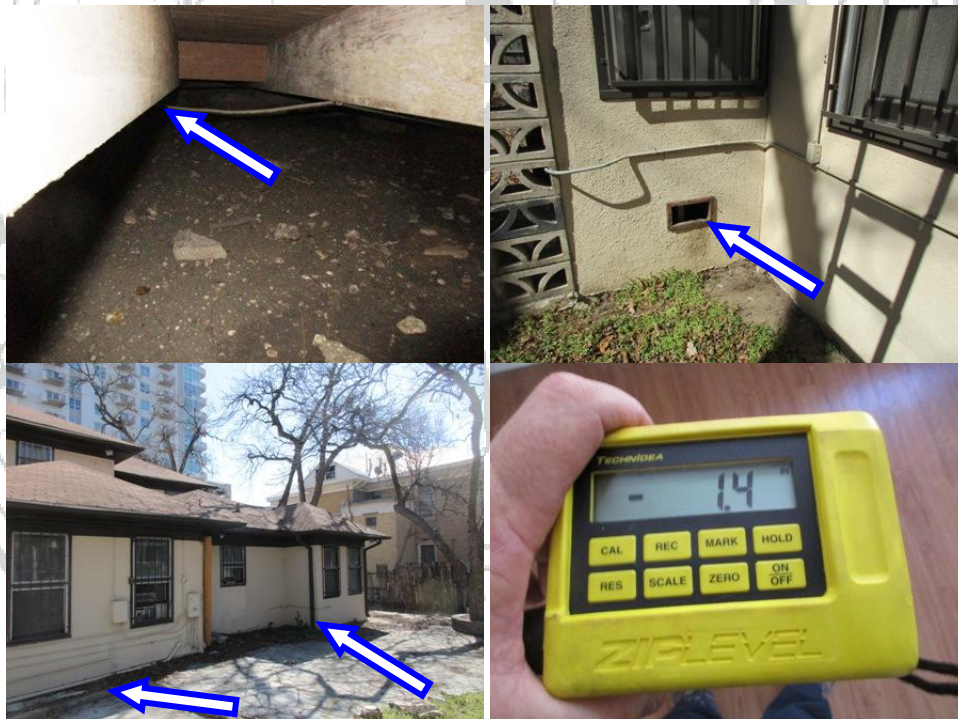
- Missing supports / piers. Joists under the home are over spanned and need additional piers installed to properly support the flooring.
- This foundation shows to be in need of significant repair. Floors are not deemed level throughout the structure. Under home supports were in need of additional supports. Current pier and beam supports under the home are aged and beginning to crumble. Full pier replacement is highly recommended.

- Interior doors do not close and latch properly due to foundation settlement.
- Strong musty odors were noted throughout the home. Ventilation is missing at all sides of the foundation skirting. Cross ventilation is required to allow naturally occurring moisture under the home to escape.

- It is highly recommended this foundation support structure be fully replaced by a qualified foundation repair contractor.
- Sampling of photos noted below.

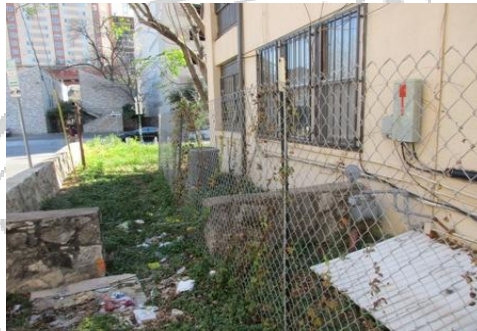
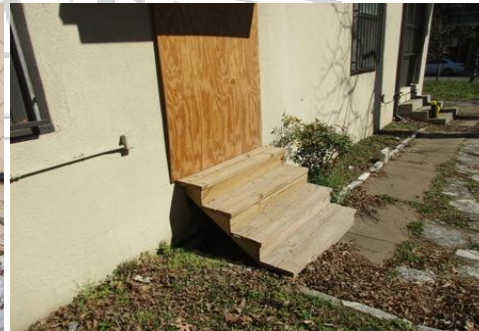
- Poor drainage noted at the rear and sides of the home. Recommend addition buried drains or swales be installed to allow water to drain away from these areas. Soils need to be sloped approximately 2" inches for every 10' ft away from the property to all proper drainage.

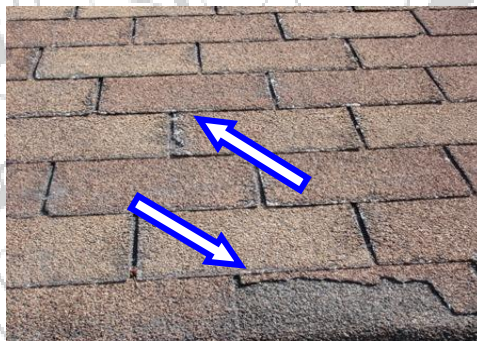
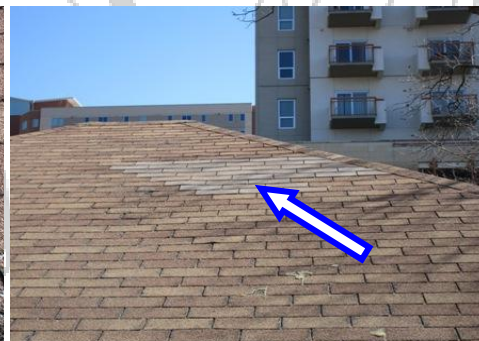
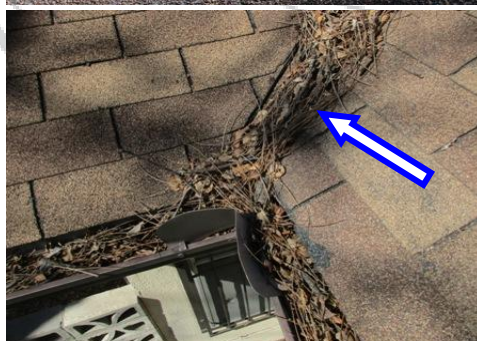
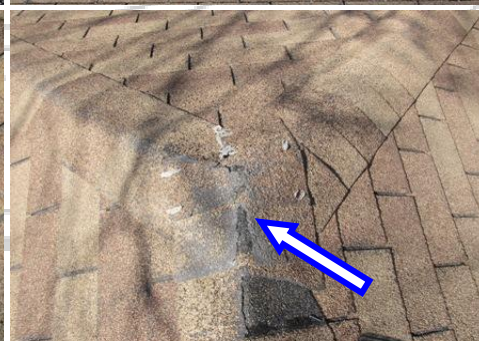
- Roof shingles are worn, damaged, loose, and beyond their serviceable life; replacement is highly recommended. Interior water stains at the walls and ceiling indicated current leaks. Previous patches were attempted but poorly installed.
- Full replacement is highly recommended as this roofing is at the end of its serviceable life expectancy.
- Sampling of photos noted below.

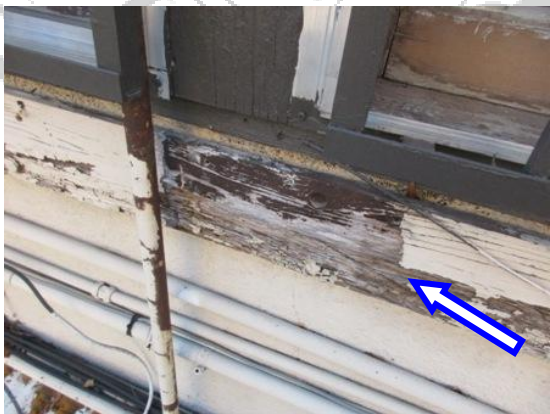
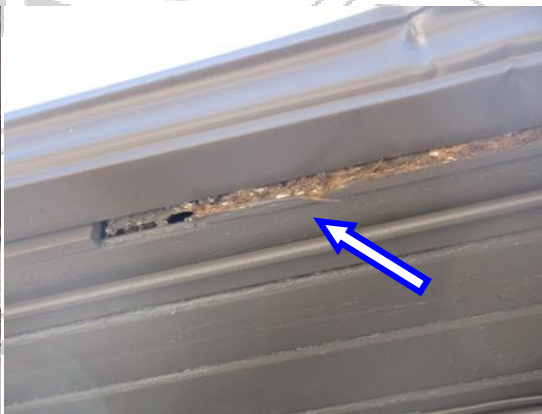
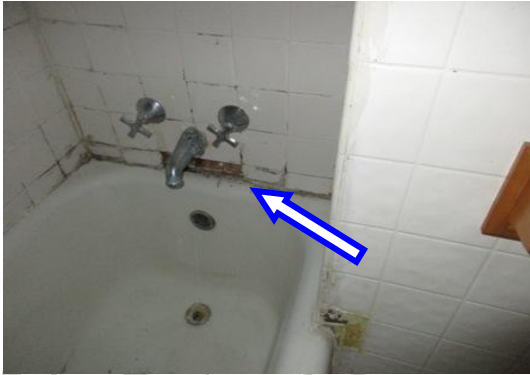
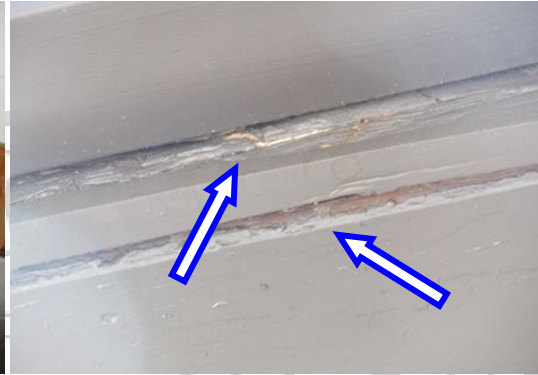
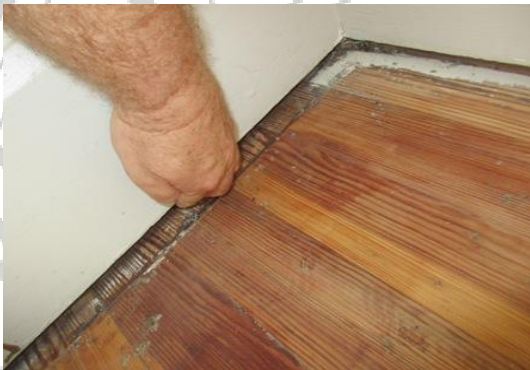
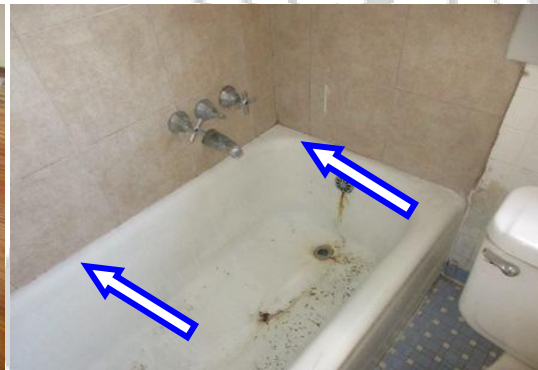
- Nearly all exterior wood trim and fascia boards were noted to be heavily weathered, damaged, or missing.
- Water damaged / leaks were noted around numerous window frames throughout the home. This has damaged the framing and window sills.

- All bathrooms were noted to have at least some serious wall / moisture damaged with many areas missing substantial sections of wall tiles. Bathroom areas are NOT deemed to be water tight around the tub and shower assemblies.

- Wall at the top of the stair landing has pulled away from the floor at approx. 2".
- A qualified Professional Engineer should be consulted to provide a full plan of replacement / repair for all framing.

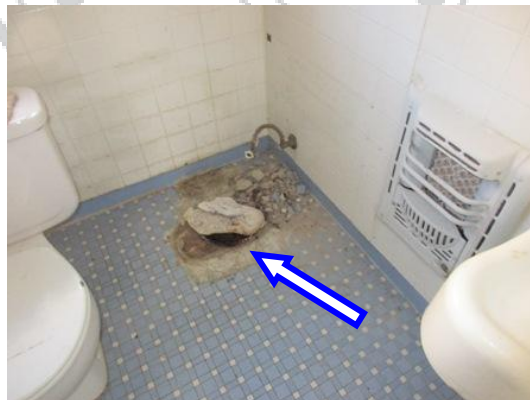
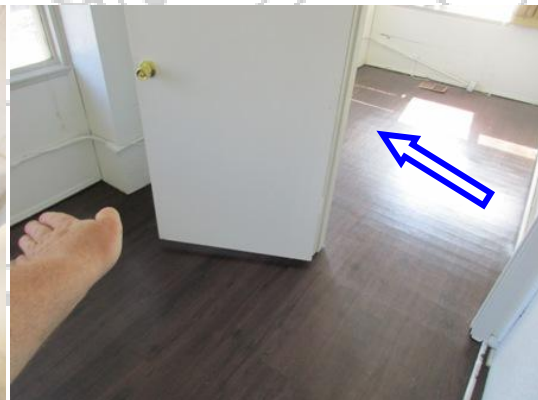
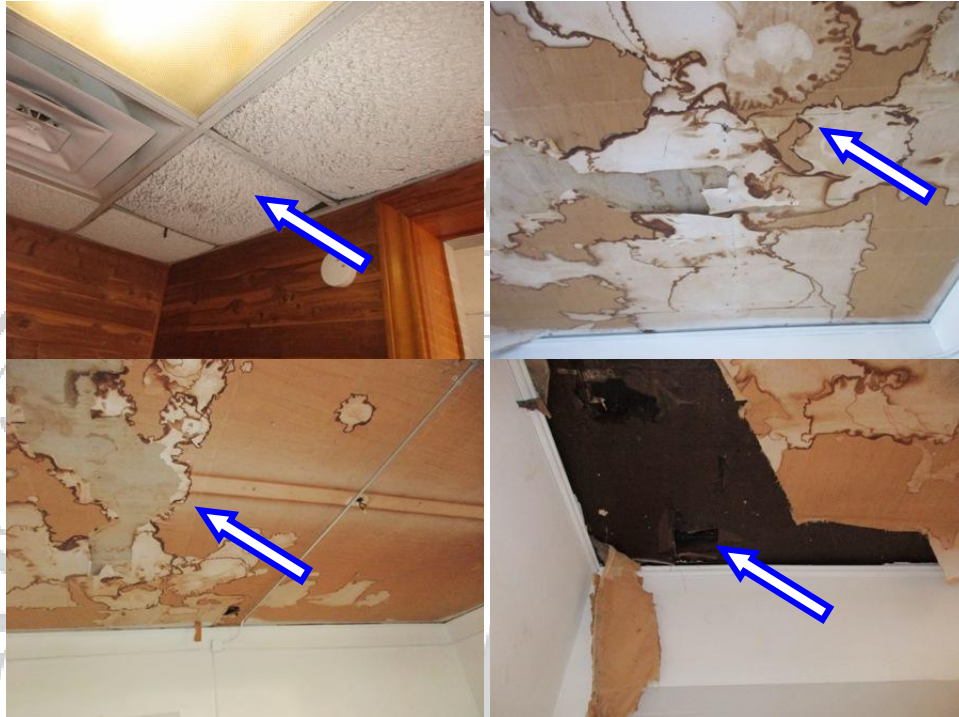
- Significant water damage was noted throughout the home at the floors and ceilings.
- Floor tiles were noted to be missing at many of the rooms. The majority of flooring was noted to be beyond their serviceable life and should be replaced.
- Cracks at the ceilings in most rooms should be patched or repaired.
- Upstairs flooring at the south side of the property sags due to settlement.
- Sampling of photos noted below.

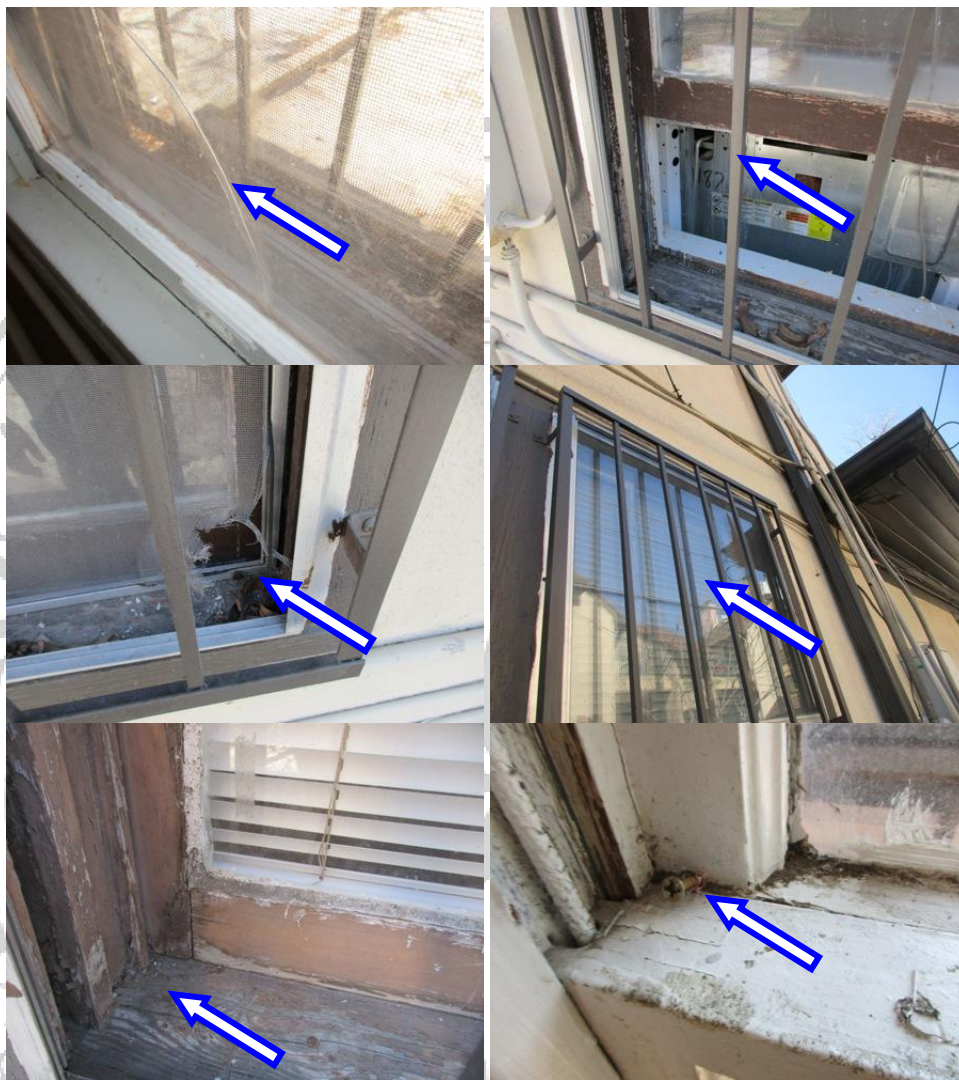
- Burglar bars at all windows need to be removed. Fire / safety hazard exists where these bars to not have a properly installed breakaway latch.
- Windows did not all have a proper moisture flashing installed. All exterior windows must be properly flashed and caulked to prevent moisture penetration.

- No safety glass installed in required locations. While not required when this home was originally constructed. Safety glass is now required at all window locations within 24" of any exterior door.

- Windows throughout this home are an older style single pane wood framed window. These windows are aged and rotted at most locations and should all be replaced with a more energy efficient type of double pane window.

- Window screens were torn or missing at most windows.
- Glass at the rear kitchen window is broken and needs repair.
- Significant repair costs for windows should be expected due to age of the windows, moisture leakage, and lack of energy efficiency.

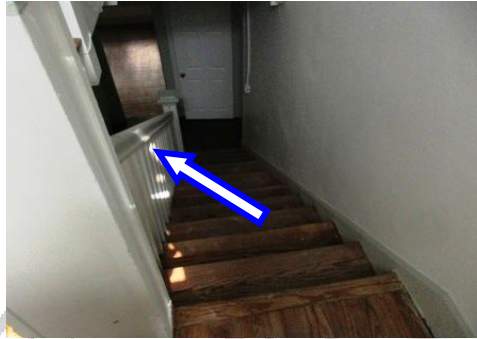
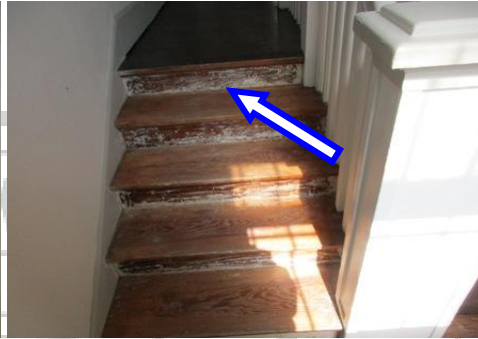
- Stairs at all levels are NOT deemed safe for use.
- Handrails are missing and unevenly spaced stairs were noted. Stairs are the most frequent location of injury accidents in the home. A consistent rise and run is important for safety. The tallest riser can be no more 3/8<sup>th</sup> inch higher than the shortest and the deepest tread can be no more 3/8<sup>th</sup> inch greater than the shallowest. Proper handrails and landings are also critical.
- Sampling of photos noted below.

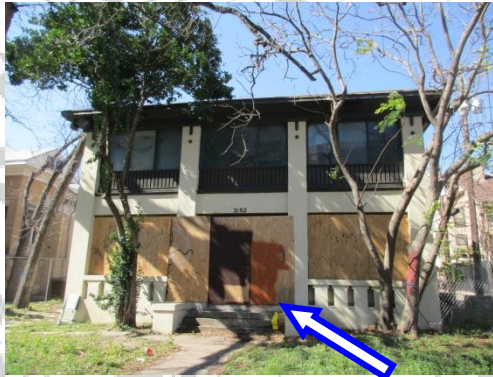
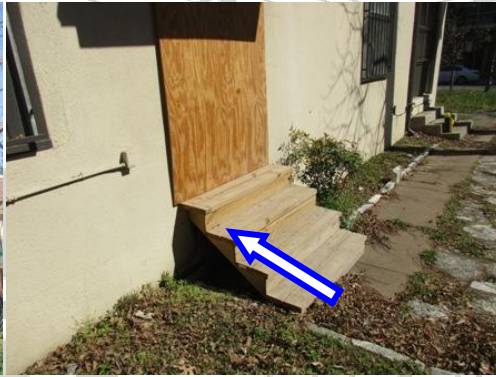
- Porches require a graspable handrail at the side and front of the property.

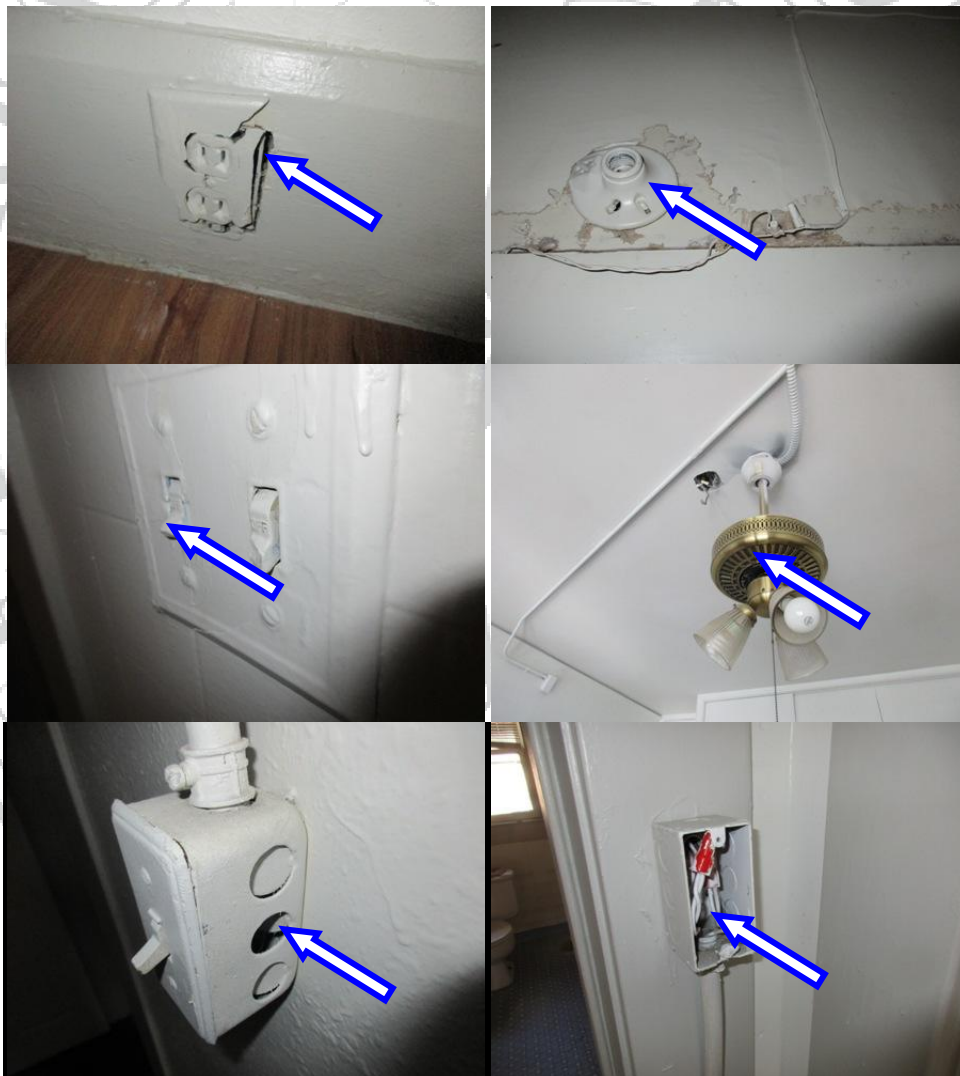
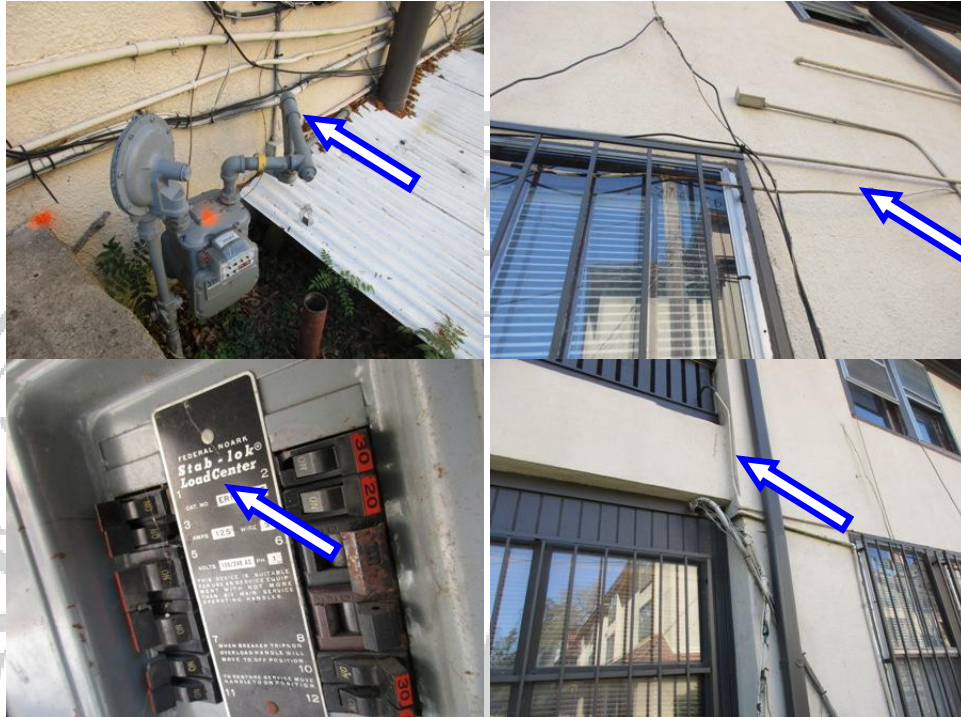
- A Federal Pacific Electric Company "Stab-Lok" electrical panel is in use. I recommend that this panel be replaced by a licensed electrician. These panels have been noted to present a latent hazard by malfunctioning under certain conditions resulting in a jammed breaker which afterward may not trip under load, failure of the bus connections due to inadequate bending space for the service entry conductors, and potential arcing problems.

- The majority of plugs in the home are not grounded. Ungrounded receptacles are a potential safety hazard. Numerous outlets and switches were noted to be broken and need to be replaced.

- Many light fixtures were noted to be missing or damaged. Exposed wiring where the fixtures were removed need to be properly capped off. Safety Hazard.

- No working GFCI protected outlets present at required areas. While this was the building standard when this home was constructed, today's building standards now require GFCI protection. Ground Fault Circuit Interrupter (GFCI) protection should be located at all bathroom, exterior, and at all kitchen counter outlets.

- Insufficient receptacles at the kitchen counter areas. 2ft/4ft rule applies for countertop spaces. Receptacles are required at least 24" from the wall of a counter and at least 48" between all other outlets so that no point is ever more than 24" from a receptacle.
- Exterior wiring run along the sides of the property are not encased inside an approved conduit. Safety Hazard.
- Smoke detectors are needed in all bedroom areas.
- Carbon monoxide detectors are needed in all hallway areas outside of bedrooms.
- Grounding / bonding is missing at the exterior gas meter as required per current building standards.
- All open / exposed electrical junction boxes need to be covered or sealed.
- Not all breakers are marked. All breakers at the service panels need to be fully identified as to their intended purpose.
- Sampling of photos noted below.

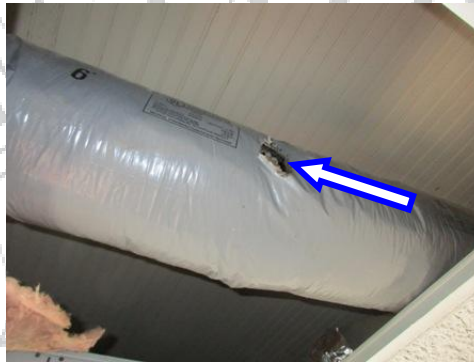
- HVAC ducts are older style grey plastic covered duct. This plastic is photosensitive and thus breaks down with exposure to light and heat and cannot be repaired. Ducts are not fully sealed and are leaking air. Recommend replacement for increased energy savings.
- Sampling of photos noted below.

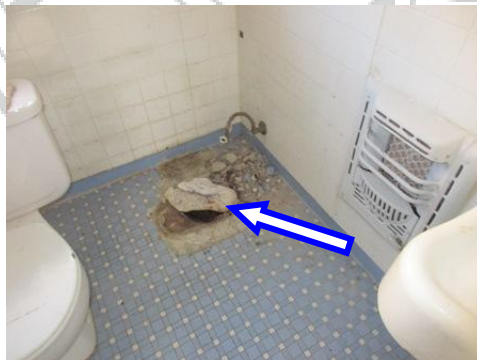
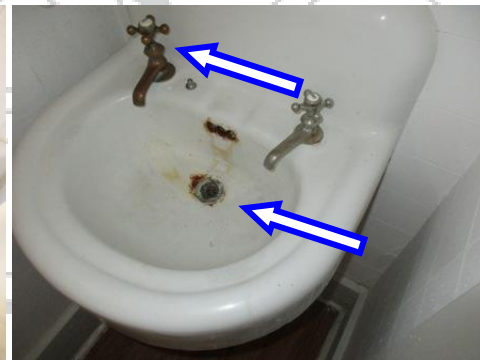
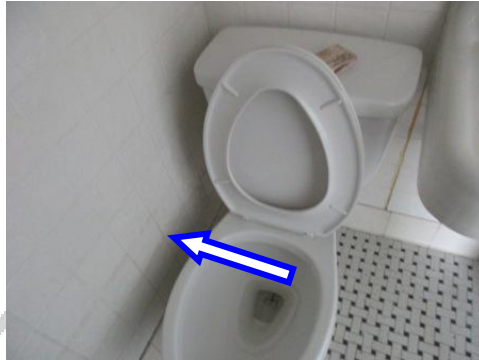
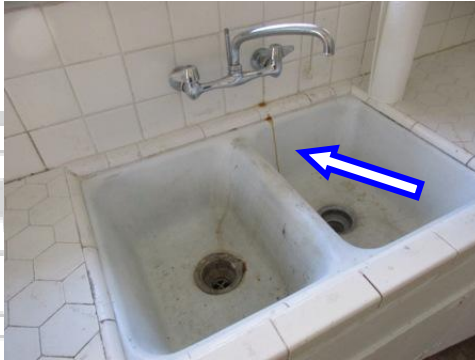
- Water was turned off at this property. No working water heaters were located but may be inside the sealed off attic areas. Condition is unknown.
- Anti siphon devices are not installed at all exterior faucets.
- All toilets were noted to be loose or damaged.
- All loose toilets need to be fully secured to the floors and caulked and sealed.
- All sinks, faucets, and tubs were noted to be chipped, corroded, and in overall poor repair.
- Upstairs toilet was installed too close to the wall. A minimum 15" between wall & center of the bowl is required. Larger persons may find it difficult sitting on toilet.
- Condition of water lines under the home could not be viewed due to lack of access.
- Sampling of photos noted below.

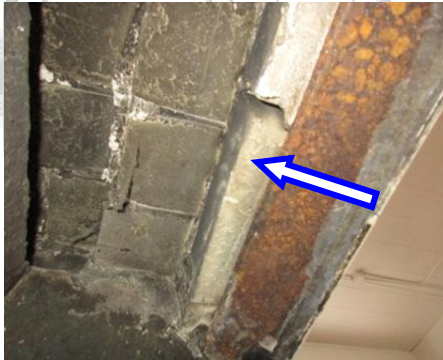
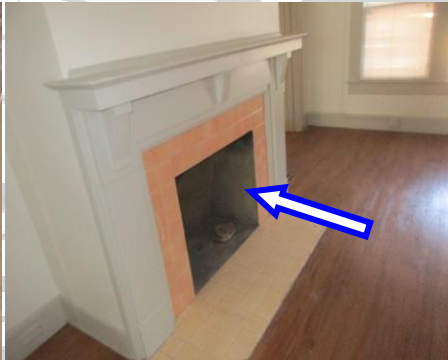
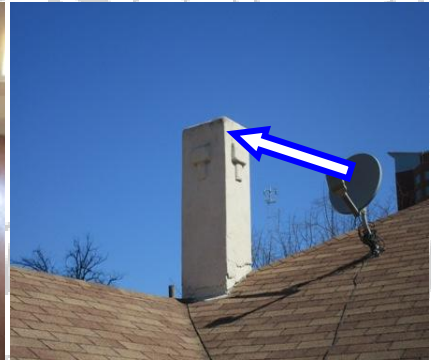
- This fireplace is not deemed safe for use.
- Damper is missing or damaged.
- No makeup air vents are installed at the roof chimney.
- Chimney / Vermin cap is missing.
- Fire bricks and mortar inside the fireplace are deteriorated.
- Sampling of photos noted below.

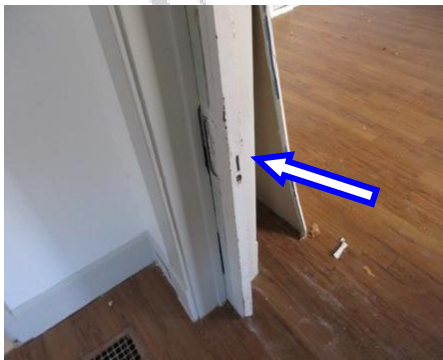
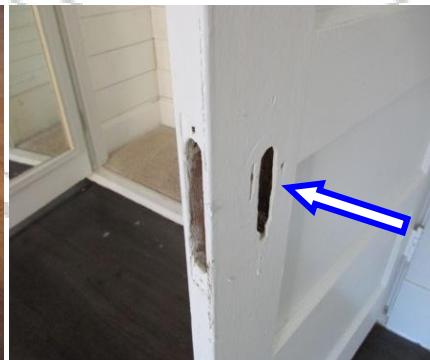
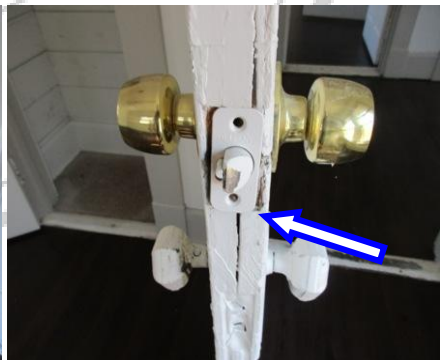
- Nearly all interior doors or door hardware are damaged or missing.
- Sampling of photos noted below.
