# PROPERTY INSPECTION REPORT

Concerning: **702 W. 21stth Street (Dormitory property)**

By: **Kenneth L. Larson / TREC # 5702**

**February 15, 2016**

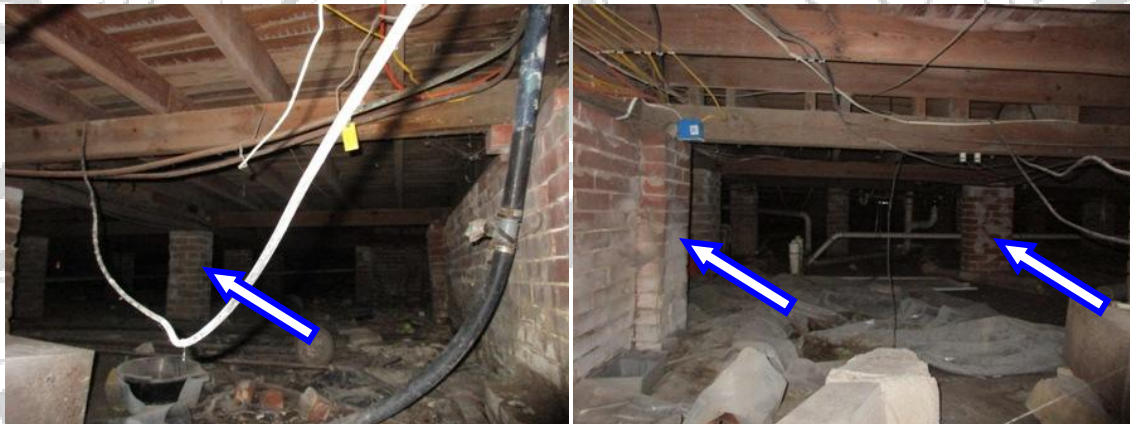
- This home uses a concrete and block perimeter beam with unevenly spaced block and wood supports under the home. Due to the age of this home being over 35 yrs, the type of concrete used is highly suspect due to pitting and deterioration.

- This foundation shows to be in need of significant repair. Floors are not deemed level throughout the structure. Under home supports were in need of additional supports. Current pier and beam supports under the home are aged and beginning to crumble. Full pier replacement is highly recommended.

- Strong musty odors were noted throughout the home. Ventilation is missing at all sides of the foundation skirting. Cross ventilation is required to allow naturally occurring moisture under the home to escape.

- It is highly recommended this foundation support structure be fully replaced by a qualified foundation repair contractor.
- Sampling of photos noted below.

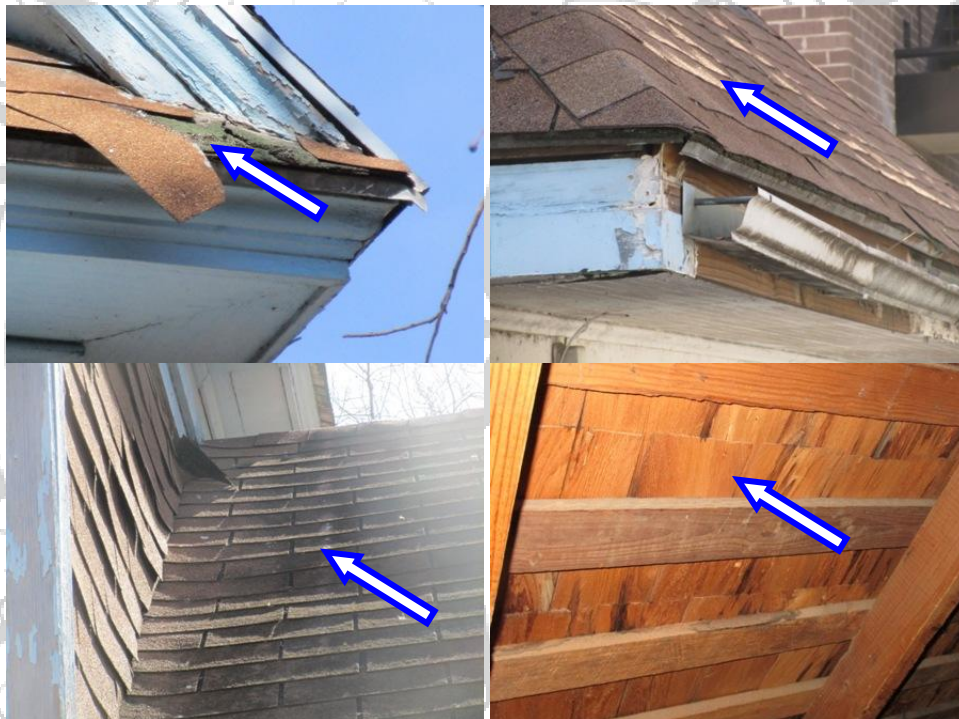
- Due to known difficulties in getting insurance on composition roofing material laid over older wood shingle type roofing material, you are strongly encouraged to have your Insurance Company physically inspect the roof, prior to closing, to fully evaluate the insurability of the roof.
- Roof shingles are worn, damaged, loose, and beyond their serviceable life; replacement is highly recommended. Interior water stains at the walls and ceiling indicated current leaks. Full replacement is highly recommended as this roofing is at the end of its serviceable life expectancy.
- Sampling of photos noted below.

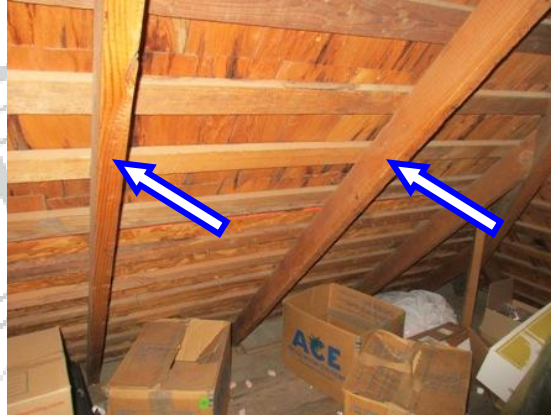
- Client is advised that the current framing may not be able to support the weight of a second layer of roofing materials. All current roofing materials will need to be fully removed, roofing framing replaced, before any new roofing materials are added.
- Attic insulation is deemed to be non-existent, sparsely placed, and should be brought up to minimum the building standards of at least R-30 for increased energy efficiency. Air leaks and drafts were noted throughout the attic areas.

- A qualified Professional Engineer should be consulted to provide a full plan of replacement / repair for this attic structure.
- Sampling of photos noted below.

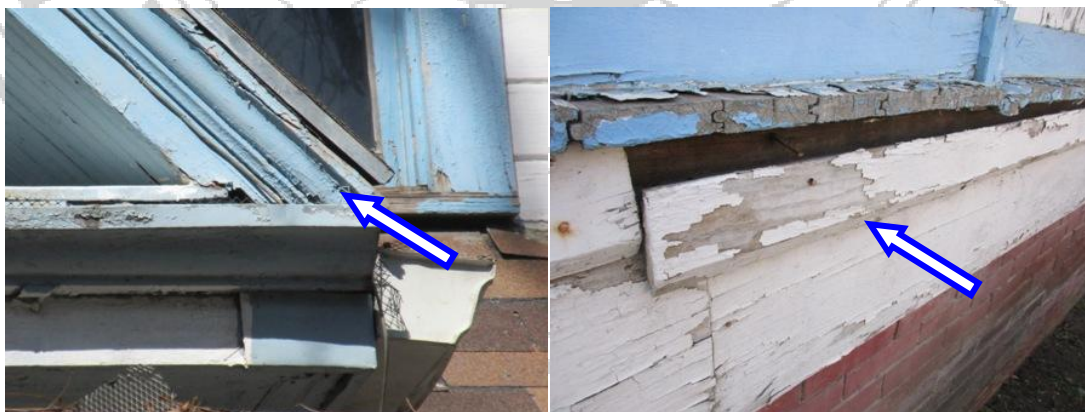
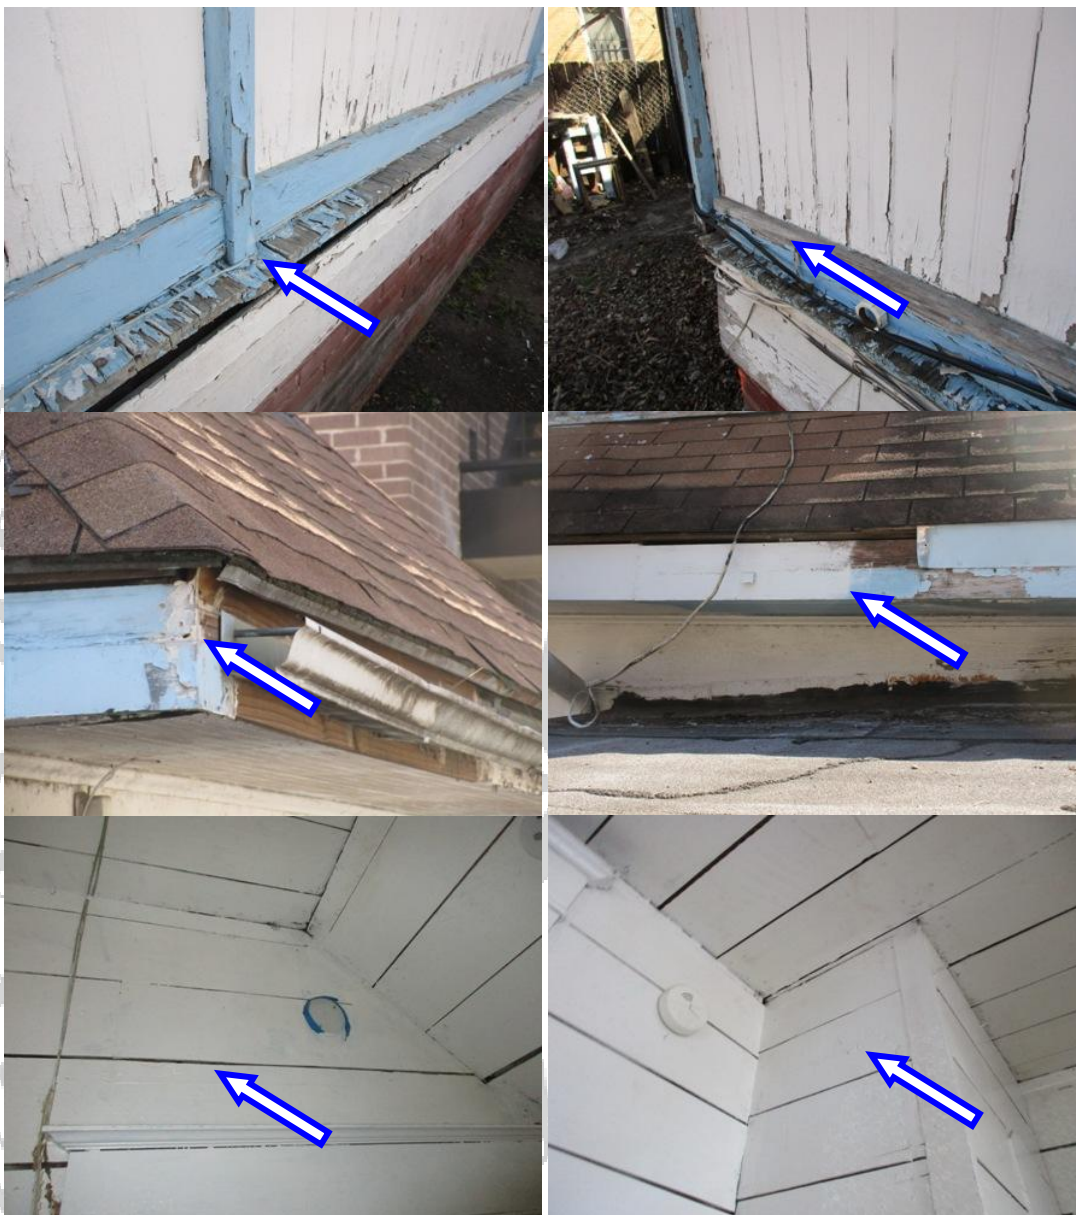
- It is the opinion of this inspector that this home is NOT deemed safe for habitation due to items noted, but not limited to, issues noted below. Significant expense repair should be expected. This report is NOT deemed to be all inclusive and lists only some of the issues found during this visual inspection. Other problems may be found during repair not already included in this report.

- Nearly all exterior wood siding, trim, and fascia boards were noted to be heavily weathered, damaged, or missing.
- Water damage / leaks were noted around numerous window frames throughout the home. This has damaged the framing and window sills.

- About half of the interior walls were covered over with boards / planks.
- A qualified Professional Engineer should be consulted to provide a full plan of replacement / repair for all framing.

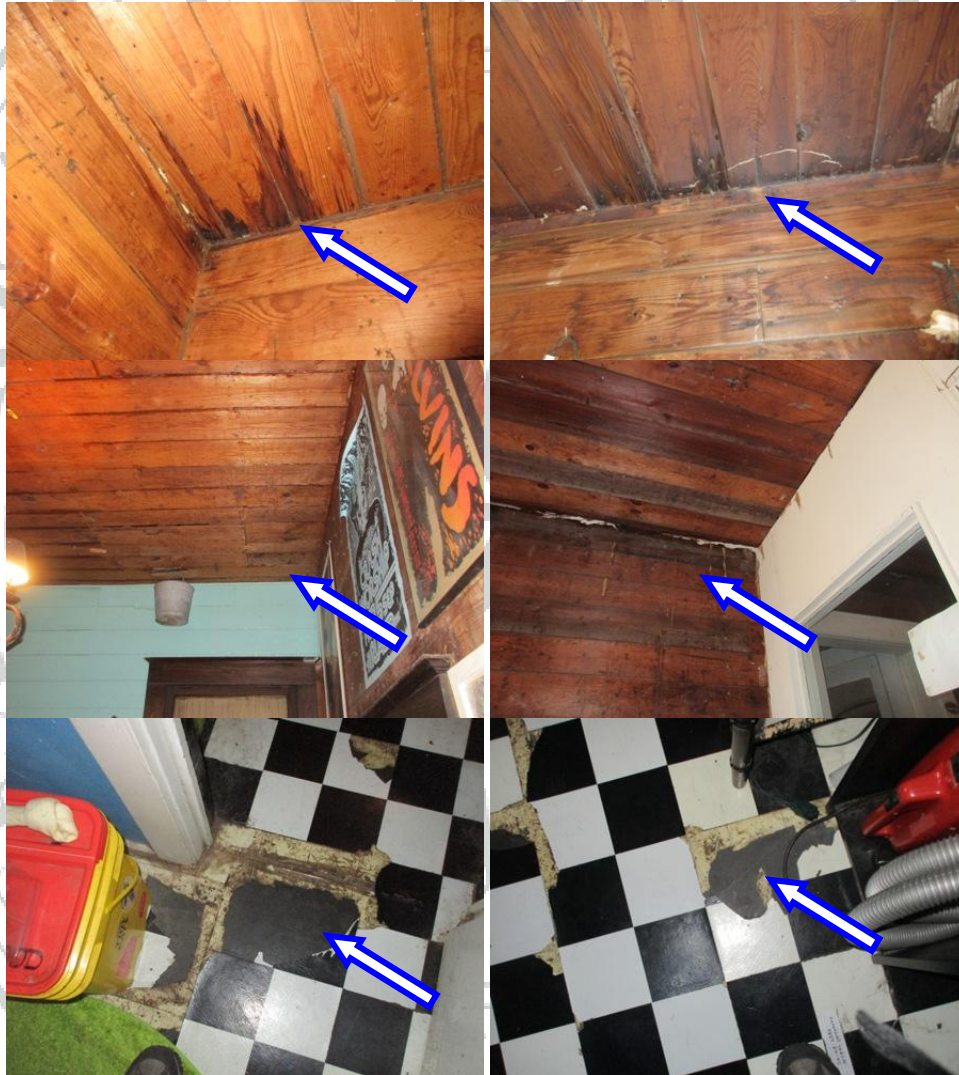
- Significant water damaged was noted throughout the home at the floors and ceilings.
- Floor tiles were noted to be missing at many of the rooms. The majority of flooring was noted to be beyond their serviceable life and should be replaced.
- Cracks at the ceilings in most rooms should be patched or repaired.
- Sampling of photos noted below.

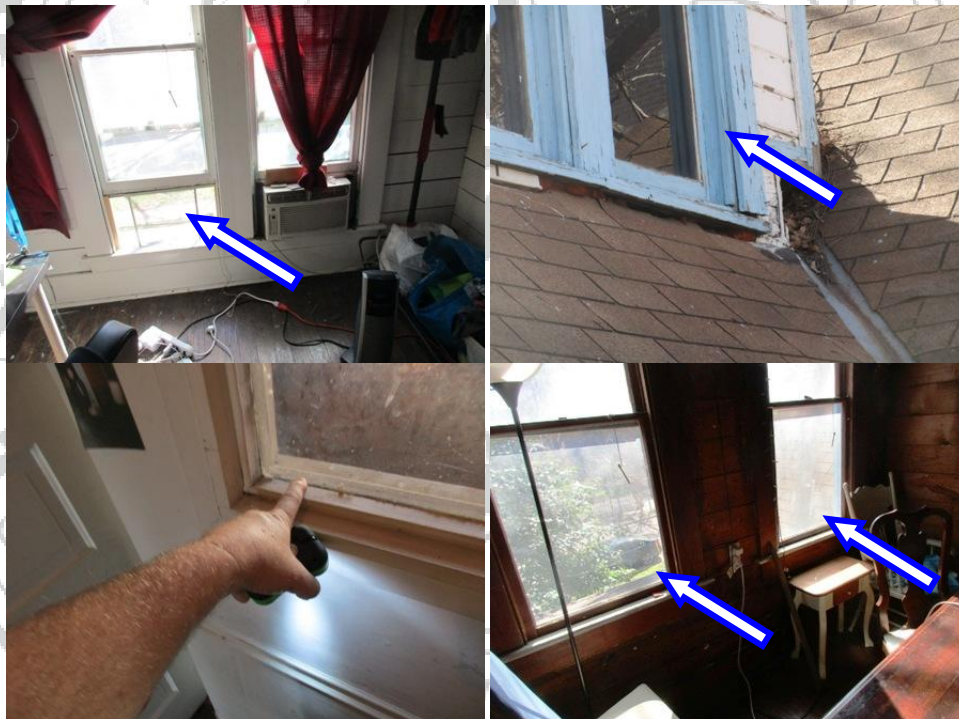
- While NOT required when this home was originally constructed there is no safety glass / window catch / or safety bars installed at the upstairs bedroom windows where they are lower than 24" to the floor. Current building standards require additional safety where a child could easily fall through the windows.

- Windows did not all have a proper moisture flashing installed. All exterior windows must be properly flashed and caulked to prevent moisture penetration.

- No safety glass installed in required locations. While not required when this home was originally constructed. Safety glass is now required at all window locations within 24" of any exterior door.

- Windows throughout this home are an older style single pane wood framed window. These windows are aged and rotted at most locations and should all be replaced with a more energy efficient type of double pane window.

- Significant repair costs for windows should be expected due to age of the windows, moisture leakage, and lack of energy efficiency.
- Sampling of photos noted below.

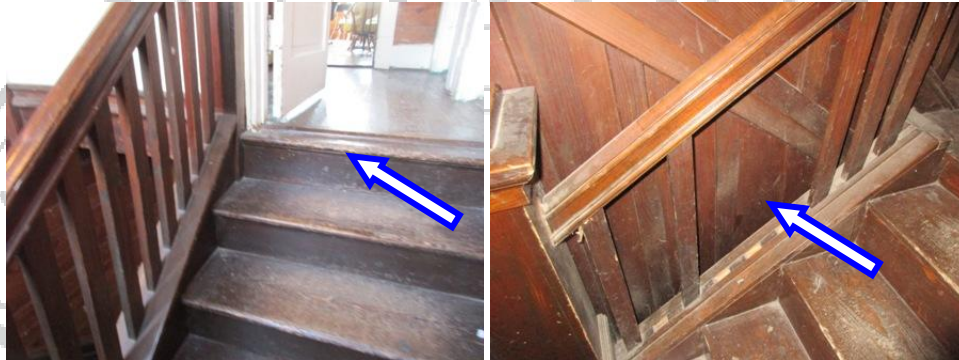
- Railing balusters are missing / damaged at the interior staircase.
- Handrails at the interior stairway are not returned to the walls at the top and bottom of the rails. Open ended railings are a potential safety hazard.

- Stairs at all levels are NOT deemed safe for use. Handrails are missing and unevenly spaced stairs were noted. Stairs are the most frequent location of injury accidents in the home. A consistent rise and run is important for safety. The tallest riser can be no more 3/8<sup>th</sup> inch higher than the shortest and the deepest tread can be no more 3/8<sup>th</sup> inch greater than the shallowest. Proper handrails and landings are also critical.
- Sampling of photos noted below.

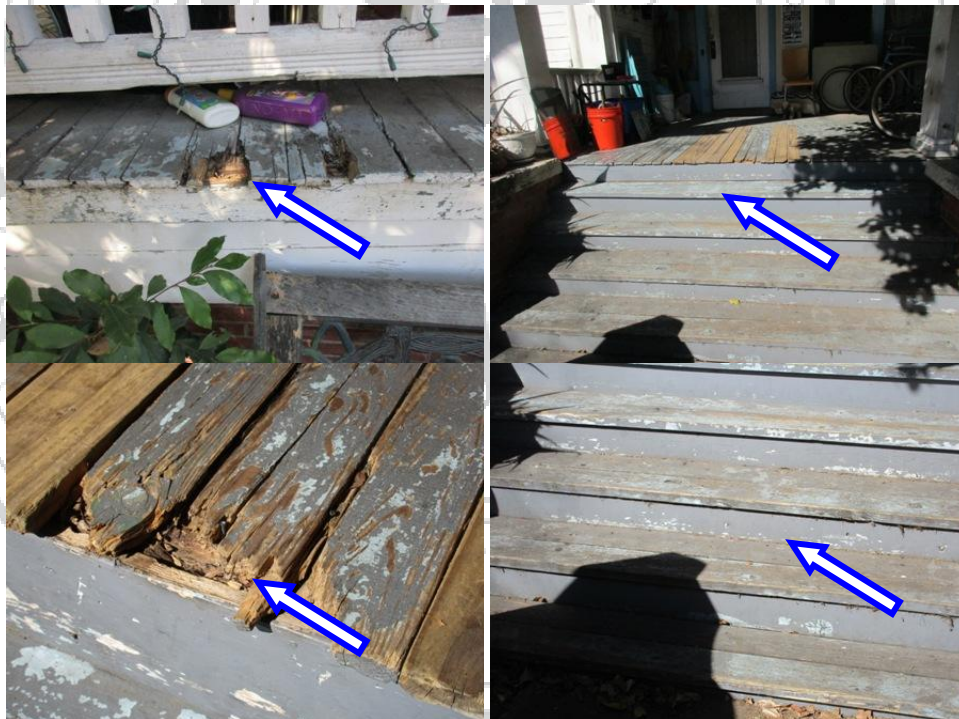
- Porches are in overall poor repair. Significant repair is required where the wood steps and porch areas have deteriorated, no graspable handrails are installed.

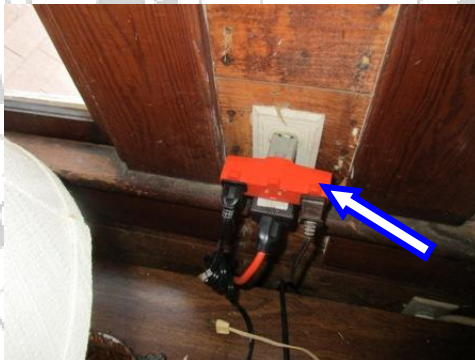
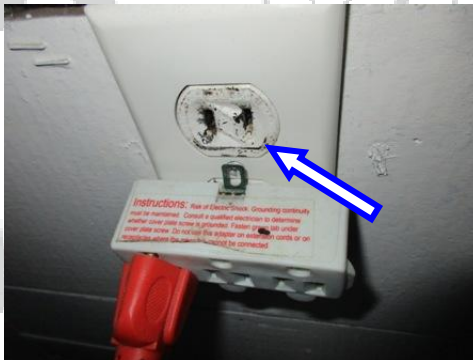
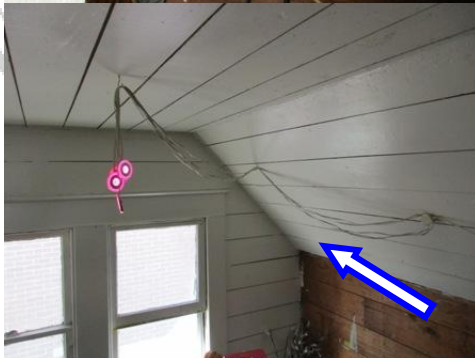
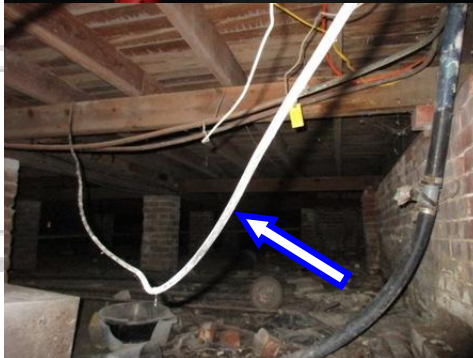
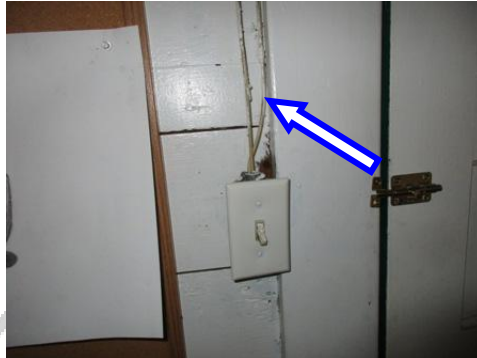
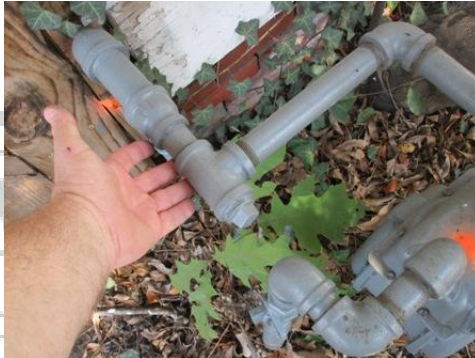
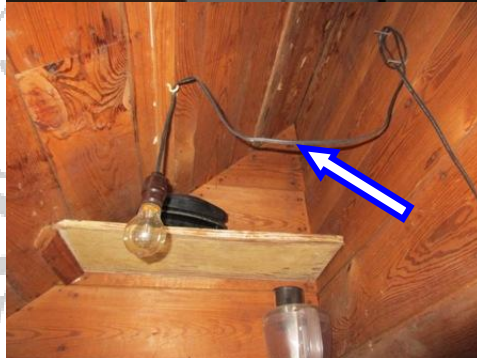
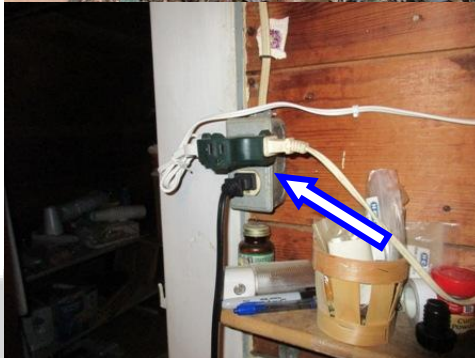
- Significant electrical issues noted. This home is NOT deemed safe for occupancy. This list is NOT deemed to be all inclusive and represents a sampling of the major issues found during this limited visual inspection.

- No electrical service panels could be accessed. Side gates were padlocked and could not be accessed to view main panel boxes.
- No working GFCI protected outlets present at required areas. While this was the building standard when this home was constructed, today's building standards now require GFCI protection. Ground Fault Circuit Interrupter (GFCI) protection should be located at all bathroom, exterior, and at all kitchen counter outlets.

- The majority of plugs in the home are not grounded. Ungrounded receptacles are a potential safety hazard.
- Insufficient receptacles at the kitchen counter areas. 2ft/4ft rule applies for countertop spaces. Receptacles are required at least 24" from the wall of a counter and at least 48" between all other outlets so that no point is ever more than 24" from a receptacle. Use of multi-plugs is a potential fire hazard.

- Grounding / bonding is missing at the exterior gas meter as required per current building standards.
- All under home wiring in the crawl space needs to be properly secured to framing.

- All wiring is required to be inside approved conduit. Stapling of wires to the walls is deemed a fire / safety hazard as noted in many of the rooms in this property.

- Smoke detectors are needed in all bedroom areas.
- Carbon monoxide detectors are needed in all hallway areas outside of bedrooms.
- Sampling of photos noted below.

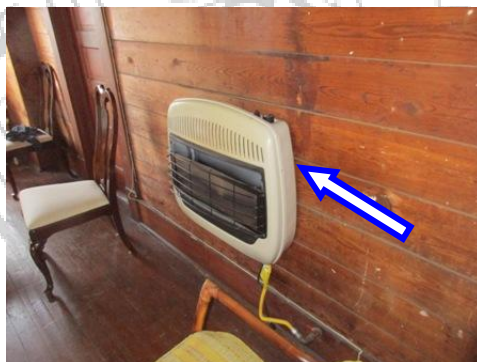
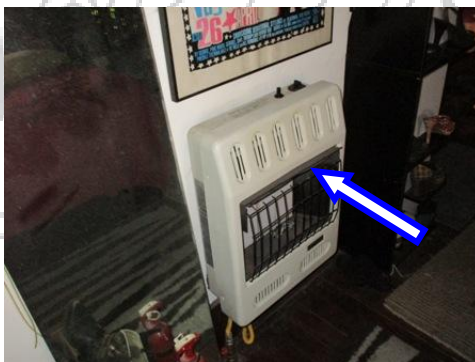
- No working central system found. Room heaters only.

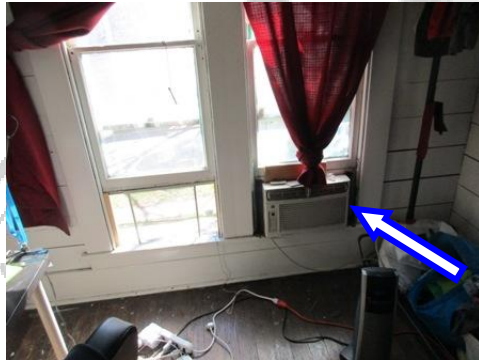
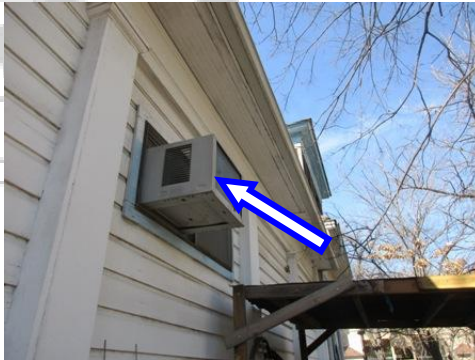
- No working central system found. Window unites only.

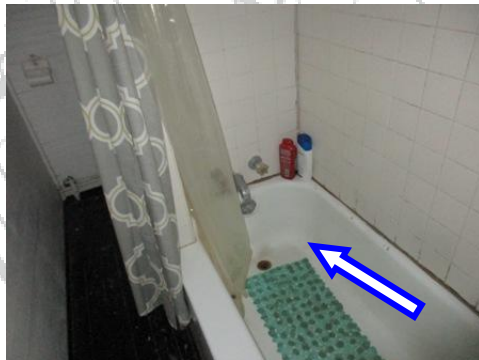
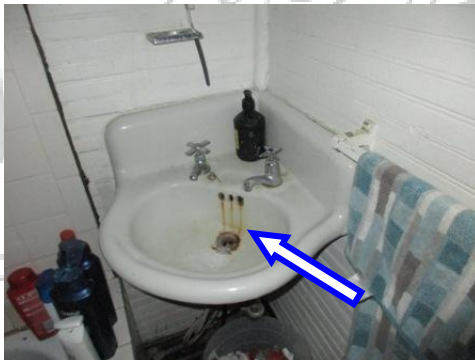
- All sinks, faucets, and tubs were noted to be chipped, corroded, and / or in overall poor repair.
- Water heater was not located.
- Sampling of photos noted below.
