PROPERTY INSPECTION REPORT

(Name of Clien	1)			
Concerning:	1308 East 12th Street, Austin, Texas 78702				
	(Address or Other Identification of Inspected Property)				
Ву:	Tanner Robertson TREC#21464	2/15/2016			
	(Name and License Number of Inspector)	(Date)

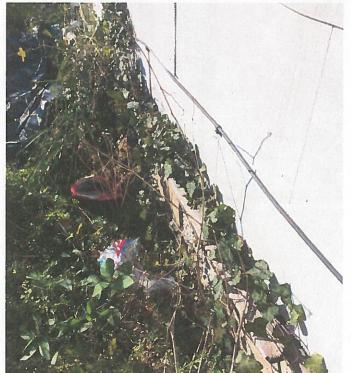
Heavy Foliage / Vines should be pulled away

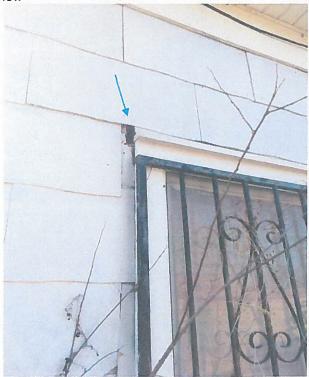
Siding gaps and other imperfections

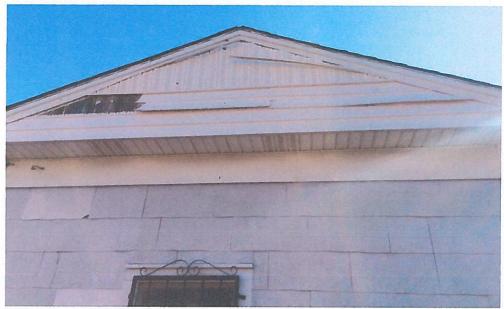
Siding damage.

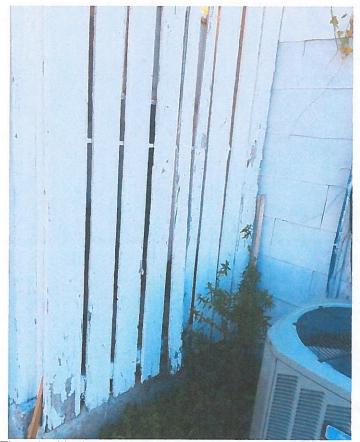
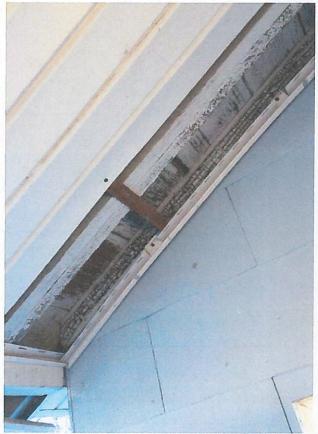
There is chipping paint and minor rot at the rear porch cover. Vinyl cover over rear porch damaged. Exposed decking.

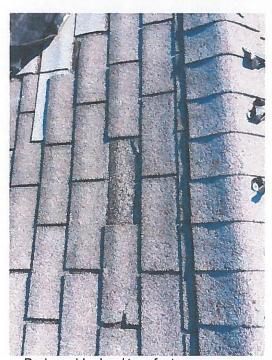
Broken shingles / tarp fasteners

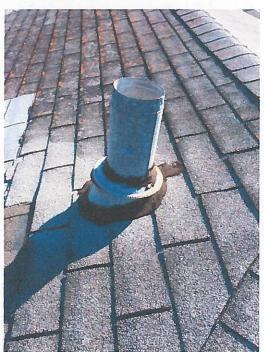
Improper repair around plumbing vent flashing.

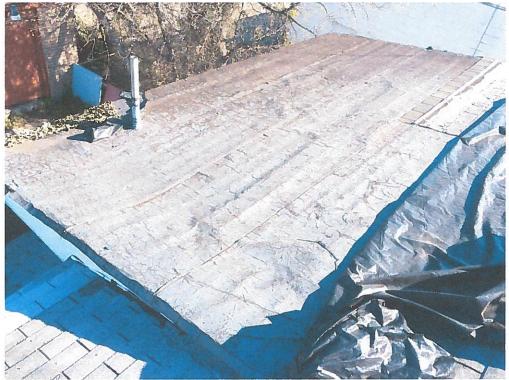
Improper roof covering over rear right addition space.

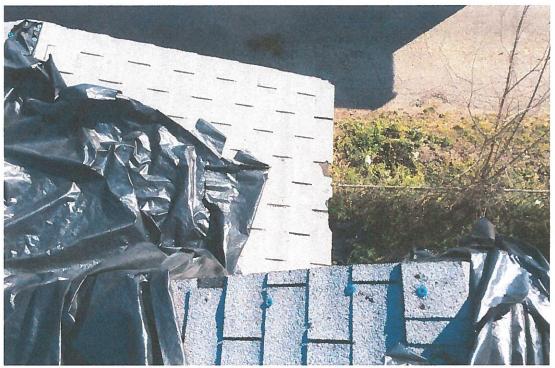
Broken shingles. The draped tarp now serves only to hold water on the roof.

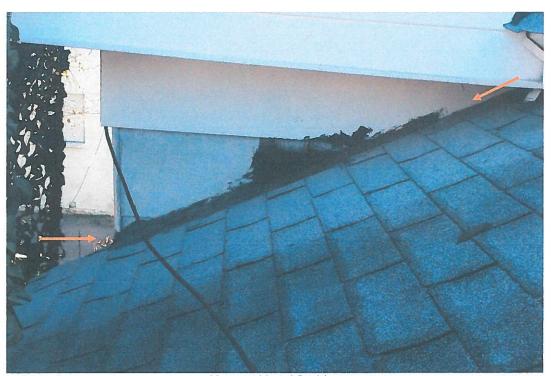
No transitional flashing

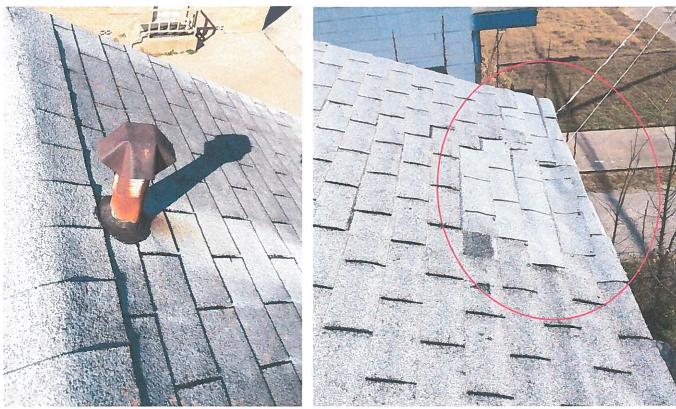
Rusted vent – improperly flashed

Damaged, wavy roof decking

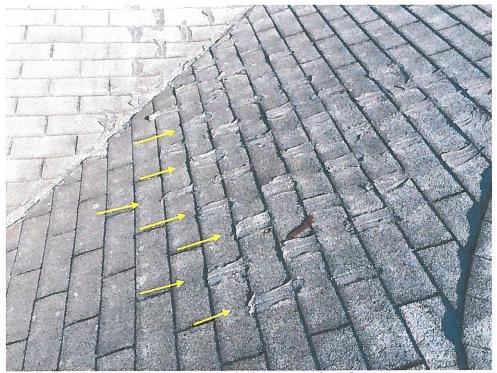
Improper use of silicon to patch roof

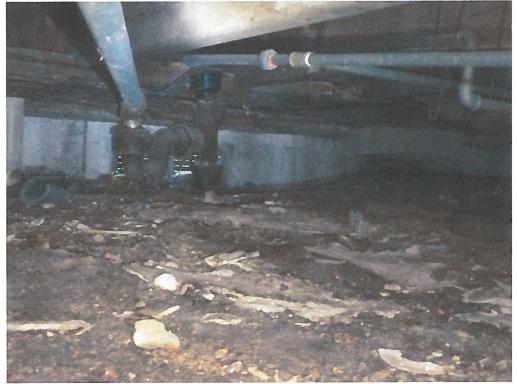
• The main plumbing drainage trunk line is evidenced to be cast iron piping. Cast iron piping has an average useful underground life of 50 to 60 years; recommend budgeting for replacement.

4" Cast iron waste plumbing piping enters ground near rear of home. Recommend budgeting replacement.

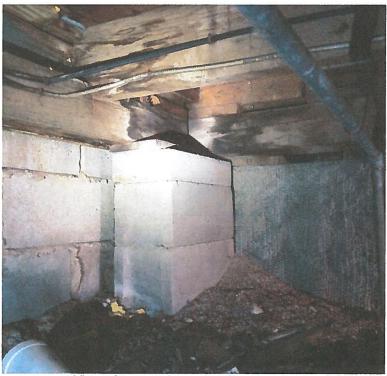
View of corner pier and moisture staining.

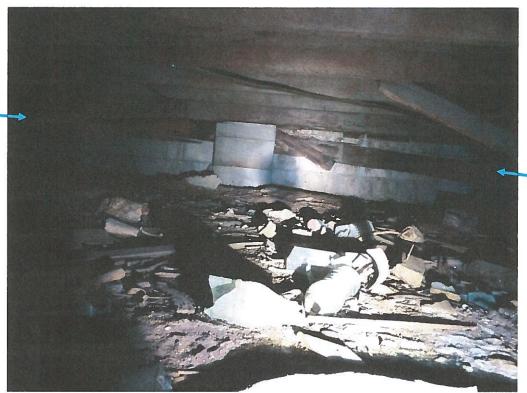
View of damaged ledger at the right side of home where soil line and foliage is high

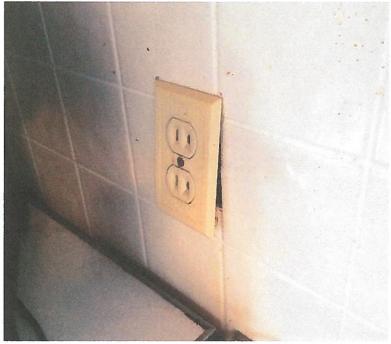
Panel cover loose. Not grounded.

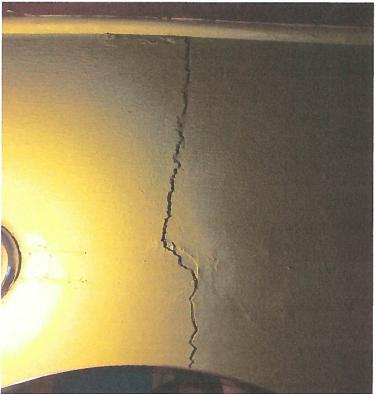
Settlement crack in bathroom.

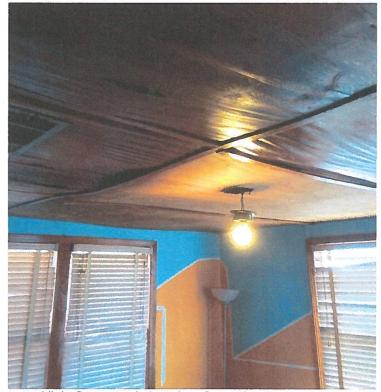
Damaged light fixture not in housing. Severely water damaged ceiling.

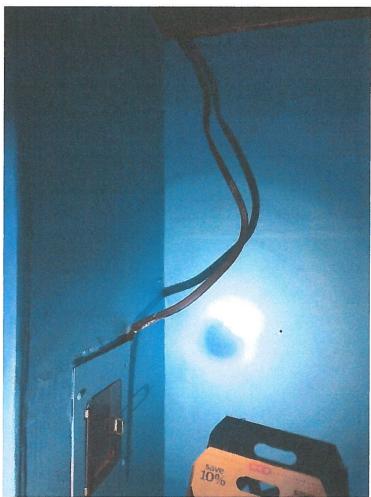
Improper wire termination to panel
