2011 Chestnut

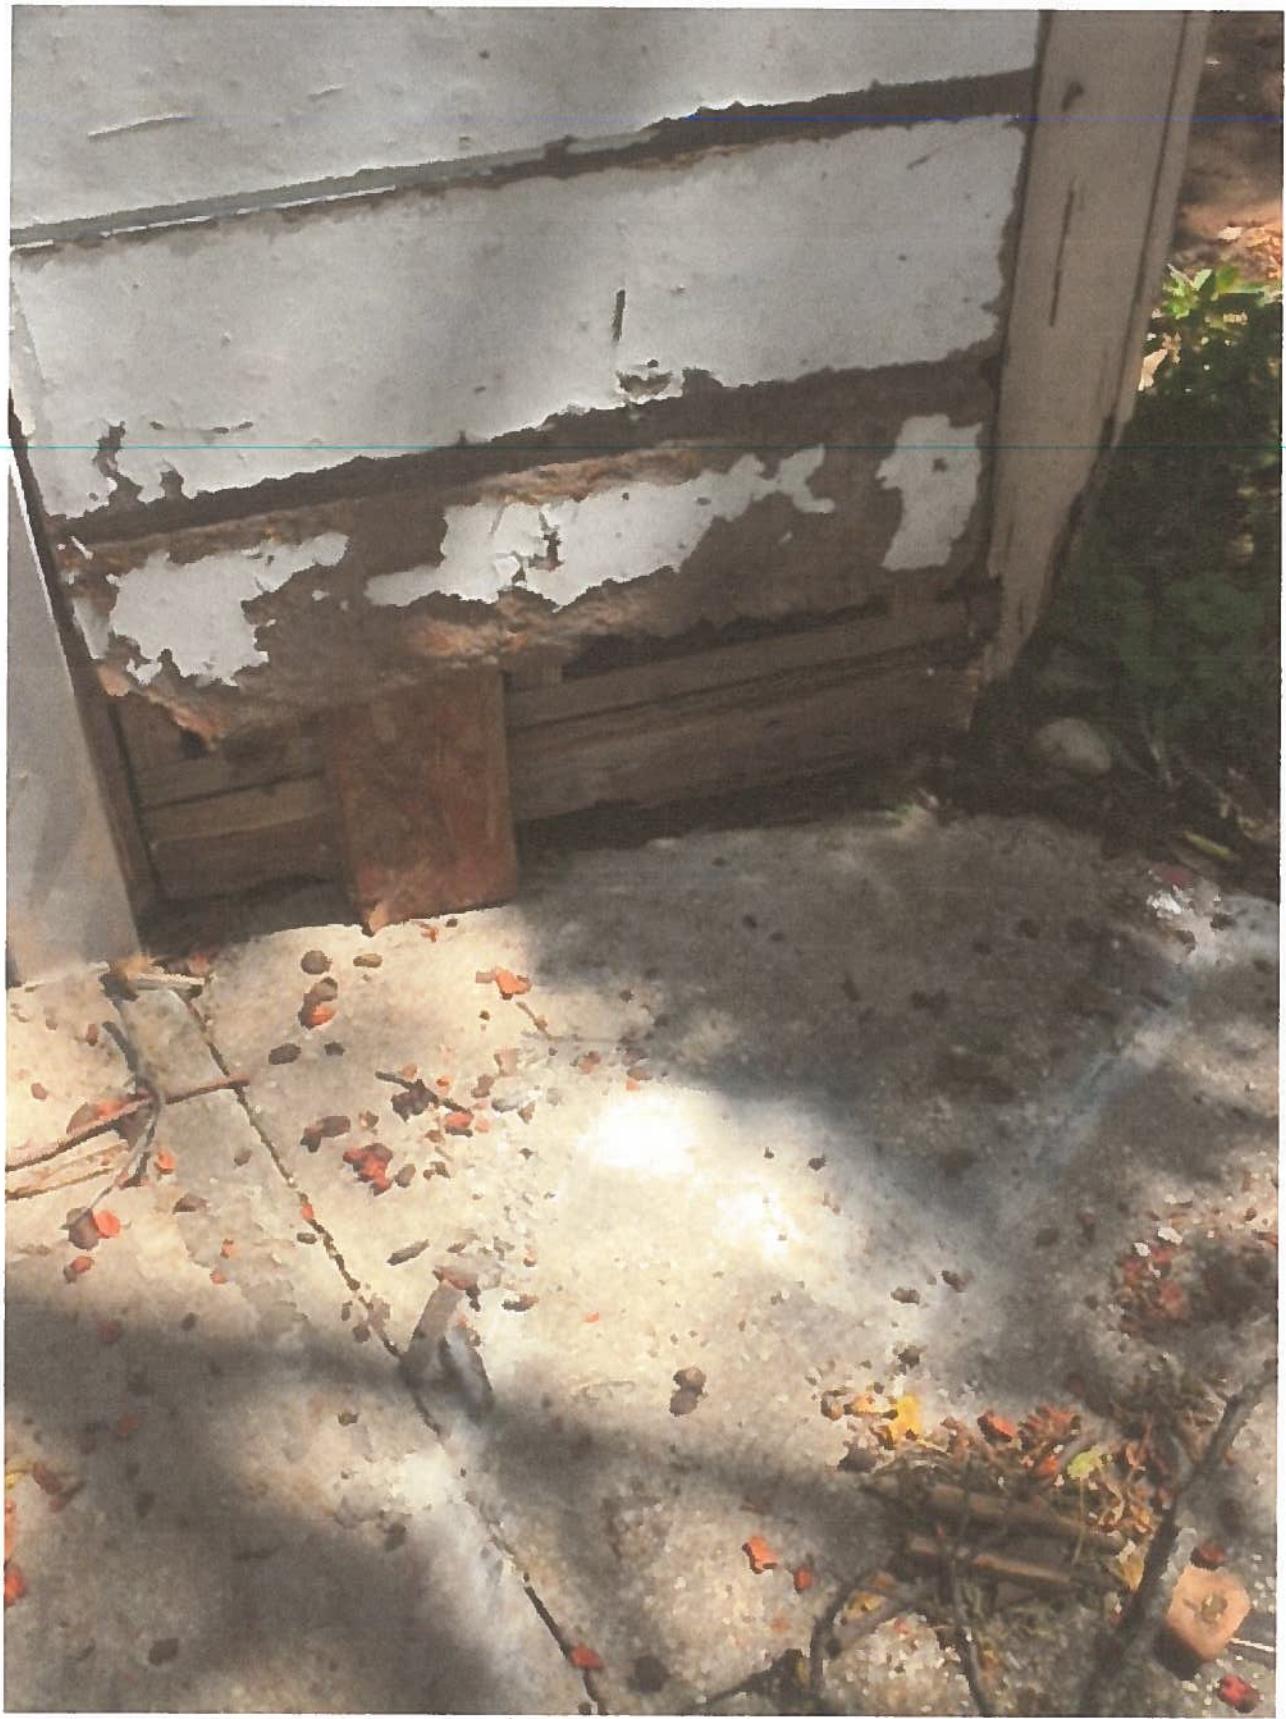
Damaged siding
Foundation not to code

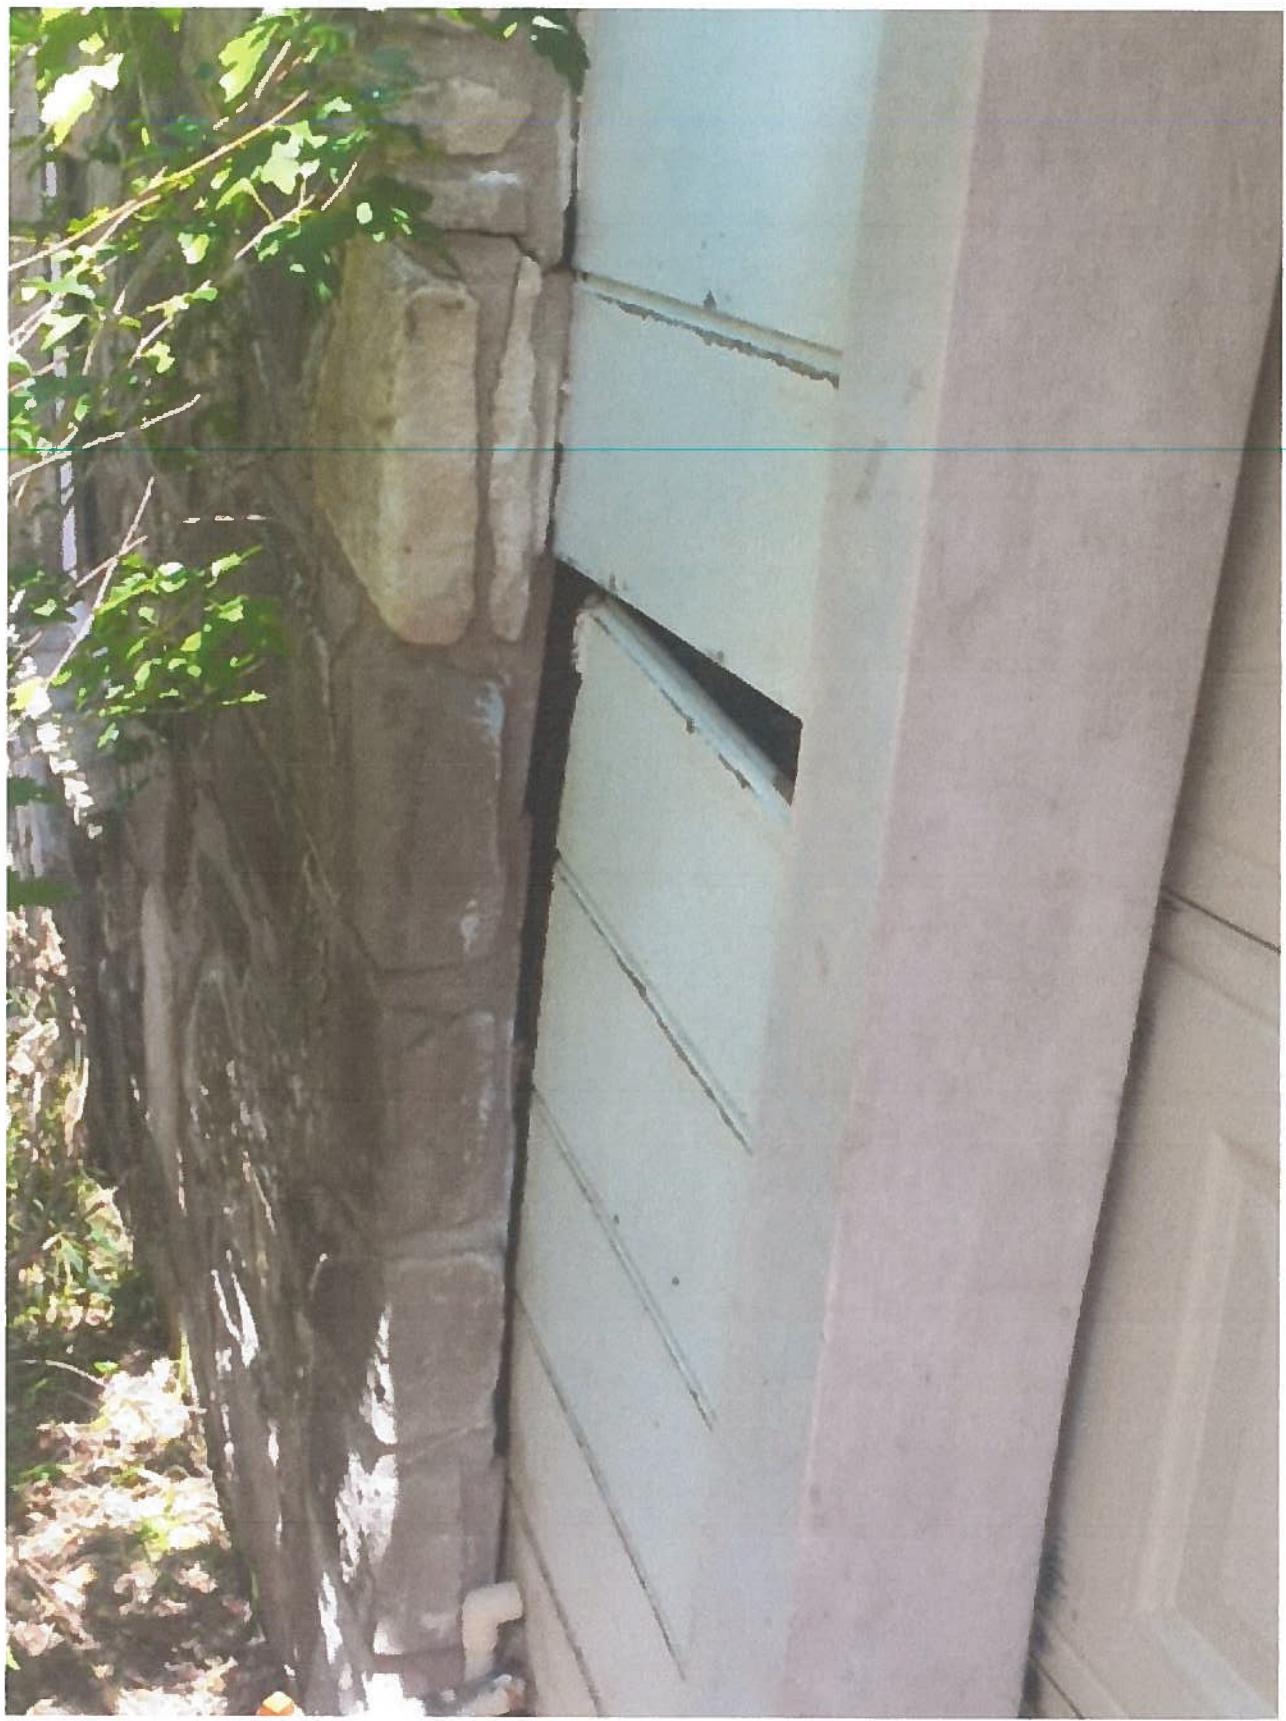
Siding Pulling away > Structure
Rock loose

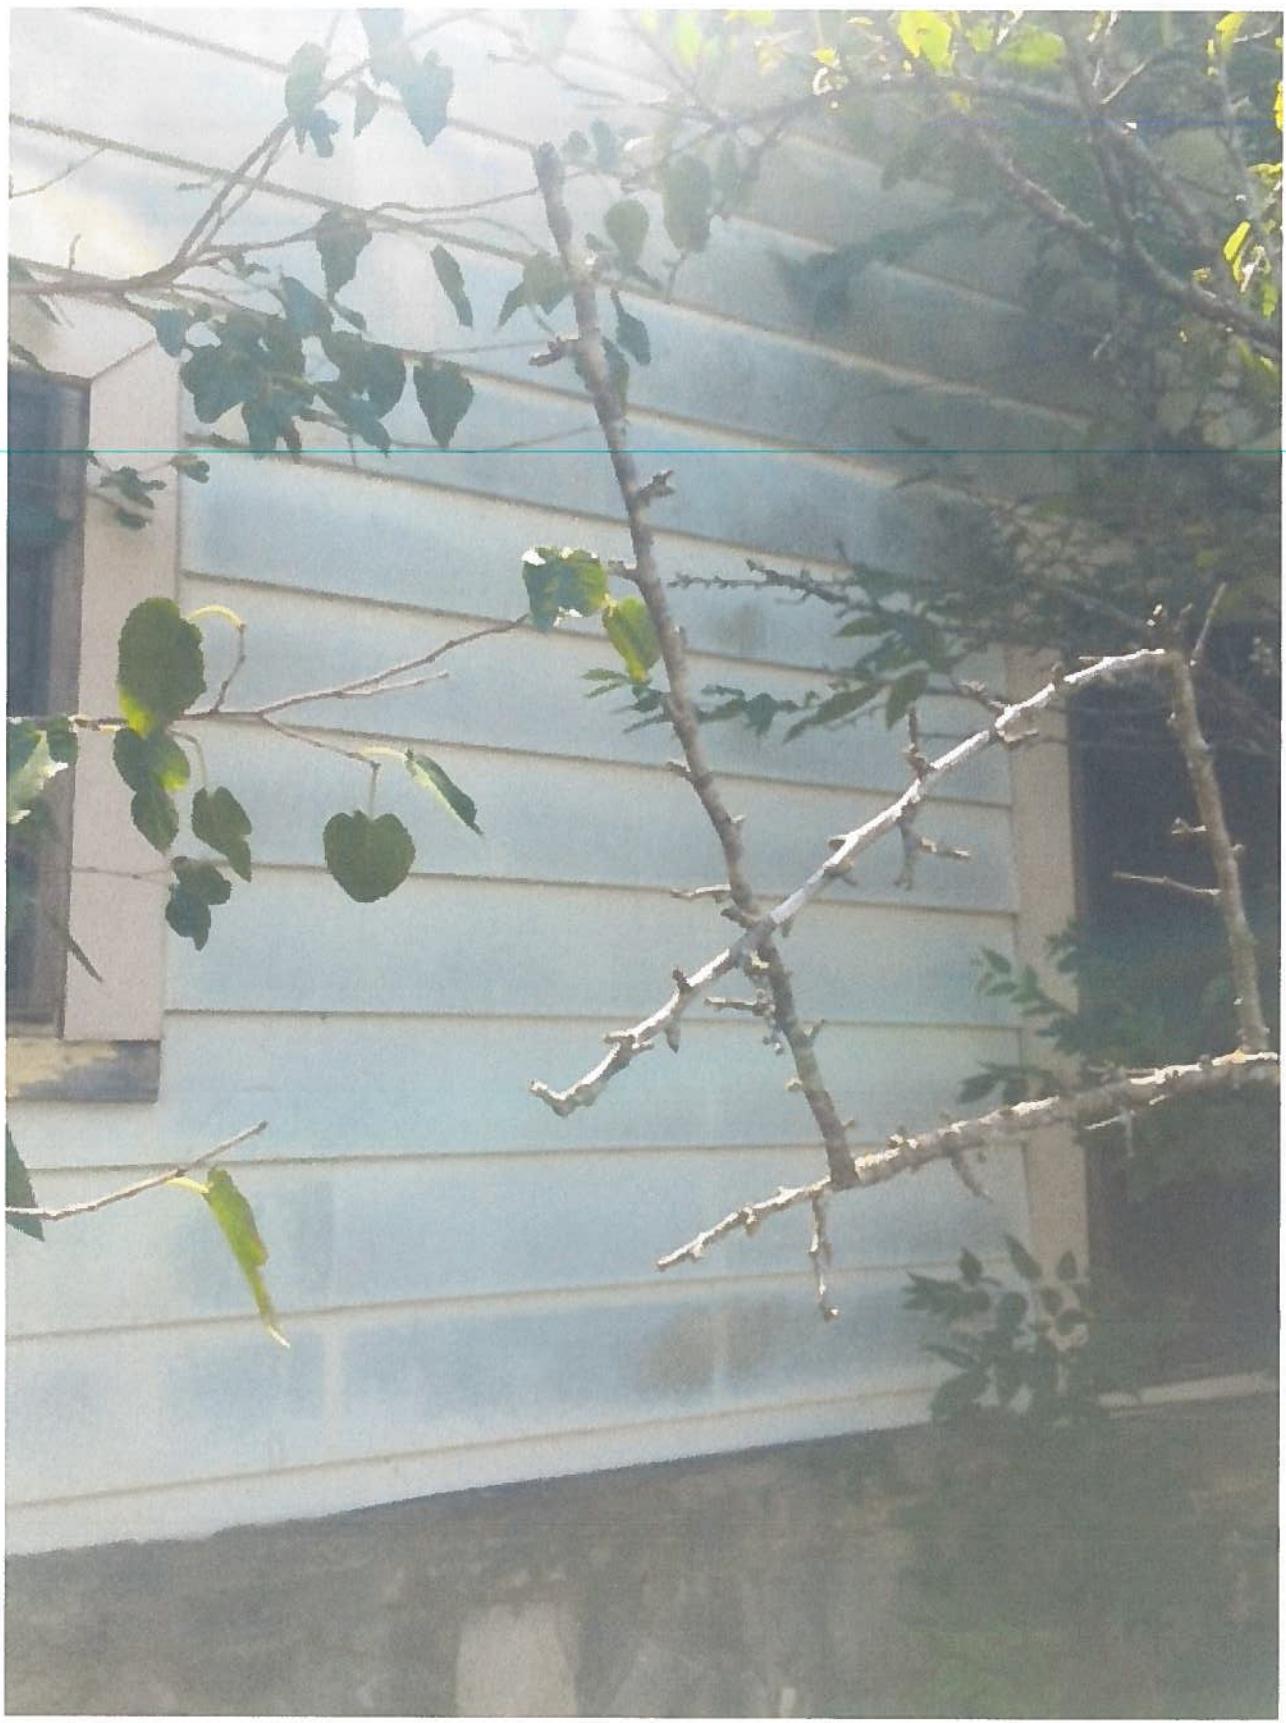
Vinyl Siding Not original

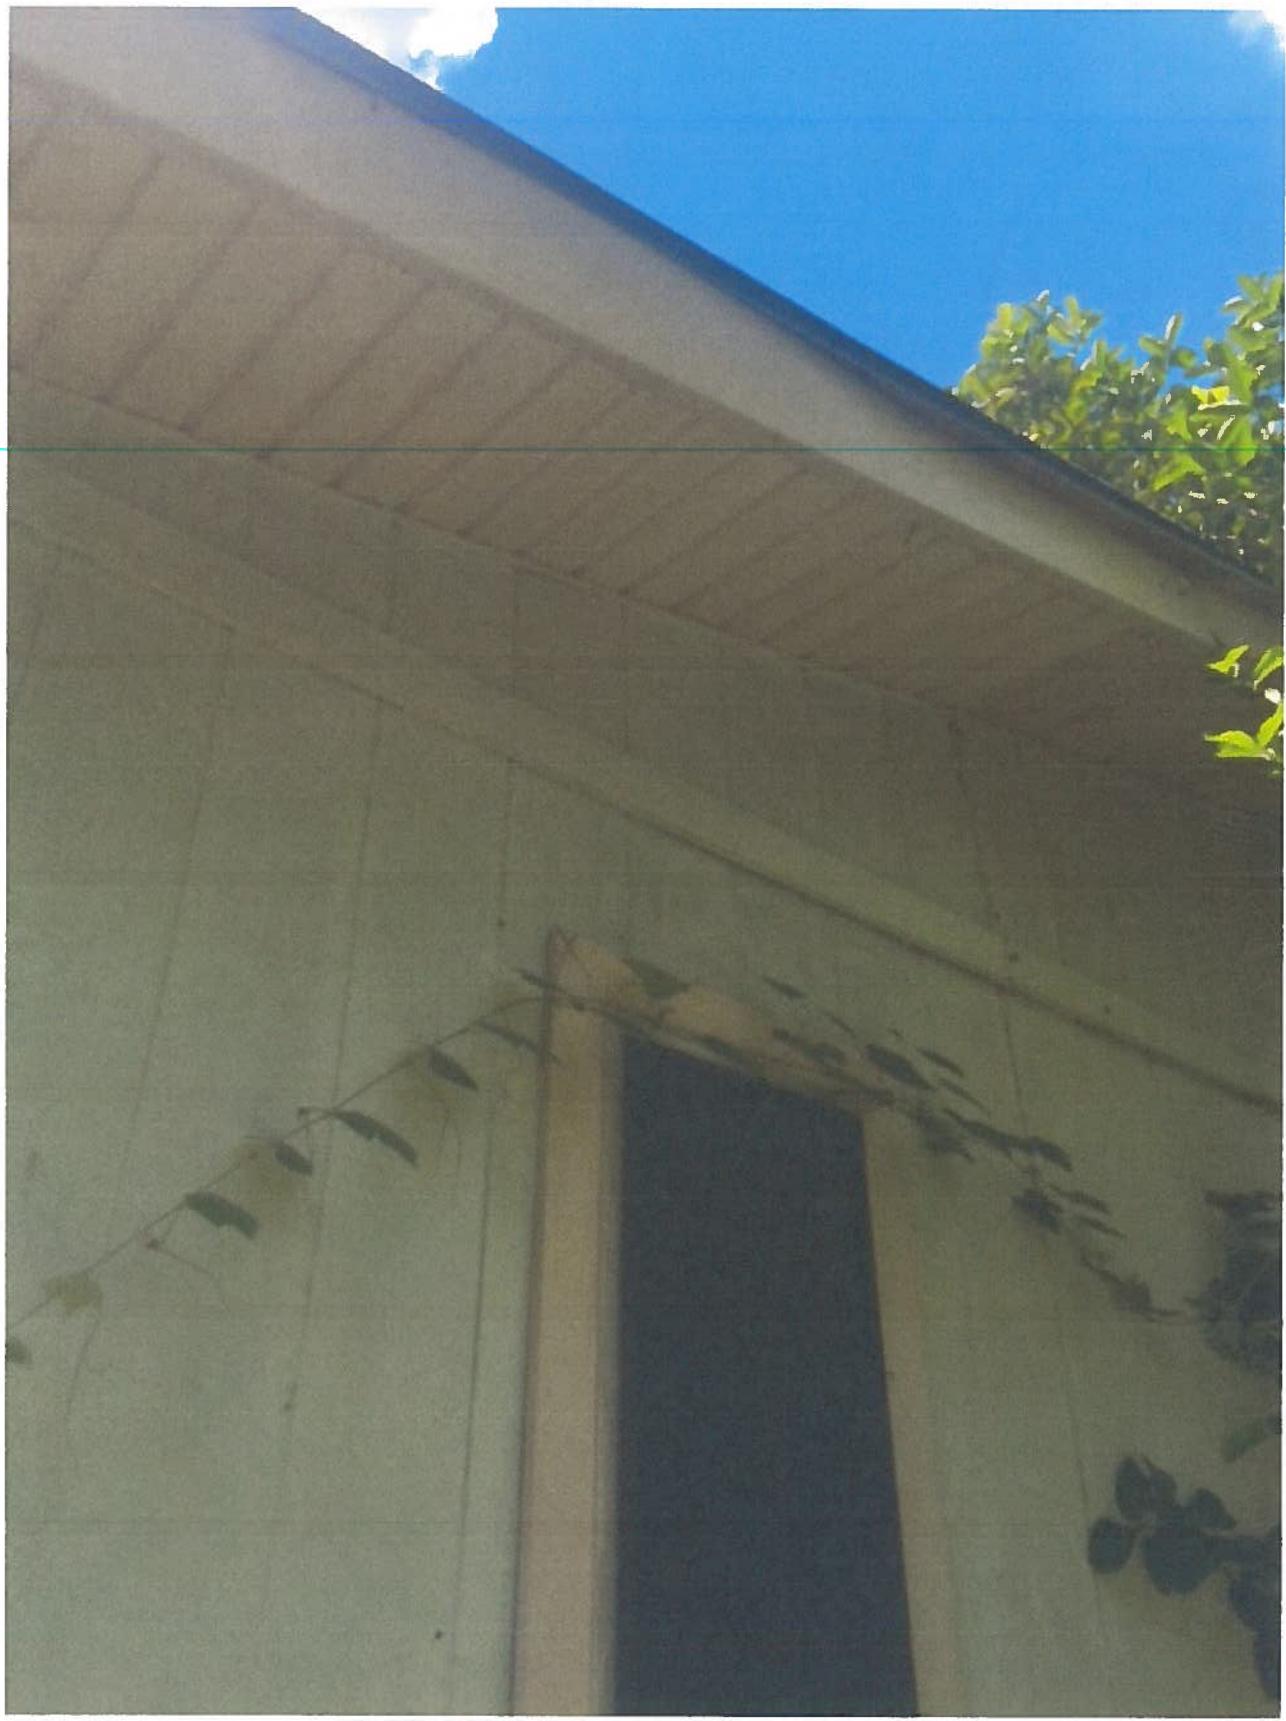
VINYL SOFFIT NOT original

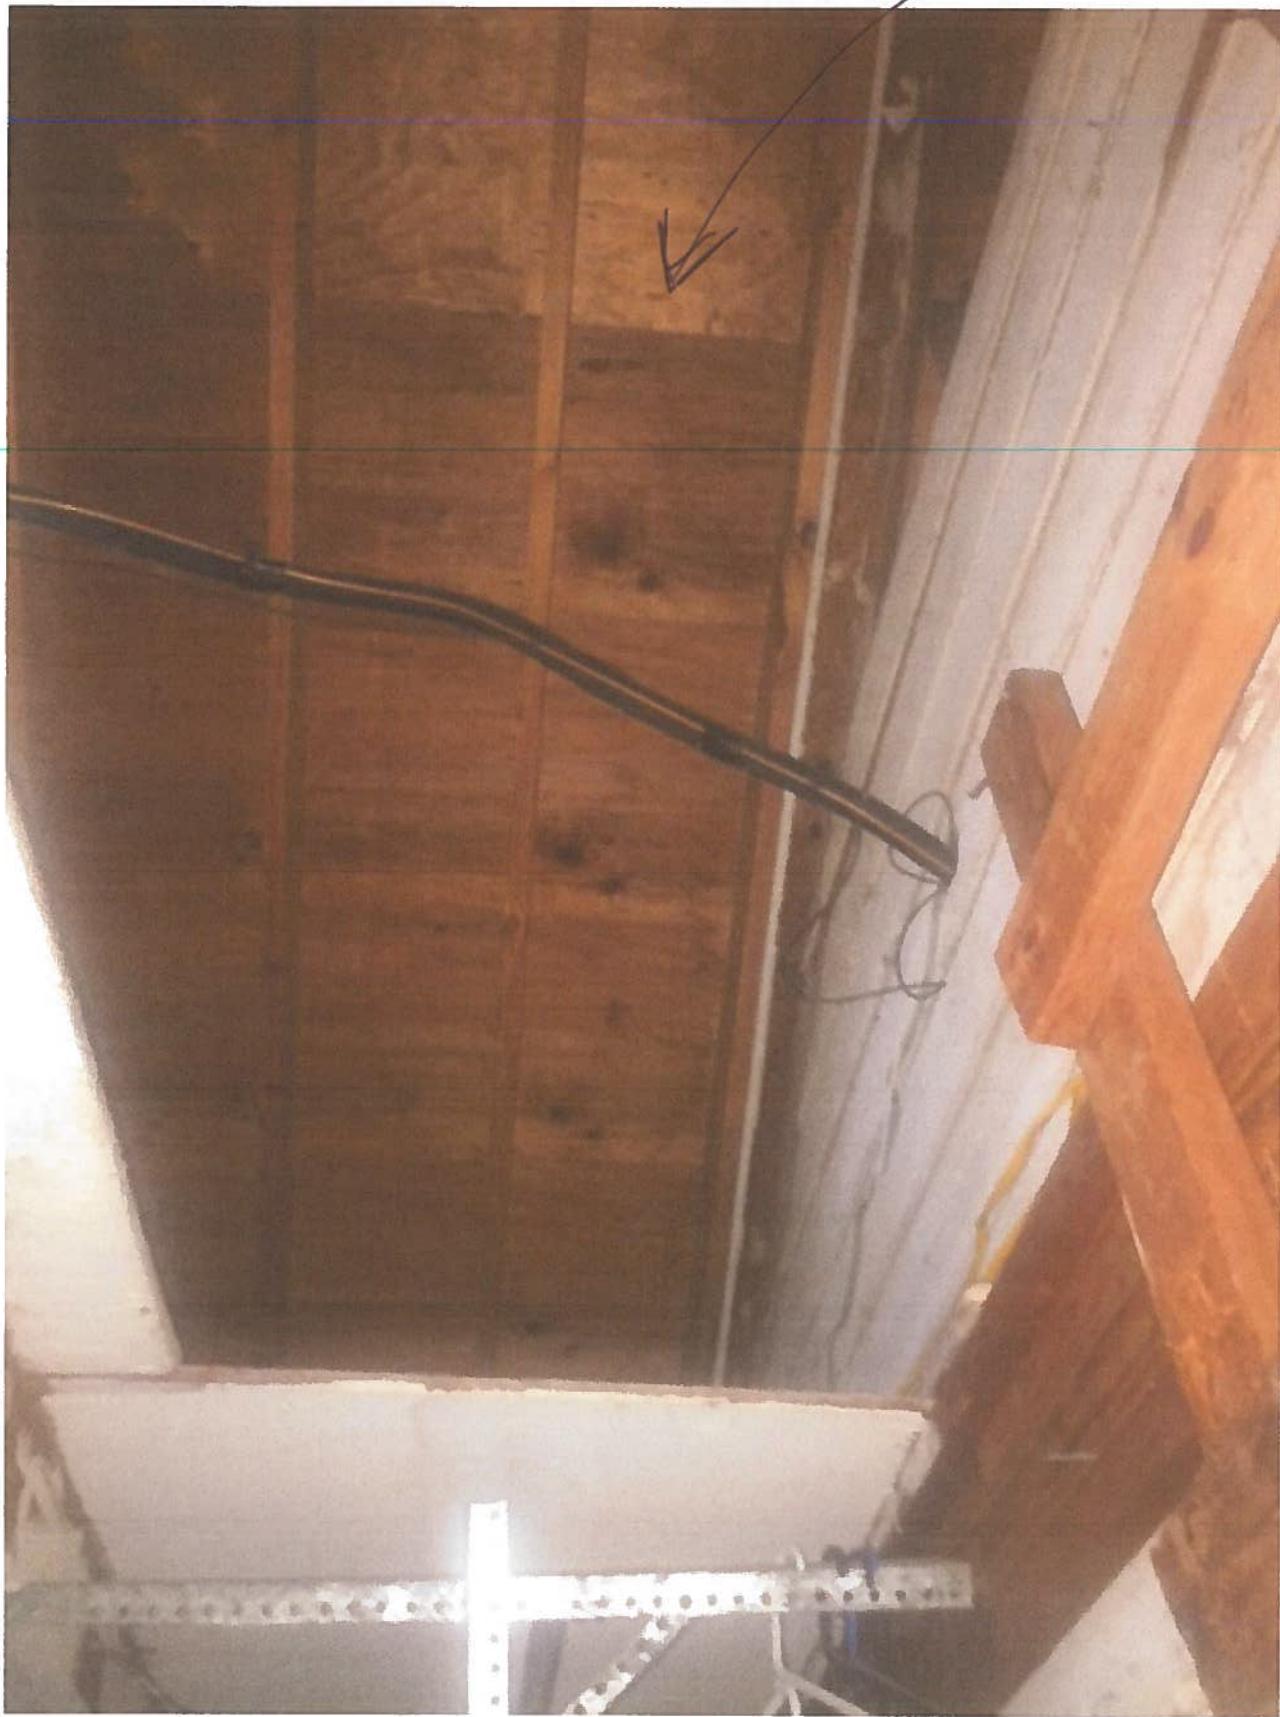
Roof decking of garage

Not original

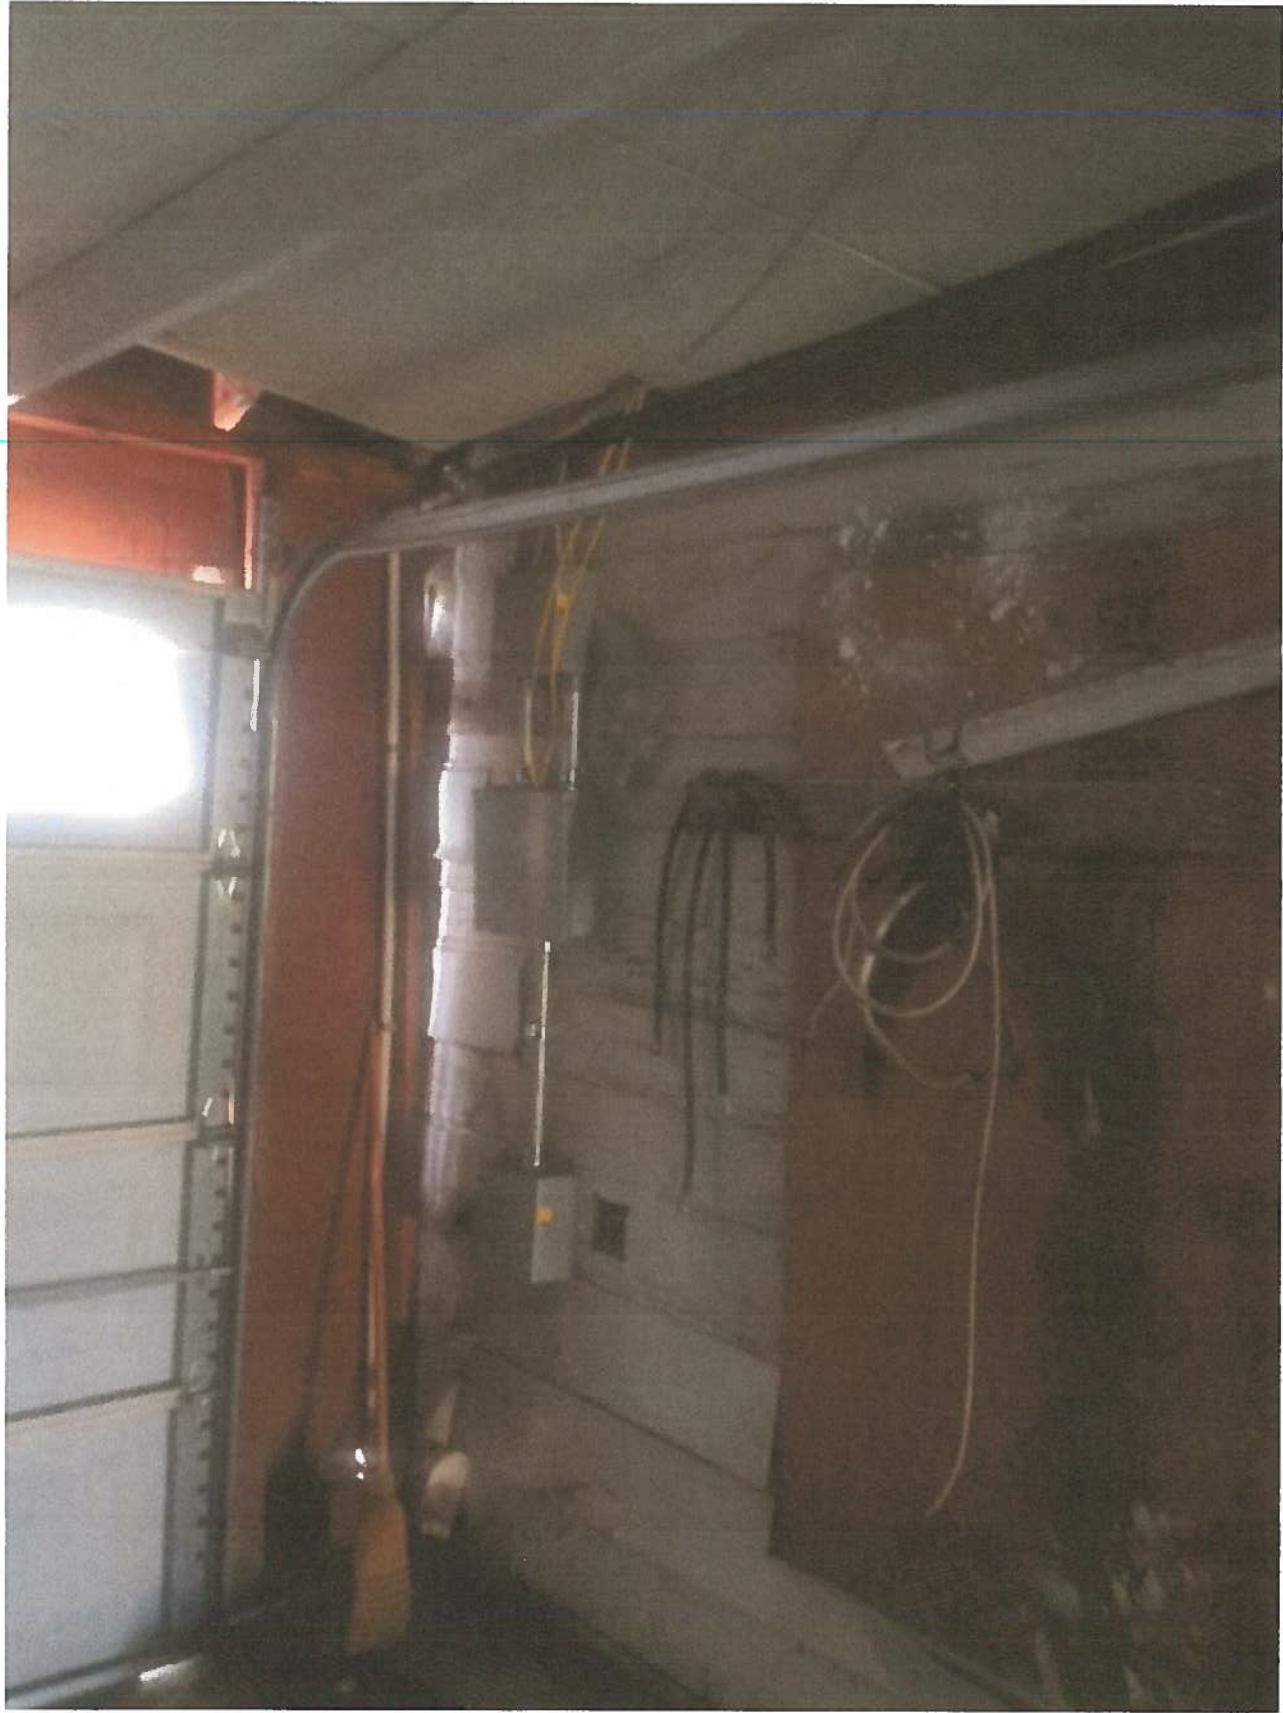
Garage addition - not inspected

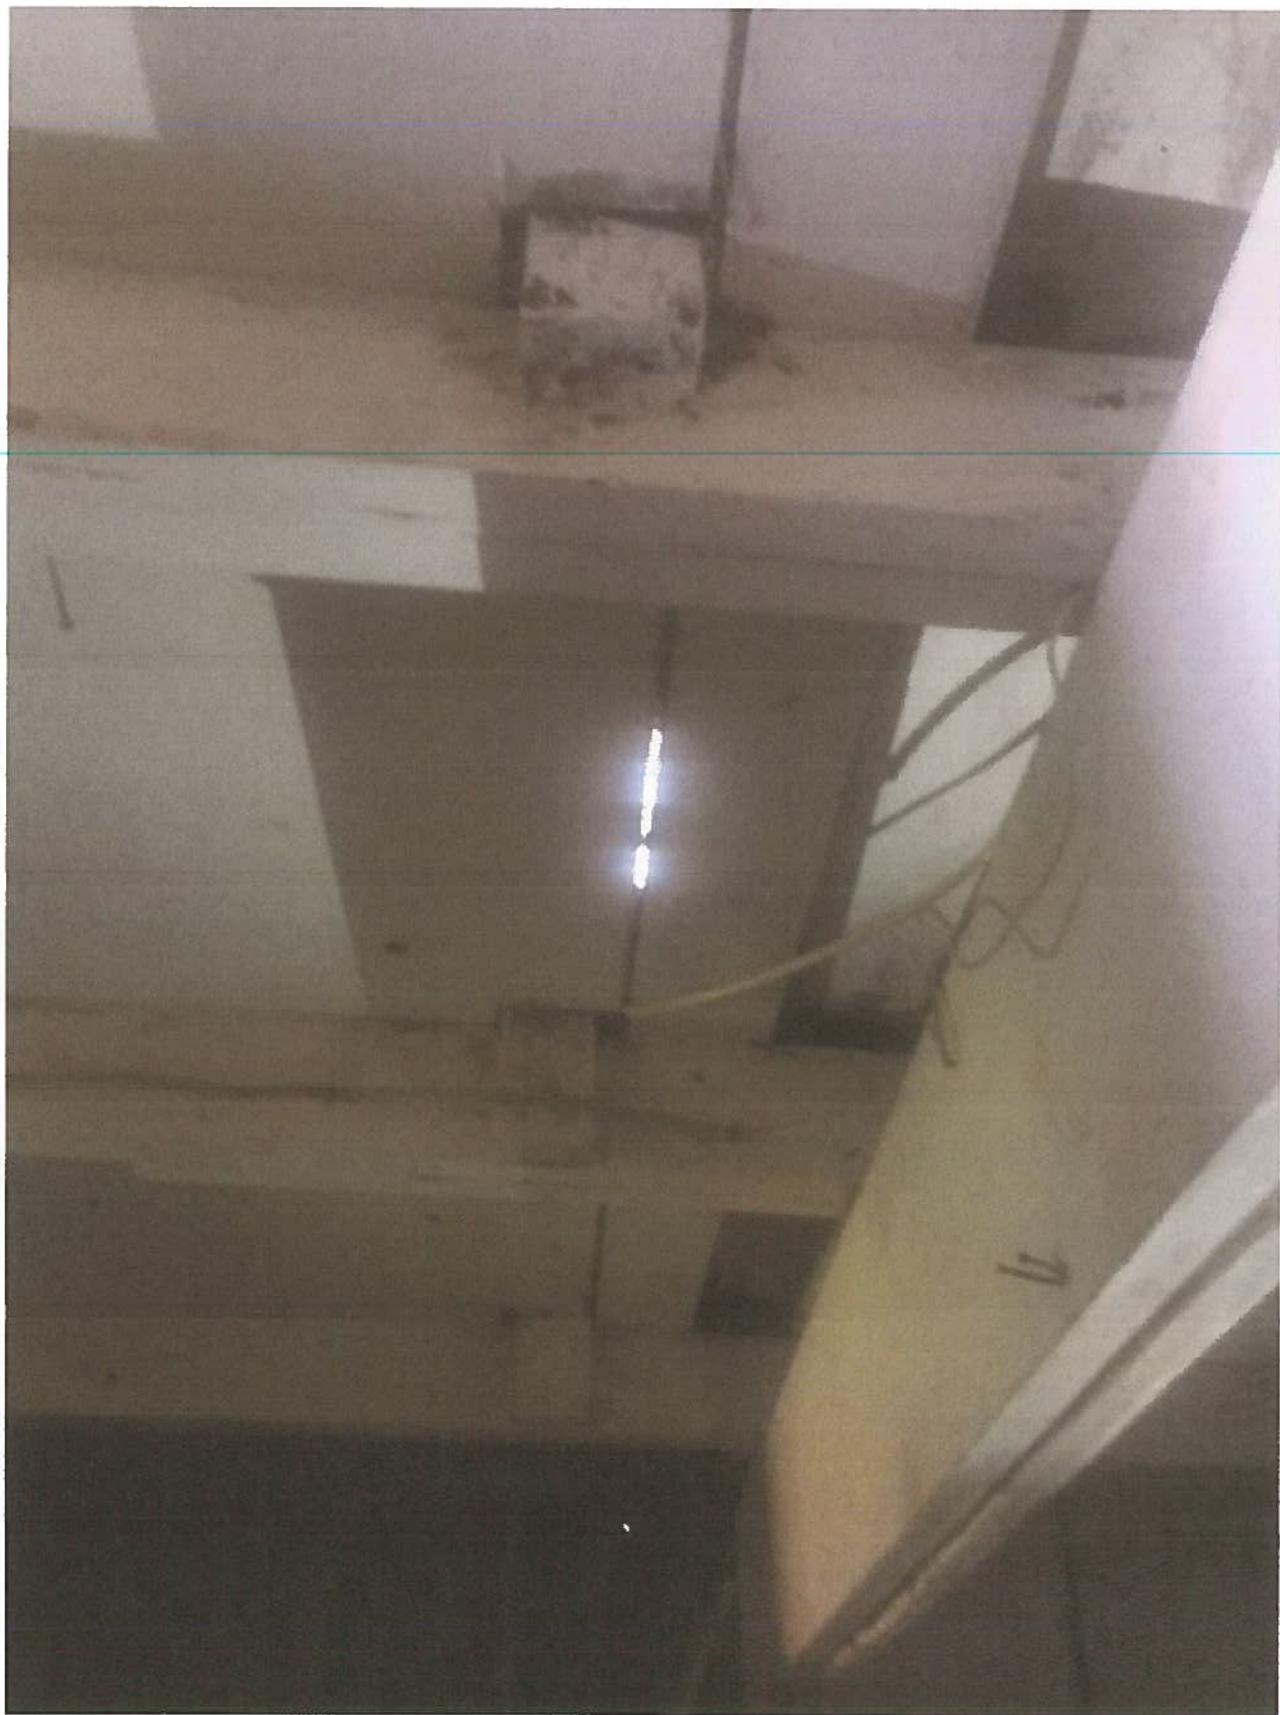
Daylight through roof over garage

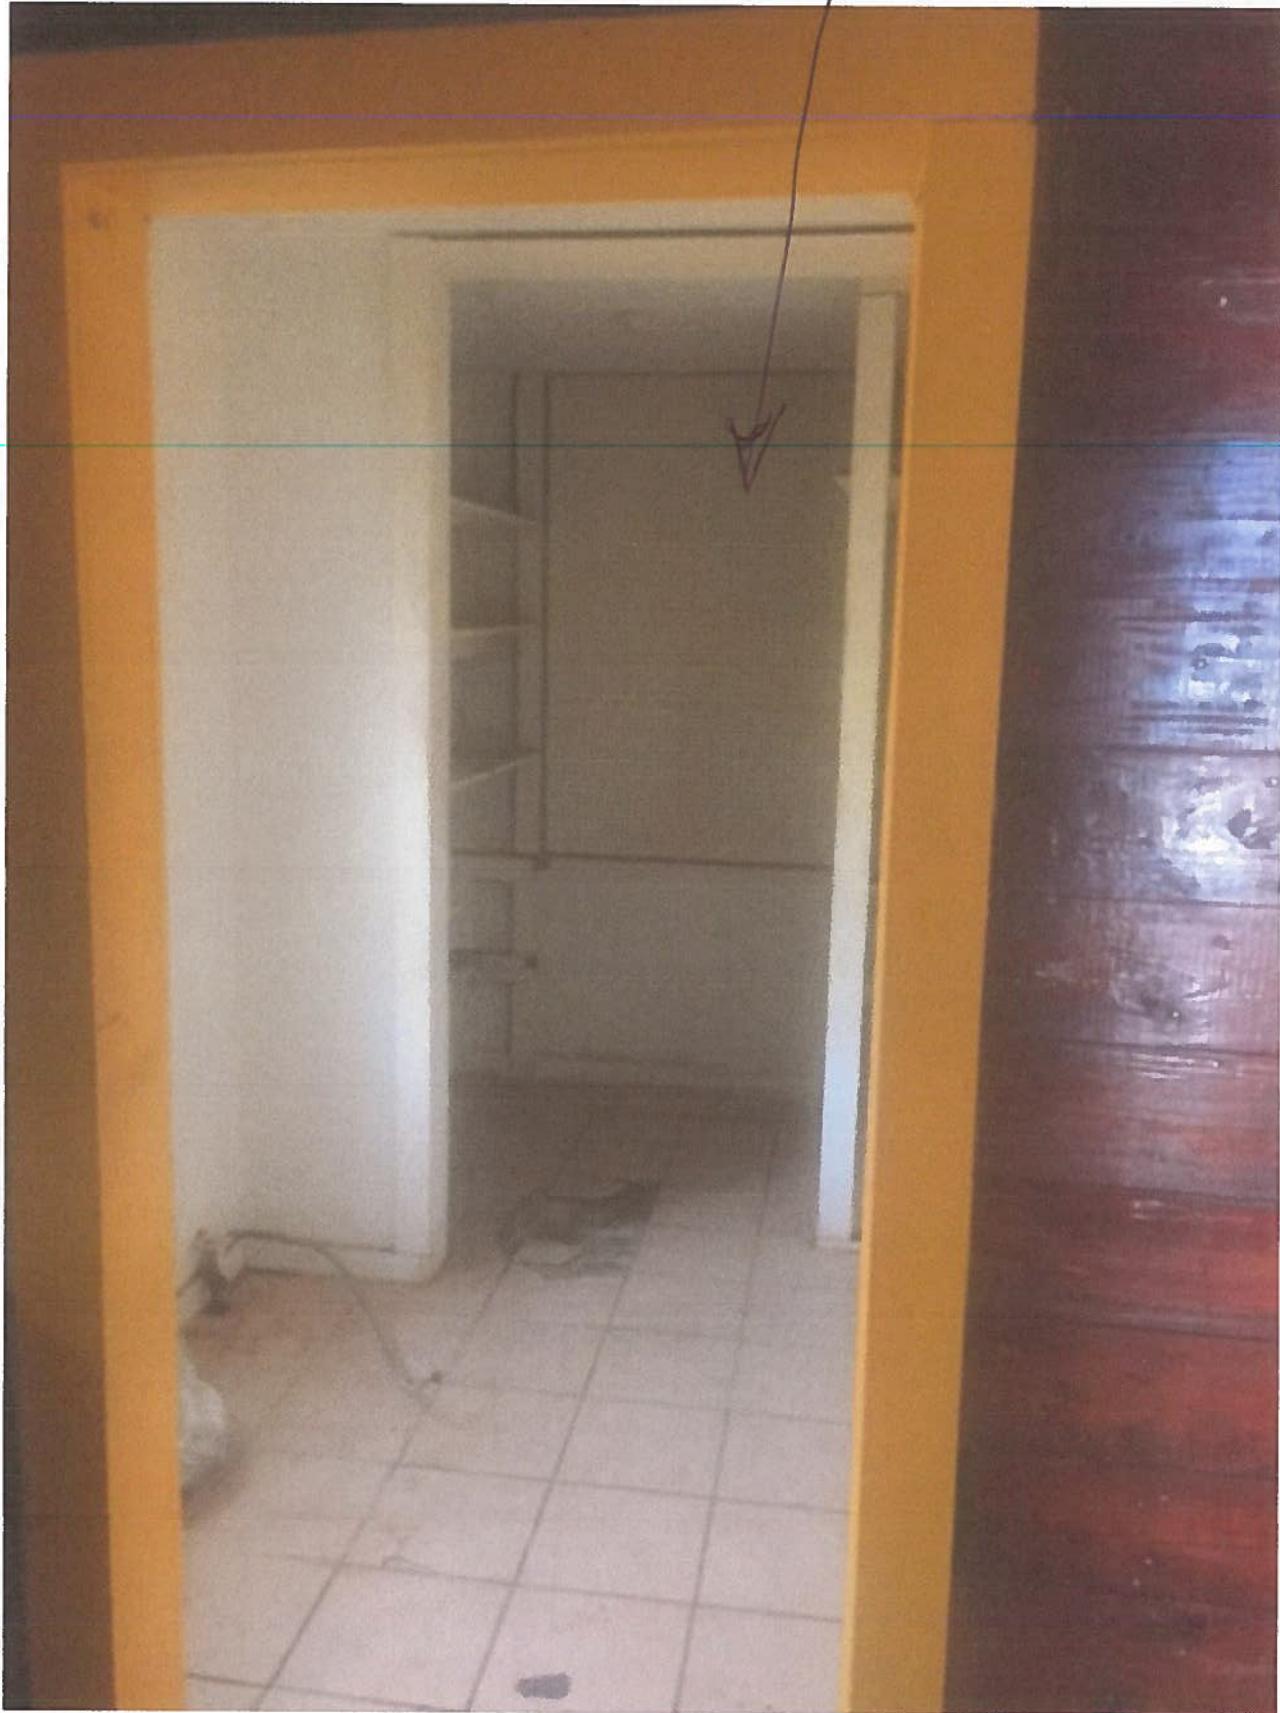
addition to house this area

termite, dry rot. inside bedroom

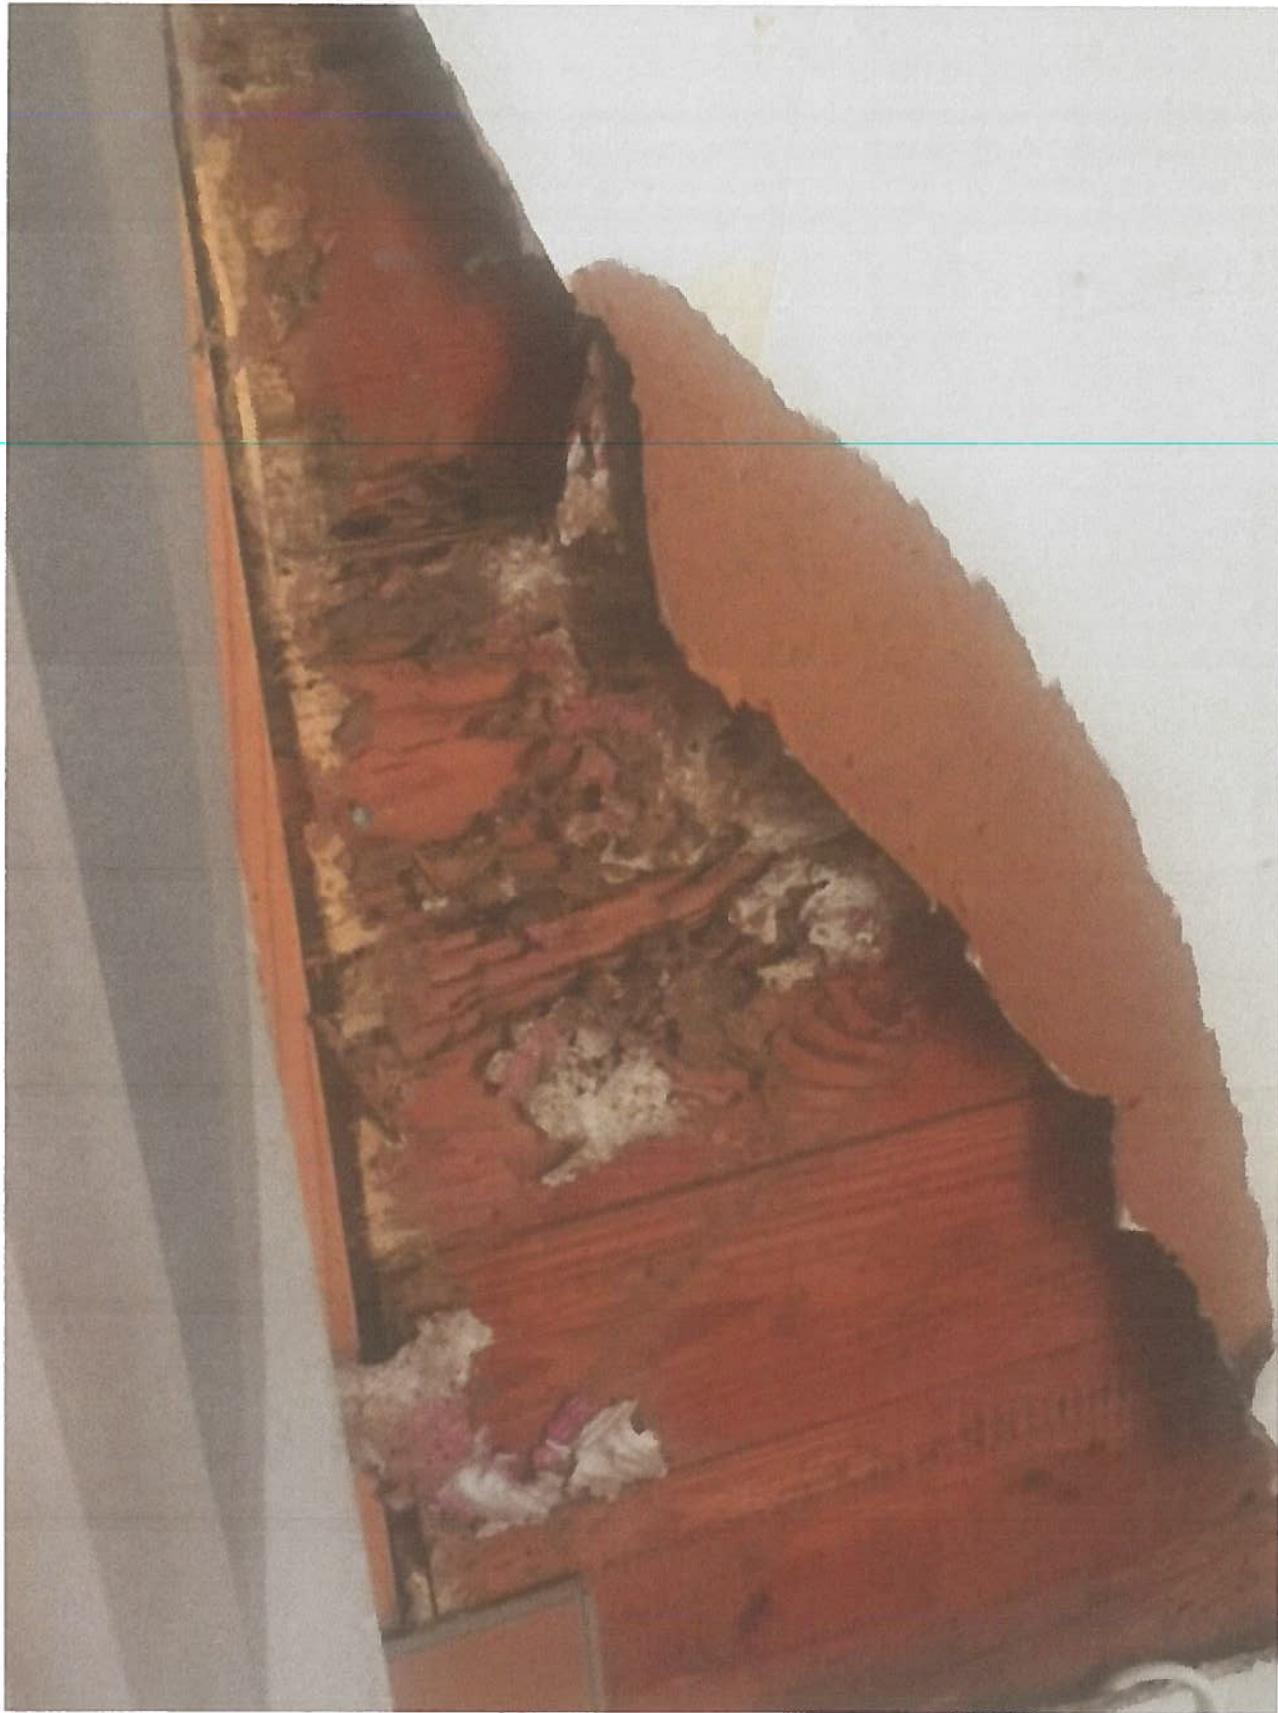
addition to house, not original

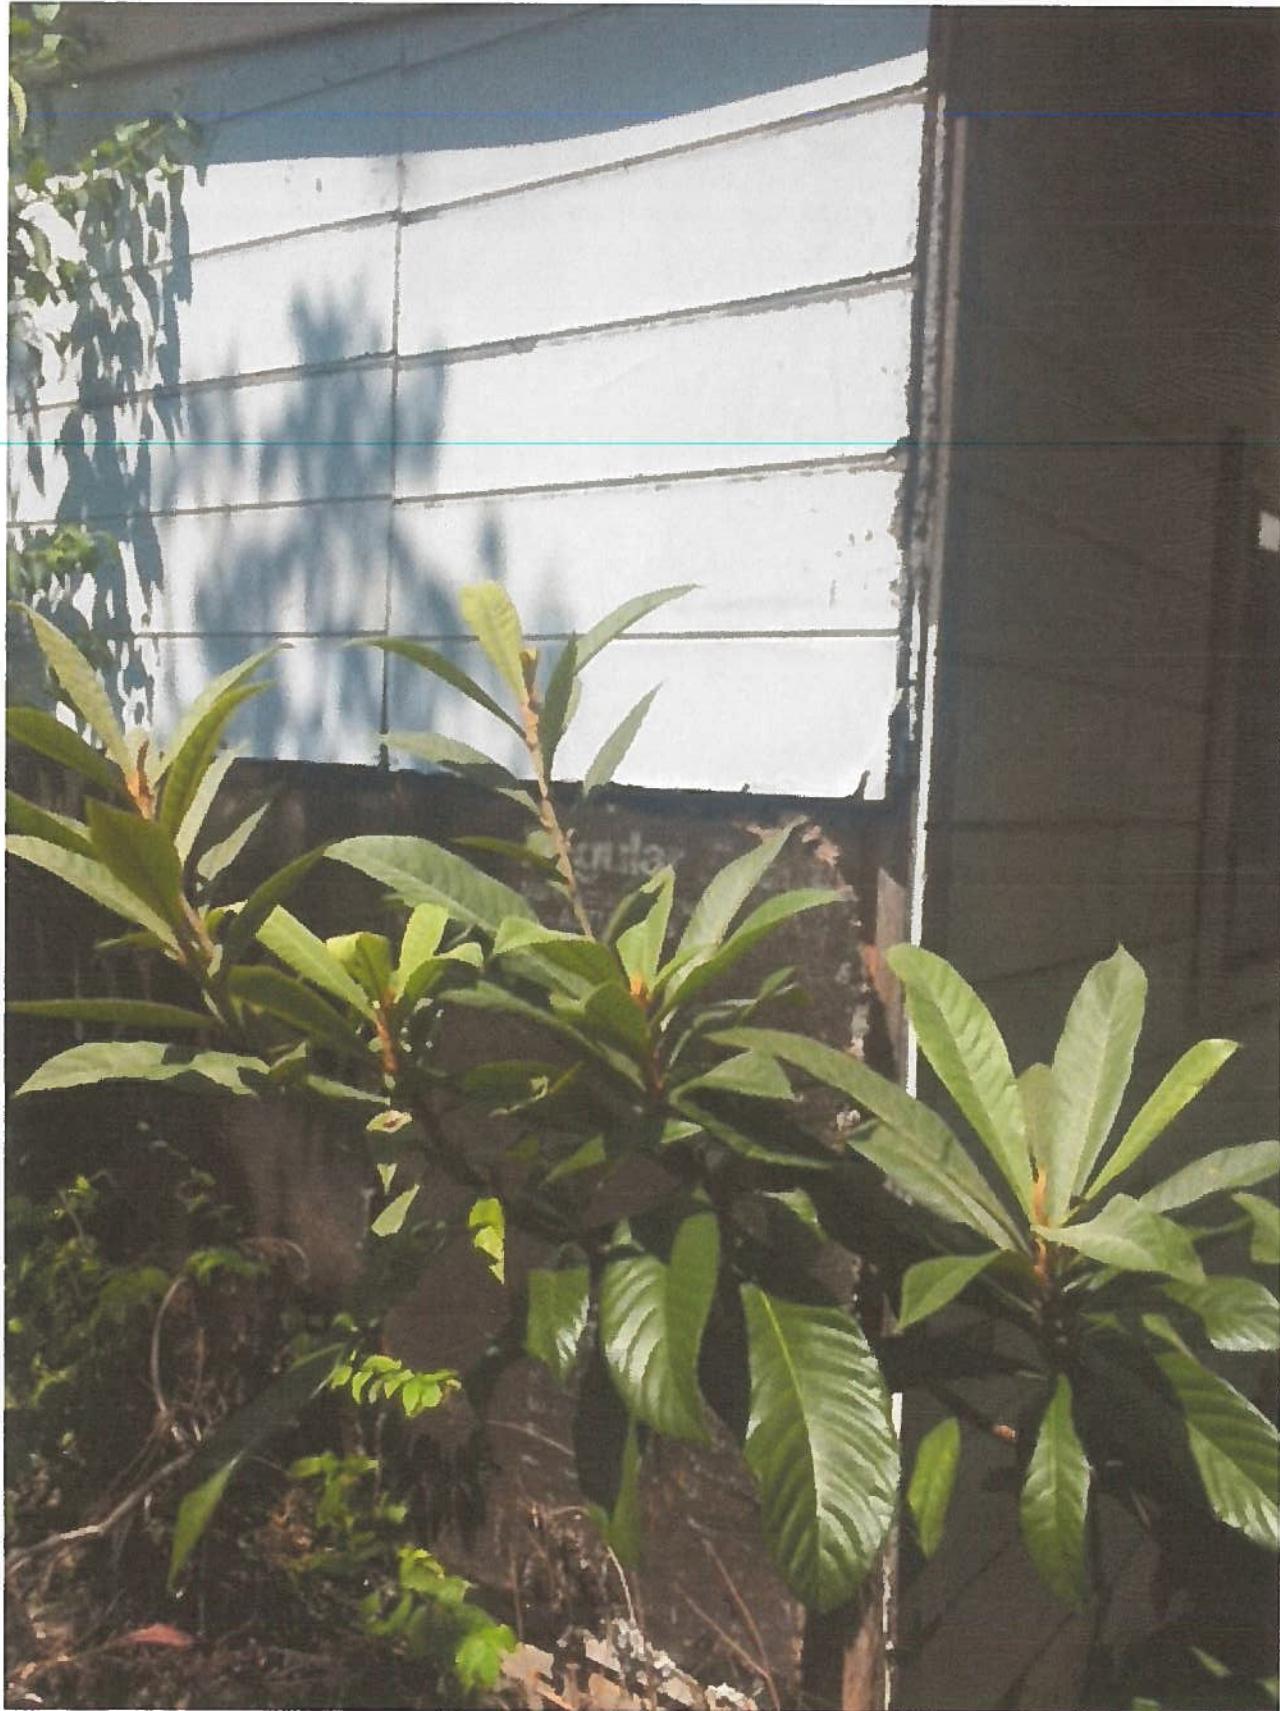
damaged siding - particle board
