2011 Chestnut

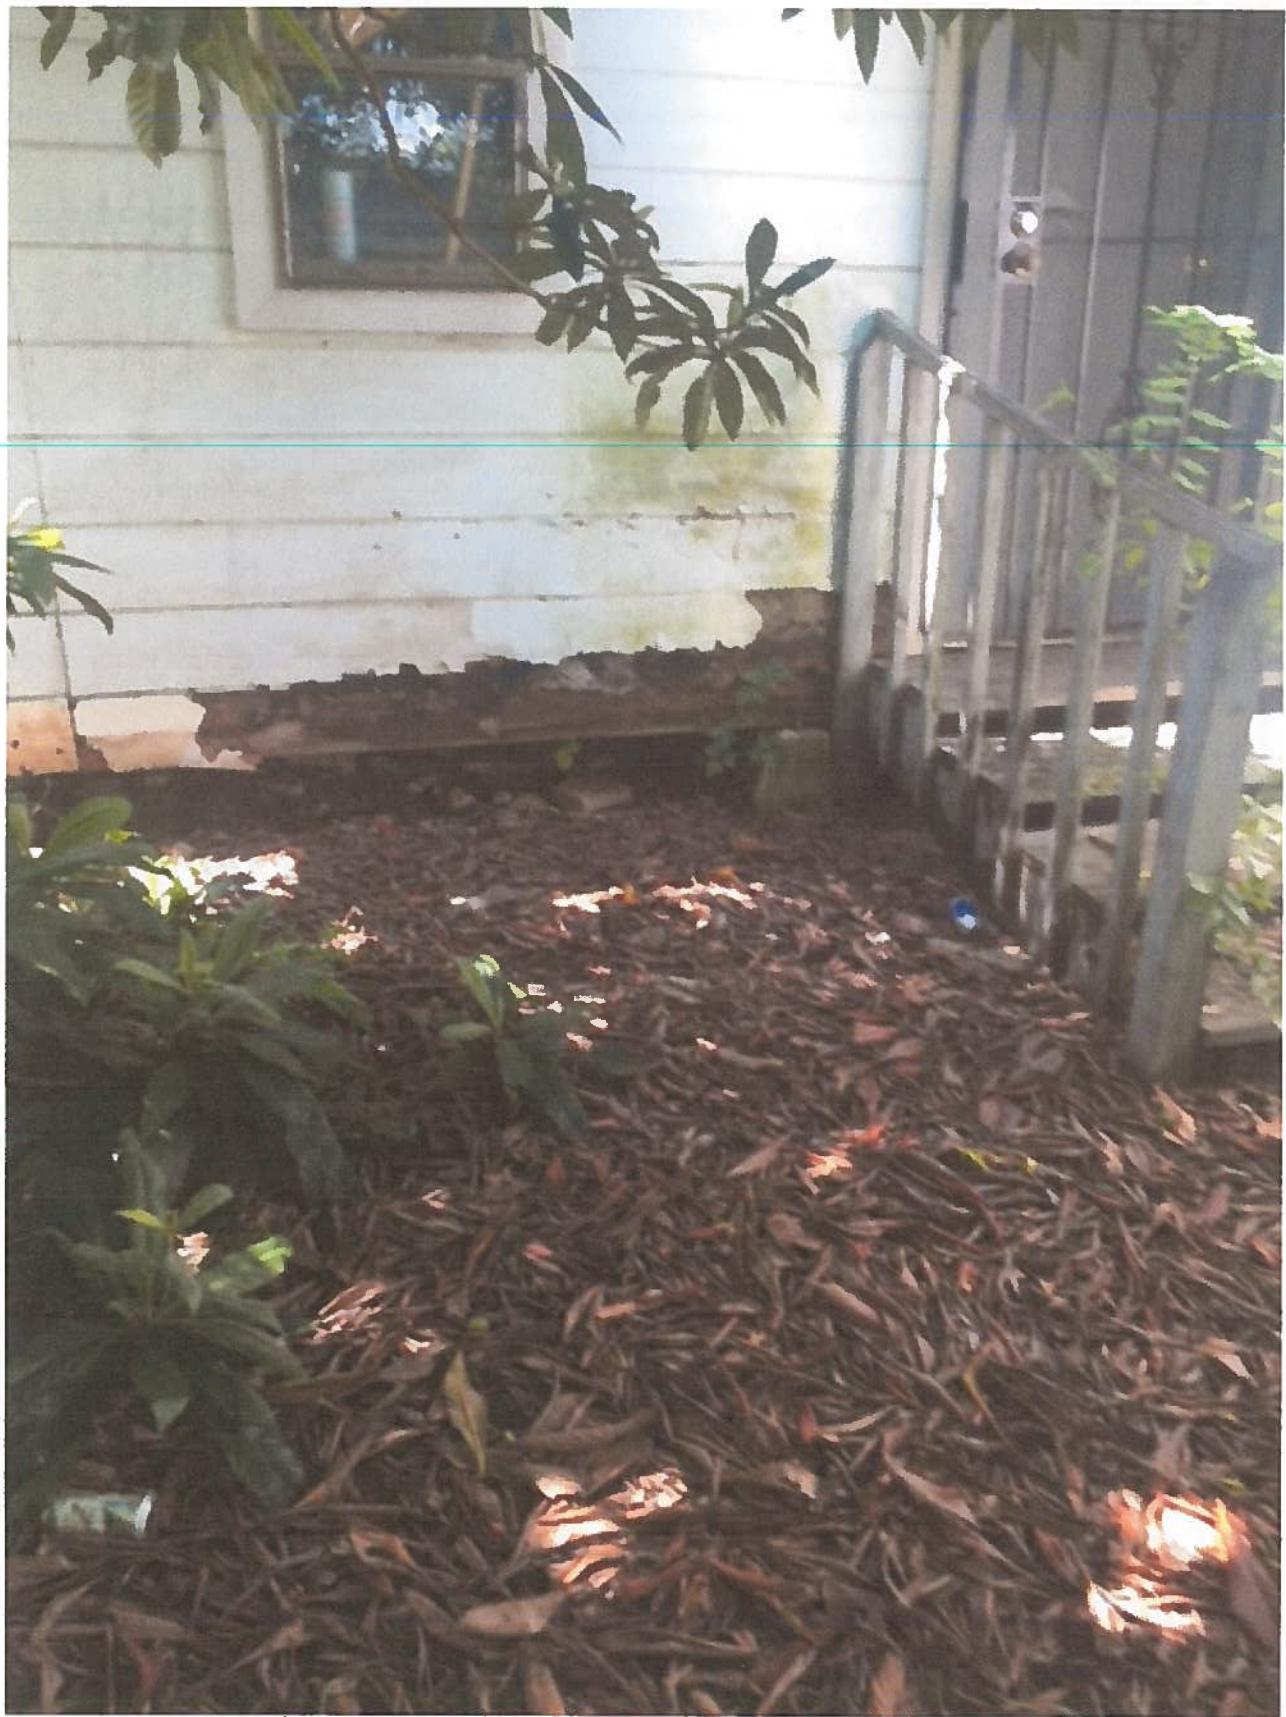
BACK of House - foundation has rotted
members, on porch deck concrete post base

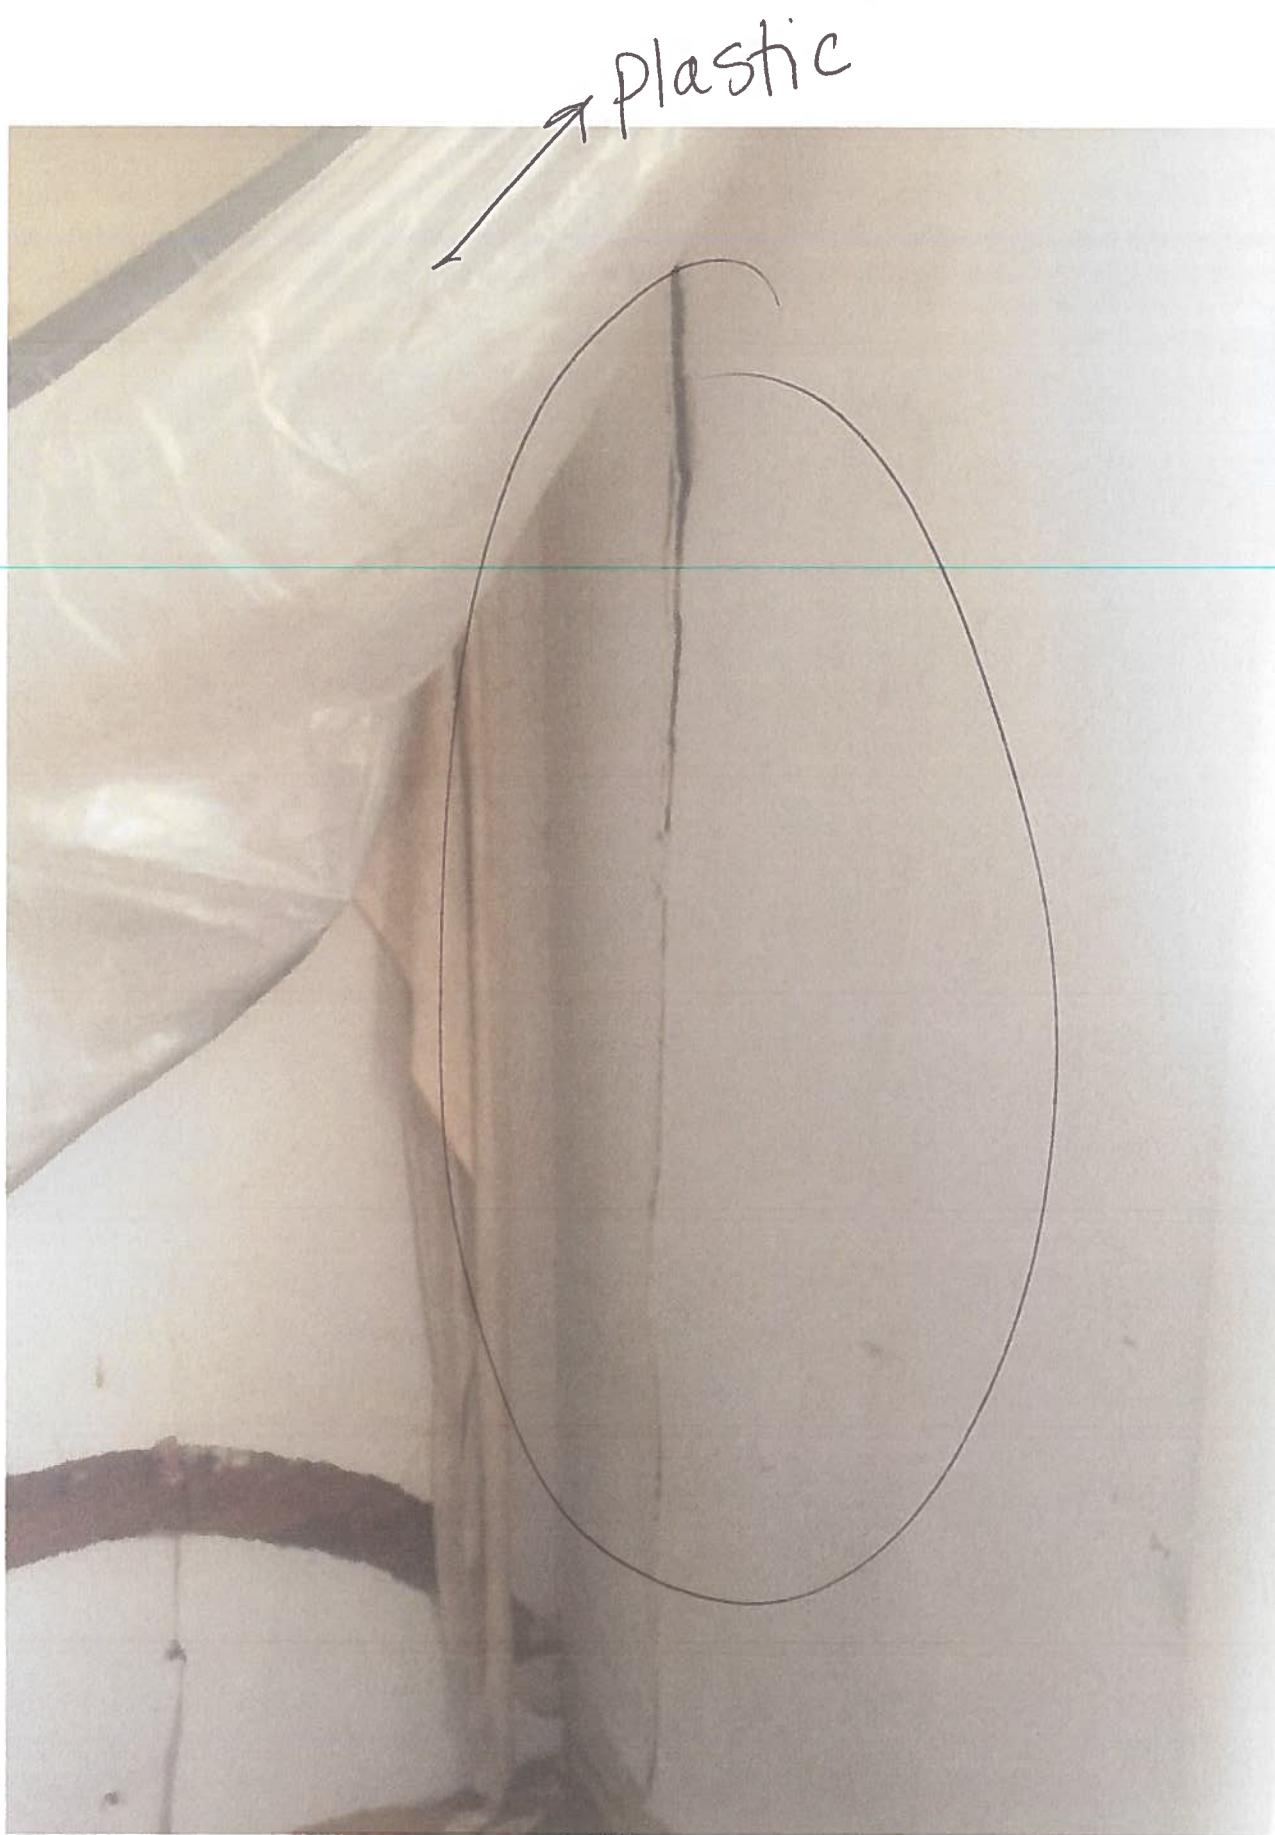
Water damage in bedroom

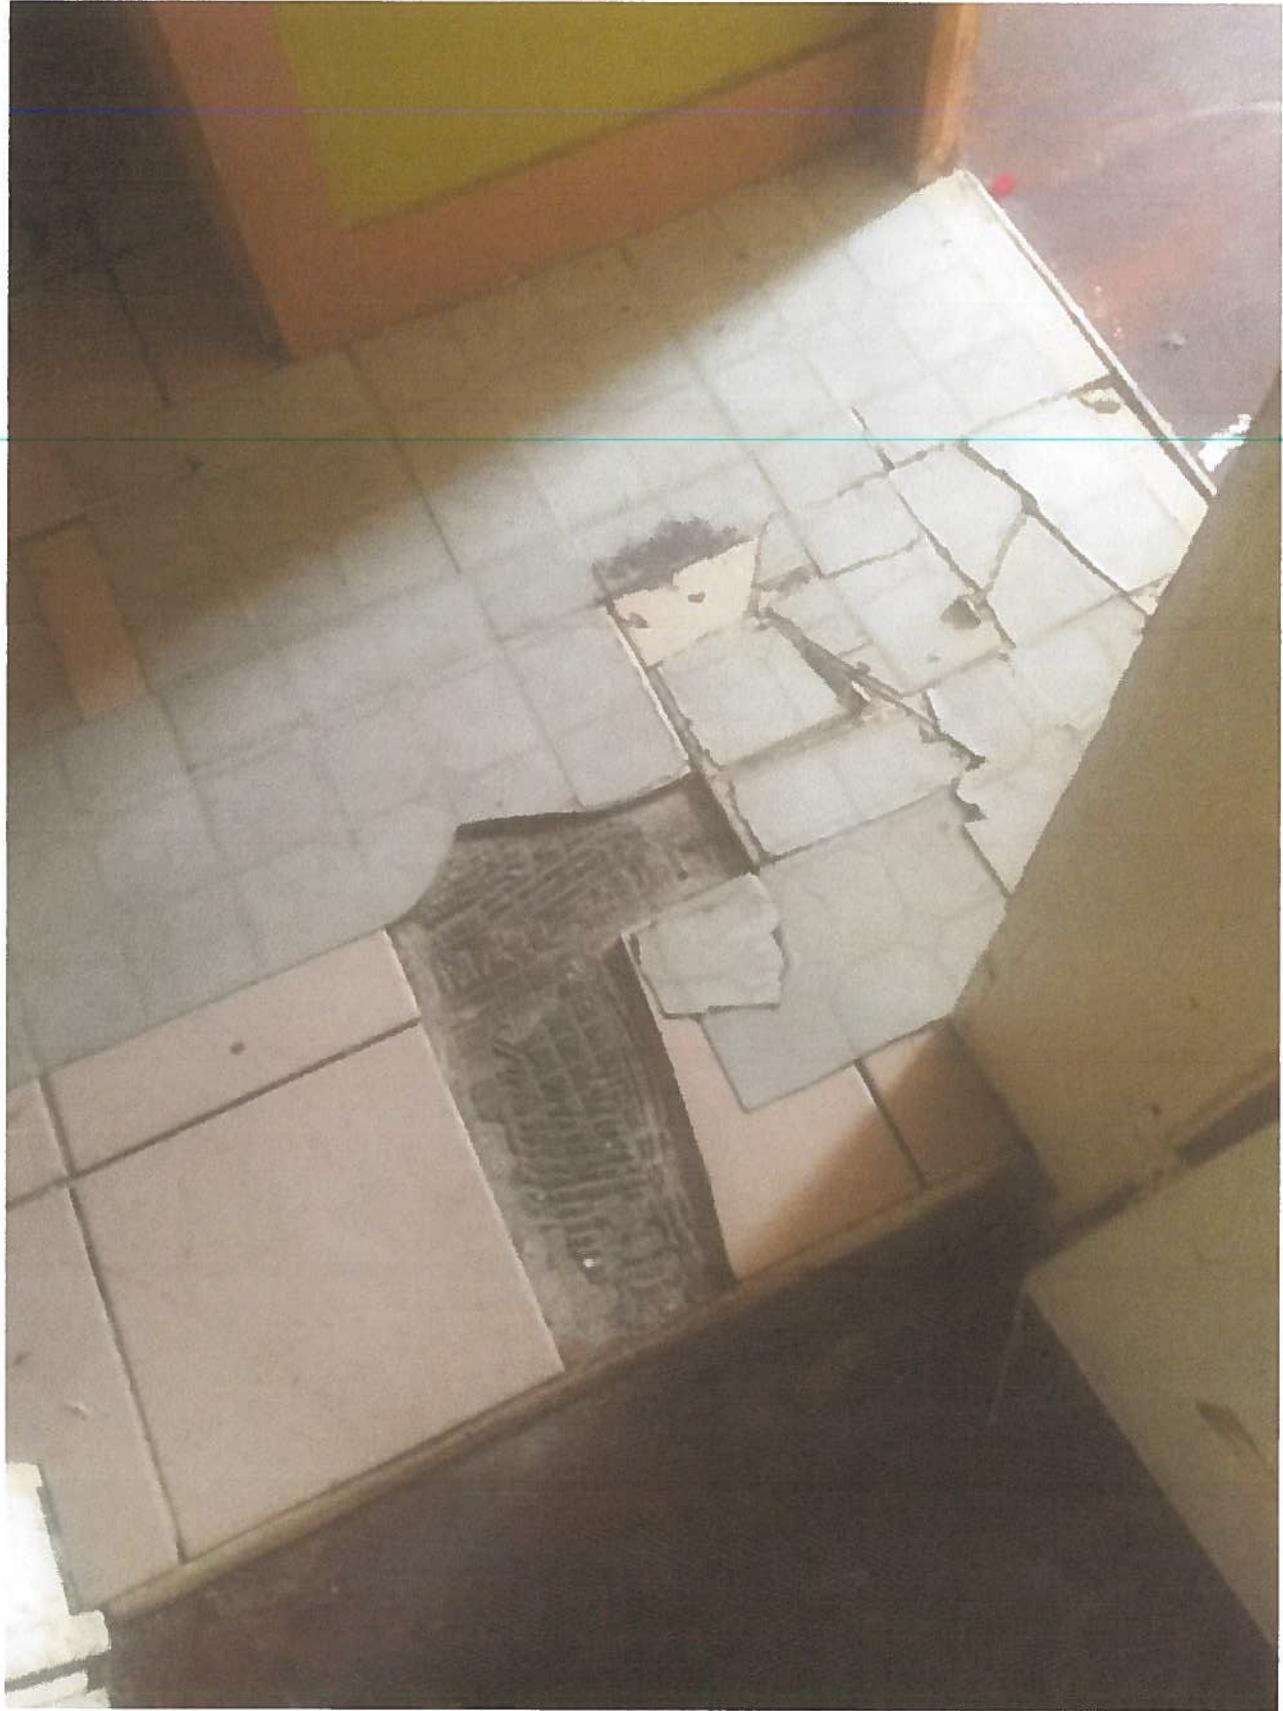
tile floor popping due to foundation

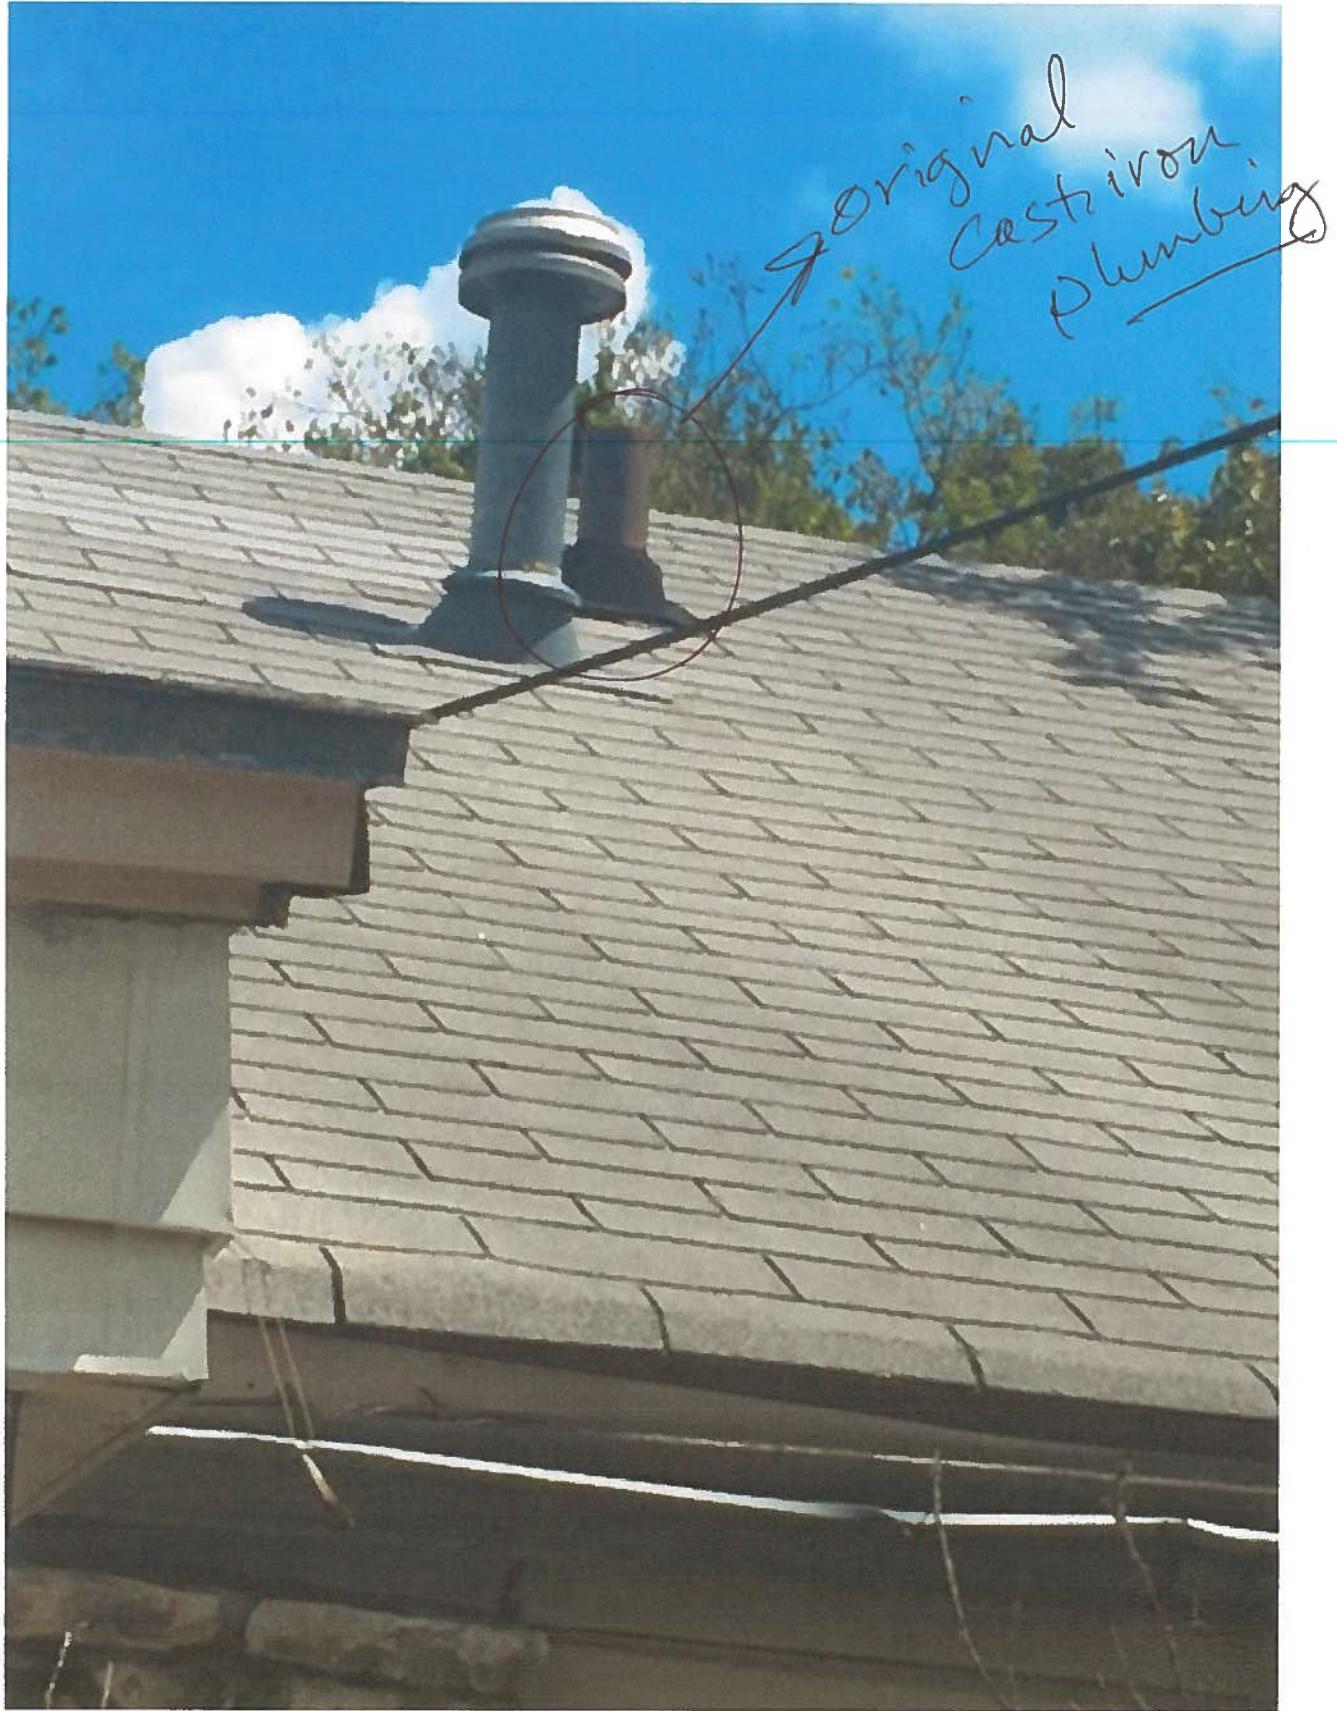
original
cast iron
plumbing
