**Historical Land Commission
1811 Cedar Avenue
Austin, Tx 78702**

1811 Cedar Street
Evaluation of Historic Significance
November 14, 2016

Re: Historic / Structural Evaluation
1811 Cedar Avenue
Austin, TX
Engineer's Job #1601087000002

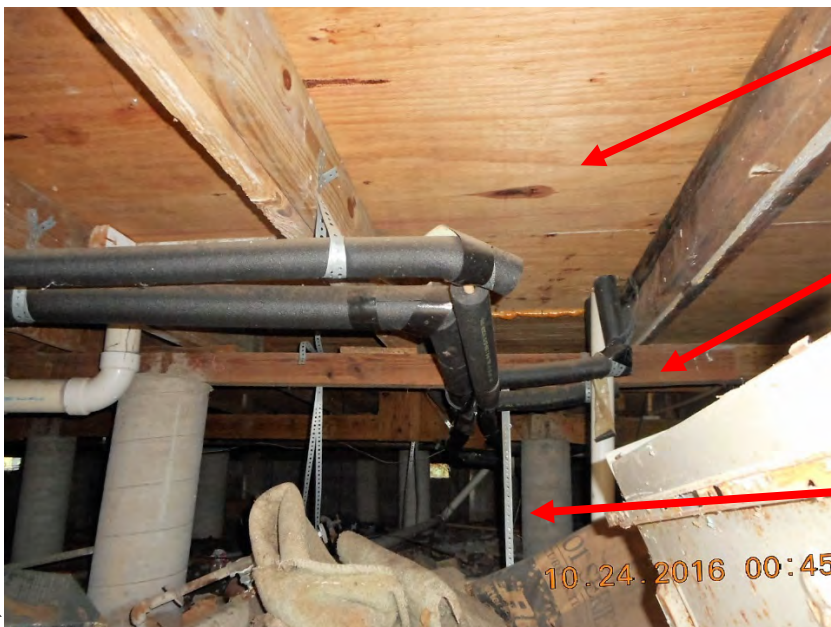
We also suspect that the the rear of the house was extended and part of a large remodel that must have occurred in the past. Note the plywood subfloor vs tongue and groove flooring.

The original girder and joists are overspanned and will need complete reinforcement for any future use. The old system was continued for the addition.

The original cedar post support system was removed and modern footings with "sonotube" columns constructed. All this is shallow and allowing the floor framing to move with the clays. We estimate 3 inches of movment.

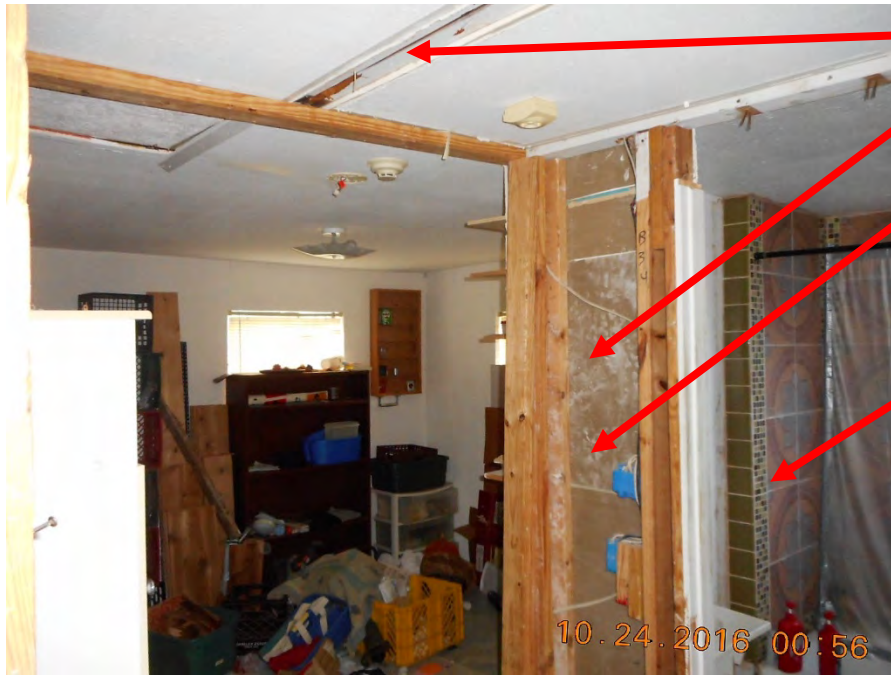
Old wall line

New sheetrock

The walls have been modified and the original construction techniques are no longer evident.

New bathroom

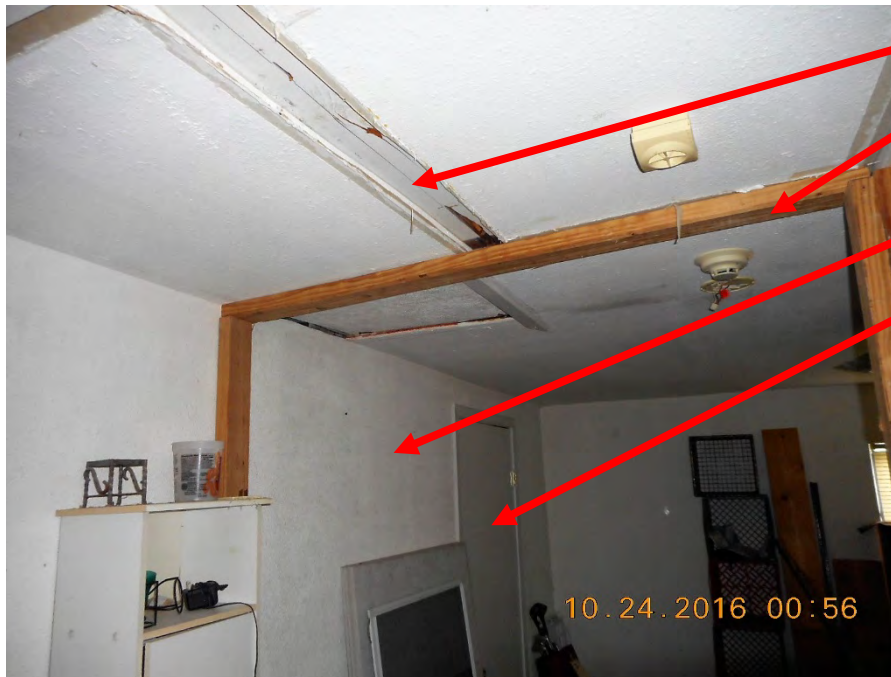
Old wall line

New framing
(haphazardly placed)

New sheetrock

New doors

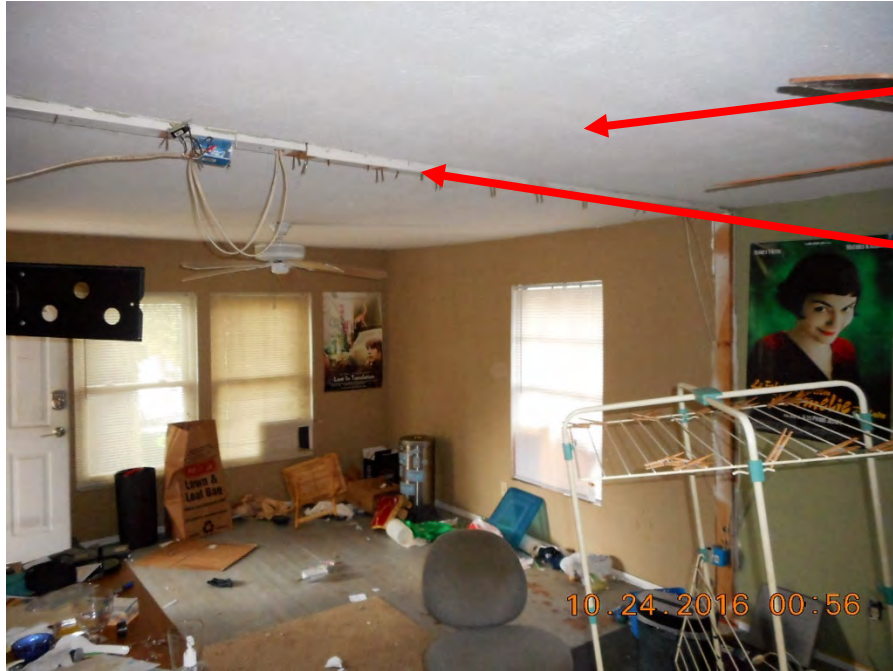
New sheetrock

Load bearing wall removed
(we have photo showing the
roof sagging pushing the
exterior wall outward)

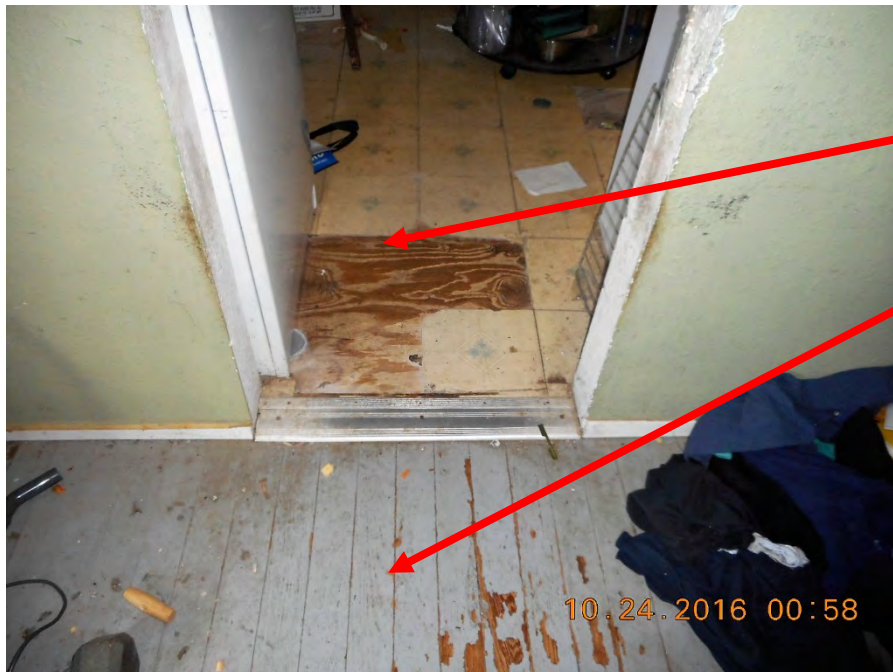
New addition to the back of
the house, note the plywood
subfloor and awkward door
threshold.

Old flooring

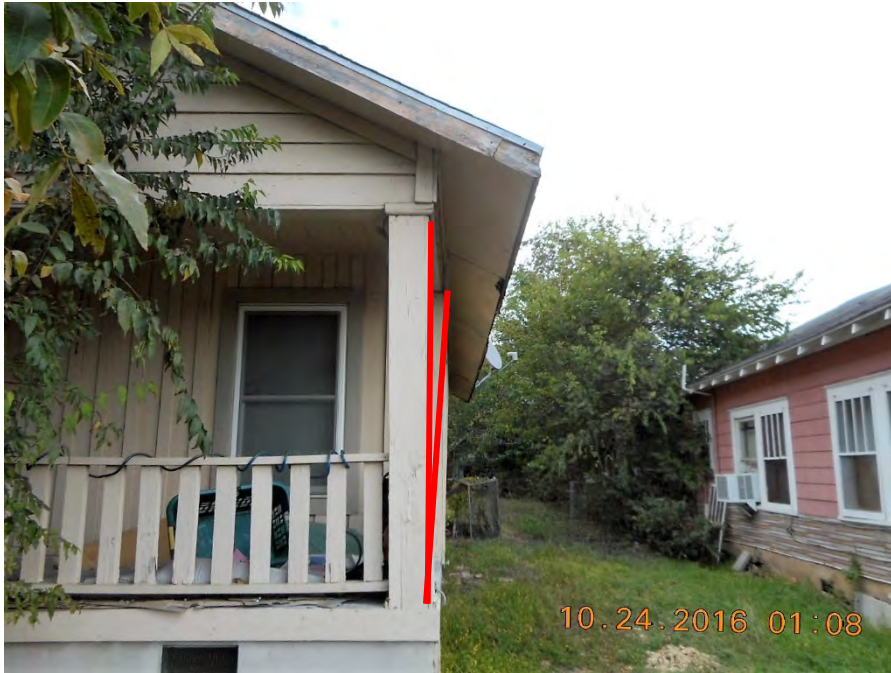
Since the load bearing wall was removed in the living room the ceiling and roof are not supported. We noted that the exterior wall framing was being pushed outward.

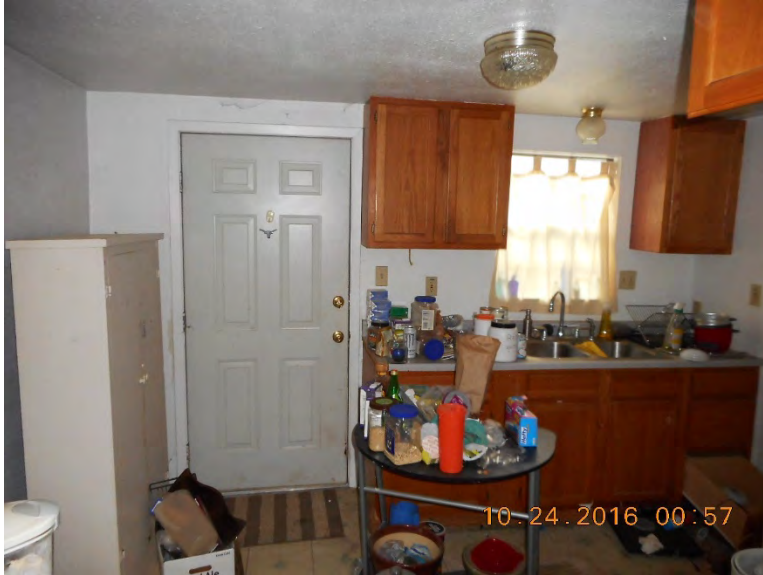
The house was remodeled and there was an addition built on the rear. The new kitchen was installed with builder grade materials.

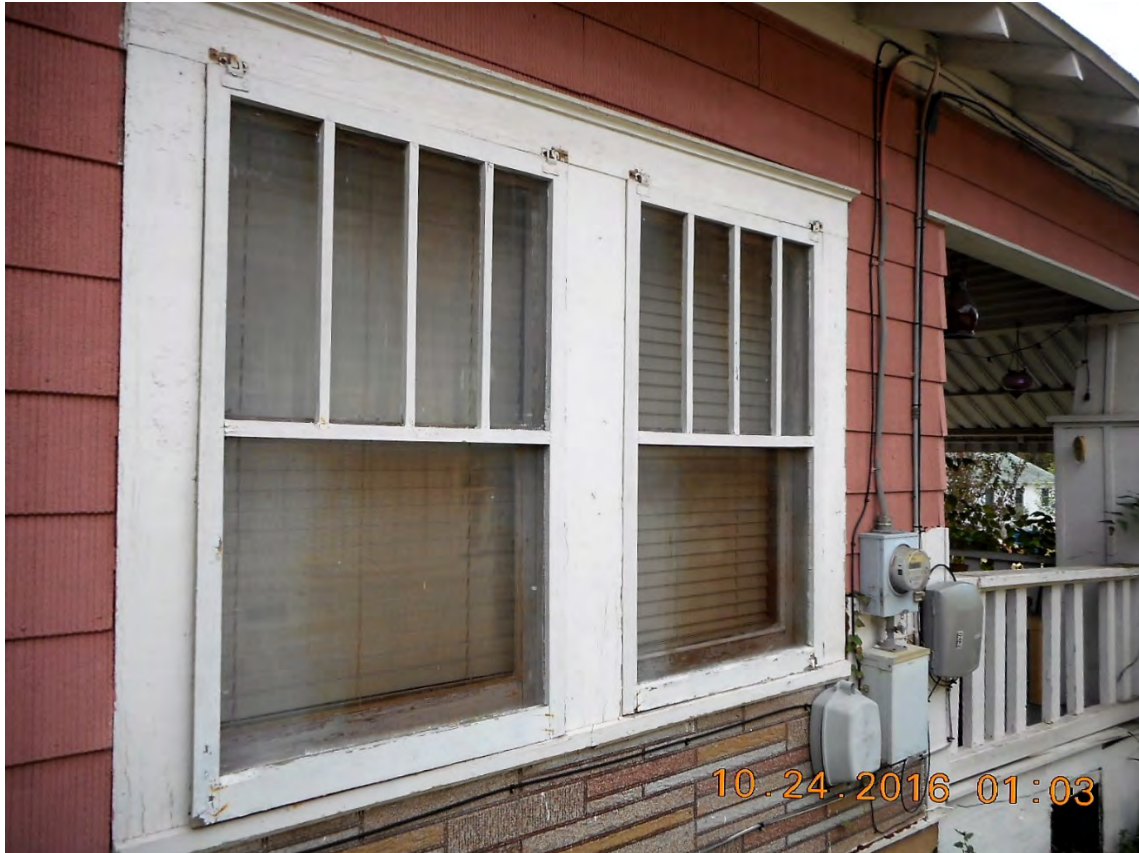
Property to the Right of 1811 Cedar Ave.

1. Still has the original wood windows
2. Still has the original leaded glass
3. Original "slash" cut rafters
4. Column Trim

In our opinion this property is a better candidate for restoration and historical consideration since much of the original building materials are still present and could be restored to the original beautiful look.

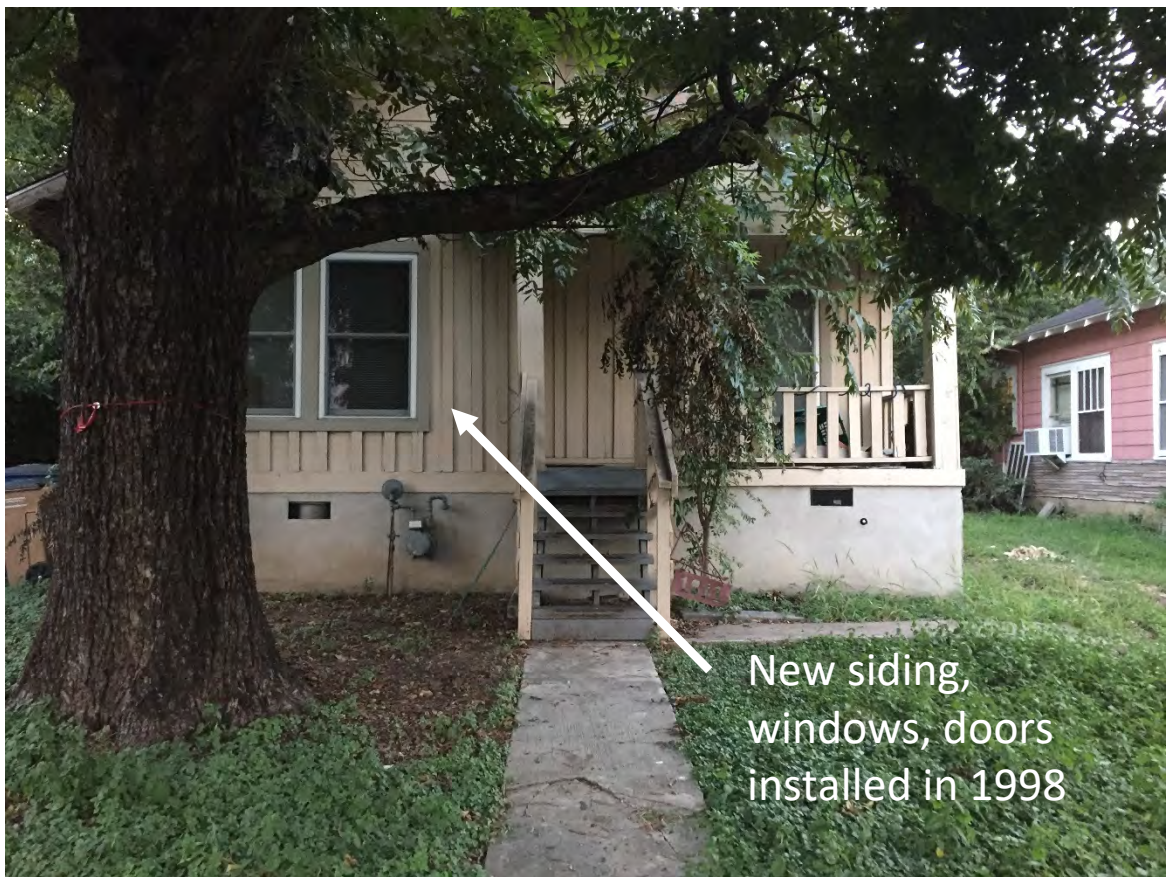
New siding,
windows, doors
installed in 1998

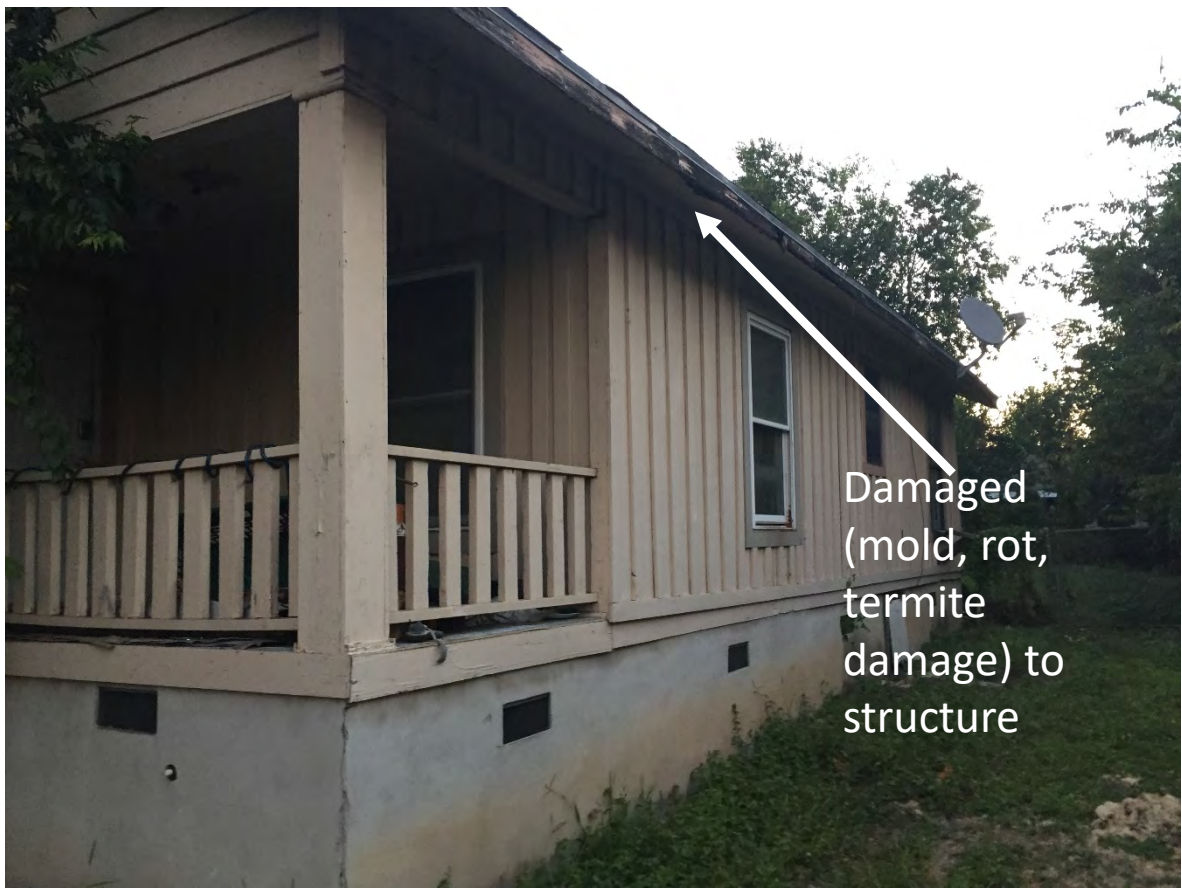
Damaged
(mold, rot,
termite
damage) to
structure
