Re: Structural Engineering Assessment of Existing Buildings
4705 & 4703 Burnet Rd, Austin, Texas
AG&E Project No. 17-107

F I E L D R E P O R T

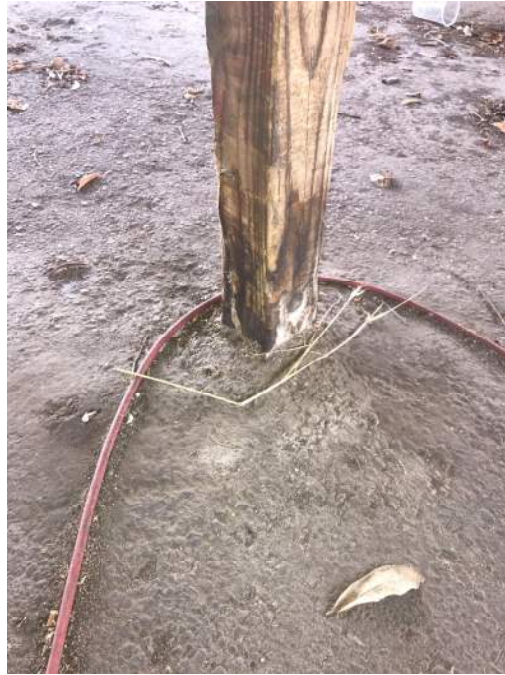
At the canopy behind building 4705, there is a wooden column cast into the concrete foundation (Exhibit 1). Wood cast in concrete creates an environment likely to cause the wood to rot and give way without warning. It appears this base condition is the only thing providing stability to this portion of the structure. This method of construction is not permitted under current codes.

Exhibit 1: Improper column connection

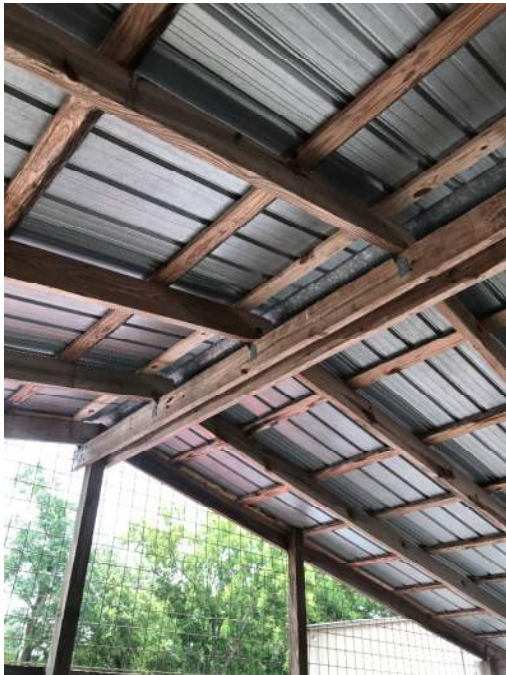
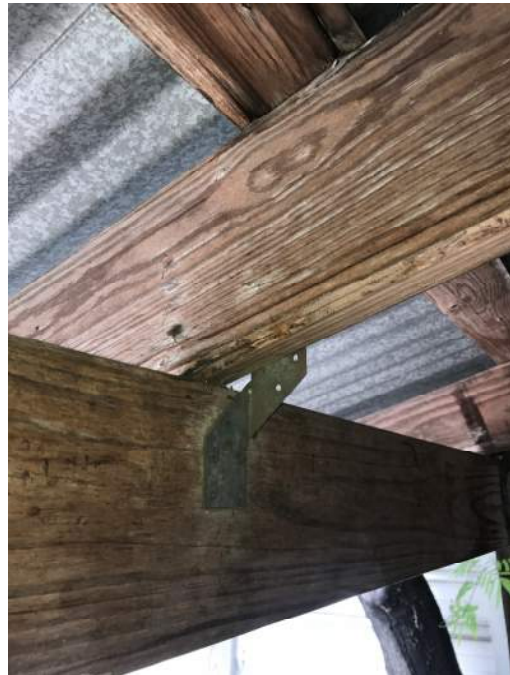
The roof rafters behind building 4705 are using what appears to be a Simpson H2.5A clip at the connection of the roof joists to the ridge beam (Exhibit 2). These clips are not good at transferring lateral loads in shear. With a gable roof, gravity and lateral loads contribute to a shear load at the bearing points. This condition could be addressed by the addition of blocking between the roof joists and additional connector clips.

Exhibit 2: Improper rafter connection for transfer of lateral loads and stability

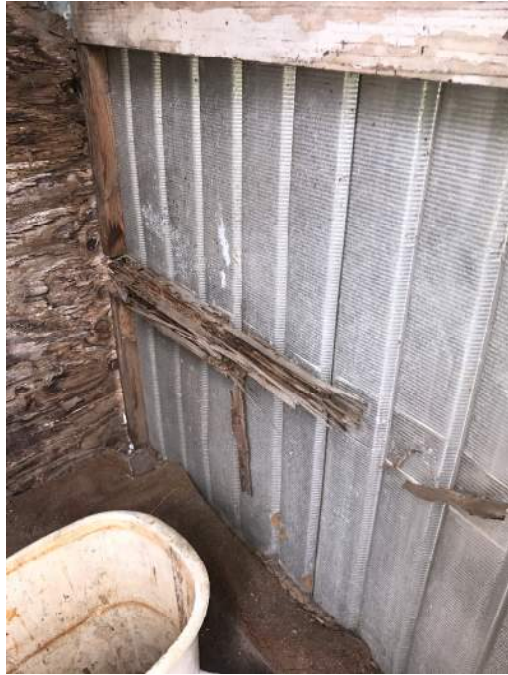
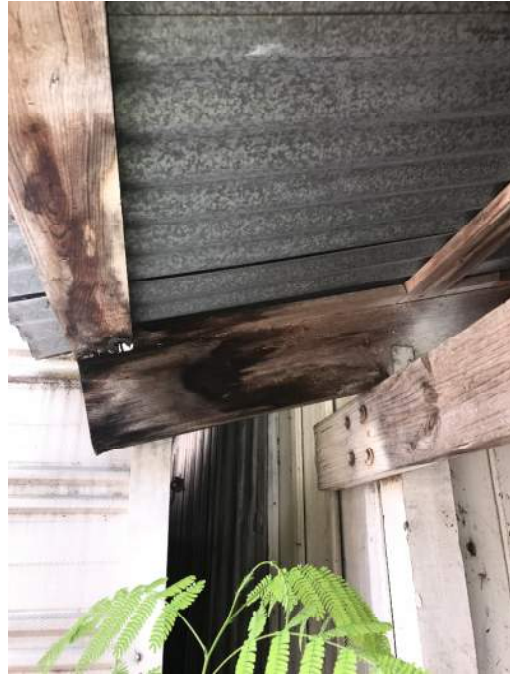
Wood rotting was found at various places around the structure (Exhibit 3). As the building ages and wood continues to rot without being replaced, structural integrity is reduced and can lead to failure.

Exhibit 3: Rotting structural members

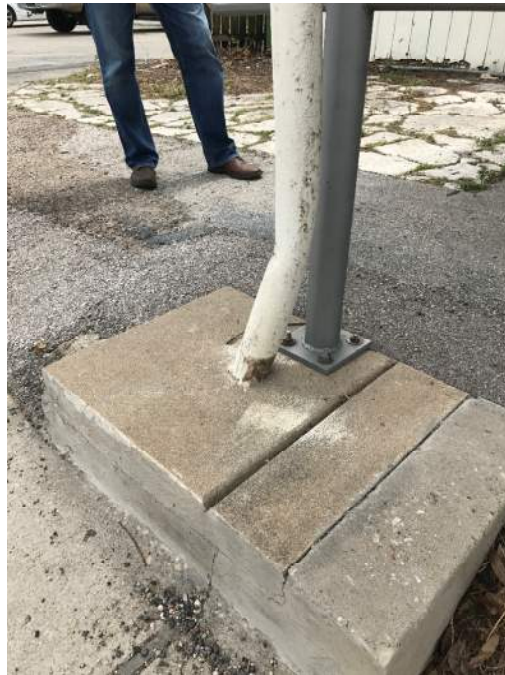
The steel post supporting the canopy in front of building 4705 is damaged and has permanent deformation at the base. The capacity of the member is compromised and may well be inadequate to support code required forces.

Exhibit 4: Buckled canopy post

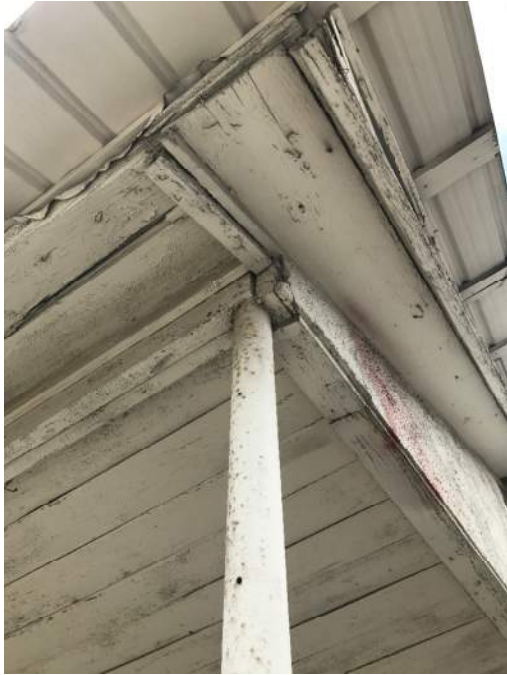
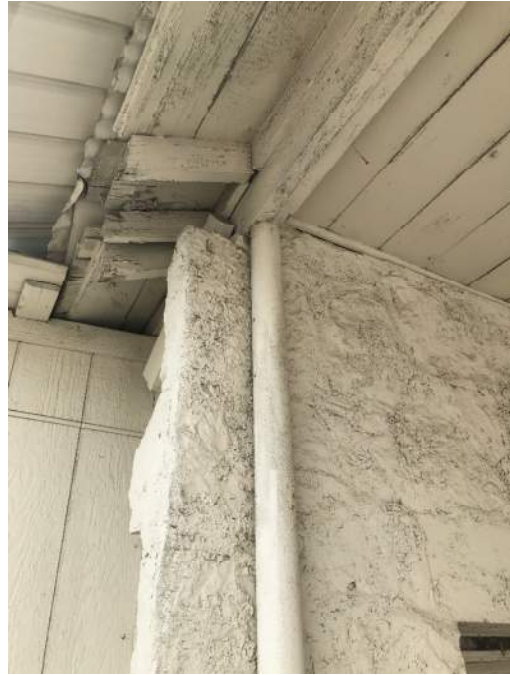
The connection of the steel posts supporting the canopy in front of building 4705 are not adequate for lateral forces and column stability (Exhibit 5). The posts simply rest below the wood framing member. The connection needs to be

reinforced to provide resistance to wind uplift loads and to resist the horizontal forces required to provide lateral stability to the beam and the column.

Exhibit 5: Inadequate connection at top of column

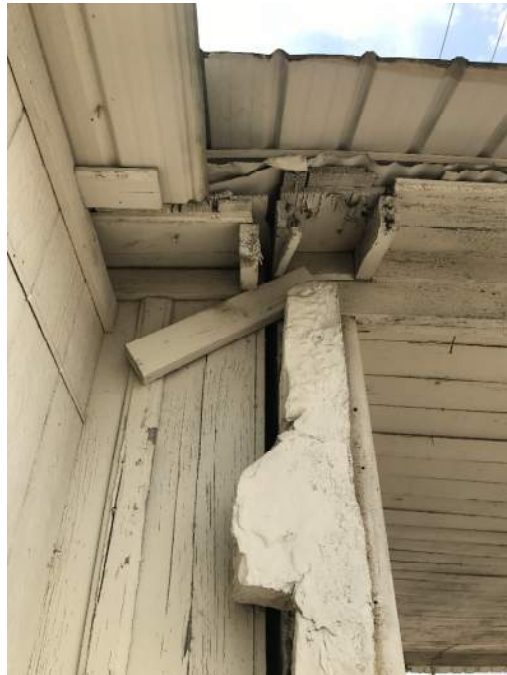
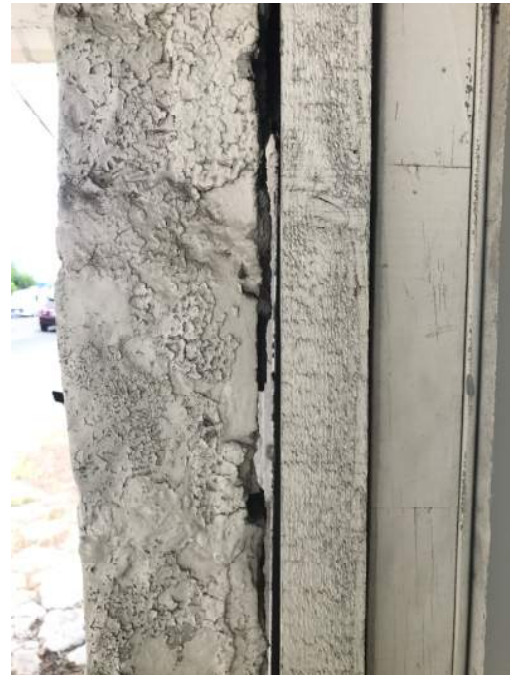
On the face of building 4705, the stone veneer may not have ties back to structure. It was possible to see into the cavity behind the stone in places, but no ties were visible. If the stone is not tied to a structural support, it is vulnerable to being pulled off the face of the building under wind load, an obvious life safety concern.

Exhibit 6: Stone façade potentially unsupported by wall

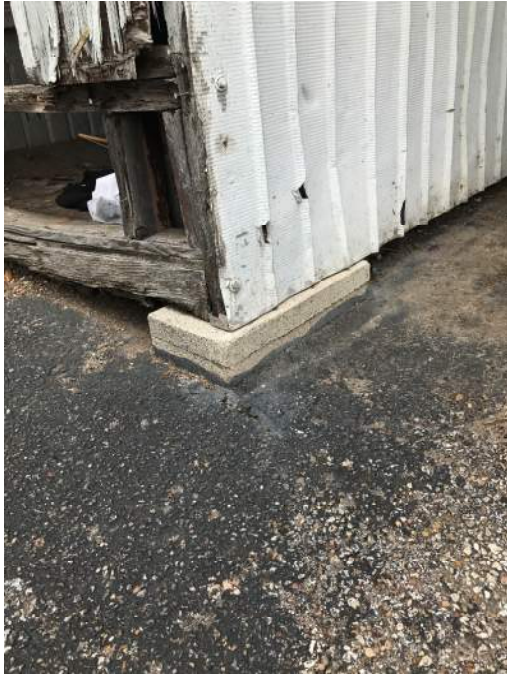
The shed behind building 4703 is resting on top of CMU, which is not a proper foundation (Exhibit 7).

Exhibit 7: Improper foundation

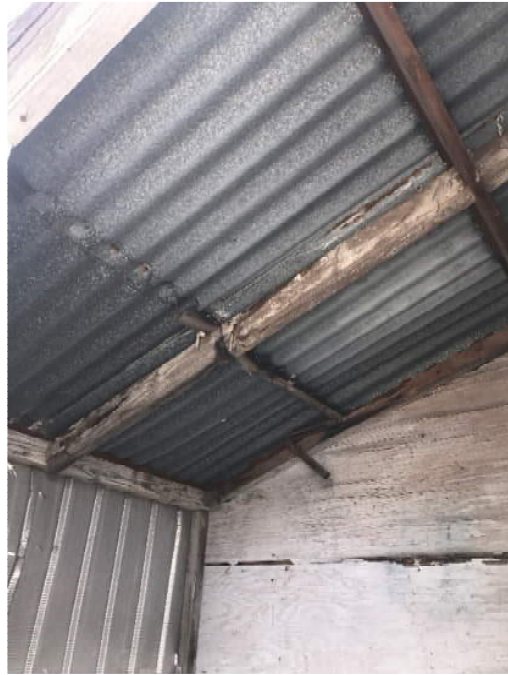
At the shed behind building 4703, the wood roof rafter framing was notched at various points in the member (Exhibit 8). The capacity of the notched members is greatly reduced and the member is almost certainly structurally deficient.

Exhibit 8: Notched wood rafters

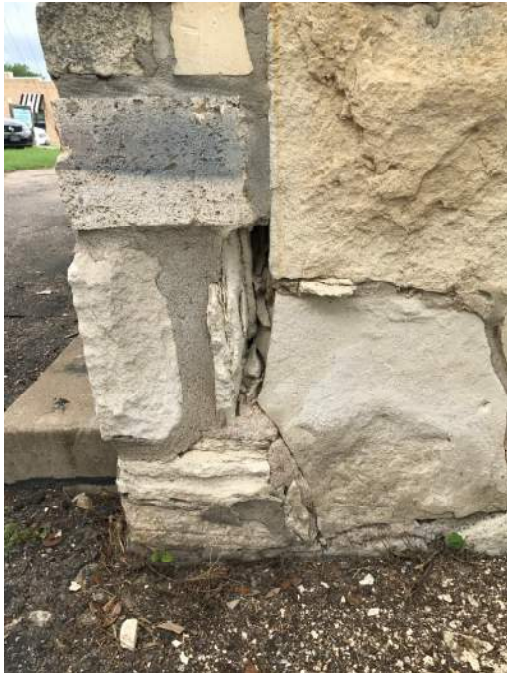
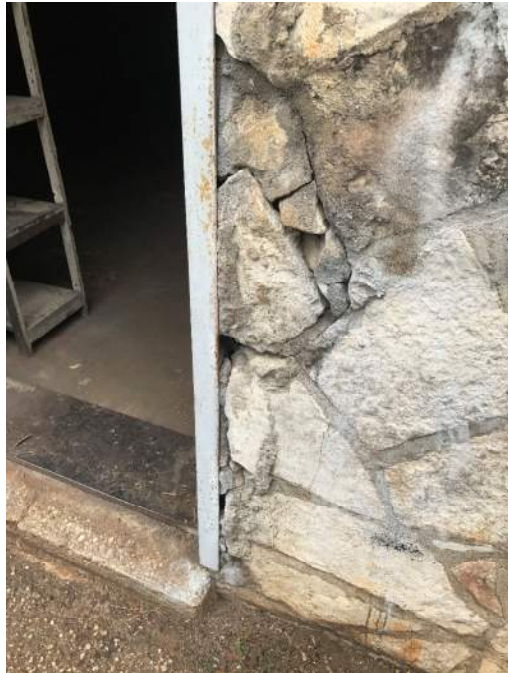
At various locations on the side of building 4703, the stone wall is cracked at mortar joints. Over time, this condition will worsen and could eventually lead to a serious condition. The mortar should be monitored and repaired under the supervision of a structural engineer by tuckpointing or more aggressive means if required.

Exhibit 9: Cracking at mortar joints in the rock façade

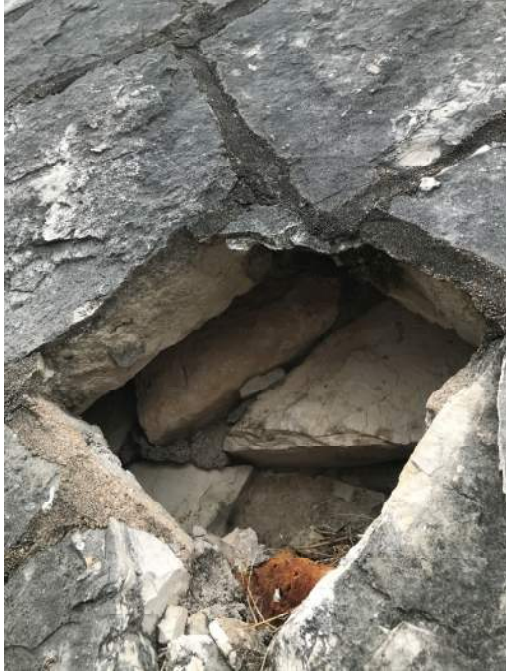
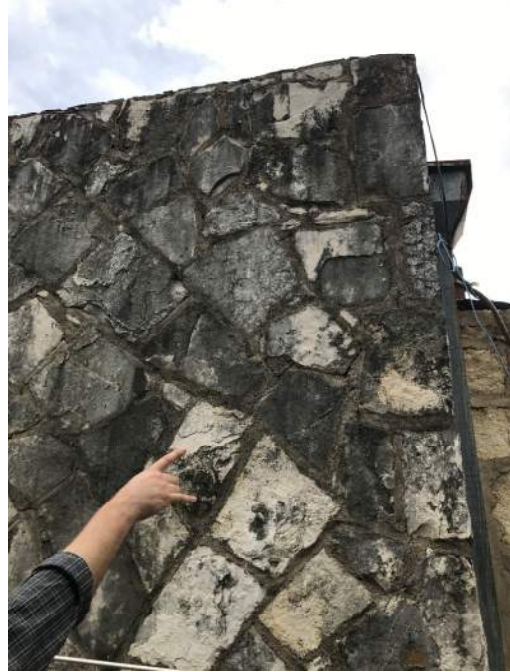
Exhibit 10: Cracking and holes in the rock façade

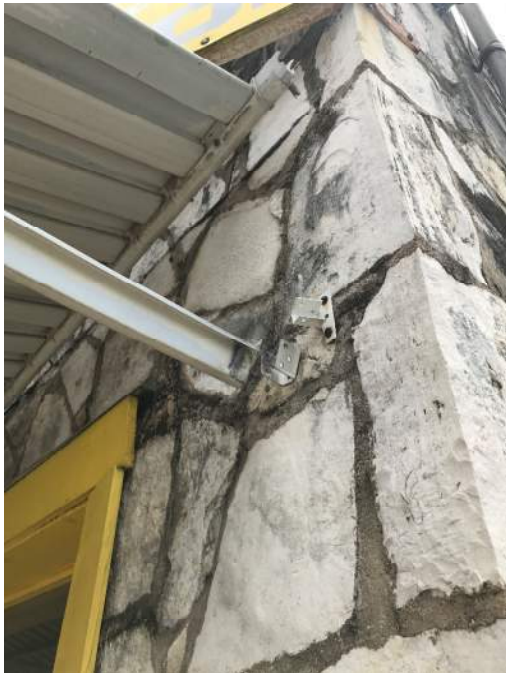
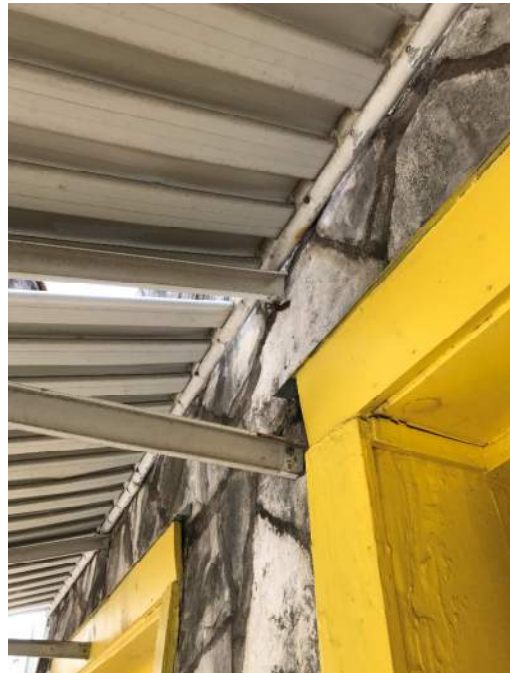
The canopy in front of building 4703 is not properly connected to the building (Exhibit 11).

Exhibit 11: Canopy connection failures

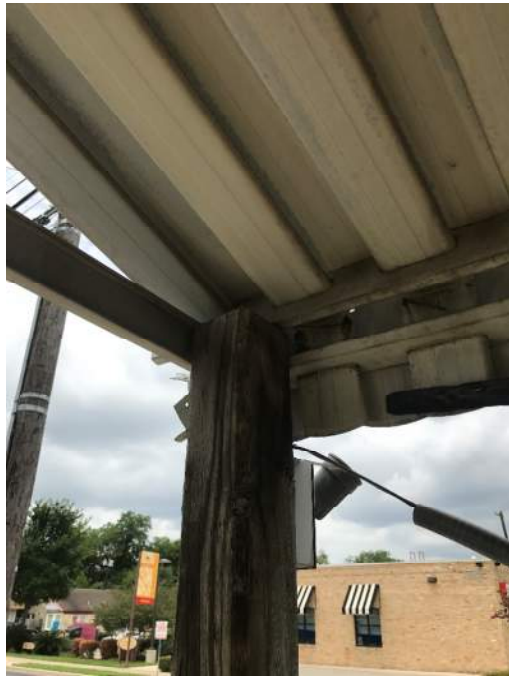
The columns supporting the canopy in front of building 4703 have compromised top connections or no top connection at all, which creates a potential instability (Exhibit 12). Loads at this condition should be analyzed by an engineer and the connection retrofitted to provide adequate capacity to resist those forces.

Exhibit 12: Column connection to canopy inadequate

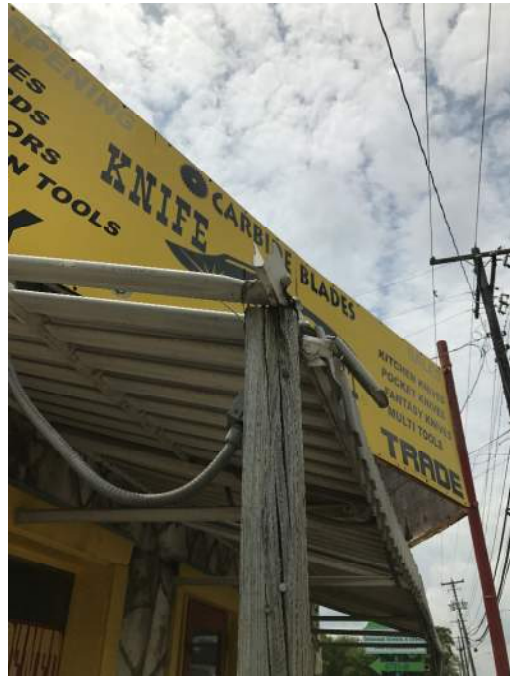
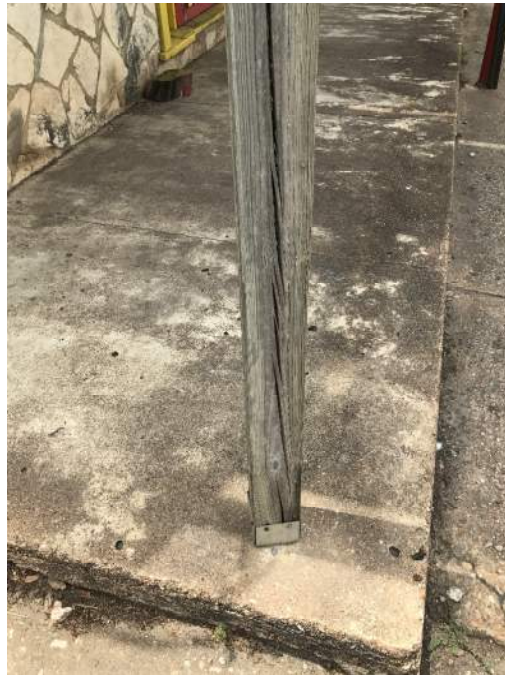
The columns at the front of building 4703 supporting the canopy are seeing significant splitting within the member (Exhibit 13) or warping (Exhibit 19). This can compromise the strength of the wood and promote decay of the member.

Exhibit 13: Significant checking of wood post

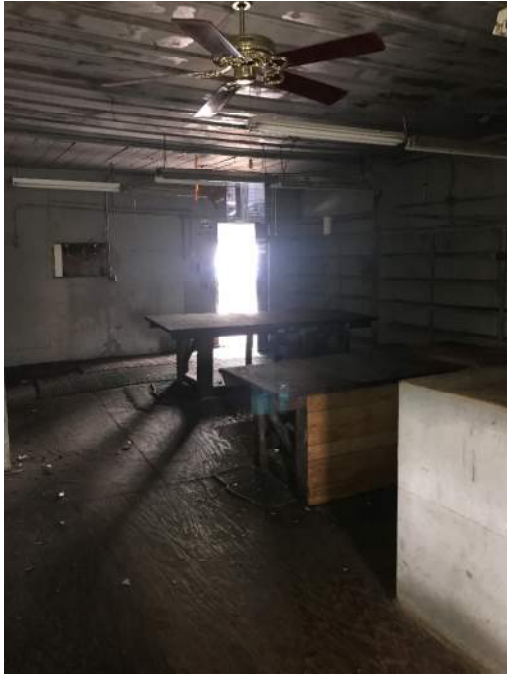
The floor of the original structure appears to be plywood sheathing fastened directly to an uneven bearing surface beneath. It is not clear whether the uneven surface is concrete, asphalt, or even bare earth. The floor varies substantially in elevation and would not pass a Texas Accessibility Standards review. Furthermore, the load bearing capacity of the floor is in question until such time as the substrate can be observed and evaluated.

Exhibit 14: Floor settlement and uneven floors

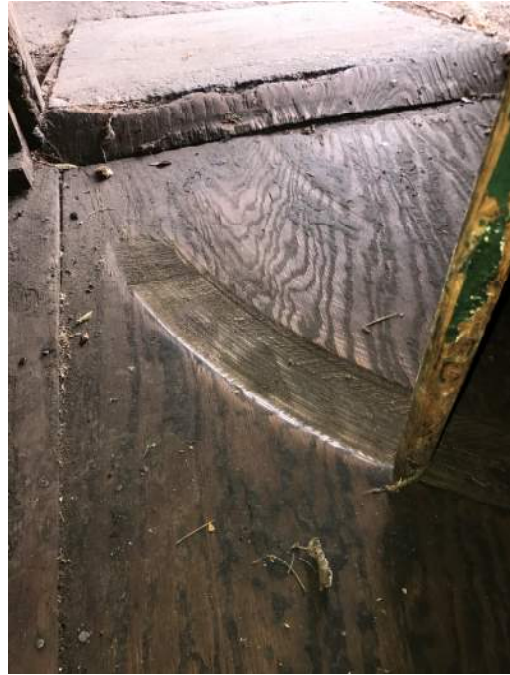
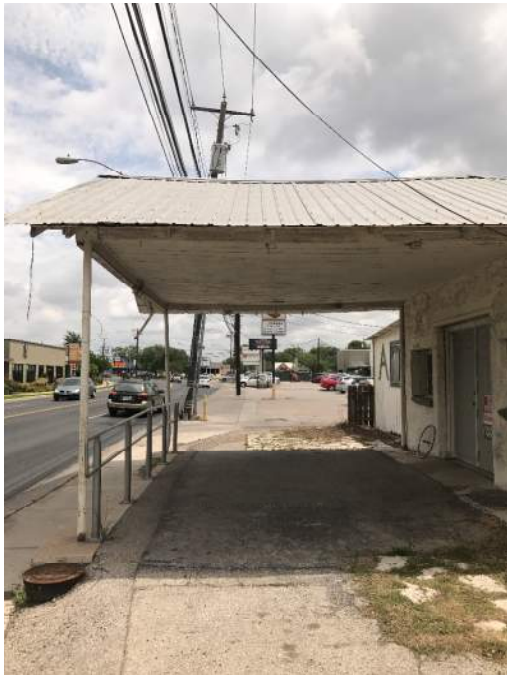
Significant canopy displacement can be observed at the front of building 4705 (Exhibit 15).

Exhibit 15: Significant canopy deflections

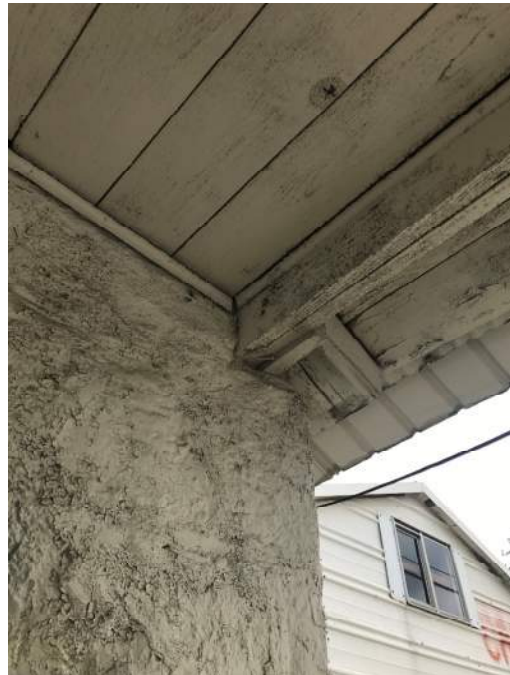
The wooden beams in front of building 4705 are bearing on the stone veneer may not be designed as a bearing wall (Exhibit 16).

Exhibit 16: Inadequate bearing condition

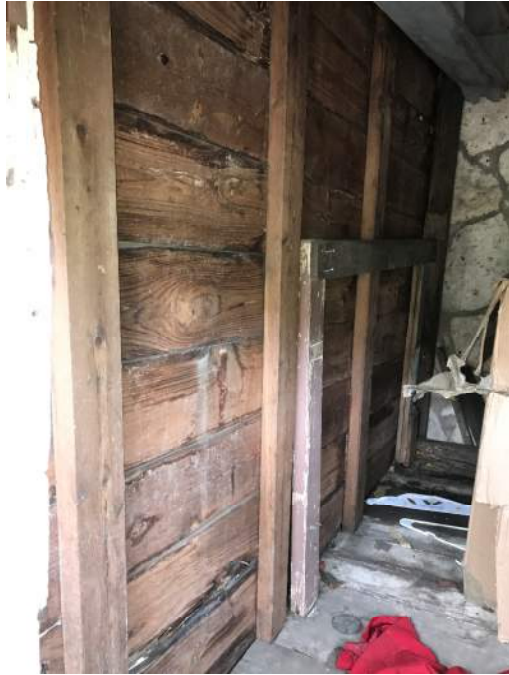
The walls within the shed behind building 4703 are improperly built, as the studs should have been rotated at a 90-degree angle (Exhibit 17).

Exhibit 17: Improper stud wall framing

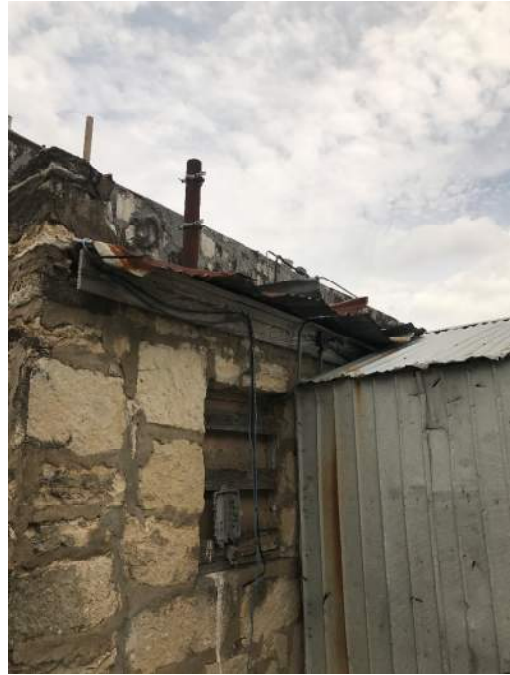
The roof deck on addition to building 4703 is warping (Exhibit 18). This is most likely due to age and exposure to weather. Also, proper connection may not have been made to hold the decking in place.

Exhibit 18: Metal roof deck warping

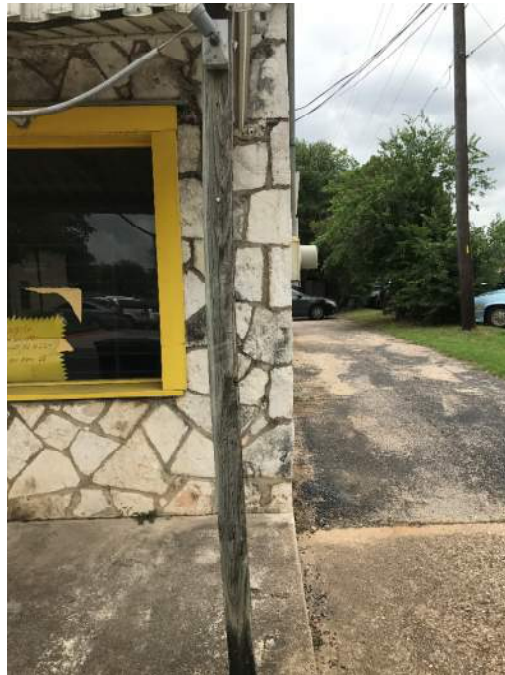
Exhibit 19: Wood column warping, deteriorating at base.

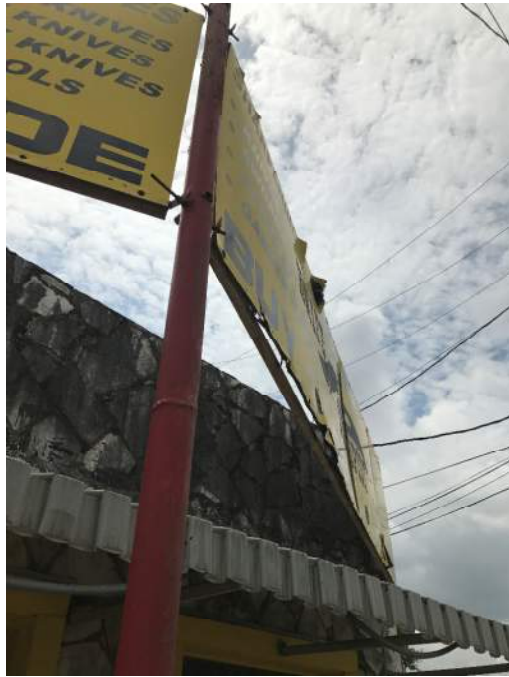
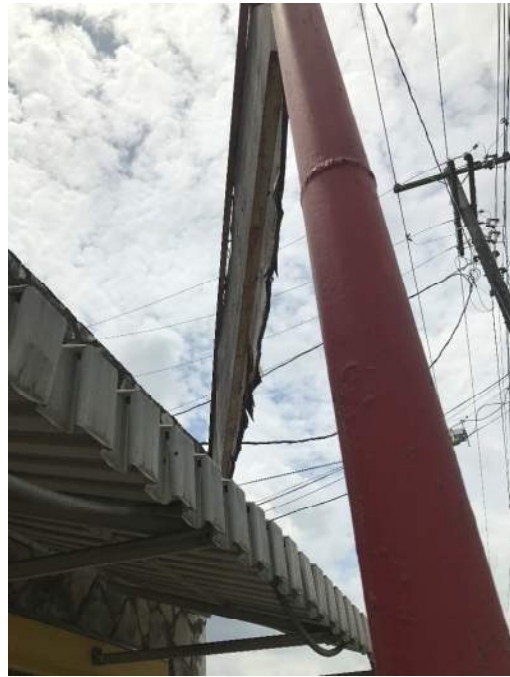
The sign in front of building 4703 is supported by a thin steel member spanning a significant distance. Also, the sign is no longer continuously fastened to the support (Exhibit 20). Even though the sign is a necessary piece of the building structure, it does create a risk if it falls or becomes windborne.

Exhibit 20: Sign not properly supported; falling/flying debris hazard.

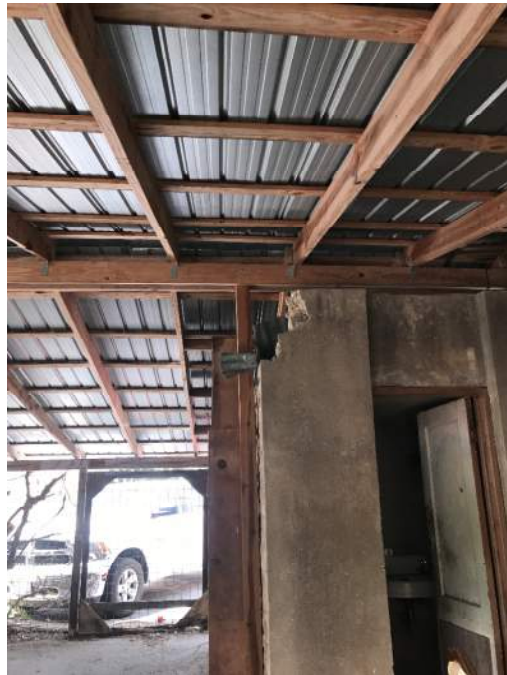
Nonbearing unreinforced concrete wall is seeing excessive spalling (Exhibit 21).

Exhibit 21: Spalled concrete Wall
