Re: Existing Residential Foundation and Superstructure Assessment

1410 E 3rd St., Austin, TX 78702 (Lot 4A)

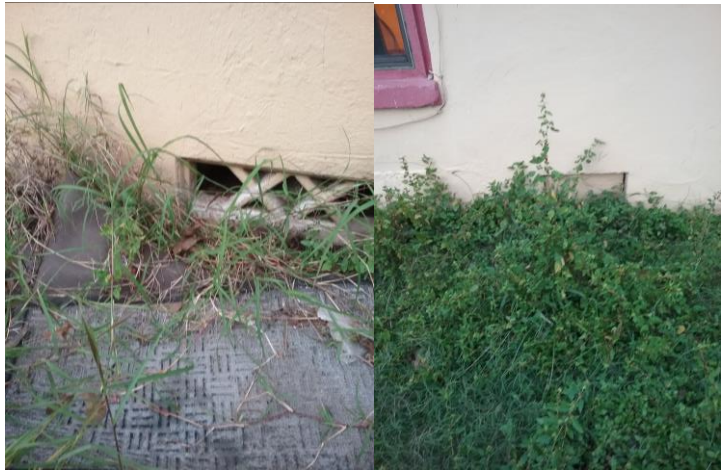
Available records indicate that the structure was built in 1948. It consists of a single story residential structure. The main house is apparently supported by a CMU continuous perimeter footing that created a crawl space under the wood framed floor. Access to the crawl space is only possible at locations where vents were installed. The continuous footing appears to be a 4" thick CMU which is very unusual on properly engineered foundations. Floor framing could not be inspected due to access restraints (Figure 1).

Figure 1: Limited crawl space access

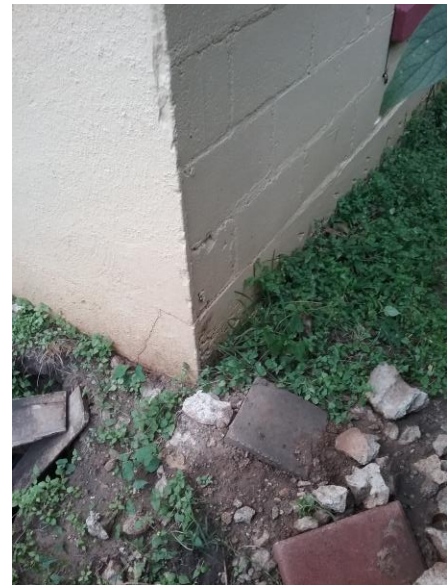
All the interior and exterior walls are made of a concrete product of some sort (CMU or stucco applied on wood laths, Figure 2), but it certainly isn't anything seen in current construction standards. These walls are very heavy in comparison to drywall or interior plaster. This puts a tremendous amount of additional load on the floor system. The subfloor is getting *spongy* and soft throughout, which may indicate improper design, insufficient subfloor thickness or termite/water damage.

Figure 2: Exterior CMU wall

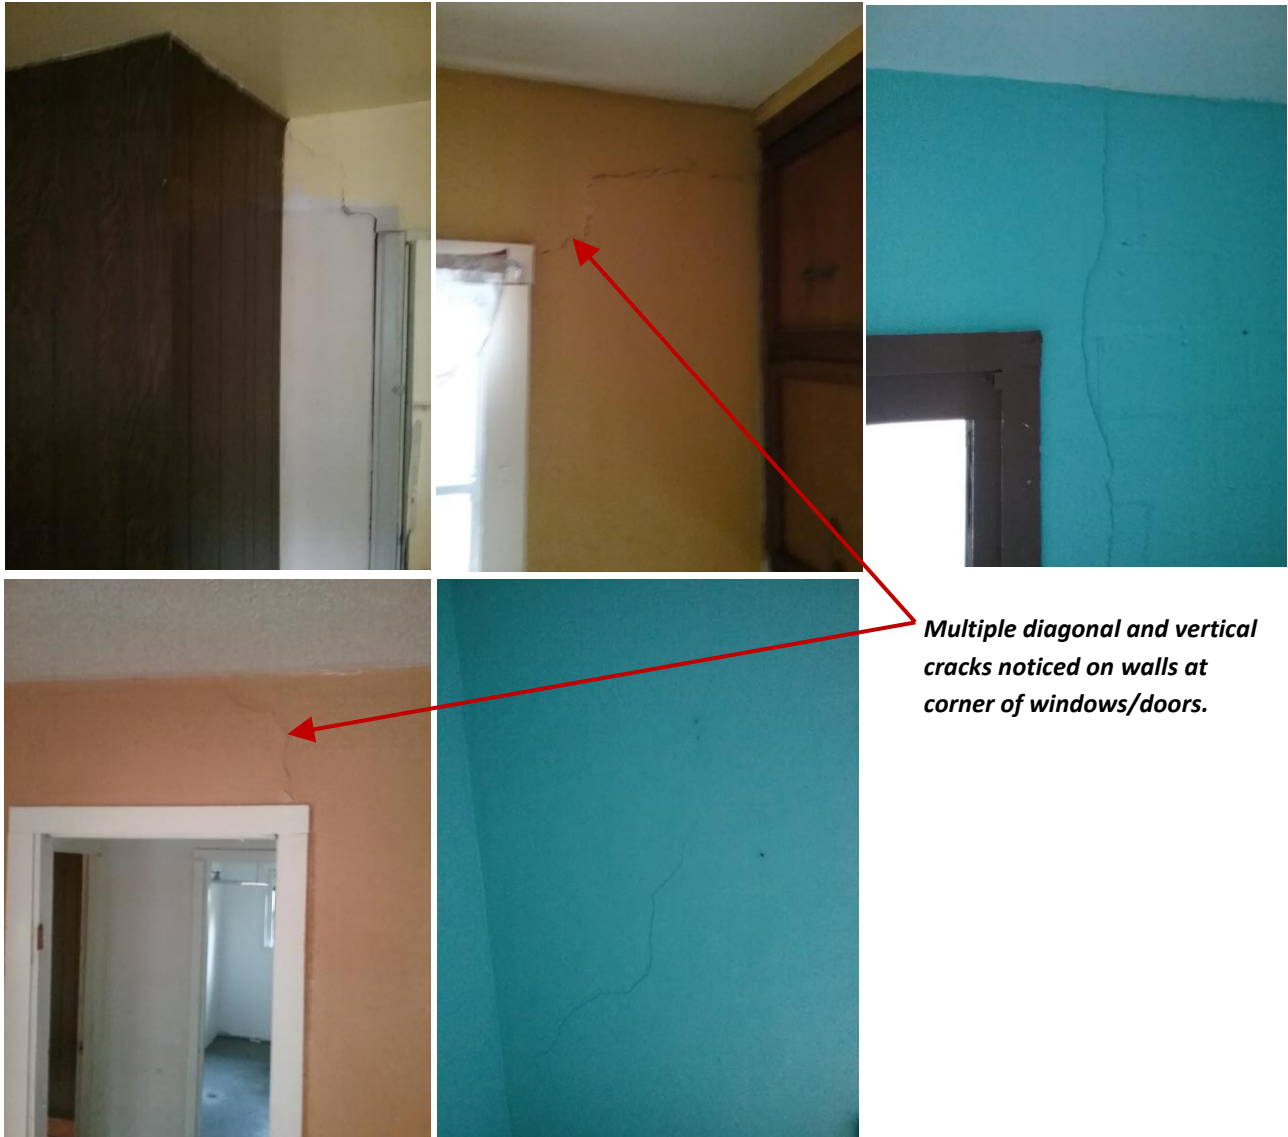
- Several stair-stepped cracks in interior and exterior walls. These cracks are common indicators of excessive foundation movement.

Figure 3: Cracks in walls

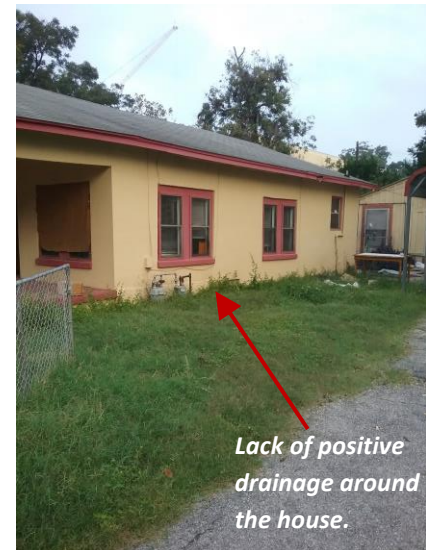
- Noticeable deflection of roof elements, possible due to undersized rafters (2x4's @24"o.c).
- Surface drainage appears inadequate in some sections around the property (Figure 4). Proper surface drainage (typically 5% or 6 inches per 10ft of positive drainage) will prevent water accumulation against the foundation structure, aggravating swelling of clays and consequent heaving.

Figure 4: Site Drainage
