Table of Contents for Block 36 Site Plan
Heritage Tree Variance Package

SITE PLAN #: SP-2018-0015C

SITE PLAN: Block 36 (SP-2018-0015C)

REQUEST: The applicant is requesting to remove two heritage trees, each with a single-stem greater than 30 inches as allowed under LDC 25-8-643

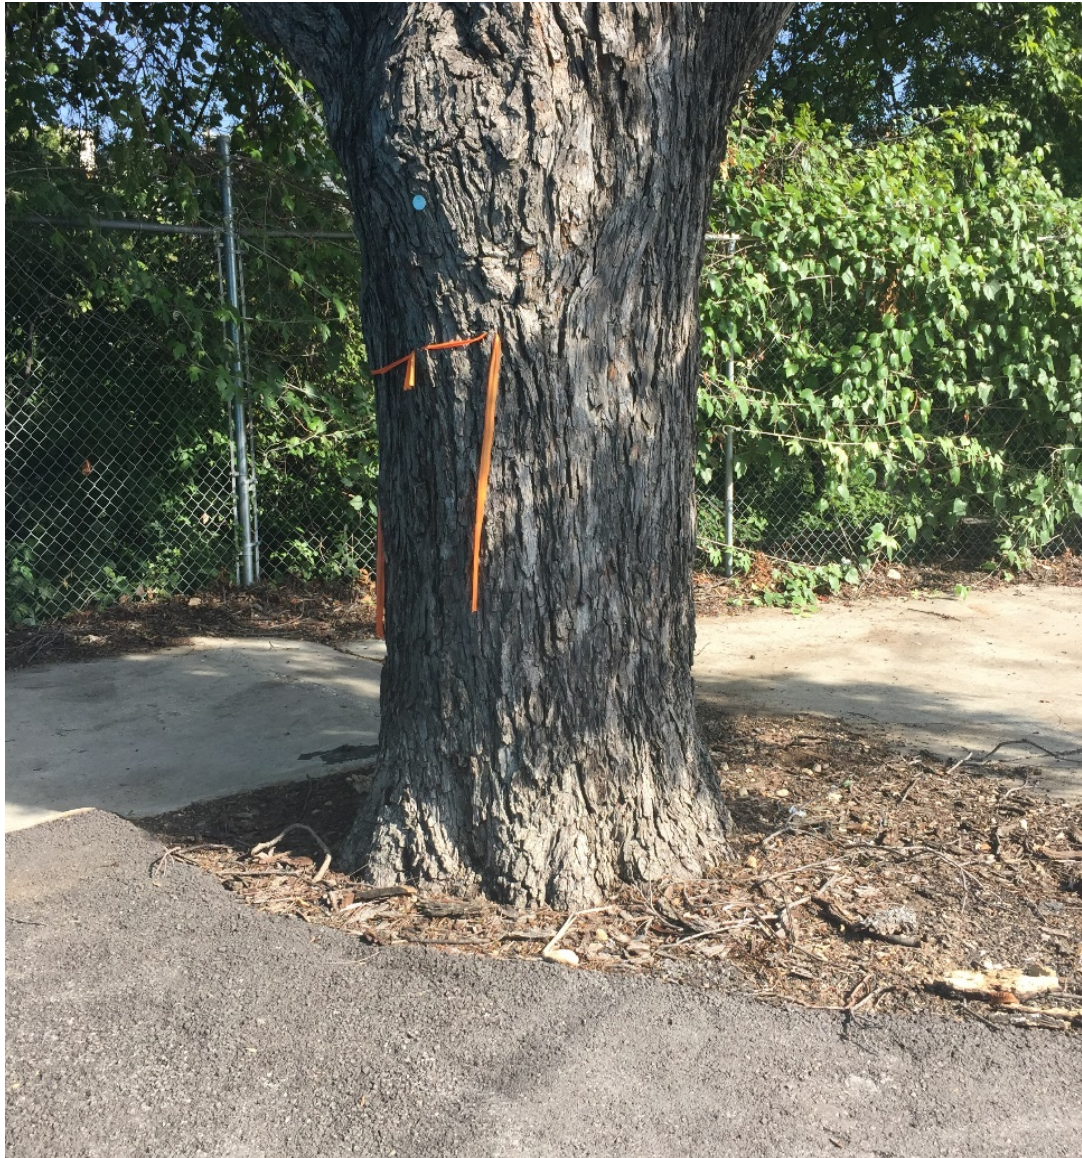
Exhibit 1-Tree #4008
Root System

Tree #4008 – This tree is not an active hazard, but is structural compromised and the branch structure cannot be corrected without significant canopy removal. There is also concern about existing rooting conditions due to the majority of rooting area covered by impervious cover. (Exhibit 4).

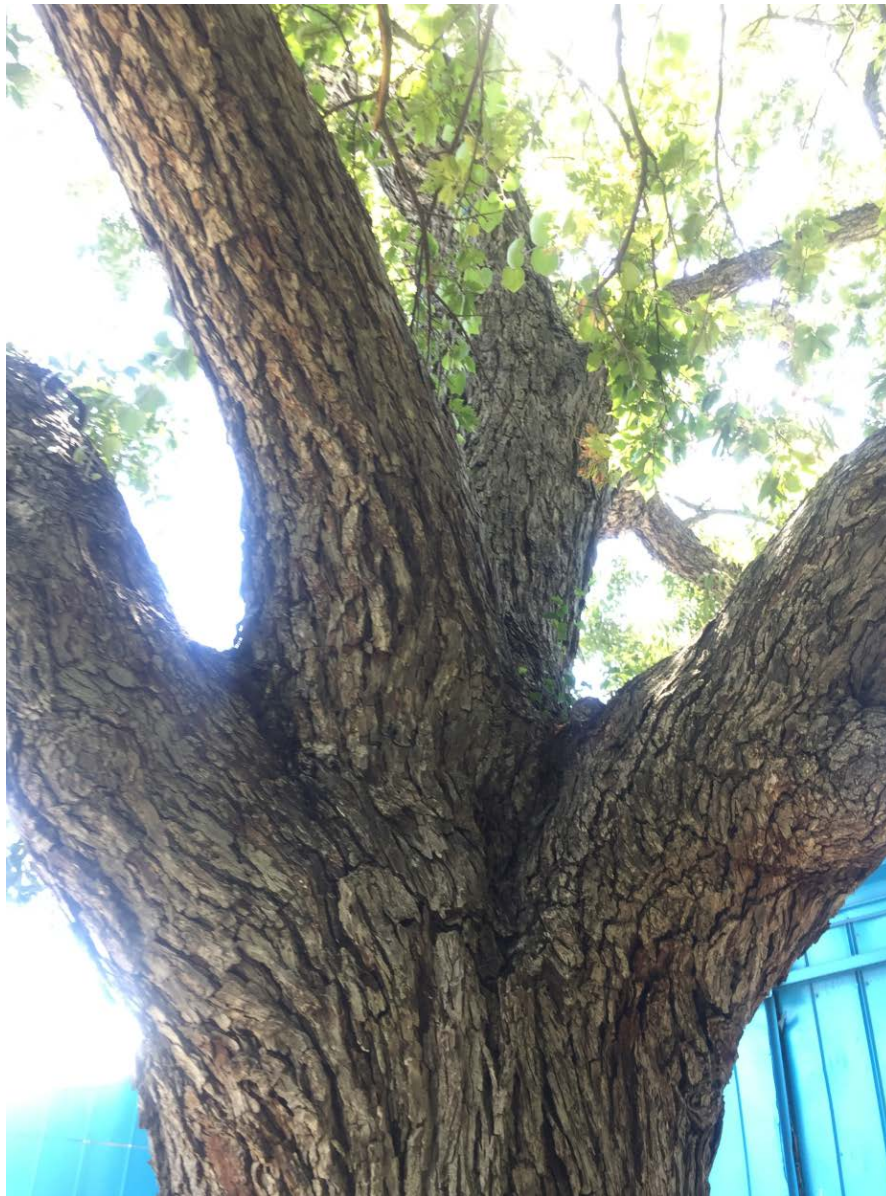
Exhibit 2 -Tree #4008
Trunk/Major stems

Tree #4008 – Trunk splits into four large stems with included bark between the stems. Some old decay/wounds are present higher up on major limbs likely a result of past storm damage. (Exhibit 2)

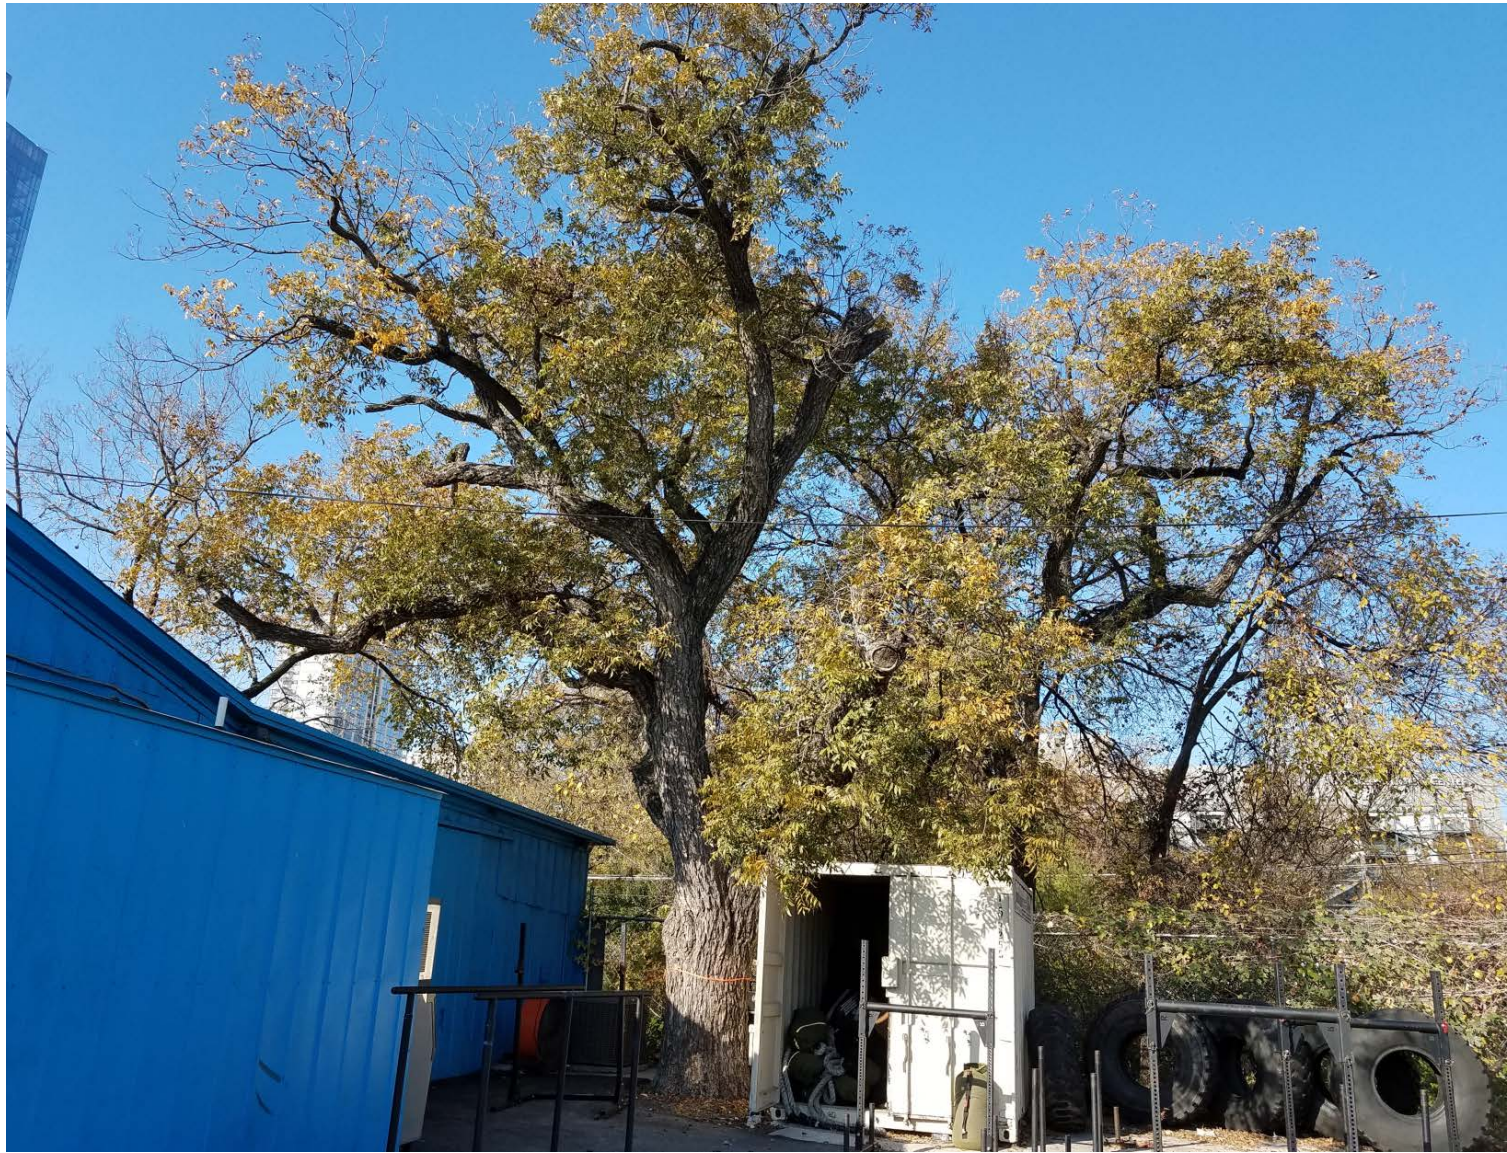
Exhibit 3-Tree #4008
Canopy Condition

Tree #4008 – Has significant dead/dying scaffold limbs and canopy has been improperly pruned at multiple points. (Exhibit 3)

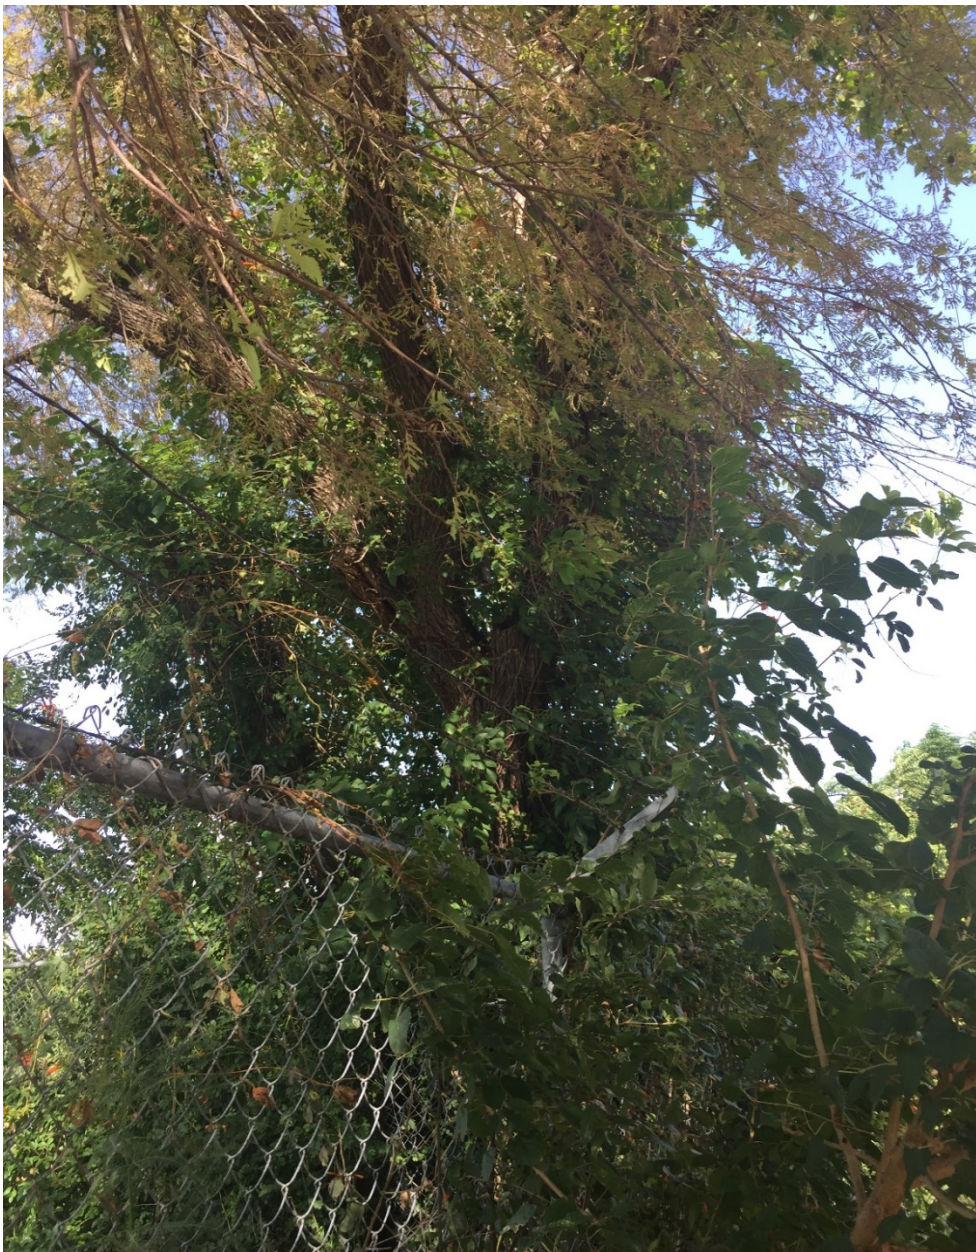
Exhibit 6-Tree #4009
Trunk/Major stems

Tree #4009 – Has multiple codominant (2-3 tightly fused) stems with weak unions (included bark) which could present future structural issues. Some old decay and cavities are present in very brittle branches. (Exhibit 6)

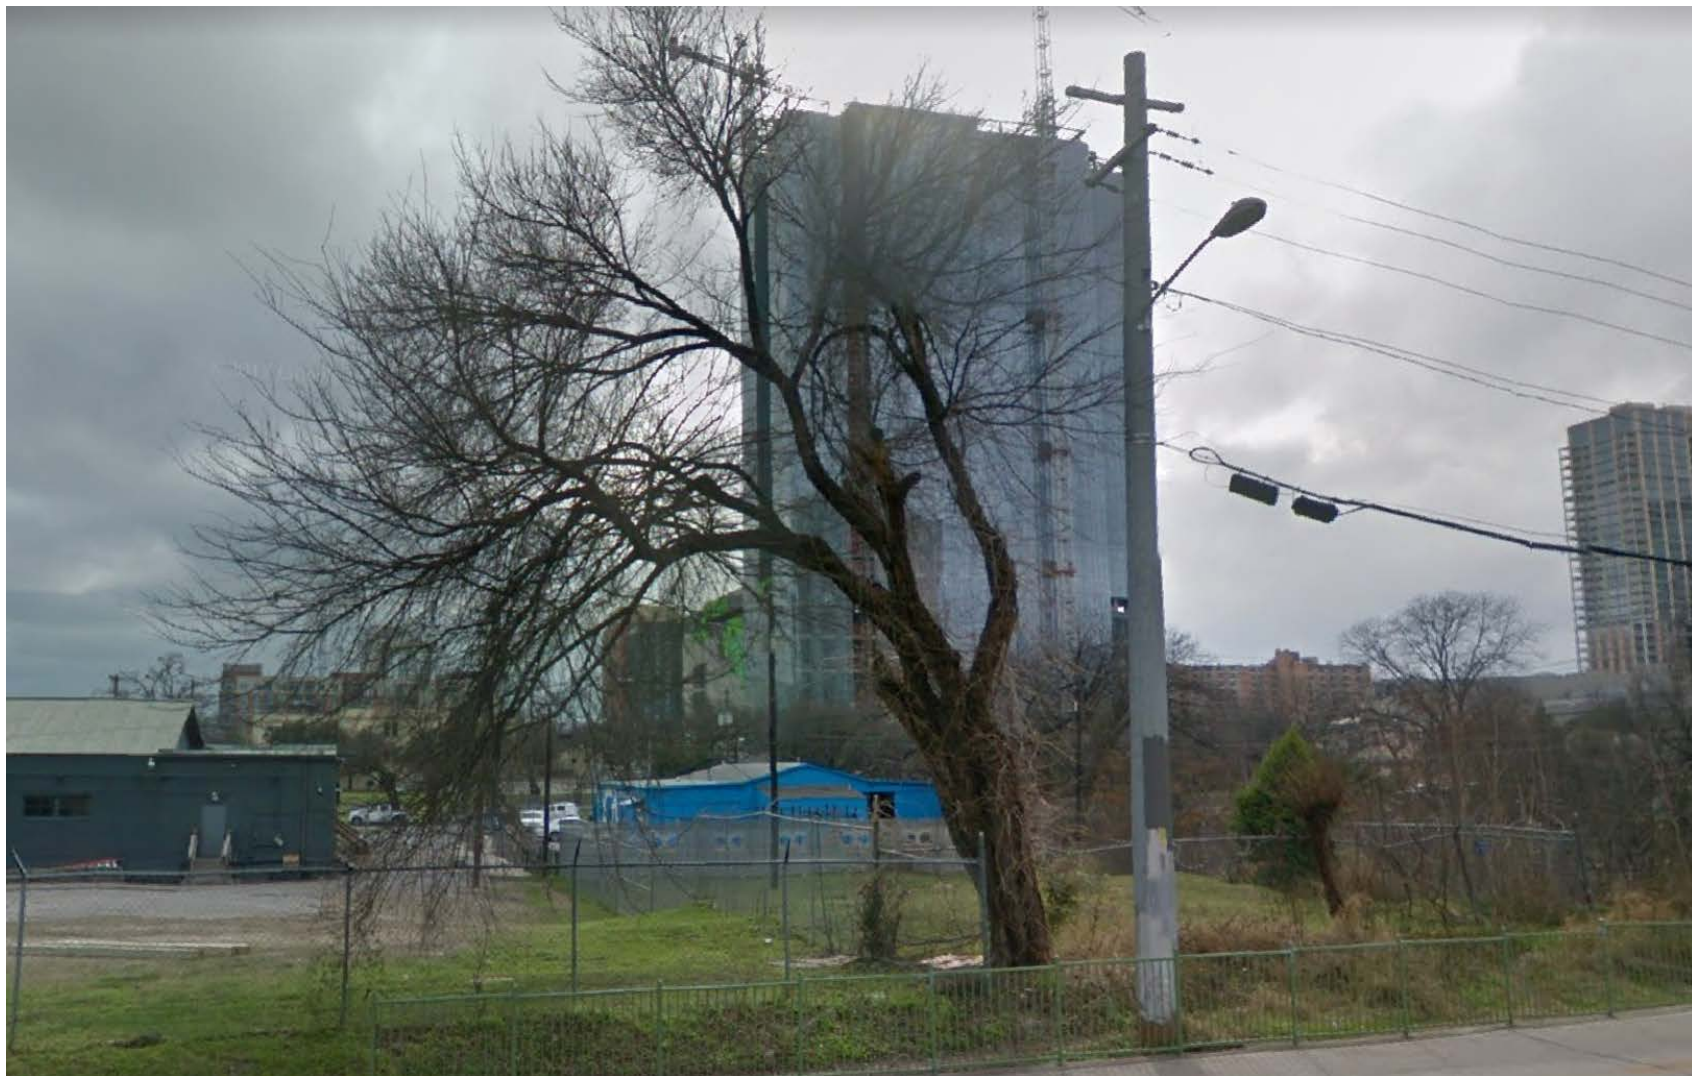
Exhibit 8-Tree #4009
Overall Condition

Tree #4009 – This tree is not an active hazard, but it is structurally compromised and that structure cannot be corrected. More details on the overall condition can be found in the City Arborist Tree Evaluations (Exhibit 8).

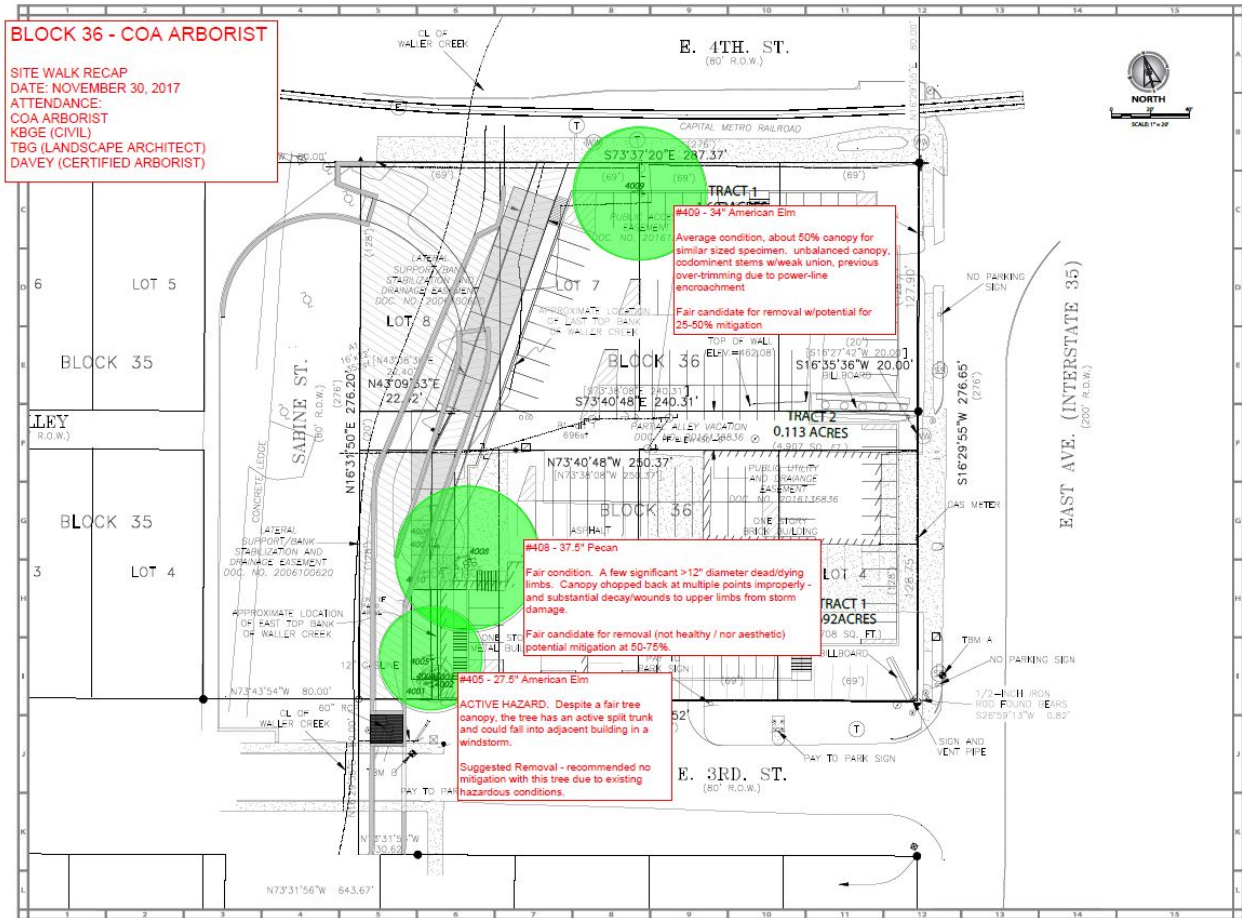
EXHIBIT B

Site survey showing 34" American Elm and 37.5" Pecan trees proposed for Land Use Commission Approved removal. The 27.5" American Elm also shown is proposed for administratively-approved removal.

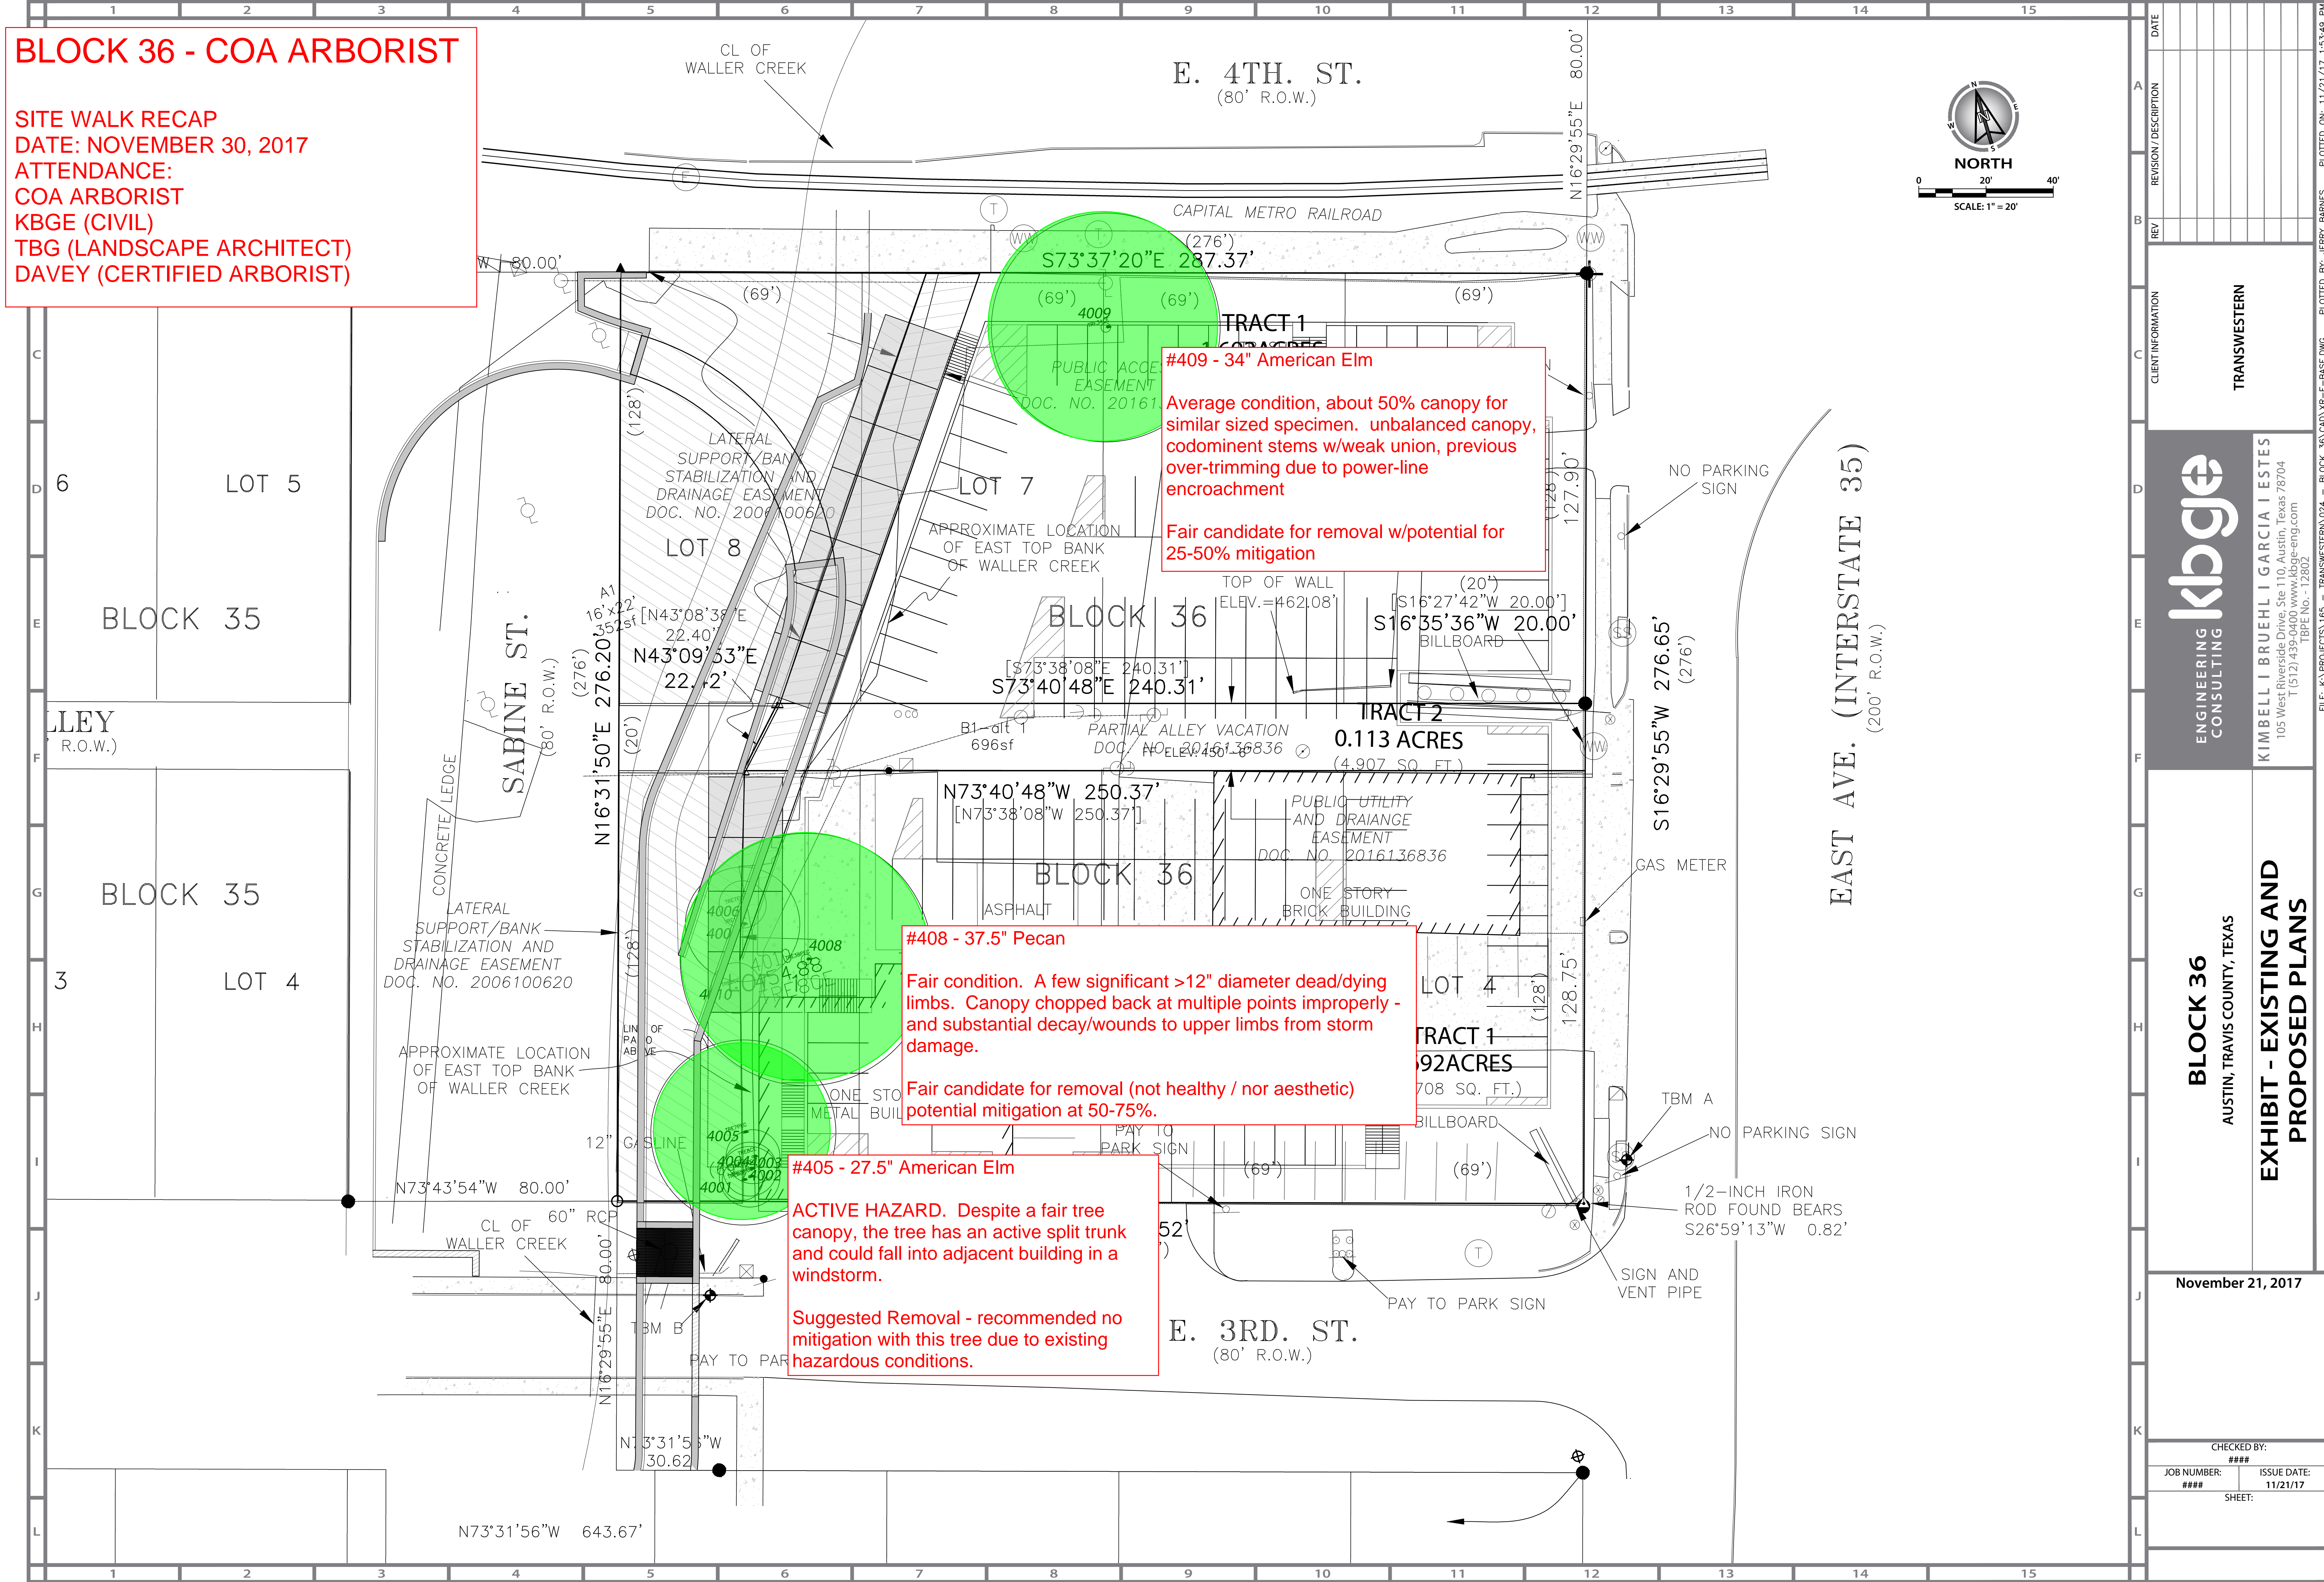
409 34" American elm – Average condition. Only retains ~50% of canopy of similar-sized specimen. Tree ~40' tall x 50' wide. Has heavily unbalanced canopy to east/southeast and multiple codominant stems with weak unions which could present future structural issues. Heavy poison oak infestation (~60%) present and evidence of previous over-trimming near power lines.

408 37.5" Pecan – Fair/Average condition. ~40' tall x 55' wide. Has a few significant (12" diameter) dead/dying scaffold limbs. Canopy has been topped back at multiple points in past improperly. Some old decay/wounds higher up on major limbs and a few places of past storm damage.

405 27.5" American elm – Fair condition (was mistakenly labeled a pecan). ACTIVE HAZARD. This tree has a fair canopy but an actively split trunk that could rip over onto the building in the next good windstorm. There would be no mitigation with this tree being hazardous.

- This tree is a fair candidate for removal. It's not an active hazard, but it's not in a great condition and is also in a poor location. I'd *estimate* that this could be dropped down to a 25-50% mitigation rate.

- This tree is a fair candidate for removal. It's not an active hazard, but it's not a healthy/pretty tree that would be viable to preserve thru construction due to ~80% of its roots having been covered by pavement for many years. I'd *estimate* that this could be dropped to a 50-75% mitigation rate.
