Arborist Report

Tree Condition Evaluation

September 14, 2018
Camelback Project, 78730

City of Austin Environmental Resource Inventory

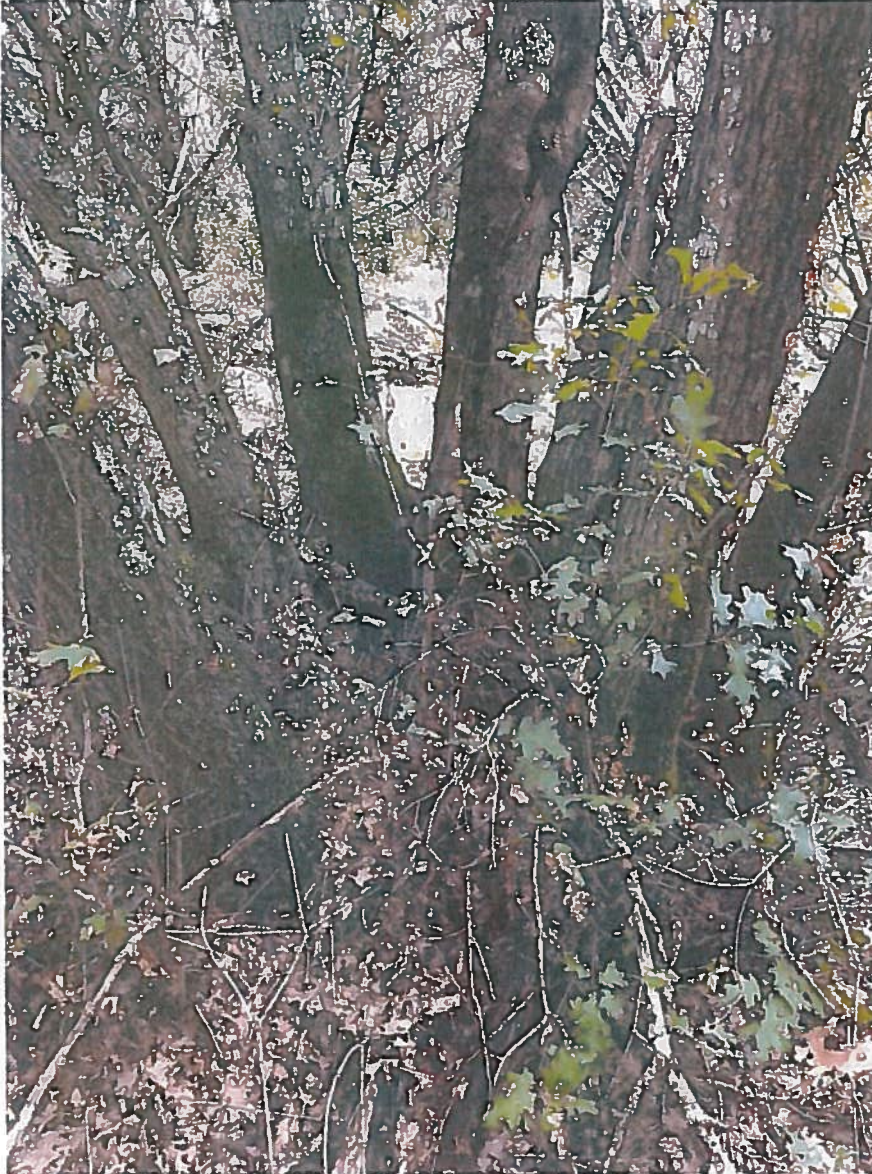
Tree 23179 : Red Oak

All of the stems on this tree are regrowth from an old rotten stump. Half the stems are dead and all have decay and structural defects

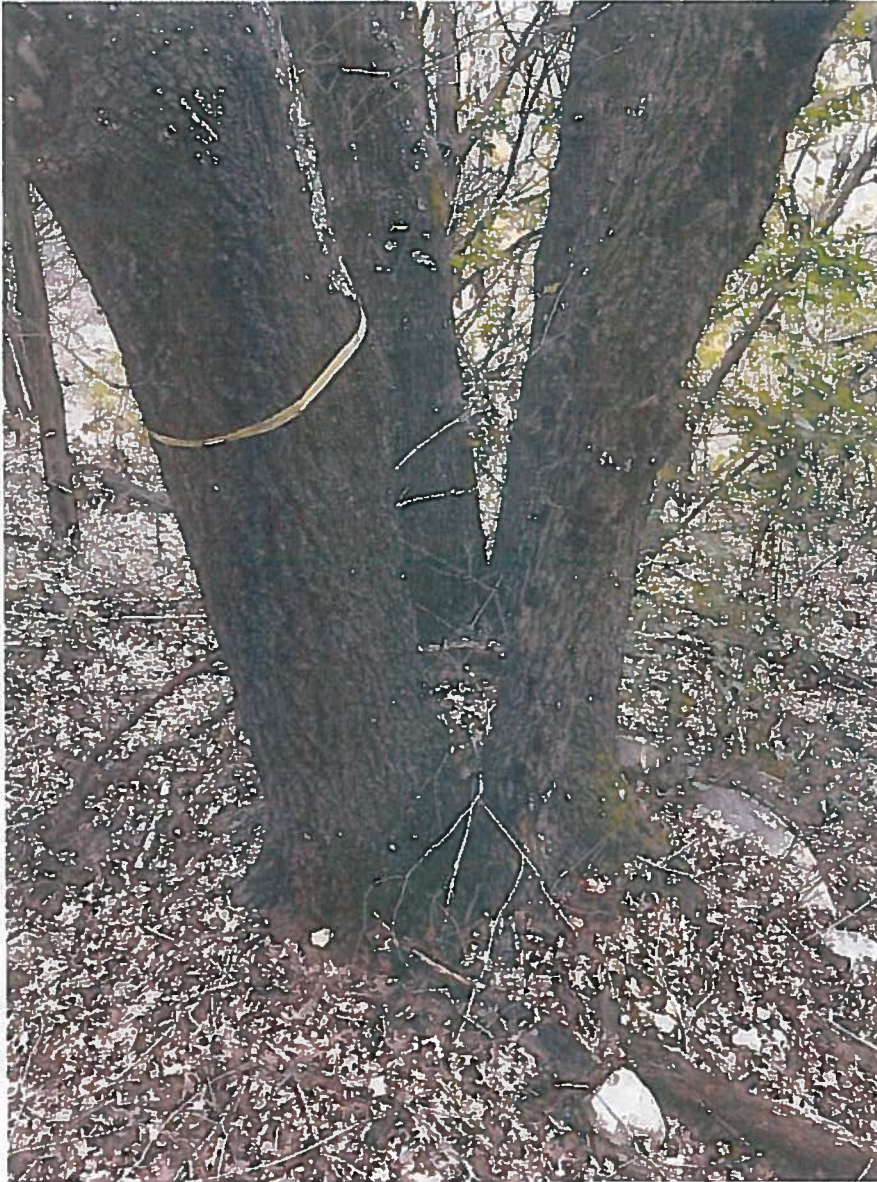
Tree 23231 : Red Oak

Multi-stem tree with extensive decay at the base and root flare area. Armillaria mushrooms are present near the base of the tree.

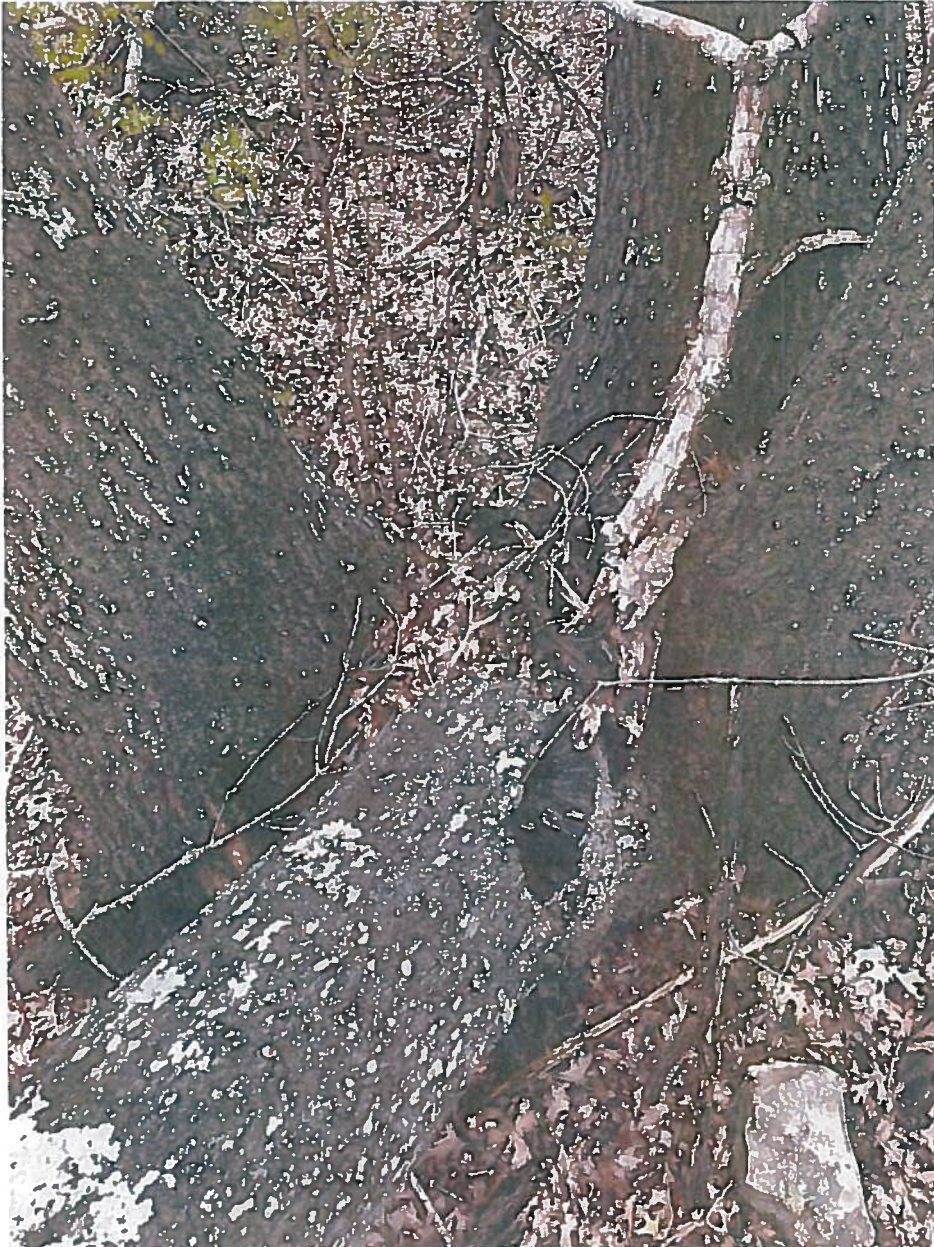
23399 : Red Oak

Multi-stem tree with one stem already failed. Other stems have significant lean. High likelihood of extensive decay in the lower trunk and buttress roots.

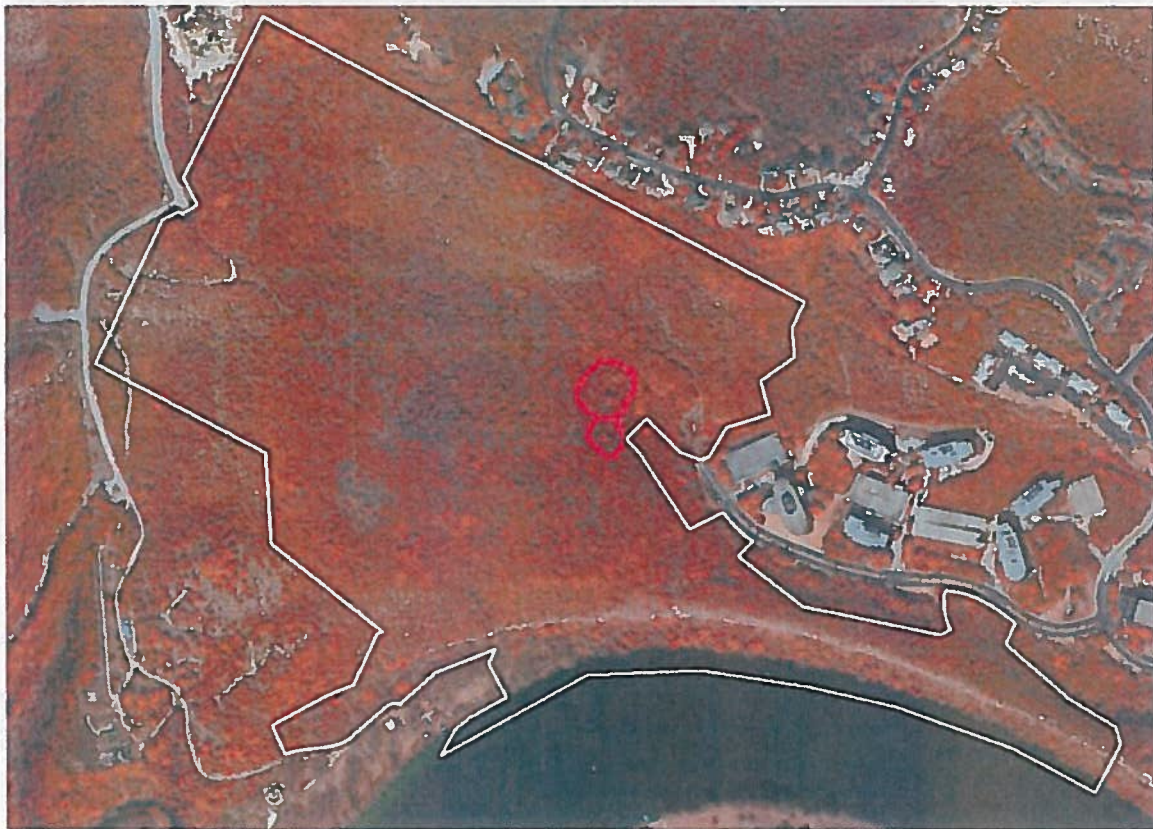
The infrared imagery below shows two trees that stand out and are circled on the image. I located these two trees in the field. The northern tree is the 20.5" live oak referenced previously in this report and the other is a group of two oaks: 17.5" multi-stem and 14" dbh red oaks. In the same way these two trees stand out on IR, they are also the best quality trees I observed in the field.

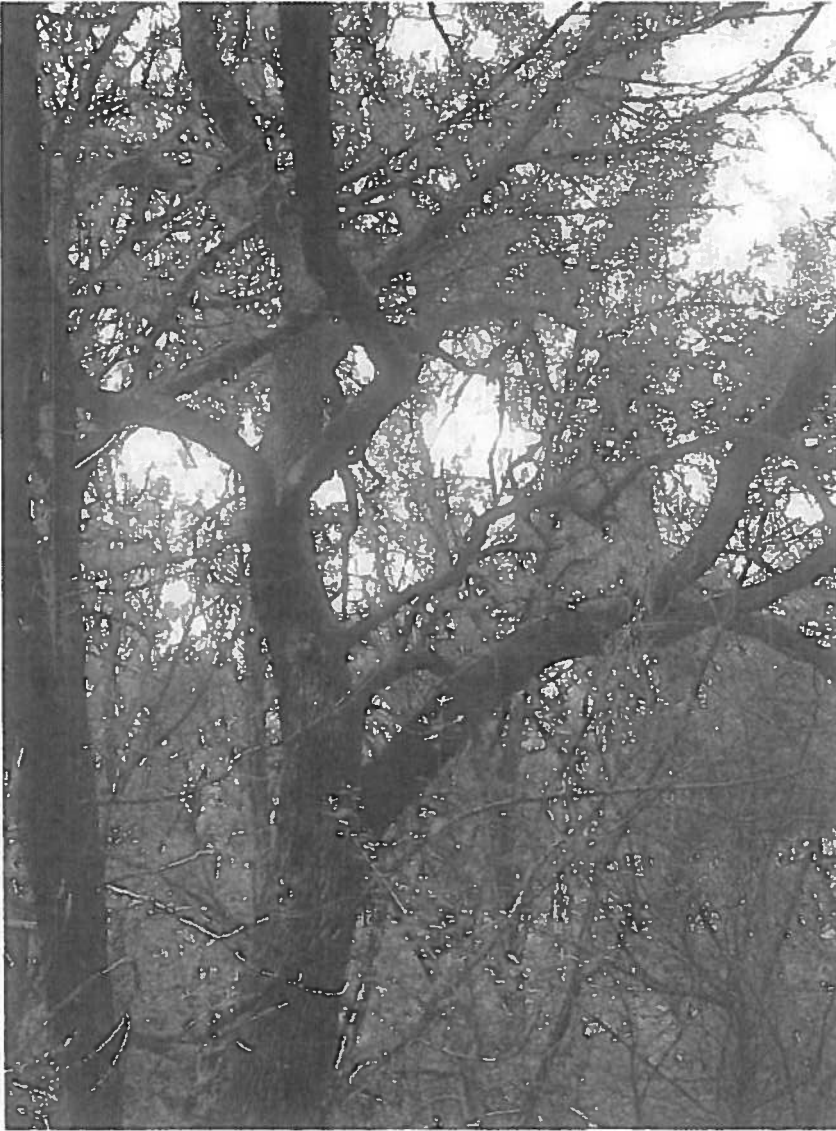
20.5" dbh Live Oak (northern tree circled above)

I was unable to get a good canopy photo due to surrounding vegetation.

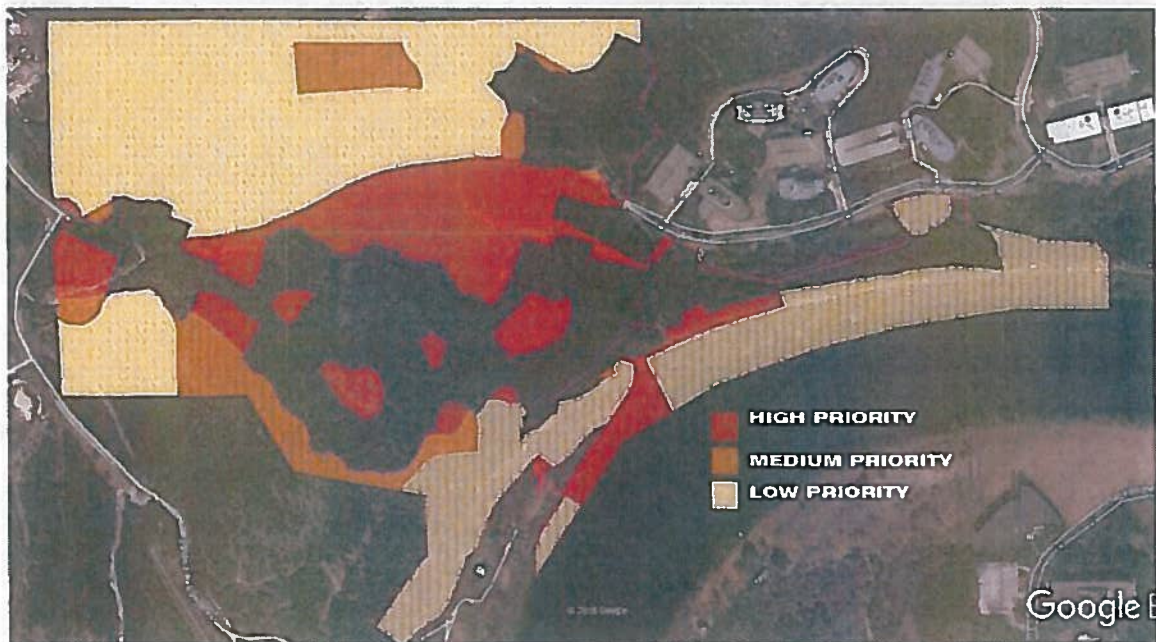
The red areas indicated below were identified to me as priority areas to inventory. I have thoroughly walked these areas and can confidently confirm there are no heritage trees in these areas. The one exception is the red area along the waterfront. I have not thoroughly inventoried these trees. In addition to the red areas, I have very thoroughly walked the center of the site and found no additional heritage trees. The large, yellow area to the north (low priority) are very steep slopes with no realistic possibility of significant trees. The medium priority, orange area in the center of the large yellow area is a drainage valley. The best trees from this north tract are surely located here but I don't expect they are significantly different from the large trees found on the southern slopes' drainage valleys (probably no heritage trees other than multi-stem red oaks).

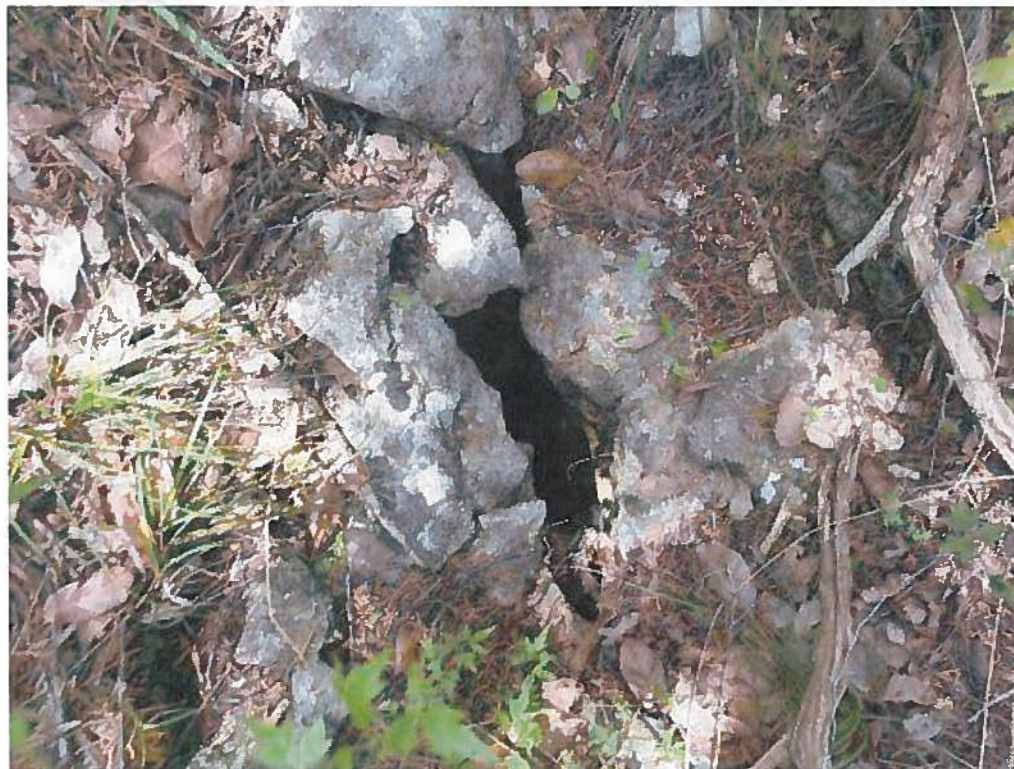
- Feature K-1 is classified as a solution enlarged fracture located within the Walnut Formation. The feature consists of two intersecting fractures; the primary fracture trends N85°E and the secondary fracture is nearly normal to this fracture and trends N15°W. Neither of the fractures corresponds to the dominant structural trend of the area, which is toward the northeast. The primary fracture measures approximately 3 inches wide and 30 inches long and extends vertically to about 36 inches where it appears to pinch closed. The secondary fracture measures about 8-inches wide by 24 inches long and extends vertically to about 7 feet deep where it appears to pinch closed. The feature has a limited catchment area and its potential for recharge is considered low to moderate. The feature is considered to be a CEF and a developmental buffer appears to be warranted.

Photo 33 View of K-1.

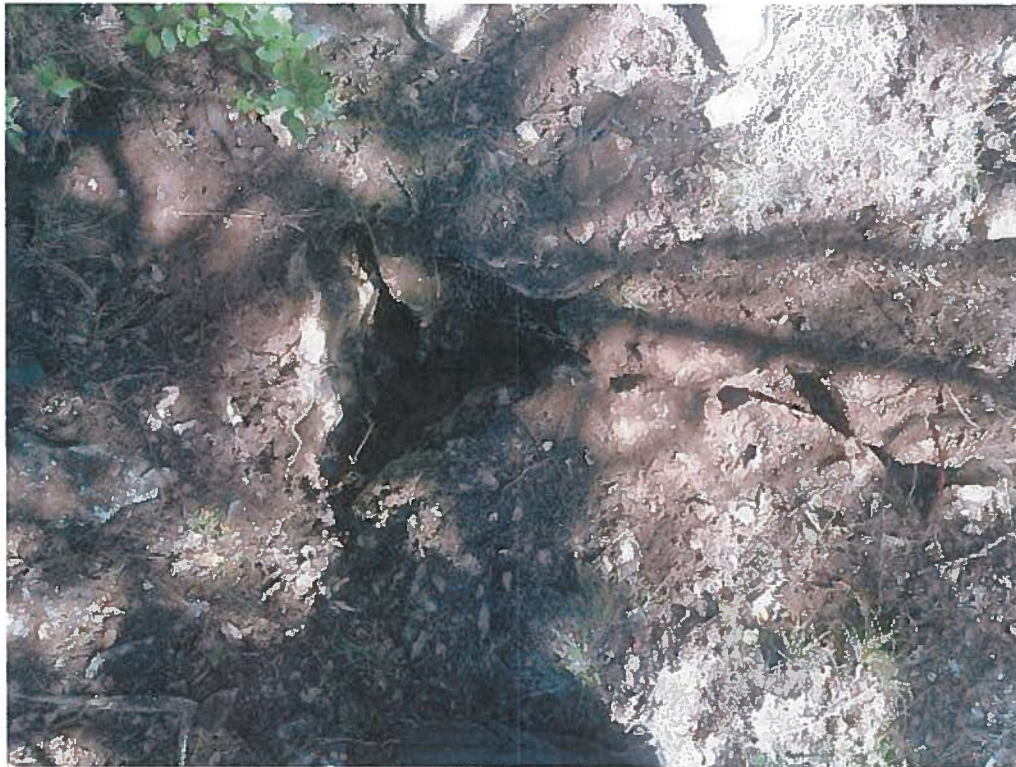
Photo 45 View of K-1 after hand excavation on June 6, 2018.
