The following is a Summary of a Property Inspection Report. The report was done for Mr. and Mrs. Smith by Jim Inmon TREC Professional Inspectors Lic. #103 SPCS CA #29945 PT of Texas Inspection Service of Austin Inc. The inspection was done on 9/5/18 at 4200 Wildwood Rd. Austin, Texas 78722. The inspection was started at 9:05 AM and was completed at 3:38 PM. The weather was cloudy to partly cloudy and the temperature ranged from 79° to 93°. The items cited in the original report as "*Deficient*" and "*Comments*" are included here. Photos of selected items can be viewed at the conclusion of the text. Refer to pages 3-9 of the original TREC report for a checklist format of items inspected, not inspected, not present and additional comments. Read and understand pages 1-2 of the original TREC promulgated 9 page report on form REI 7-5 for the purpose, limitations, inspector/client responsibilities, consumer notice concerning hazards and deficiencies, important additional information provided by the inspector and agreements.

Description of Property: The property is a one story wood frame single family residence on a combination slab on grade/pier and beam foundation. The exterior walls a

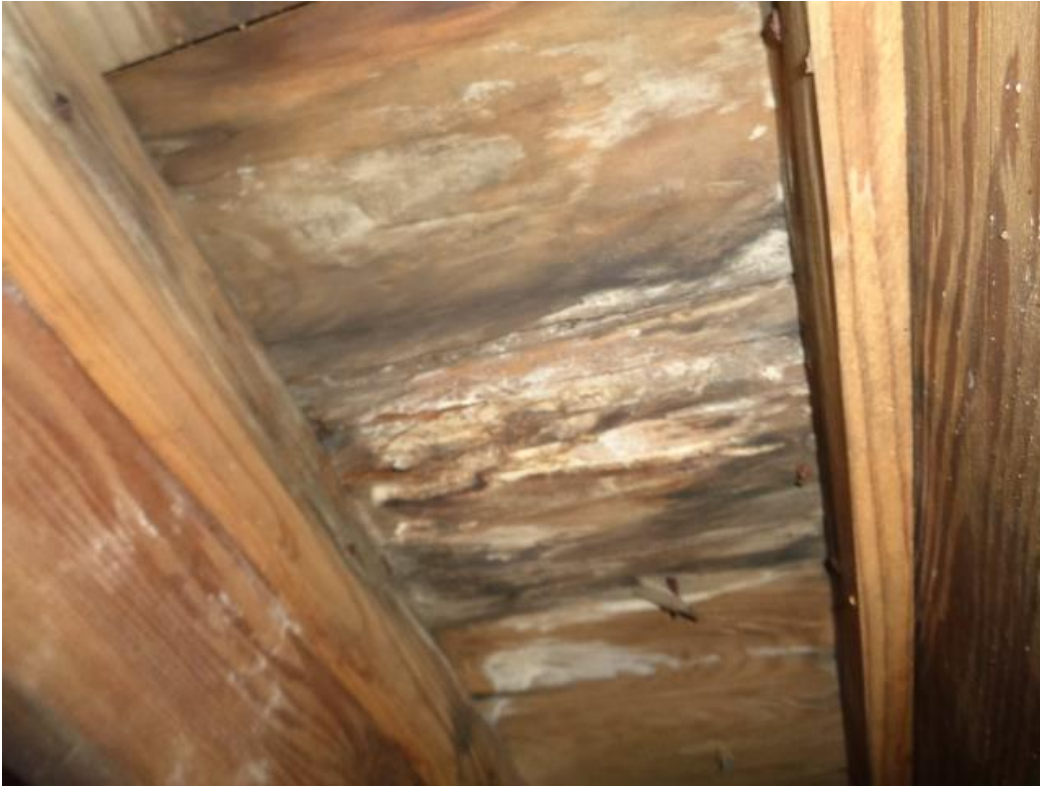
- Eight inch piers are in use - ten inch piers are now the minimum standard.
- The subfloor is water damaged under the 3/4 bathroom shower stall - indicating a failed shower pan. *See Photos 2, 3.*
- The skirting is in poor condition:
- The skirting is buckled/damaged under the rear breakfast room wall. *See Photo 4.*

Photo 2: The water damaged subfloor under the front bathroom shower.

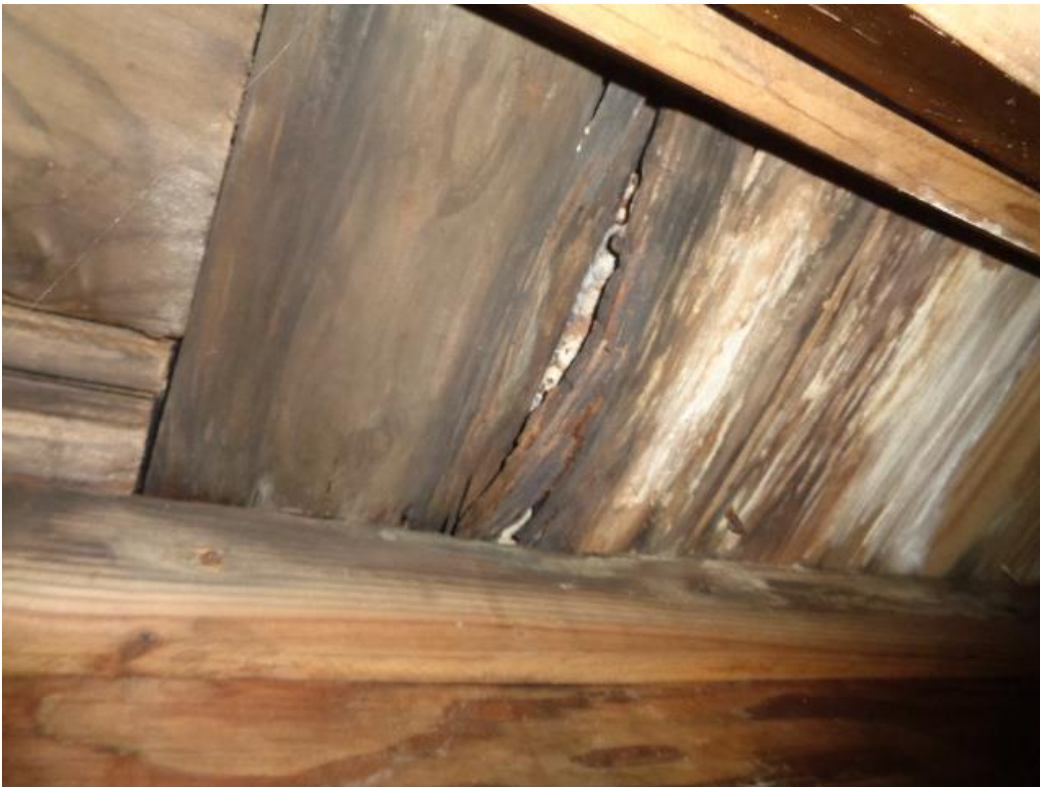
Photo 3: The water damaged subfloor under the front bathroom shower.

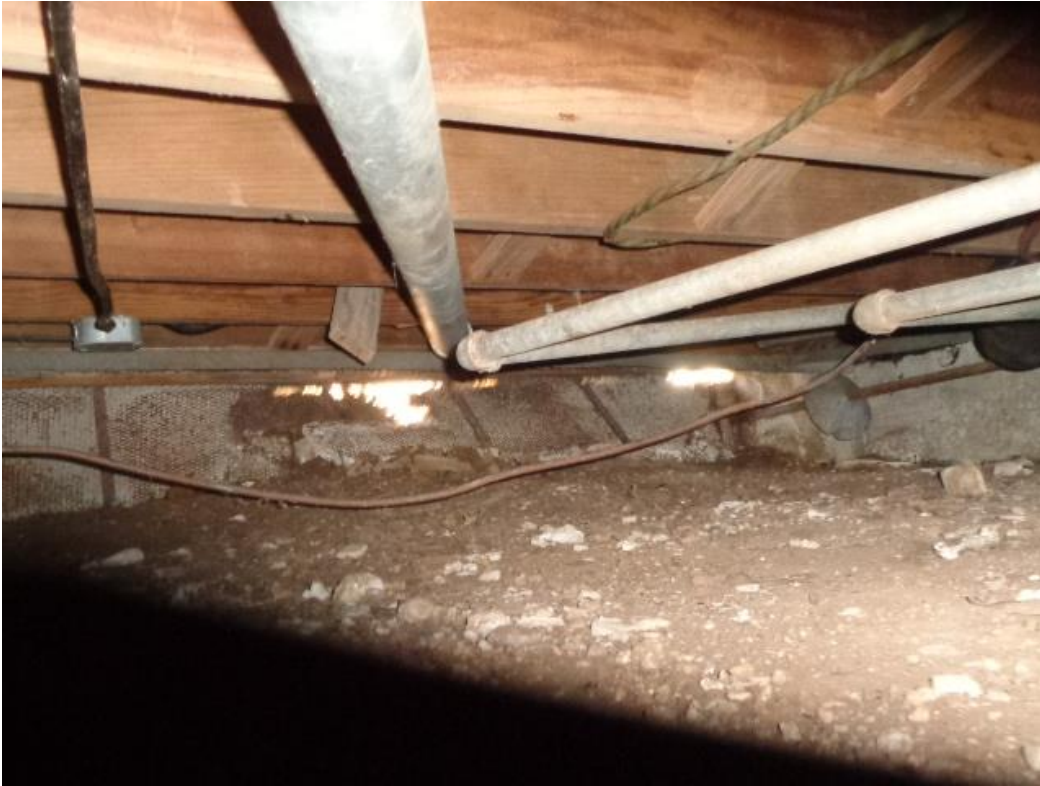
Photo 4: The buckled, damaged skirting under the breakfast room wall as seen from the crawl space.

- There should be no openings large enough for vermin to gain entry to the crawl space.
- There is no beam under the left hall wall.. The wall is supported by floor joists only. As a result, the hall floor slopes to the left and the bedroom doorways are out of square. This construction is typical for 1940's and 1950's construction and does not affect the overall integrity of the foundation. However, if leveling the floor and straightening the doorways is desired, a new beam and pier row is necessary to be added to the crawl space.
- It is recommended to consult with a qualified foundation company on the deficiencies cited above - new skirting under the walls with siding is indicated. .

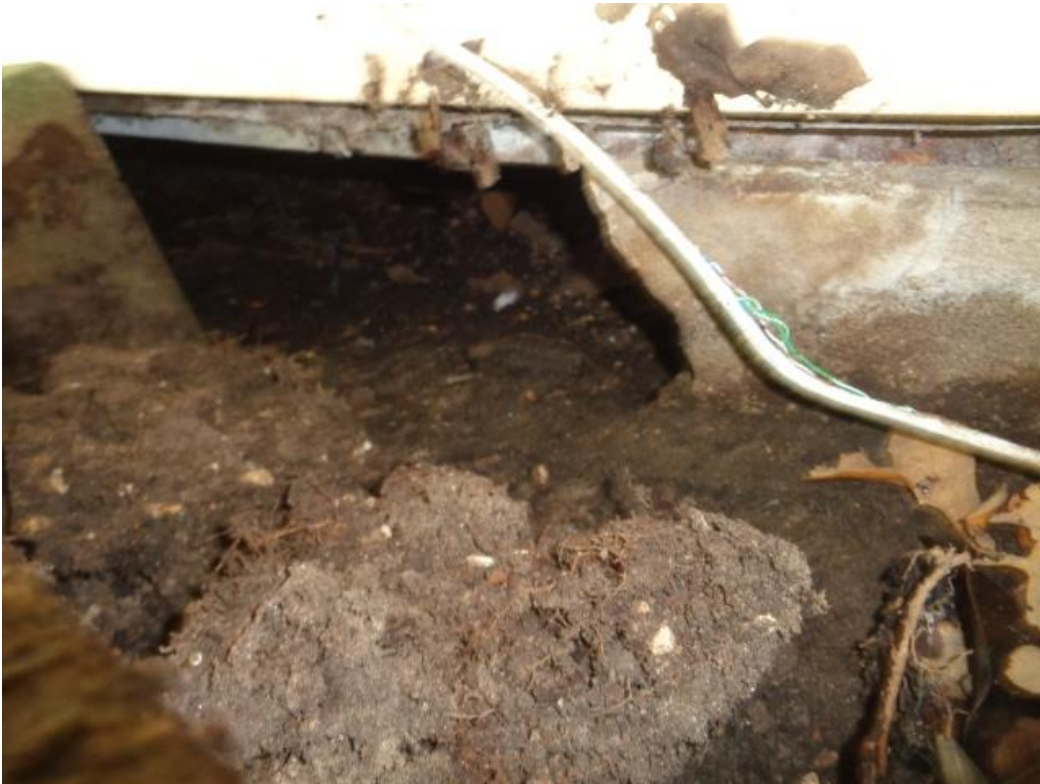
- There is no skirting at all behind the cinderblocks stacked on the ground under the rear living room rear wall. *See Photo 5.*
- Under the right rear bedroom wall (beside the rear planter), shifting has occurred - opening a 2" opening to the crawl space. *See Photo 6.*
- The skirting is loose/damaged at the left rear corner of the home. *See Photo 7.*

Photo 5: The missing skirting behind the cinder blocks under the rear wall.

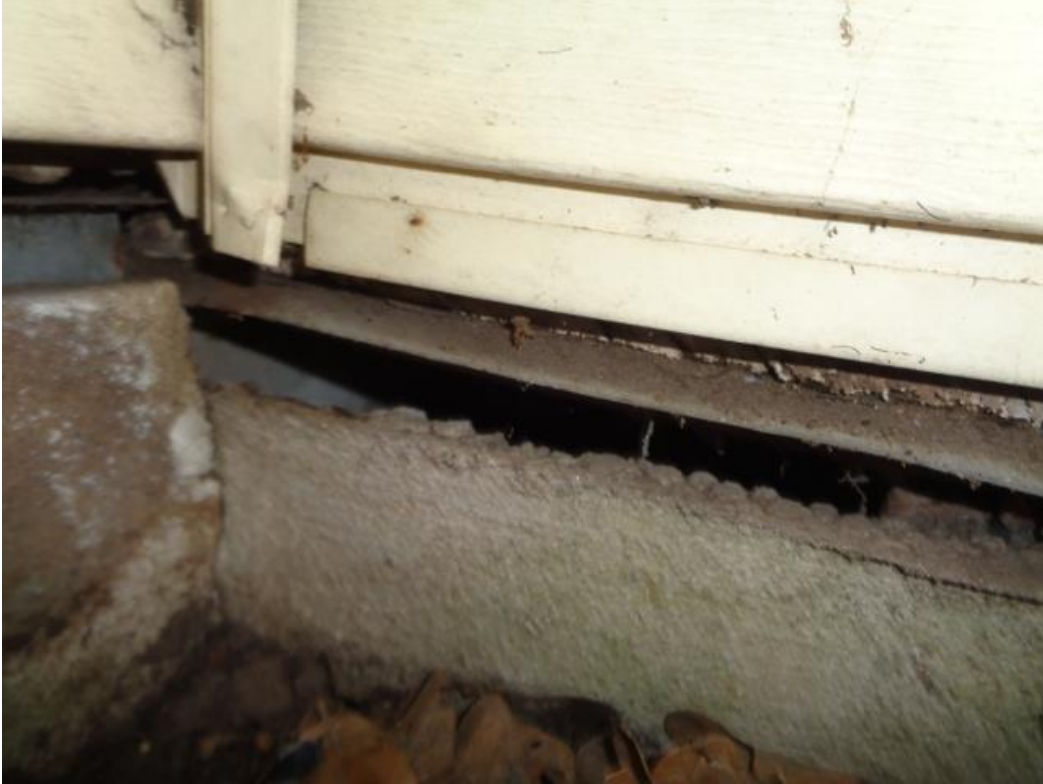
Photo 6: The opening to the crawl space under the right rear bedroom wall.

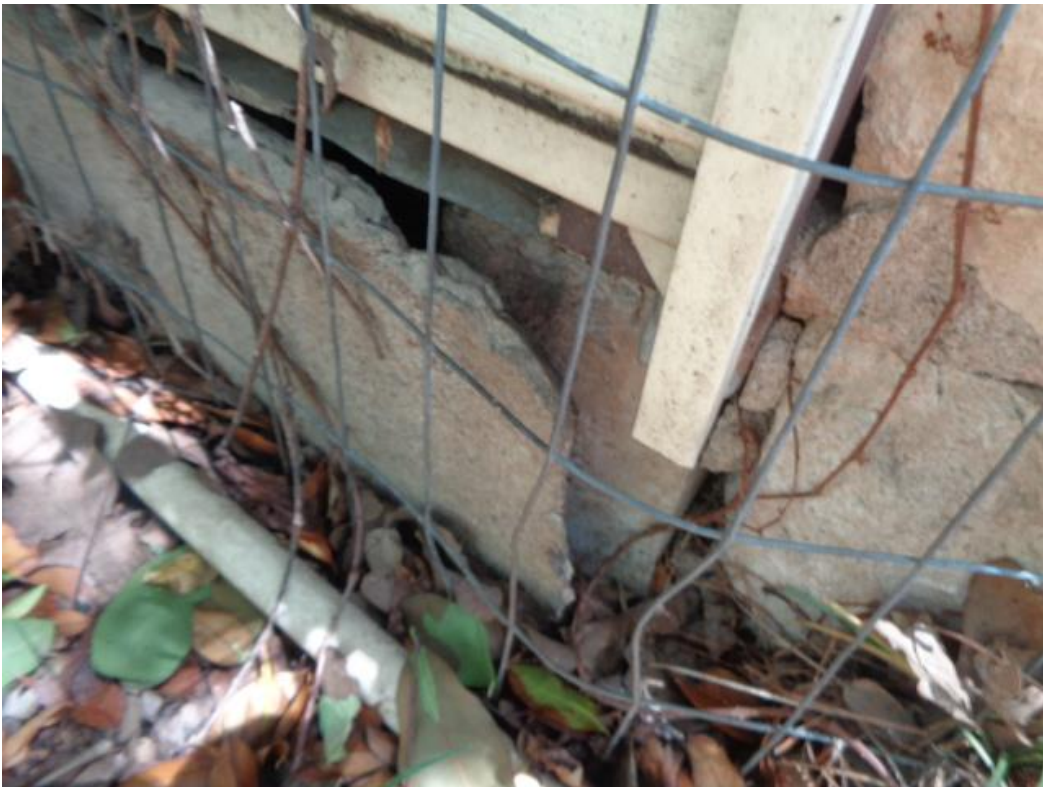
Photo 7: The loose/damaged skirting at the left rear corner.

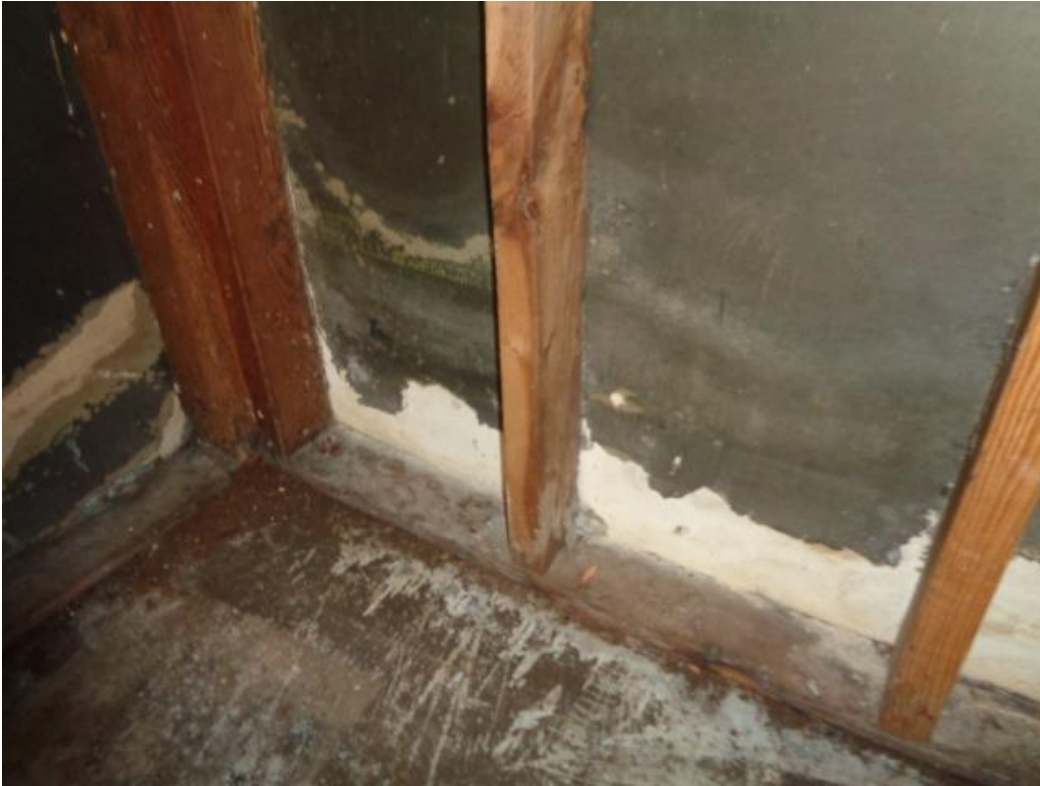
- The grading and drainage need improvements.
- The soil is above the level of the carport at the right side.
- The soil is too high at the slab outside the storage room/laundry room on all sides - the slab is covered with soil and at the rear, the slab is also covered with a railroad tie. This high soil has caused water penetration into the storage room causing water damage and has attracted subterranean termites. *See Photos 8, 9.* Four to six inches of slab should be established and maintained.

Photo 8: The water damaged walls in the right rear storage room.

- Drainage specialist to advise on all of the above.

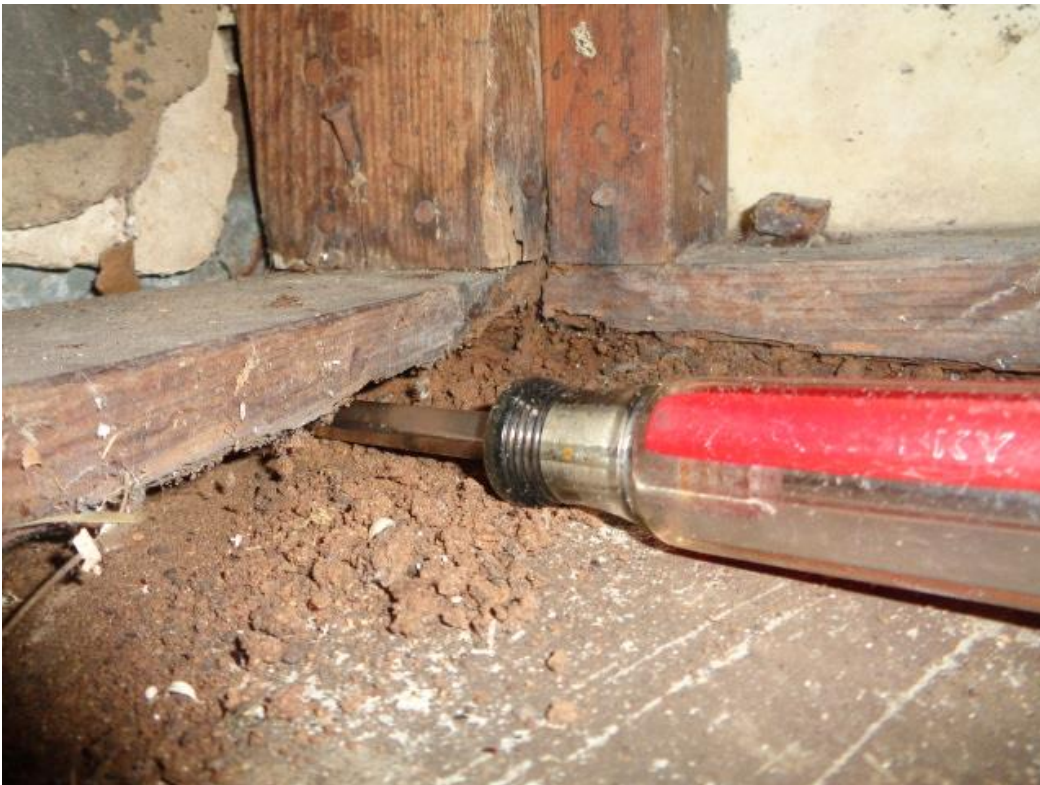
Photo 9: The damage from subterranean termites at the bottom sill in the right rear storage room.

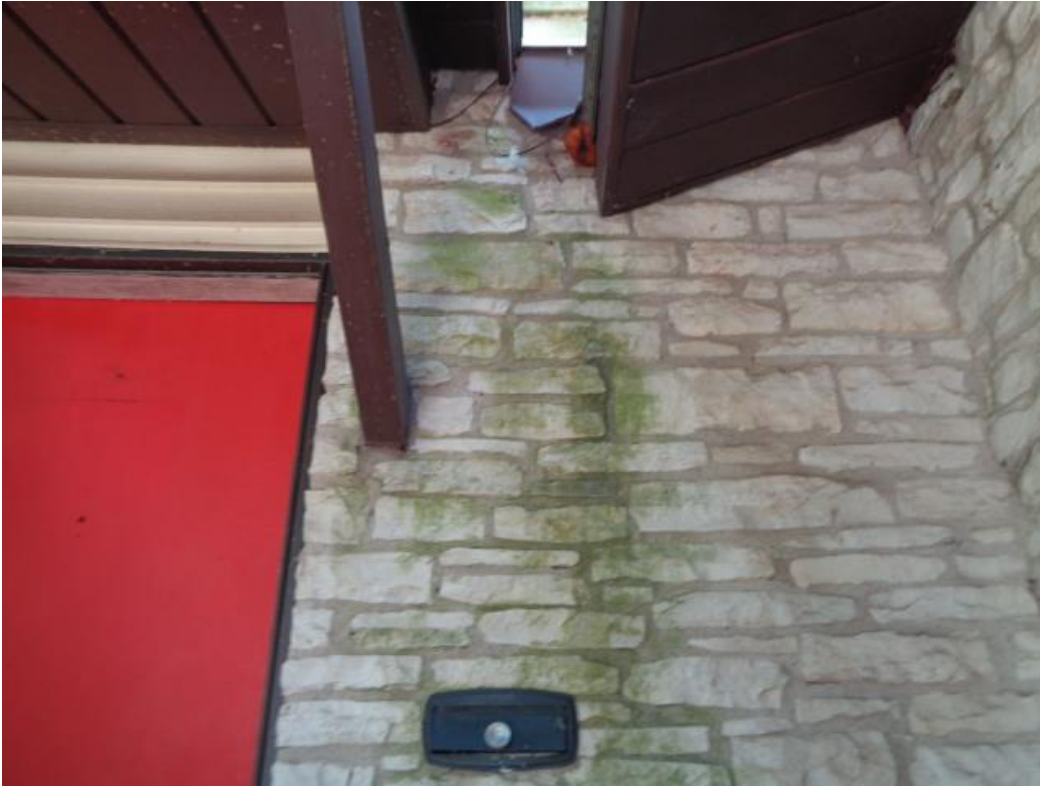
- The front kitchen roof face slopes downward toward the front courtyard and allows water to drain onto the rock wall by the front door. *See Photo 10.* Water from this roof face then drains to the courtyard behind the front porch.

- The rock wall to the right of the front door is stained from roof runoff. *See Photo 10.*
- There is algae build up at the right upper wall above the roof line.
- The siding is bent/damaged at the right rear corner outside the rear living room exterior door. *See Photo 24.*
- The siding is damaged at the left rear corner by the rear storage room door. *See Photo 25.*
- The siding is loose at the left rear gable vent. *See Photo 26.*
- Seal the openings in the siding at the left side by the AC refrigerant lines. *See Photo 27.*

Photo 10: The stains from the roof runoff by the front door.

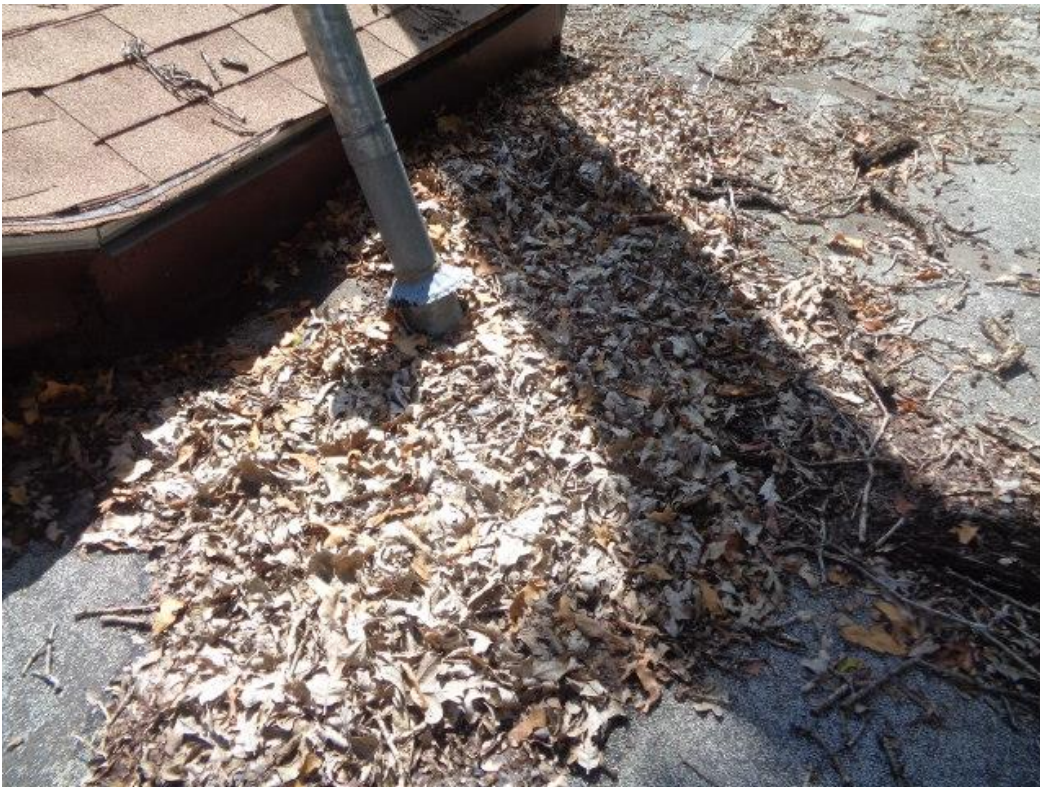
- There is excessive tree debris that has been allowed to build up on the roof surfaces (poor maintenance). Clear off all roof debris. *See Photos 11, 12.*

Photo 11: The excessive debris build up on the roof.

- It is recommended to consult with a qualified roofer on all of the above.
- Flat roofs and low pitched roofs tend to allow ponding and leak. Regular inspections and maintenance are required.

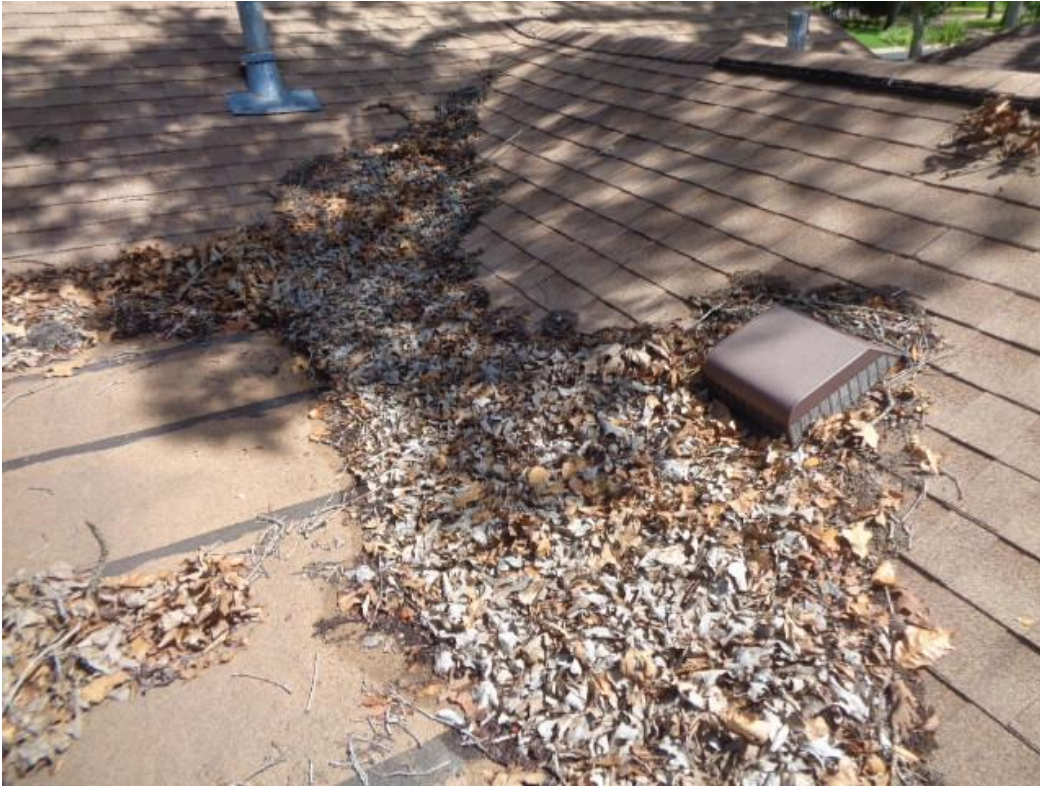
Photo 12: The excessive build up on the roof.

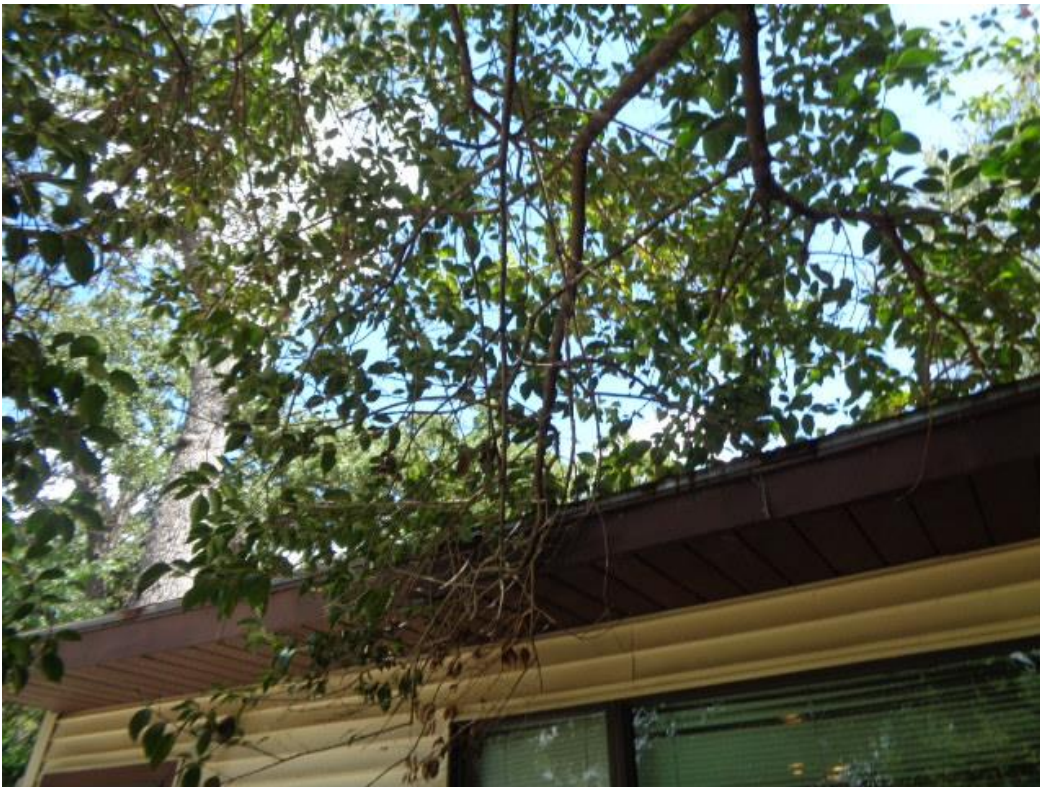
- Tree and bush limbs have been allowed to overgrow onto the roof - trim all tree and bush limbs away from the roof surfaces - a clearance of 6' is recommended. *See Photos 13, 14.*

Photo 13: Trim the trees away from the roof.

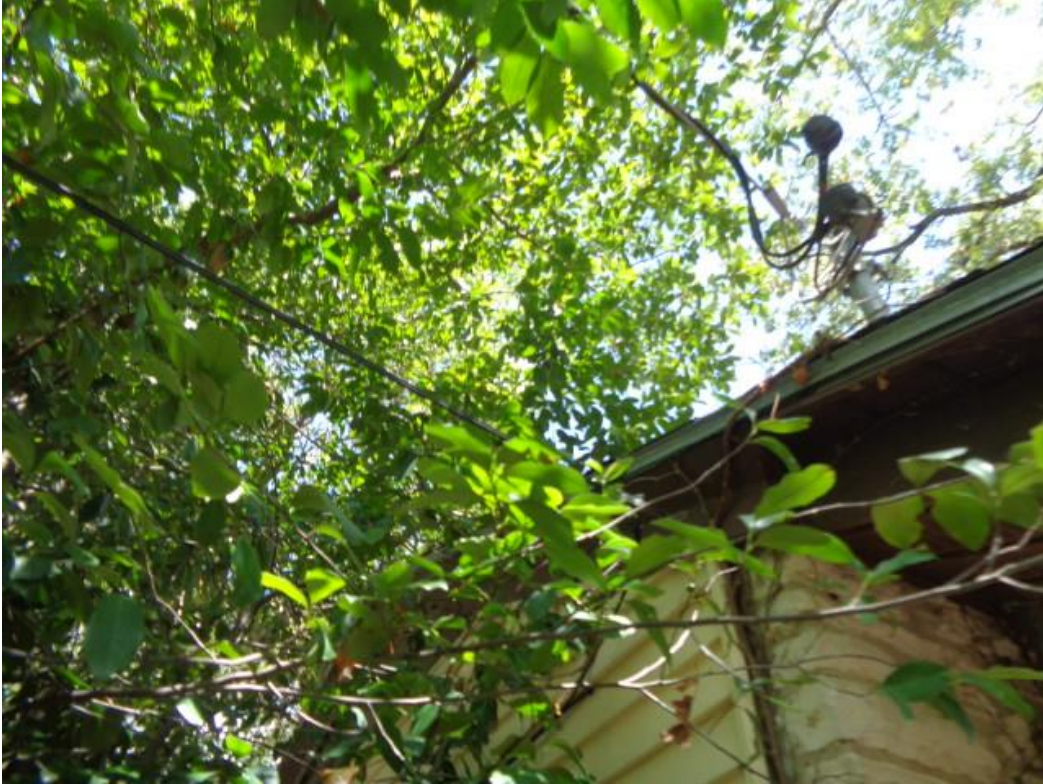
Photo 14: Trim the trees away from the roof.

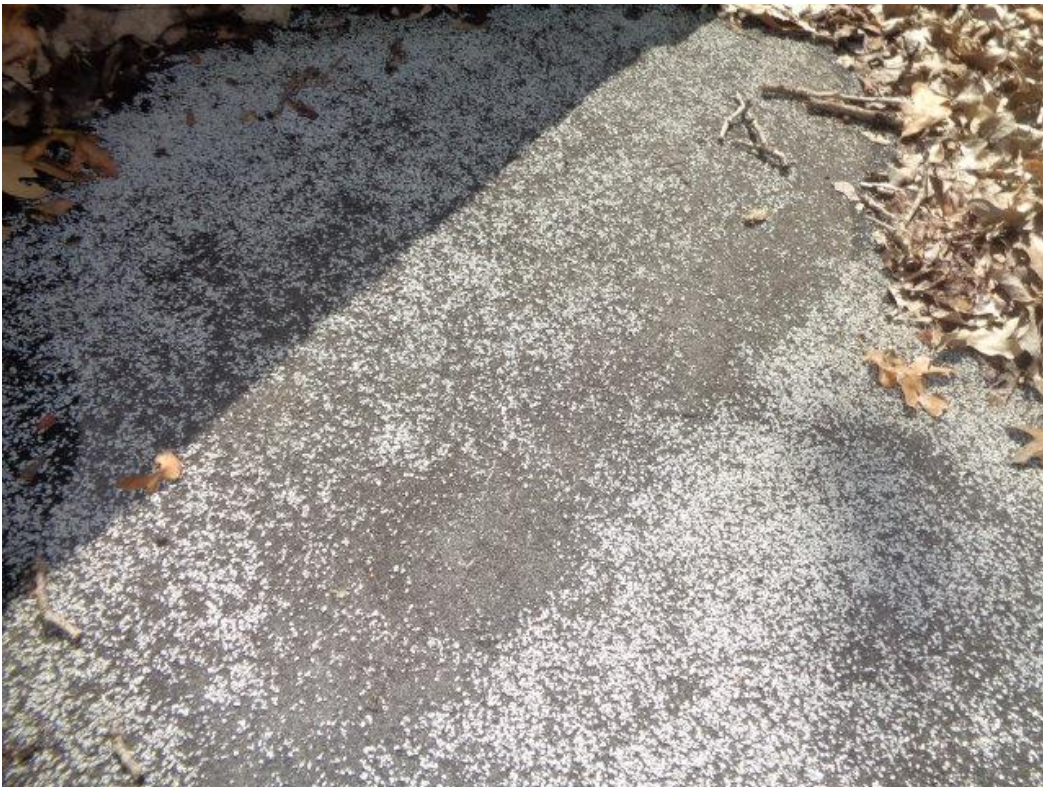
- The modified bitumen at the flat roof over the carport and laundry room/storage room is in poor condition and has been patched over the carport. *See Photo 15.*

Photo 15: The aged modified bitumen at the flat roof.

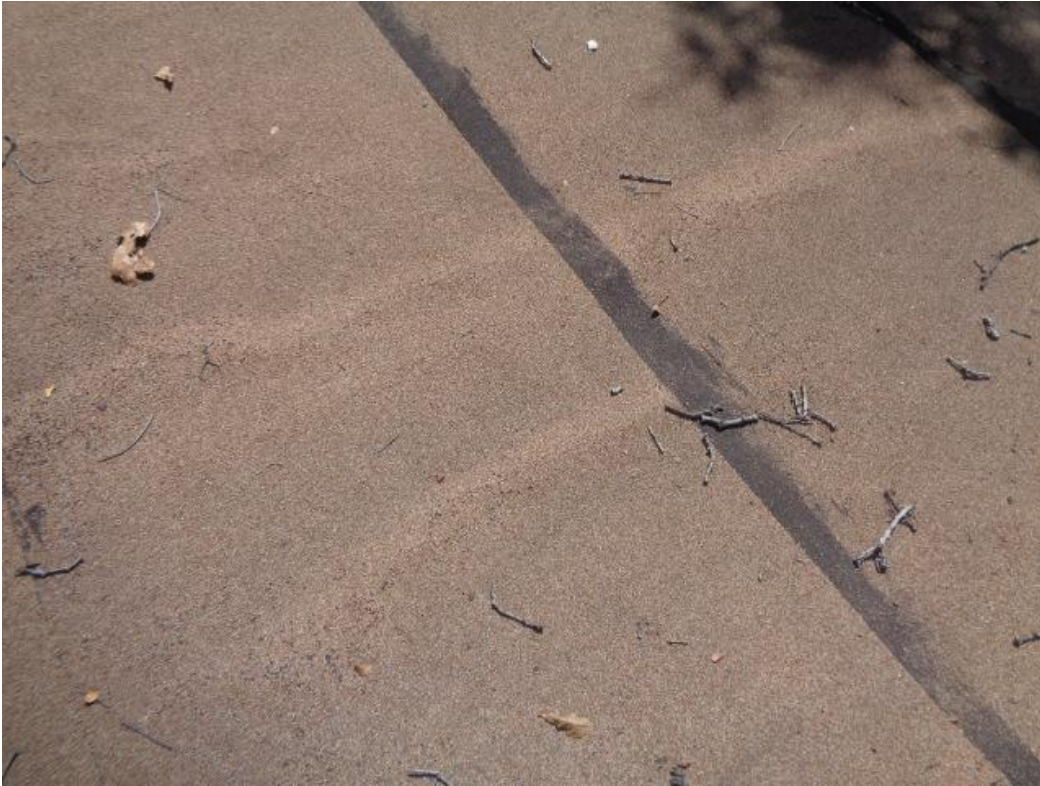
- The modified bitumen over the rear living room is poorly installed - the material is wrinkled and the surface granules at the wrinkles are deteriorated. *See Photo 16.*

Photo 16: The wrinkling at the modified bitumen at the rear living room low pitched roof.

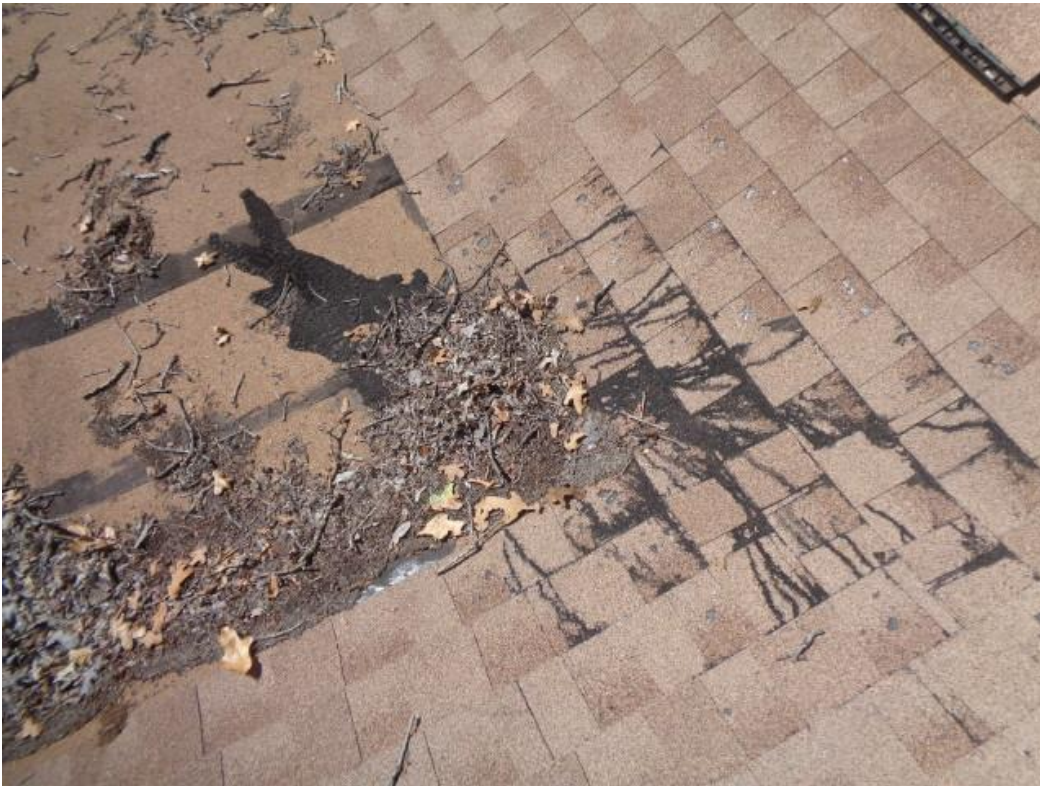
- There is a poorly done repair at the right rear roof valley - spilled tar. *See Photo 17.*
- There are blistered shingles at the right rear valley area that indicate insufficient attic ventilation. *See Photos 18, 19.*

Photo 17: The poorly done repair at the right rear valley.

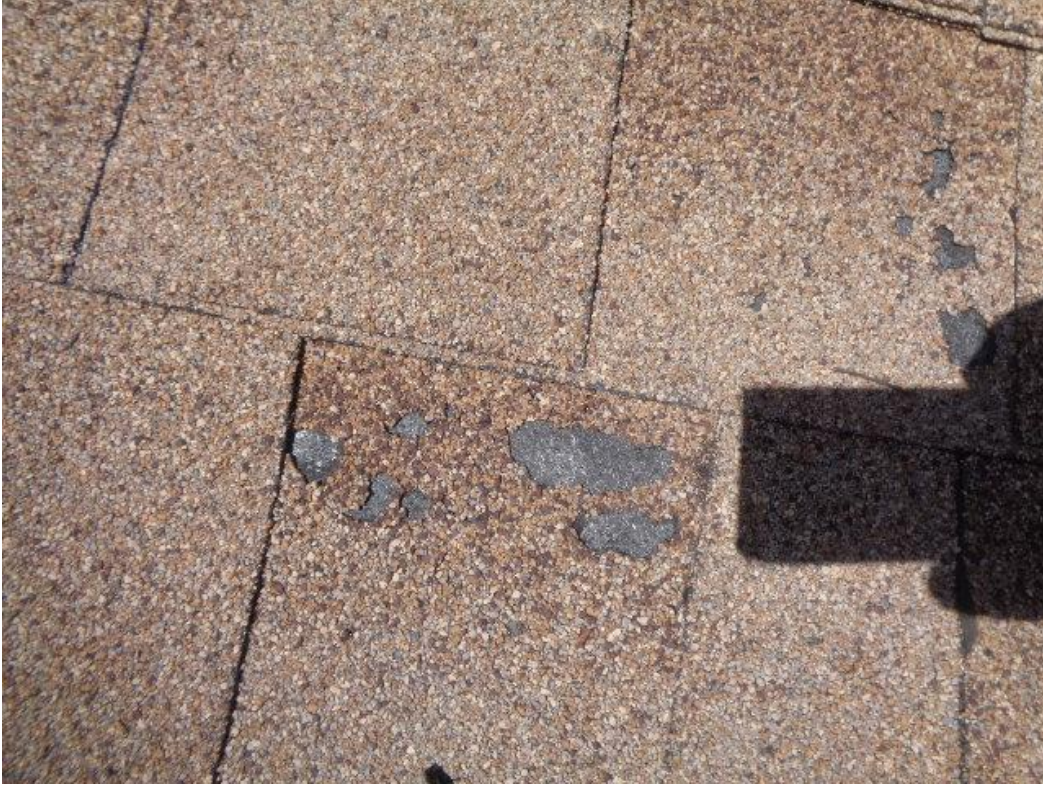
Photo 18: The blistered shingles at the right rear valley area.

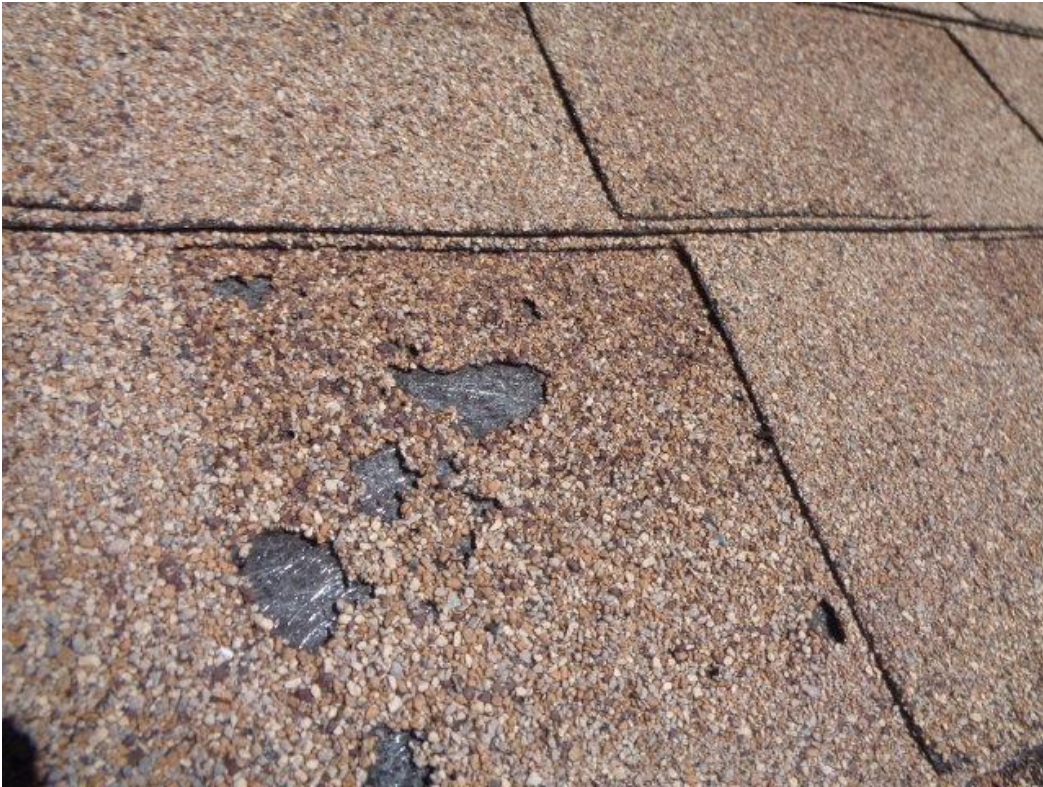
Photo 19: The blistered shingles by the right rear valley.

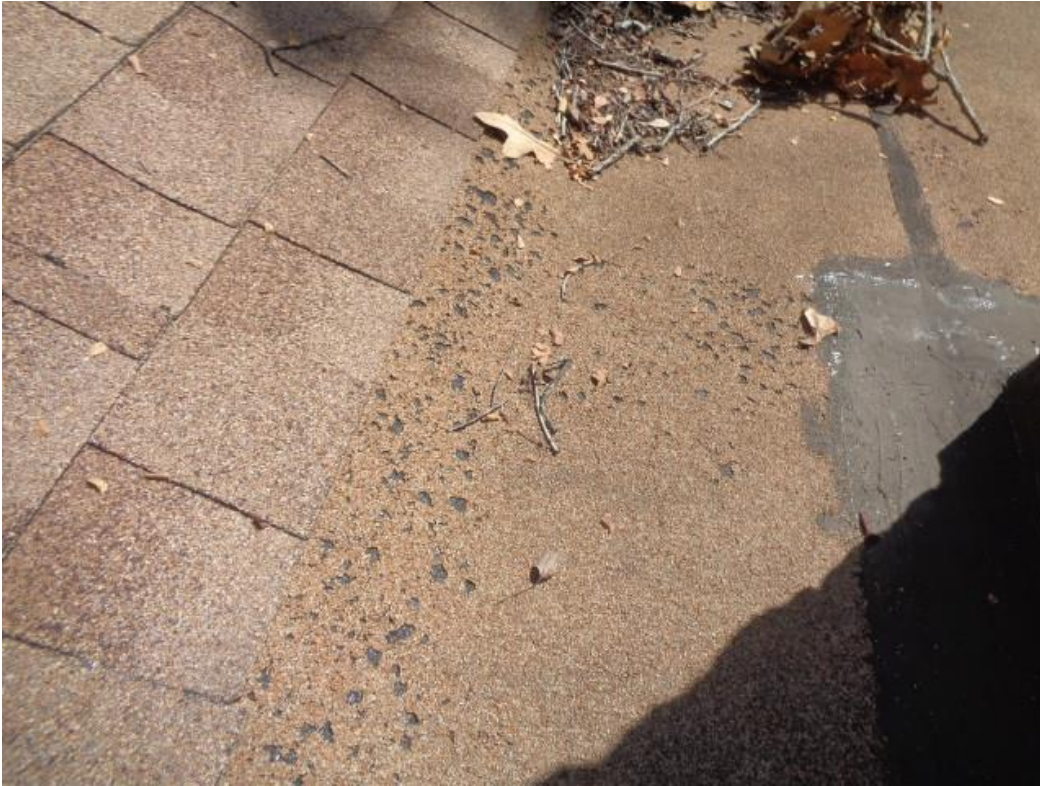
- There is blistering at the modified bitumen behind the chimney indicating insufficient attic ventilation. *See Photos 20, 21.*
- There is ponding at the carport roof. *See Photo 22.*

Photo 20: The blistering modified bitumen behind the chimney.

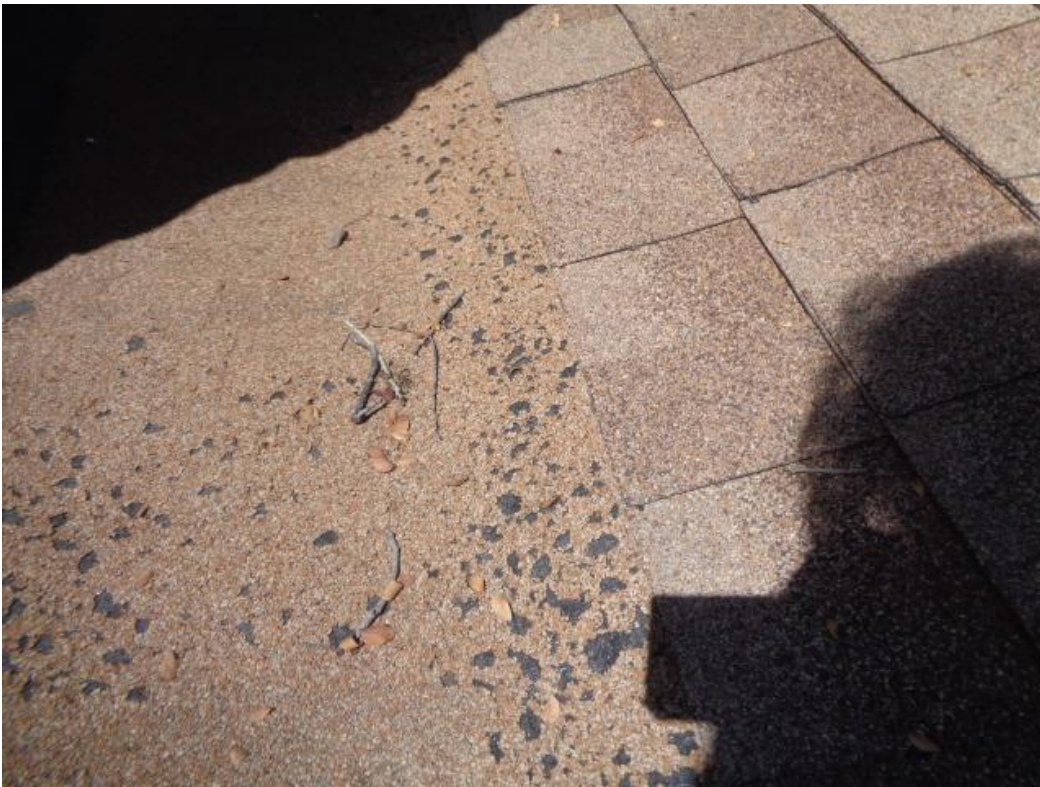
Photo 21: The blistered modified bitumen by the chimney.

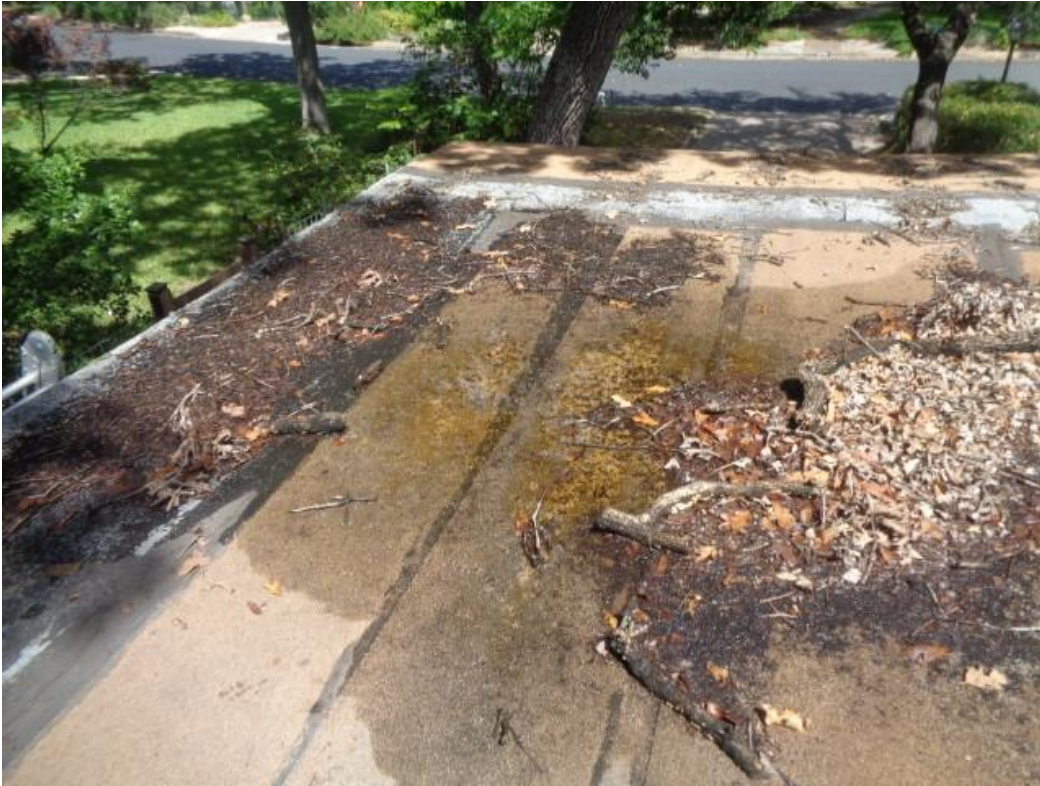
Photo 22: The ponding on the carport roof.

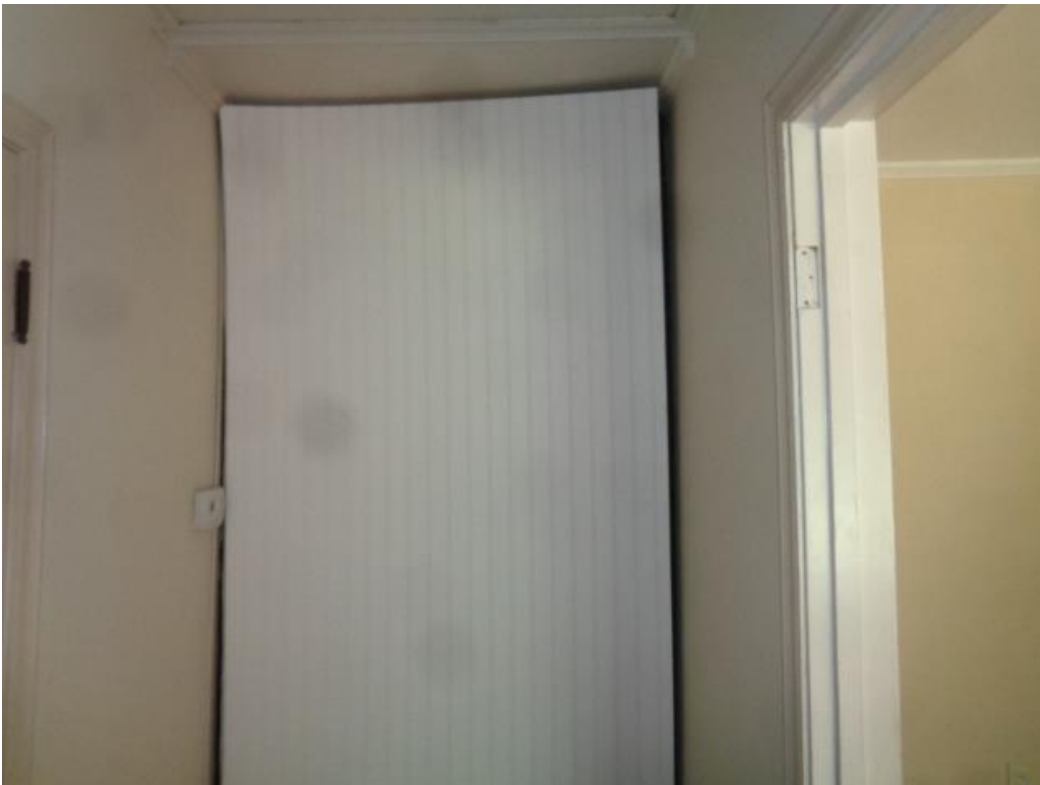
- There is a poorly designed partition in the hall - warped, loose drywall and bead board. *See Photo 23.*

Photo 23: The poorly installed partition in the hall.

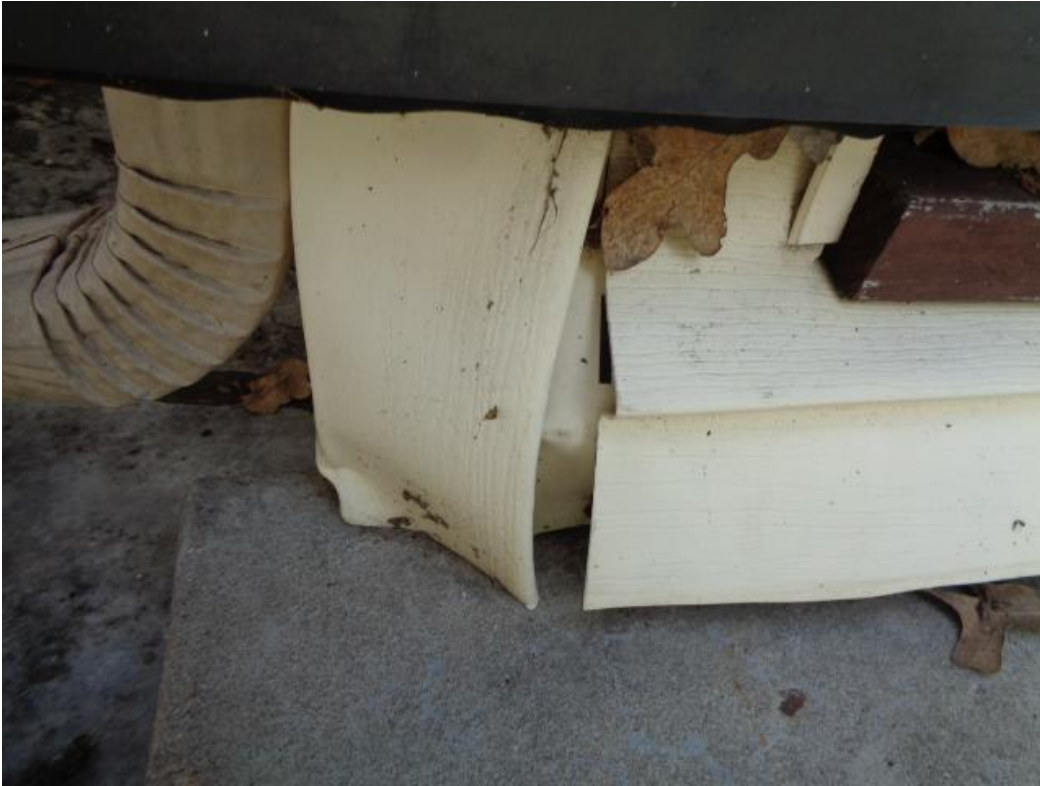
Photo 24: The bent/damaged siding by the rear living room exterior door stoop.

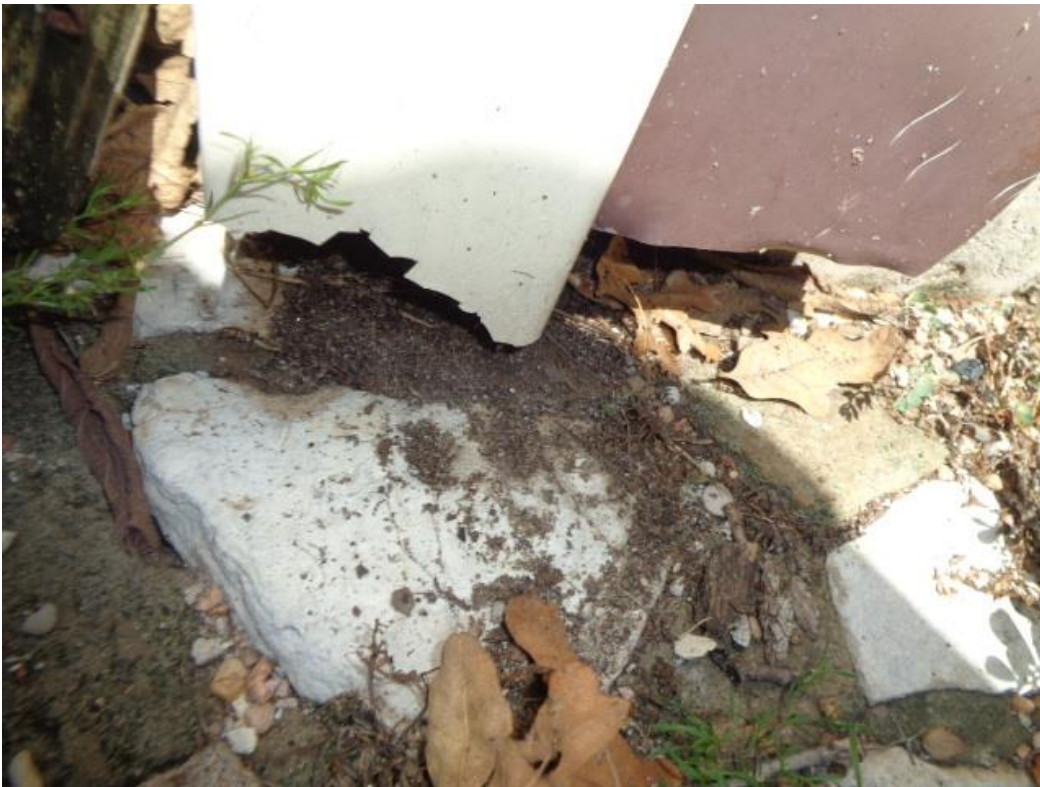
Photo 25: The damaged siding by the storage room exterior door.

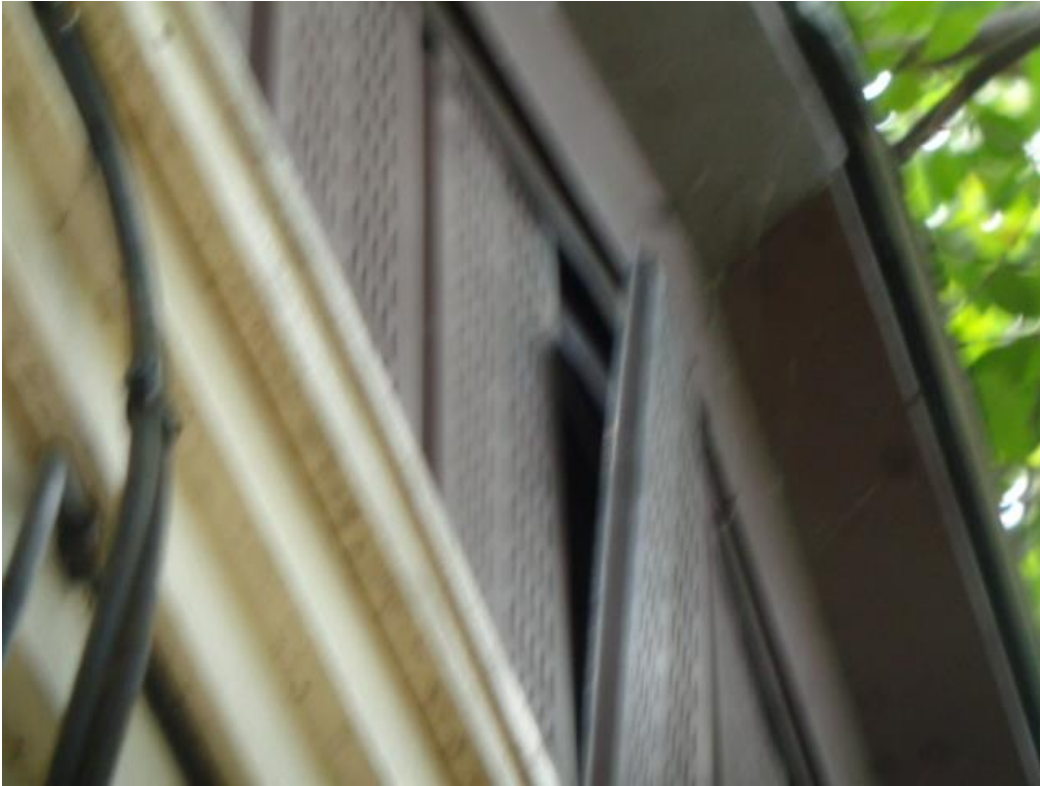
Photo 26: The loose siding at the left rear gable vent.
