The following is a Summary of a Property Inspection Report. The report was done for Mr. and Mrs. Smith by Jim Inmon TREC Professional Inspectors Lic. #103 SPCS CA #29945 PT of Texas Inspection Service of Austin Inc. The inspection was done on 9/5/18 at 4200 Wildwood Rd. Austin, Texas 78722. The inspection was started at 9:05 AM and was completed at 3:38 PM. The weather was cloudy to partly cloudy and the temperature ranged from 79° to 93°. The items cited in the original report as "*Deficient*" and "*Comments*" are included here. Photos of selected items can be viewed at the conclusion of the text. Refer to pages 3-9 of the original TREC report for a checklist format of items inspected, not inspected, not present and additional comments. Read and understand pages 1-2 of the original TREC promulgated 9 page report on form REI 7-5 for the purpose, limitations, inspector/client responsibilities, consumer notice concerning hazards and deficiencies, important additional information provided by the inspector and agreements.

Description of Property: The property is a one story wood frame single family residence on a combination slab on grade/pier and beam foundation. The exterior walls a

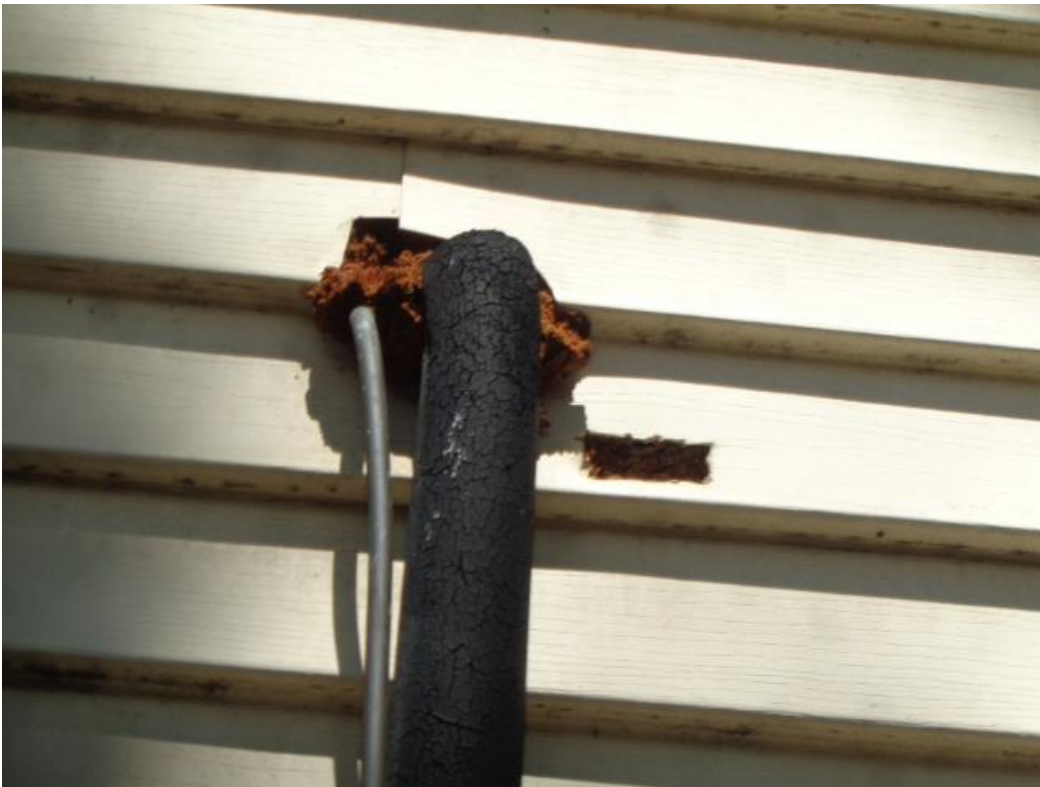
- The rock wall to the right of the front door is stained from roof runoff. *See Photo 10.*
- There is algae build up at the right upper wall above the roof line.
- The siding is bent/damaged at the right rear corner outside the rear living room exterior door. *See Photo 24.*
- The siding is damaged at the left rear corner by the rear storage room door. *See Photo 25.*
- The siding is loose at the left rear gable vent. *See Photo 26.*
- Seal the openings in the siding at the left side by the AC refrigerant lines. *See Photo 27.*

Photo 27: Seal the openings at the left wall siding.

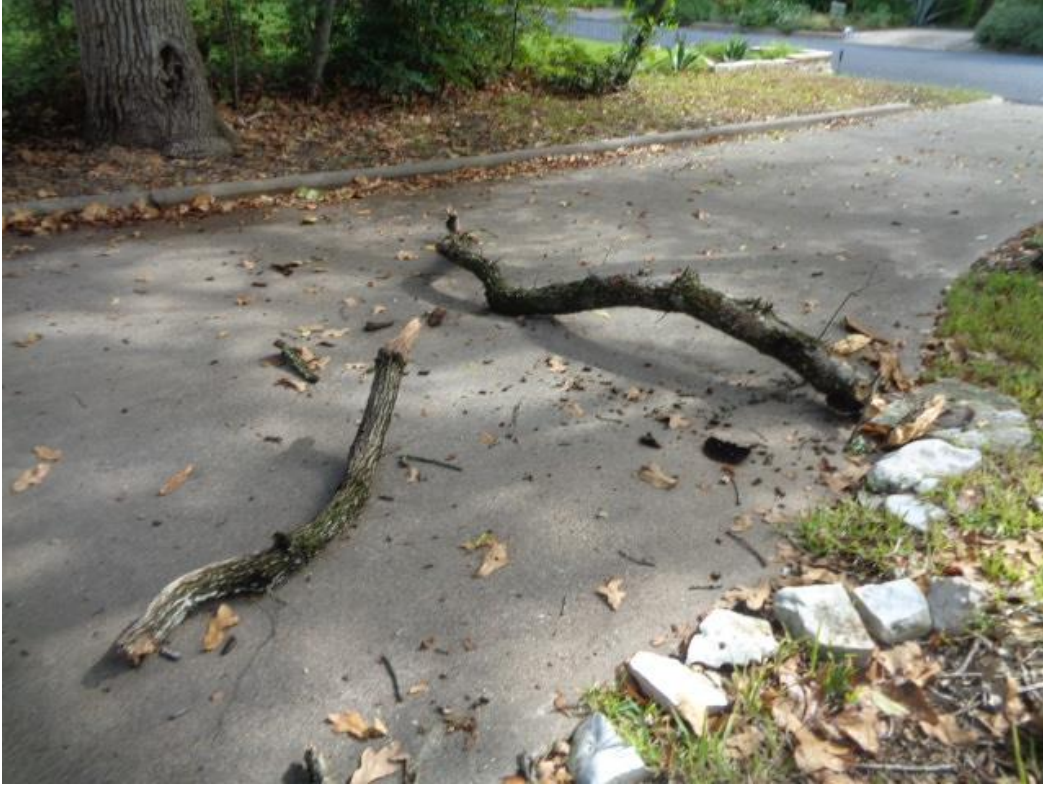
- Large tree limbs were observed to have fallen directly onto the driveway after recent rain - trim all dead wood from the tree to prevent personal and property damage. *See Photo 28.*
- Rodent droppings were observed in the HVAC closet and in the attic. In addition, there is a heavy rodent odor in the attic - licensed pest control company to advise.
- The front 3/4 bathroom shower is in poor condition and appears to leak - the floor has large cracks, the walls are poorly patched and the ceiling is covered with bead board. Removal of the shower is indicated. *See Photos 29-31.*

Photo 28: The branches that have fallen recently onto the driveway.

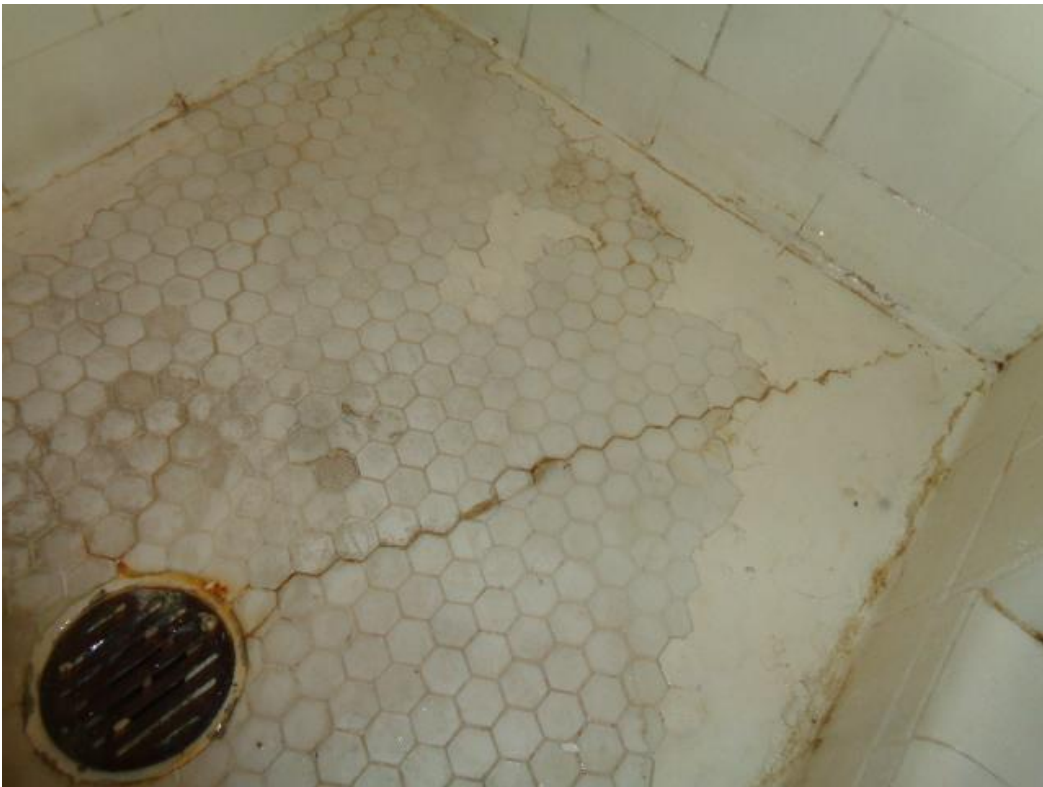
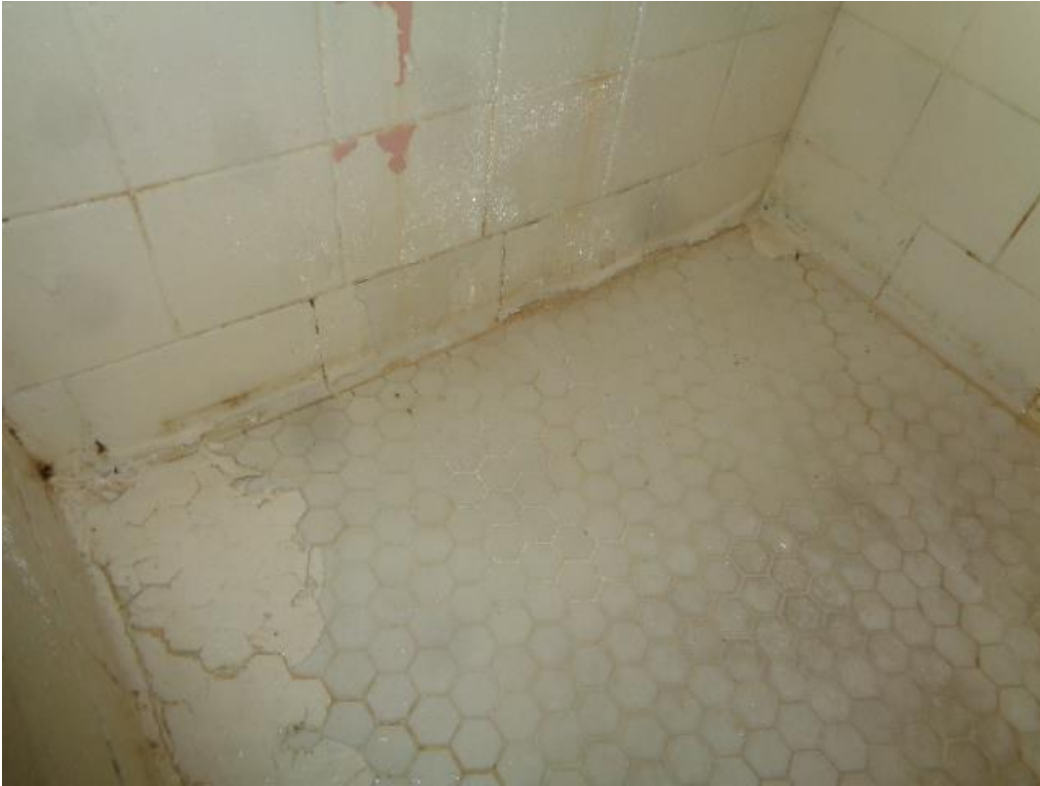
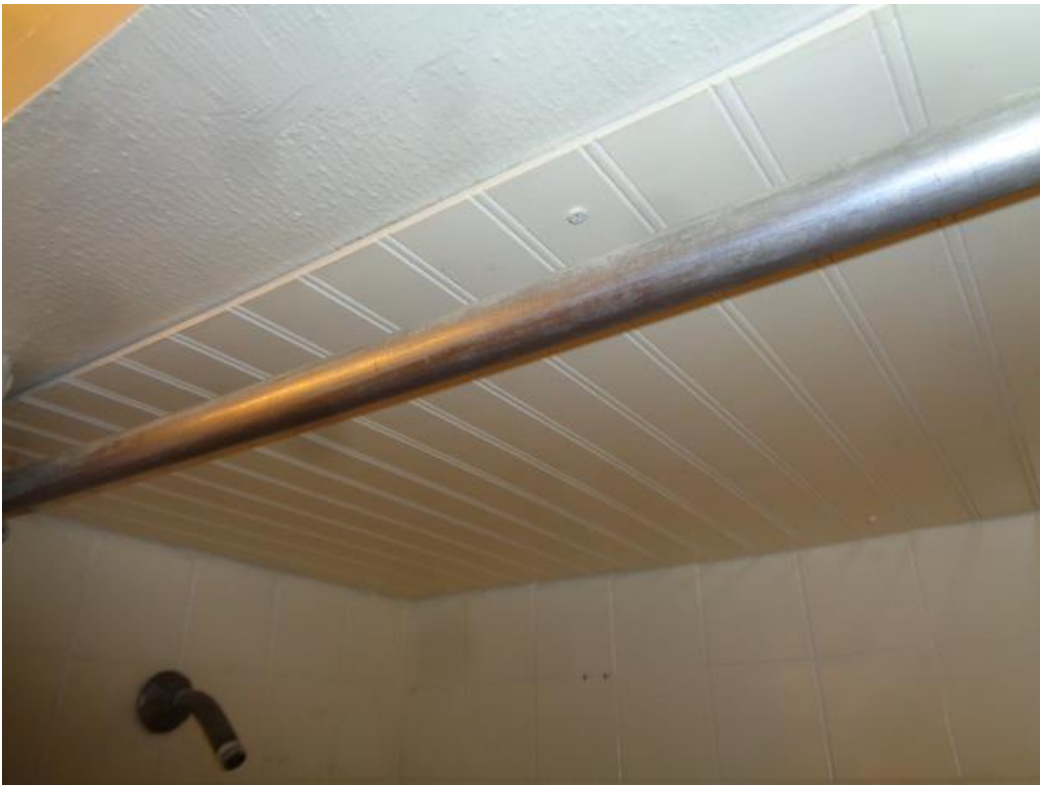
Photo 29: The front bathroom shower is in poor condition.

Photo 30: The front bathroom shower is in poor condition.

Photo 31: The bead board at the ceiling in the front bathroom shower.

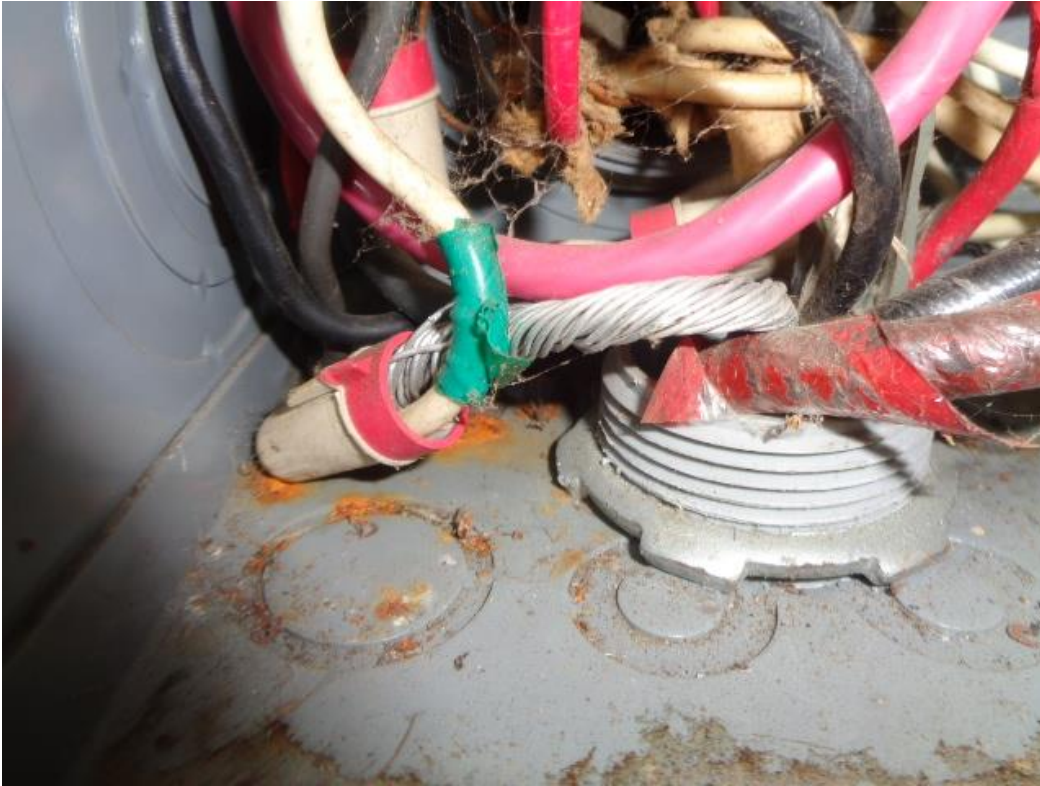
- Trim the tree limbs away from the service wire.
- There is no bonding at the gas meter (newer code).
- At the rear exterior subpanel, the breakers are not labeled and there appear to be circuits that share common neutrals but the breakers are not trip tied.
- There are splices in the rear subpanel that combine silver wiring with copper. This silver wire is likely nickel coated copper in which case, there is no problem with the splice. However, if the wire is aluminum, this splice is not recommended - licensed electrician to advise. *See Photo 32.*
- The wiring to and in the old Square D subpanel in the hall is not to today's standards - the feed from the rear subpanel is a 3-wire feed (not a 4-wire) and there are no grounds for the branch circuits in the panel. In addition, the breakers in the subpanel are not labeled.

Photo 32: The silver wiring that is spliced in the rear exterior wall subpanel - make sure this is not an aluminum/copper wire splice.

- Licensed electrician to advise on all of the above.

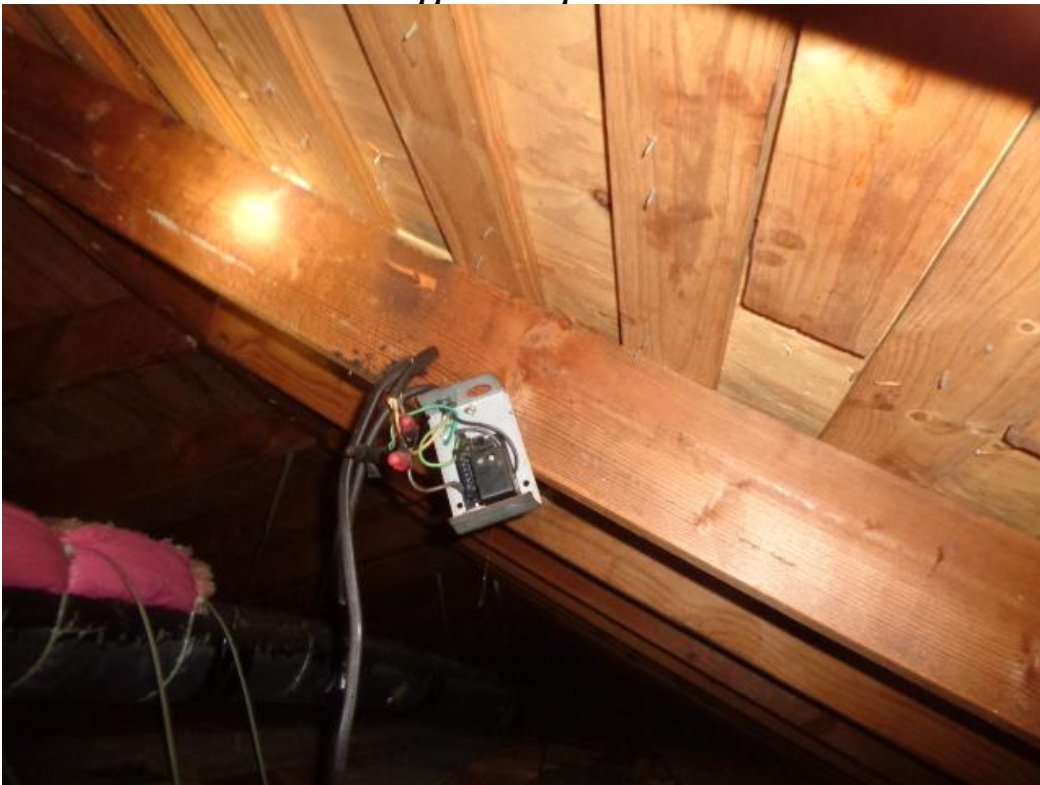
- The 240 volt clothes dryer receptacle is a 3-wire plug - not the newer 4-wire.
- The rear bedroom ceiling fan shakes.
- In the attic, there is what appears to be a fan limit switch with exposed splices - function unknown. *See Photo 33.*

Photo 33: The box that appears to be a fan limit switch with exposed splices in the attic.

- The functions of all switches could not be determined.
- The GFCIs in the rear full bathroom are not grounded. However, GFCIs do protect ungrounded circuits.
- Licensed electrician to advise on all of the above.

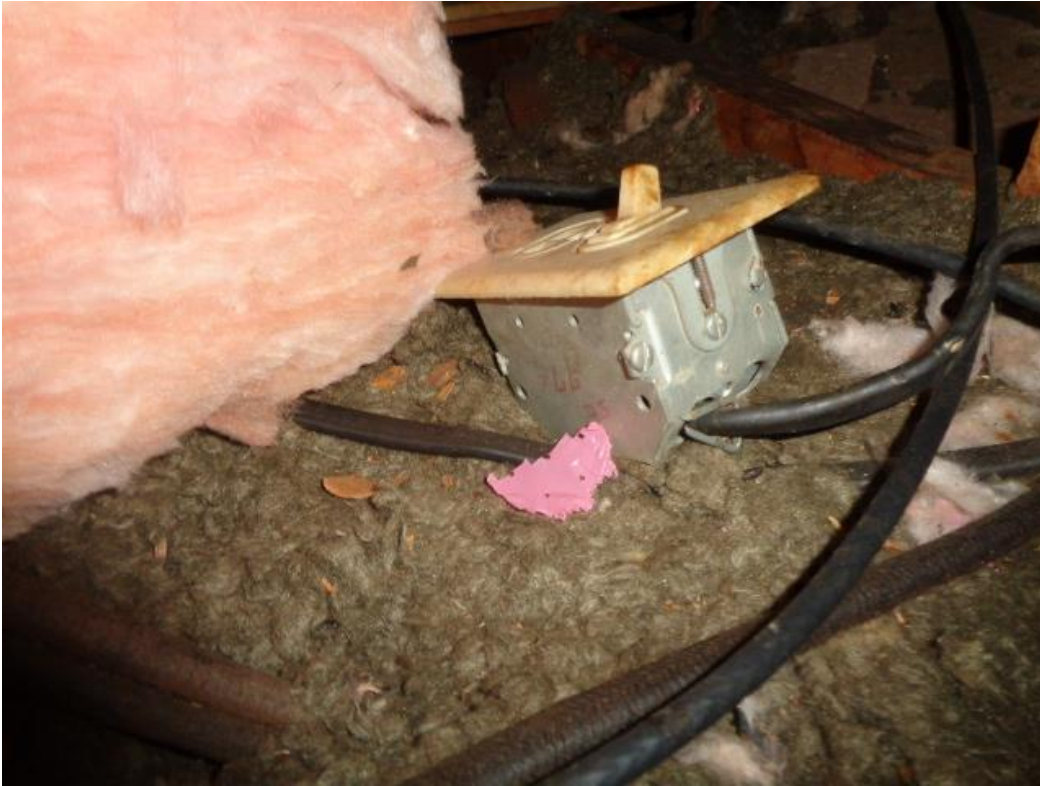
- In the attic, there is a loose switch - function unknown. *See Photo 34.*
- A power strip is used for the rear bedroom window AC unit - not recommended.

Photo 34: The switch in the attic - function unknown.

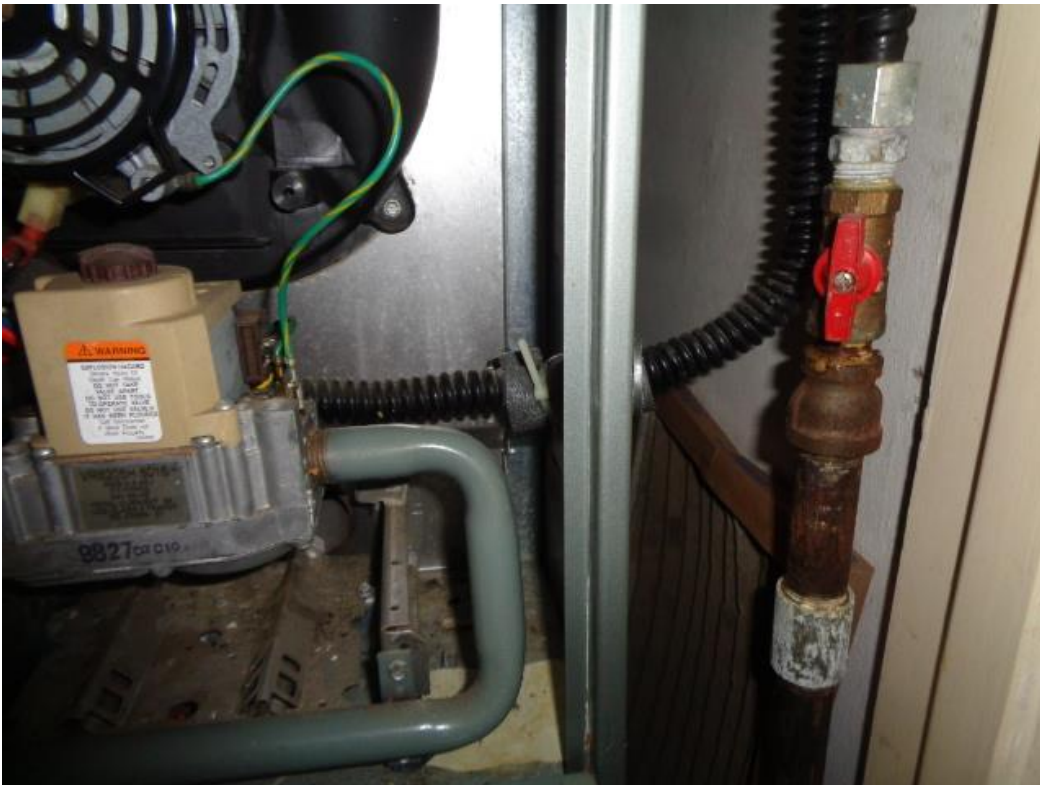
- The gas line is not rigid pipe as it enters the heater cabinet (red tagged by the gas company in 2014). *See Photo 35.*
- There is no sediment trap at the gas line.
- The flue contacts wood above the heater closet in the attic - 1" clearance is required. In addition, the flue terminates with 3' of a 10' diameter of roof shingles on the roof.
- The combustion air for the heater is improperly supplied from an open ceiling.

Photo 35: The heater gas line is not rigid pipe as it enters the heater cabinet.

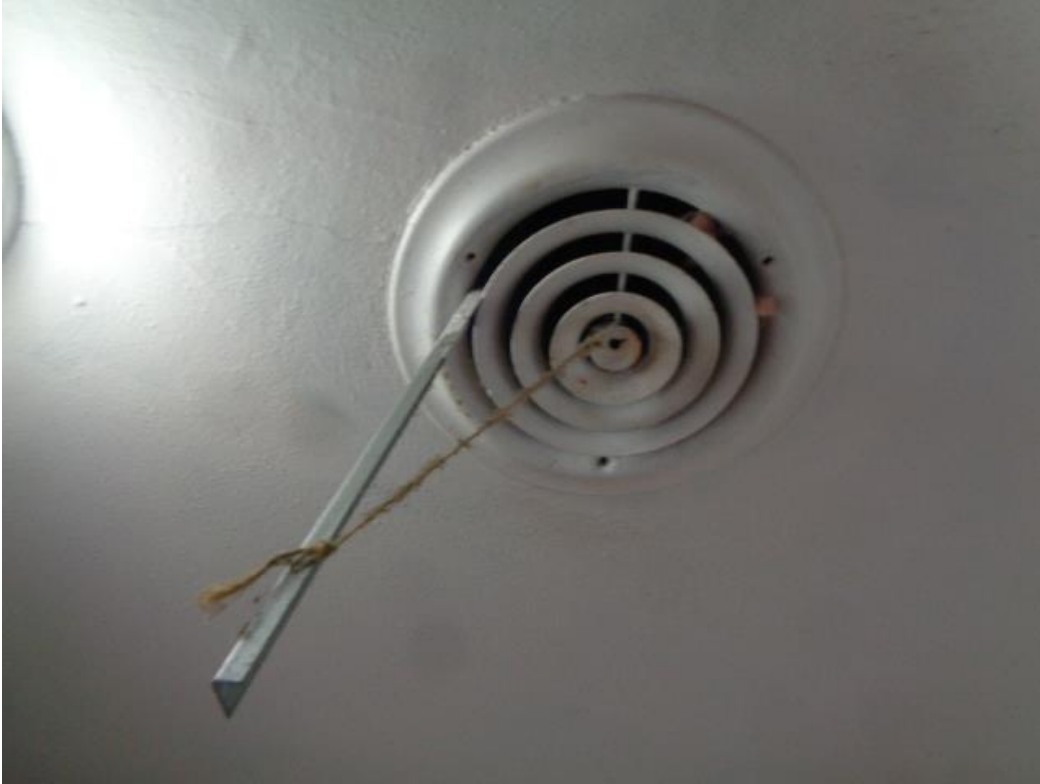
- There is a gas line run through the return air chase under the air handler - not permitted.
- The return air grate is dirty - dog hair/poor maintenance.
- The pull chain for the kitchen ceiling register is too short (broken off) so the damper for the register is held open with a string and a metal rod. ***See Photo 36.***
- In the attic, there is damage at some of the Mylar flexible ducts. At both the metal and flexible ducts in the attic, there are "repairs" to the ducts that were not done by a licensed HVAC company - the ducts are wrapped with fiberglass wall insulation. ***See Photos 37-39.***

Photo 36: The damper for the kitchen register is held open with a string and a metal rod.

- Licensed HVAC company to advise on all of the above.

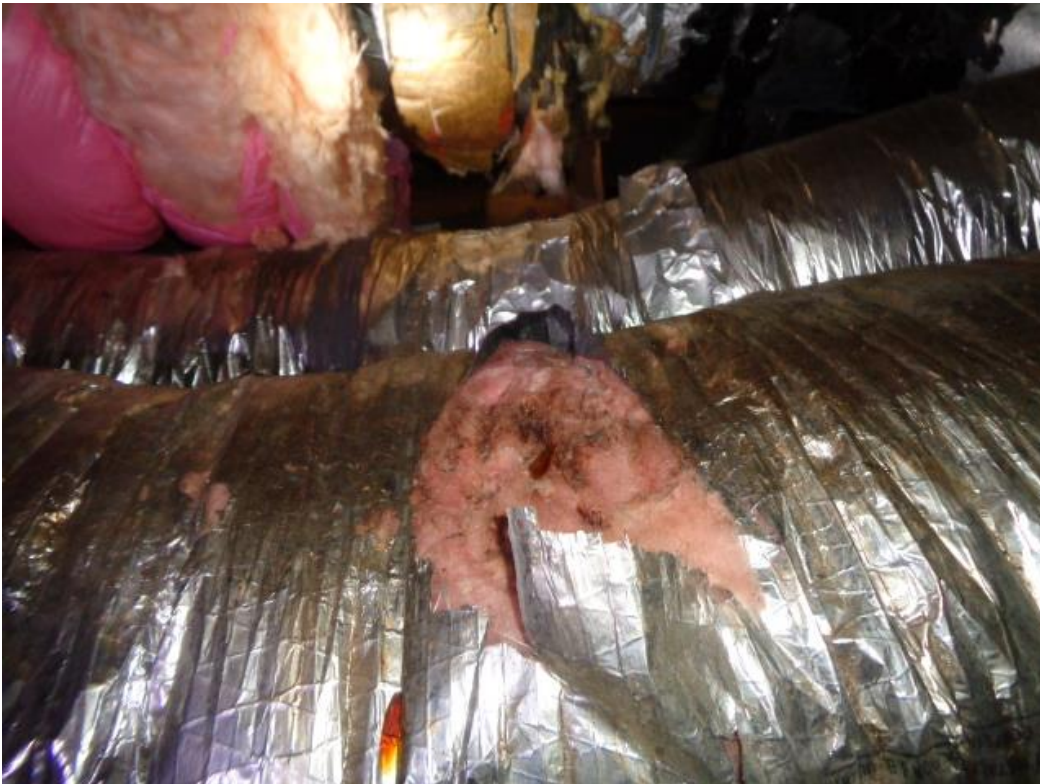
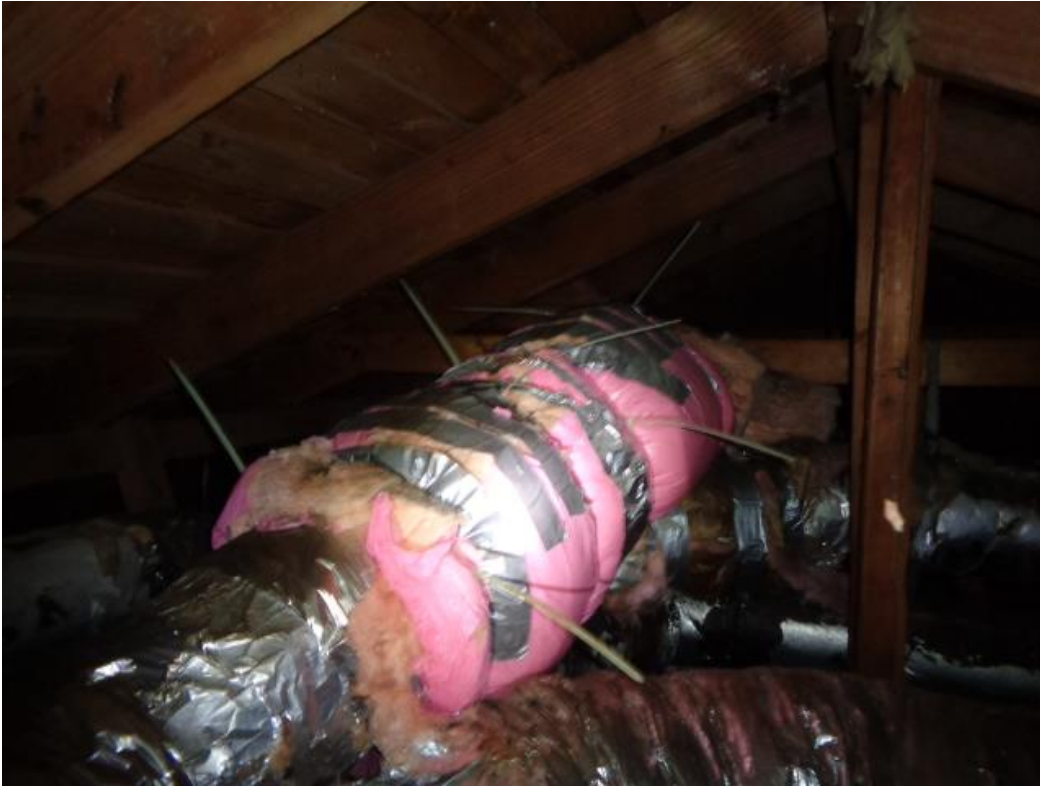
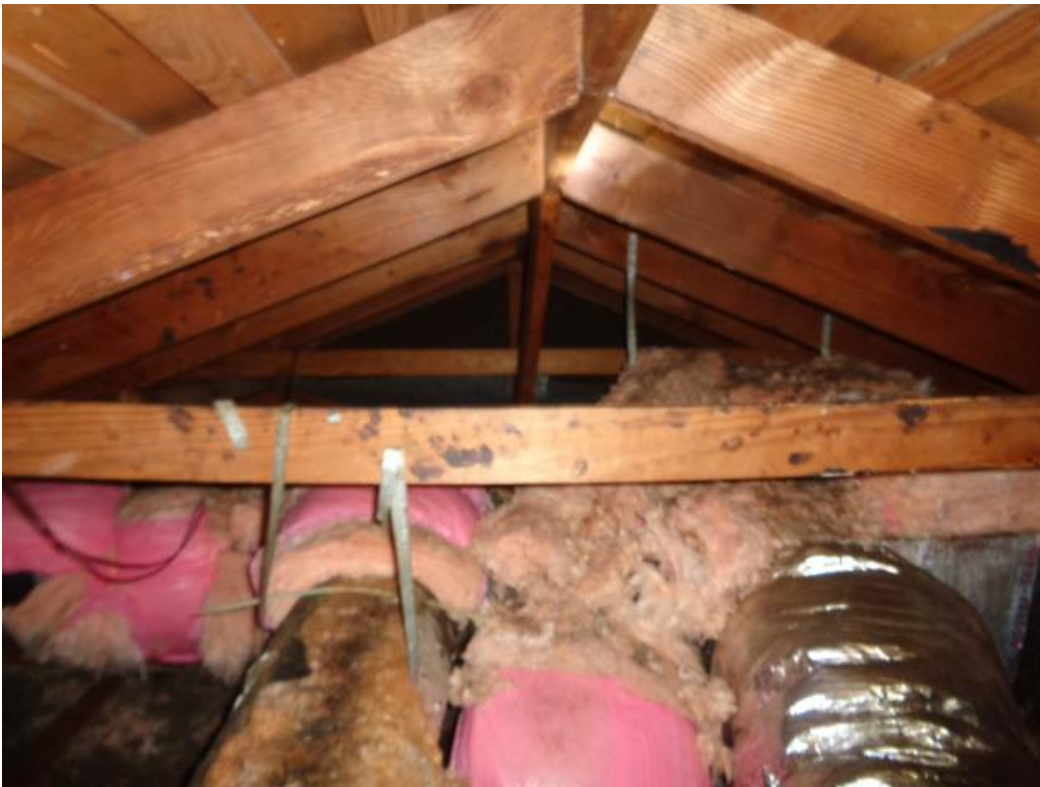
Photo 37: The damaged Mylar ducts in the attic.

Photo 38: The poorly done repairs to the ducts.

Photo 39: The poorly repaired ducts.

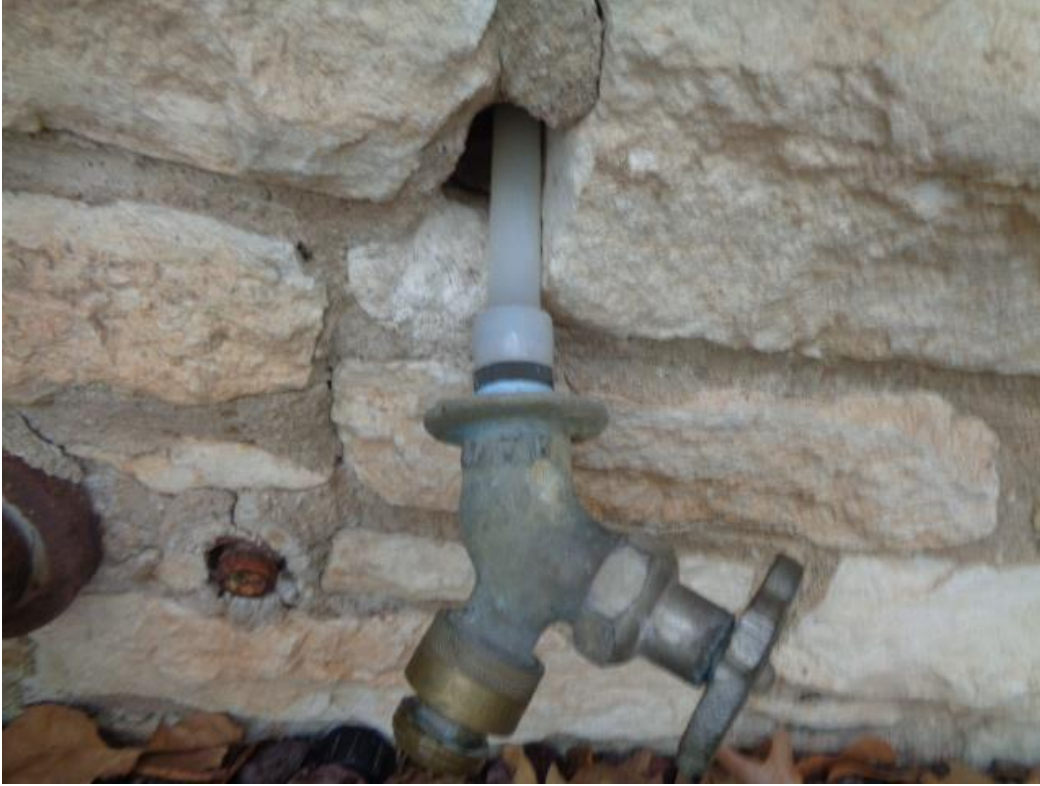
- There is no shower head at the front 3/4 bathroom shower.
- In the rear full bathroom, the toilet fill valve leaks in the tank and stops and starts while filling. In addition, the fill valve is not the correct size for the tank.
- In the rear bathroom, the pressure is low at the sink faucets.
- In the rear bathroom, the tub diverter valve sticks - is not easily operated. In addition, when the diverter valve operates, a loud water hammer occurs.
- The front hose faucet/pipe is exposed, not secured and loose - failure/leakage possible - secure and insulate. ***See Photo 40.***
- The hose faucet at the left front soil is dry - not connected.

Photo 40: The unsecured, loose, uninsulated water line at the front hose faucet.

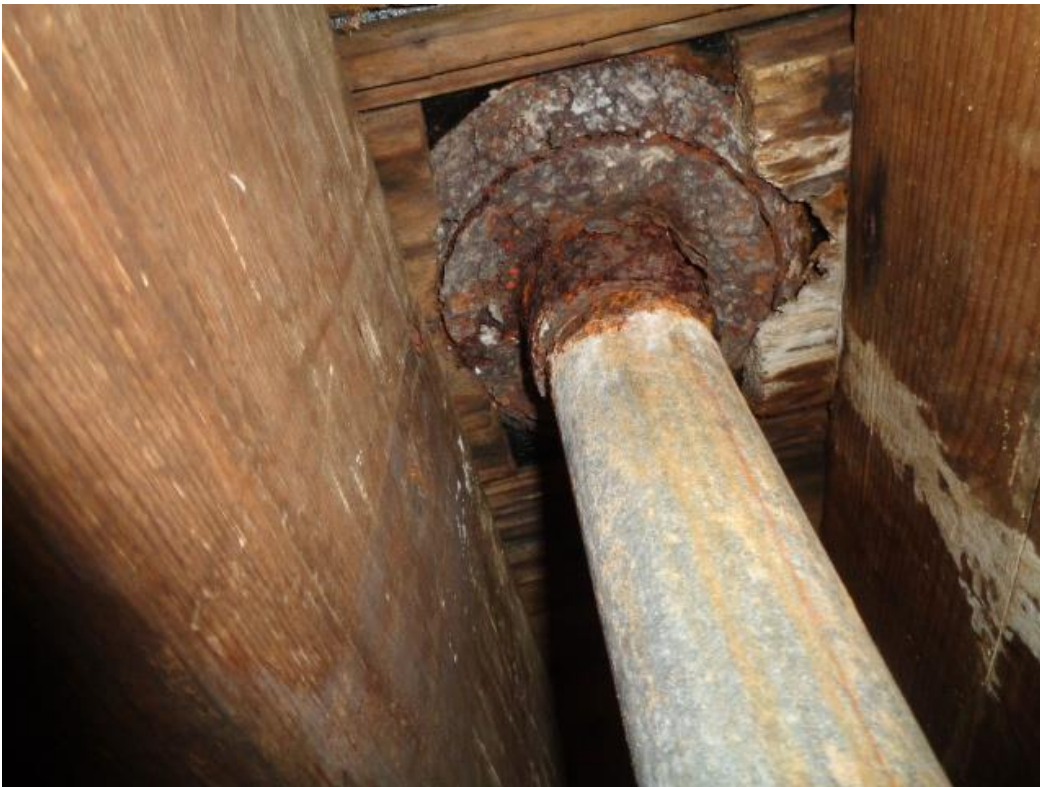
- The drain connection under the front 3/4 bathroom shower is corroded. *See Photo 41.*

Photo 41: The corroded front bathroom shower drain as seen from the crawl space.

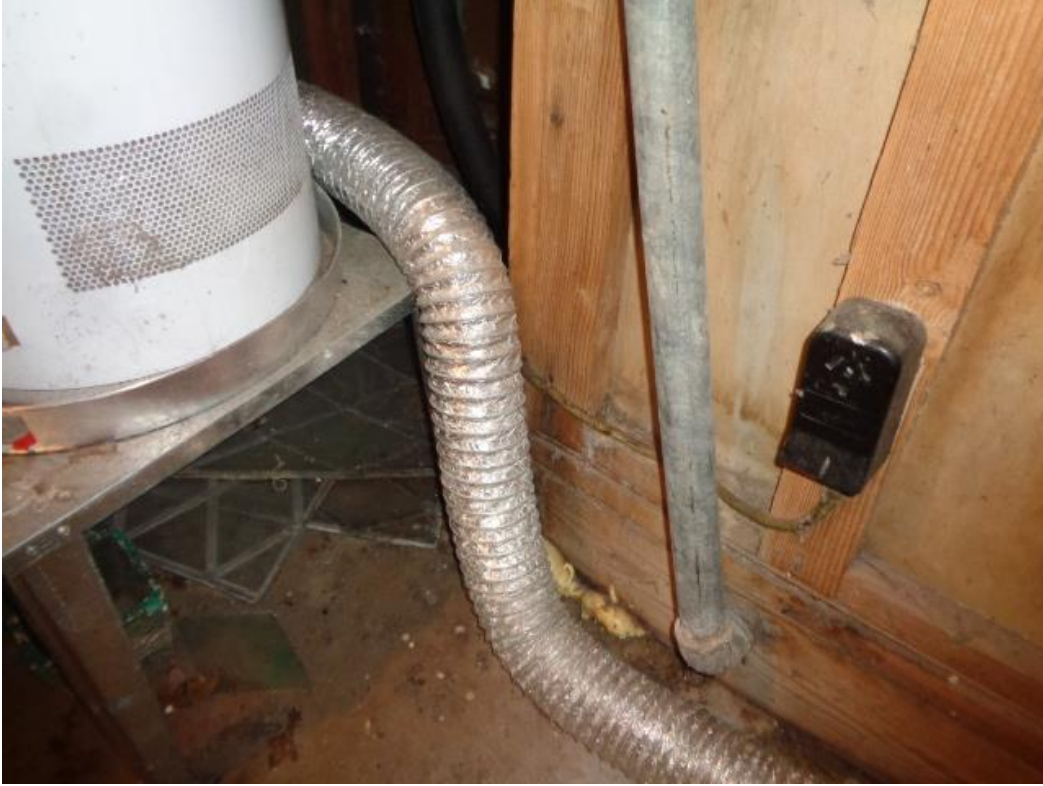
- There is no anti-siphon loop at the drain line for the dishwasher.
- There are wooden shelves that are within 30" of the kitchen cooktop - not permitted.
- There is an electrical short at the right rear kitchen cooktop (audible).
- The upper oven door is loose and the lower oven door binds.
- The upper oven cooked cool - it reached 275° when set at 350°.
- There are no exhaust fans provided for the bathrooms.
- The gas space heater in the front 3/4 bathroom is not connected to gas - do not reconnect to use - these heaters are not vented and pose a carbon monoxide poisoning hazard.
- The flue for the dryer exhaust is flexible Mylar as it extends through the laundry room area - rigid metal is required. *See Photo 42.*

Photo 42: The dryer flue is not rigid metal as required.
