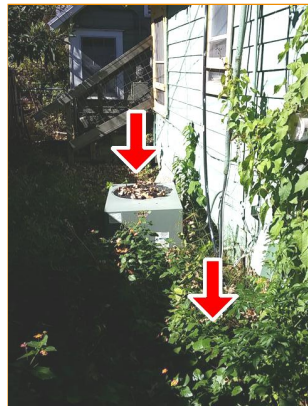
B. Item 1(Picture)

(1) There was a negative slope observed towards the home in one or more areas. Proper drainage is critical to the performance of the foundation. All grades should drop away from the structure at a rate of 6 inches for every 10 feet. Improve drainage as needed so that water flows away from the home.

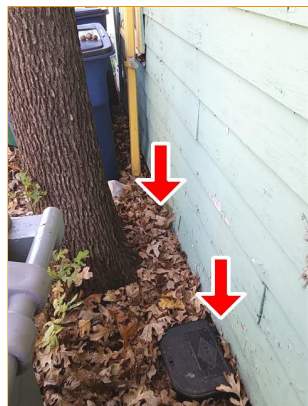
B. Item 2(Picture)

(2) It is advisable to maintain at least 3-6 inches minimum of clear area between the ground and exterior finishes.

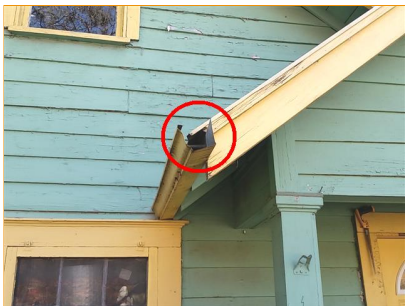
B. Item 5(Picture)

(4) End caps were missing at one or more gutters.

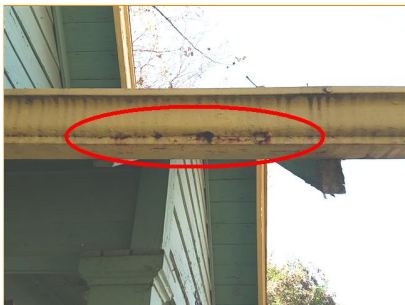
B. Item 6(Picture)

(5) Rust was observed at one or more gutters.

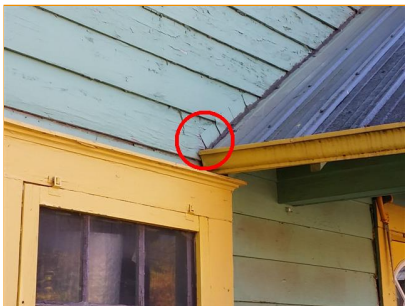
C. Item 1(Picture)

(1) Kick-out flashing is recommended at roof-to-wall connections to divert water away from exterior finishes. Have a roofer correct where needed.

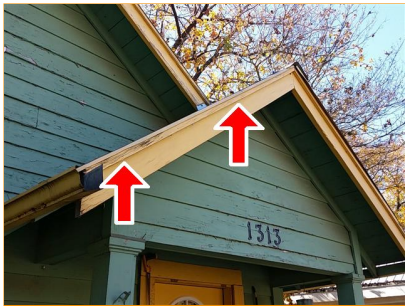
C. Item 4(Picture)

(3) There was no drip edge flashing observed at the roof perimeter. Per current code standards, a drip edge shall be provided at eaves and gables of shingle roofs. Adjacent pieces of drip edge shall be overlapped a minimum of 2 inches. Drip edges shall extend a minimum of 0.25 inch below the roof sheathing and extend up the roof deck a minimum of 2 inches. Drip edges shall be mechanically fastened to the roof deck at a maximum of 12 inches on center. Underlayment shall be installed over the drip edge along eaves and under the drip edge on gables. Unless specified differently by the shingle manufacturer, shingles are permitted to be flush with the drip edge.

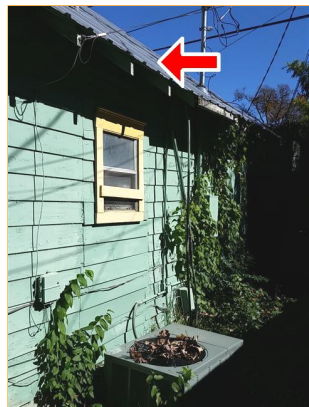
C. Item 6(Picture)

(5) Diversion flashing is recommended over the AC condenser at the roof edge. Roof run-off can damage the fan and fan bearings.

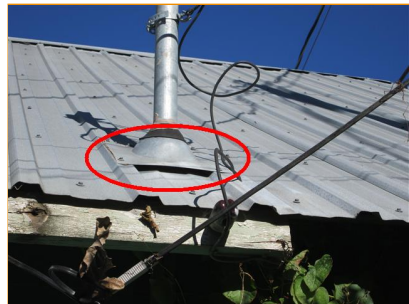
C. Item 7(Picture)

(6) The roof jacks for plumbing and electrical penetrations did not appear to be properly installed. Water staining was observed at the roof structure beneath these areas.

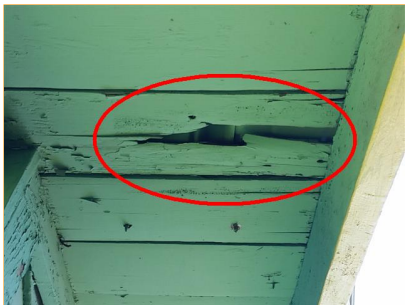
D. Item 3(Picture)

(2) Rot was observed at various areas of the roof sheathing. Repair or replace all damaged and rotten wood.

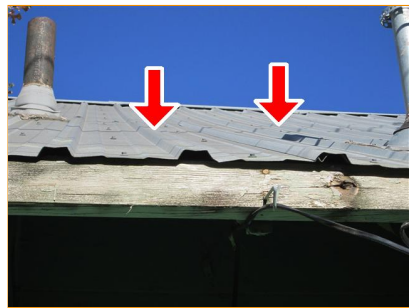
D. Item 8(Picture)

(4) The roof plane at the rear of the home was sagging. The roof structure did not appear to be properly

supported in this area. Recommend further evaluation by a qualified framing contractor or structural engineer.

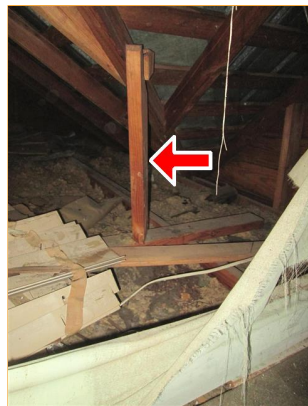
D. Item 9(Picture)

(5) No strong backs (T-bracing) were present at roof supports. T-bracing helps prevent supports from bowing. Repair as needed.

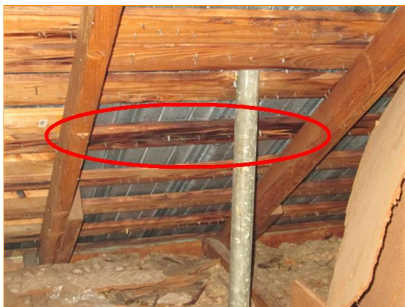
D. Item 14(Picture)

(9) Water staining was observed at various areas of the roof sheathing.

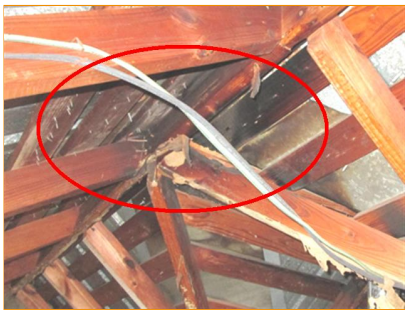
D. Item 17(Picture)

(10) Fire damage was observed at the roof structure above the center of the home.

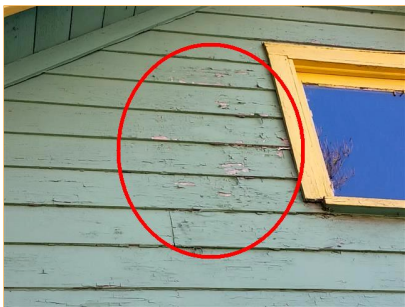
E. Item 1(Picture)

(1) The paint is failing and/or worn at one or more areas of the exterior wood. I recommend prepping and painting at all exposed areas to prevent rot.

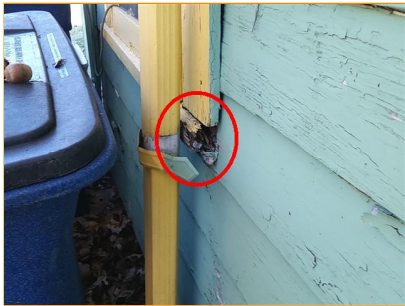
E. Item 3(Picture)

(2) Rot was observed at the siding and/or wood trim in one or more areas. Replace or repair all damaged and rotten wood.

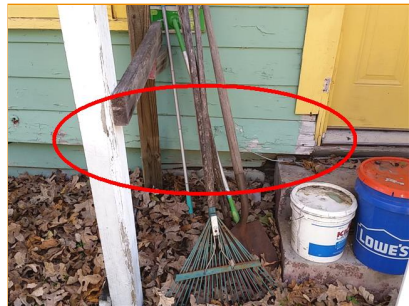
E. Item 7(Picture)

(4) The siding was not properly secured at the right side of the home.

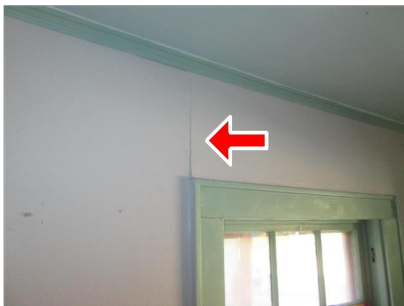
E. Item 11(Picture)

(7) Settlement was observed at one or more interior walls.

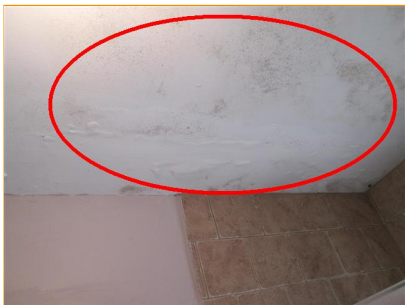
F. Item 1(Picture)

(1) Mildew was observed at the ceiling in the bathroom.

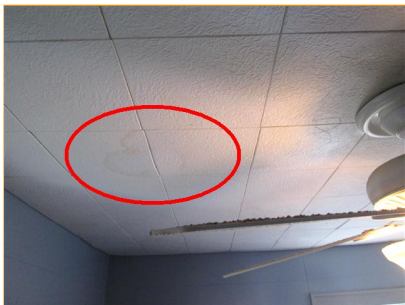
F. Item 3(Picture)

(2) Water staining was observed at the ceiling in the right rear bedroom.

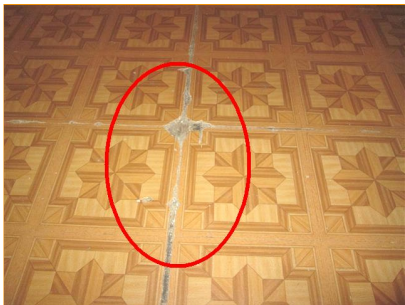
F. Item 5(Picture)

(4) Damage was observed at the floor covering in the kitchen.

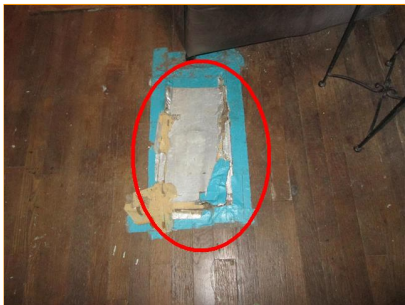
F. Item 6(Picture)

(5) Damage was observed at the flooring in the living room.

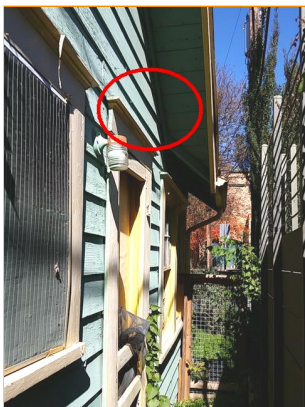
G. Item 1(Picture)

(1) A roof or porch covering is recommended over all exterior doors. Monitor these doors in wet weather.

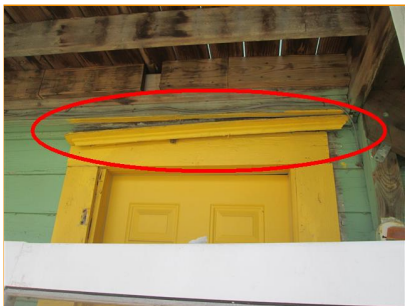
G. Item 2(Picture)

(2) The casing was not properly secured at the top of the right exterior door.

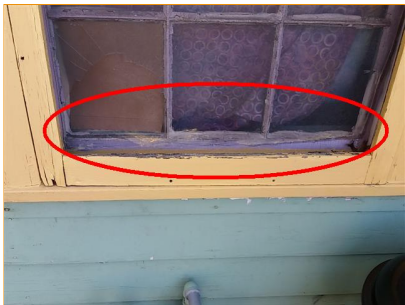
H. Item 7(Picture)

(3) Damage was observed at one or more window screens.

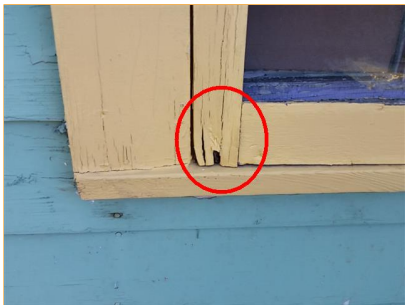
H. Item 8(Picture)

(4) Rot was observed at one or more window screen frames. Repair or replace all damaged and rotten wood.

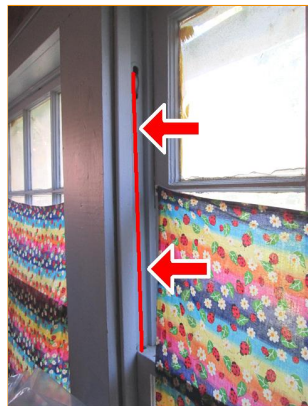
H. Item 11(Picture)

(6) Sash cords were missing at various windows.

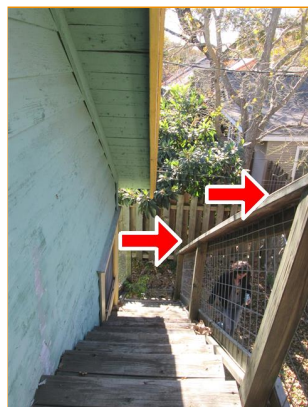
I. Item 3(Picture)

(2) Today's code standards require that all stairway hand railings be easily graspable. Repair as needed.

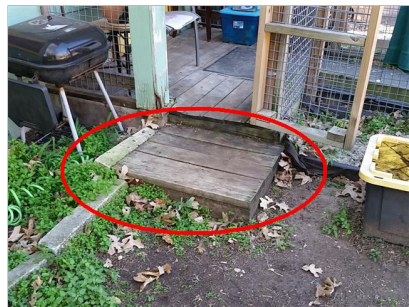
K. Item 1(Picture)

(1) Wood-to-ground contact is conducive to rot and wood-destroying insects.

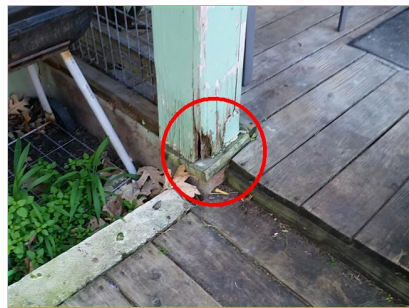
K. Item 2(Picture)

(2) Rot was observed at the front porch columns. Repair or replace all damaged and rotten wood.

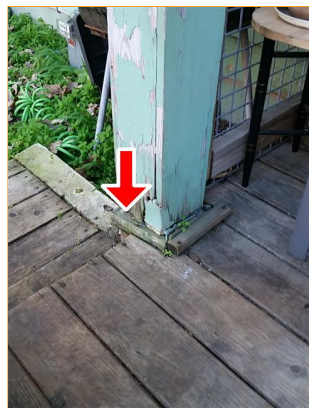
K. Item 3(Picture)

(3) Settlement was observed at the left front porch column.

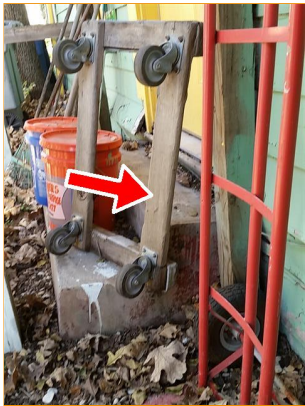
K. Item 4(Picture)

(4) The steps at the right exterior door were not level.

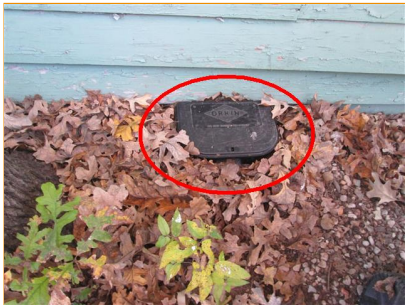
L. Item 1(Picture)

Rodent traps were observed at the home's exterior. Continued pest control is recommended.

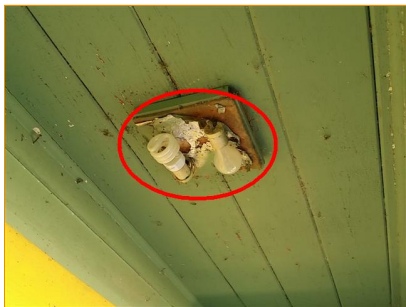
B. Item 1(Picture)

(1) Bulb shields were missing at one or more light fixtures. Bulb shields are recommended at all exposed bulbs.

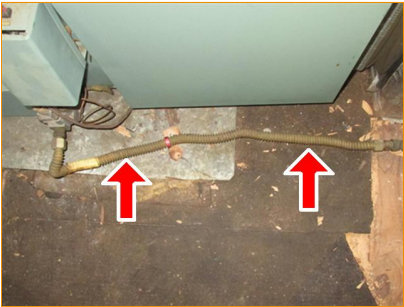
A. Item 1(Picture)

(1) The flexible appliance connector is outdated and should be replaced.

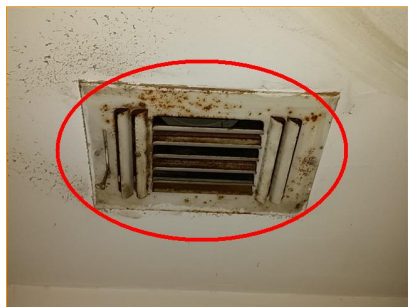
C. Item 4(Picture)

(2) Rusted HVAC ceiling registers can be a sign of poor HVAC performance and/or excessive humidity.

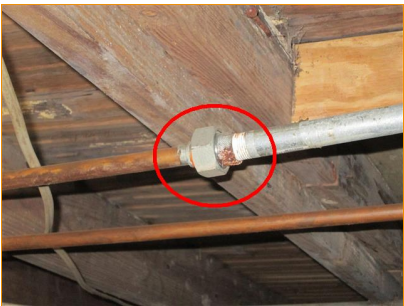
A. Item 2(Picture)

(2) Dissimilar piping types were present at various areas of the crawlspace. These connections are prone to leaking and should be monitored.

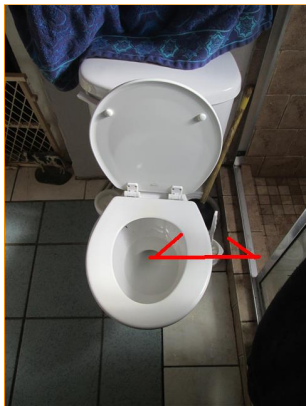
A. Item 7(Picture)

(5) Toilet does not have proper clearance from the shower door. Plumbing code calls for 15" from the center of the toilet to the nearest wall or cabinet.

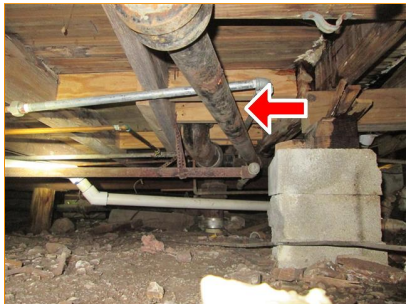
B. Item 1(Picture)

(1) Cast iron drain lines were present under the home and/or between the home and public sewer system. Recommend a static test or drain scope to verify the integrity of the plumbing system. The inspector does not run the amount of water during the inspection that would emulate the daily use of a family.

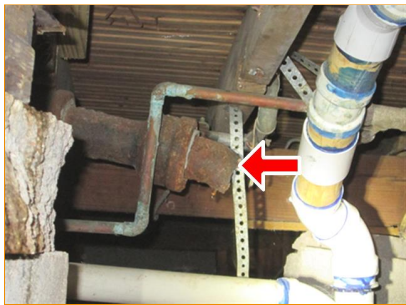
B. Item 2(Picture)

(2) One cast iron drain line termination did not appear to be properly capped in the crawlspace. This may allow sewer gases to enter this space.

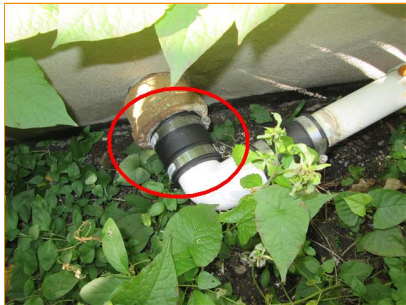
B. Item 3(Picture)

(3) Dissimilar drain piping types were observed at the inspected home. These connections are prone to leaking and should be monitored.

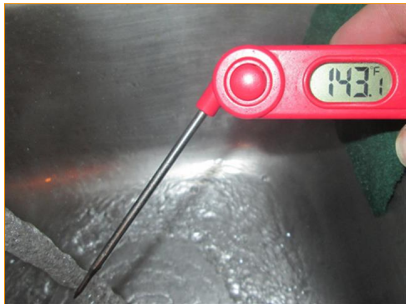
C. Item 1(Picture)

(1) The hot water temperature is set too high, creating a risk of scalding. The Consumer Product Safety Commission recommends that water heaters be set at 120° F.

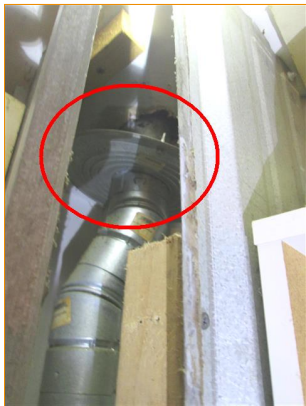
C. Item 3(Picture)

(3) The ceiling collar needs to be secured at the water heater vent.

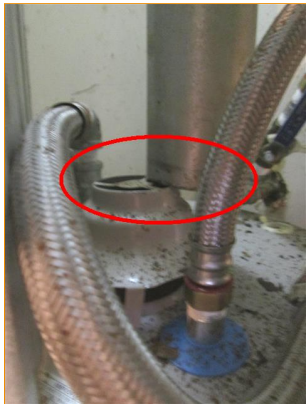
C. Item 4(Picture)

(4) The exhaust vent was not secured to the draft diverter at the top of the water heater. This will allow exhaust gases to enter the home. Recommend immediate repair by a licensed plumber.

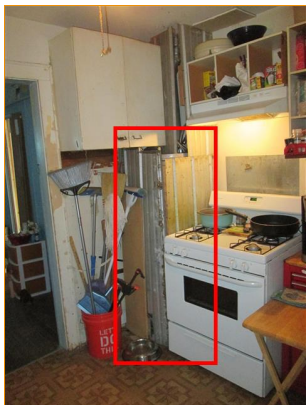
C. Item 5(Picture)

(5) The water heater was not accessible for complete inspection.
