# PROPERTY INSPECTION REPORT

Concerning: 1400 Winstead Ln. Austin, TX  
(Address or Other Identification of Inspected Property)

By: Bill Durtschi 2612 2/20/2019  
(Name and License of Inspector) (Date)

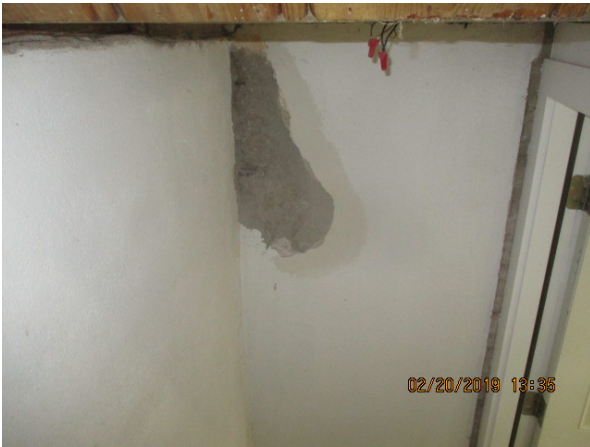
- The concrete foundation wall at the garage stairwell is damaged.
- The access opening to the pier/beam foundation crawl space is blocked with metal air ducts and therefore the pier/beam foundation could not be inspected. Recommend an access opening be created and a qualified technician inspect the area and all components of the crawl space.

Damaged concrete foundation wall in the garage stairwell

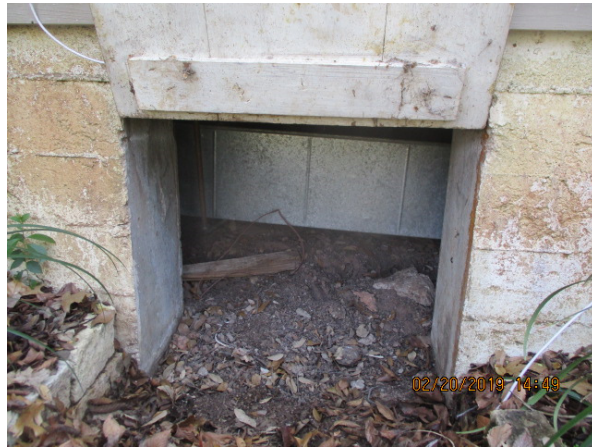
Access to the foundation pier/beam foundation crawl space is blocked by air ducts.

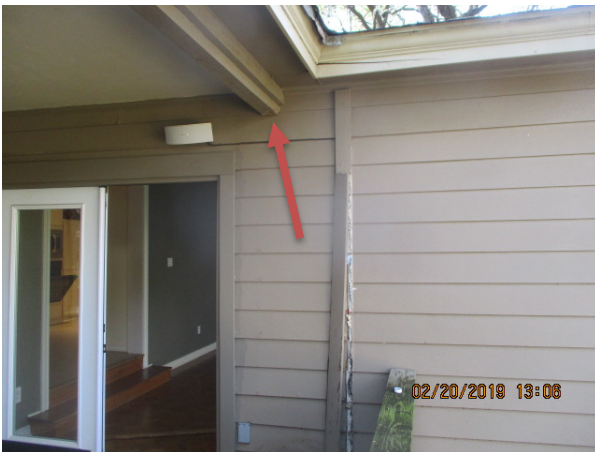
- A support post is missing (removed) from underneath a patio canopy ceiling beam, the patio canopy has partially collapsed.
- The attic is not properly vented for air flow; the roof eaves do not contain air vents.
- The attic scuttle cover in the master bedroom and upstairs hallway are not insulated.
- The R-value of the insulation is R-19, less than the recommended R-38 value, and is missing at various areas.

A support post is missing under this patio canopy ceiling beam. Notice the crack in the fascia board above due to partial collapse of the canopy.

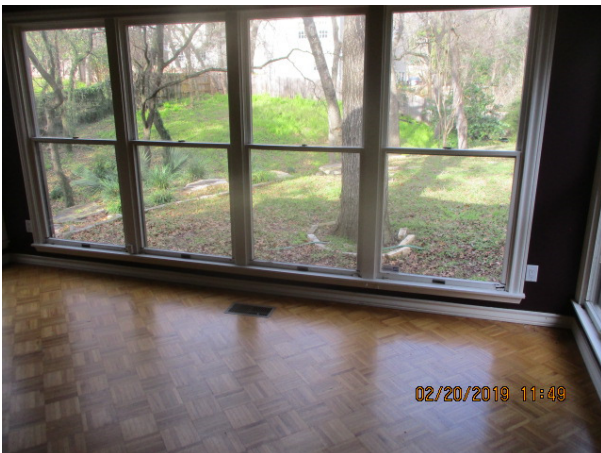
- There is evidence of rain water having leaked around the window case in the family room back wall, around the window case in the side wall of the formal dining room, and the window case in the master bedroom (Note: It is common for there to be water damage to the concealed wall framing around doors and windows that leak water. The amount of damage, if any, cannot be determined without opening the wall cavities for inspection. Also, see the WINDOWS comments below regarding these window case).

- The window case and the wood windows sash in the family room back wall and in the formal dining room side wall have considerable water damaged.
- The wood window sash in the upstairs front left bedroom and upstairs back bedroom are water damaged.
- In the upstairs right front bedroom, the window sash in the vinyl windows are not properly aligned and do not lock.
- One window sash in the master bedroom has defective balance springs.
- Many of the wood window sash in the house do not open.
- Screens are not installed on the windows.

Photo of the window case in the family room back wall. Like the dining room windows, there is considerable water damage to the window case and most window sash.

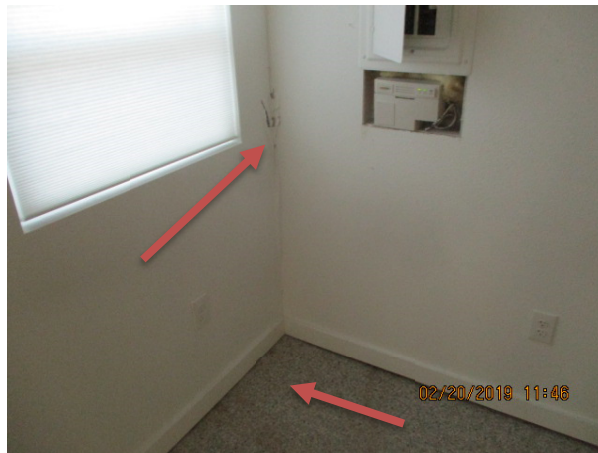
- The exterior paint on wall siding, trim and decorative shutters have deteriorated.
- There is evidence of runoff water from the backyard having penetrated the garage and stairwell foundation walls (indicating insufficient moisture barrier on the walls).

Water stains on the garage floor and blistered wall paint due to water having leaked through the garage wall.

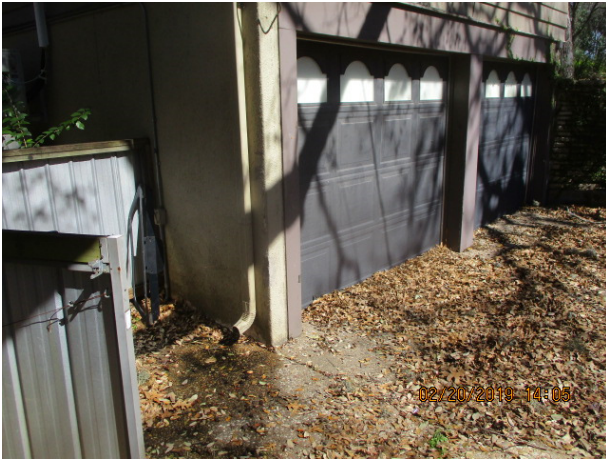
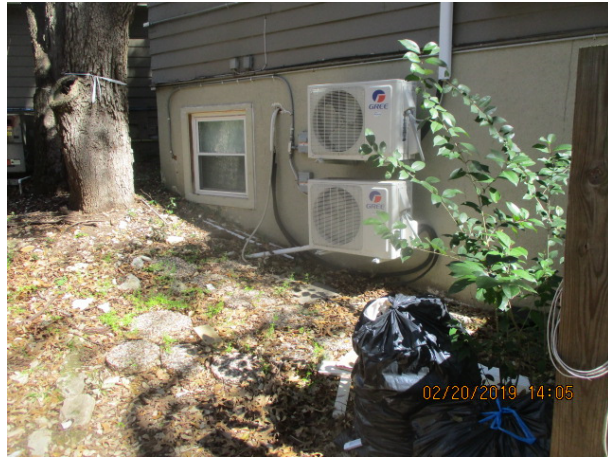
- The stucco and wood exterior wall siding on the garage walls does not have proper clearance from the soil and/or solid concrete surfaces (Note: Exterior wall siding with insufficient clearance is susceptible to insect infestation and water penetration into the wall cavities). Holes in the stucco siding are not properly sealed.

Two photos of the stucco and wood siding on the garage that does not have proper clearance from the soil and concrete surface.

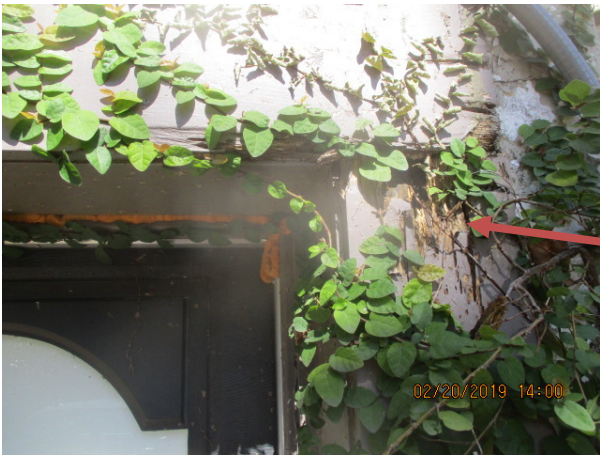
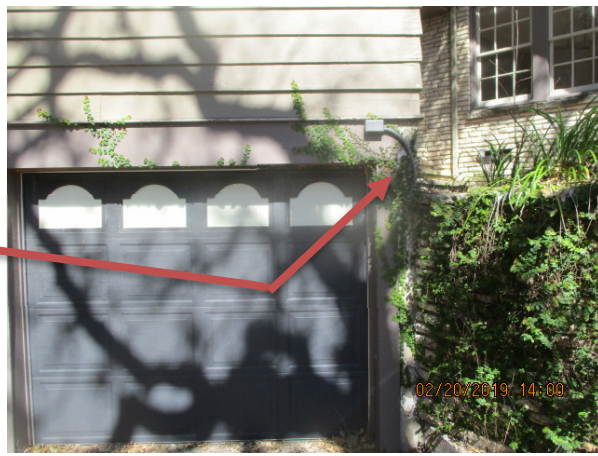
- There is evidence of rain water having leaked into the garage wall cavity around the auto entries, the exposed wall framing at both upper corners of the auto entries is damaged (The extent of damage to the wall structure cannot be determined without opening the wall cavity).

A close up and distant photo of the exposed wall framing at the upper right corner of the garage opening that is water damaged.

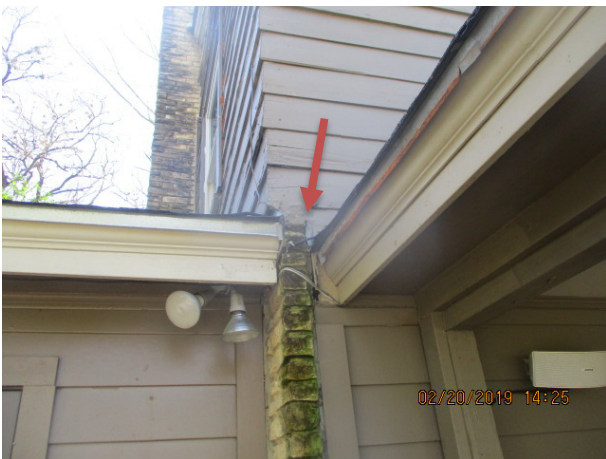
- There is evidence of rain water having leaked into the mud room (next to the downstairs guest bathroom) wall cavity, the exposed wall framing is water damaged (The extent of damage to the wall structure cannot be determined without opening the wall cavity).

Exposed wall framing on the mudroom back wall is water damaged, partially due to improper installation of the roof flashing above.

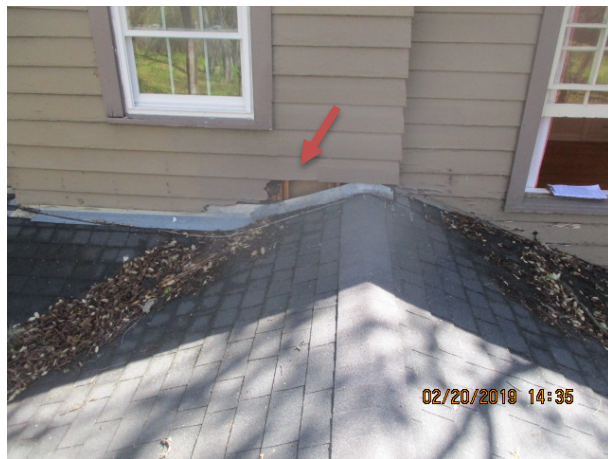
- The exterior wall lap siding (both wood and press board type), trim and wood drip ledges are damaged at many and various areas of the house and garage.

One of damaged areas of the exterior wall siding.

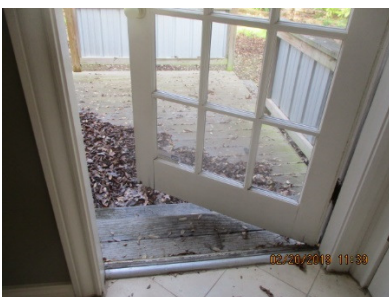
- The mud room exterior door is water damaged.
- The glass panes in all exterior doors are not labeled as safety/tempered type panes.
- Hardware (tracks, springs and rollers) are missing from both garage over head doors, the doors will not open.

The mud room back door is water damaged.

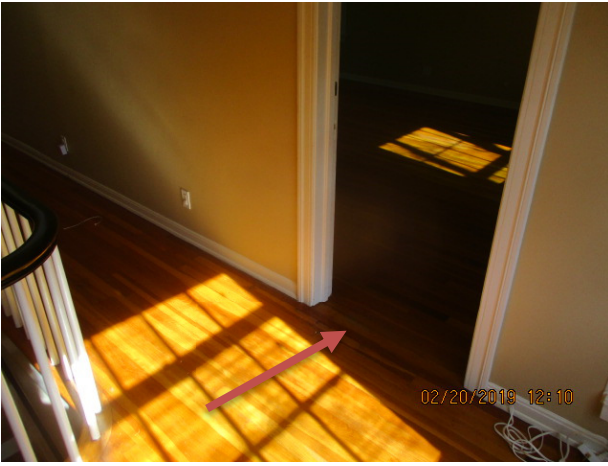
- The floor deflection at the door entry of the upstairs front right corner bedroom (green color walls) and stress marks in the floor covering indicating insufficient support of the floor structure at this area.
- The wood floor structure is not insulated.
- The furdow in the garage stairwell is less than 6ft. 8in. above the stairway steps.

There is a noticeable floor deflection at the entry of the upstairs front right side bedroom due to apparent insufficient floor support.

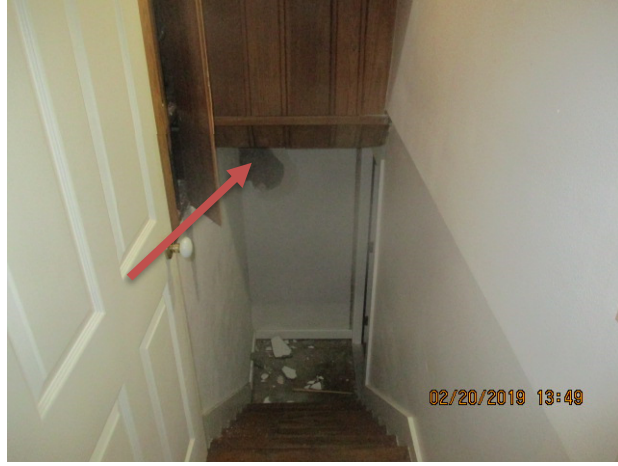
The furdown in the stairwell ceiling is too low.

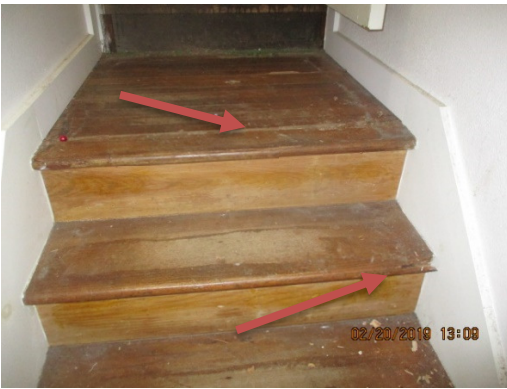
- Two of the wood treads on the garage steps are damaged (Note: The damage appears to be insect related, therefore the concealed members of the wood stairway may contain additional damage).

Insect damage to the stairway step treads.

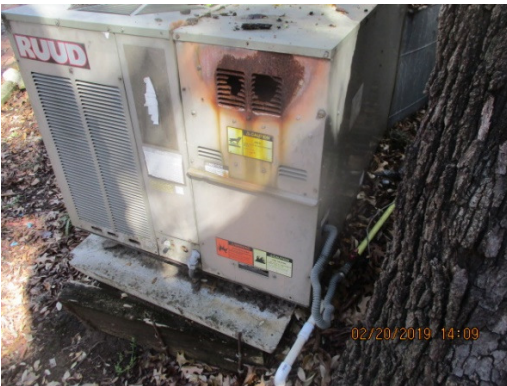
- The exterior gas furnace dedicated to the family room has considerable heat damage at the exhaust grill (Possibly due to a defective heat exchanger inside the furnace which is a carbon monoxide hazard).

Heat damage to the family room gas furnace.

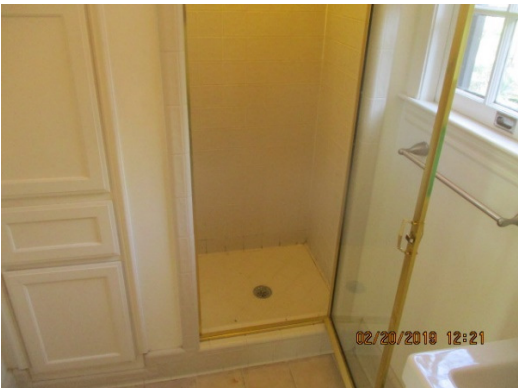
- Water leaks from the master bathroom shower stall (typically due to a defective shower pan), the lower course tiles in the shower stall are loose.
- Water pressure to the house is too high at 90 PSI.

Water leaks from the master bathroom shower stall.
