PROPERTY INSPECTION REPORT

Prepared for: Shailene Smith
(Name of Client)

Concerning: 1400 Winstead Ln. Austin, TX
(Address or Other Identification of Inspected Property)

By: Bill Durtschi 2612 2/20/2019
(Name and License of Inspector) (Date)

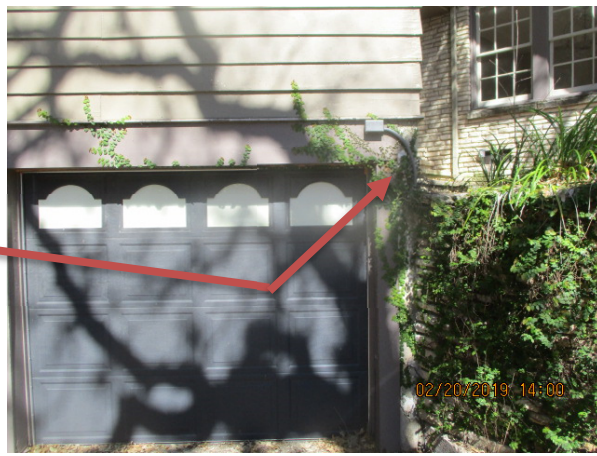
- There is evidence of rain water having leaked into the garage wall cavity around the auto entries, the exposed wall framing at both upper corners of the auto entries is damaged (The extent of damage to the wall structure cannot be determined without opening the wall cavity).

A close up and distant photo of the exposed wall framing at the upper right corner of the garage opening that is water damaged.

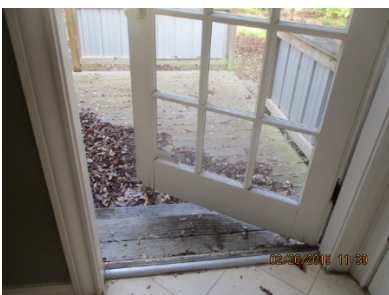
The mud room back door is water damaged.

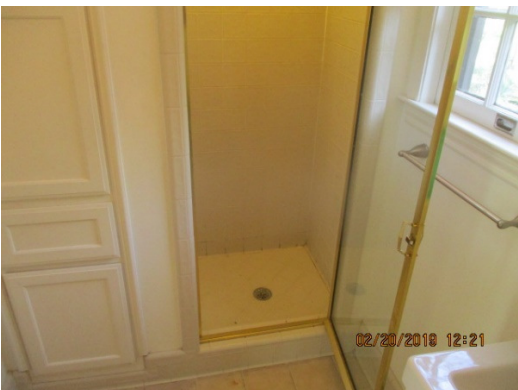
- Water leaks from the master bathroom shower stall (typically due to a defective shower pan), the lower course tiles in the shower stall are loose.
- Water pressure to the house is too high at 90 PSI.

Water leaks from the master bathroom shower stall.
