507 W 17th Street

Permit for Demolition

Engineer Judgment on Structurability

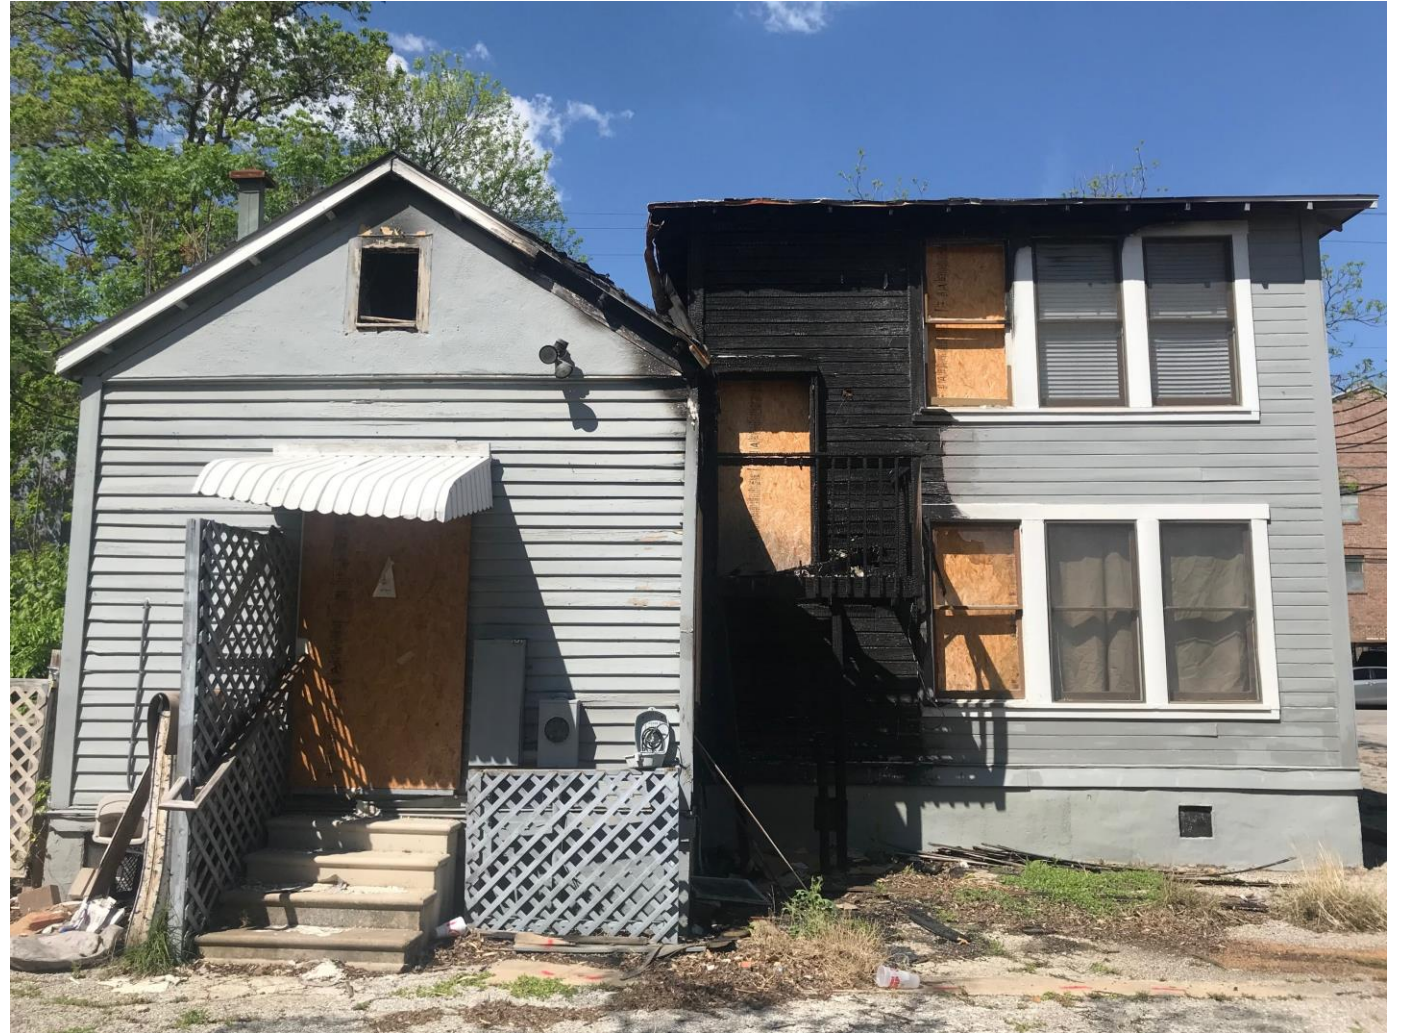
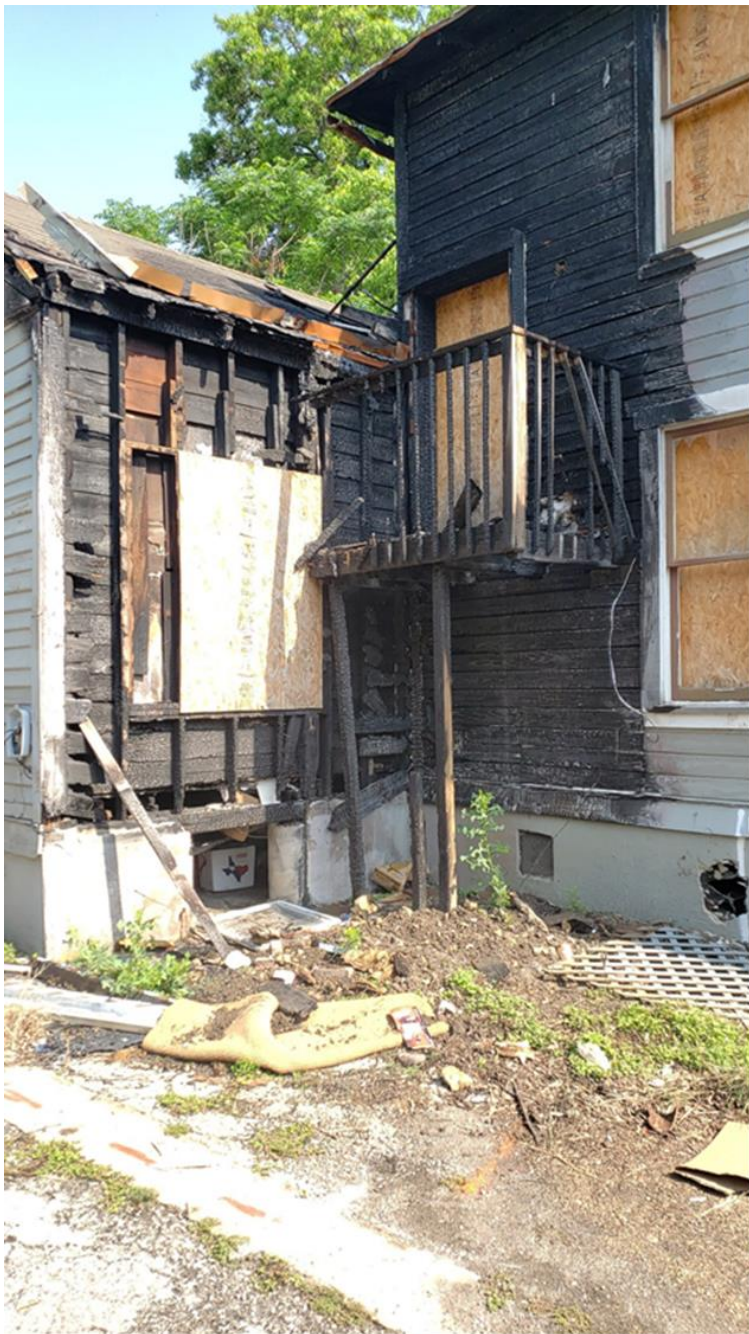
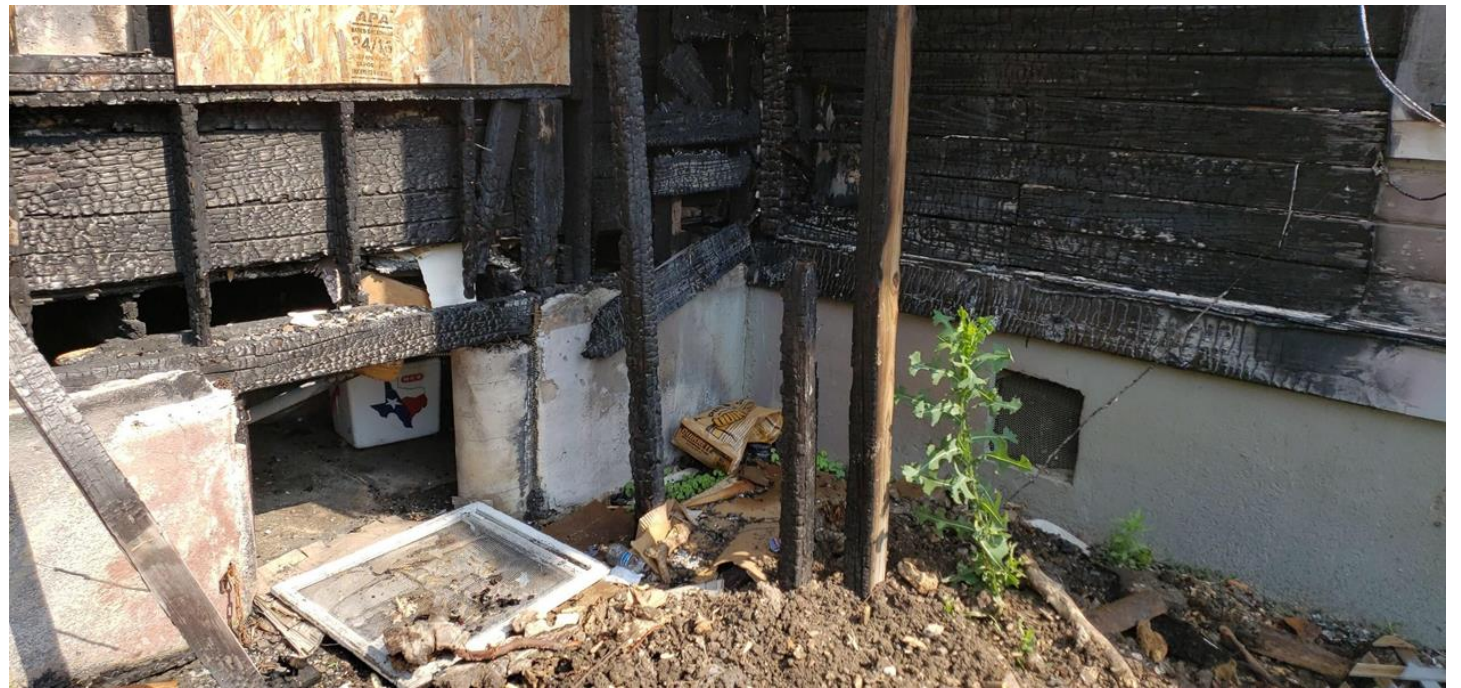
Exterior Fire Damage

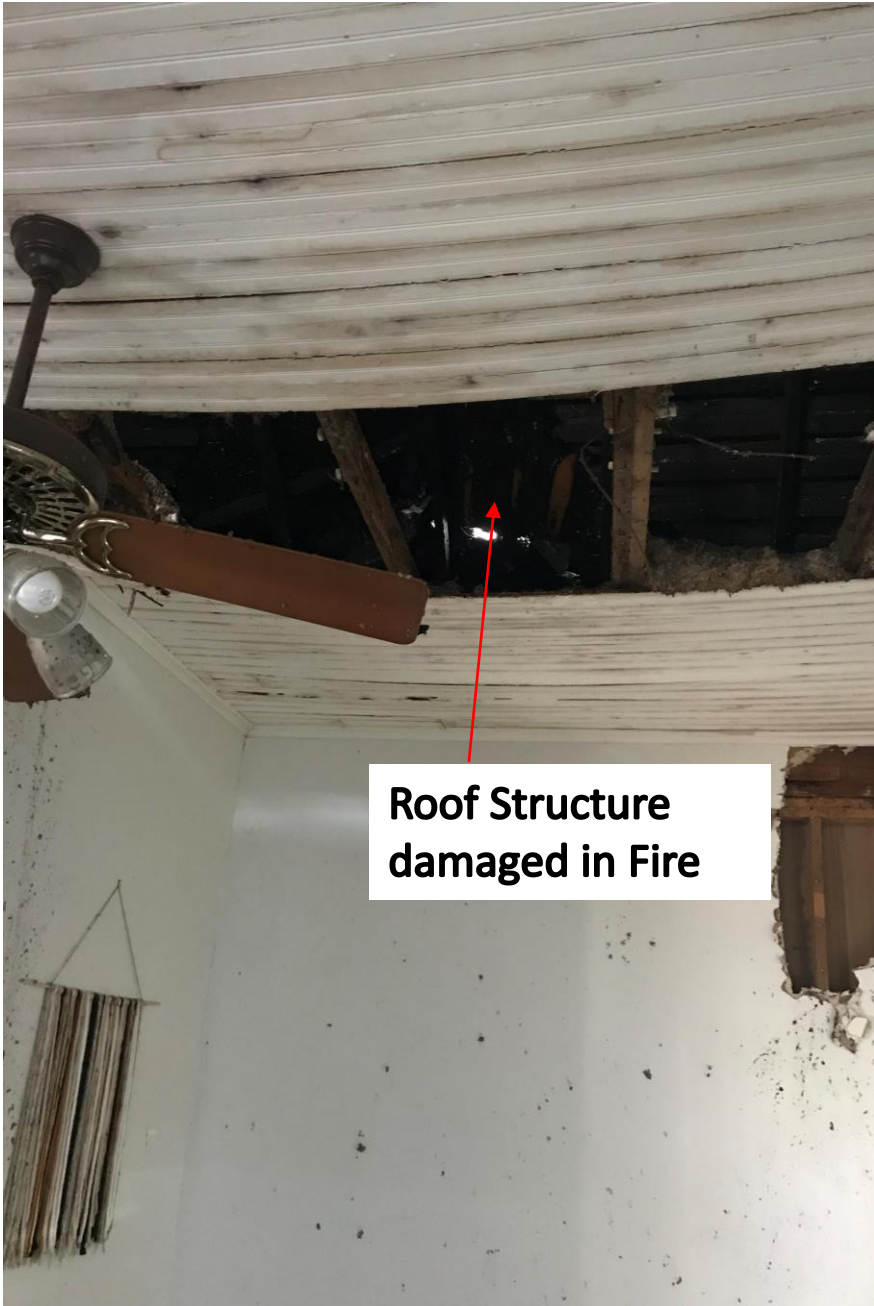
Interior Mold & Fire Damage

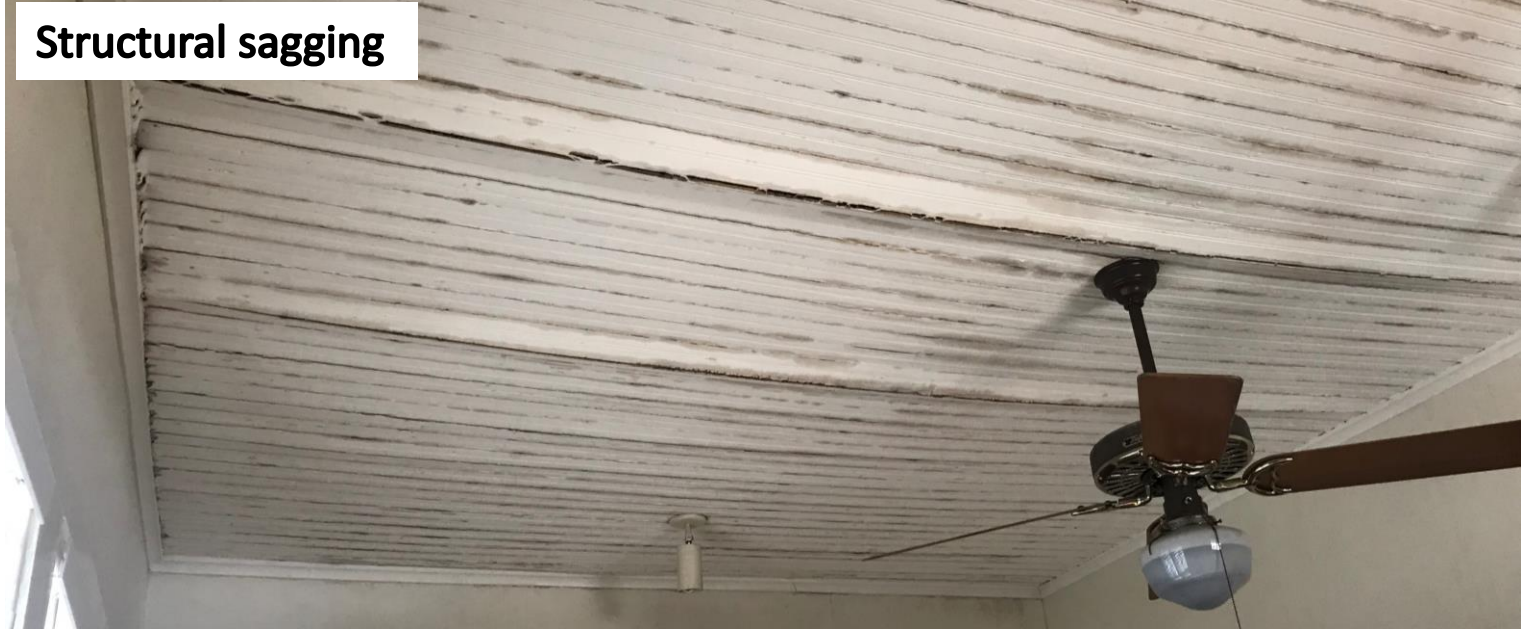
**Roof Structure
damaged in Fire**

Structural sagging

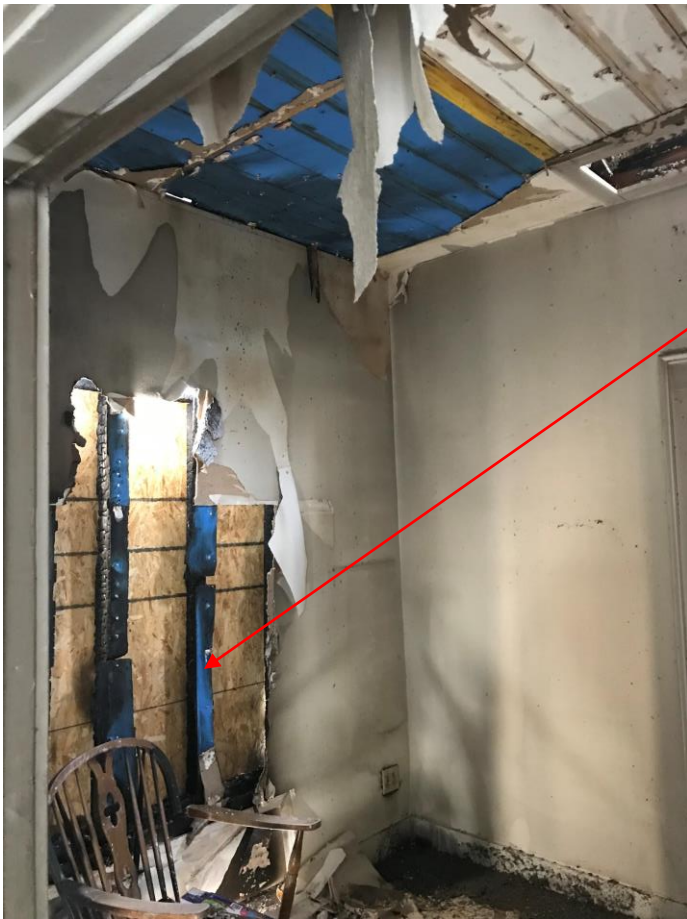
Interior Structural Damage- Sagging Roof Joists

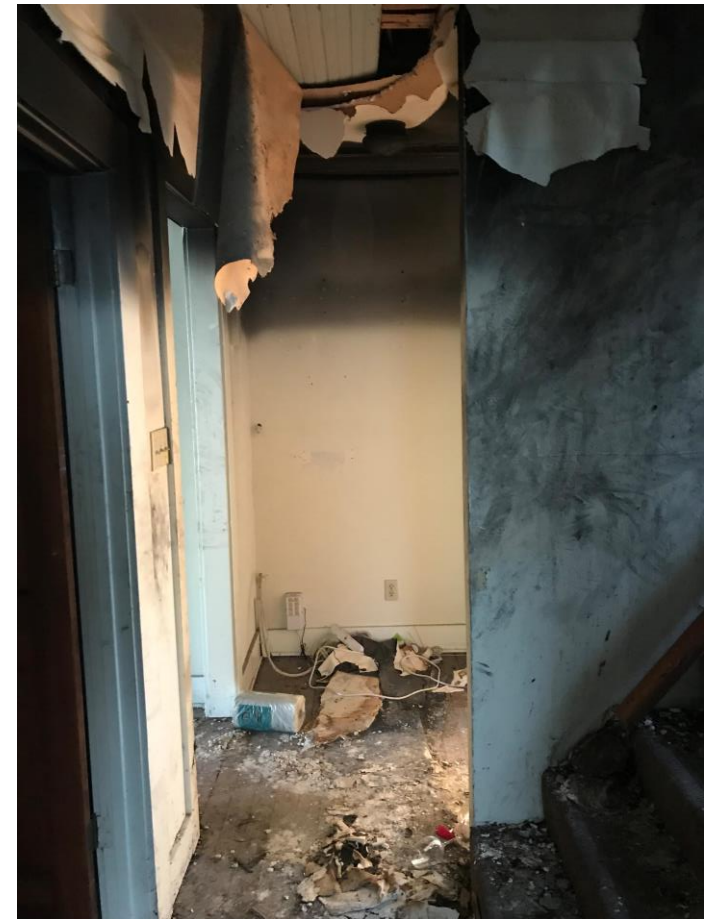
Structural
unsupporte
d Studs
