# BARTON SPRINGS POOL TURBIDITY EVENT December 2018

City of Austin/Environmental Commission

June 19, 2019

City of Austin/Watershed Protection Department

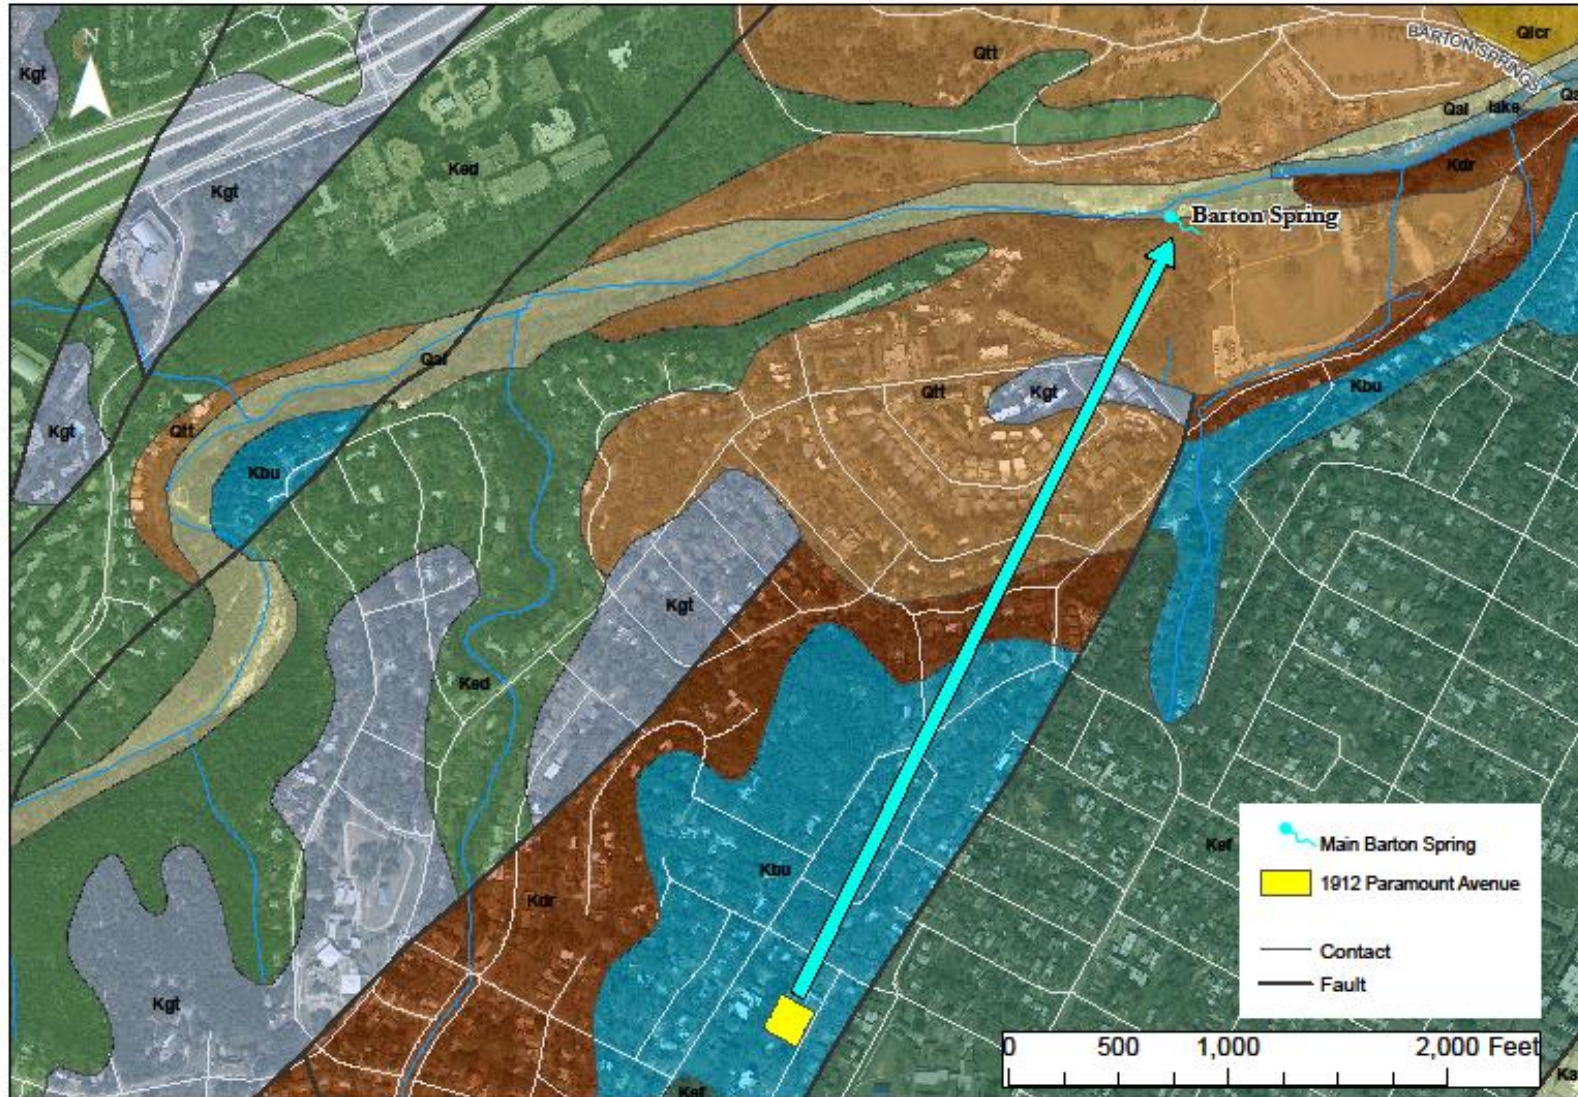
Barton Springs Turbidity Event: Approximate Flow Path

Approximate Travel Distance: 4,000 Feet
