EXTERIOR

ELEVATIONS

1 EAST ELEVATION

ASI-06

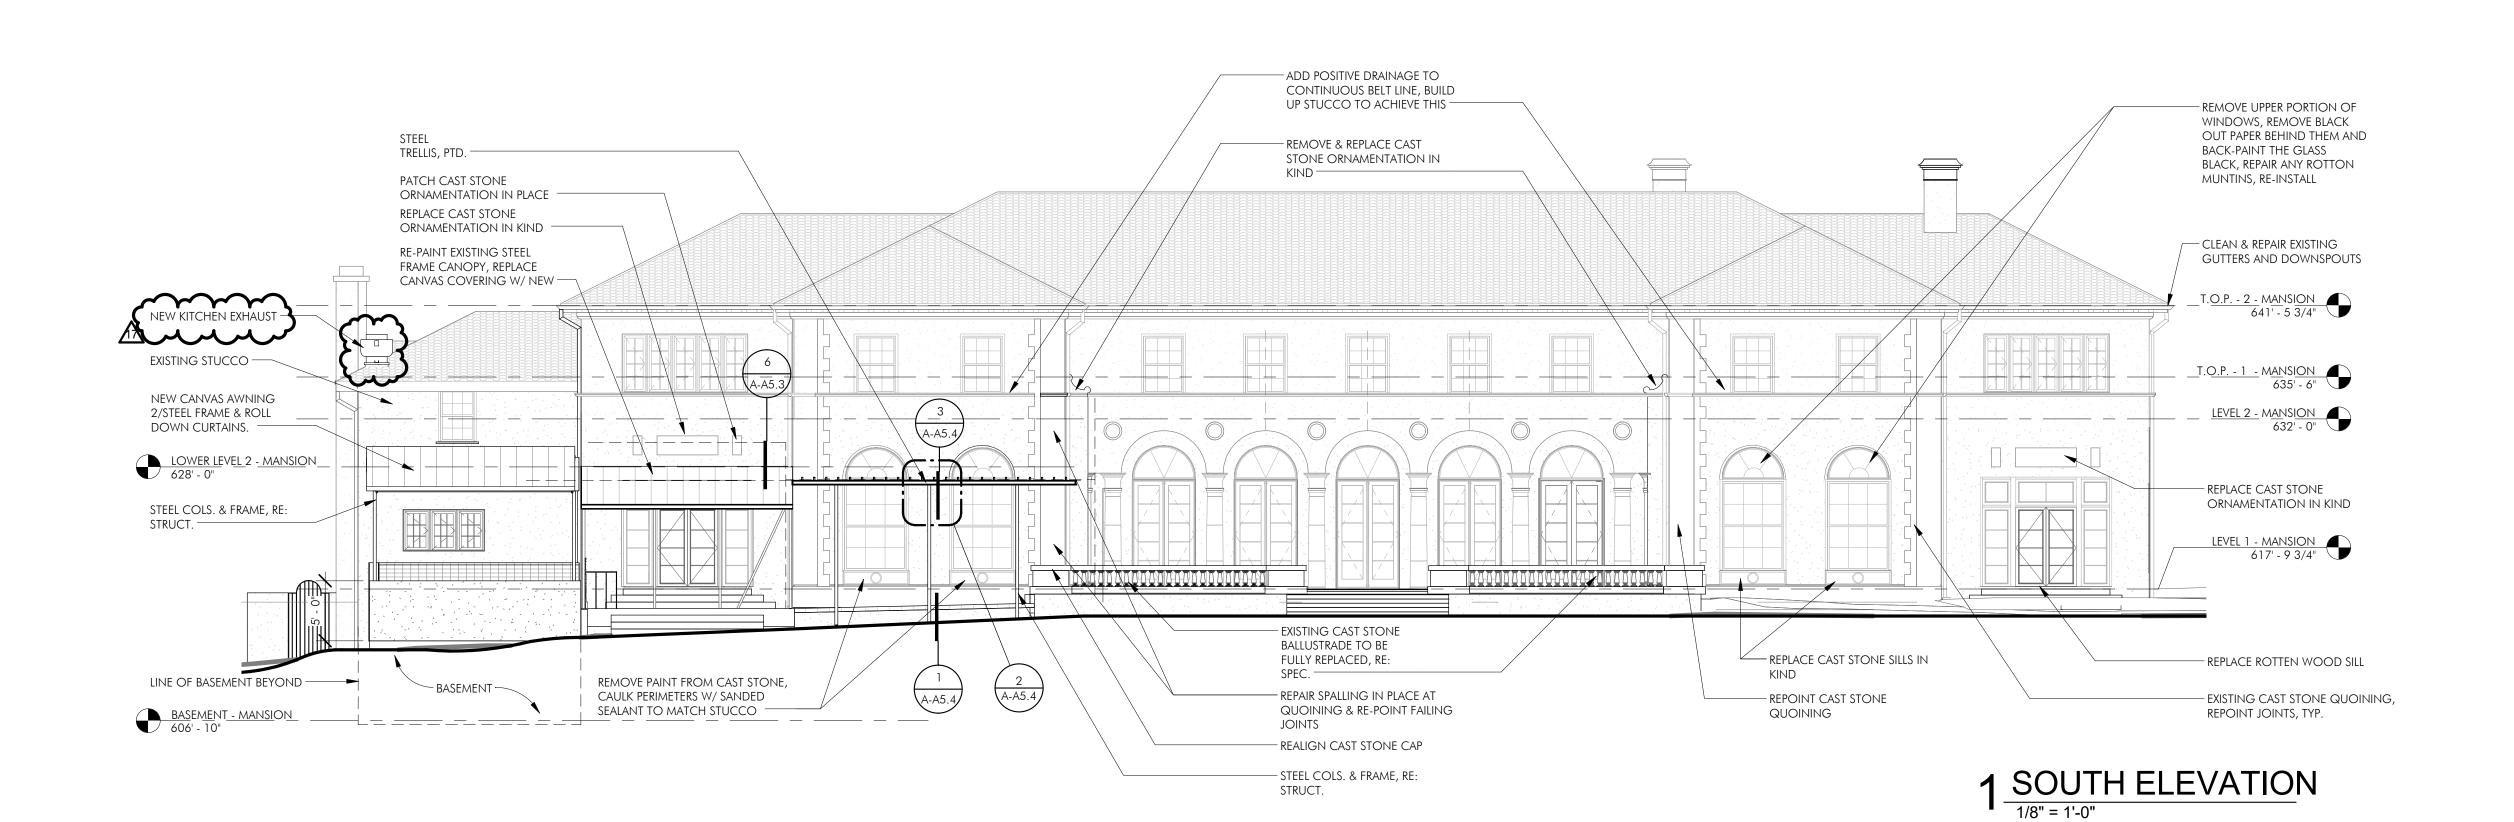
- CAST STONE QUOINING NEEDS RE-POINTING

REPOINT ALL JOINTS AT CAST

STONE MASONRY UNITS,

REPLACE CAST STONE

ORNAMENTATION TO

REPLACE CRACKED CASTSTONE

UNDER WINDOWS, RE: SPEC.

MATCH —

REPAIR SPALLING IN PLACE AT QUOINING & RE-POINT FAILING

JOINTS —
