2019-038373 PR--1903 New York Ave

RE: Demo Permit Application Pics/Notes Pertaining to Condition & Architectural factors diminishing historical value/significance of the structure.

Key Considerations/Factors: Exterior Wall Materials Replaced, Windows Replaced, Doors Replaced, Porch Altered

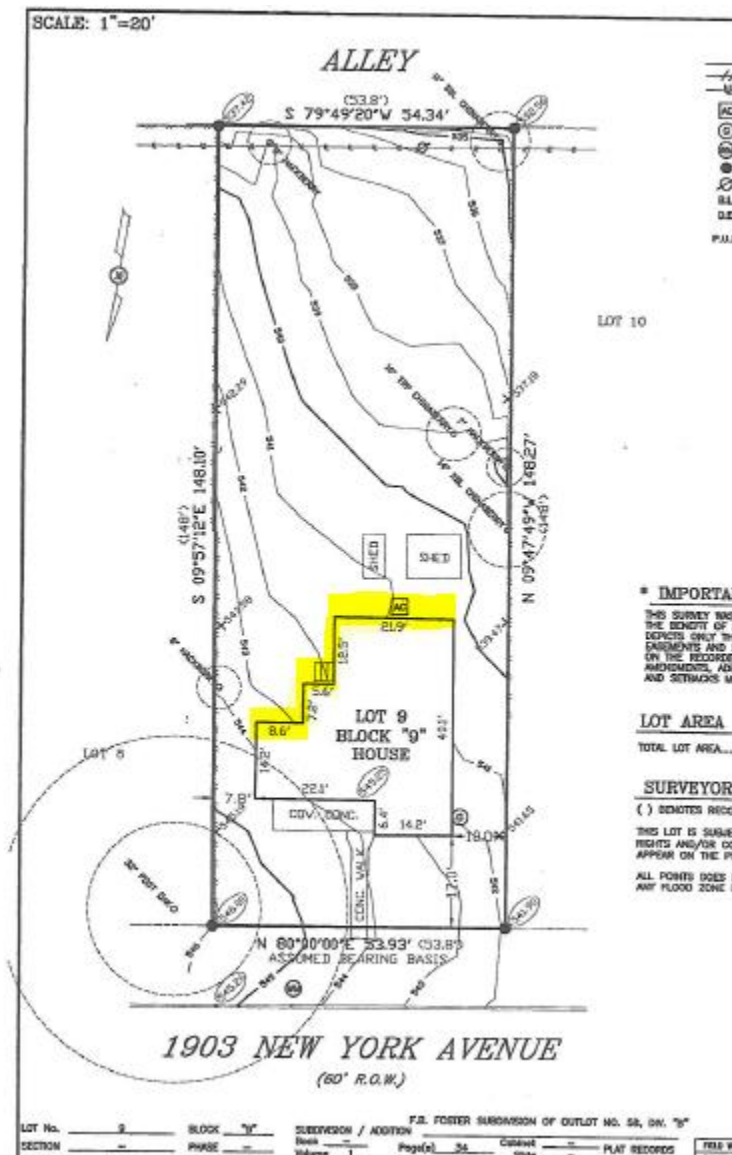
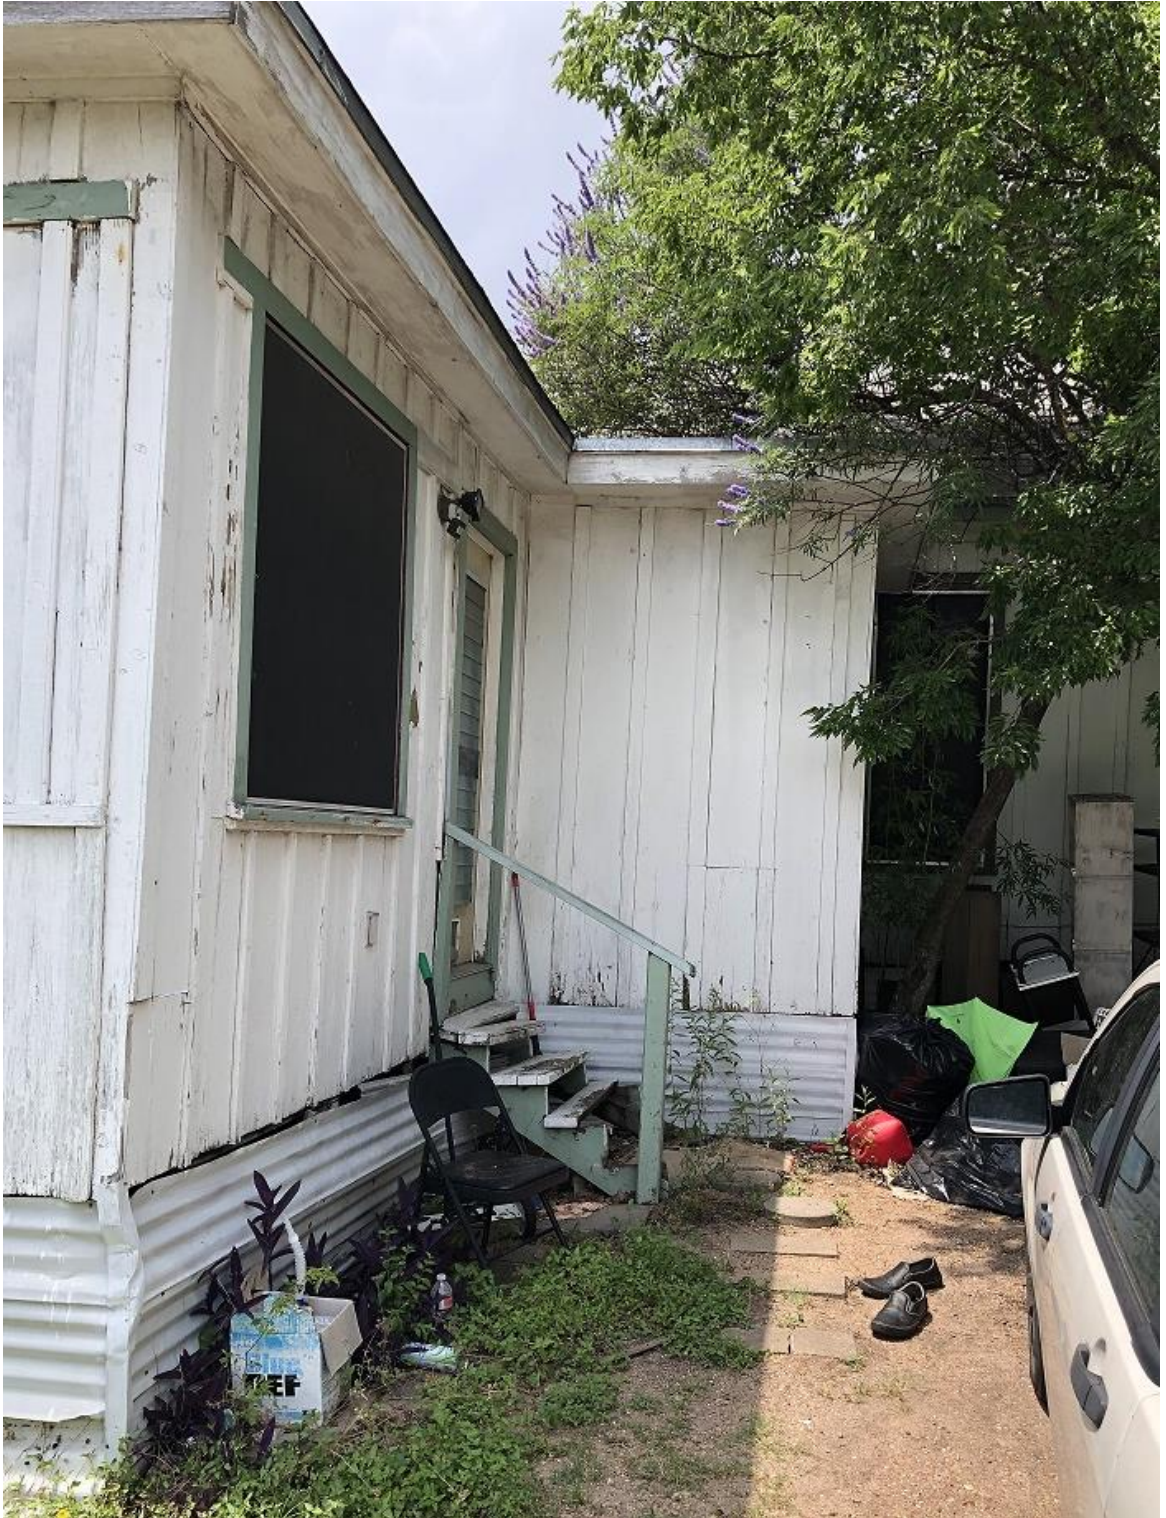
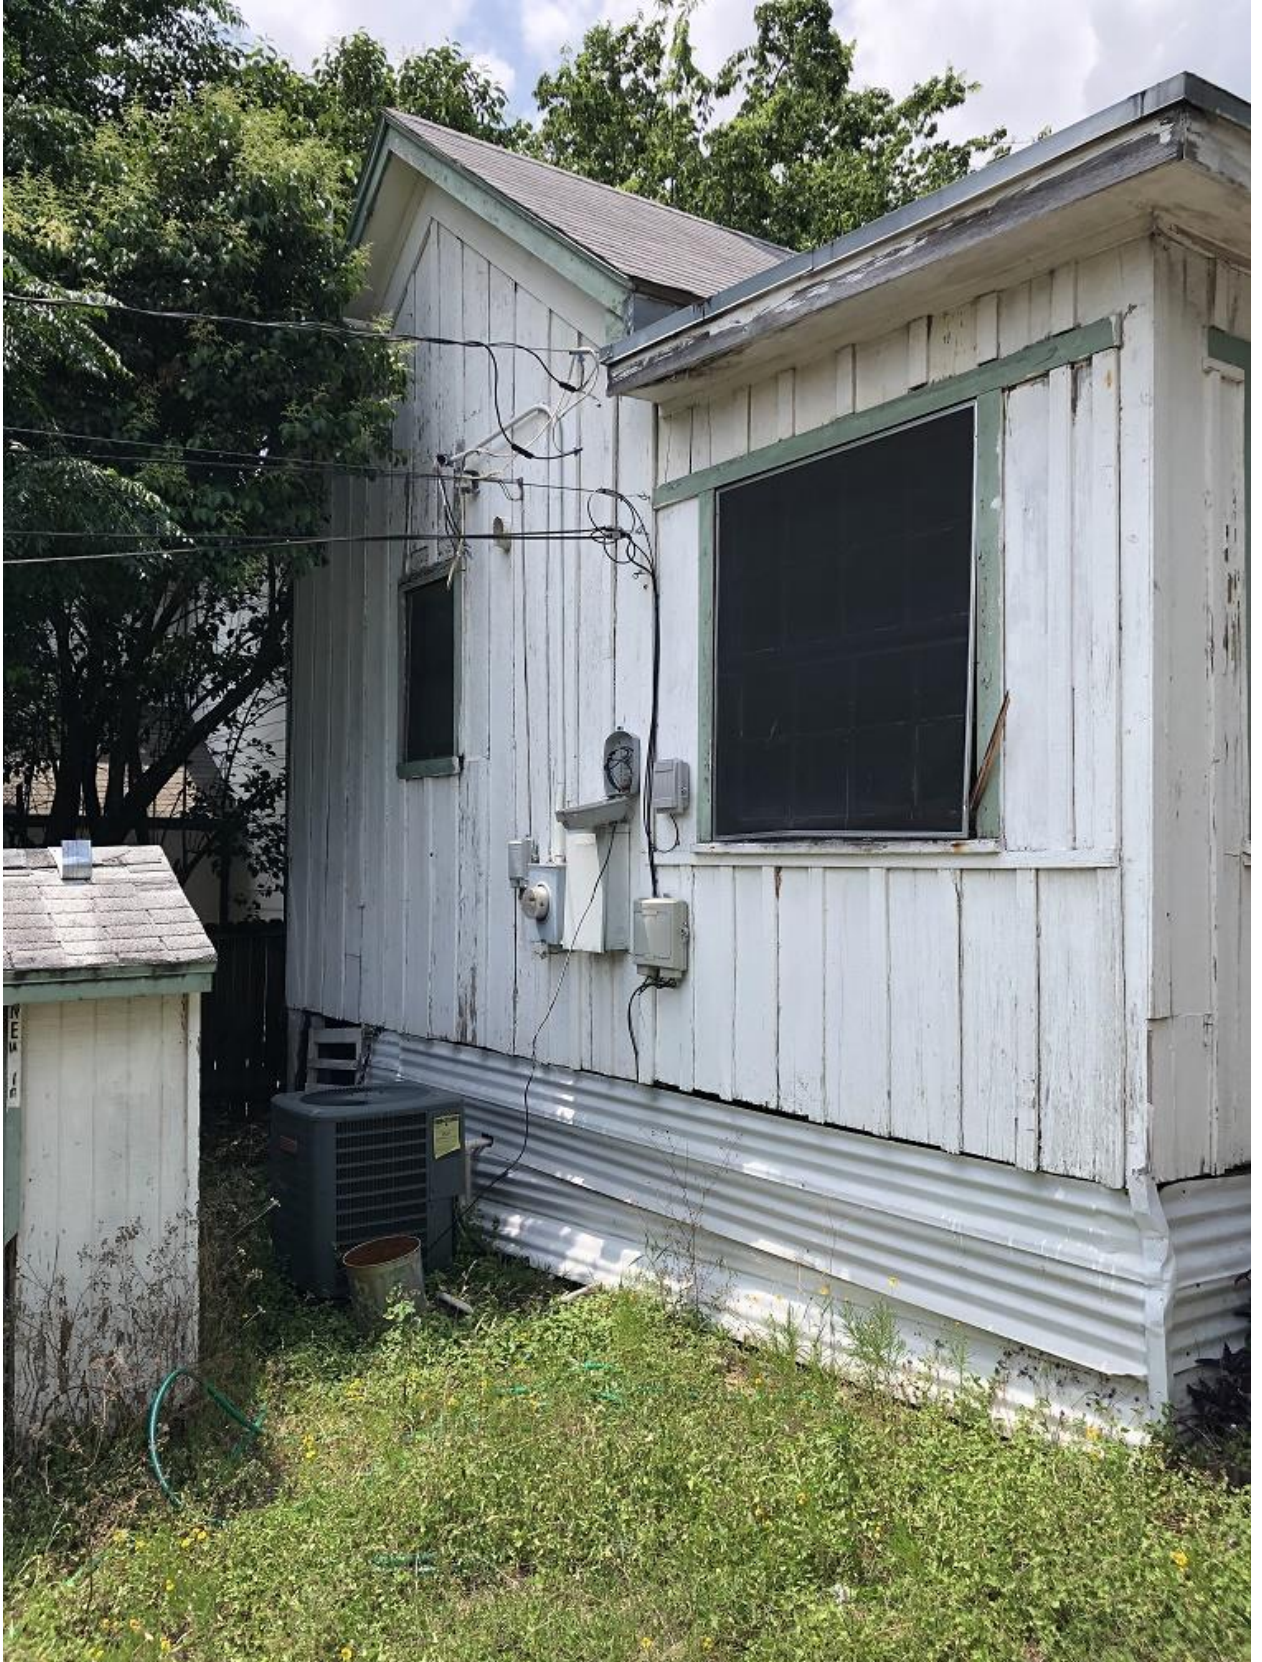
1. Of the 152 linear feet of total siding on residence, 56 linear foot of siding at the sides/rear of the house was replaced with non-matching siding. This is 37% of siding on the house. See survey indicating locations & corresponding images. This work appears to have been done in 1980 under a Remodel Permit on file.

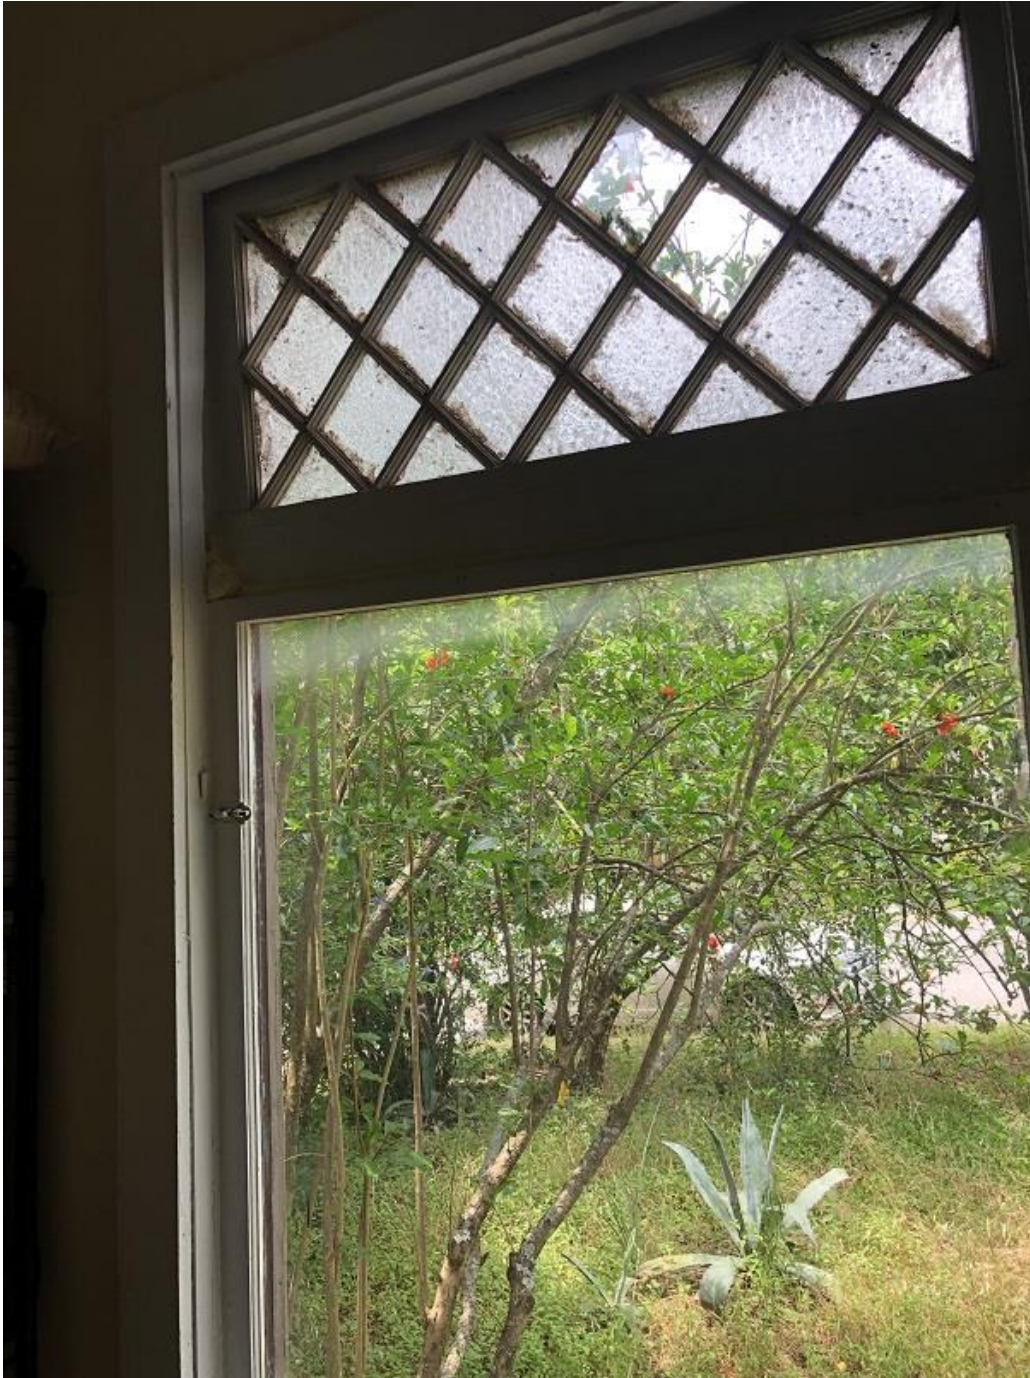
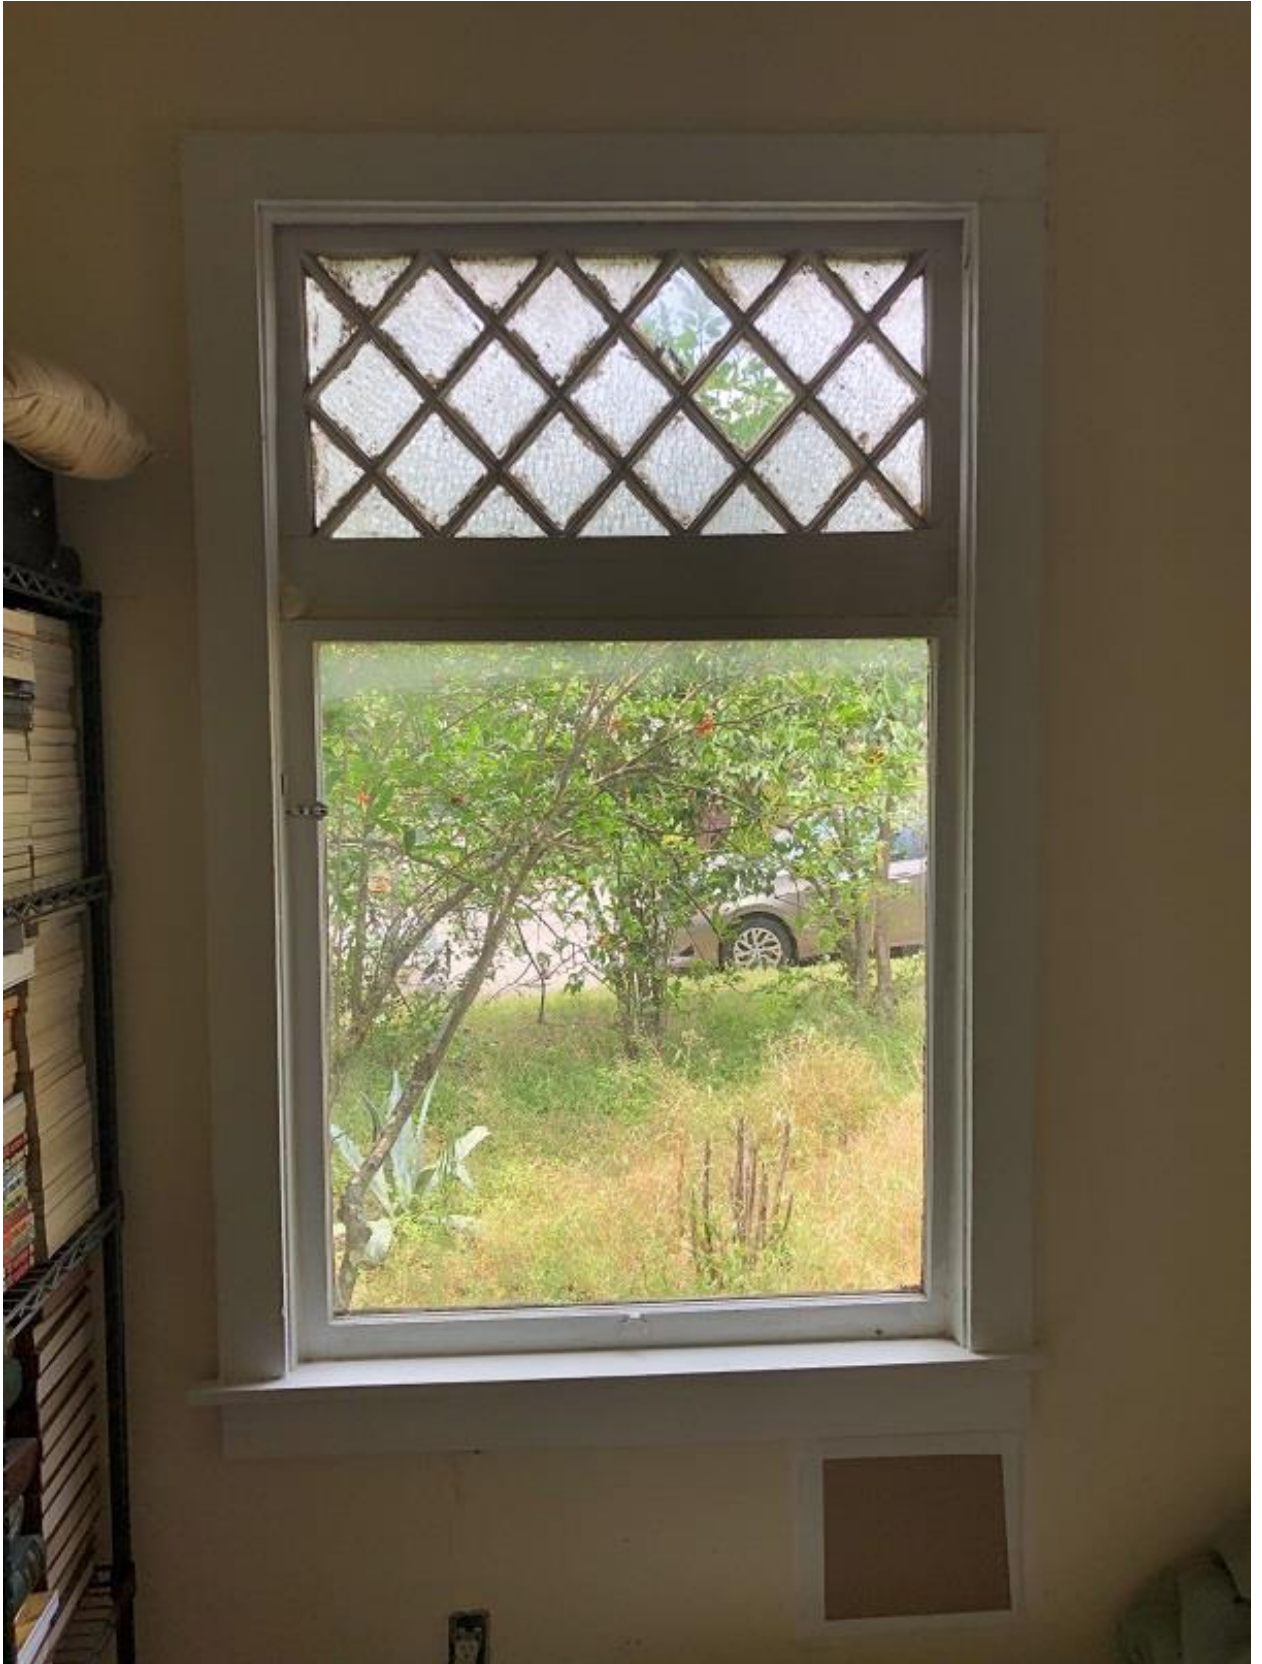
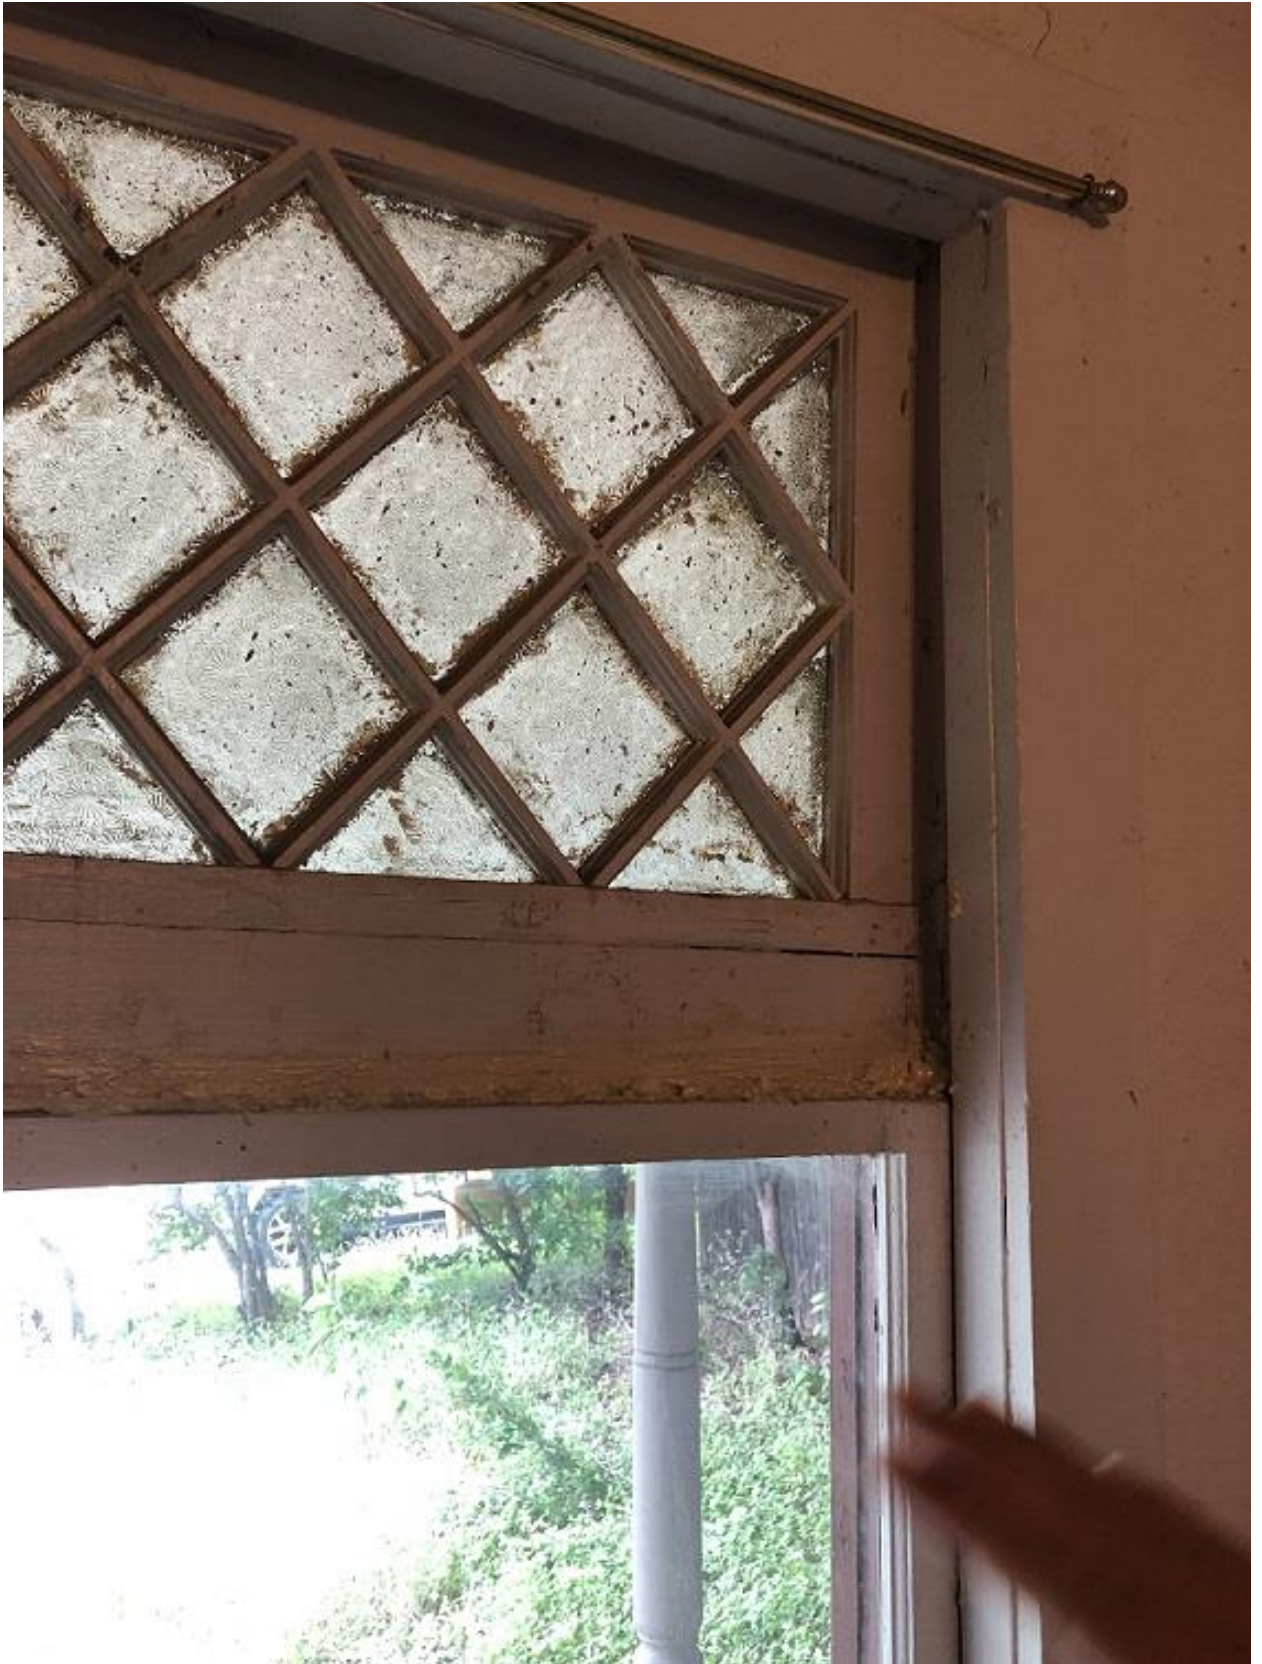
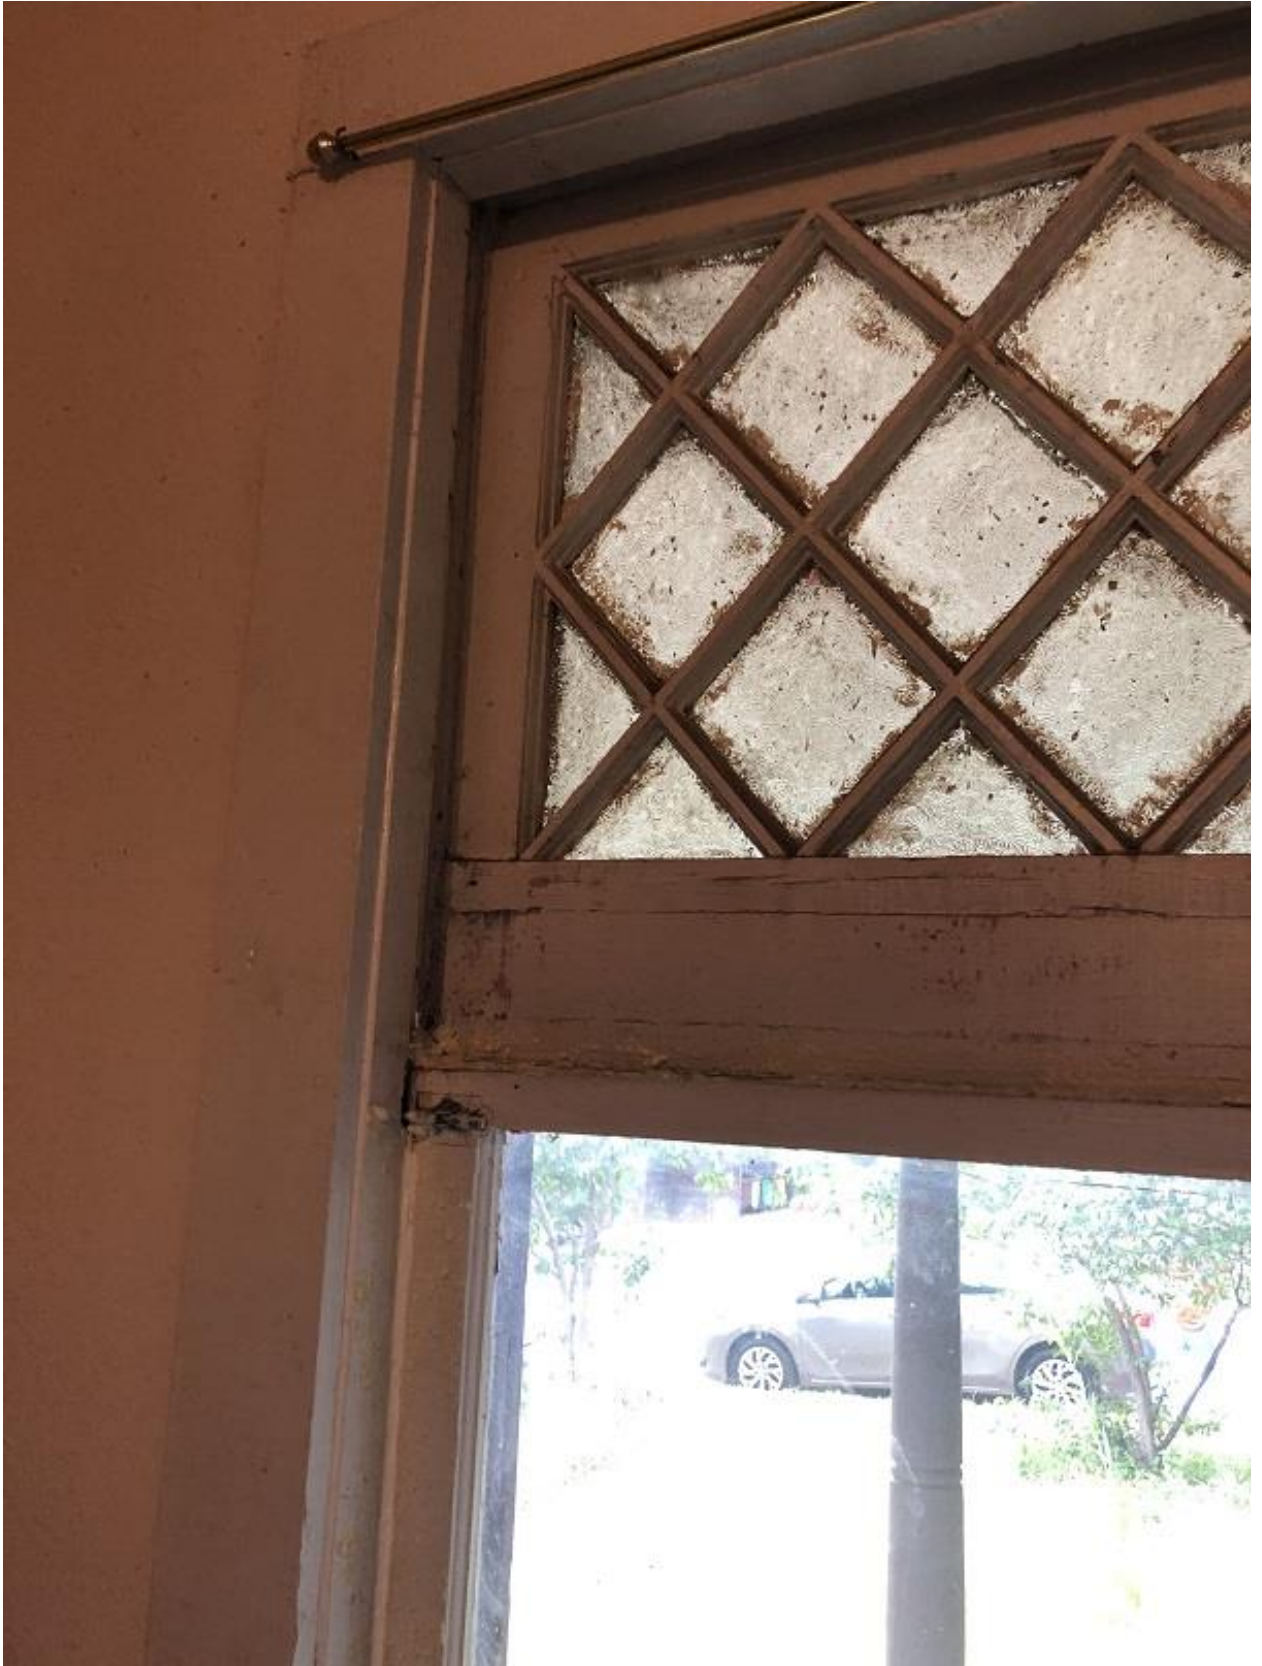
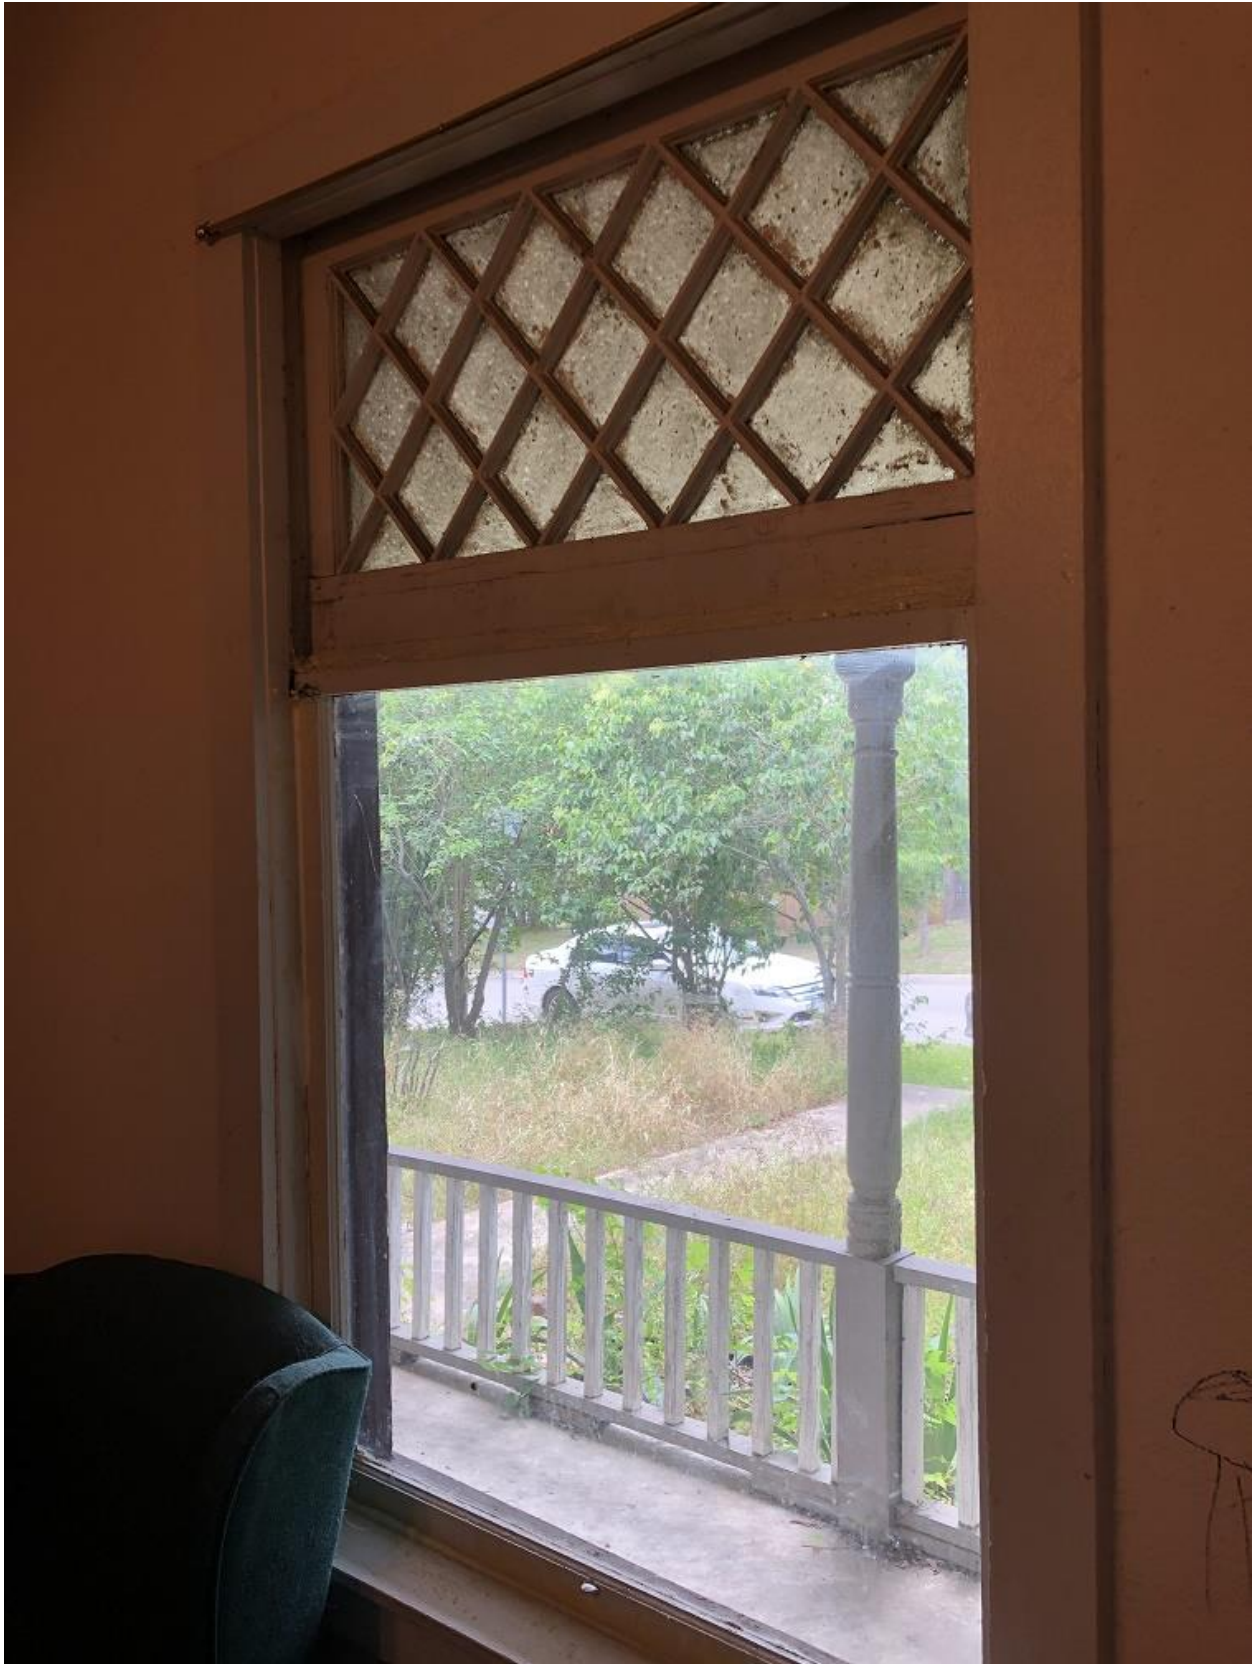
2. "Faux Victorian" Front windows are NOT original and not placement/locations are not consistent with period of significance-- replaced with mismatched sashes from other windows. These are windows are non-operable and screwed in place with pieces of filler wood and trim to fill in gaps.

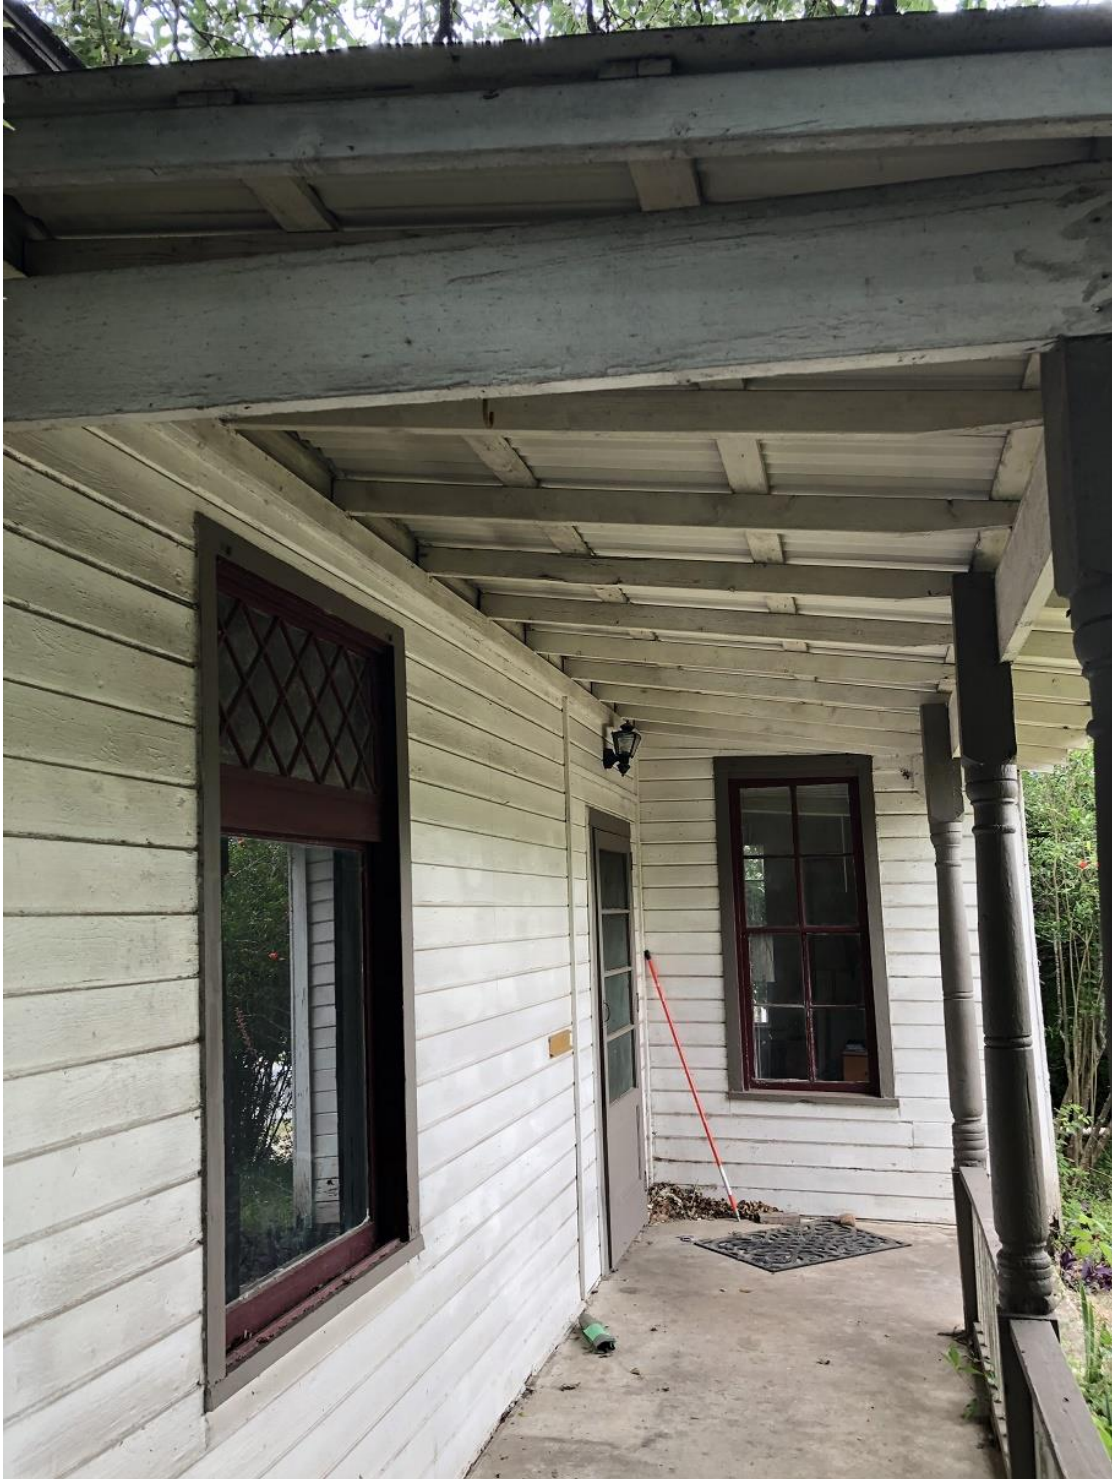
3. Front Porch has been altered & reconstructed with modern-day materials, likely in conjunction with other remodeling per the 1980 Remodeling Permit

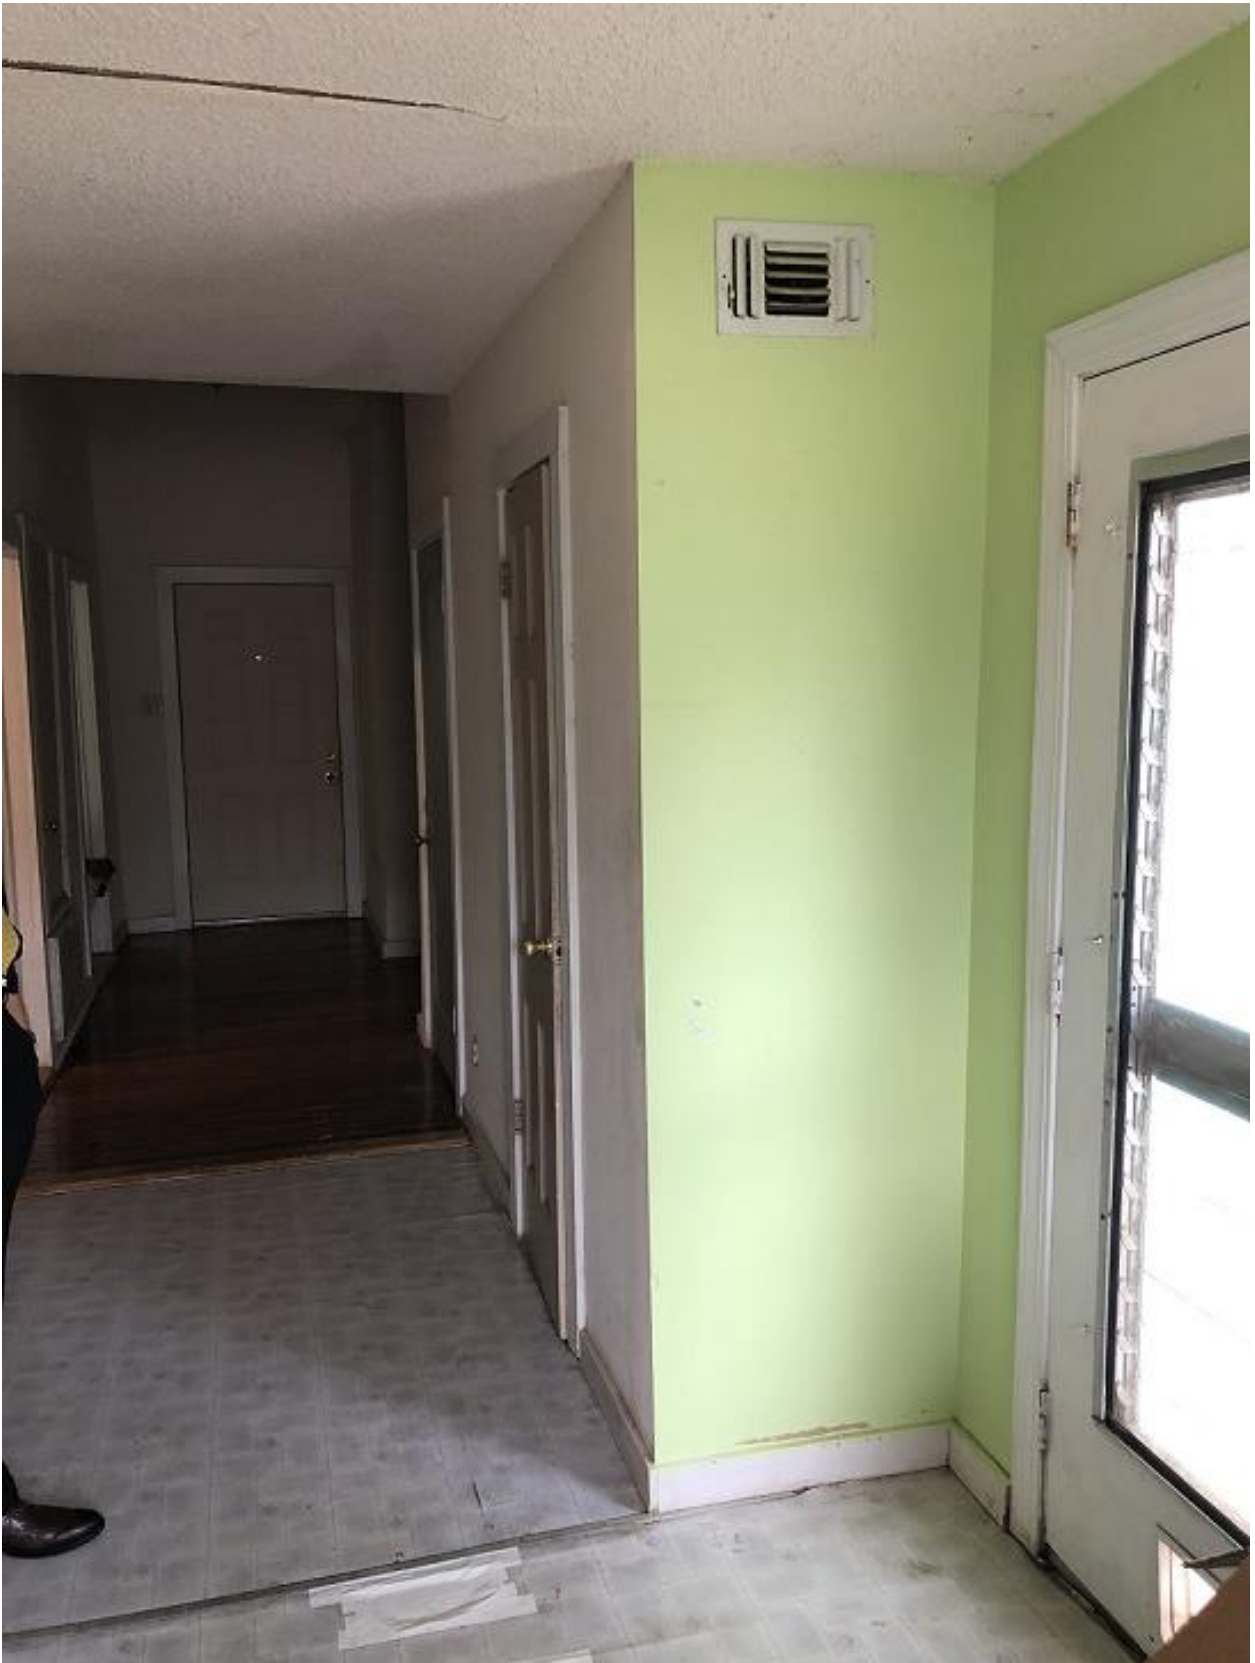
4. Front & Rear Doors not original-

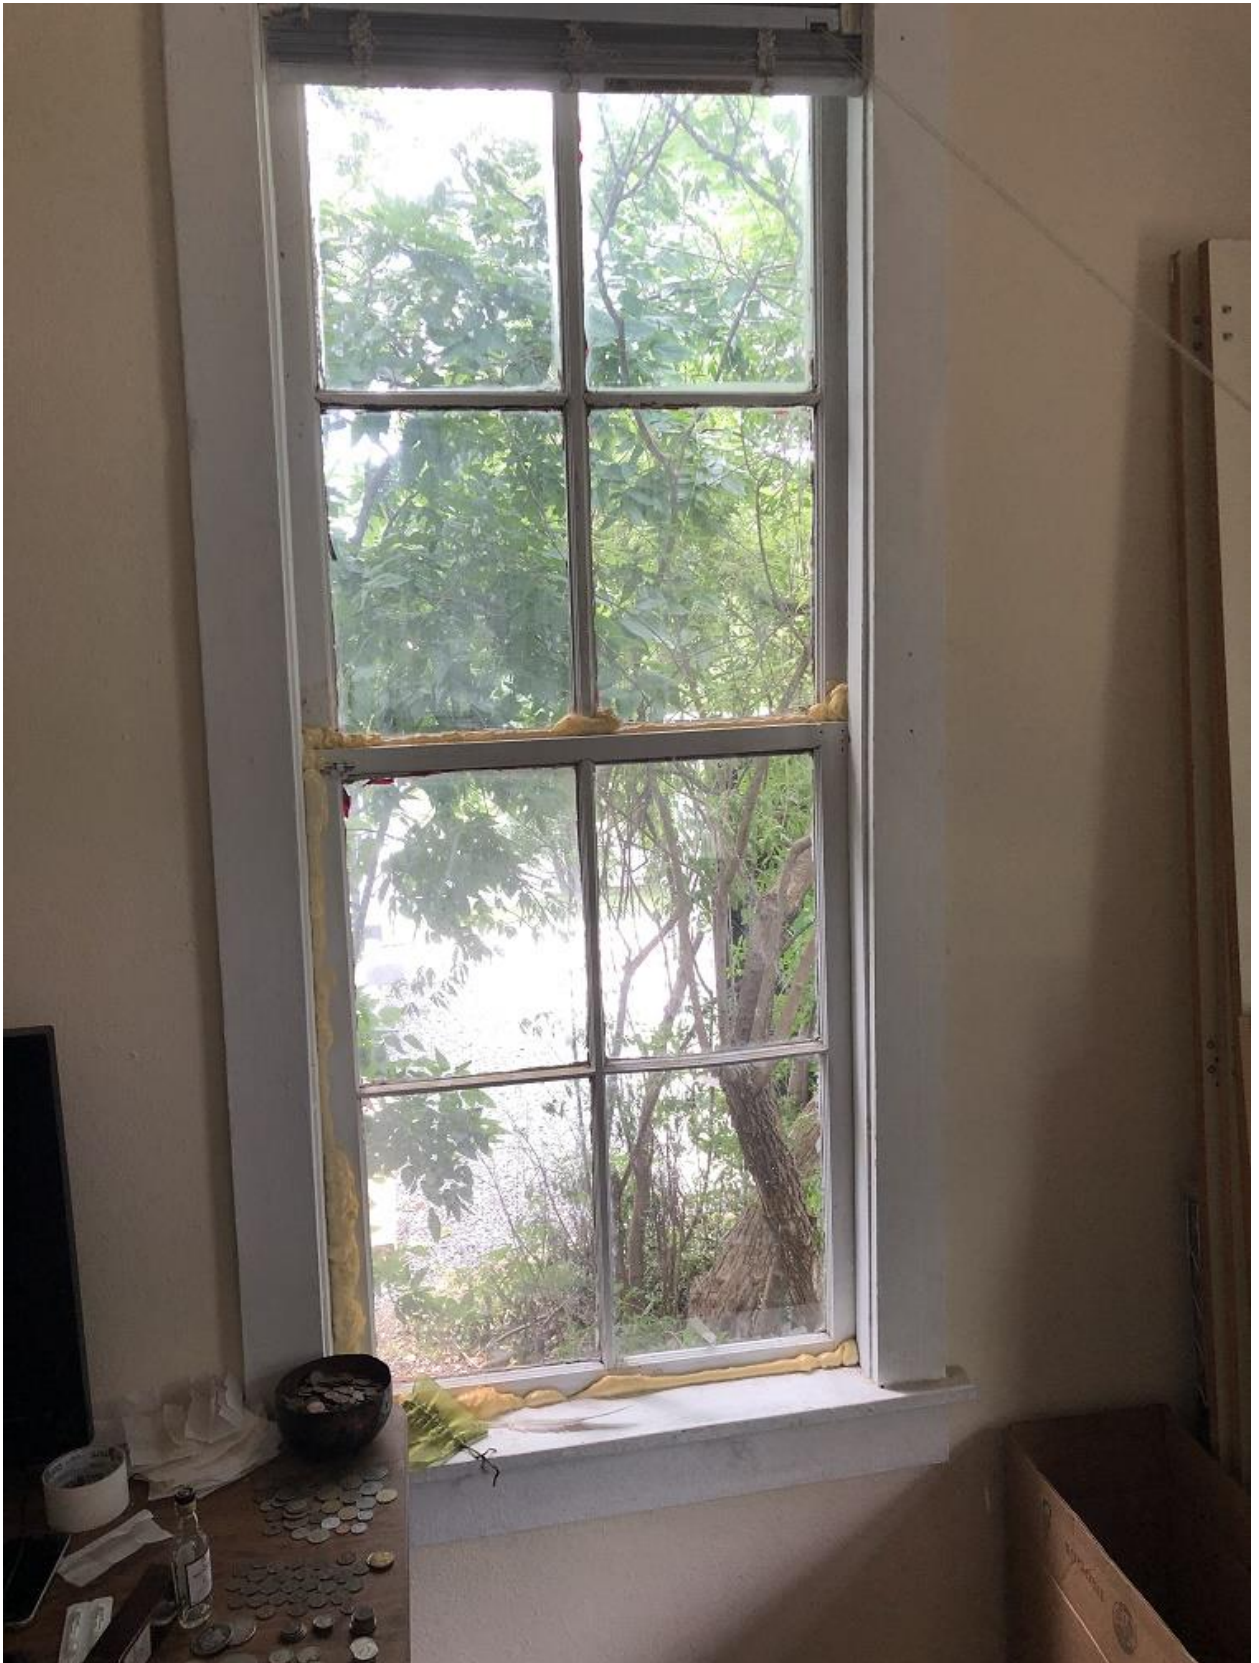
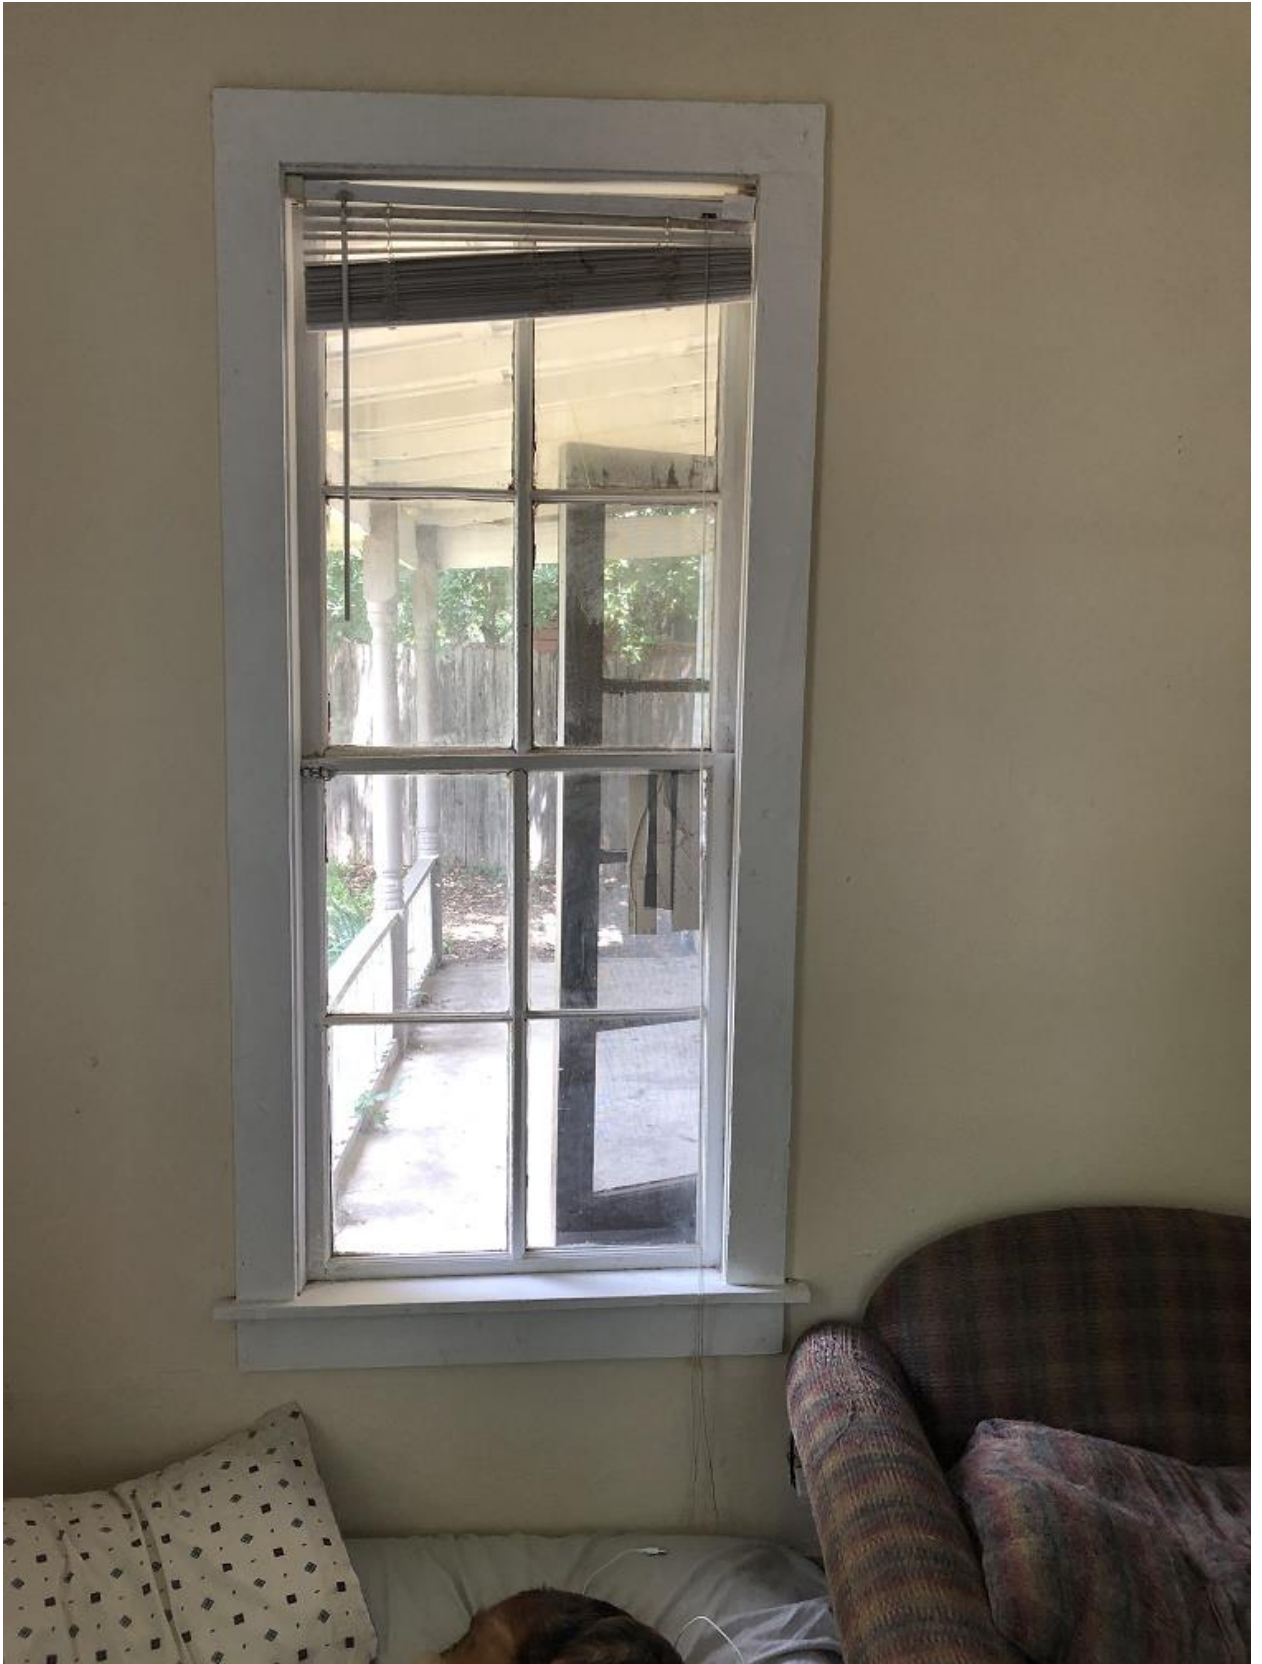
5. Remaining original windows have been nailed/sealed shut and are inoperable-
