2019-038373 PR--1903 New York Ave

RE: Demo Permit Application Pics/Notes Pertaining to Condition & Architectural factors diminishing historical value/significance of the structure.

Key Considerations/Factors: Exterior Wall Materials Replaced, Windows Replaced, Doors Replaced, Porch Altered

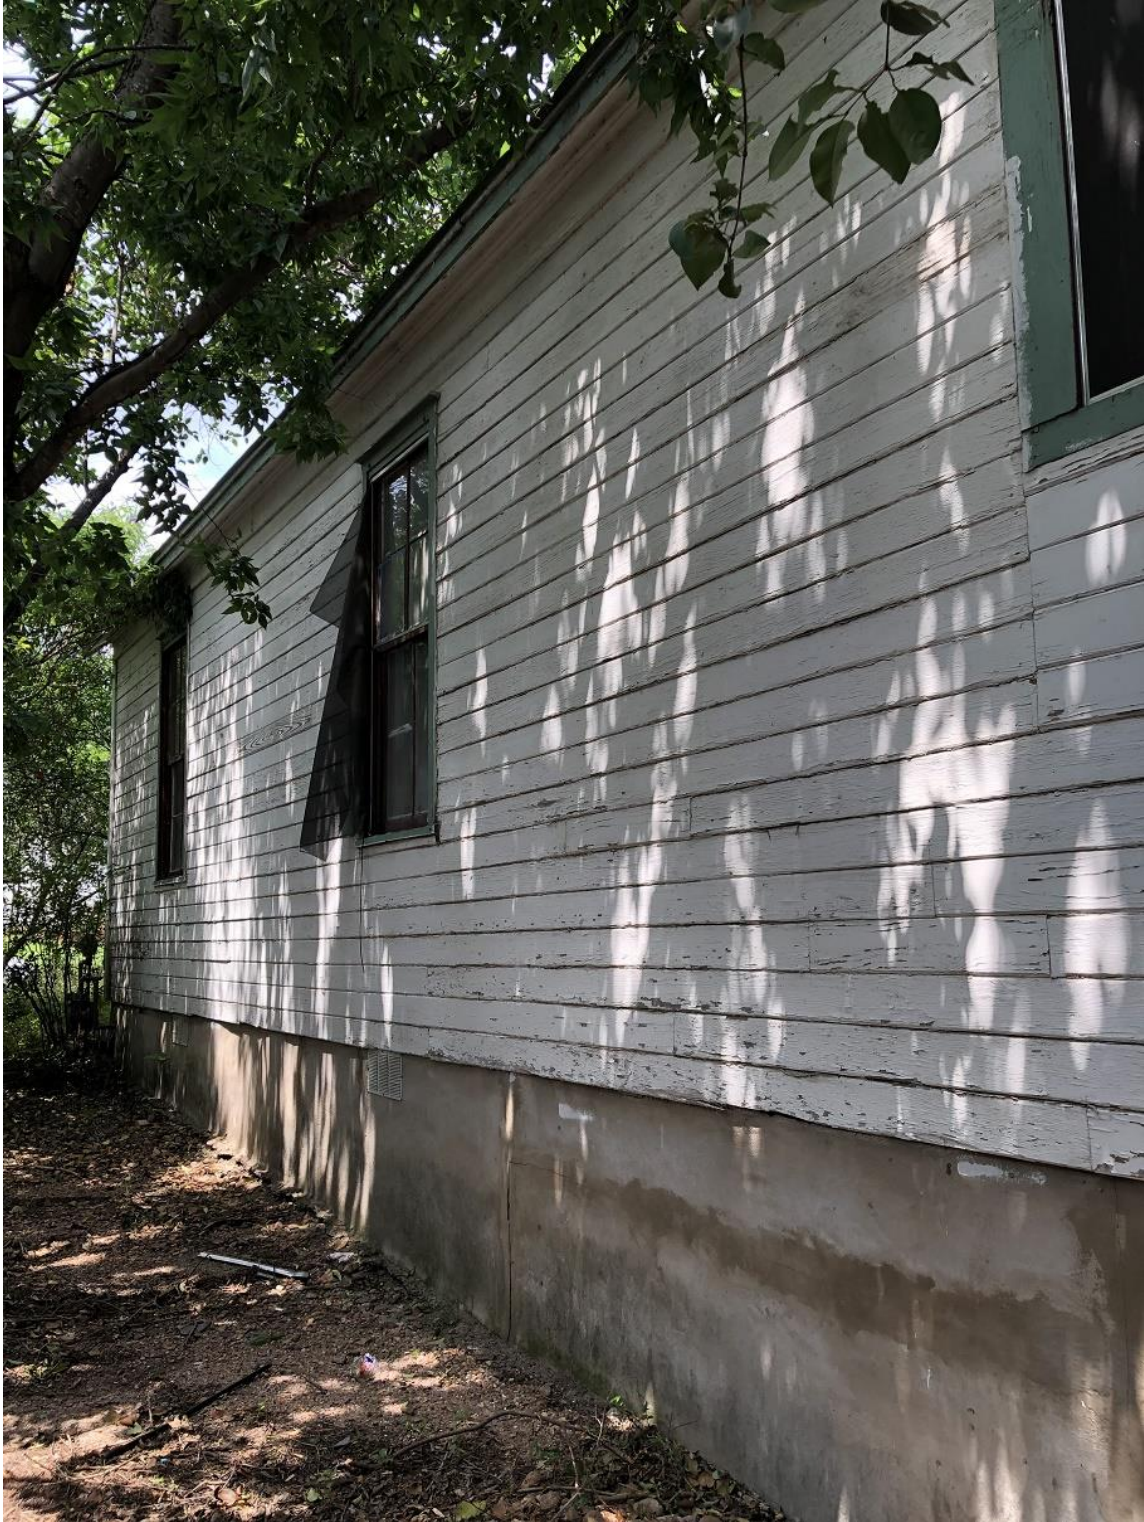
6. Significant portions of remaining Original siding are beyond repair due to dry-rot/deterioration/damage; portions have been replaced with newer materials

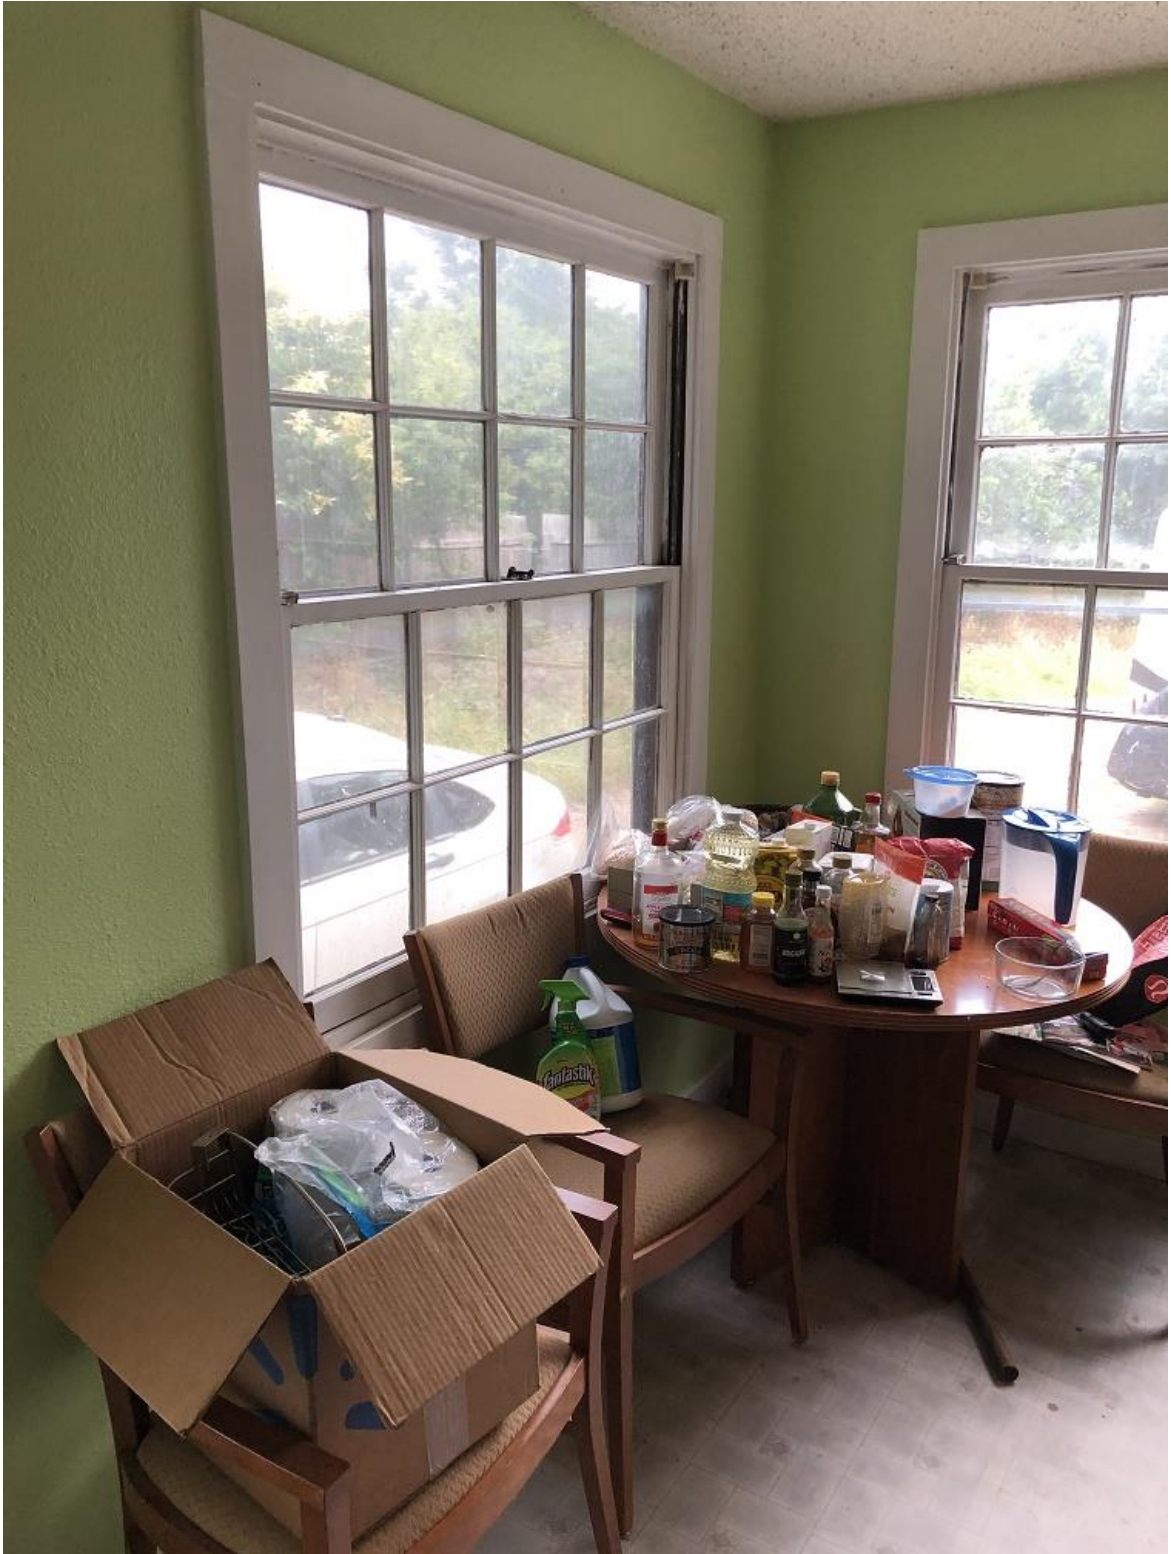
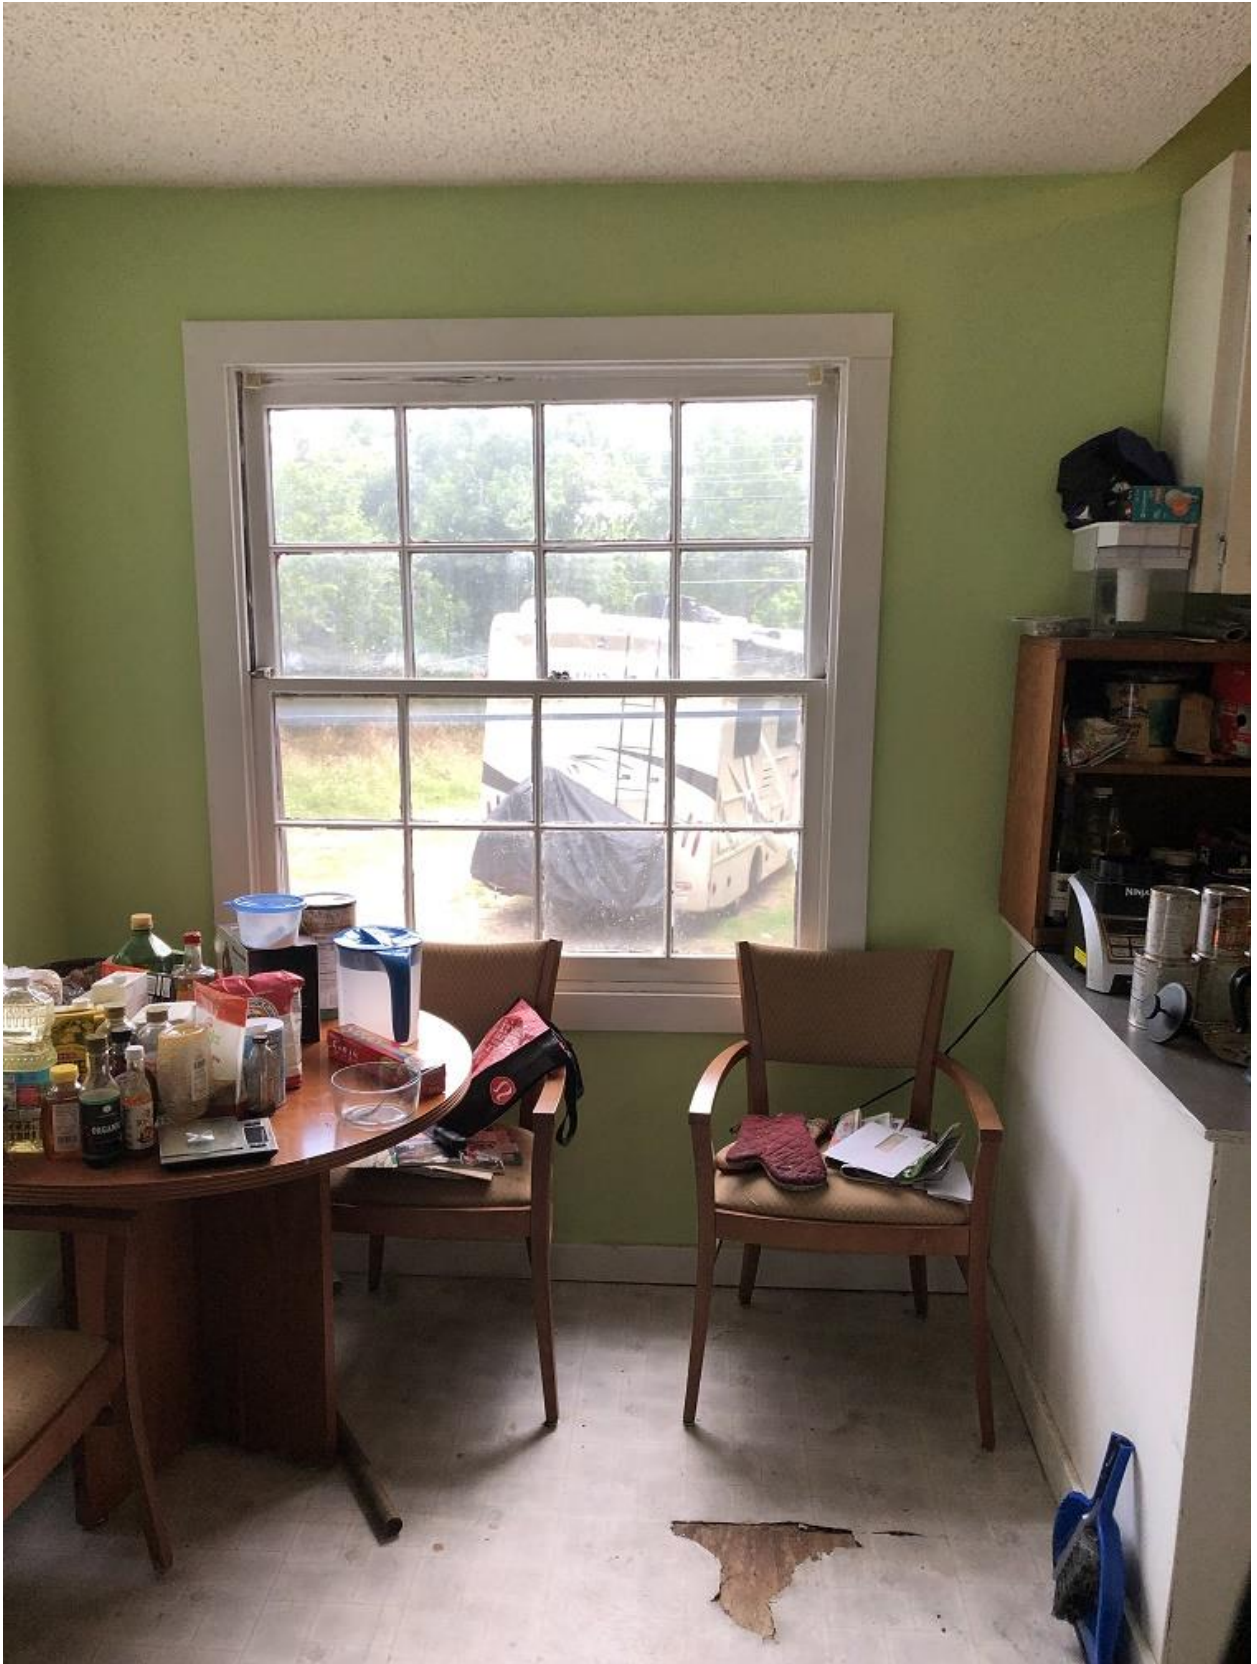
7. Additional windows not consistent with original construction
