FIELD REPORT IMAGES

For existing conditions at 1410 and 1408 West 9th Street

Survey Date: Monday, June 17, 2019  
Time: 1:30pm - 3:45pm  
Location:  
Participants: Webber + Studio (Architect): Marek Hnizda (MH)  
JB Cumby Construction (Contractor): Robin Moore  
**BLACK** indicates action required.

- I. TOPICS:
- (1) Survey of Existing windows/doors/siding at 1410 West 9th Street
  - (2) Survey of Existing windows/doors/siding at 1408 West 9th Street

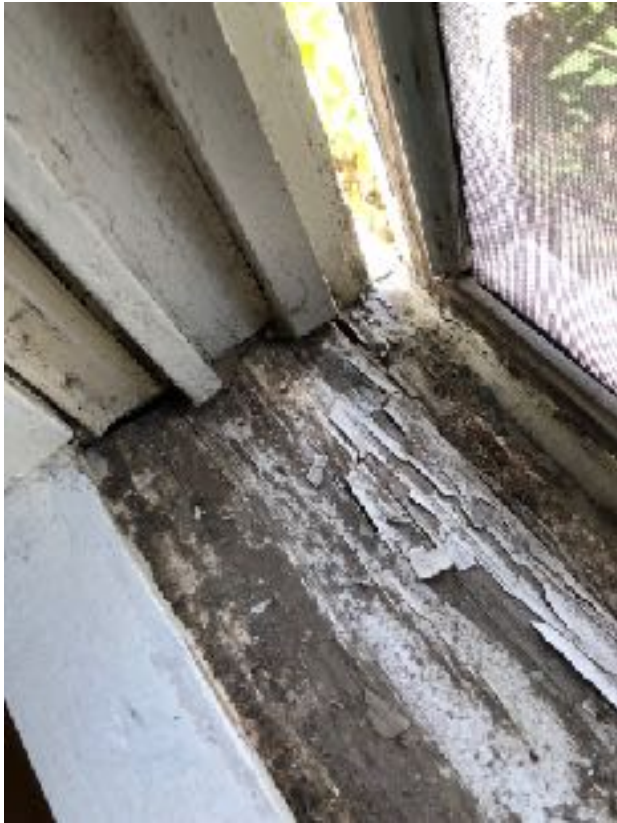
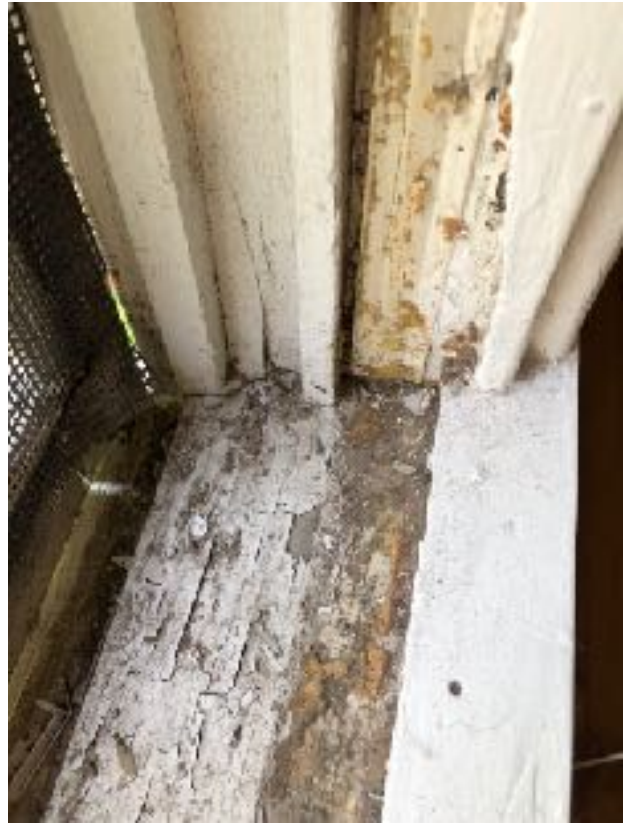
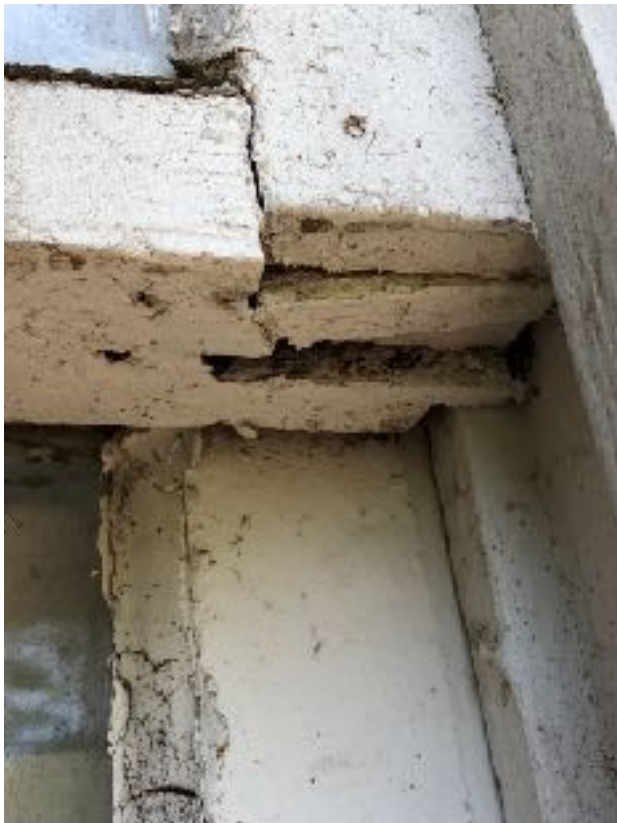
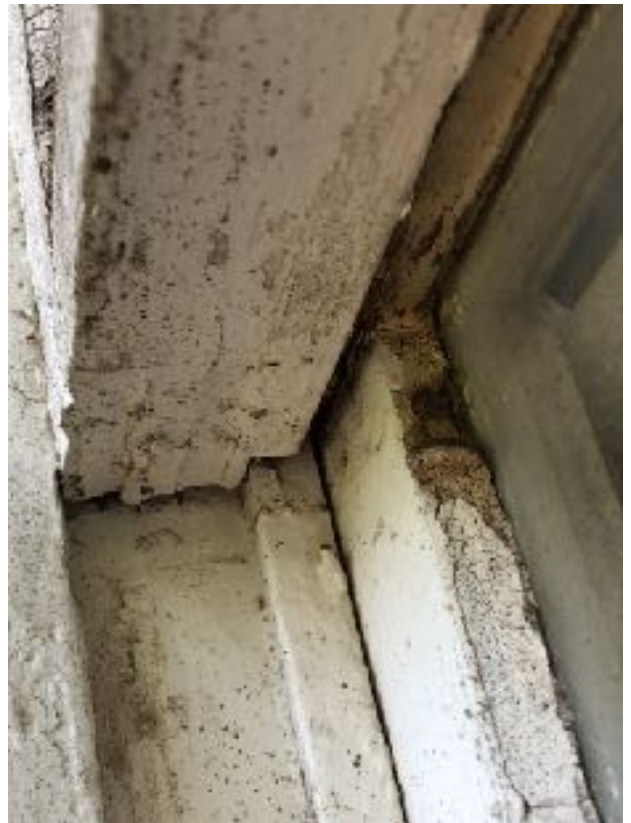
**Image of window condition 1410 West 9th Street (this page). Evidence of Rot, Termite damage, and physical damage present.**

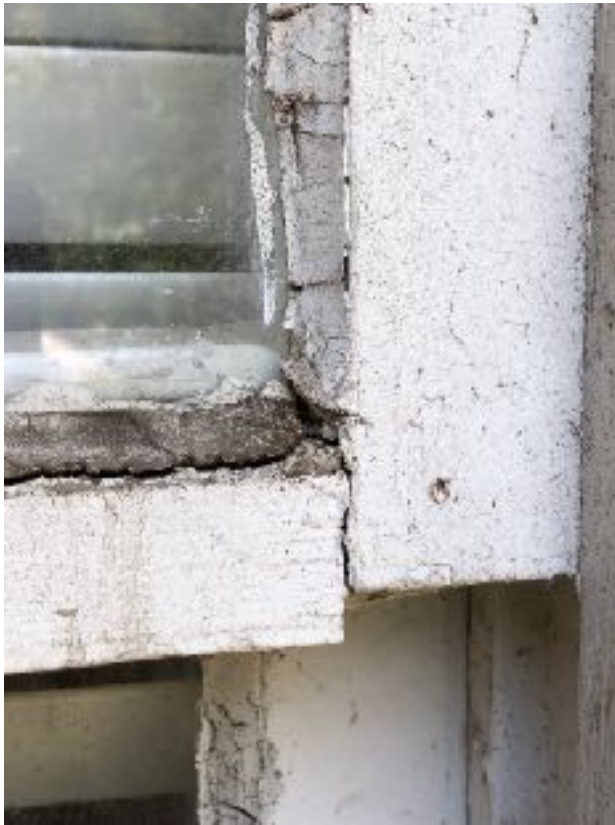
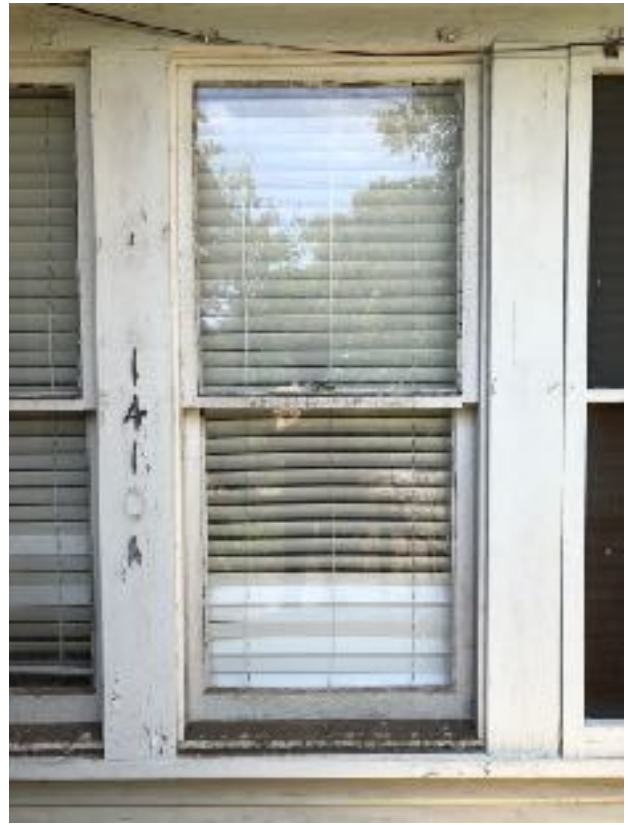
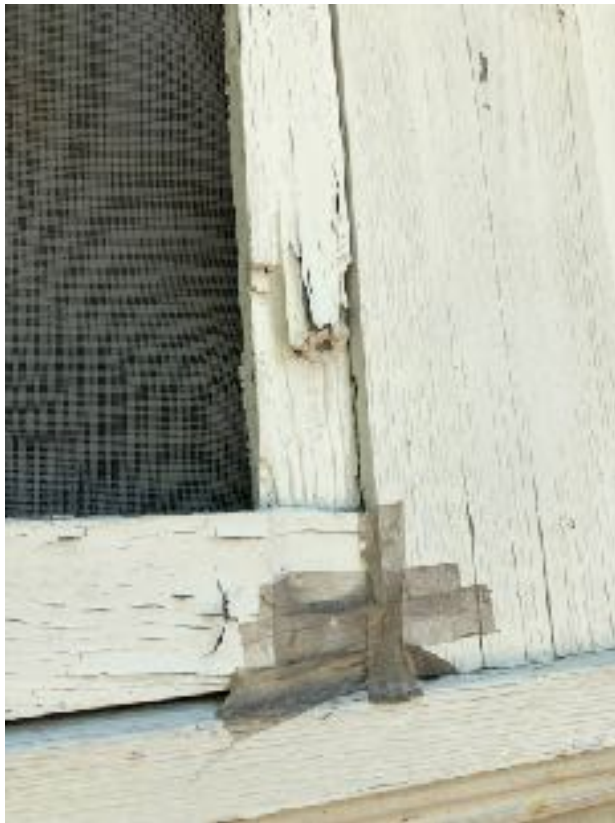
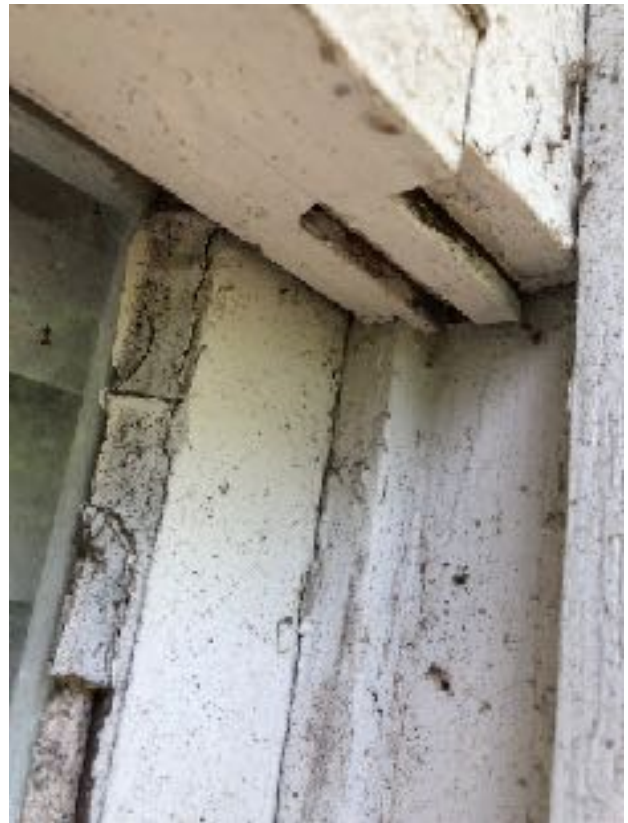
Image of window condition 1410 West 9th Street (this page). Evidence of Rot, Termite damage, and physical damage present.

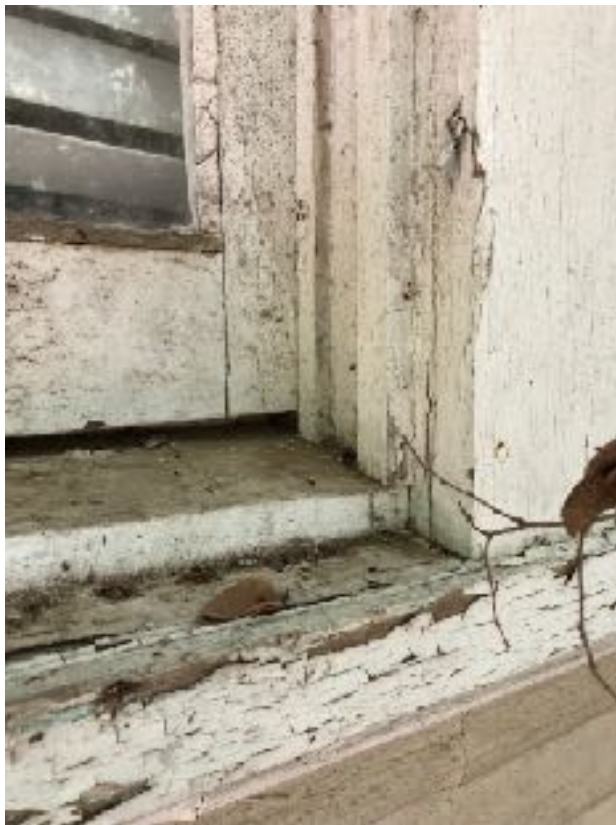
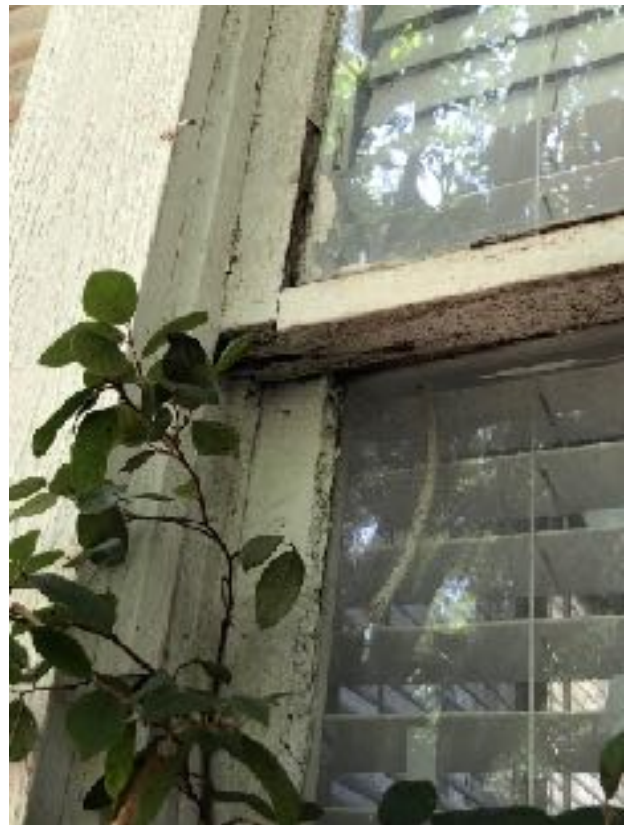
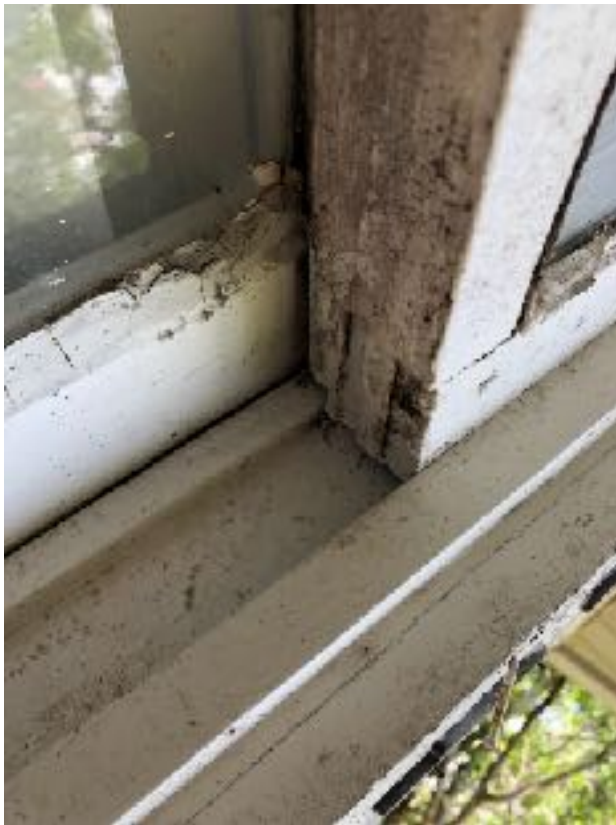
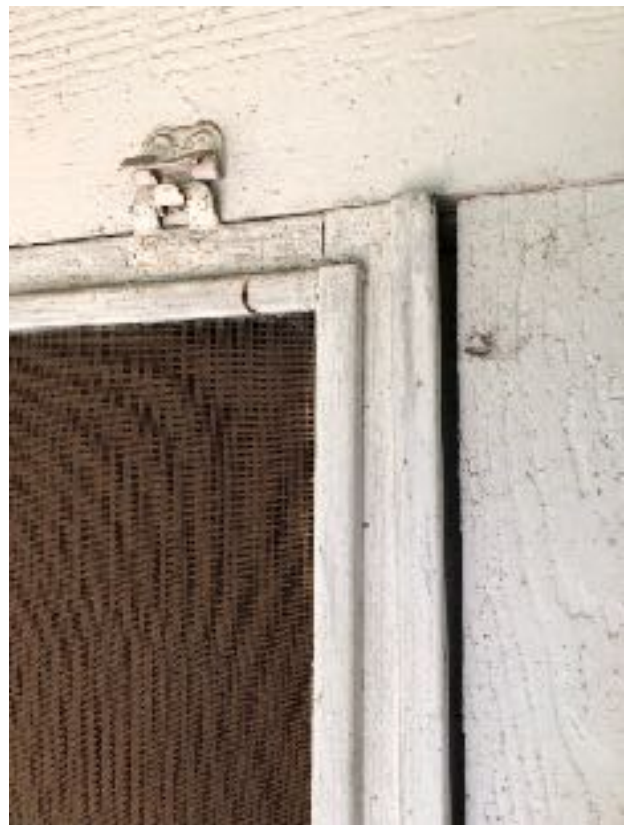
**Image of window condition 1410 West 9th Street (this page). Evidence of Rot, Termite damage, and physical damage present.**

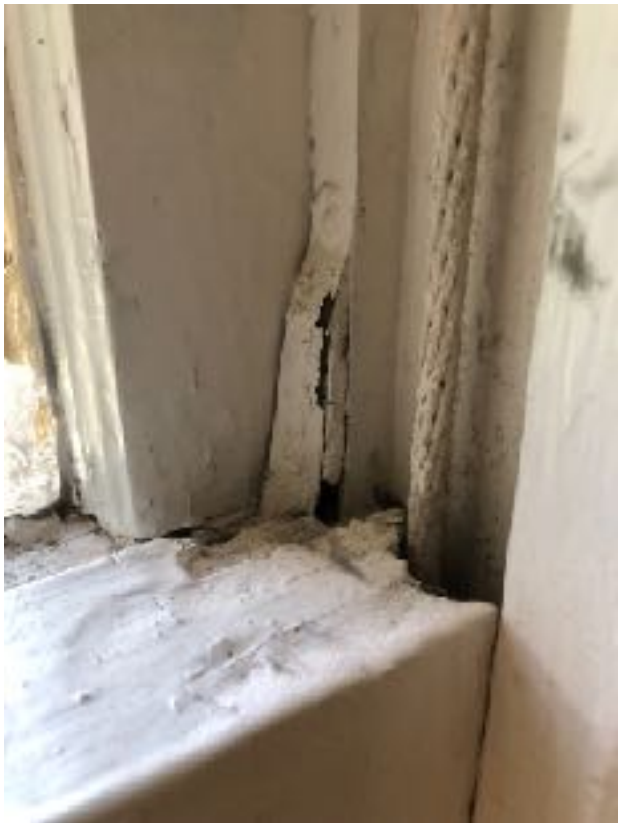
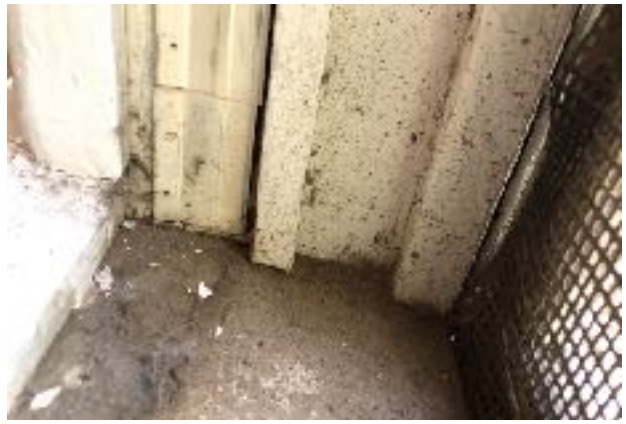
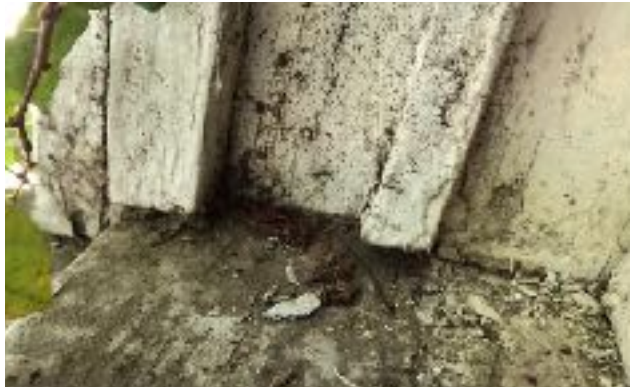
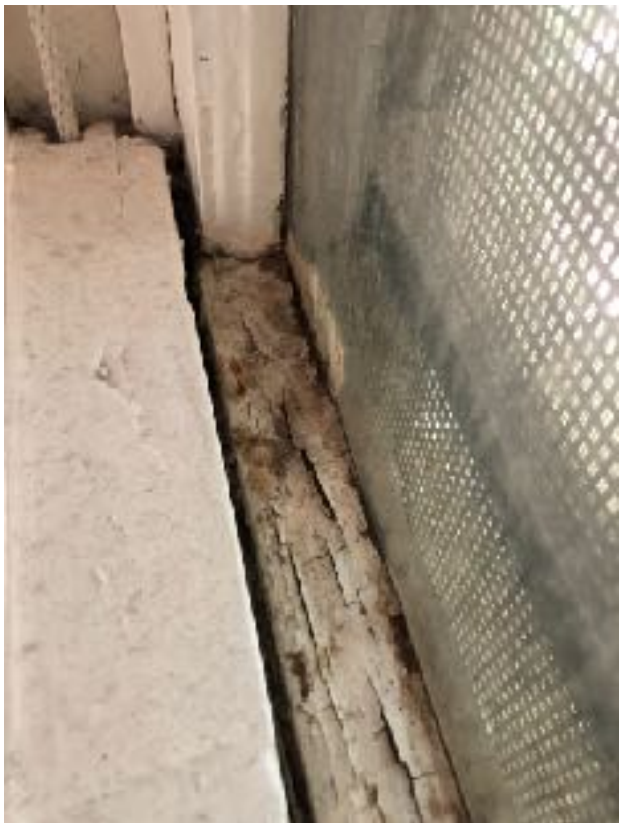
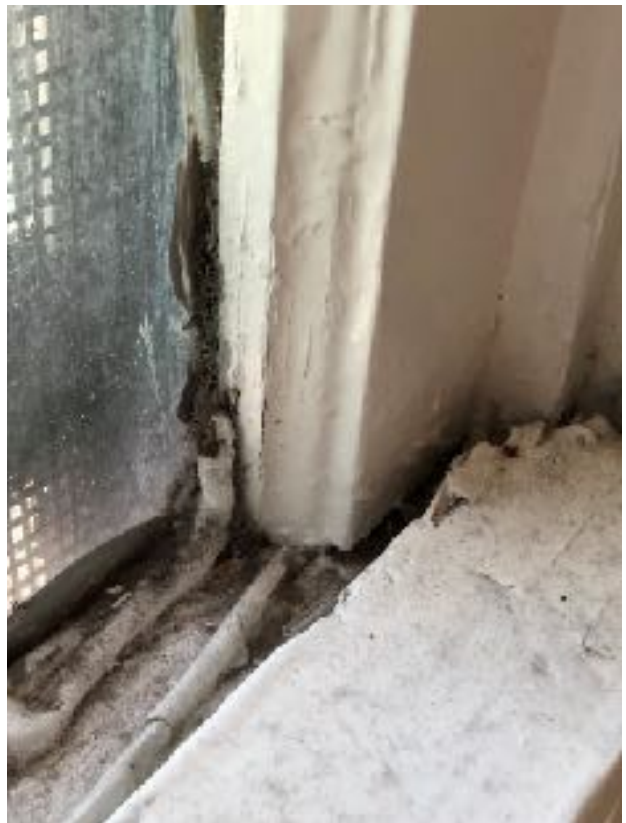
**Image of window condition 1410 West 9th Street (this page). Evidence of Rot, Termite damage, and physical damage present.**

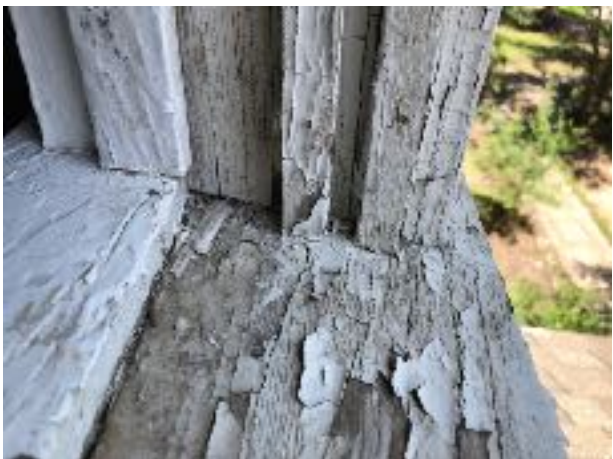
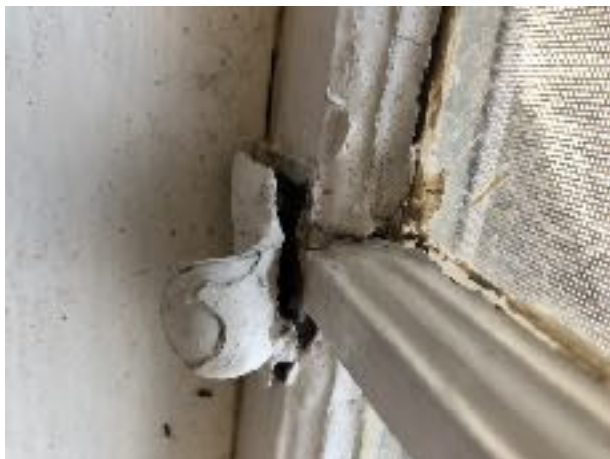
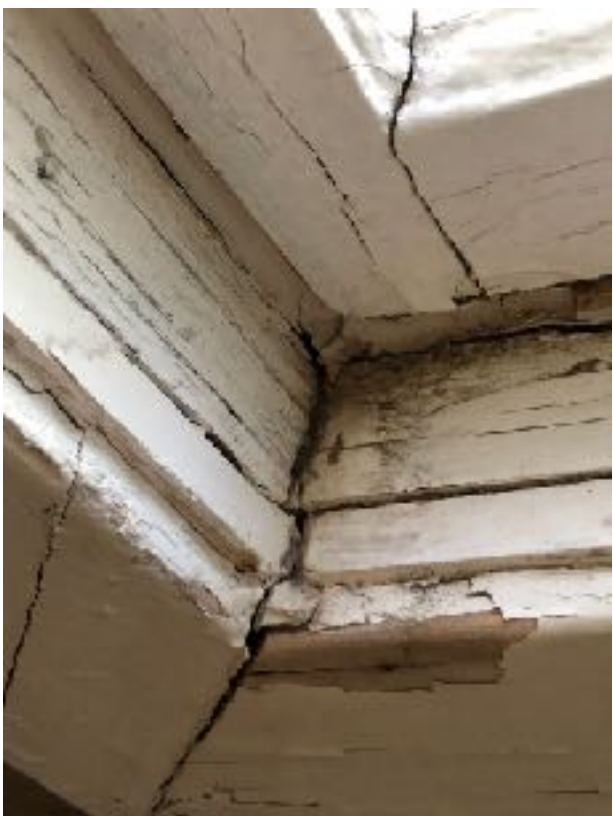
**Image of window condition 1410 West 9th Street (this page). Evidence of Rot, Termite damage, and physical damage present.**

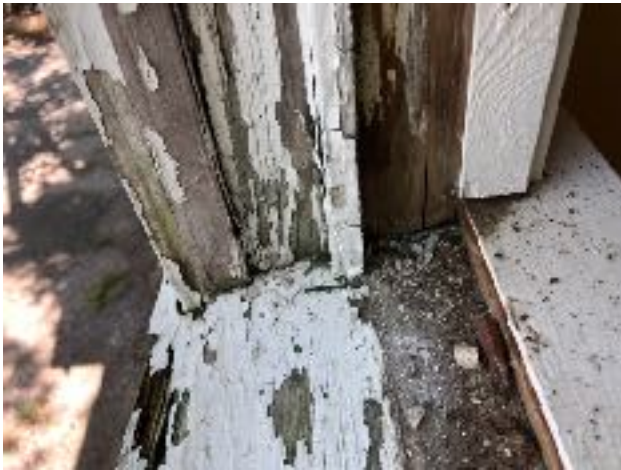
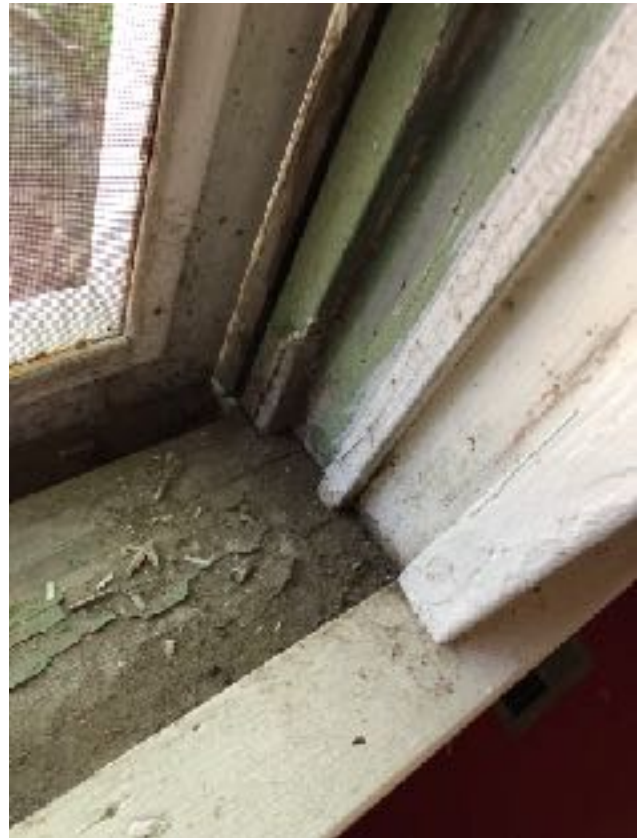
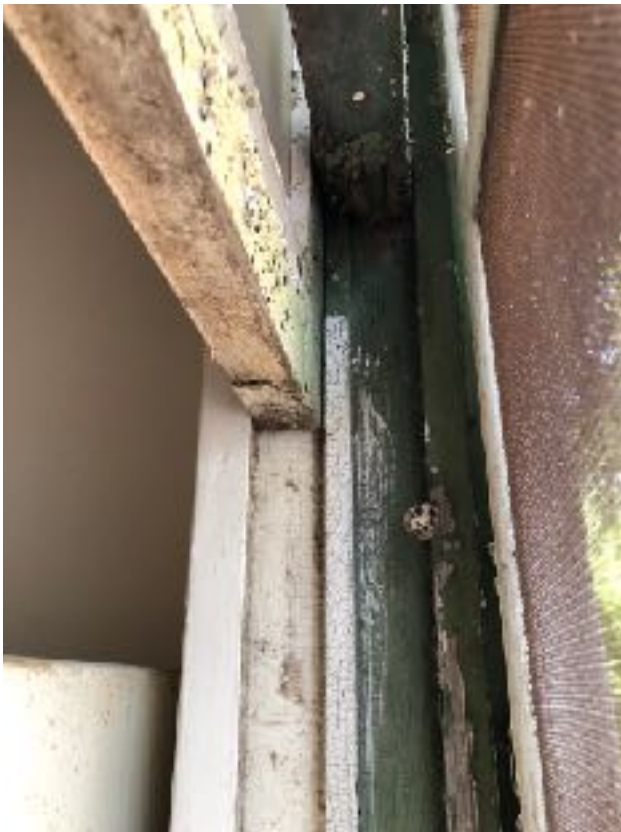
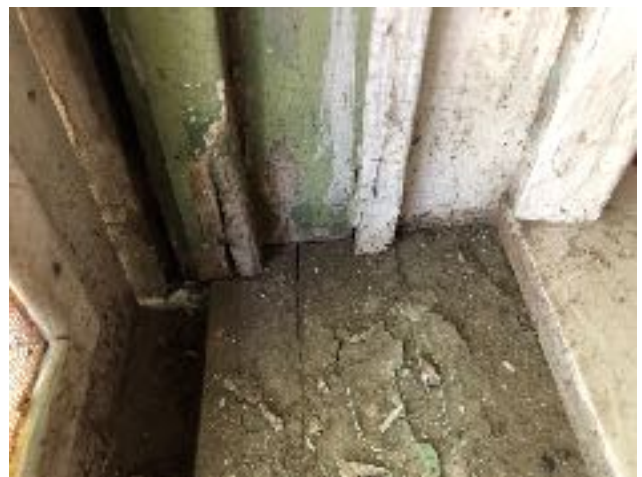
**Image of window condition 1408 West 9th Street (this page). Evidence of Rot, Termite damage, and physical damage present. Damage to existing windows due to plexiglass reinforcement and lack of weatherstripping causing further moisture damage at window frame.**

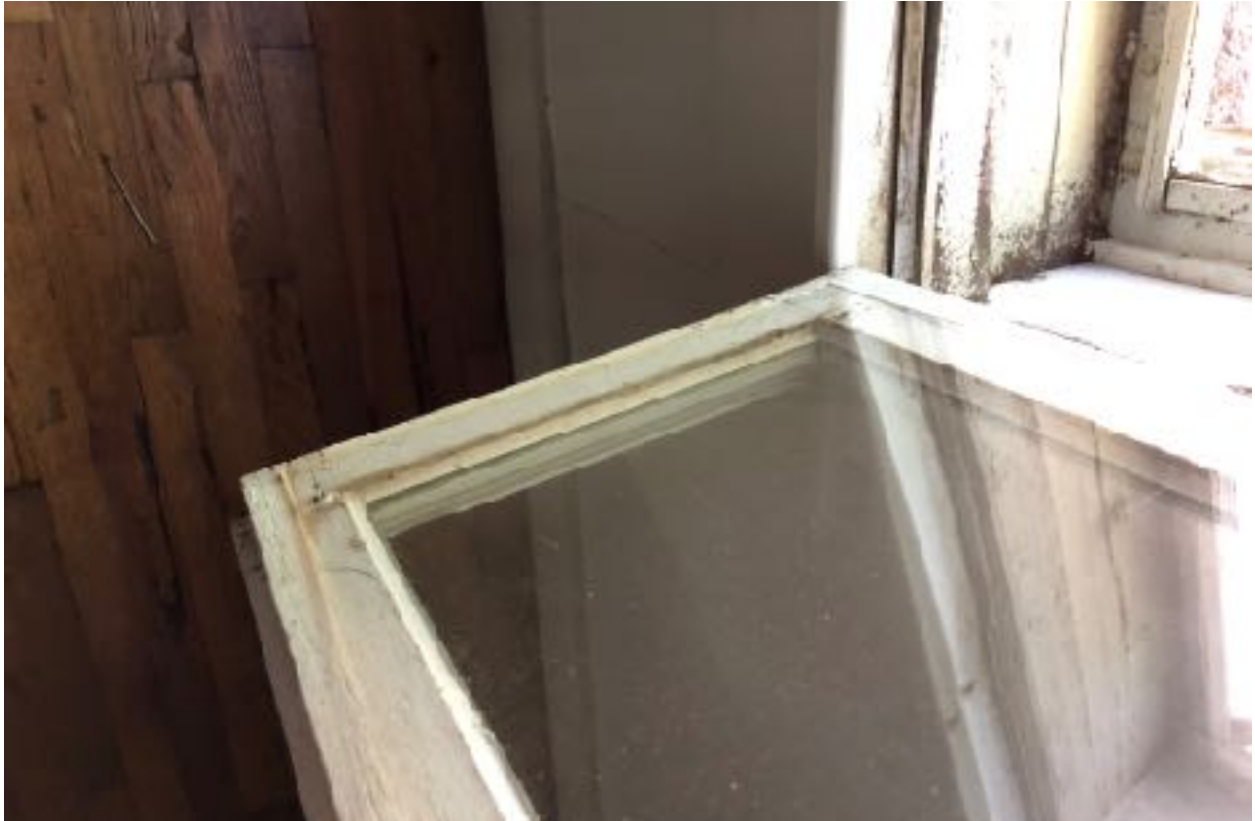
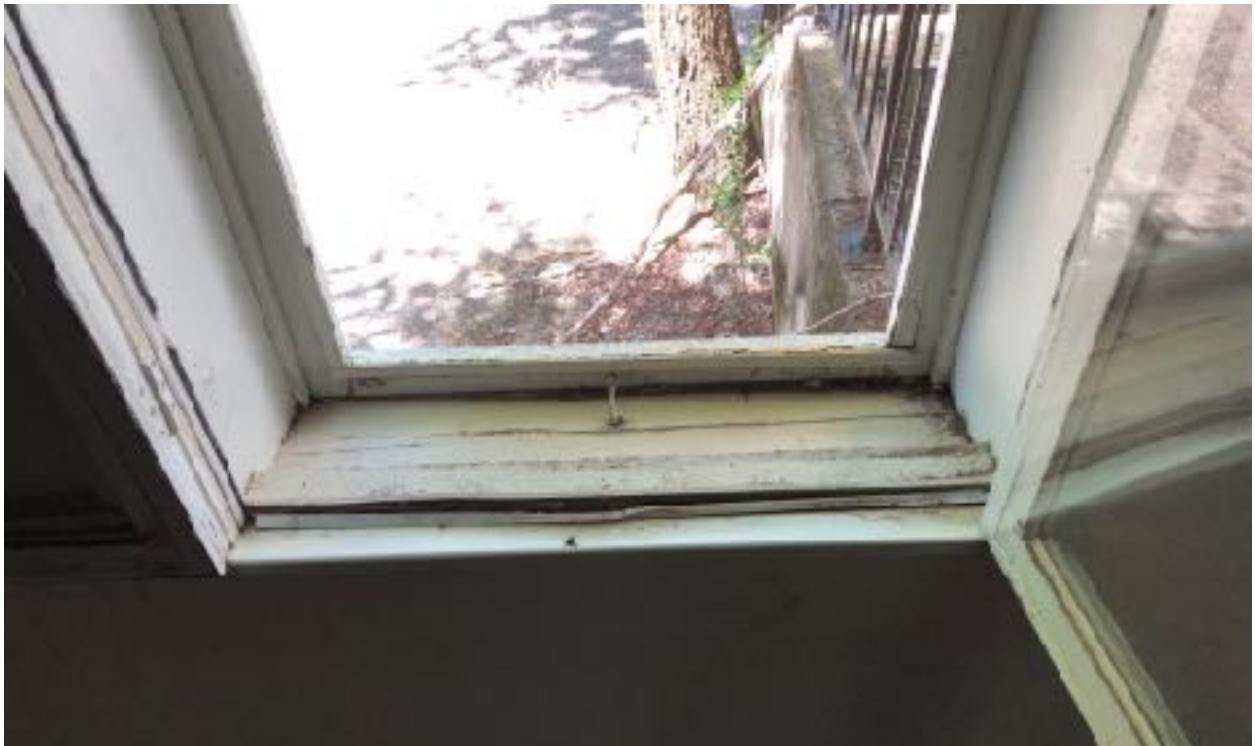
**Image of window condition 1408 West 9th Street (this page). Evidence of Rot, Termite damage, and physical damage present. Damage to existing windows due to plexiglass reinforcement and lack of weatherstripping causing further moisture damage at window frame.**

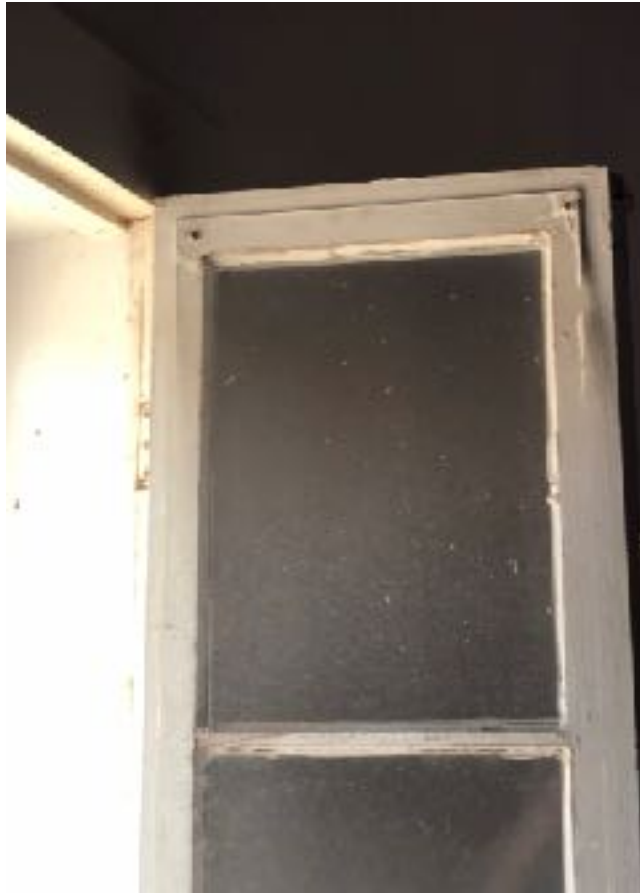
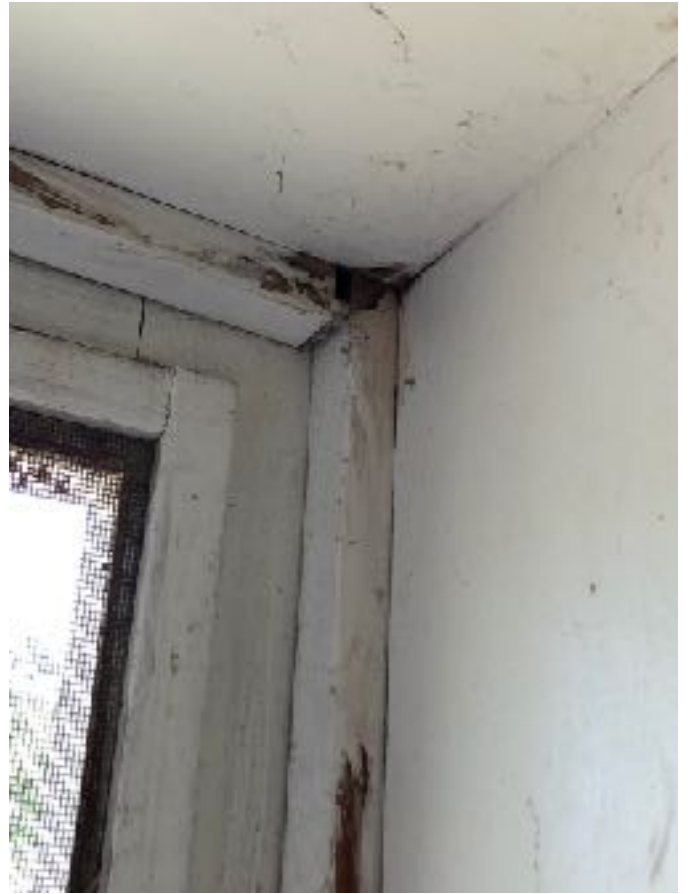
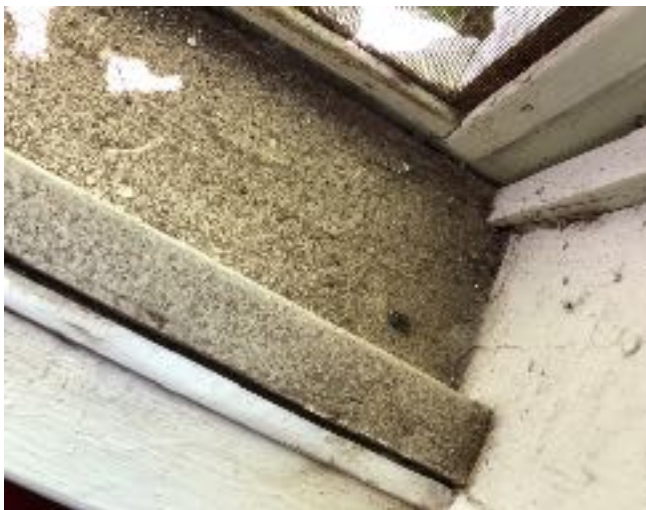
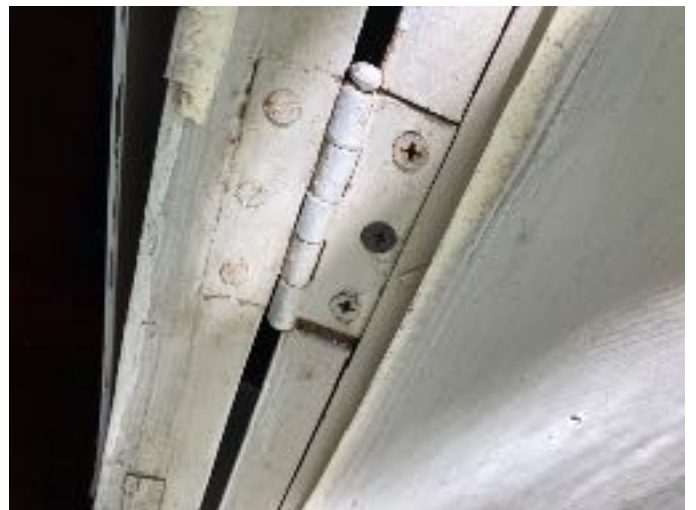
**Image of window condition 1408 West 9th Street (this page). Evidence of Rot, Termite damage, and physical damage present. Damage to existing windows due to plexiglass reinforcement and lack of weatherstripping causing further moisture damage at window frame.**

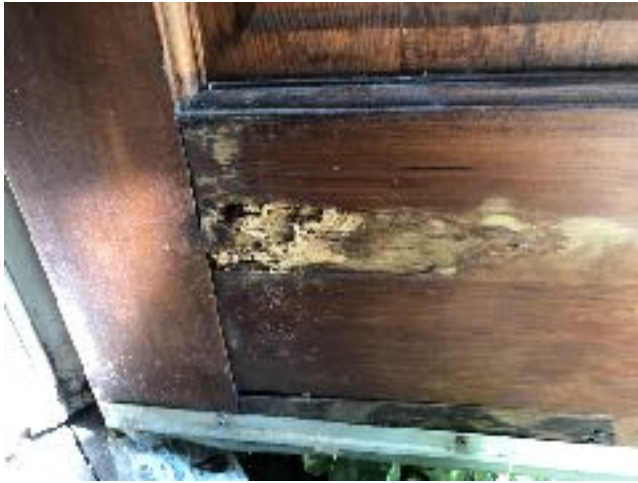
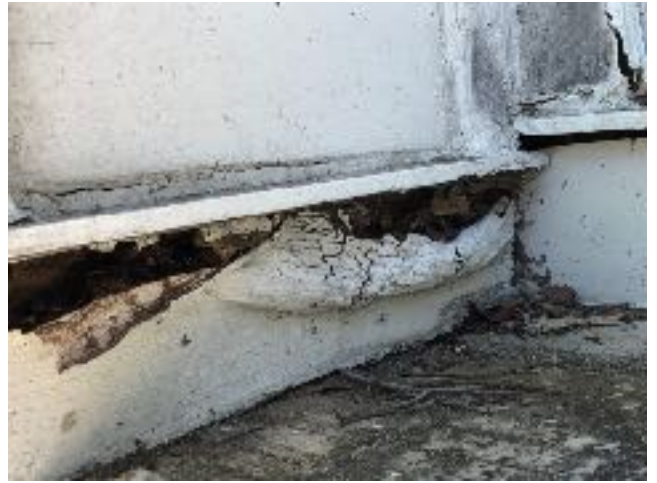
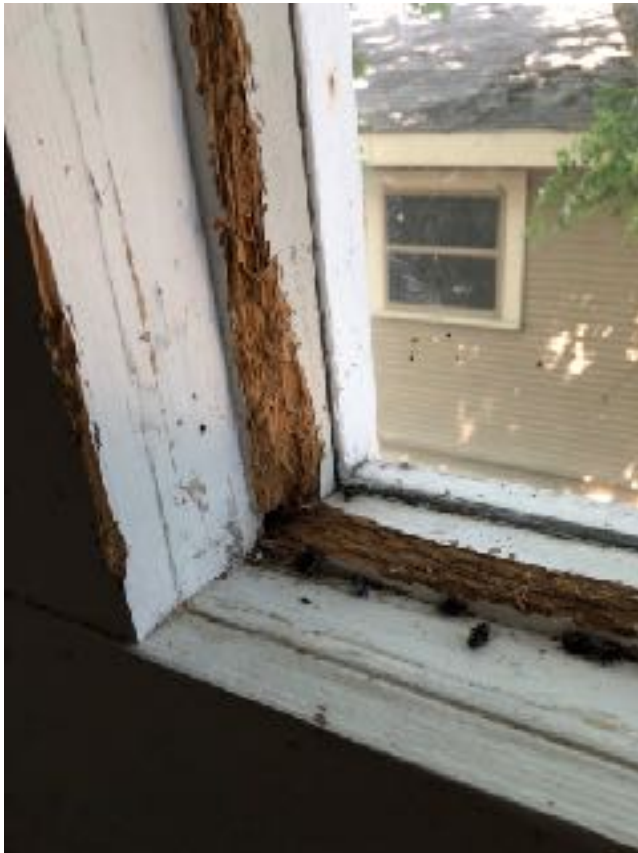
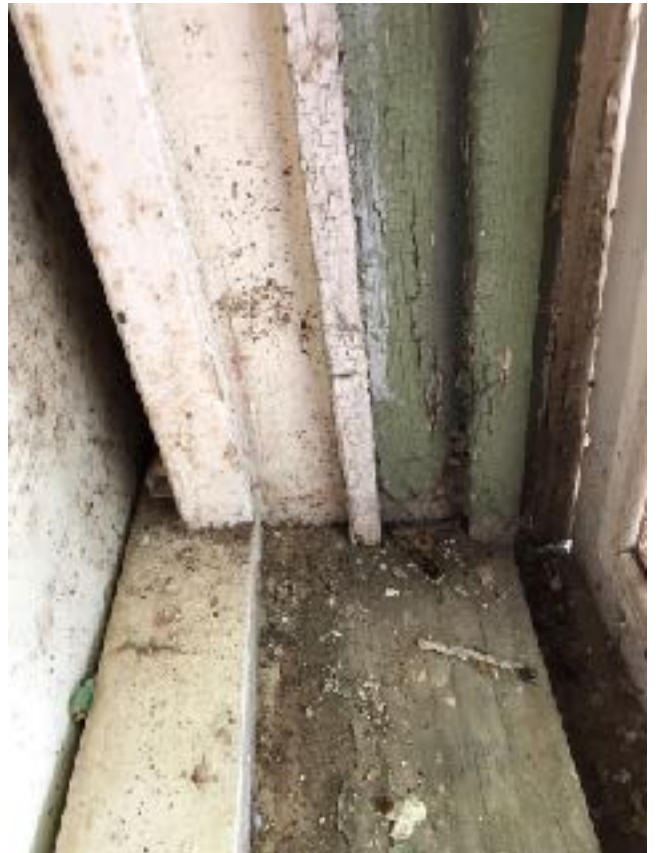
**Image of window and door condition 1408 West 9th Street (this page). Evidence of Rot, Termite damage, and physical damage present. Replacement windows without weatherstripping causing further moisture damage at window frame.**

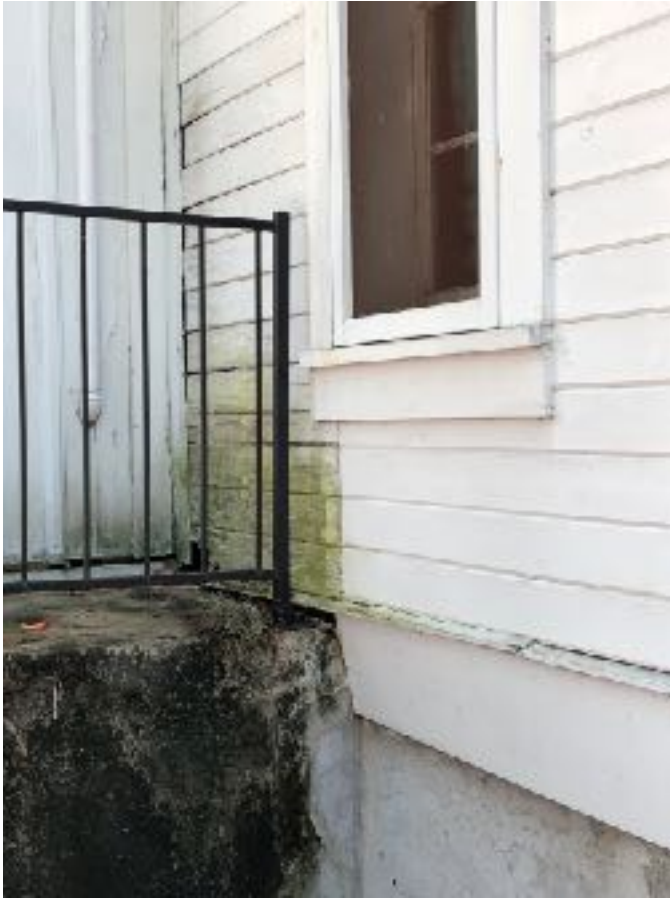
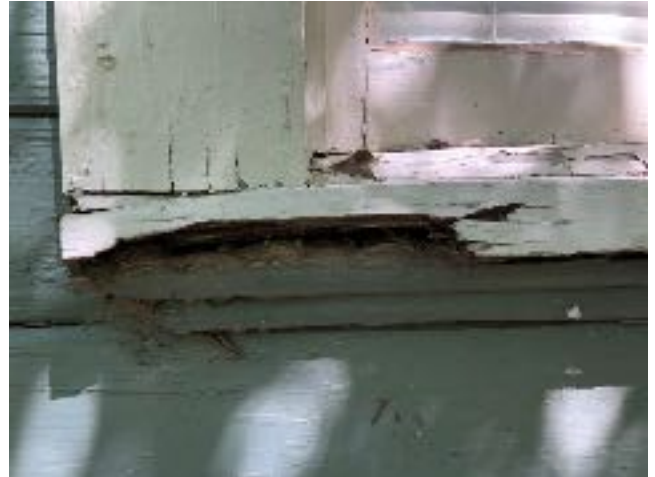
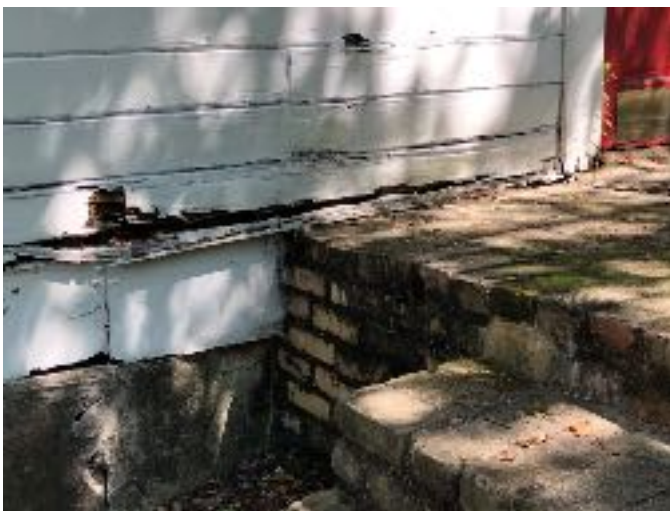
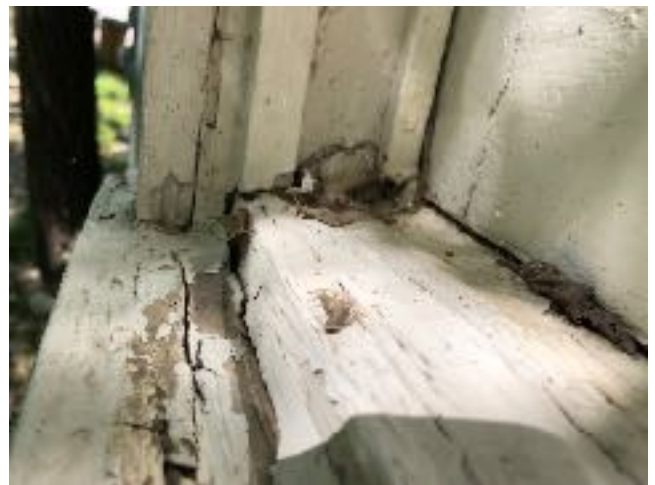
**Image of window and siding condition 1408 West 9th Street (this page). Evidence of Rot, Termite damage, and physical damage present.**

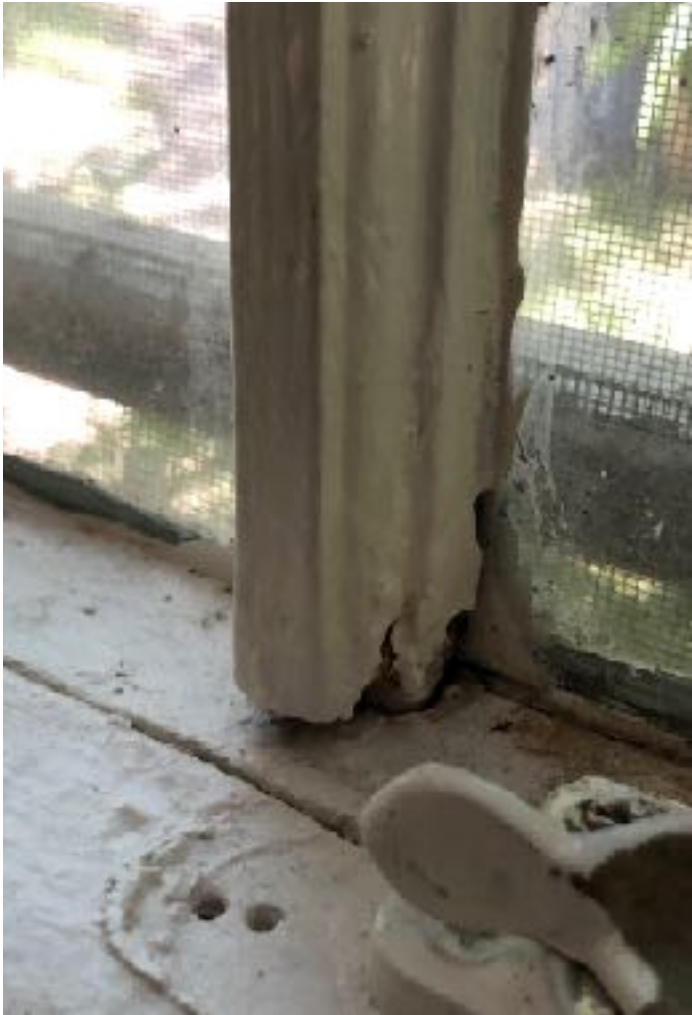
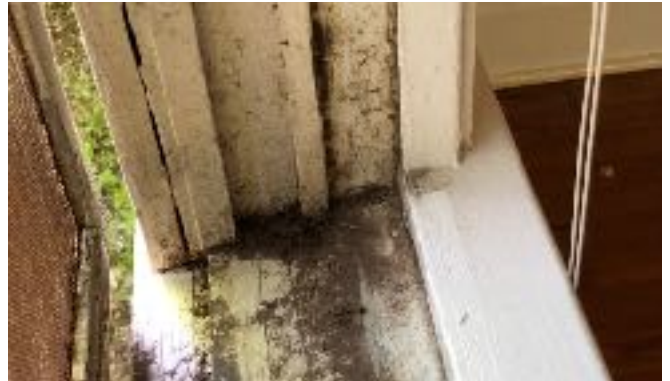
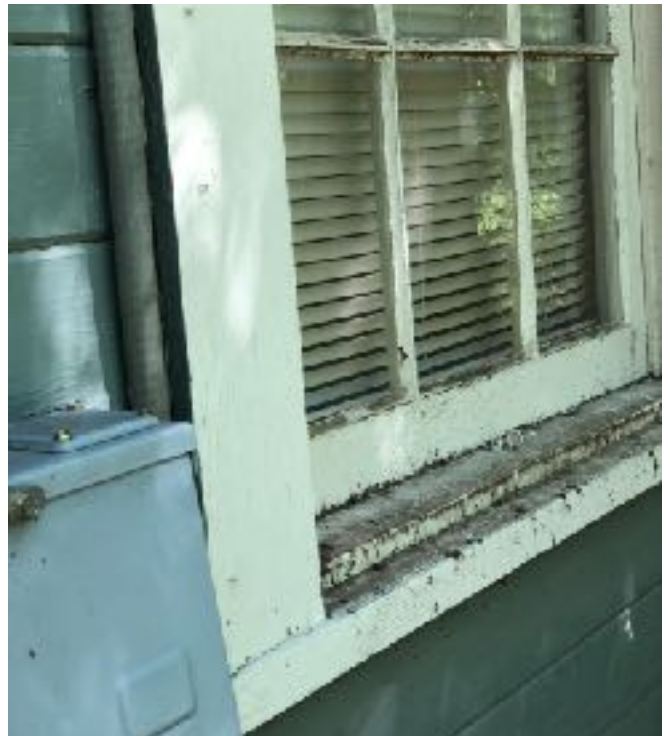
**Image of window condition 1408 West 9th Street (this page). Evidence of Rot, Termite damage, and physical damage present. Damage to trim detailing. Repair/replacement in-kind proposed.**

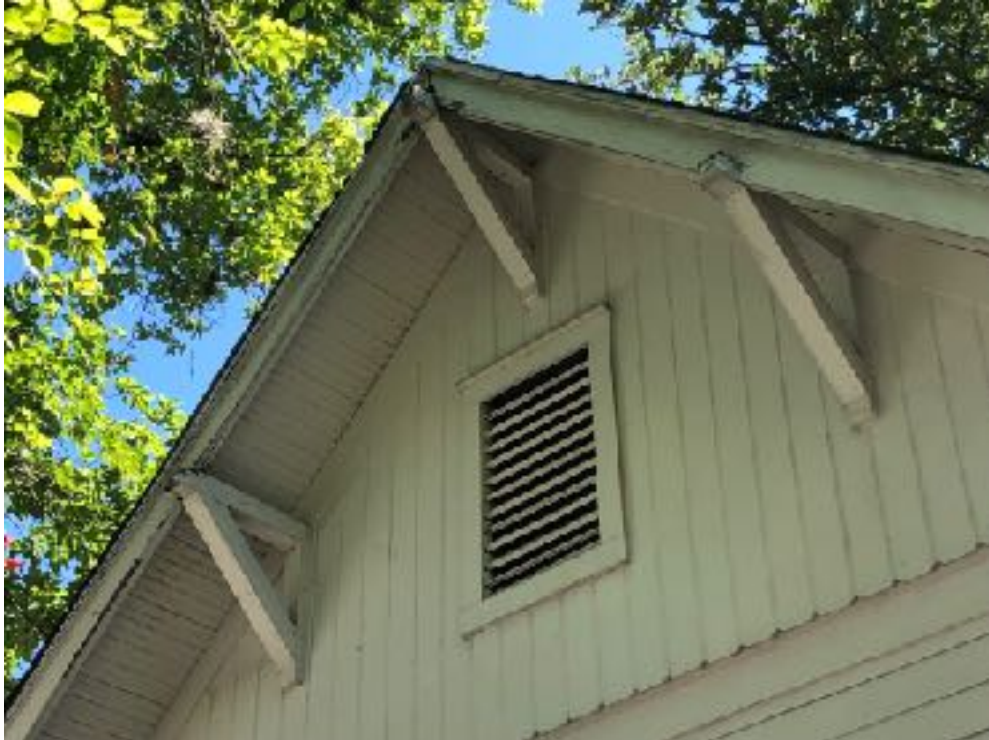
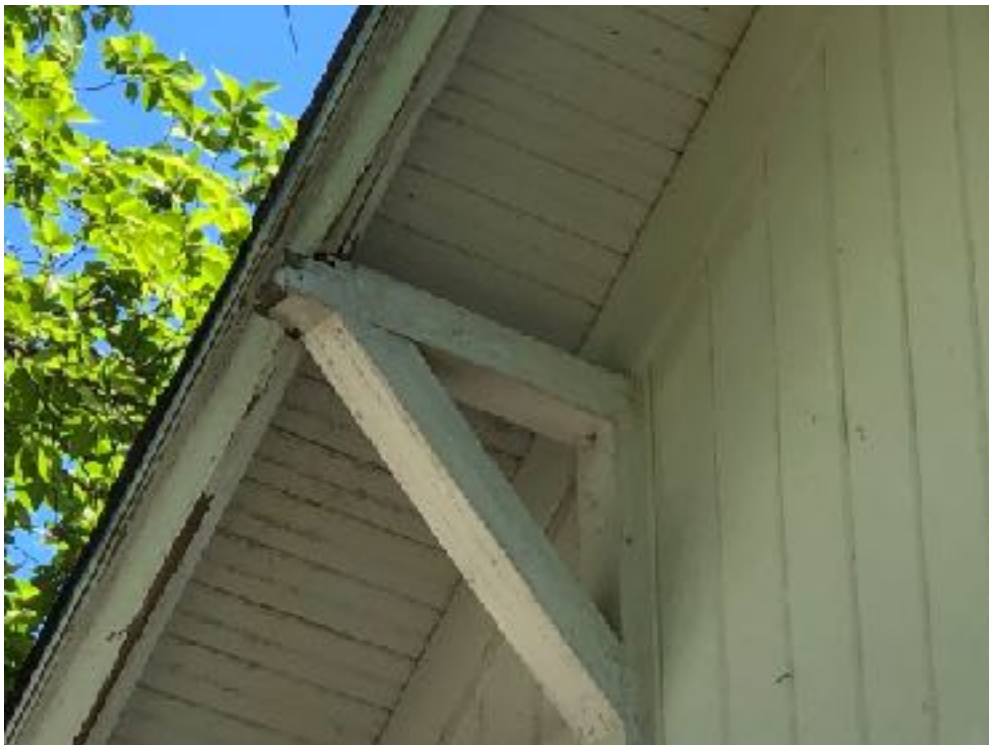
**Image of exterior trim siding condition 1408 West 9th Street (this page). Evidence of Rot, Termite damage, and physical damage present. Damage to trim detailing. Repair/replacement in-kind proposed.**
