Re: Existing Residential Foundation and Superstructure Assessment

1707 Newning Ave.
Austin, TX 78704

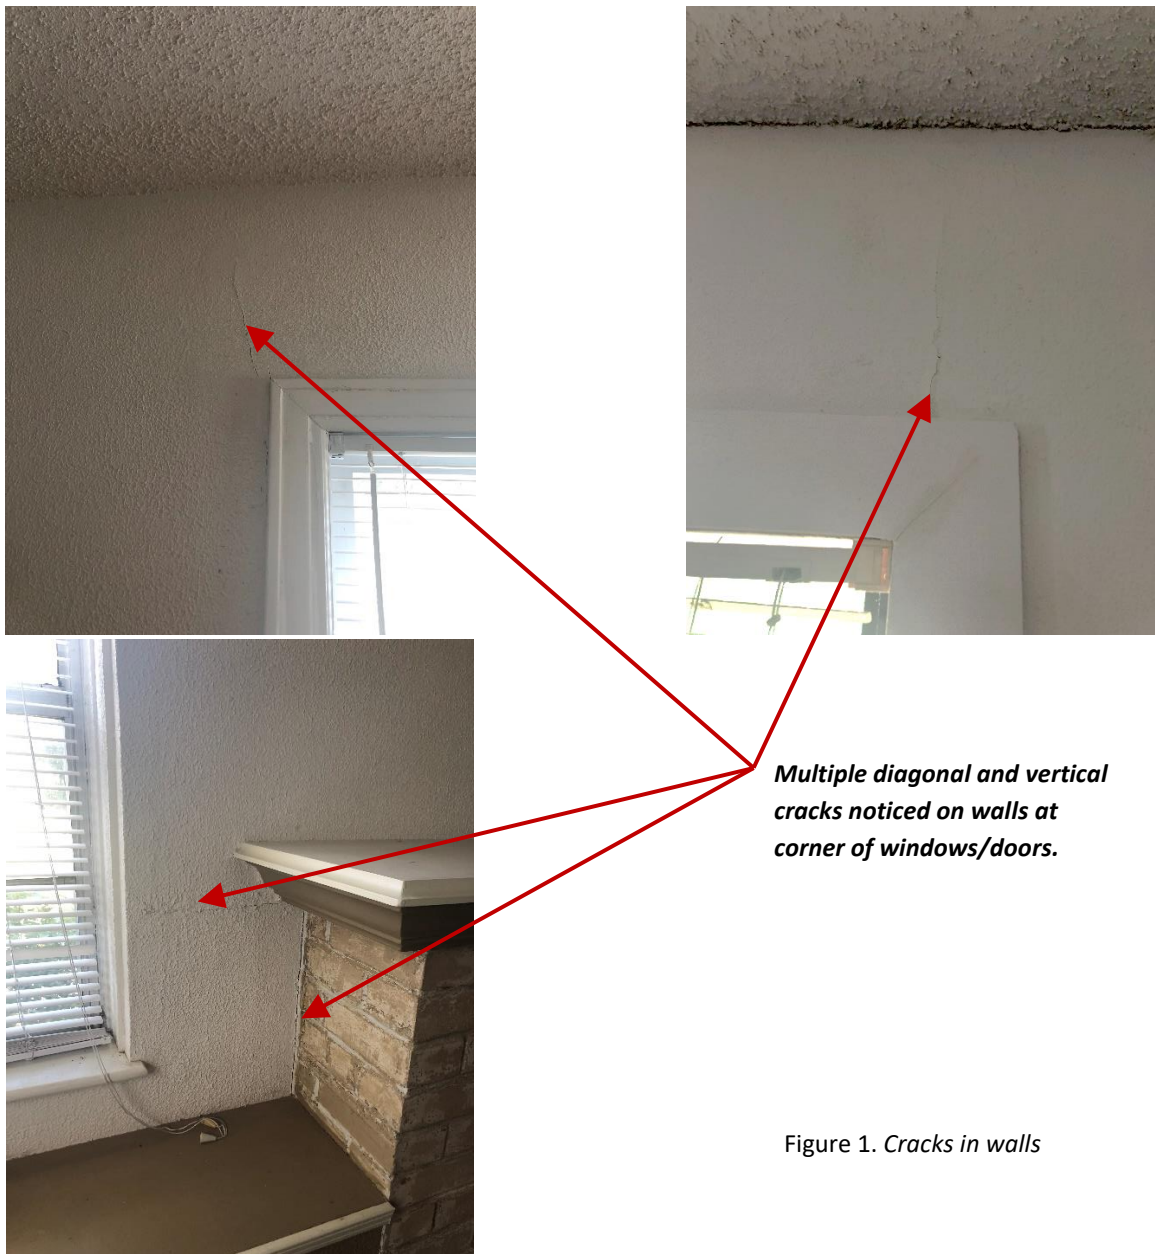
- Lack of proper connection between the original portions of the house foundation/framing and subsequent additions. Seams and cracks, as well as floor displacements can be readily observed throughout the house.
- *Several* stair-stepped and vertical cracks on interior walls. These cracks are common indicators of foundation movement (Figure 1).

Figure 1. Cracks in walls

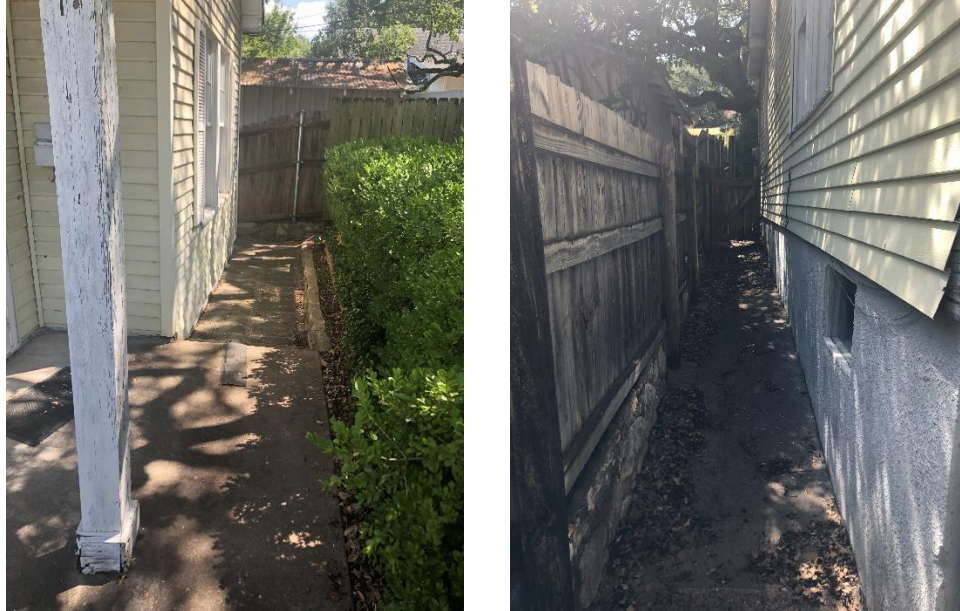
- Inadequate surface drainage appears in some sections around the property (Figure 2). Proper surface drainage (typically 5% or 6 inches per 10ft of positive drainage) will prevent water accumulation against the foundation structure, aggravating swelling of clays and consequent heaving. The presence of yard masonry walls also makes drainage even more difficult.

Figure 2. Site Drainage. Inadequate drainage and walls limiting water runoff

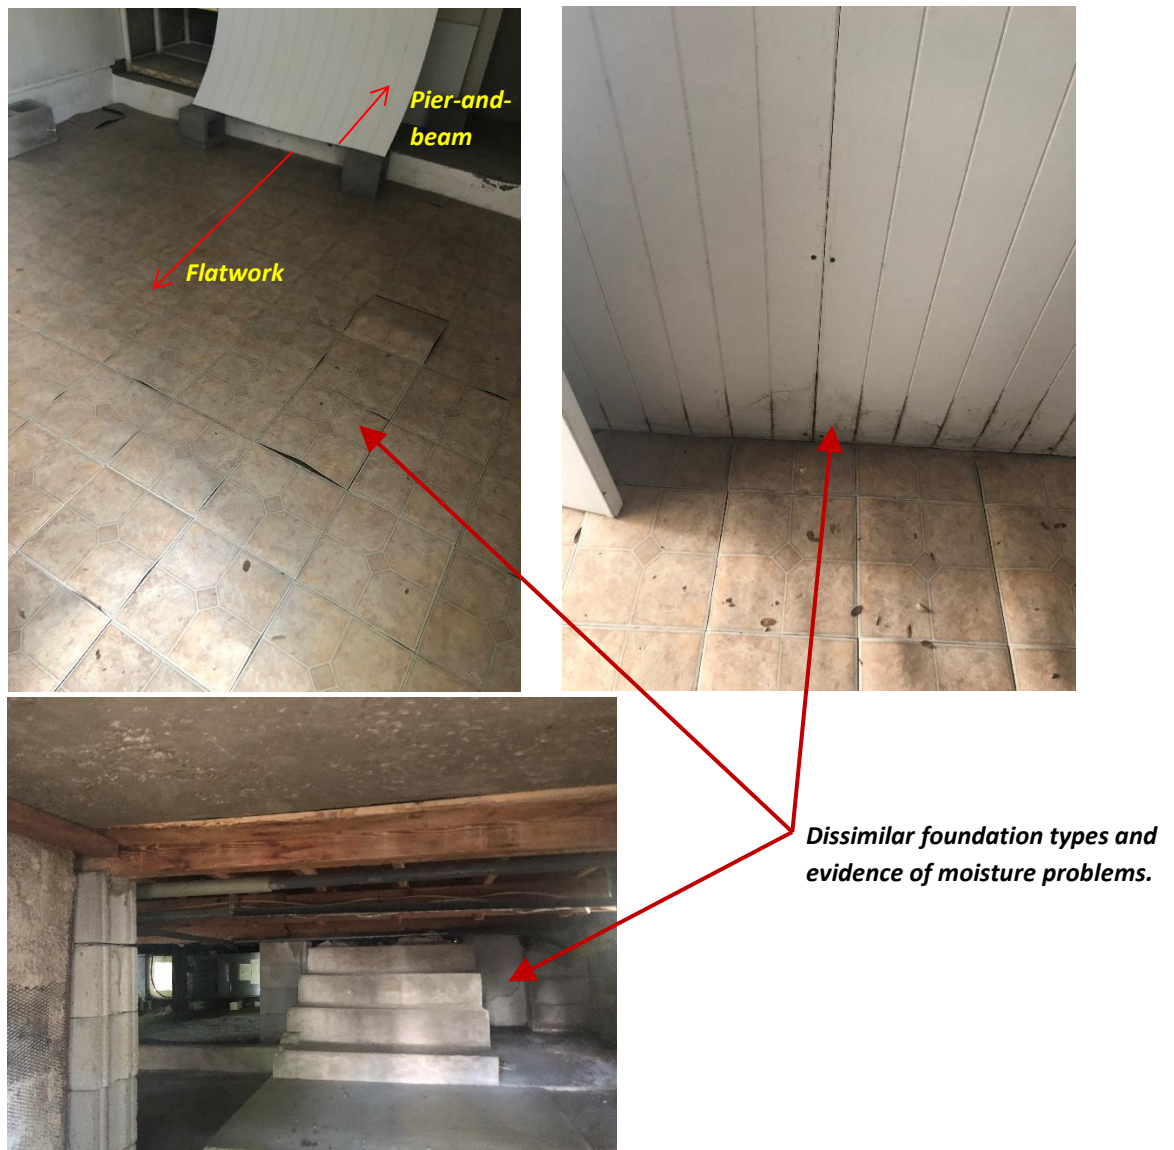
- Dissimilar foundation types: portions of the subsequent additions have “slab on grade/flatwork” foundation in contrast with the “pier-and-beam” of the original structure. The multiple foundation types, when not properly engineered, *are not a good construction practice and most likely contributed to the extensive signs of distress observed*. Flatwork construction is not an engineered slab and has no structural value to support residential structures. Large separations were noticed between slab on grade/pier-and-beam and flatwork areas, Figure 3.

Figure 3. *Dissimilar foundation types*

The multiple foundation types (pier-and beam; concrete flatwork) and wall construction (wood framing) will not allow a proper retrofitting strategy (e.g., drilled piers) without *permanently compromising* the structural integrity of the entire building. In addition, the flatwork and most of the

original portions of the pier-and-beam foundation are not structurally “sound”¹ and must be completely removed and replaced with properly engineered foundation.

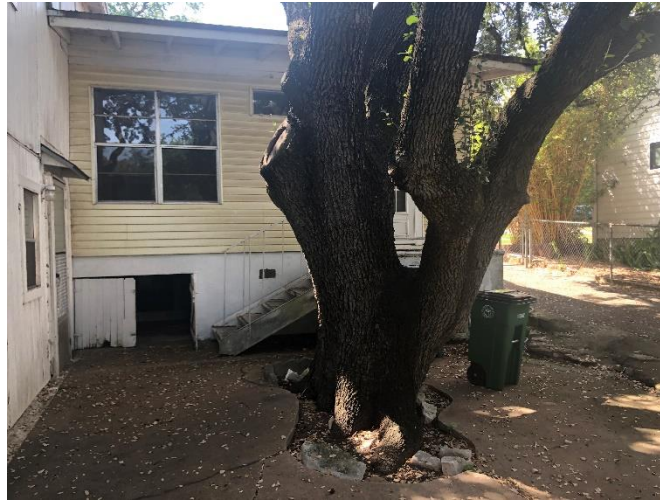
- Proximity of the house to large trees. The presence of trees near the foundation will change moisture content of the clay soils underneath the foundation and may cause damage to the structure, Figure 4.

Figure 4. Proximity of large trees.

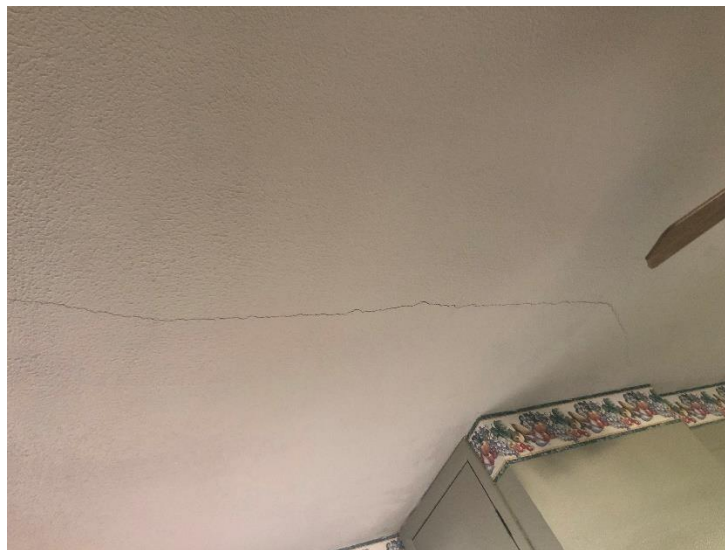
- Interior Floor elevations indicate that the floor is approximately 3.0" out of level (*pier-and-beam*). This may indicate a high degree of foundation shifting/settlement. Most variations in elevation measurements inside particular rooms are equal or over 1.5", pointing to excessive movement.
- Signs of excessive deflection of ceiling elements were noticed on the sheetrock, Figure 5.

Figure 5. Multiple cracks in ceiling.

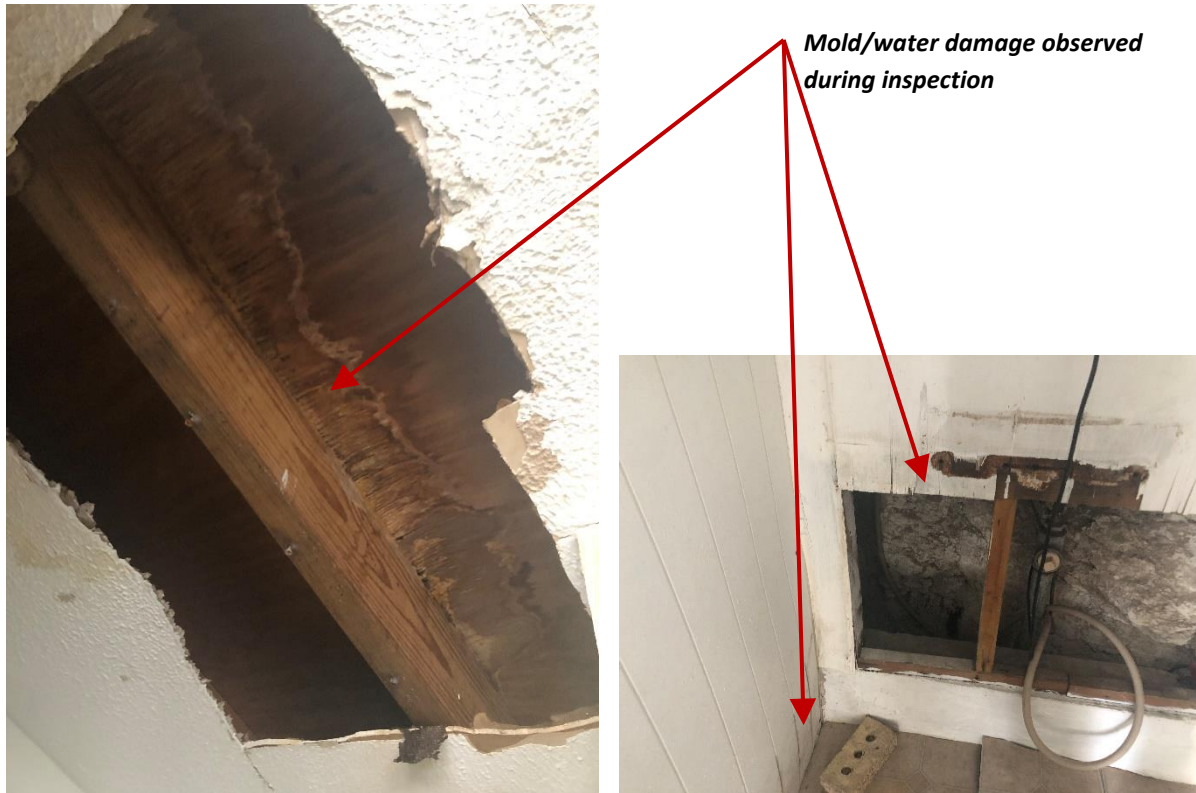
- Mold and framing deterioration were observed in more than a few rooms. The extent of damage could not be determined. Figures 3 and 6.

Figure 6. *Mold and framing deterioration*
