1911 Robbins Place conditions assessment photographs from Applicant

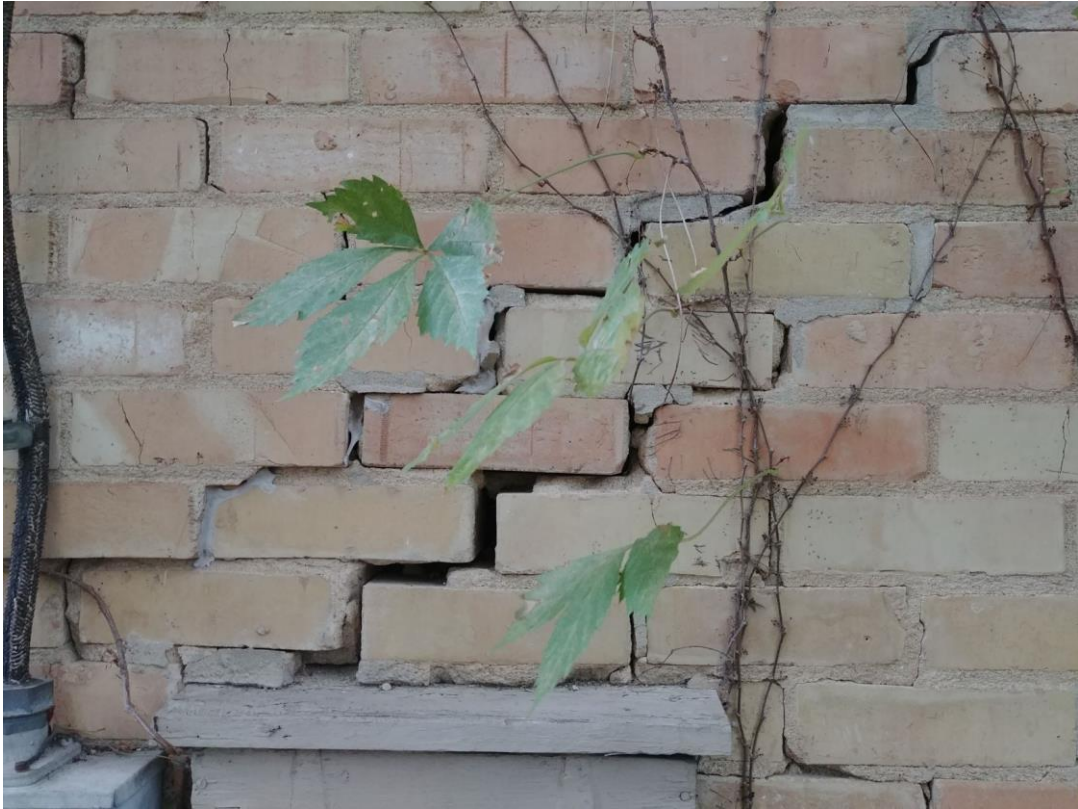
East elevation, low cracks

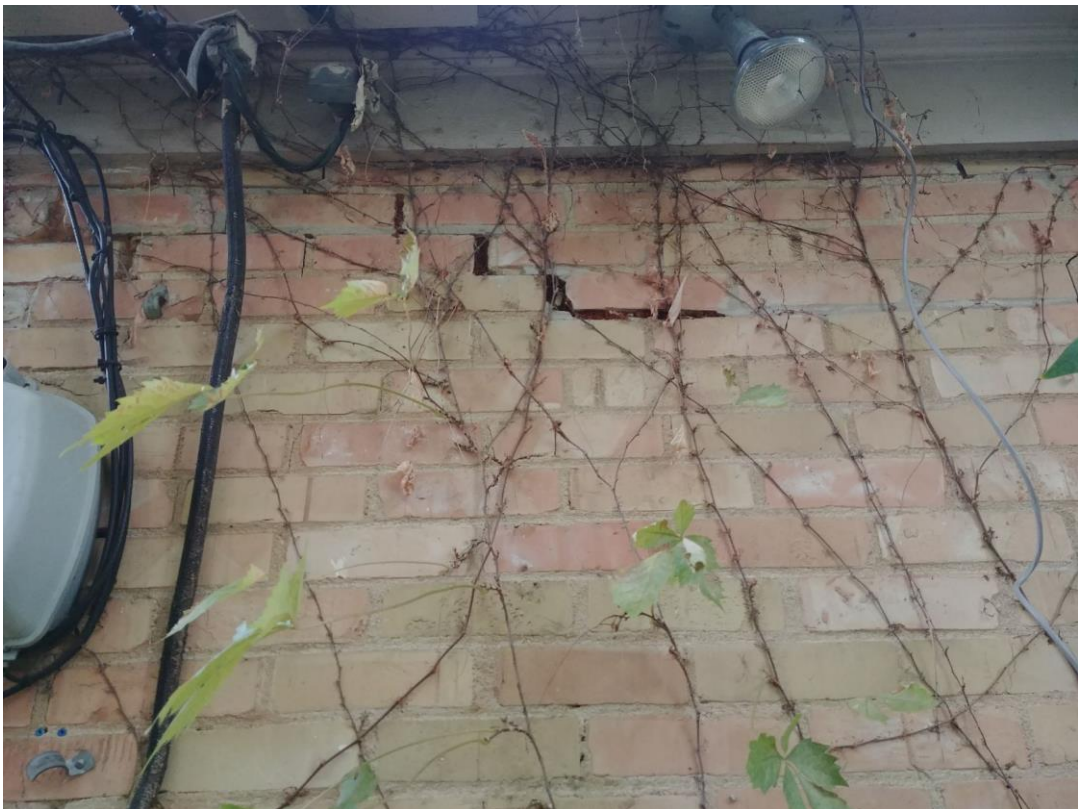
East elevation, high cracks

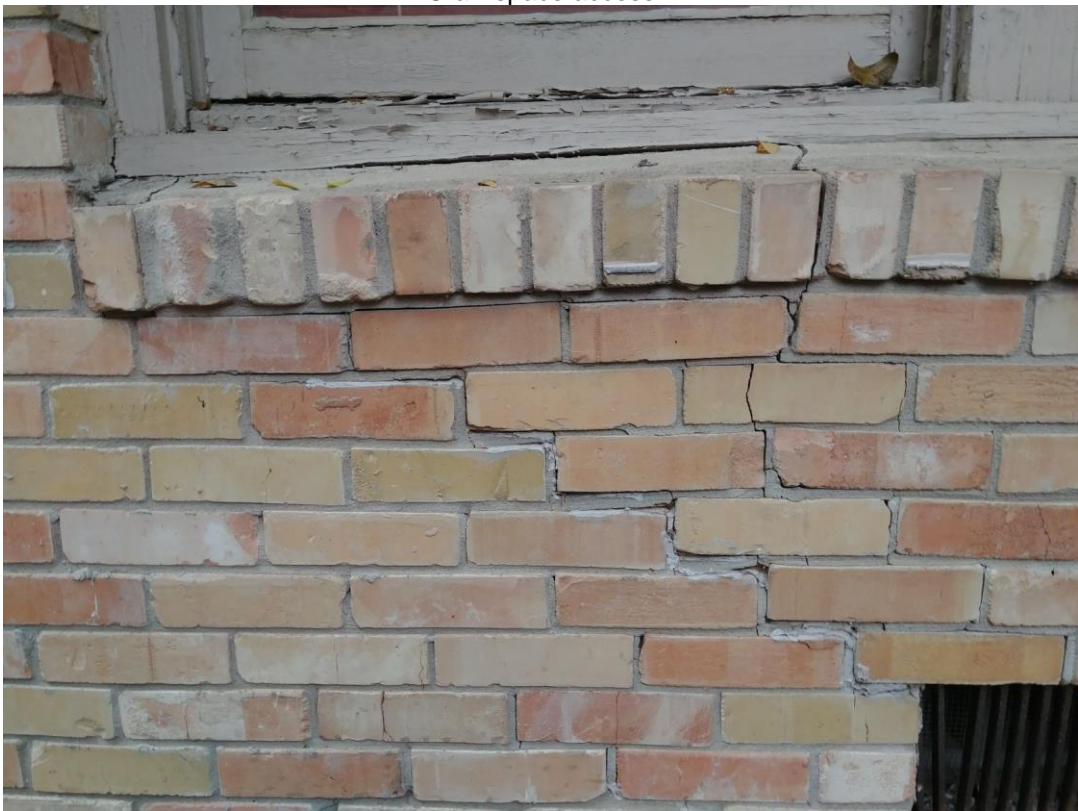
Sinking sill on south elevation

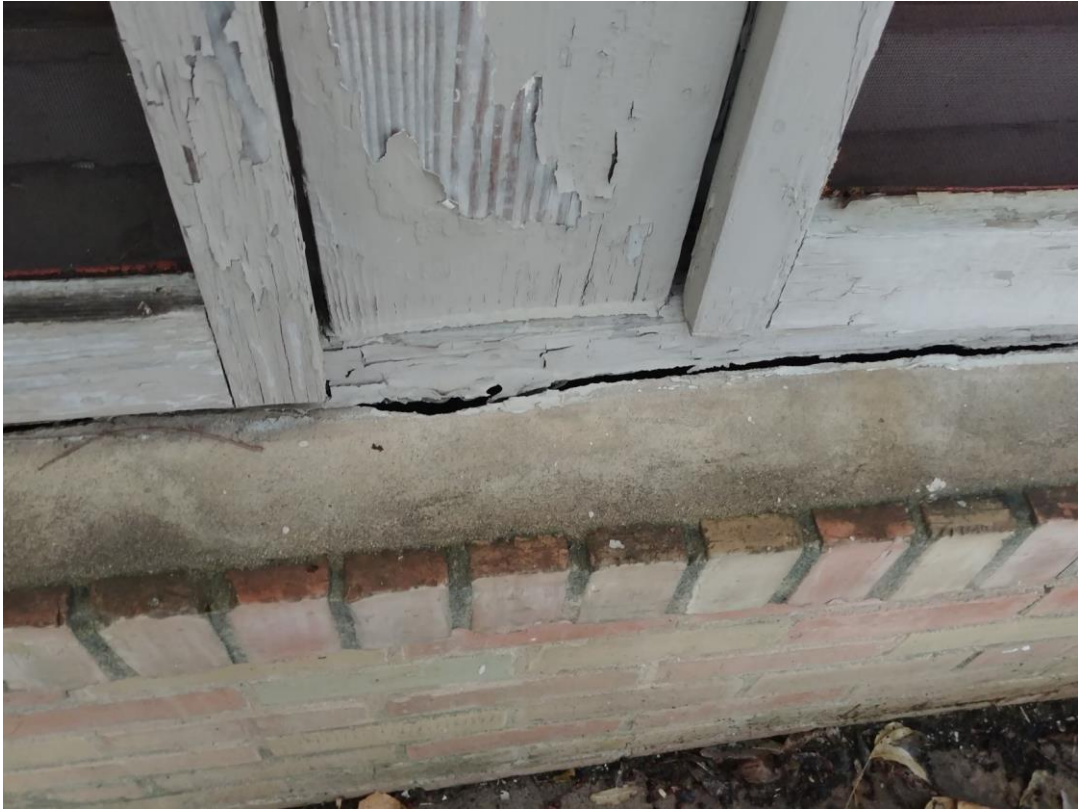
Open sill on west elevation

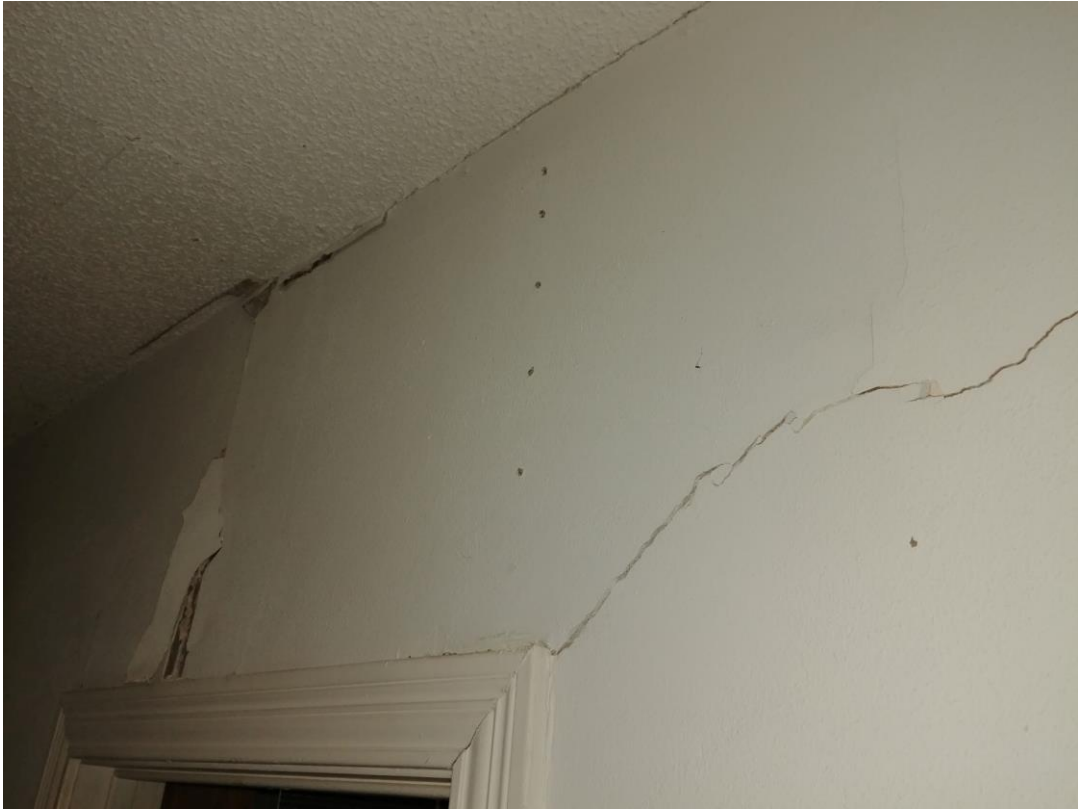
Interior cracks

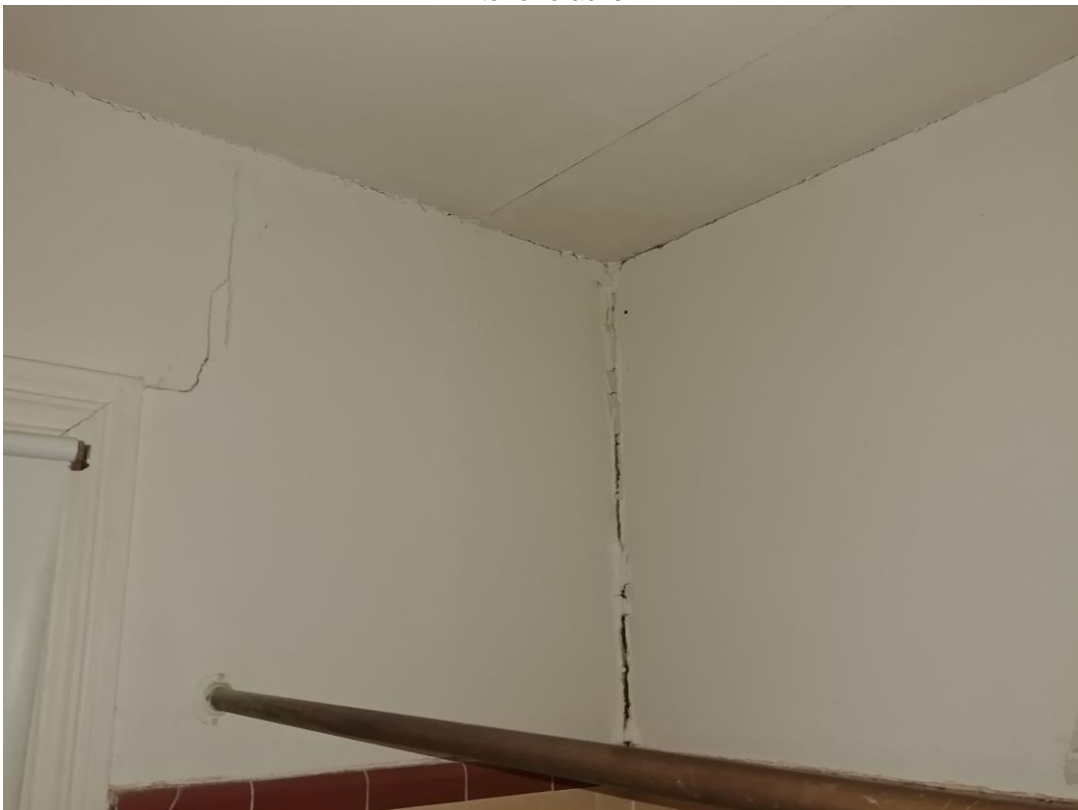
Interior cracks
