## **EXHIBIT A: DESCRIPTION OF SERVICES**

EXHIBIT (A)

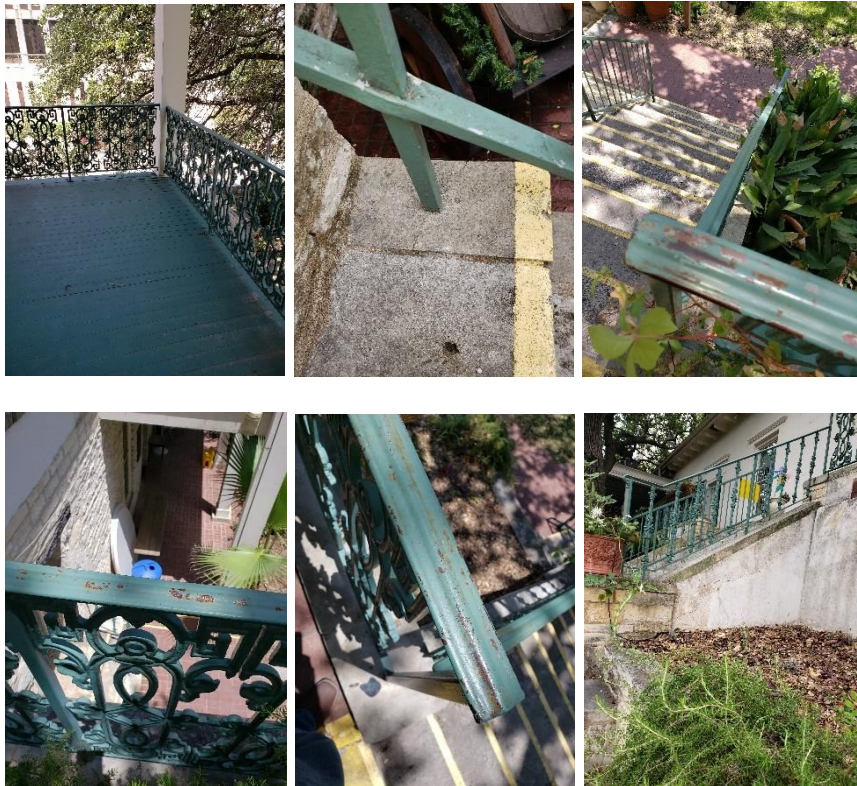
ARTICLE 1

Upon visual inspection there is the need to have the railings repaired, re attached, secured, prepped, and Painted. See EXHIBIT (B).

- A) Repair missing support clips, fasteners, supports and anchors.
- B) Remove any flaking paint, damaged surface, rust, and any loose debris.
- C) Repair all holes, cracks, welds, and damaged areas.
- D) Prime all new metal, exposed metal, repaired sections, and high traffic areas with rust inhibitive Direct To Metal primer.
- E) To repaint all railings, supports, brackets, anchors, and decorative iron on entire west side of structure. Will be painted the same color and sheen.
- F) To include 191 lineal feet of railing on 2 gates, 1 balcony, and two sets of steps.

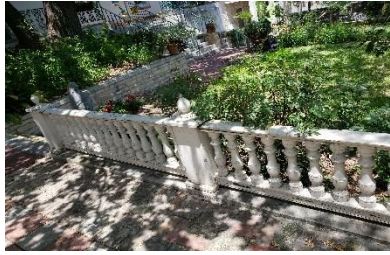
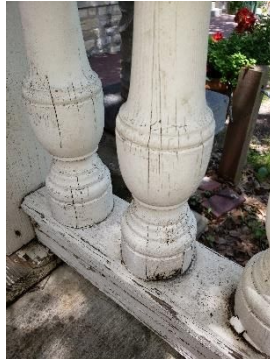
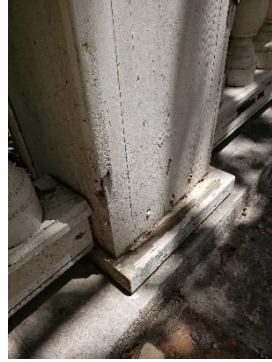
ARTICLE 2

Upon visual inspection the surface is in poor overall condition. There will need to be extensive replacing of custom milled materials. Also, thorough waterproofing will need to be done to prevent future damage. See EXHIBIT (B).

- a) Clean surface with mold killer and wood treatment.
- b) Remove any rot, broken, or damaged wood.
- c) Replace all rotted, broken, or missing wood.
- d) Fill all cracks, seams, and watershed areas with appropriated rated caulk, wood filler, and sealer.
- e) Prime all raw wood with an alkyd penetrating primer
- f) Paint matching color and sheen, 2 coats.

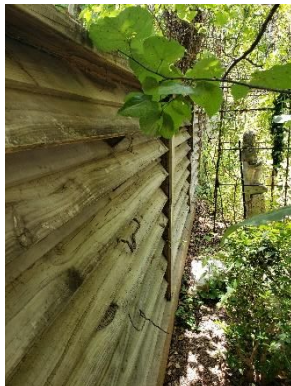
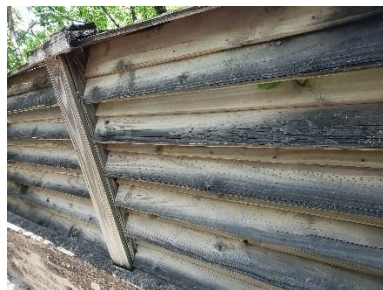
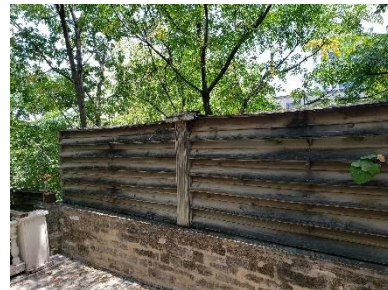
**ARTICLE 3**

The visual inspection revealed warped, rotting, and damaged areas through out fence. I believe the fence to need to be replaced completely as it is not functioning properly and is a potential hazard due to risk of it collapsing. SEE EXHIBIT (B).

- a) Remove existing fencing and dispose.
- b) Repair any structural supports as needed.
- c) Rebuild horizontal style, angled picot, fence sections to match previous design.
- d) Attach sections to wall and encase vertical supports
- e) All treated, dimensional 1x6 deck boards to be used.

- f) Anchor all sections as needed.

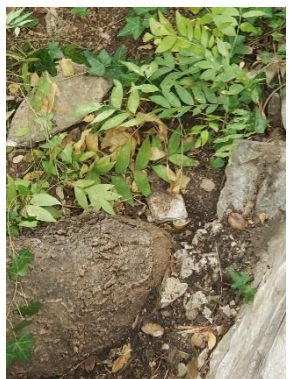
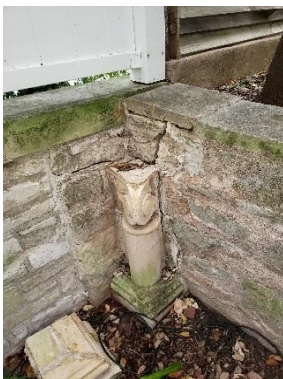
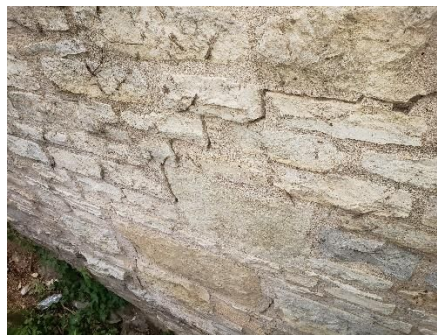
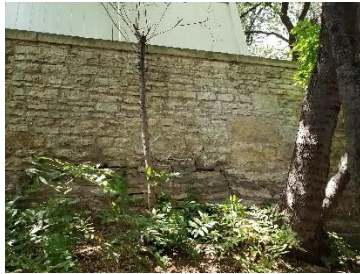
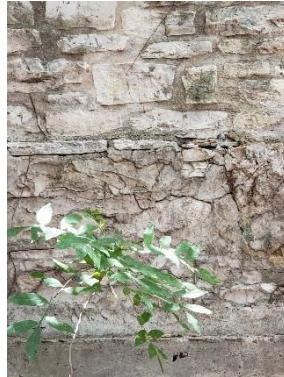
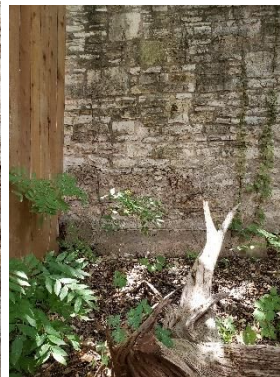
**ARTICLE 4**

After inspecting the damage to the wall, I found a tree intrusion to be the cause of the damage. As the Hackberry tree has matured it has began forcing the footer in an up direction. This has caused extensive cracking. To repair the issue, I will attempt to alleviate the burden on the tree by excavating behind the wall, securing the entity, then cutting out the footer around the tree. I will then put in a lintel to support the opening. In addition to this I will anchor the wall with concrete footers, or piers reinforced with 5/8-inch rebar. Insuring it does not fail. See EXHIBIT (B).

- a) To excavate behind Northwest section of wall, exposing problem area and ensure structural integrity.
- b) Temporarily support wall with external reinforcement allowing repairs to not cause wall failure.
- c) To cut and remove footer and adjoining stone near obtrusion area. Notching around the Hackberry tree.
- d) To install 1/2-inch steel plate to support wall over notched out area.
- e) To form and pour anchoring on back side of wall. Will be formed and tied in with 5/8-inch rebar. Will support wall from future drift or collapse.
- f) Return fill behind wall.
- g) Landscape to match.
- h) \*\*If wall is found to be unsavable, an additional fee of 2,483.00 will be added for rebuild of matching style wall < 10ft x 8ft.

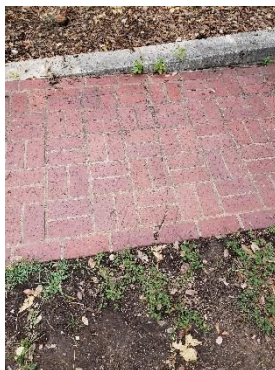
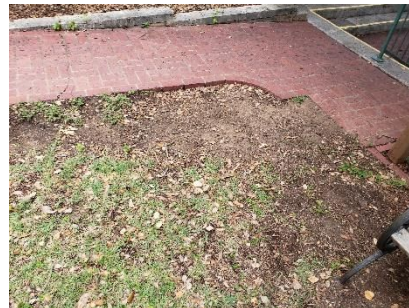
**ARTICLE 5**

Judging by the Landscape around the affected area, I believe that the middle courtyard lawn has been eroding away. This is evident in the cracks to the adjoining sidewalk, and the grade at which the lawn is now. See EXHIBIT (B). the solution to this is to build a retaining wall, fill in till level, and divert the flow of water from through the lawn to down the concrete area to the street.

- a) To build a curved retaining wall along middle lawn area where erosion is occurring.
- b) Will be a curved C shaped wall along the planter and sidewalk.
- c) Will be approximately 22 inches in height.
- d) To be limestone wall with capstone to match nearby retaining walls.

- e) Move irrigation to appropriate height for new grade.
- f) Fill behind wall with sandy loam soil to level the area and prevent future erosion.
- g) Lay sod on new soil.

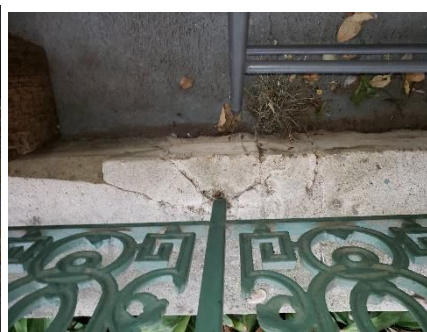
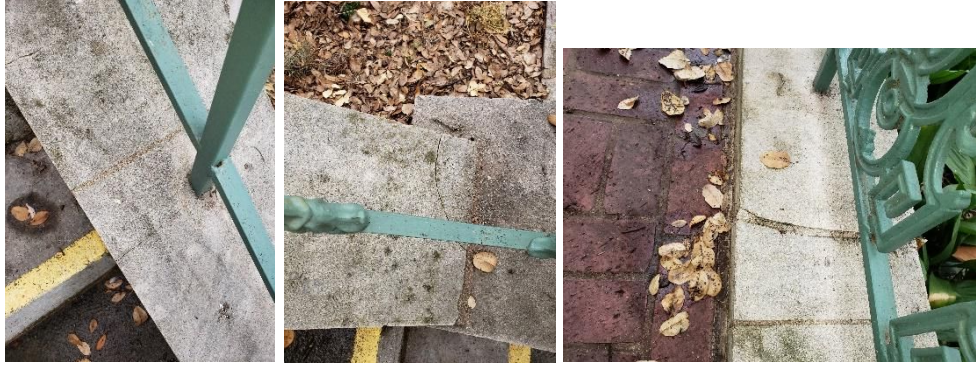
**ARTICLE 6**

Upon inspection of the handrails, I noticed there is a lot of cracking in all the Cap Stones. These cracks are affecting both the stability of the handrail and allowing water into the substrate. The possibility of water causing issues down the line, with both the walls, walkways, and the structure is imminent. I recommend replacing all the damaged cap stones to preserve the integrity of the property. See EXHIBIT (B).

- a) To remove existing damaged Cap stones.
- b) Clean substrate and prep surface for new stone
- c) Cut and install custom dimension slab style cap stone.
- d) Mortar all joints and implement expansion joints.
- e) Use SL1 in all seems to prevent future breaking.

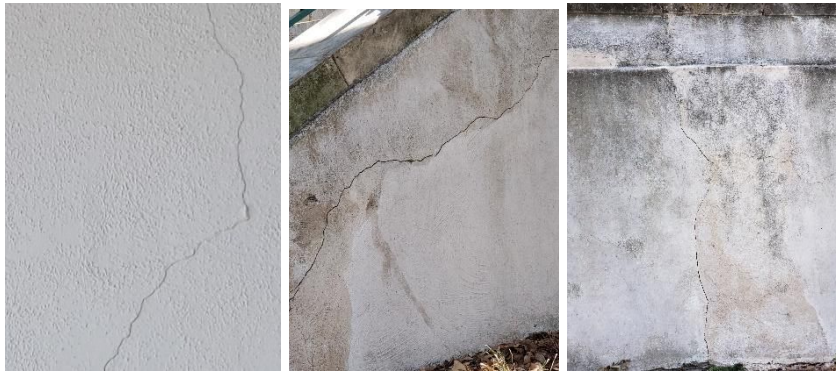
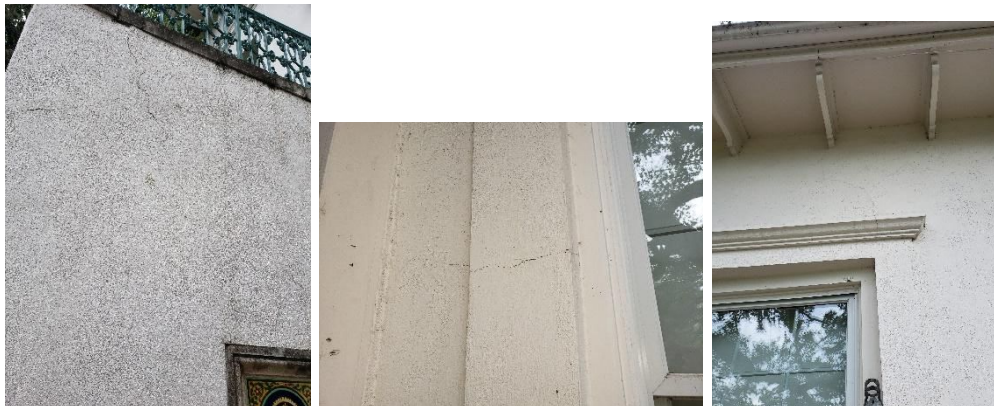
**ARTICLE 7**

After inspecting the property, I found numerous stress fractures in the masonry. To properly remedy this, we will cut out all cracked areas. We will confirm substrate integrity. Then we will Parge-coat as needed. See EXHIBIT (B).

- a) To provide access for work as needed via ladders, scaffolding or lifts.
- b) Protect all areas near work zone. Provide safe and ready access to all entrances and exits.
- c) To remove cracked areas of exterior masonry.
- d) Check for structural causes, and remedy.
- e) Recoat all masonry with appropriate mix and latex additive.
- f) Point up all masonry where fracturing has occurred.
- g) Resurface the chimney cap.

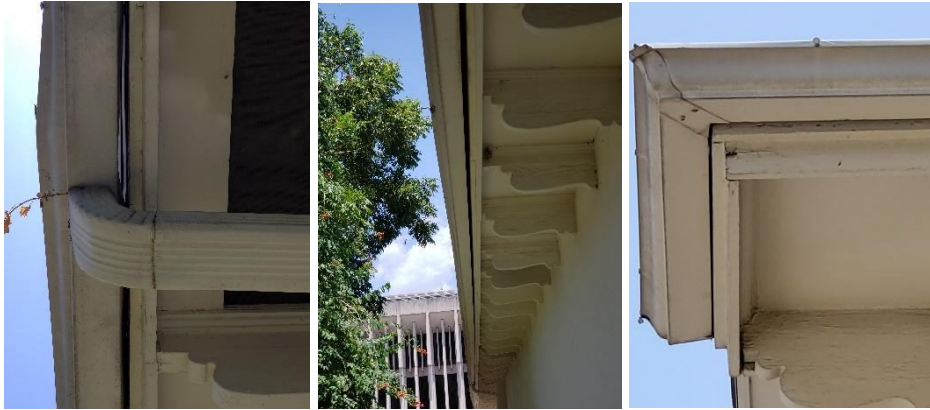
**ARTICLE 8**

Upon inspecting gutters, several areas were found where they are failing. Also the flashing was not properly installed and has caused the wood behind the gutters to swell and rot. In order to repair this, we must remove the gutters and install new ones. See EXHIBIT (B).

- a) To provide safe work platform to remove and install gutters.
- b) Remove existing gutters, downspouts, clips and fastening devices.
- c) Allow time for replacing of damaged wood.
- d) Install 260 lineal feet of 5in k fashion gutters.
- e) 5 downspouts, 4 inside corners, 4 outside corners.
- f) Dispose of all job-related debris.

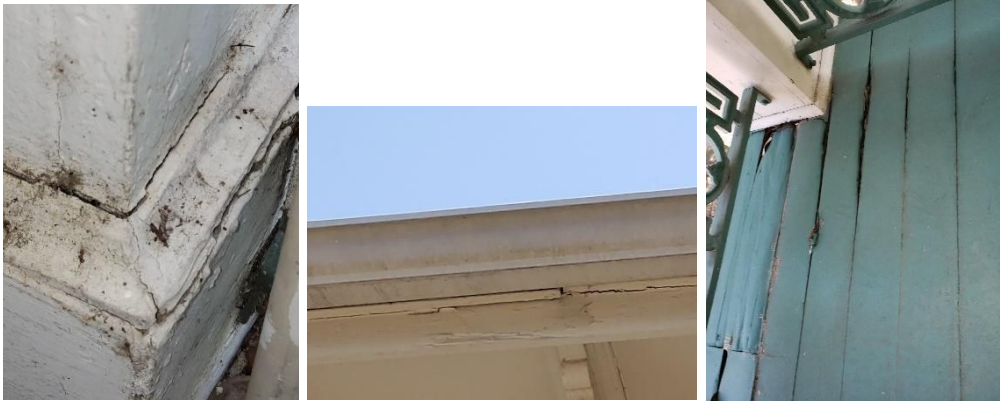
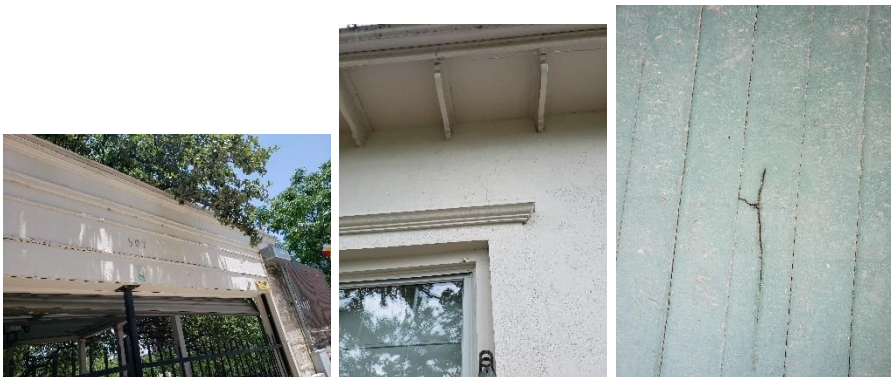
**ARTICLE 9**

The visual inspection uncovered swollen facial boards, rotten decking, rotten base on columns, and multiple areas where molding needs replacing. See EXHIBIT (B).

- a) To provide safe access to areas that need repairing via ladders, scaffold or lift.
- b) To remove flashing and replace any rotten wood on the eve assembly.
- c) To remove rotting deck boards on balcony and replace.
- d) To replace all missing or damaged wood/moldings on columns.
- e) Reinstall flashing and ready for gutters.

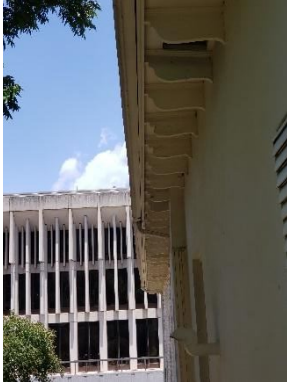
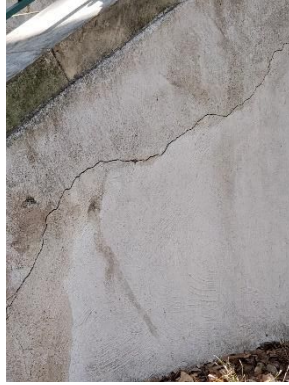
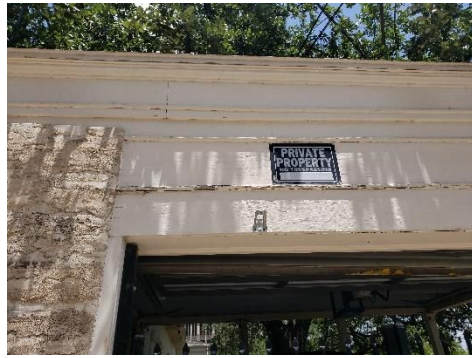
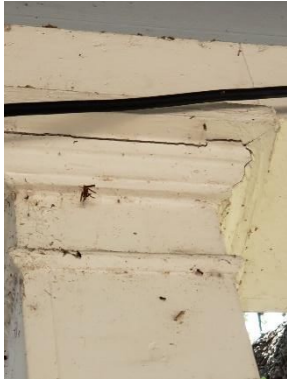
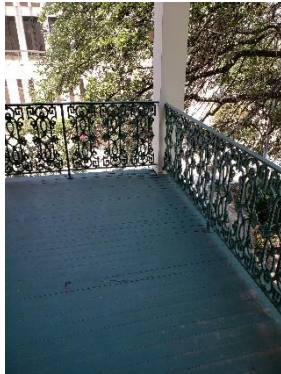
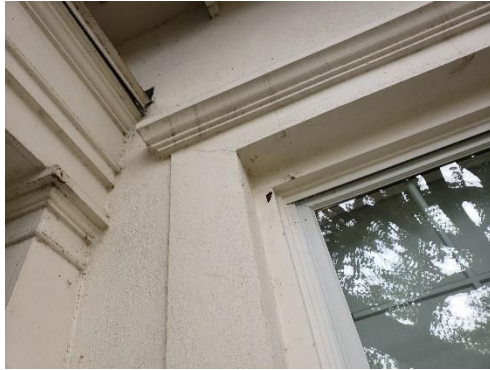
**ARTICLE 10**

A visual inspection found the structure to have numerous areas where moisture could penetrate the surface. Main problem areas are around the flashing, behind the gutters, on all horizontal surfaces

where water can stand, and along dozens of fractures in the concrete around the house. to remedy this, we will seal all areas appropriately, and use an elastomer product made to expand and contract on concrete surfaces. See EXHIBIT (B).

- a) Prime all masonry with effervescent primer.
- b) Prime all exposed wood with a penetrating alkyd primer.

- c) Paint all soffit, exposed rafters, and all exterior wood with 2 coats of satin.
- d) Paint all masonry with elastomeric, applied to specific manufactures specs.
- e) All colors to be painted with a color match of the existing color.
