703 Oakland Avenue

Inspection Report : Exterior Walls

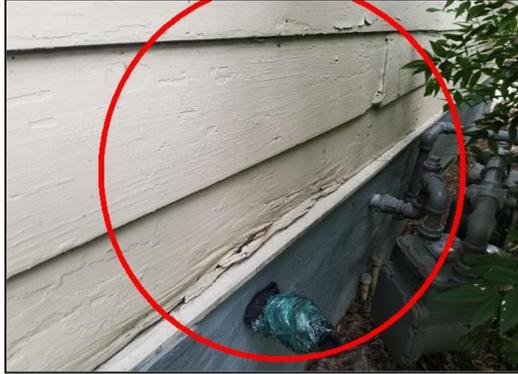
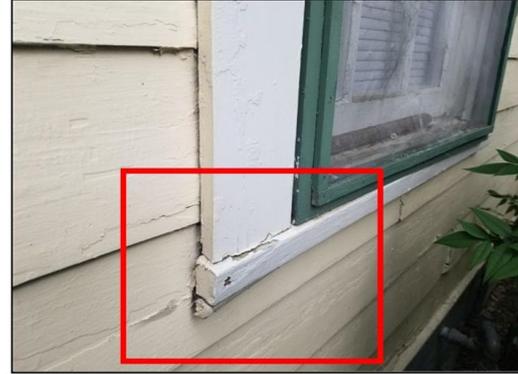
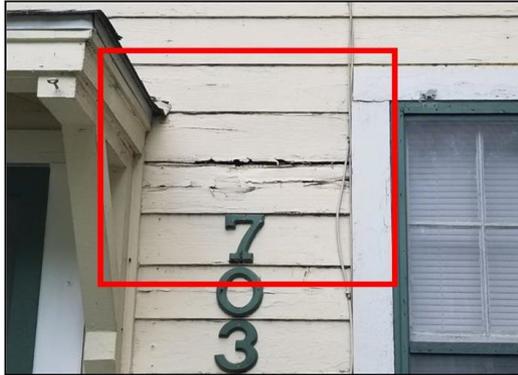
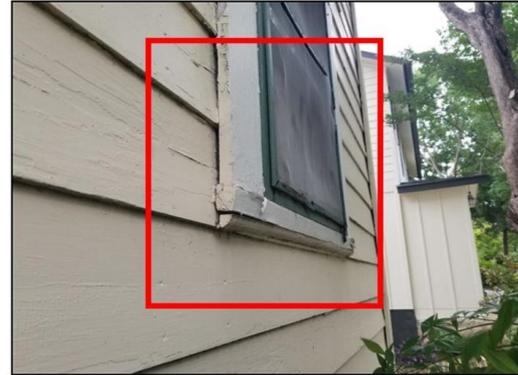
Deficient: Significant and detrimental water damage observed at wall assemblies. Condition is most severe at east wall and "garage" transition. Other locations included around all wall openings (doors, windows, etc.). As repairs are conducted, additional areas are expected to be discovered. The water damage is correlated with deferred maintenance, missing flashing and weatherization details and poor construction practices. **If ignored, condition will progress.**

(3) **Deficient:** End-of-life conditions observed at siding veneer. Defects included: wood rot, deterioration, water damage, loose boards, damaged boards.

Installed flashing and water barrier (zip board)
for long term preservation.

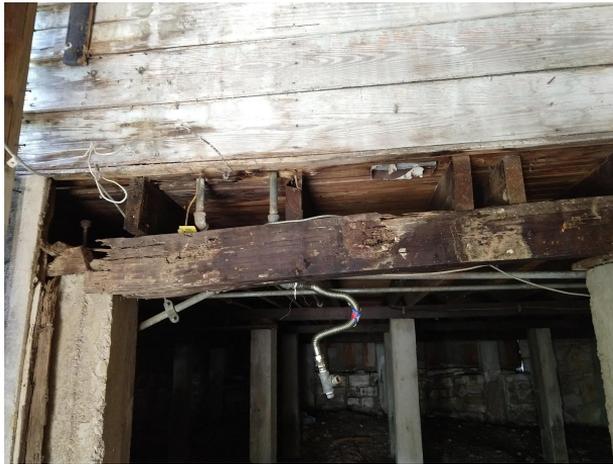
Visible active termites

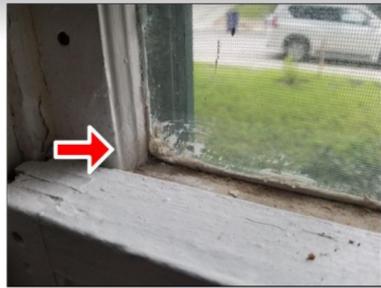
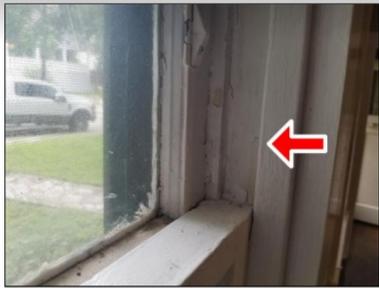
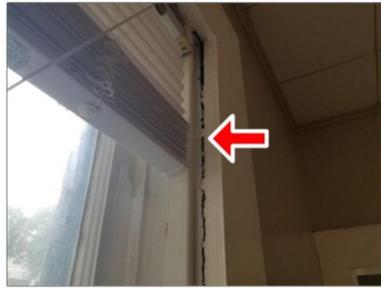
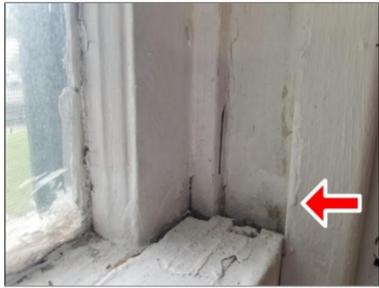
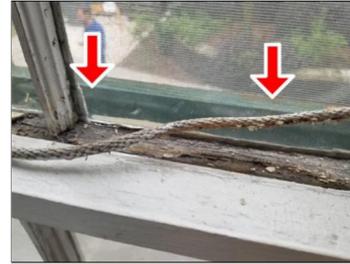
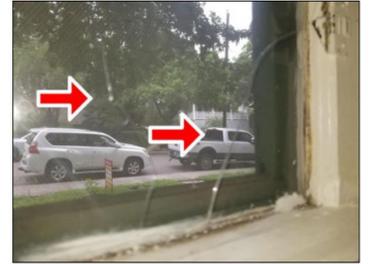
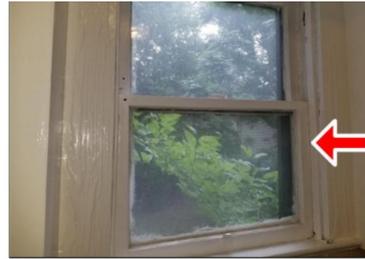
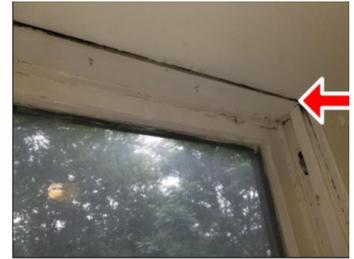
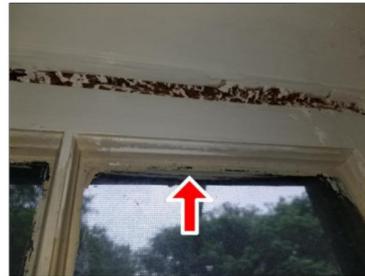
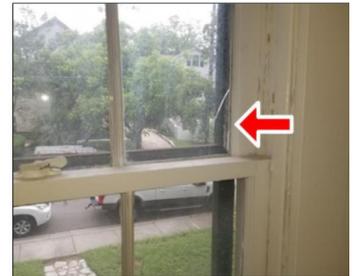
Deficient: The windows are in over-all very poor condition. The majority of windows observed with water penetrations issues, air infiltration issues, deteriorated glazing, cracked panes and damaged/missing counter balance springs, impeded egress (can not escape during emergency - windows do not open).

1. Did not enlarge or relocate any window openings with the exception two rear kitchen windows (south wall - facing backyard)
2. Retained and repaired all possible historic windows by mixing and matching components which were salvageable.
3. For necessary replacement of historic windows, used windows that are the same size and match the dimensions, profile, and configuration of historic windows
4. Substituted materials are appropriate to the profile and finish appearance of the historic window.
5. Replacement windows were installed so that they maintain the same planar relationships and joint patterns as existed historically relative to window frames, exterior wall planes, and other exterior features.

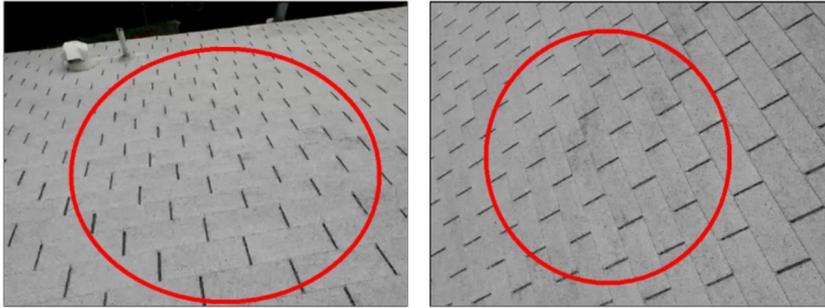
(2) **Deficient:** End-of-life conditions observed at shingles. Defects included: granule loss, exposed substrate, "premature bald" patches, bond failure, damaged shingles (abrasions), probable fastening failure. Current conditions will accelerate that the wear rate on the roof. Areas will require patching with tar as leaks develops. Expect replacement recommendation from Roofing Contactor.

1. Retained original roof shape, including pitches, profiles, and eave heights and depths within 15 feet of the front
2. Cut back trees
3. Requesting Snap Lock Galvalume roofing to be installed.
(50 year)

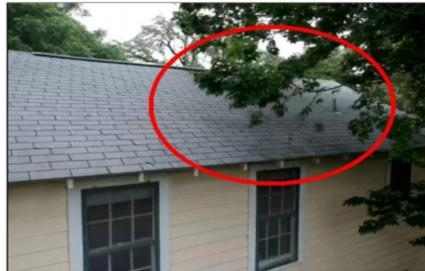
(3) **Deficient:** Overhanging tree branches in-close-proximity to shingles. Current building standards require 3ft tree clearance from roof covering to prevent shingle damage from wind.

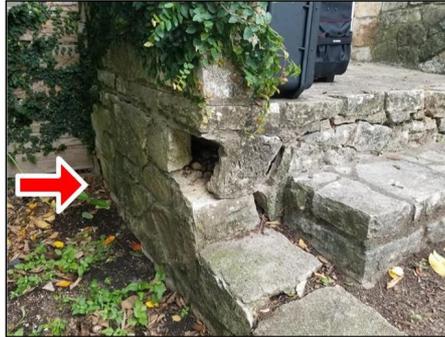
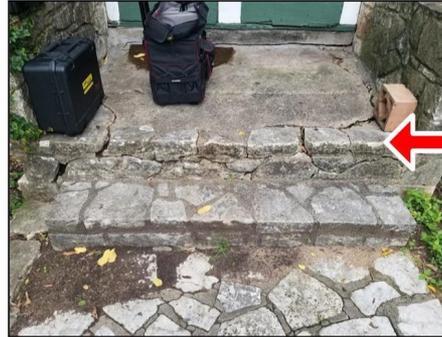
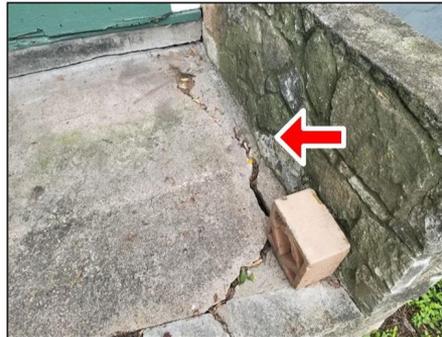
(1) **Deficient:** Porch shows cracking, loose stones, out-of-level appearance, in-adequate riser and tread dimensions.

K Ertle note: The original steps were not to code.

Kept all historical stones to rebuild a safe and code compliant set of stairs leading to front doors. Remaining stones can be used for landscaping around front of house. Stairs must be code-compliant.
