PROPERTY INSPECTION REPORT

703 & 705 Oakland Avenue, Austin, TX 78703

By: Nathan W. Vick (TREC#20219), Professional Inspector, TREC #20219, 5/12/2019

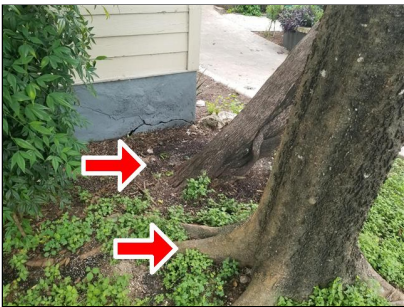
B. Item 1(Picture)

(2) **Deficient:** Southwest and northwest trees in close proximity to structure. Northwest tree appears "dead" and could pose hazards due to proximity.

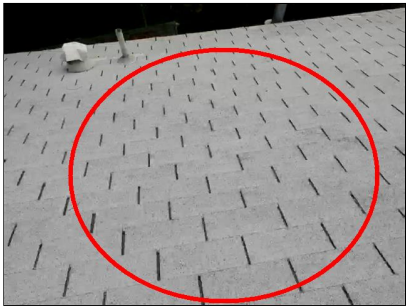
C. Item 1(Picture)

(2) **Deficient:** End-of-life conditions observed at shingles. Defects included: granule loss, exposed substrate, "premature bald" patches, bond failure, damaged shingles (abrasions), probable fastening failure. Current conditions will accelerate that the wear rate on the roof. Areas will require patching with tar as leaks develops. Expect replacement recommendation from Roofing Contactor.

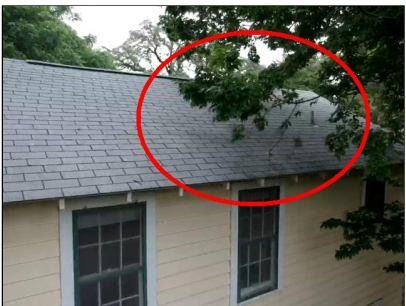
C. Item 4(Picture)

(3) **Deficient:** Overhanging tree branches in-close-proximity to shingles. Current building standards require 3ft tree clearance from roof covering to prevent shingle damage from wind.

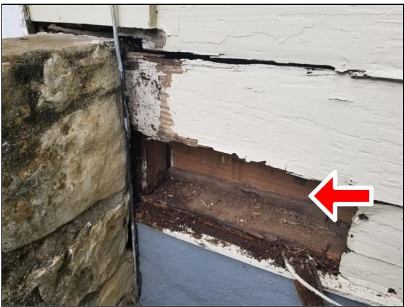
E. Item 1(Picture)

(2) **Deficient:** Significant and detrimental water damage observed at wall assemblies. Condition is most severe at east wall and "garage" transition. Other locations included around all wall openings (doors, windows, etc.). As repairs are conducted, additional areas are expected to be discovered. The water damage is correlated with deferred maintenance, missing flashing and weatherization details and poor construction practices. If ignored, condition will progress.

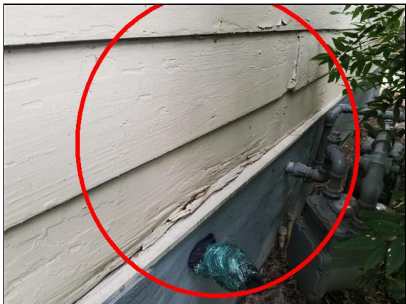
E. Item 9(Picture)

(3) **Deficient:** End-of-life conditions observed at siding veneer. Defects included: wood rot, deterioration, water damage, loose boards, damaged boards.

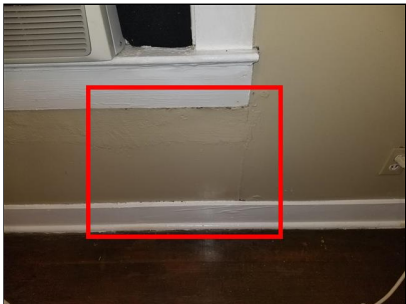
E. Item 17(Picture)

(4) **Deficient:** Considerable vertical cracks, horizontal cracks, stair-step cracks and separation at wall transitions. These appear correlated with other foundation settlement indicators.

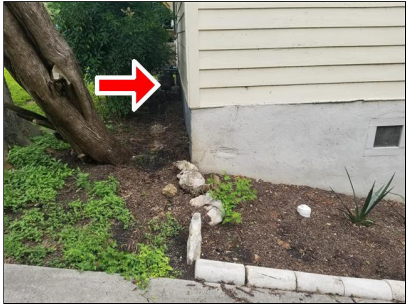
E. Item 21(Picture)

(5) **Deficient:** Bowed or leaning walls observed at east and west walls. This appears correlated with adverse conditions at crawlspace and wall assemblies.

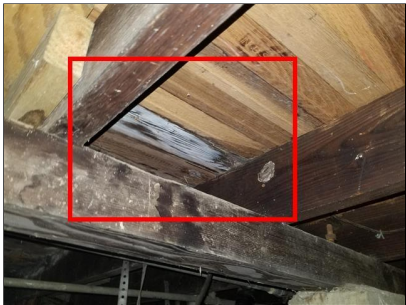
F. Item 1(Picture)

(2) **Deficient:** Water damaged floor assemblies observed near plumbing penetrations at bath rooms and kitchen.

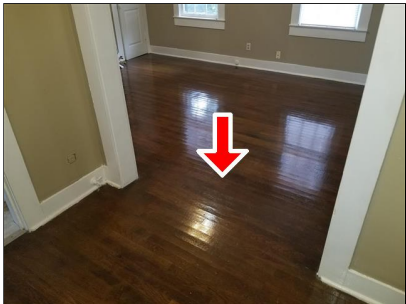
F. Item 5(Picture)

(3) **Deficient:** Ceiling and floor deflection observed at interior. This appears correlated with adverse conditions at crawlspace.

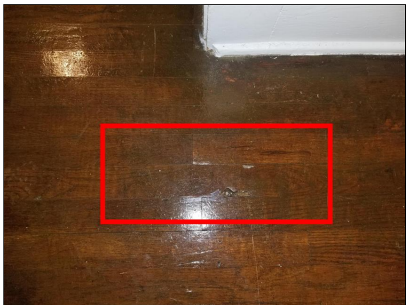
F. Item 8(Picture)

(4) **Deficient:** Termite damage observed at interior wood floors.

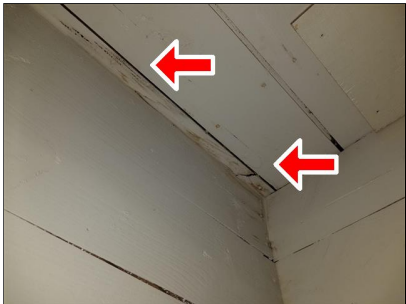
F. Item 11(Picture)

(5) **Deficient:** Possible water damage observed at various locations at ship-lap board materials.

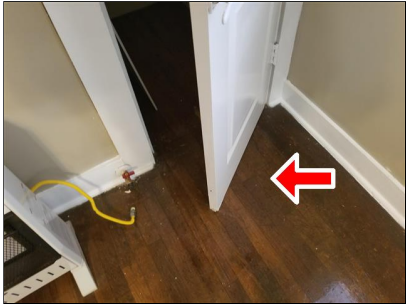
G. Item 3(Picture)

(2) **Deficient:** Exterior and interior doors are binded and out-of square. This may correlate with other foundation settlement indicators.

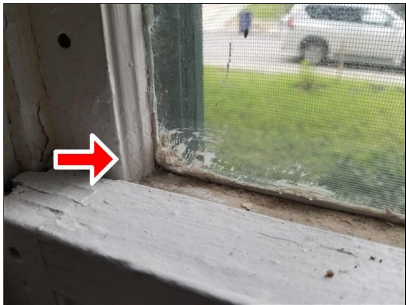
H. Item 1(Picture)

**Deficient:** The windows are in over-all very poor condition. The majority of windows observed with water penetrations issues, air infiltration issues, deteriorated glazing, cracked panes and damaged/missing counter balance springs, impeded egress (can not escape during emergency - windows do not open).

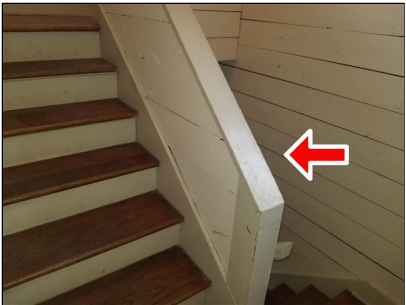
I. Item 1(Picture)

(1) **Deficient:** Inadequate guard railing height. Current building standards require all platforms with a total rise of more than 30inch above the grade or floor below shall have guardrails not less than 34inch in height measured vertically from the nosing of the treads. Code Reference: IRC (R312)

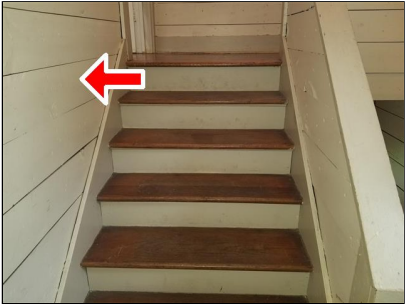
I. Item 2(Picture)

(2) **Deficient:** Missing handrail at stairs. Current building standards require handrail for 4 or more risers (steps.) Handrails must be graspable with a maximum 2.5 inches in diameter. Code Reference: IRC (R311.5.6)

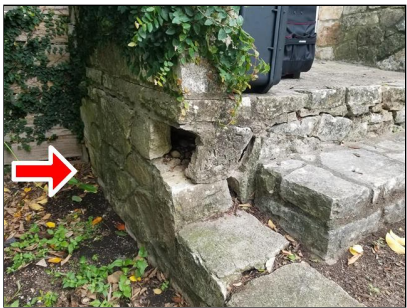
K. Item 1(Picture)

(1) **Deficient:** Porch shows cracking, loose stones, out-of-level appearance, in-adequate riser and tread dimensions.

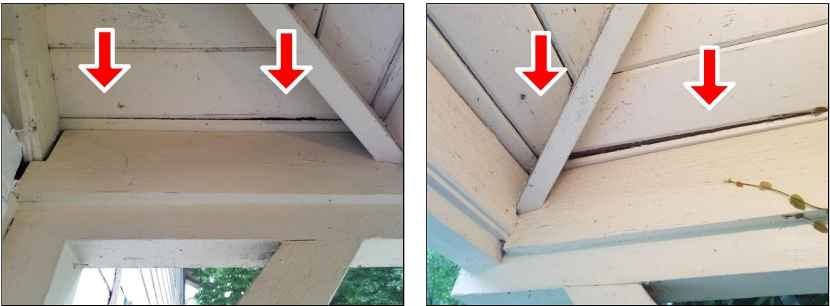
K. Item 4(Picture)

(2) **Deficient:** Porch roof covering observed with water damage at soffit materials. Water leakage is expected.

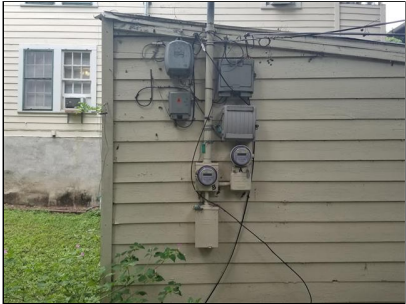
A. Item 1(Picture)

**Deficient:** Electrical Panels are in very poor condition. Defects included: FPE Panel present (known fire hazard), old fuse boxes (known fire hazard), rusted enclosures, no ground electrode observed, no bond conductor observed, no labeling, wire size/breaker size, missing breaker cover plates, missing conduit. Current adverse conditions at electrical panels represent fire and shock hazards.

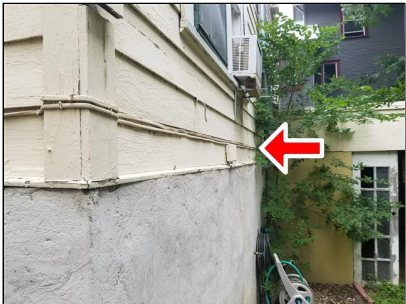
B. Item 1(Picture)

**Deficient:** Electrical wiring is in very poor condition. Defects included: exposed splices, exposed wires, unsecured wires, open ground (majority of outlets and fixtures), reversed polarity, under-sized wires, damaged face plates, missing face plates, non-functional fixtures, non-functional outlets, non-functional

switches, in-adequate number of outlets, arching at outlets, missing exterior rated outlet and switch covers, missing/defective smoke detectors, missing GFCI protection, and missing AFCI protection. Current adverse conditions at electrical branch circuits (connected devices and fixtures) represent fire and shock hazards.

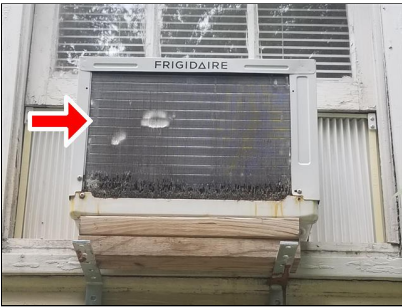
B. Item 1(Picture)

**Deficient:** Window units are in very poor condition. Defects included: damaged aluminum fins, deteriorated aluminum fins, corrosion, poorly cooled. End-of-life conditions.

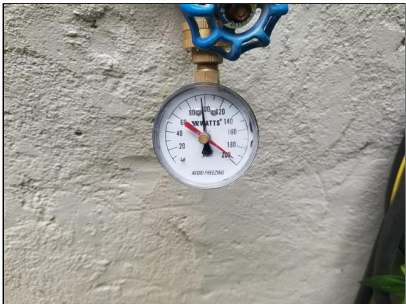
A. Item 1(Picture)

**Deficient:** Water supply systems and fixtures are in very poor condition. Defects included: rusted old galvanized steel piping, leaking old galvanized steel piping, very weak water flow at plumbing fixtures (trickle - upper unit), unprotected pipes at crawlspace, un-secured pipes at crawlspace, leaks at pipe joints and connections at crawlspace, leaks at fixtures, poorly functioning fixtures, loose toilets, rusted steel sinks, high water pressure, missing cut-off valves, rusted cut-off valves, missing Pressure Regulating Valve, missing Back-flow Preventer, missing anti-siphon valves, missing main shut-off valve.

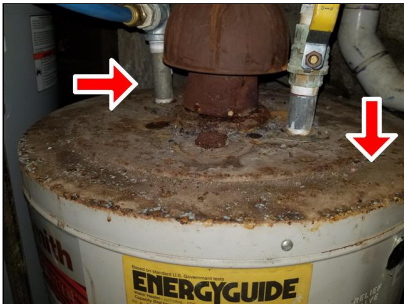
C. Item 1(Picture)

(1) **Deficient:** Upper unit water heater is in very poor condition. Defects included: leakage, diaphragm has likely failed, excess rust formation observed at multiple locations at water heater (flue, tank, connections/fittings), anode rod is fully deteriorated, missing T&P drain pipe, missing Thermal Expansion Tank.

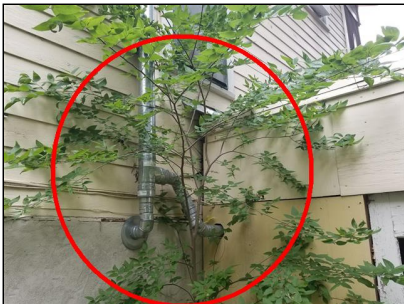
C. Item 4(Picture)

(3) **Deficient:** Vegetation in close proximity to metal flue pipes. This could pose a fire hazard.

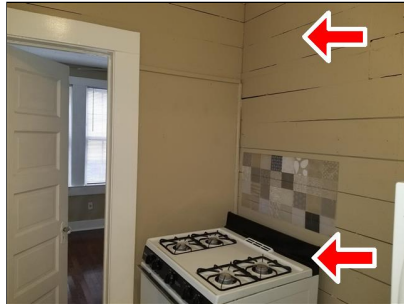
C. Item 1(Picture)

Deficient: Missing ducted exhaust for gas ranges. Current building standards require range hoods to discharge to the outdoors through a single-wall duct. The duct serving the hood shall have a smooth interior surface, shall be air tight and shall be equipped with a backdraft damper. Ducts serving range hoods shall not terminate in an attic or crawlspace or areas inside the building. Code Reference: IRC (M1503)

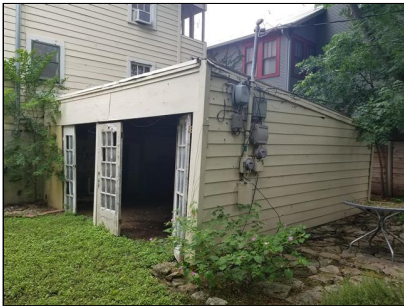
C. Item 1(Picture)

**Deficient:** Garage is in very poor condition. Defects included: under-sized supporting members, over-spanned supporting members, damaged through-out support members, out-of-plane appearance, appears very unstable, high soil elevation, expired roof covering, in-adequate flashing details, water penetration, poor weatherization. Structure will likely be condemned if inspected by City.

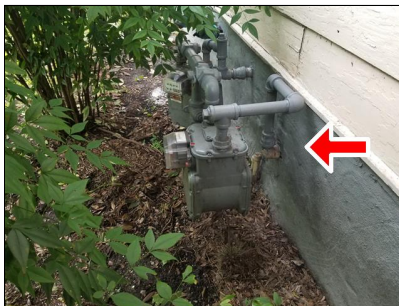
I. Item 2(Picture)

- 🏠 (2) **Deficient:** Could not locate bond at gas piping. Code Reference: NEC (250)

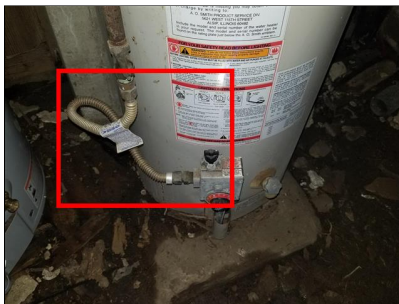
I. Item 3(Picture)

- 🏠 (4) **Deficient:** Missing drip leg (sediment trap) at water heaters and radiant heaters. A sediment trap (referred to as Drip Traps or Drip Legs), is a small "Tee" pipe assembly installed in the gas line just before the appliance. Any debris that contaminates the control can cause the system to operate unsafely. Code Reference: UPC (505)
