/Field Report

Seaholm Power Plant Rehabilitation

Report on Methods of Selection of Cleaning Process for Exterior Concrete

Issued: 9.4.12

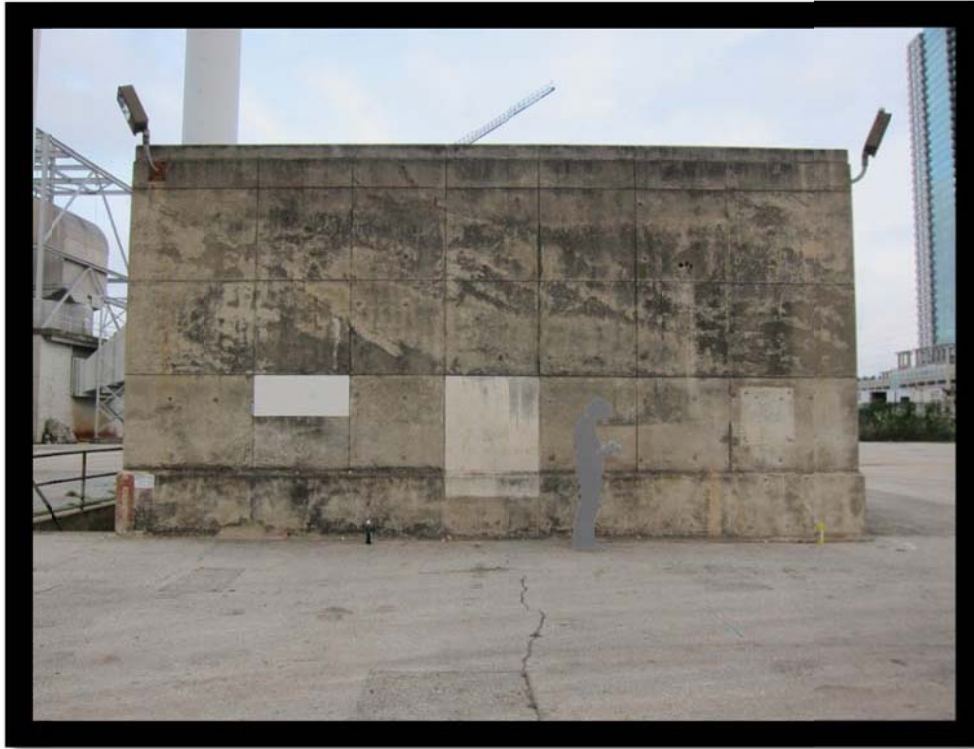
1. After a visual inspection of all four facades of the Fuel Oil Building, the eastern façade was selected for test cleaning as being representative of the overall project. Reference Photograph A for a photo of the eastern façade before any cleaning work was done.

Photograph A - Eastern facade of Fuel Oil Heating Building - Before Cleaning Work - 6.15.12, 7:30 am

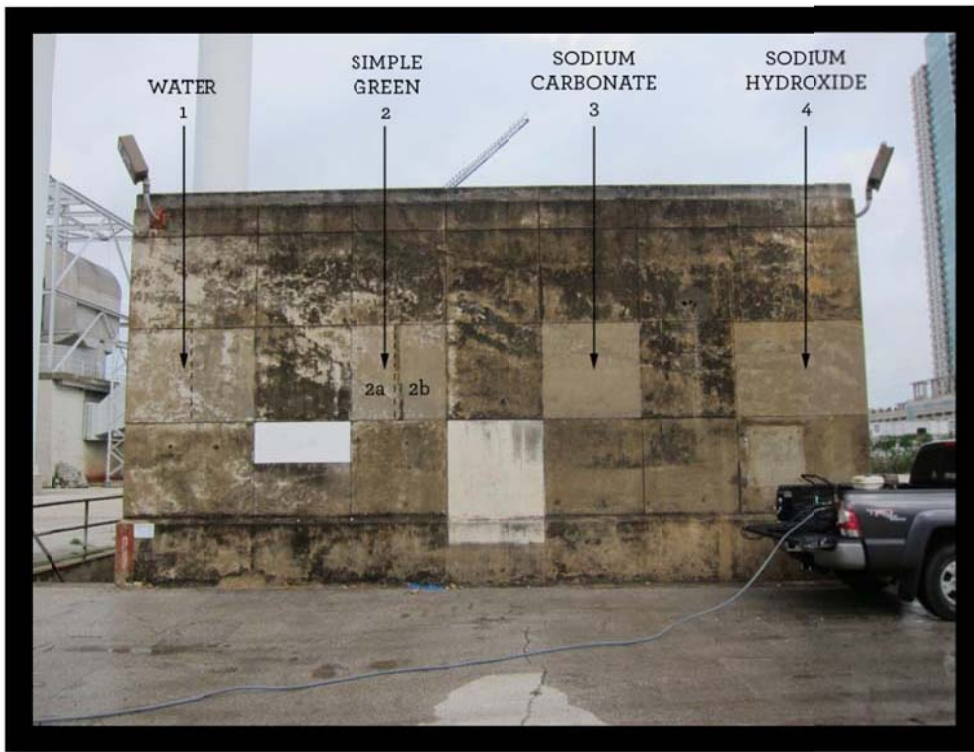
3. Test areas were wet. It was decided to meet on site again on 6.19.12 (weather permitting) at 8:00 am to review the test areas. Reference Photograph B, test areas after pressure washing (note that wall is wet). Areas of “striping,” probably due to the pressure washing wand not being perpendicular to the wall, were noted with the naked eye, but not apparent in photographs taken. For this reason we will recommend dual coverage with both horizontal and vertical cleaning patterns.

4. Ferrous staining (rust spots apparently due to corroding reinforcing steel or embedded steel anchors) were more apparent after cleaning. Ferrous stain removal is to be addressed when paint stripping takes place.

Photograph B - Test Panel Legend & Eastern facade of Fuel Oil Heating Building - After Cleaning Work - 6.15.12, 8:30 am

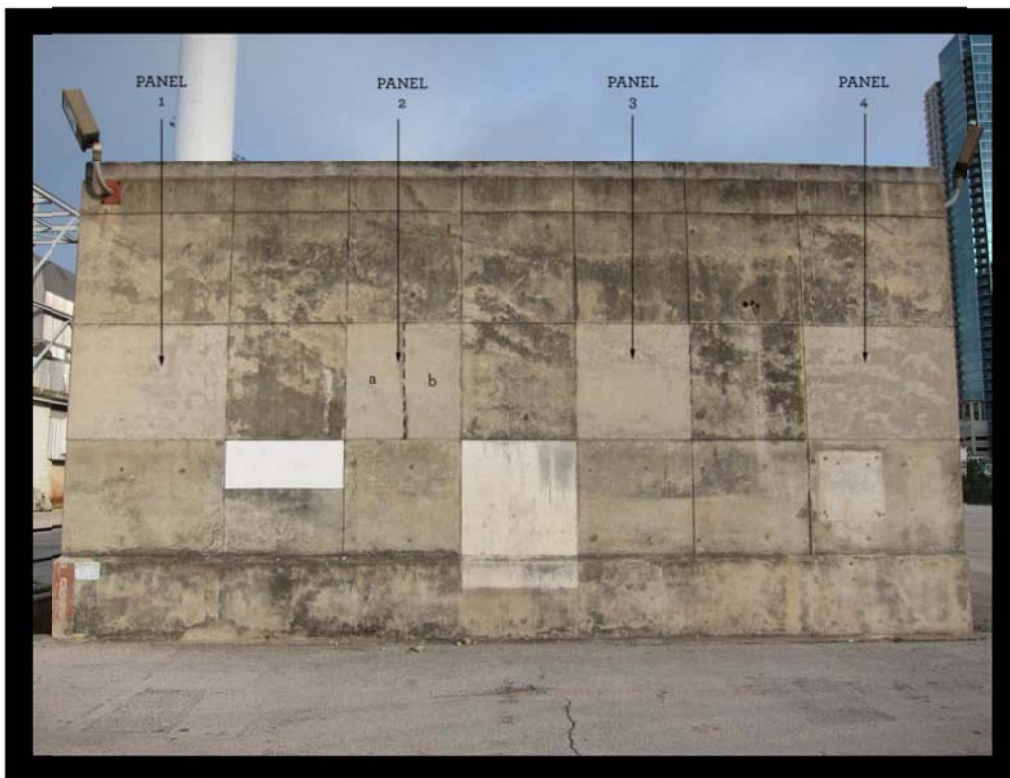
Photograph C - Eastern facade Fuel Oil Heating Building - After Cleaning Work - 6.19.12, 8:00 am

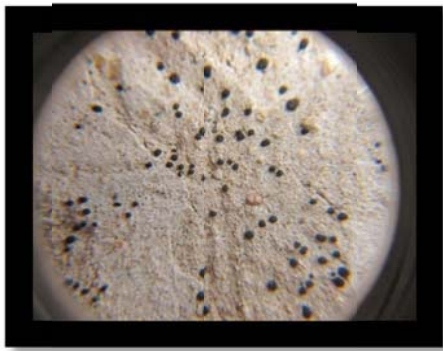
- a. Panel 1 - Organic nodules and staining (mold/mildew) were apparent on the surface of the concrete. Reference Photographs D and E.
 - b. Panels 2a & 2b - No evidence of organic nodules or staining was seen on either panels 2a or 2b. Reference Photographs F and G.

Photograph D - Panel 1; Organic Nodules Present - 10x - 6.19.12

1. The cleaning method for test panel 1 (water only) has been discarded due to its apparent ineffectiveness.
2. The cleaning method for test panel 4 (sodium hydroxide) has been discarded due to its toxicity with no apparent benefit.

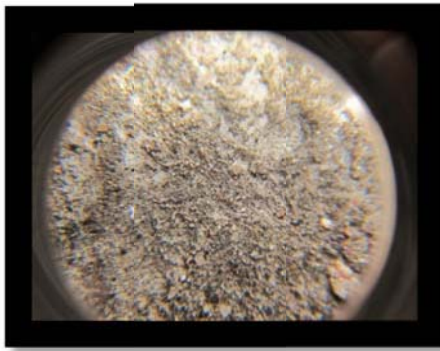
Photograph E - Panel 1; Organic Staining Present - 10x - 6.19.12

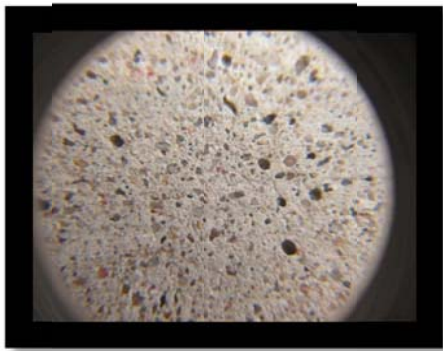
Photograph F - Panel 2a; No Organic Nodules or Staining Present - 10x - 6.19.12

4. Based on the findings to date, we recommend a full strength solution of "Concentrated Simple Green - All Purpose Cleaner" detergent be used on the Seaholm Turbine Generator Building exterior concrete. The solution should be spray applied to soak the surface of the concrete, with pressure washing to follow immediately afterwards, before the detergent dries on the surface of the building. Pressure washing is to be 2,500 psi, with ambient temperature water, with a 15 degree fan tip and a feeler gauge maintaining a minimum of 12" clearance from the building. Based on the test panel cleaning, for an approximate 20 square foot area, pressure washing should take approximately four minutes for the horizontal spray pattern and approximately four minutes for the vertical spray pattern.

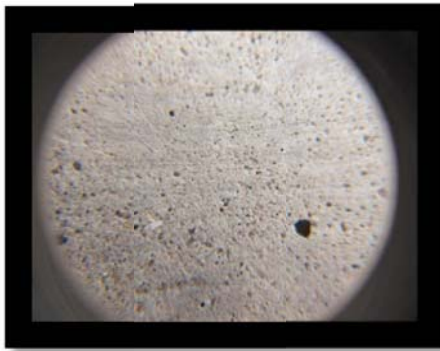
Photograph G - Panel 2b; No Organic Nodules or Staining Present - 10x - 6.19.12

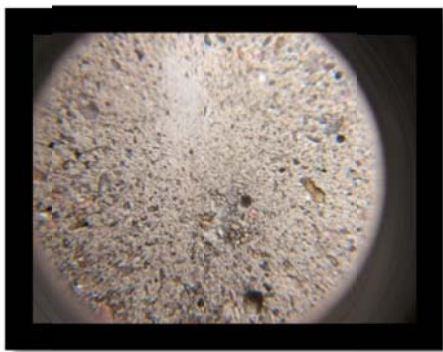
- c. Panel 3 - No evidence of organic nodules or staining was seen on panel 3. Reference Photographs H and J.
 - d. Panel 4 - No evidence of organic nodules or staining was seen on panel 4. Reference Photographs K and L.

Photograph H - Panel 3; No Organic Nodules or Staining Present - 10x - 6.19.12

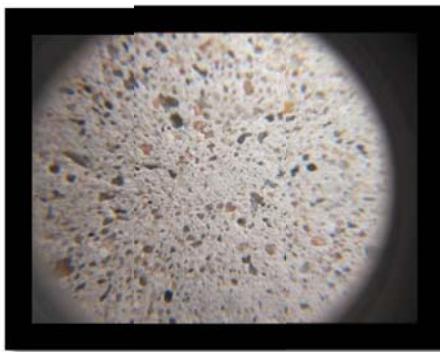
Photograph J - Panel 3; No Organic Nodules or Staining Present - 10x - 6.19.12

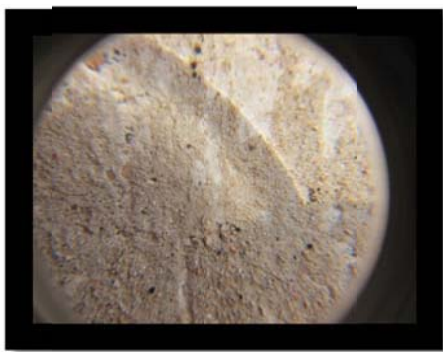
Photograph K - Panel 4; No Organic Nodules or Staining Present - 10x - 6.19.12

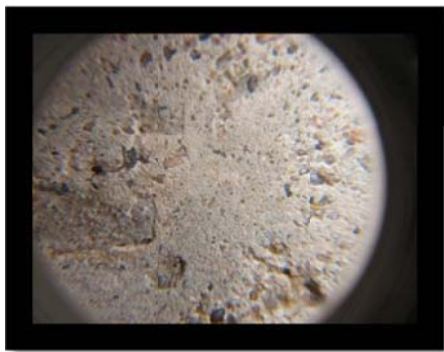
Photograph L - Panel 4; No Organic Nodules or Staining Present - 10x - 6.19.12

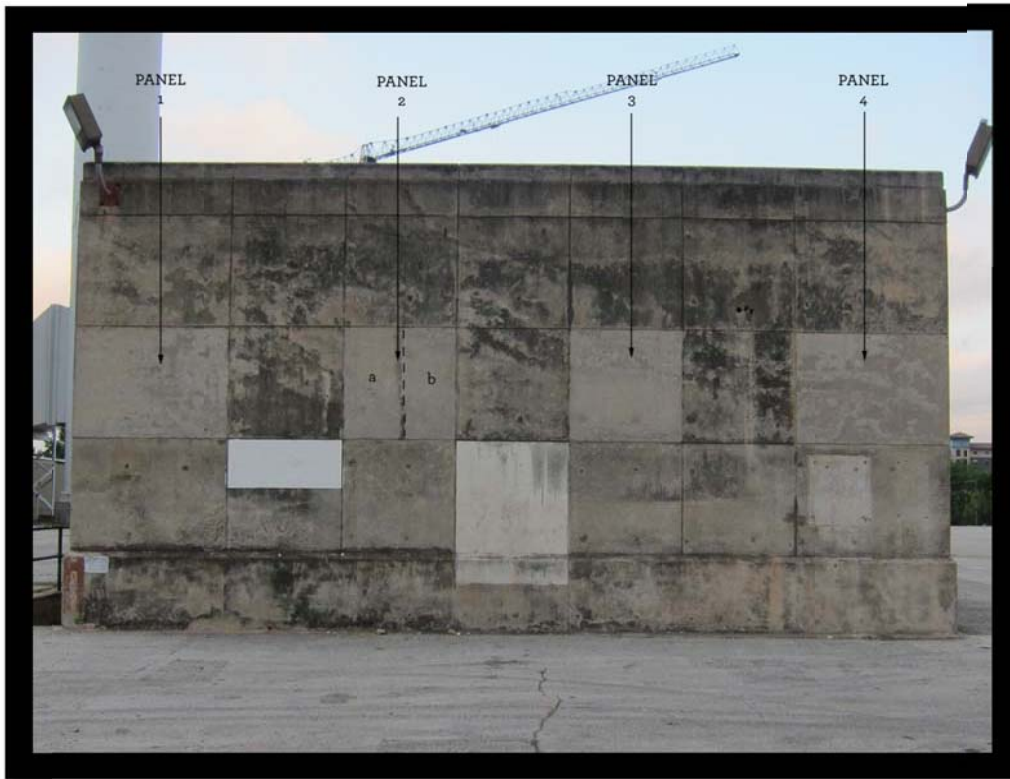
Photograph M – Eastern facade Fuel Oil Heating Building – Three Weeks After Rain - 7.24.12, 7:30 am

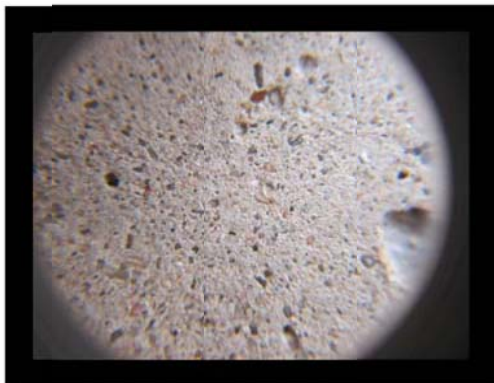
1. Test panels 2a, 2b & 3 were visually inspected by George Wilcox, with no magnification and with a 10x magnifying lens. No regrowth of organic materials was noted in any of the test panels.
 - a. Panels 2a & 2b – No evidence of organic nodules or staining was seen on either panels 2a or 2b. Reference Photographs N and P.
 - b. Panel 3 – No evidence of organic nodules or staining was seen on panel 3. Reference Photographs P and Q.

Photograph N – Panel 2a; No Organic Regrowth Apparent – 10x - 7.24.12

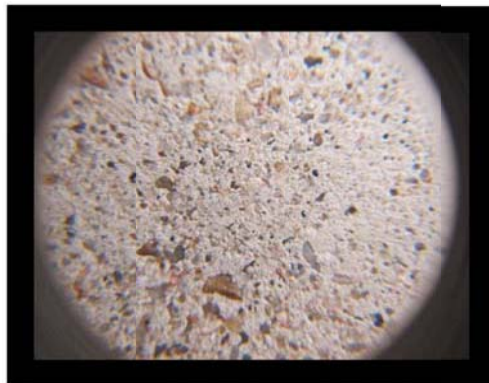
Photograph P – Panel 2b; No Organic Regrowth Apparent – 10x - 7.24.12

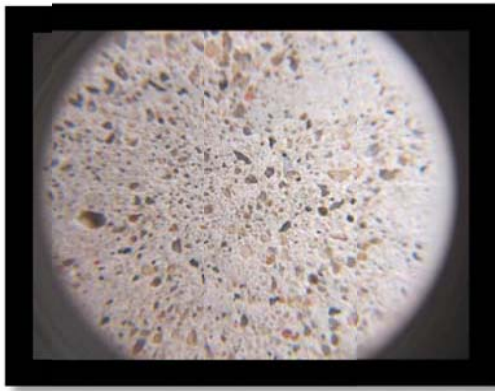
Photograph P - Panel 3; No Organic
Regrowth Apparent - 10x - 7.24.12

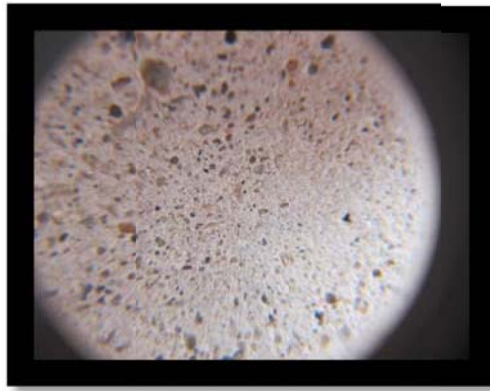
Photograph Q - Panel 3; No Organic
Regrowth Apparent - 10x - 7.24.12
