Structural Evaluation Report

2609 San Pedro St.

Austin, Texas 78705

Report Issued: September 17th, 2020

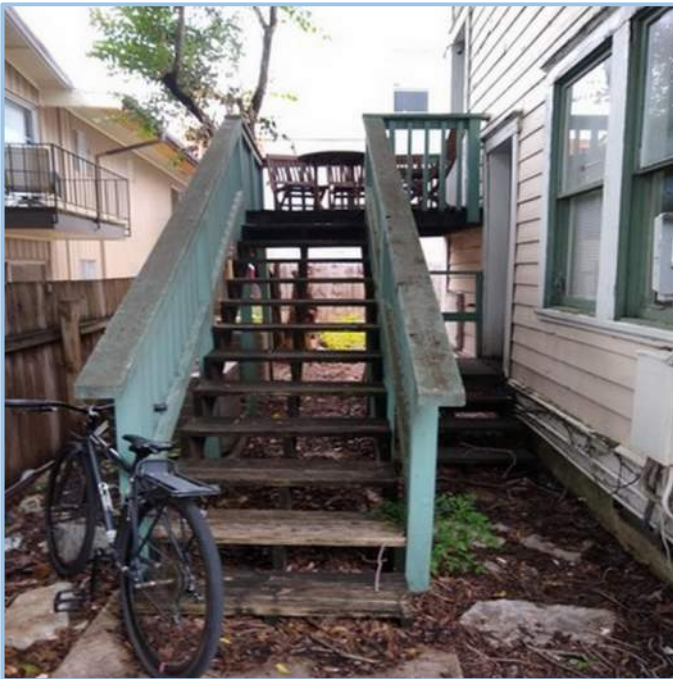
- Rot/deterioration of roof deck and fascia framing was observed likely due to improper flashing at roofs.
- Deck framing at the rear of the structure is structurally inadequate. The wood deck framing is extremely weathered and shows signs of deterioration and does not meet the requirements of the International Residential Code.

Inadequate Deck Construction

The existing structure needs extensive structural work including a new foundation elements, reinforcement of existing framing, repair and replacement of rotting lumber and siding, and replacement of deck, stairs, and railings. Based on the age of the structure and future use, the structural repairs may be cost prohibitive.

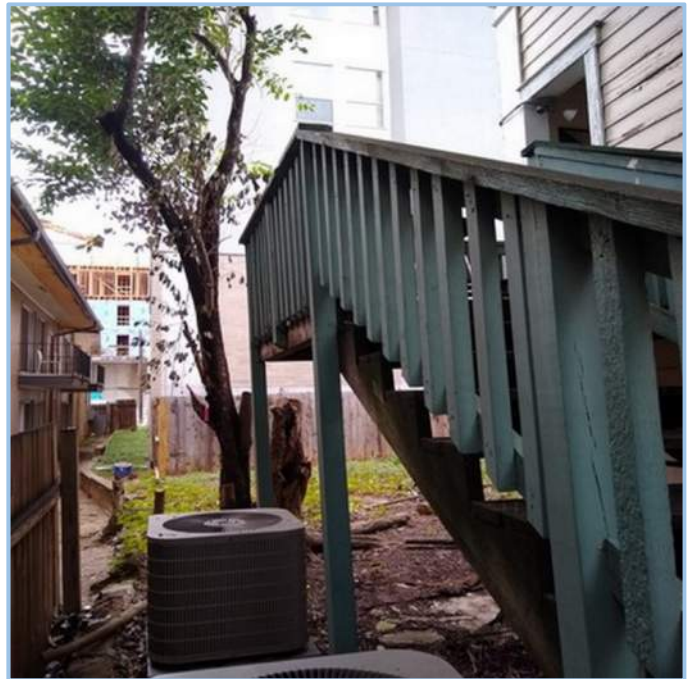
Inadequate Deck Construction

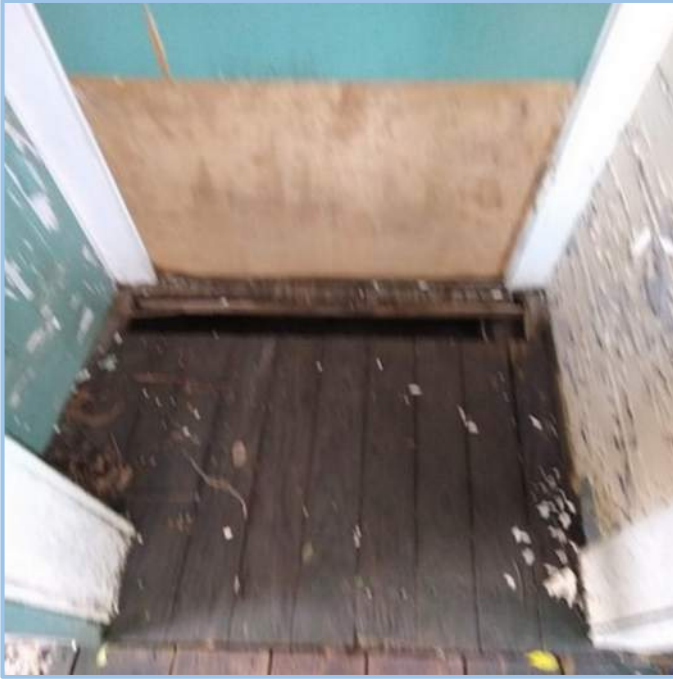
Trip Hazard at Door Threshold

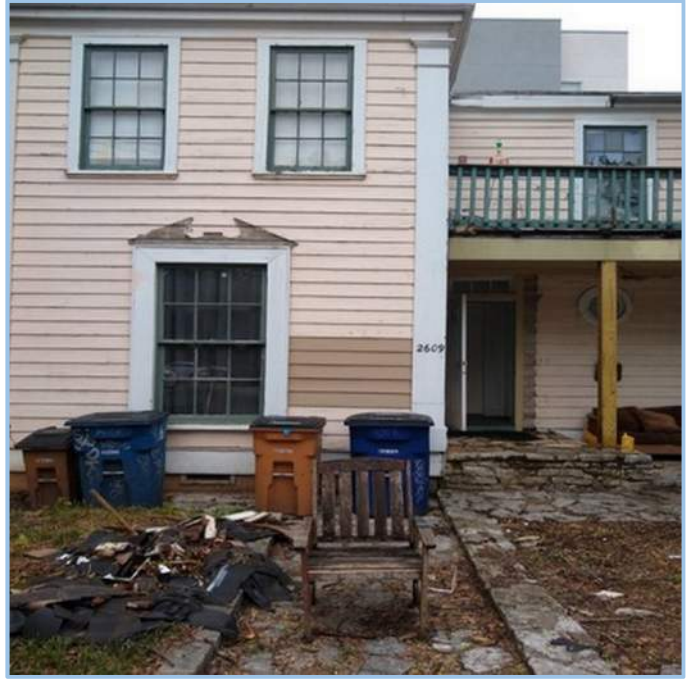
Evidence of Prior Exterior Façade Repairs

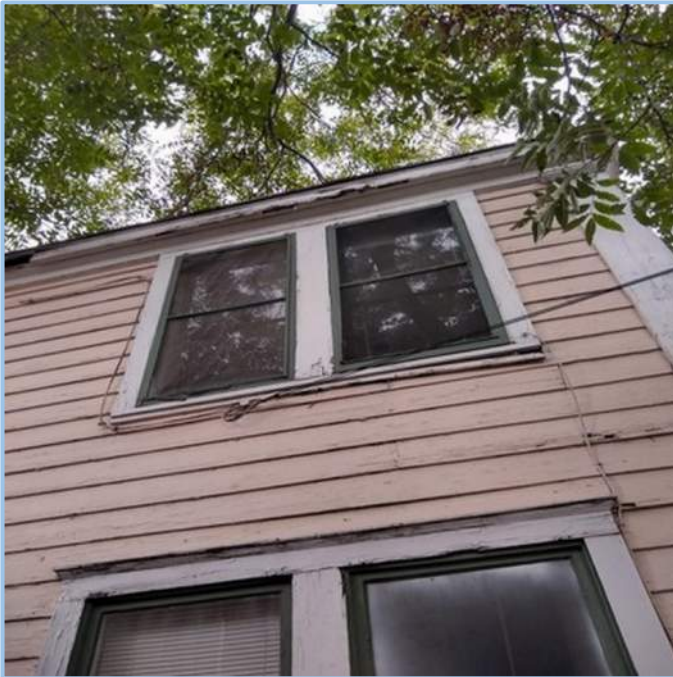
- There is widespread evidence of water infiltration at the building exterior walls. Evidence of water infiltration was observed at window sills at the building exterior throughout the structure. There are widespread areas of water staining, chipping/peeling paint, and bubbling finishes at the exterior walls. There is evidence of past façade repairs at the exterior walls which appear indicate an ongoing issue. Though not directly observed, there is likely widespread framing rot and deterioration at the exterior walls and foundation framing at areas prone to water intrusion. There is a likelihood of a presence of mold growth in the exterior wall cavities.

Water-damaged Exterior Siding
