BPG Inspection, LLC

**2609 San Pedro Street
Austin TX 78705**

Client(s): Joseph
Inspection Date: 9/15/2020
Inspector: Randal Pitts , 9911

Style of Home: Two Story, Duplex	Age Of Home: 1918	Home Faces: West
Vacant or Occupied: Occupied	Utilities Active: All	Client(s) Present: Buyer's Agent
Weather: Partly Cloudy, Hot and Humid	Temperature: Over 80	Rain in last 3 days: No
Ground/Soil Condition: Damp	Ancillary Services: Wood destroying insect	Recommended Professionals: Structural Engineer, Roofer, Licensed Electrician, Licensed HVAC, Licensed Plumber, Licensed Pest Control, Door, Window, Chimney Sweep

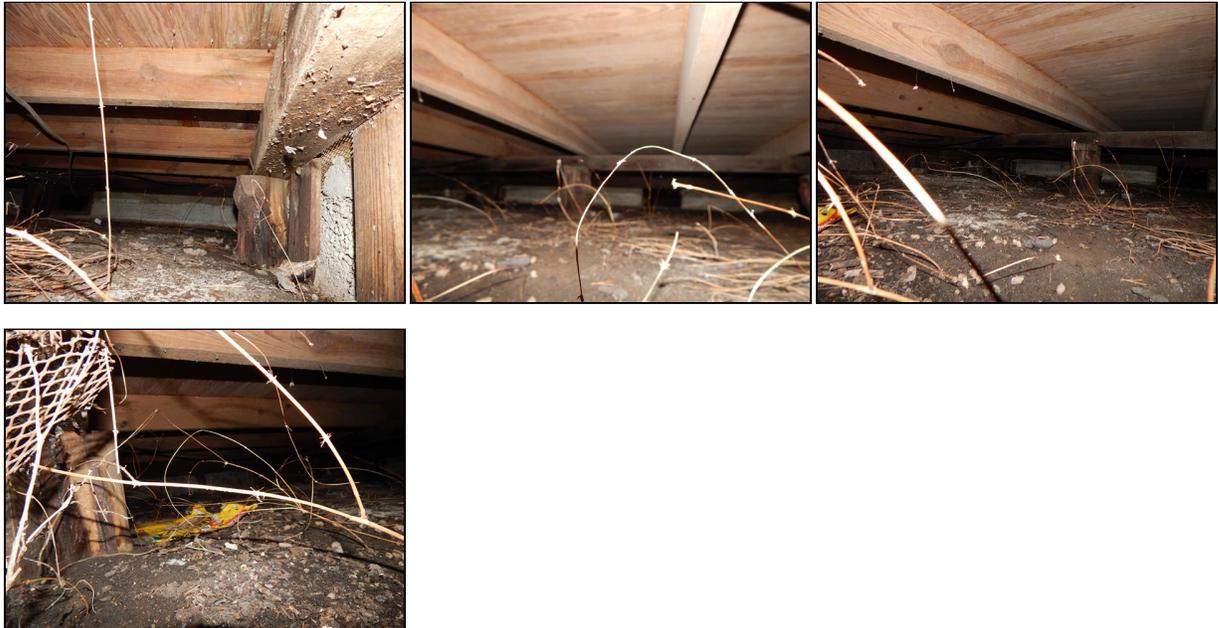
The foundation piers and structure are original to the house. The existing posts are wood (cedar), placed directly into soil with no concrete support or barrier. These posts deteriorate/rot over time and can cause the entire structure to shift and become out of level. The current construction standard is to have the beams supported on concrete pilings that are imbedded in the soil (depth determined by engineer), and the beam structure is then secured to the pilings with metal straps. I recommend this structure be further reviewed by a licensed engineer or foundation contractor to determine the extent of any needed repairs or components replacement, and to obtain an estimate on the cost of those repairs.

The pier & beam foundation structure exhibits signs of differential settling (un-level floors, doors out of square, cracks in wall and ceiling sheetrock etc.). Pier and beam foundations do require levelling or repair every few years (the intervals are dependent upon the materials and quality of construction). I recommend further evaluation of the foundation structure by a licensed foundation repair company familiar with this type of structure.

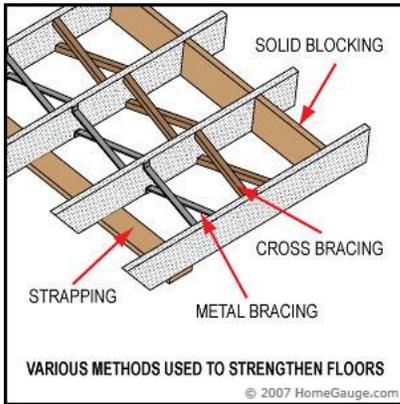
There is no cross bracing between joists were observed as would be found in current era structures. Update as recommended by a foundation contractor.

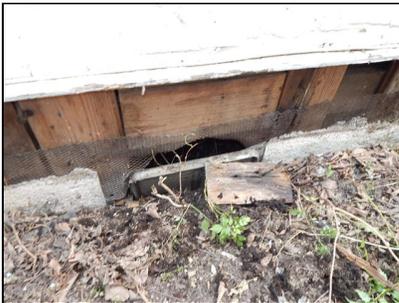
Wood underpinning is in contact with the ground at the front, rear and sides of. This can cause deterioration and attract wood eating insects.

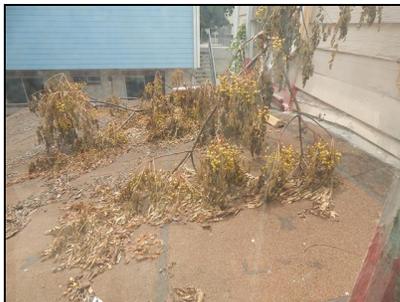
I recommend increasing the ventilation to promote the life expectancy of roof covering. 1 sqft ventilation per 150 sqft attic space.

Remove all debris from roof slopes and valleys. Leaf debris may hide possible defects and damage to roofing materials. Debris may also cause water to dam up under shingle tabs.

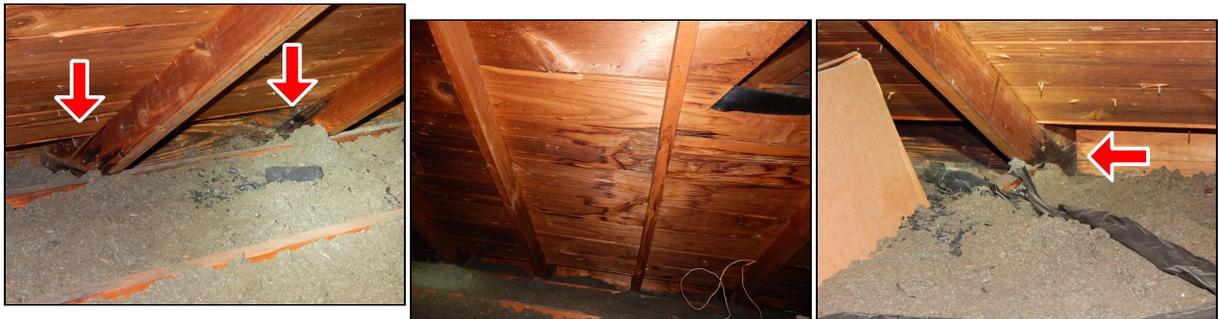
There was evidence of leaks in areas of the attic (flue pipe penetrations, chimney, valleys etc.). Some areas of the deck may require repair. Replacement of flashings, jackboots or possibly parts of the covering at these areas may be necessary to ensure it is leak free. A roofer should further evaluate roof covering, deck and exterior flashing systems for need of repair or replacement.

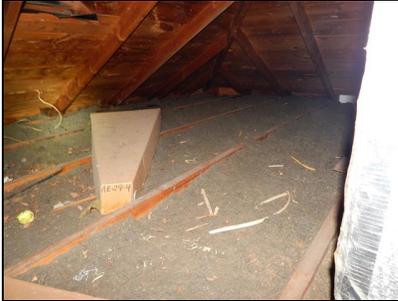
Insulation is deficient. Have contractor install additional insulation to R-40 for improved energy efficiency.

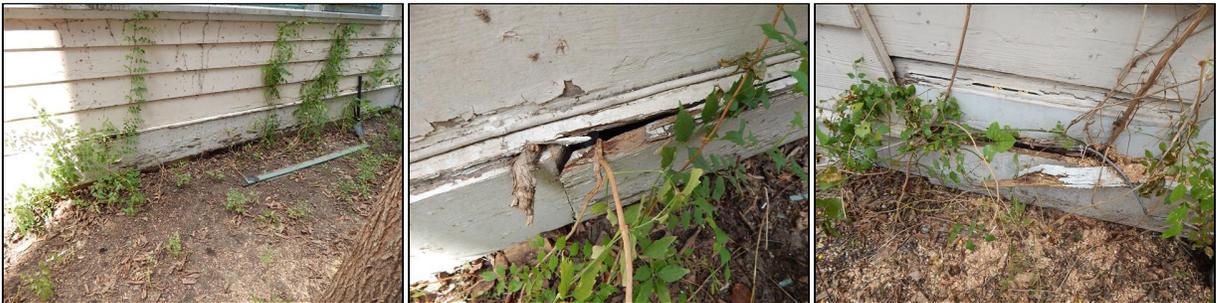
There are areas of the front, rear and sides of the exterior that have sustained varying levels of water (rot) damage and is in need of repair.

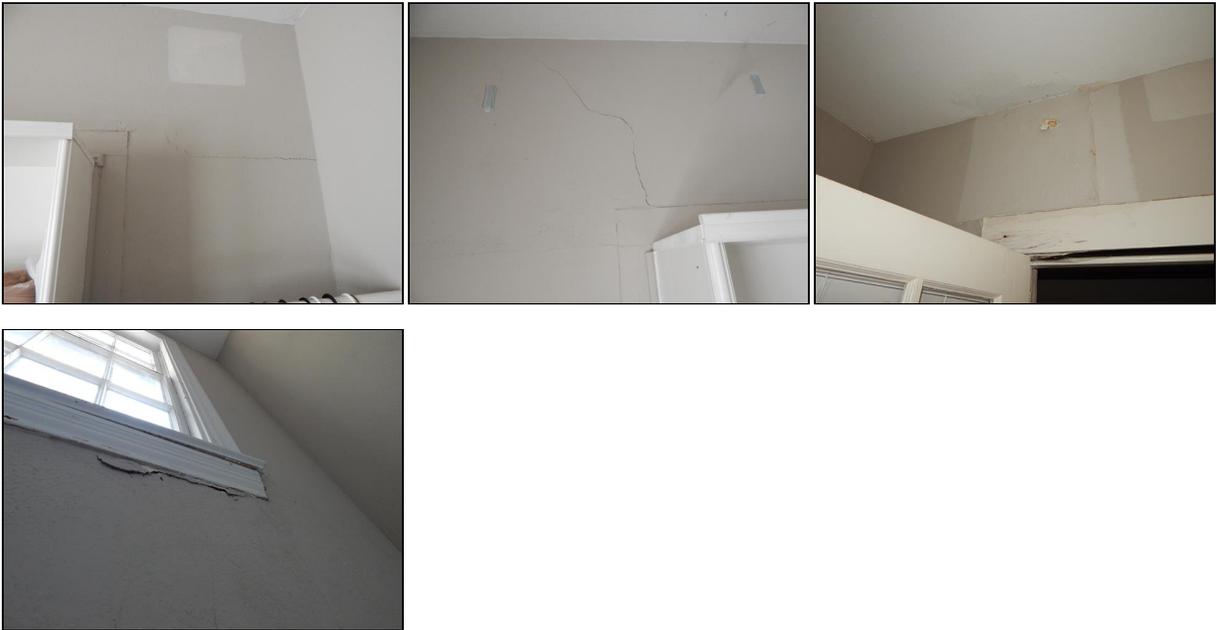
The cracks on the interior of the walls are indicators of structural deflection consistent with the age and condition of foundation.

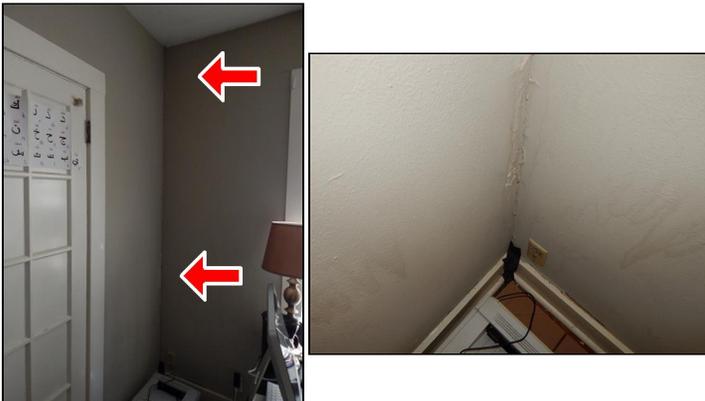
There is evidence of water penetration at the front right corner wall of the downstairs unit. This is likely from the upstairs balcony. An extraction or aggressive exploratory of the wall is needed above this area to ascertain the extent of the damage, and to determine to cause of action for repairs.

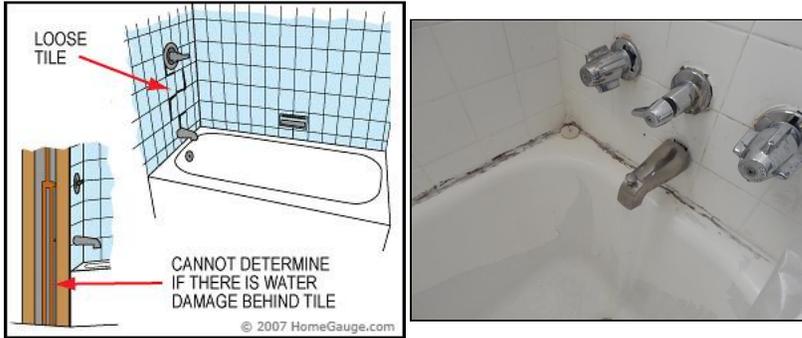
The tile surround at the bathtub wall is deteriorated and needs repair or replacement. The wall board and framing may also need repair (not visible). Recommend further evaluation by a qualified contractor.

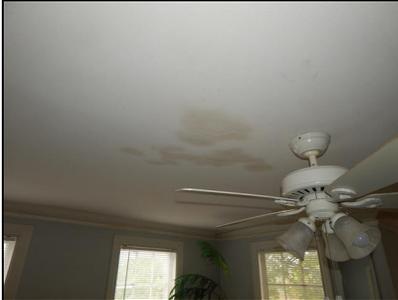
There is evidence of previous leaking observed by presence of stains on the ceiling in the living room (at upper level). This is consistent with ongoing roof leaks.

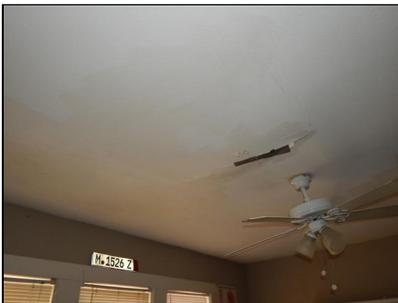
The interior floors are not level, consistent with the age, settling and condition of the foundation. the deflection was most notable and protracted at the upstairs. This is also presenting itself at the downstairs living room ceiling where the ceiling is bowed, with the drywall becoming detached. A structural engineer should include a holistic overall evaluation of the structure, as repairs and modifications to the second story floor systems may be necessary.

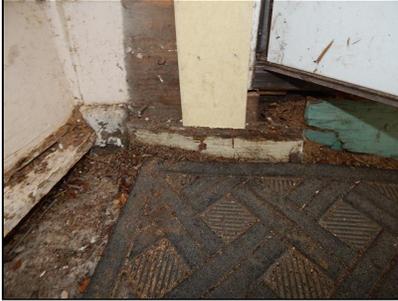
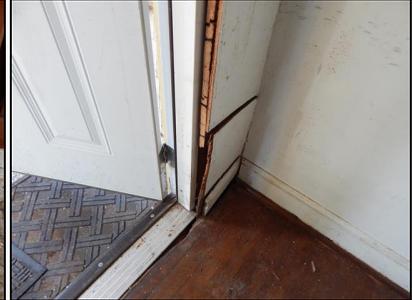
The frame is damaged from water intrusion at the downstairs front entry door and the upstairs balcony door. Repair is recommended by a qualified contractor. An entry cover or storm door may be recommended to reduce incidence of water intrusion.

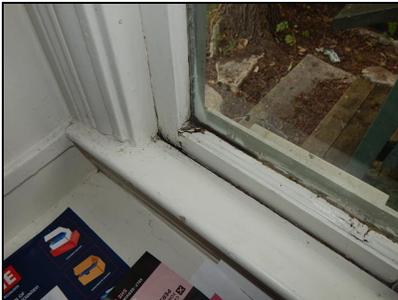
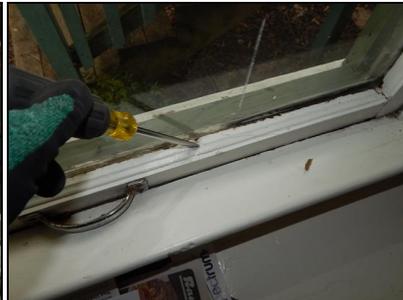
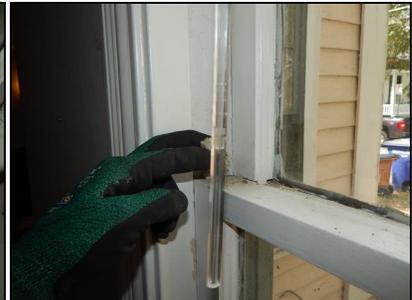
House has original single pane, wood frame windows with weighted ballasts. Due to their age they are dilapidated and most will not function: binding in frames, ballasts detached, rotted frames sashes. The windows will require replacement.

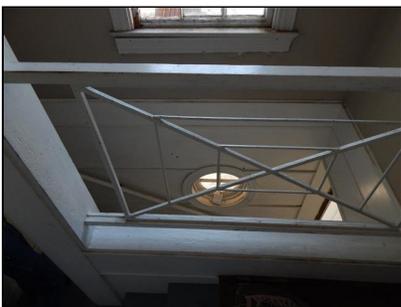
Staircase guardrails are improperly spaced greater than 4" apart as called for by today's child safety standards

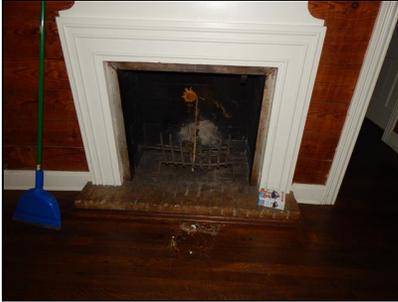
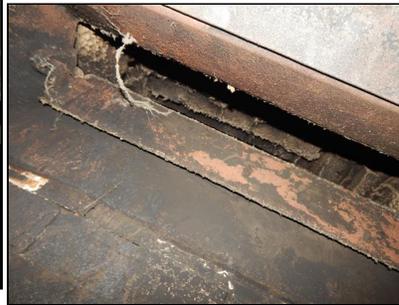
Downstairs fireplace.

There is soot and creosote buildup in the chimney. Given the age of the fireplace, it will likely require the installation of an interior sleeved flue insert. Recommend having the chimney flue cleaned and inspected by a professional chimney sweep, and any safety upgrades performed.

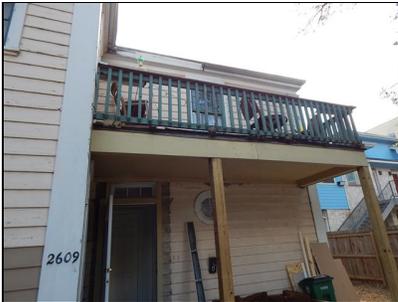
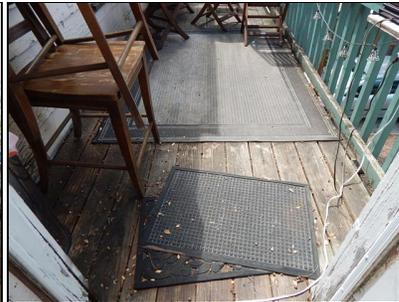
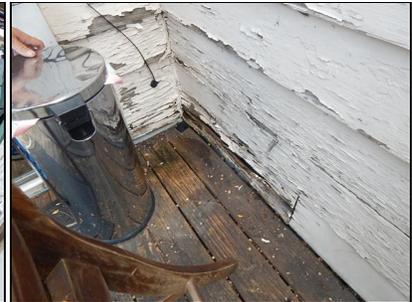
The second story balcony is in disrepair, most notably at the perimeter ledger where there is significant rot. This balcony should be further evaluated for repairs by a qualified deck contractor, and before further use.

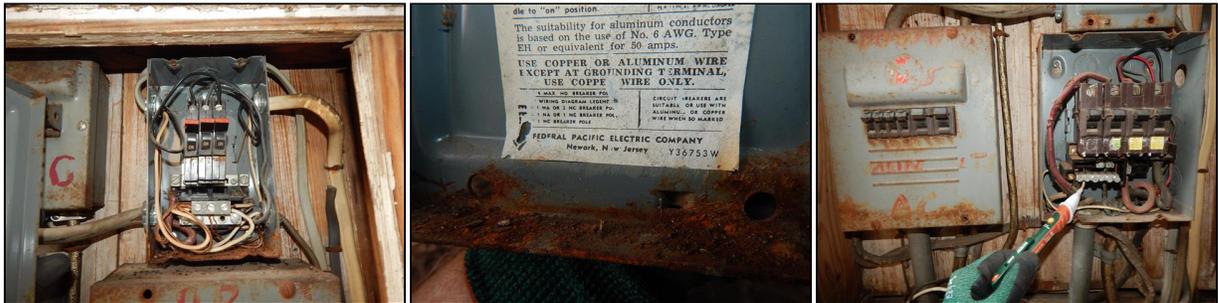
The sub panel and A/C disconnect are manufactured by FPE (Federal Pacific Electric). These panels have documented trip hazards and are no longer manufactured. Further evaluation of the panel for repairs or replacement is required by a licensed electrician.

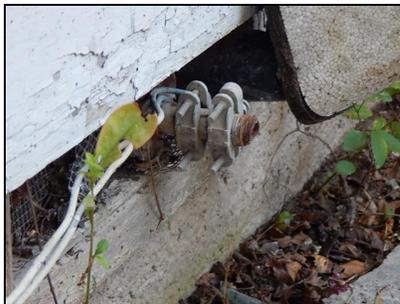
There is no verifiable cold pipe bond (1965). I recommend an electrician verify or update system ground to comply with current standards. The observed cold pipe bond was to the abandoned galvanized supply pipes, and is not considered viable.

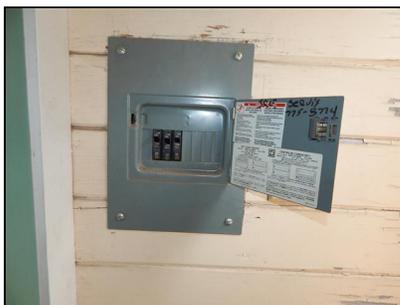
There is no ground bond on the gas supply line, as required by current standards (2008).

The left side sub panel is not rated for exterior use.

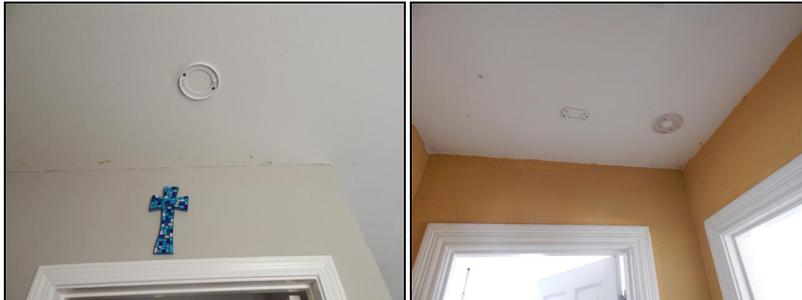
There was no carbon monoxide detector observed. It is recommended that one be installed according to the manufacturer's instructions.

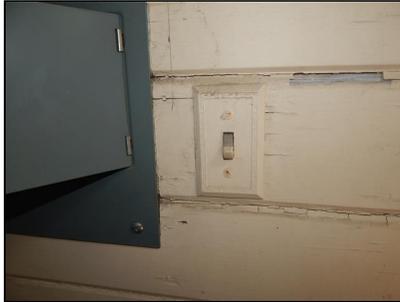
☒ There are exterior light switches that are not wet location rated. these should be replaced with proper devices.

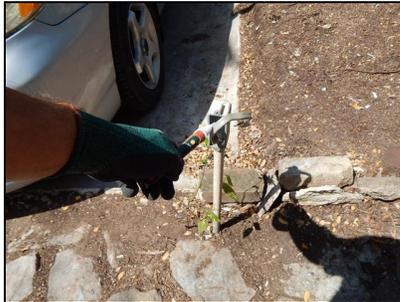
☒ There were exposed connections, open boxes observed in the driveway. This present a safety hazard. Secure, enclose in rated enclosures to prevent hazards.

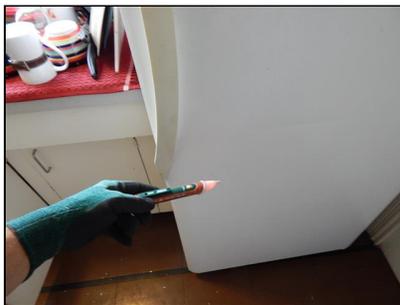
☒ The upstairs fridge was generating a voltage read as detected with a UL device. This likely is an indicator of an open neutral or reversed polarity circuit. A licensed electrical contractor should diagnose the circuit and repair a needed.

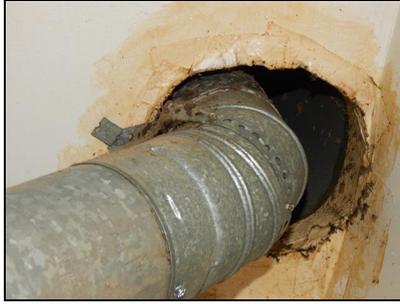
The downstairs heating system flue is in contact with building materials. Gas flues should have 1.5" of clearance surrounding the flue pipe. A heat shield should also be installed at the penetration.

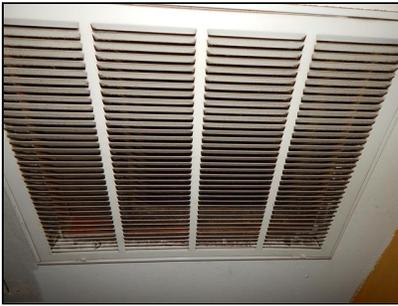
The filter is missing at the upstairs system return. This will allow debris to deposit on evaporator coils, degrading the unit's performance and reduce it's life span. An HVAC technician should service the unit and clean the coils.

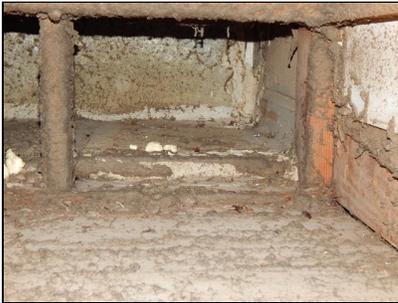
The downstairs return air chase is heavily soiled and should be cleaned of debris.

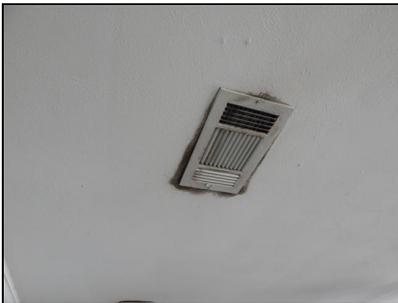
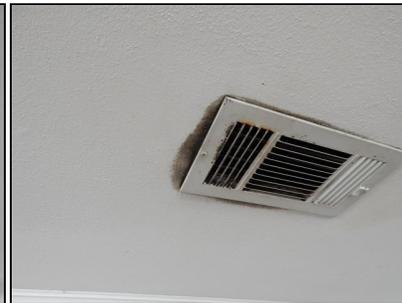
There is bio/fungal growth at the upstairs vents. This is consistent with moisture accumulation at the duct to register connection. The ducts should be evaluated by a licensed HVAC technician for cleaning or replacement. An assessment of the fungal growth should also be performed to determine if any mold remediation is warranted.

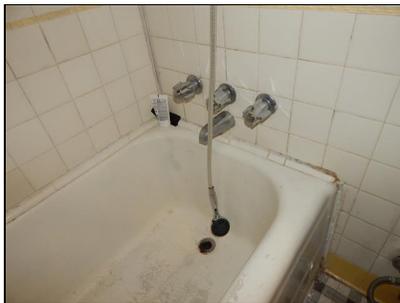
The controls are reversed in the downstairs bath. The position of the hot and cold water controls on all plumbing fixtures should meet accepted industry standards. These standards dictate that hot water controls are always located on the left and cold controls are located on the right. With single handle faucets, turning the handle to the left should increase the flow of hot water, while turning the handle to the right should increase the flow of cold water. Fore and aft action fixtures should have the hot to the rear.

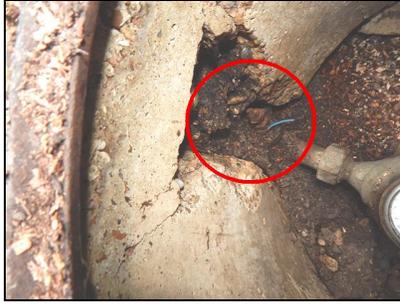
The left side main user shutoff is damaged and inoperable.

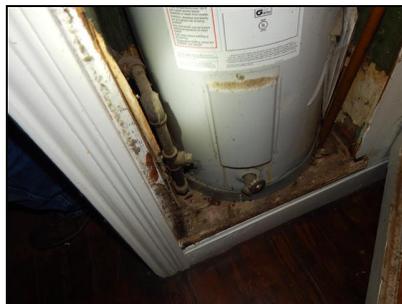
The drain pans do not extend to exterior as required by current standards. I recommend installing a drain pipe exiting directly to exterior, or installing automatic alarm and/or shutoff to prevent any damage from water heater leaks.

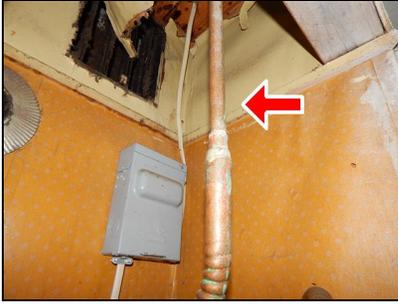
The upstairs T&P drain line has been improperly reduced in size from valve outlet. Drain pipe must be same size (3/4-1") throughout to termination point. Reducing the size of the pipe can cause damage to the unit and is a safety hazard. Replacement of the line is needed.

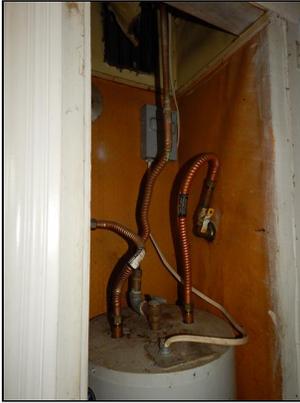
The upstairs T&P drain line is improperly plumbed (runs up), and must be gravity drained. Correction of drain line is recommended.

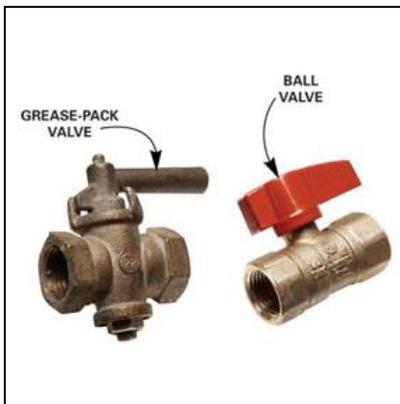
Older "grease pack" gas valves are out of code, and are known to leak over time. These should be replaced.

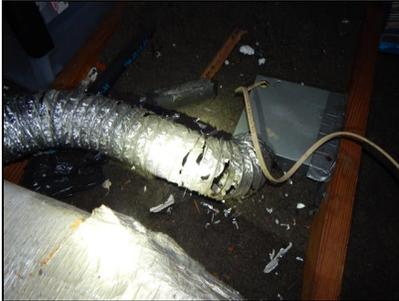
The upstairs bath vent duct is damaged from rodents. Replace as needed.
