4010 Avenue H Window Supplement

Owner Overview

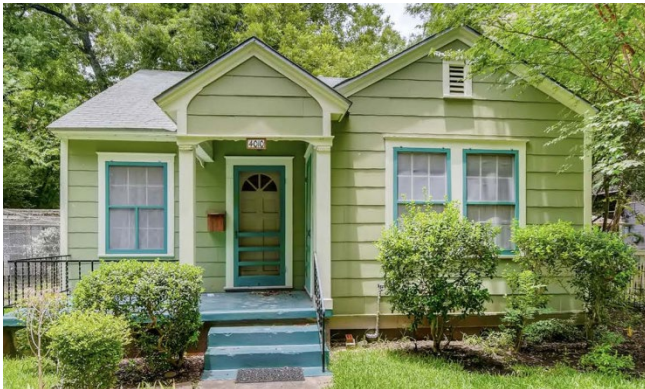
View from Street with Screens Covering Window Detail

We're proposing replacing these original windows with double hung aluminum clad wood windows in the same design as the existing. The home's windows are covered by screens that the we intend to replace with similar due to significant rotting. As a result of these screens being mounted in front of the windows, the glazing on the windows is always obscured when viewing from the exterior. If we match the existing window style, mullion pattern and proportions (which we intend to do), the view of the house from the street will be unchanged.

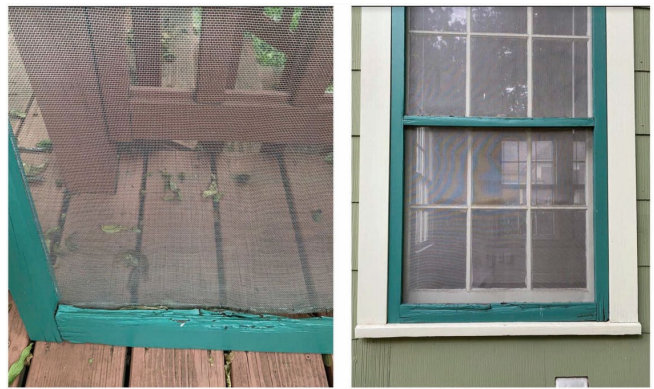
Representative Example of Screen Rotting

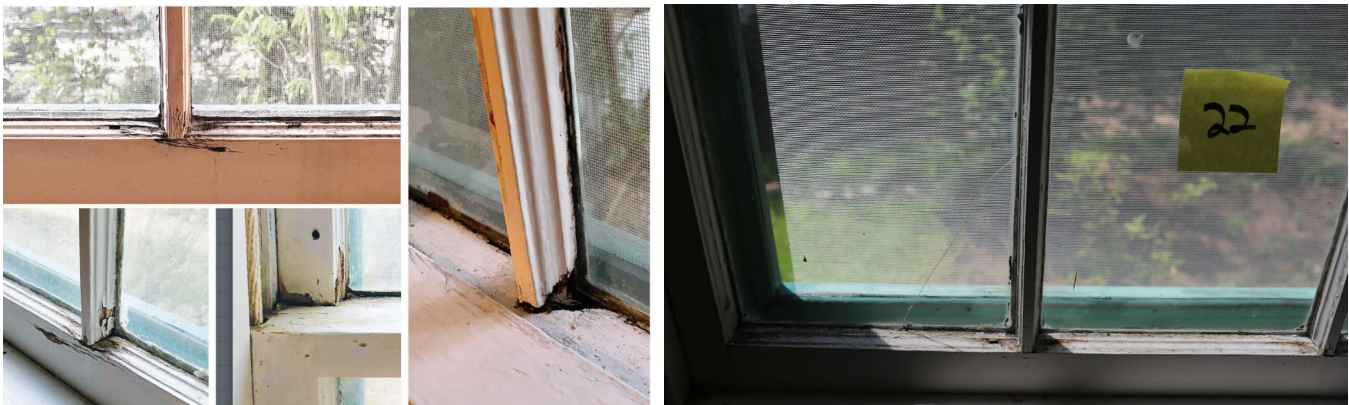
Representative Example of Window Damage
