For Historic Landmark Commission Hearing
Regarding: 1208 W.22nd St., Austin
October 20, 2020

1208 West 22nd St. Austin

Re: Structural Assessment: 1208 W 22nd Street, Austin, Texas

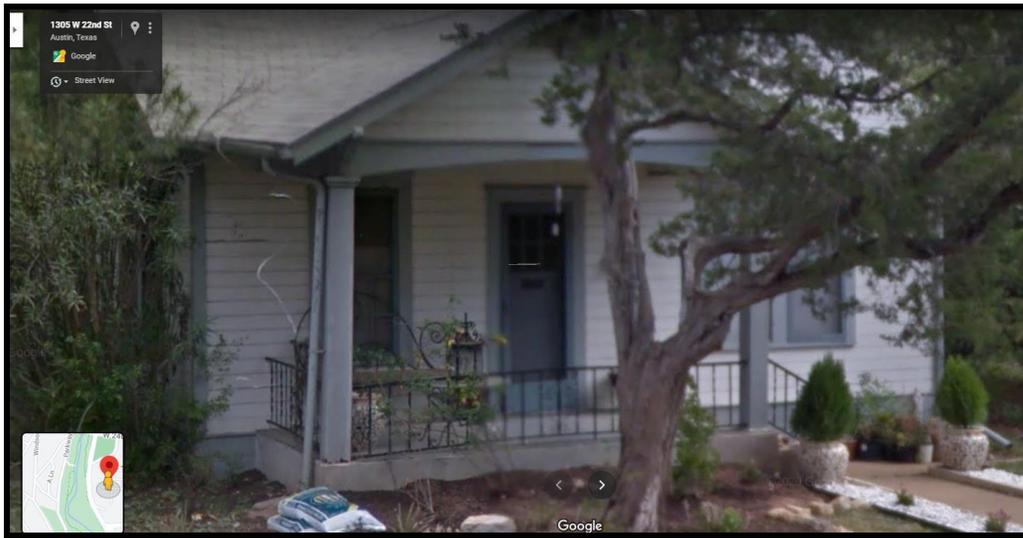
The front of the structure is characterized by two columns that are straightforward and not ornate or substantially embellished. Between the two columns is a rather plain curved arch. The door and window trim are rather routine. Neither the rest of the exterior, nor the interior, appears to have any special characteristics.

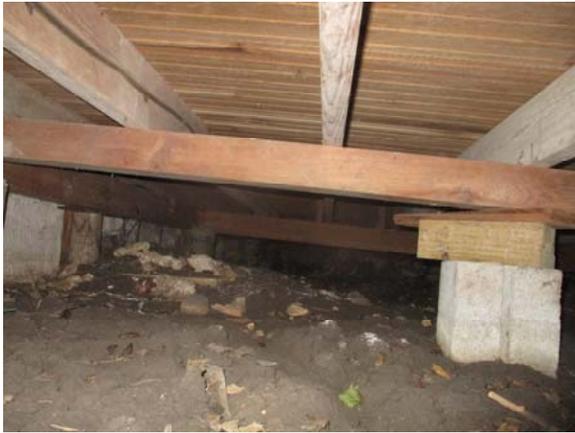
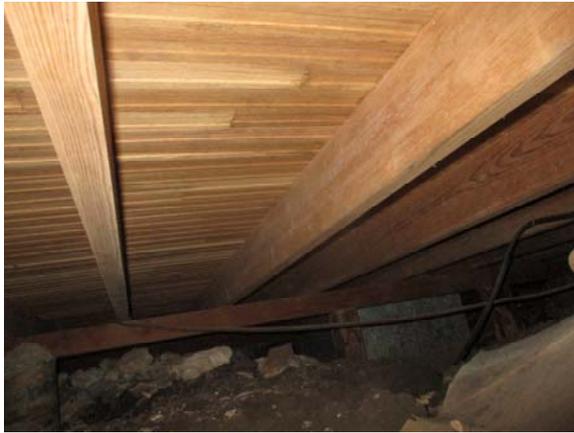
The first two photographs below document the general condition of the accessible part of the crawl space. The first photograph also includes a concrete block pier.

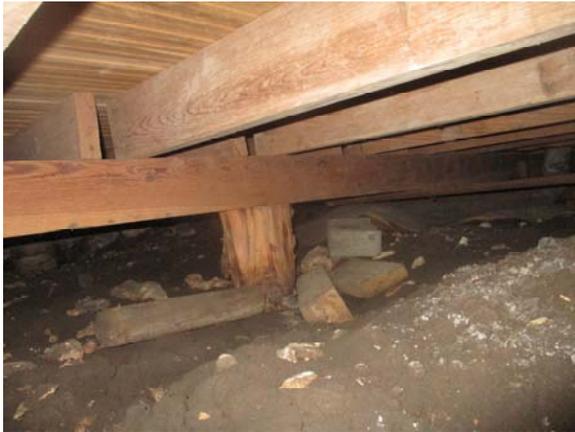
The photograph at lower left documents typical interior framing above a bois d'arc pier. The photograph at lower right documents exterior framing at a cast-in-place concrete pier.

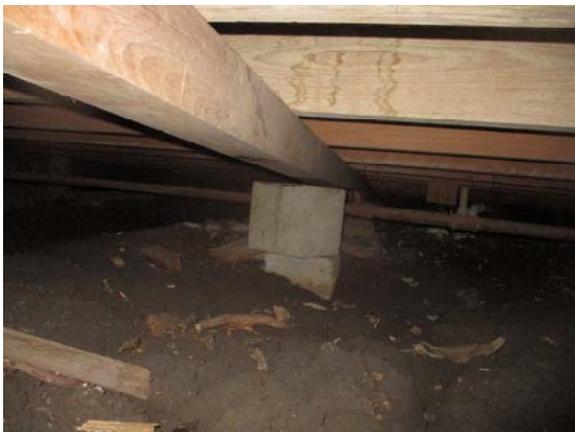
At least one of the concrete block piers is not in contact with the beam (photograph at lower left). The only water damage to the wooden subfloor framing that we observed in the accessible areas was at the bathtub. Refer to the photograph at lower right.

- Remove and replace approximately twenty bois d'arc and concrete block piers with cast-in-place cylindrical concrete piers.
- Adjust piers heights by inserting or removing steel shim plates above the concrete piers. Estimate the same number of adjustments as new piers. Note that this repair is part of new pier installation, not additive.
- Remove and replace one water-damaged 2"x 6" floor joist, approximately seven feet long, and water-damaged decking above. (Access will require removal of the bathtub).
- Remove all debris from crawl space and level surface to provide access.
- Install openings in the skirting to provide one square foot of ventilation for every 150 square feet of crawl space area (approximately seven square feet of opening is required).

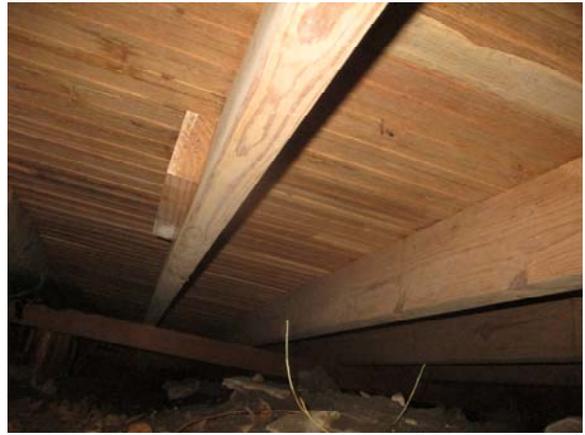
An isolated void in the perimeter skirting allowed us to insert a camera into the crawl space near the southwest corner of the kitchen. The photograph of the condition of the crawl space is below right.

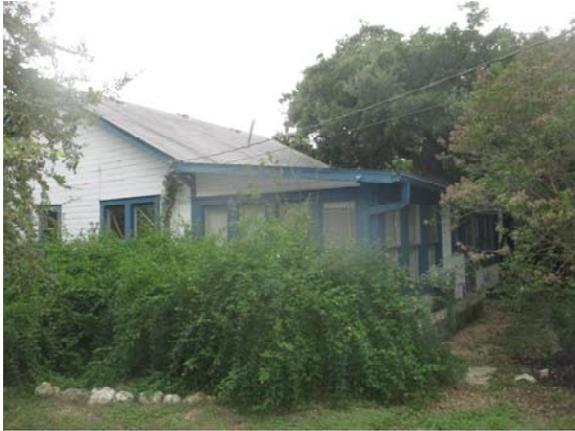
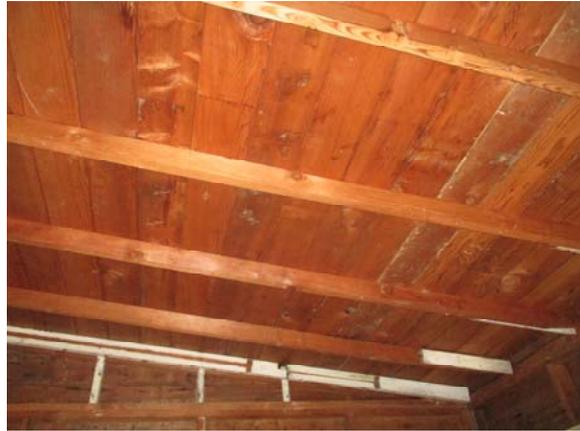
Clearance from grade to the top of the foundation addition is insufficient to completely observe the subfloor framing. Finish materials cover the floors walls and ceilings. The roof slopes downward from the existing wall top plate (photograph at lower left). The roof framing in the adjoining “screened-in” porch is visible. We observed no visible defects (photograph at lower right).

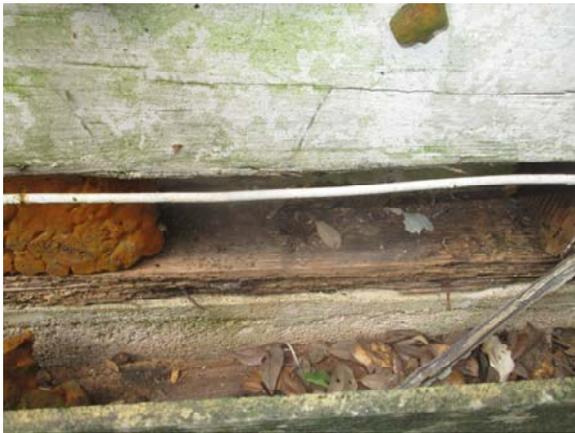
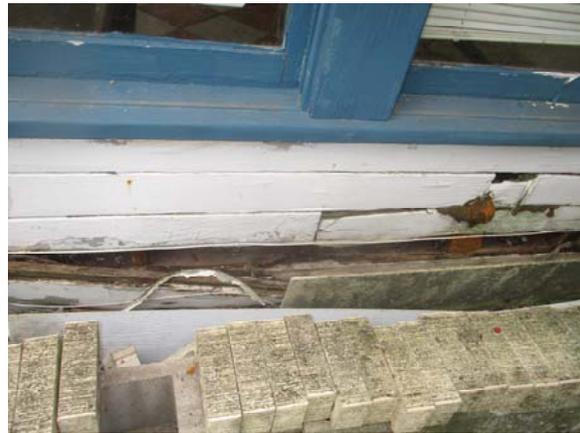
From the exterior of the addition we were able to observe that an elevated wooden floor framing system bears on a concrete slab. The photograph at lower left documents this framing pattern, as well as the deterioration of the sole plate for the exterior wall. The photograph at lower right is in the same general area, but a broader perspective. This photograph indicates that the water damage (rot) continues up the wall to the siding and presumably to the wall framing.

For this type of wall construction the building code (International Residential Code) requires a minimum of six inches from grade to the top of the foundation to prevent surface water intrusion. This clearance was not provided. The result is extensive deterioration of the exterior wooden framing.

The required repair includes removal and replacement of all water-damaged subfloor and exterior wall framing. In addition, the proper clearance between grade and the top of the foundation must be provided by either elevating the structure or excavation and installation of a sub-surface drainage system along the perimeter of the foundation. Elevation of the structure will reduce the existing roof slope, altering the drainage pattern. We anticipate that the cost of these repairs will exceed the demolition and proper new construction cost; therefore, we conclude that the addition shall be demolished. Although we did not observe indications of current structural distress, continuing deterioration will eventually create a hazardous condition.

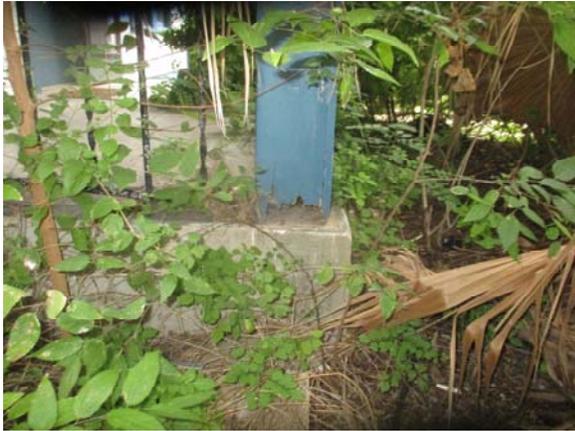
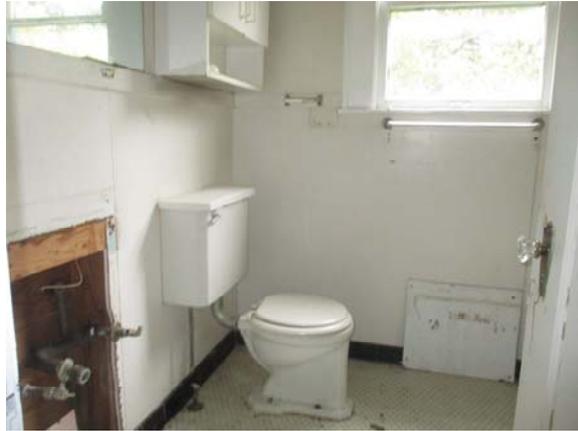
The base of the wooden column at the southwest corner of the front porch has rotted. This section shall be removed and replaced (photograph at lower left). Parts of the original bathroom have been demolished. The photograph at lower right documents the vanity, but parts of the bathtub surround have also been removed. This area shall be repaired as part of the subfloor framing replacement.

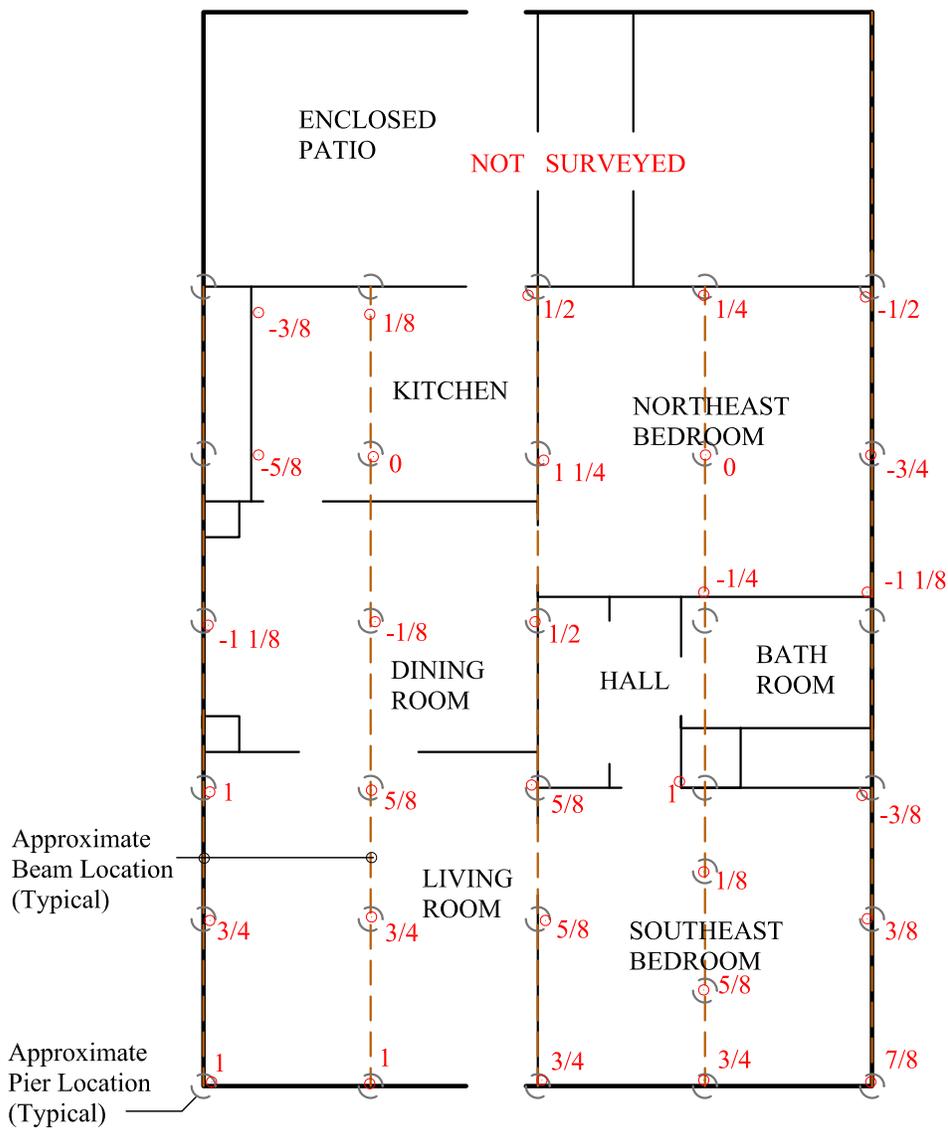
SCHEMATIC FLOOR PLAN WITH ELEVATION DATA

To determine the position of the top of the foundation, we began by measuring the relative elevations of the floor at or near existing piers and along the perimeter grade beams. We then adjusted the elevation data to account for changes in the floor covering materials. The adjusted floor elevations are representative of the elevations of the top of the foundation. Note that these measurements are not referenced to an established benchmark, but are intended to only reflect relative change in elevation between data points. A sketch of the elevation data plotted on the floor plan is attached at the end of this letter. The approximate locations of piers and subfloor beams are also indicated on this sketch.

Our crawl space observations and analysis of the elevation data indicate that foundation movement has occurred, we recommend the following repairs to the foundation:
