Appeal Regarding the Urban Forester's decision on two Cottonwood trees

42" and 20" Trees Located in the Right of Way
on Crown Ct, Austin TX

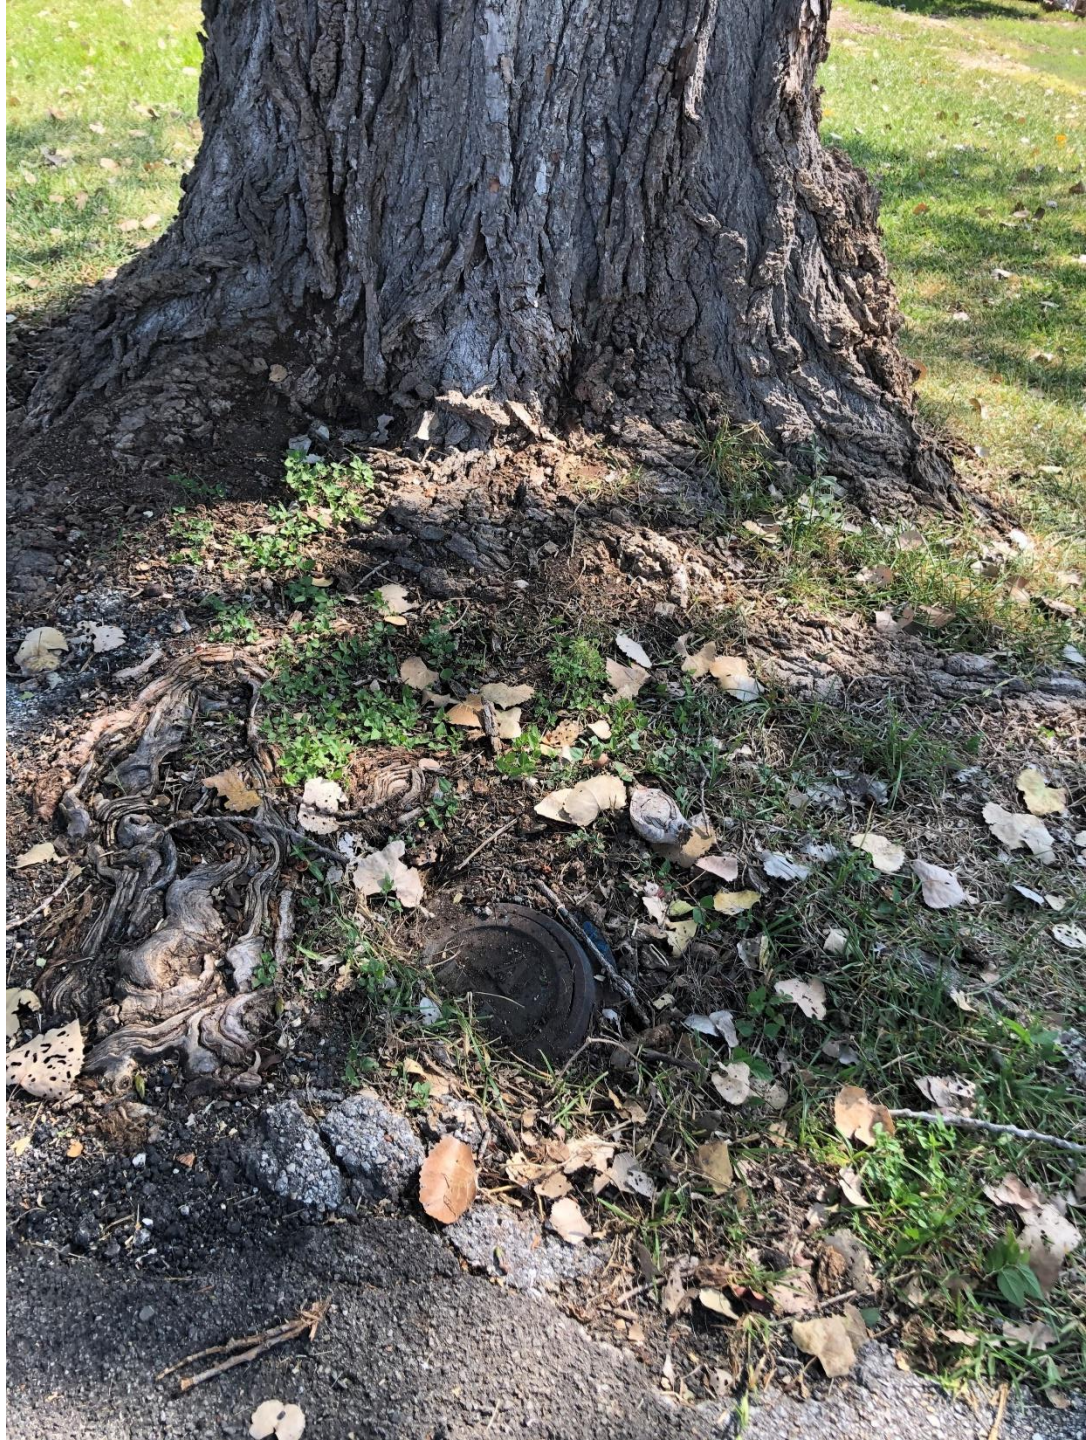
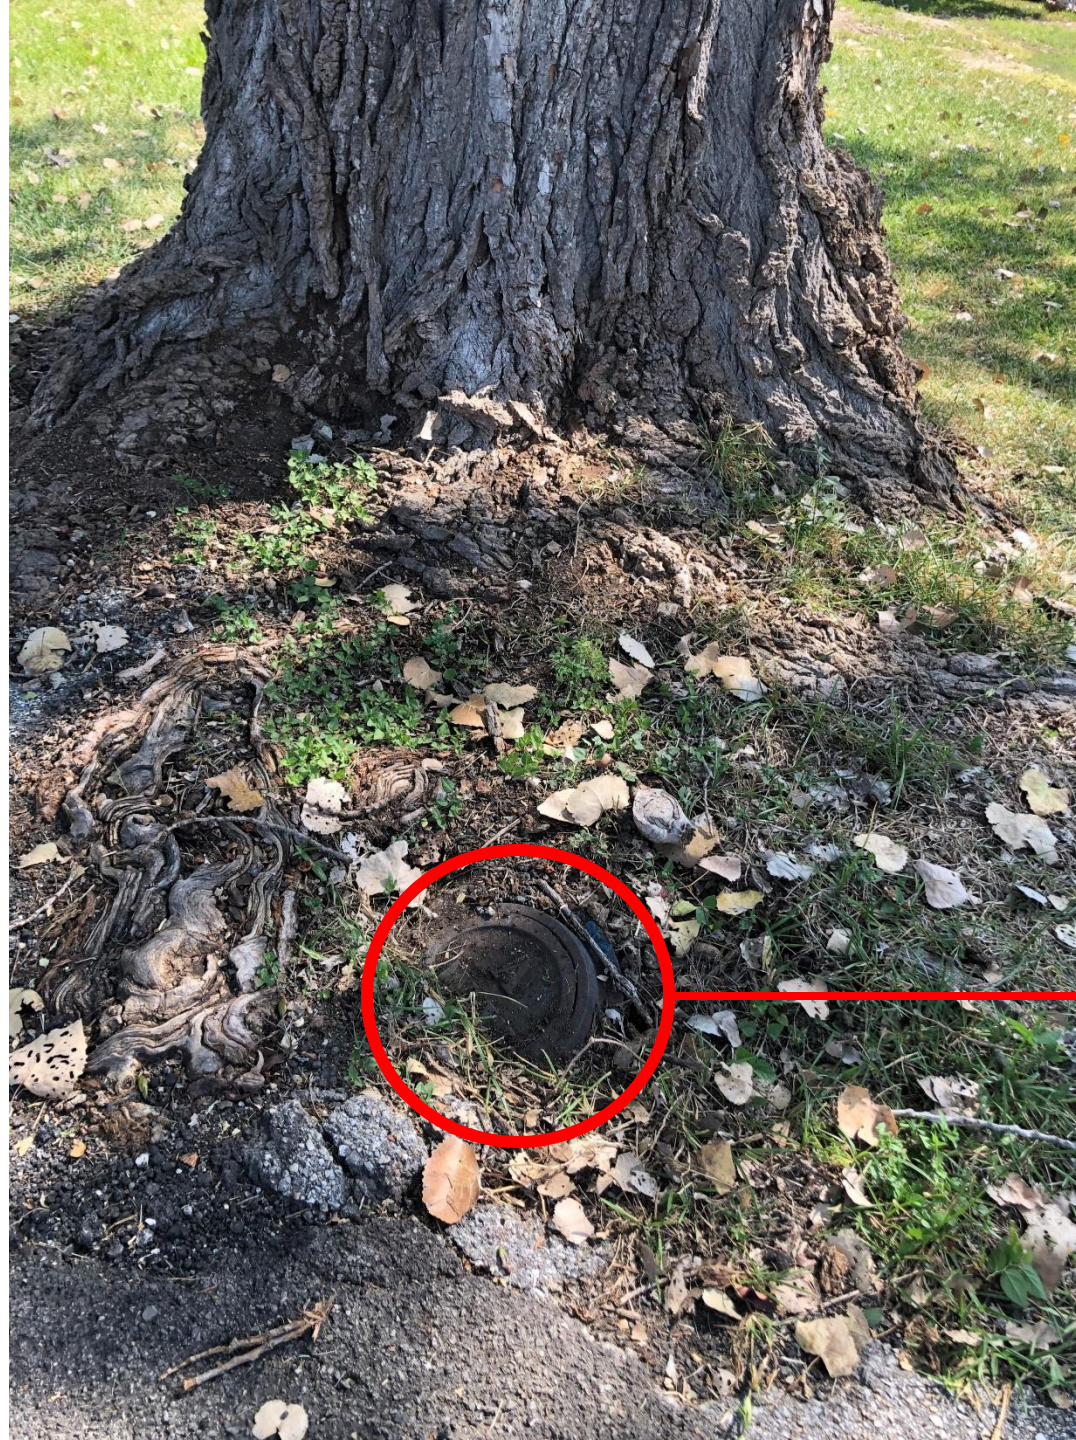
42" Cottonwood Tree and Water Main

- Largest tree in Cul-de-sac.
- Diseased and dying.
- Base of tree is less than 3ft from water main.

**Valve for water
main**

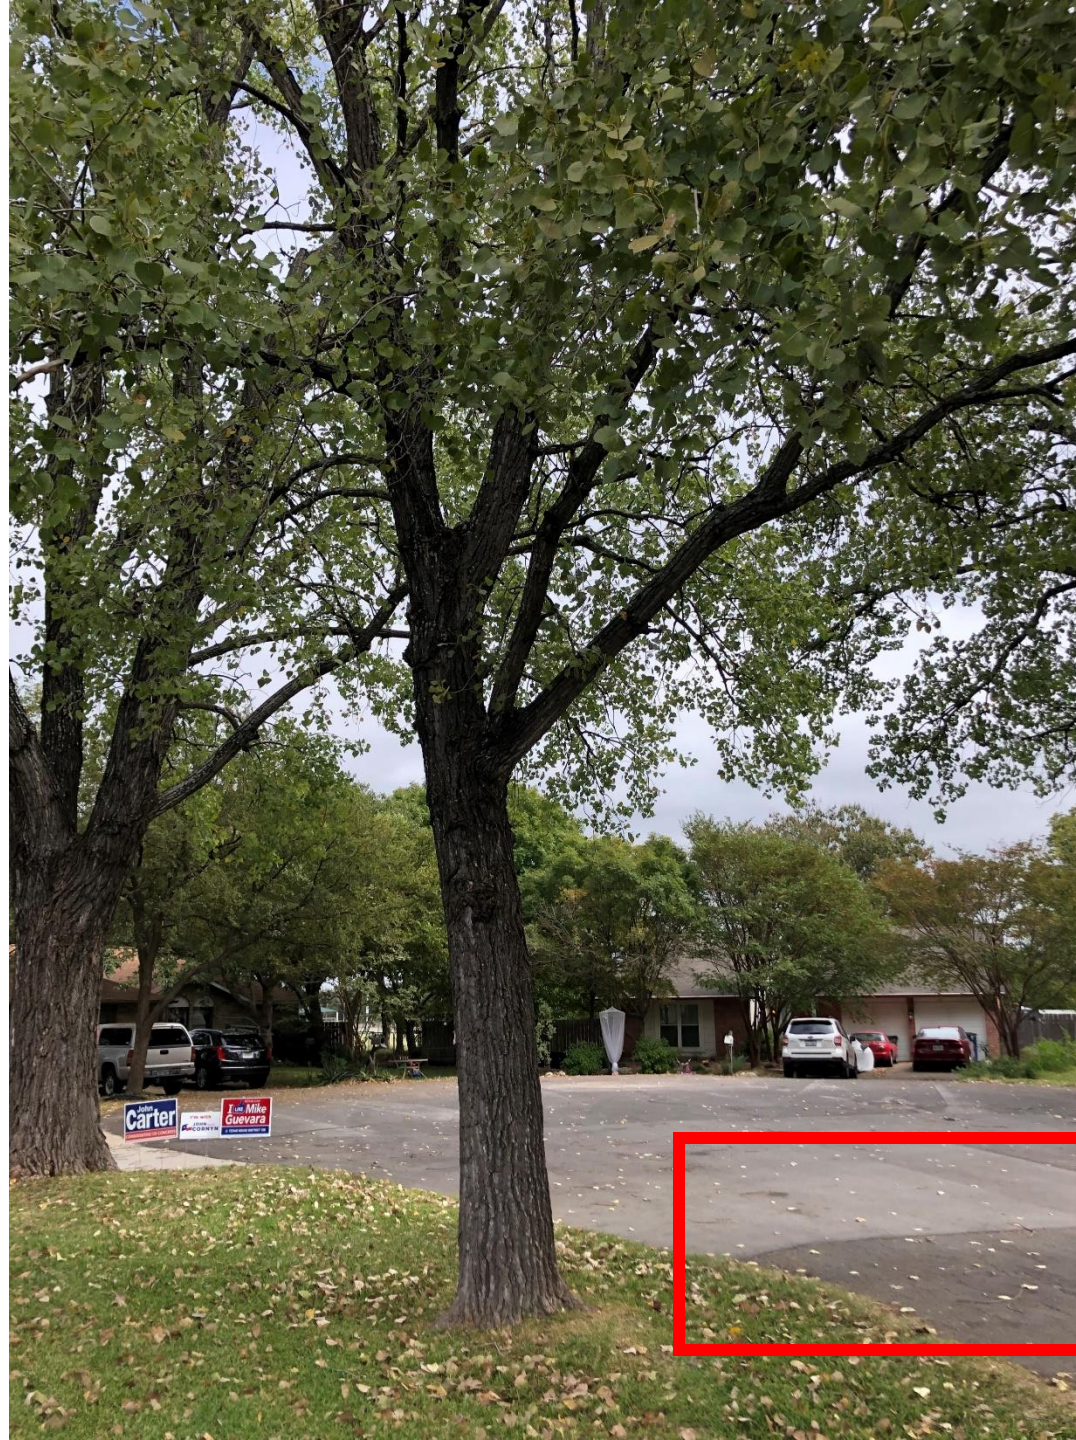
20" Cottonwood Tree and Water Main

- Base of tree is within inches of the street pavement.
- Street cuts from water main repairs are at the tree.
- Street cuts directly adjacent to this tree indicate that this tree is at least responsible for some of the damage to the water mains.

**Street cuts at
base of tree**

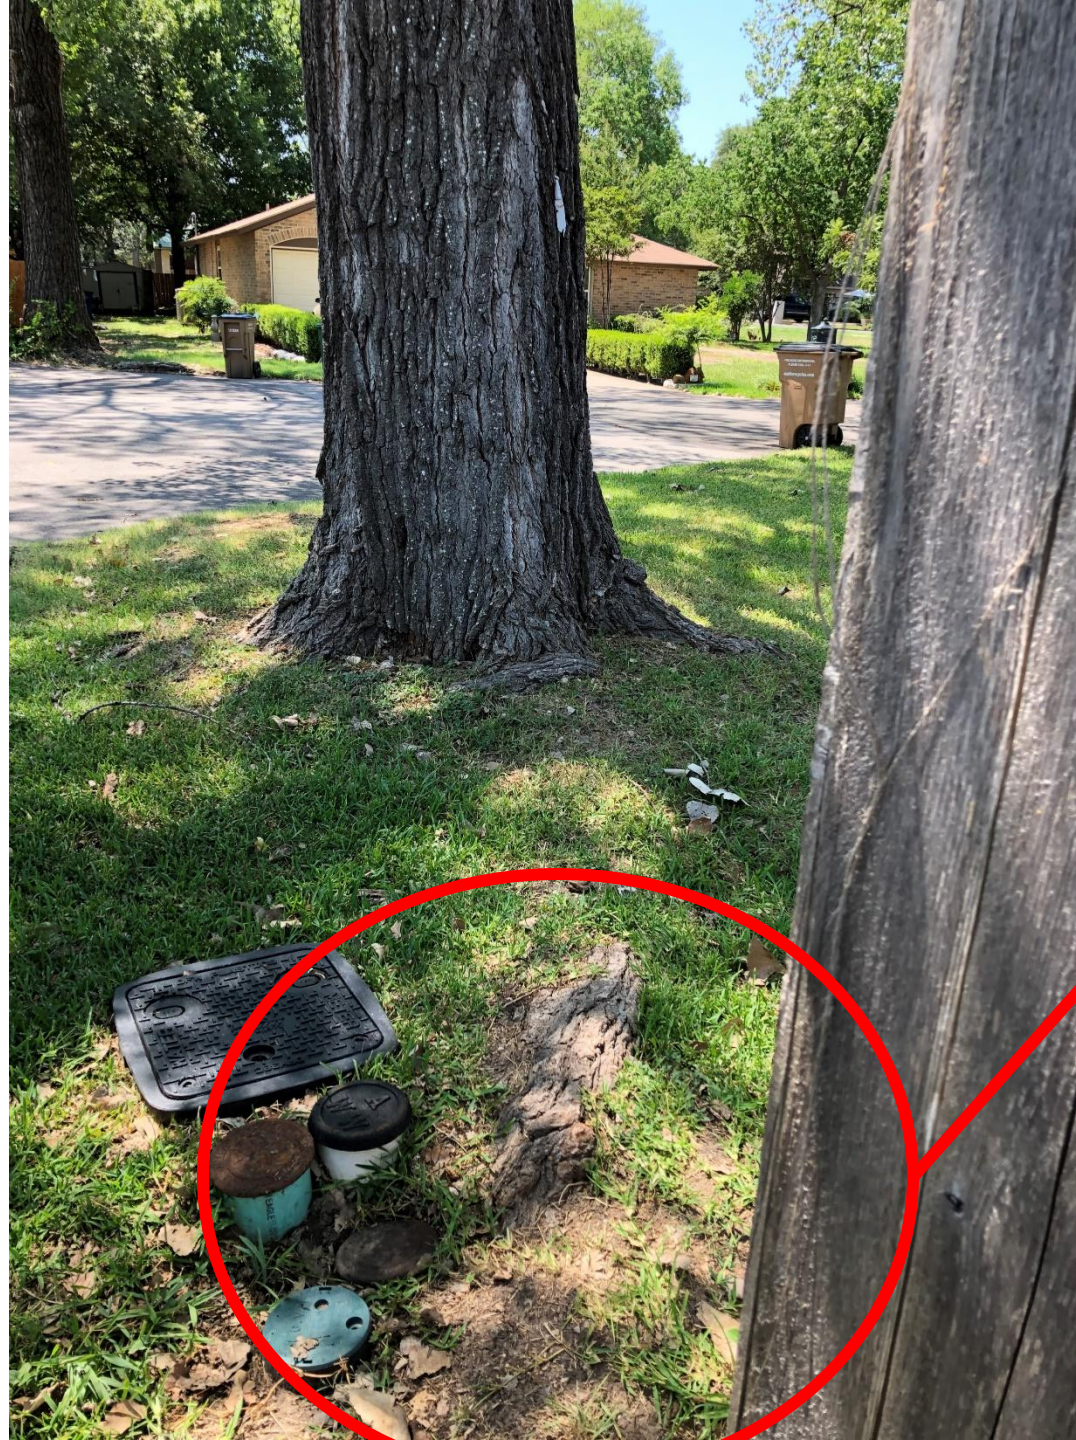
34" Tree – roots visibly bending water valves on the surface. Urban Forester refused to acknowledge this fact.

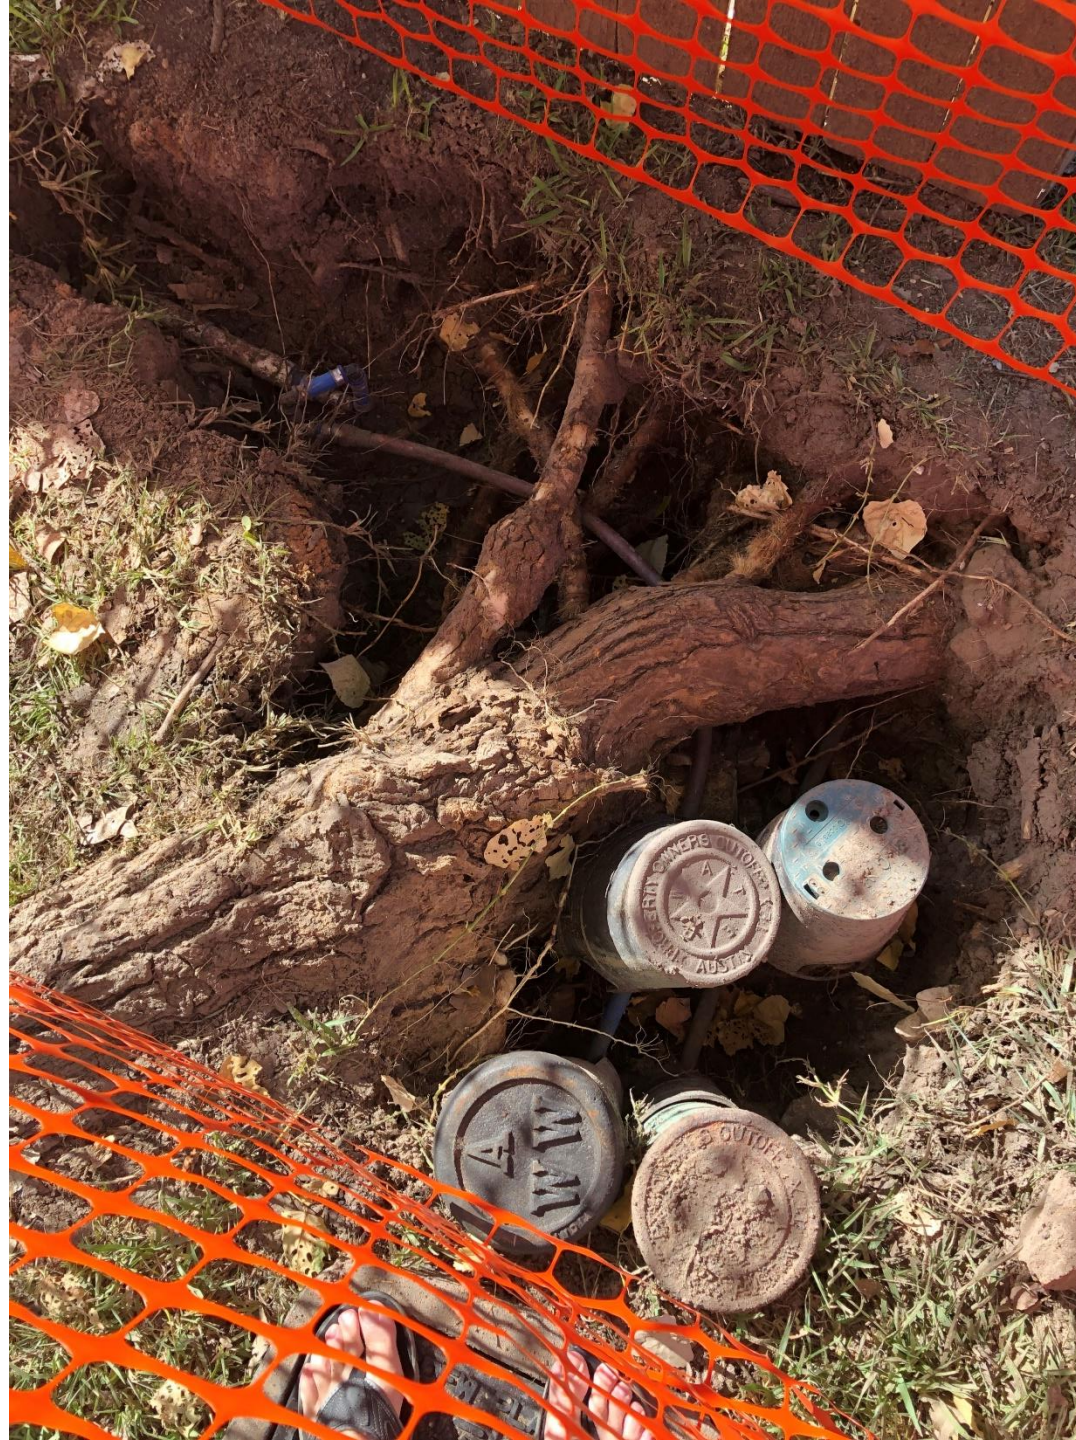
Root was excavated
by Austin Water –
Roots are clearly
destroying pipes.

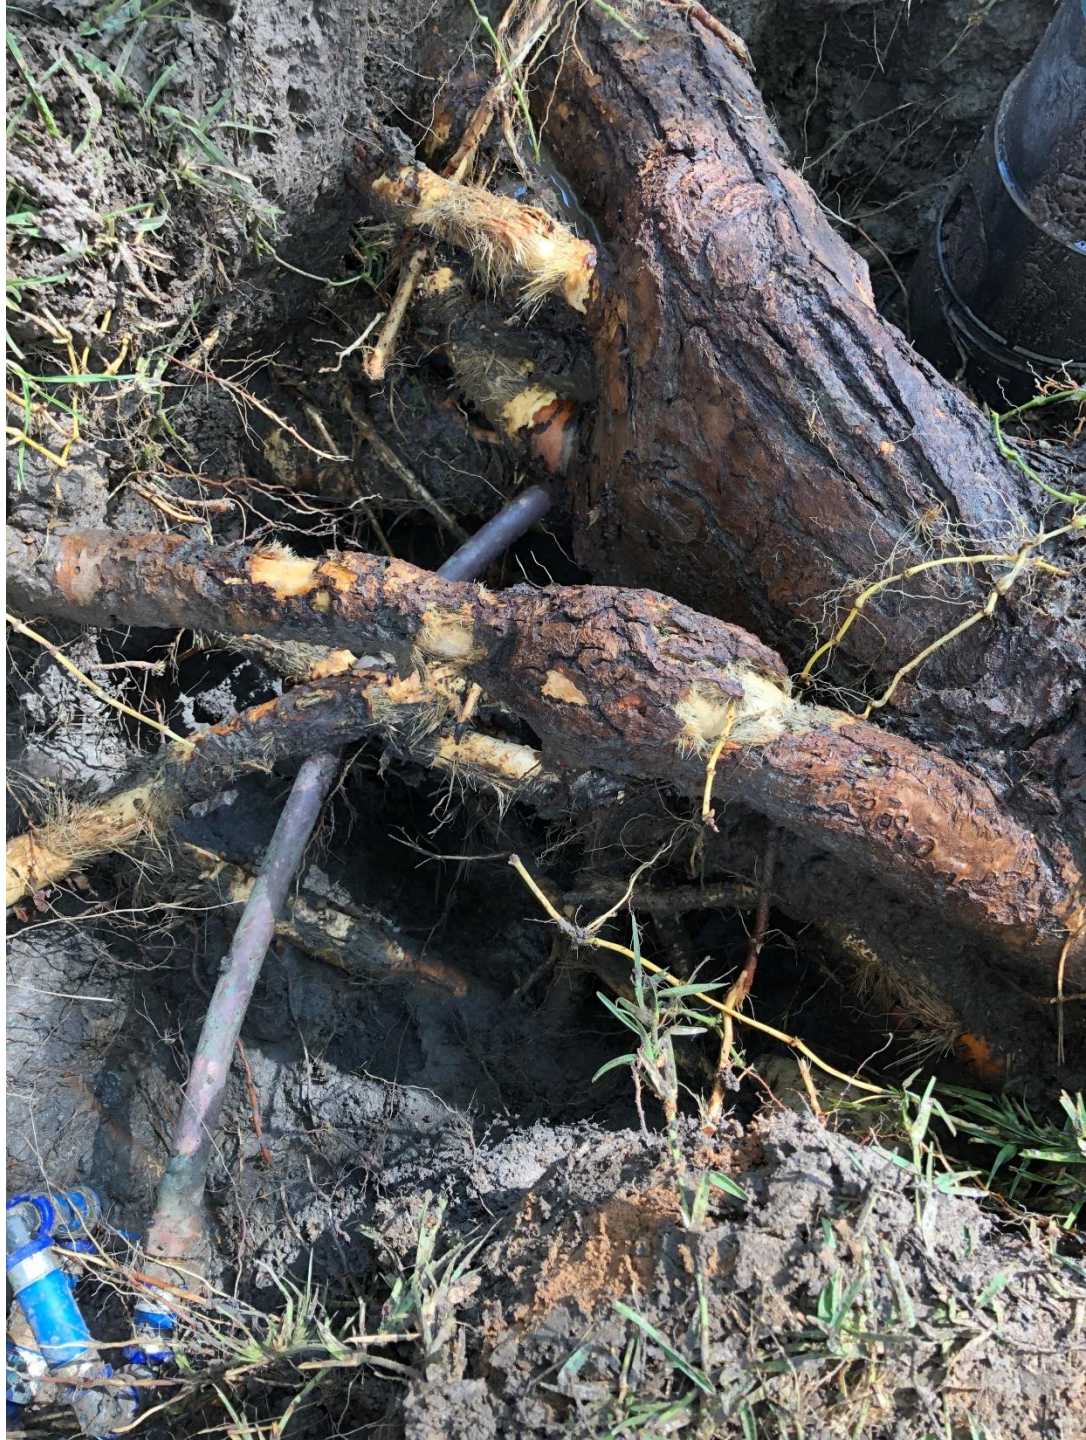
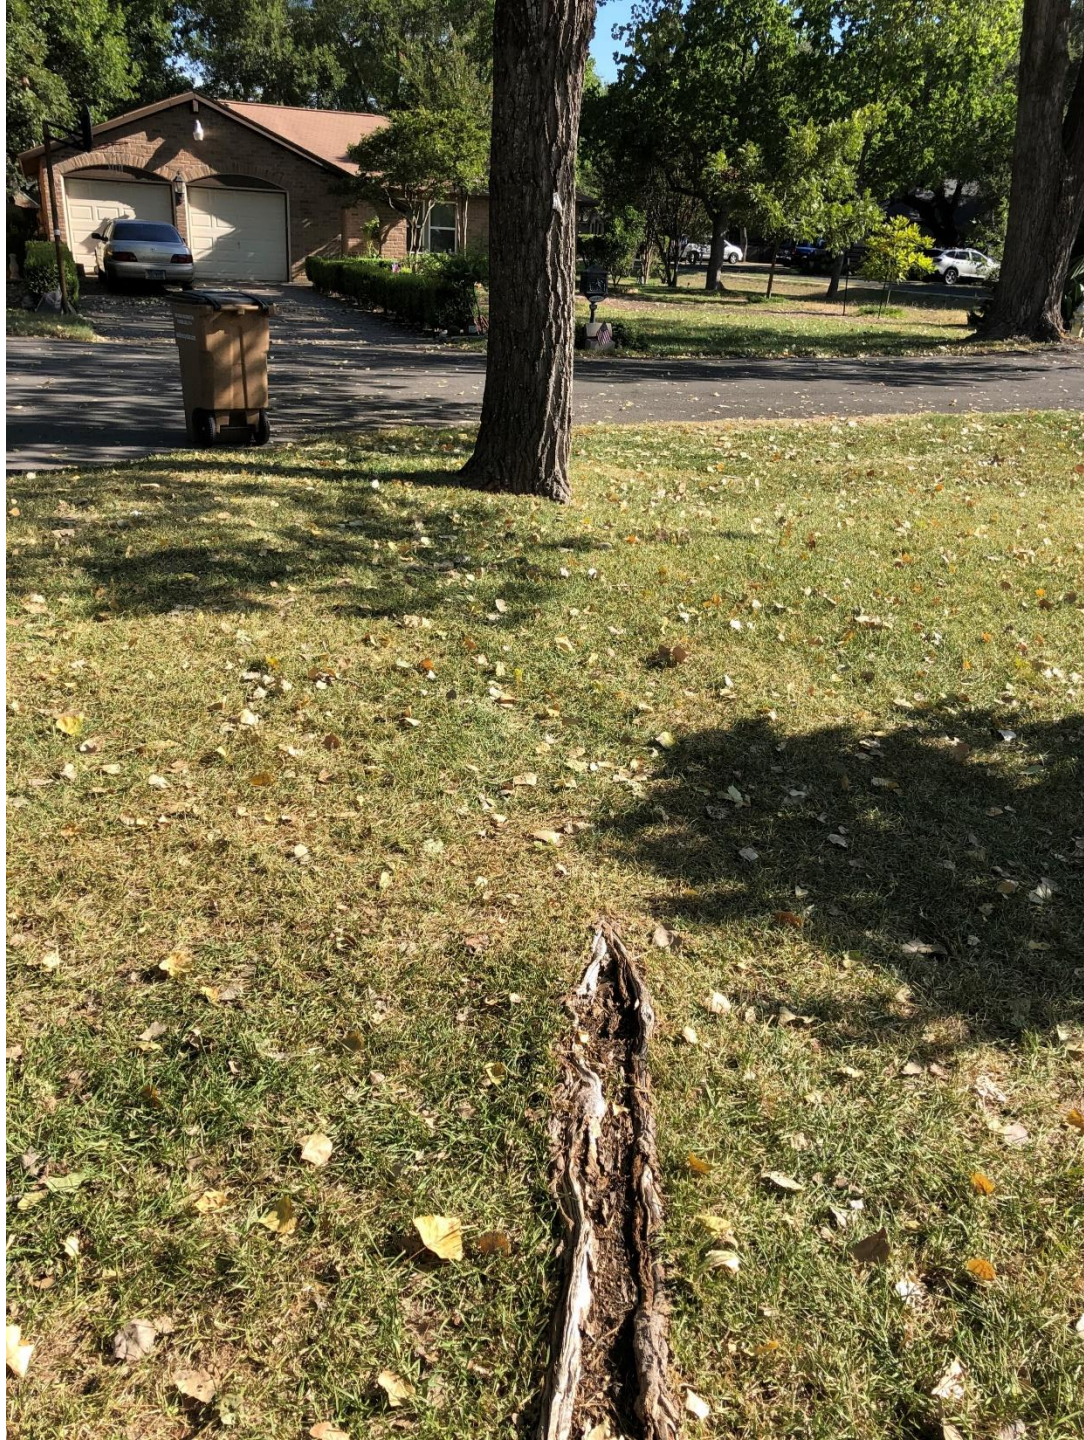
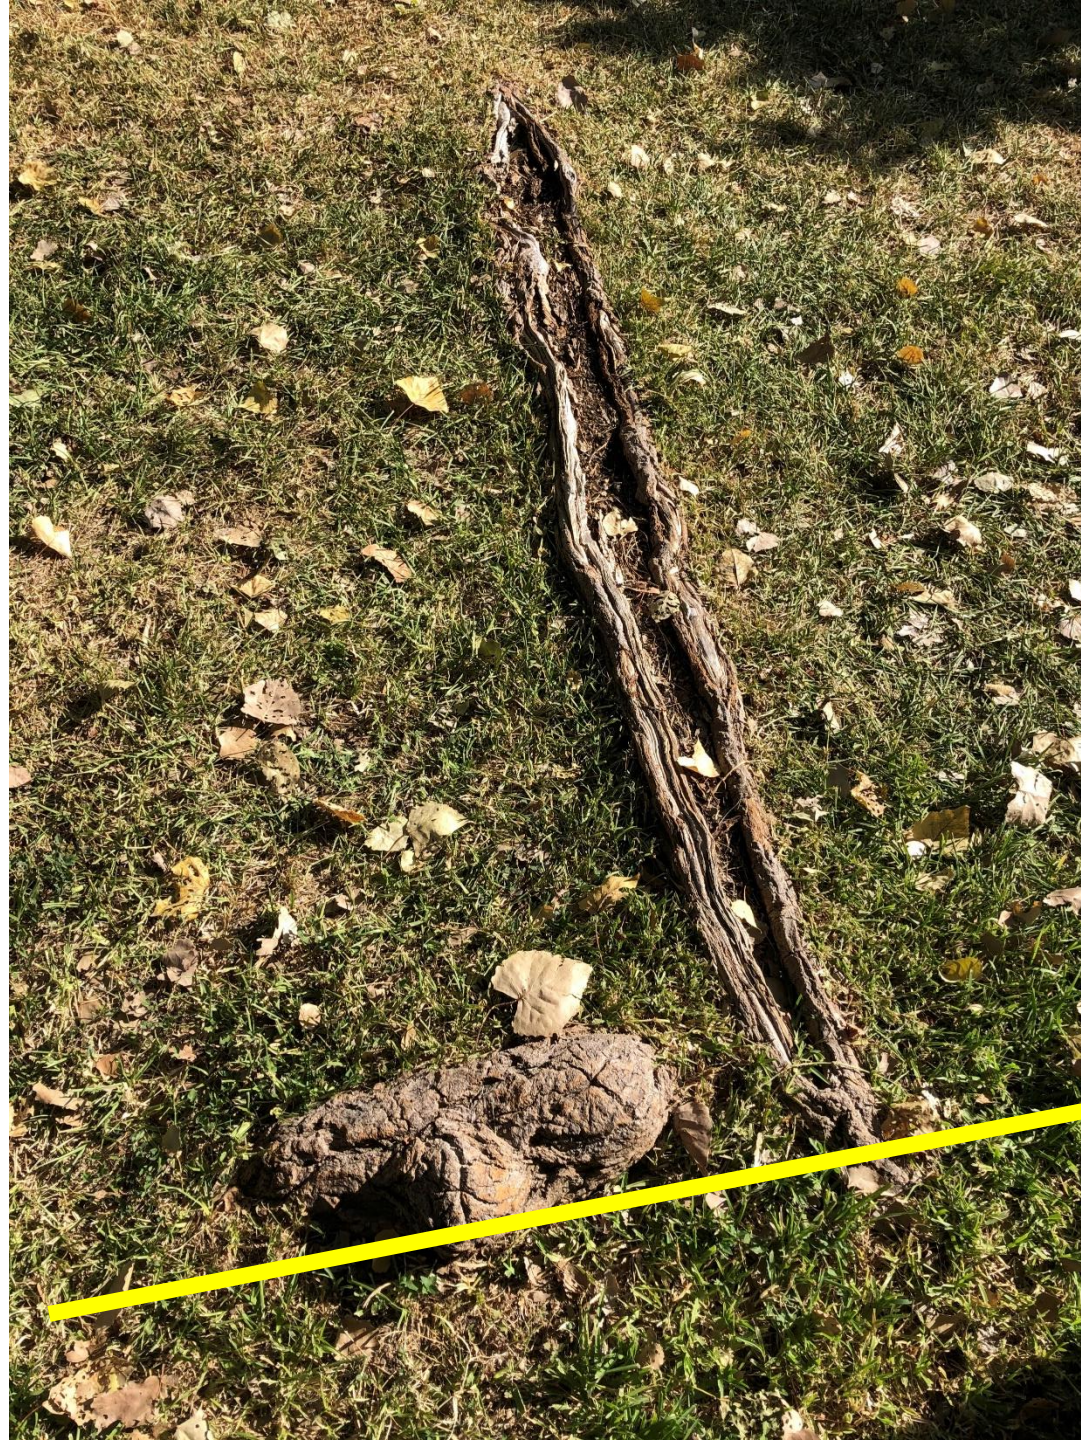
**Large root from 20"
Cottonwood tree over
my water main. Has
previously caused
damage to my pipes.
Yellow line indicates
approximate location of
water line.**

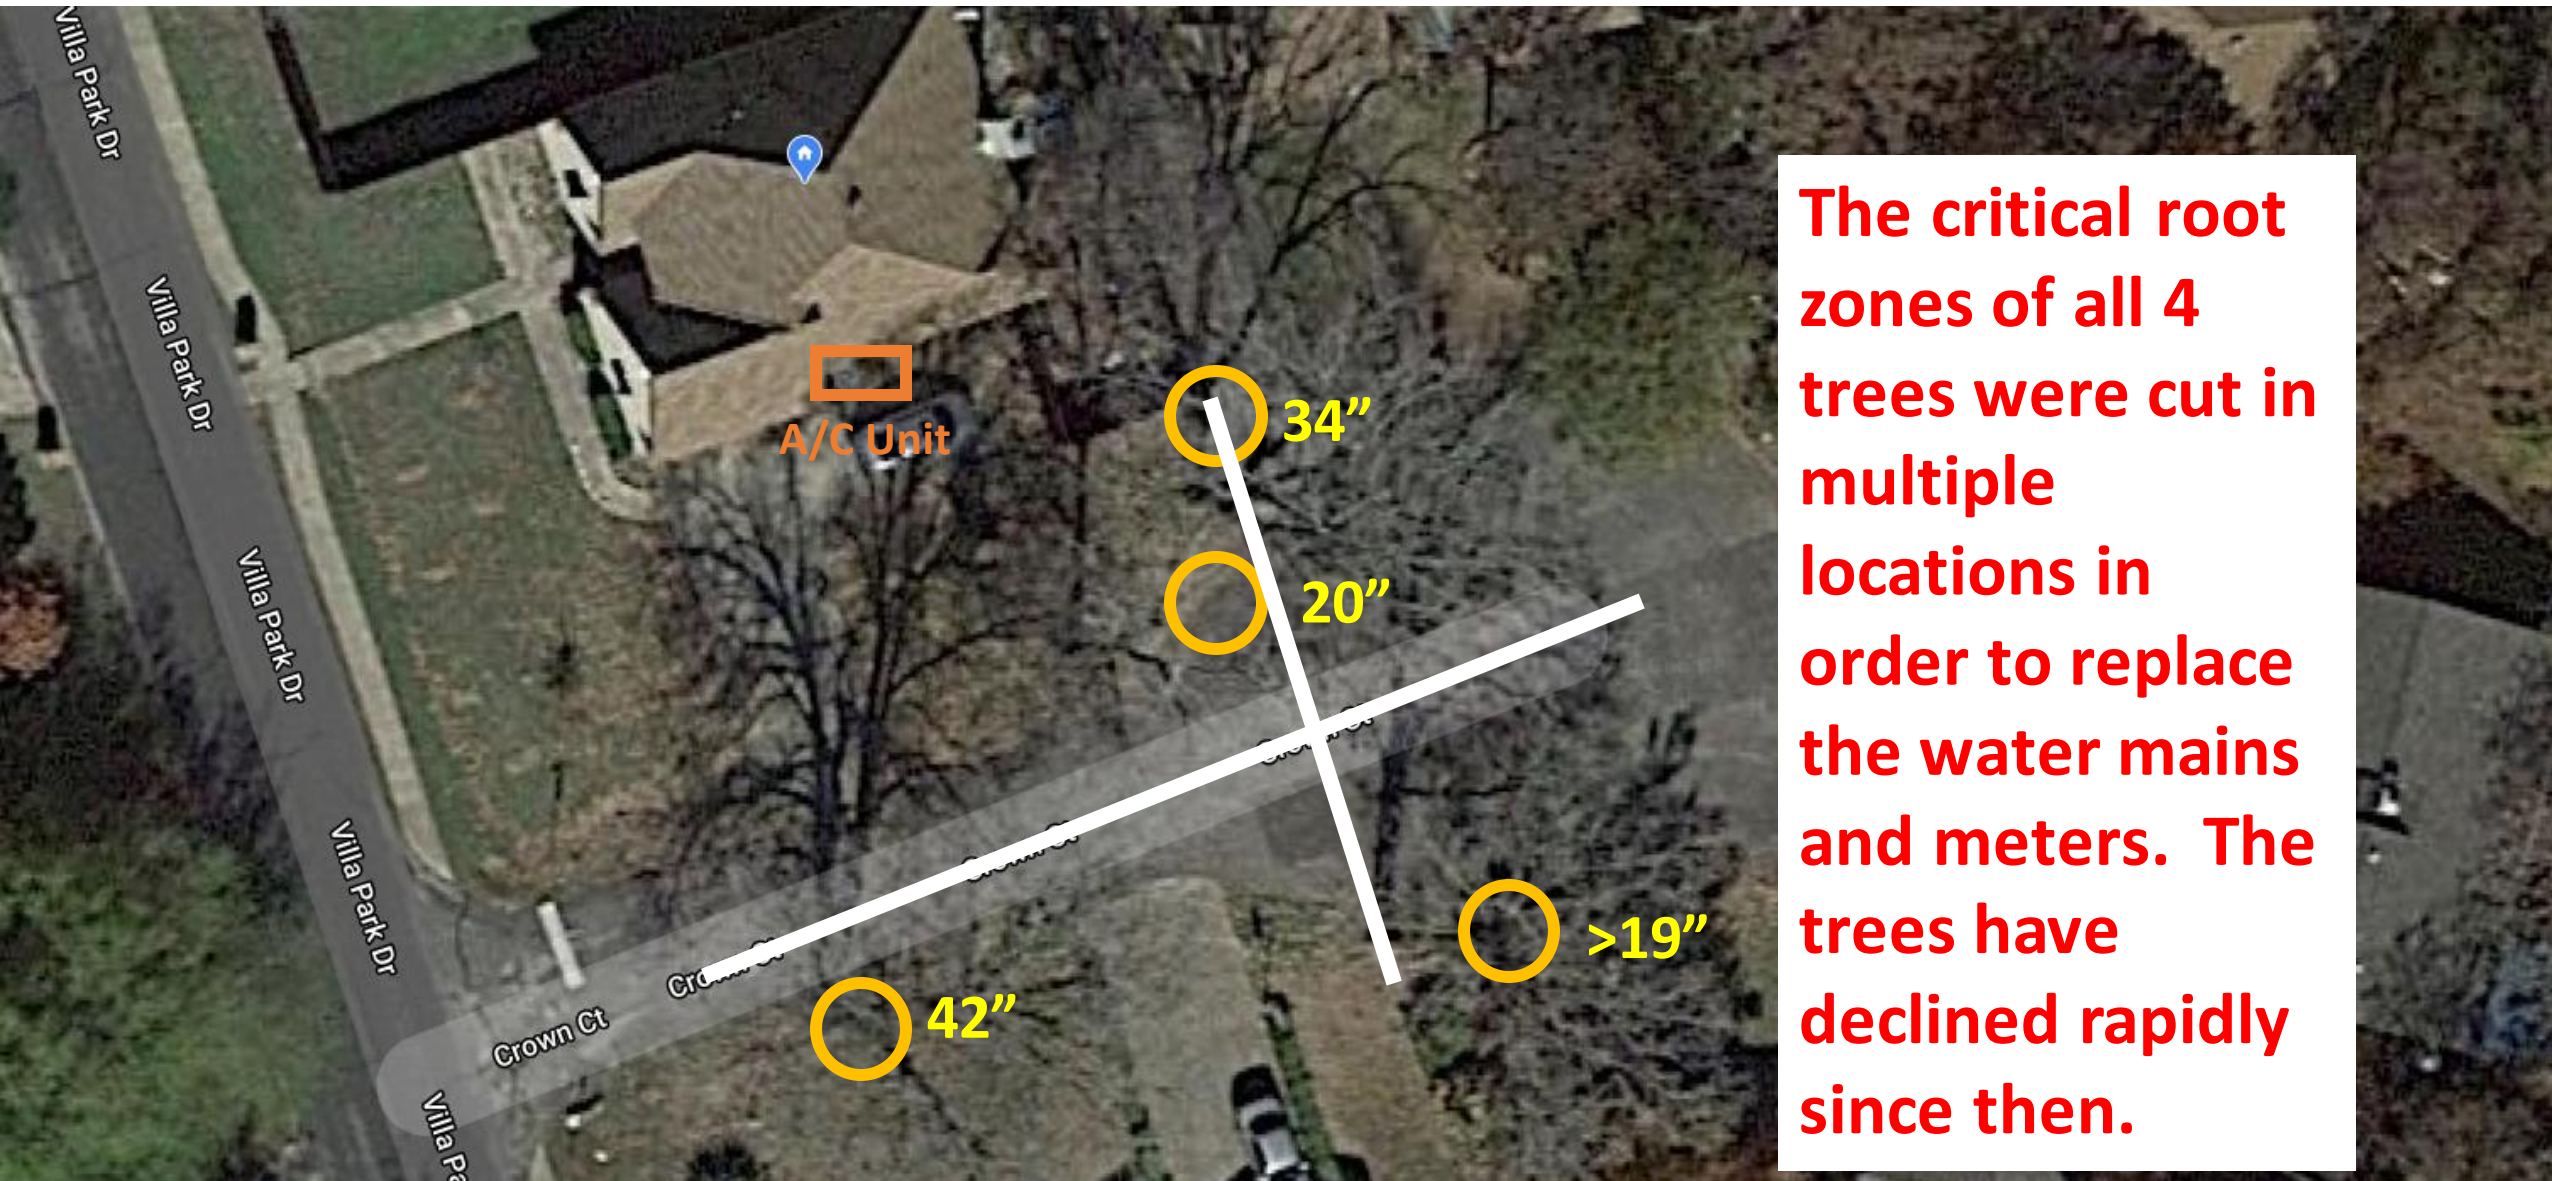
WATER MAIN REPLACEMENT – FEB 2019

The critical root zones of all 4 trees were cut in multiple locations in order to replace the water mains and meters. The trees have declined rapidly since then.

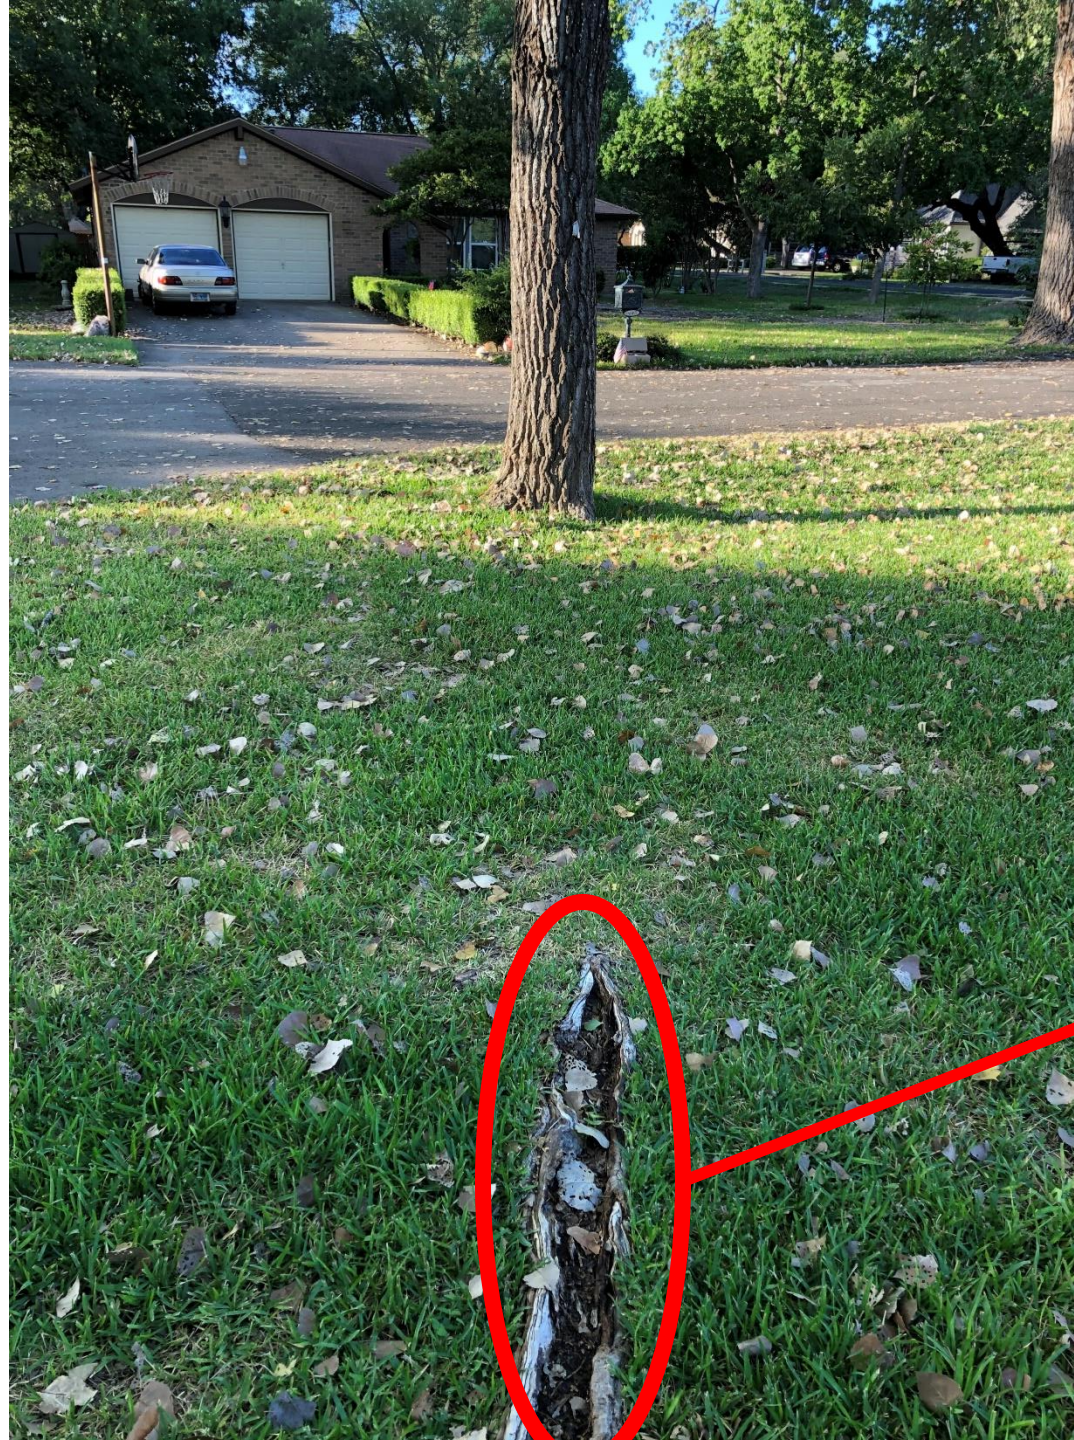
- The tree has rotted roots
- The tree has heart rot at its base, verified by the presence of carpenter ants.
- The tree has a lean and the lean has increased this summer. It leans toward the north in the direction of my driveway and house.

**Root is rotted
indicating poor
health and a
potentially
hazardous
situation**

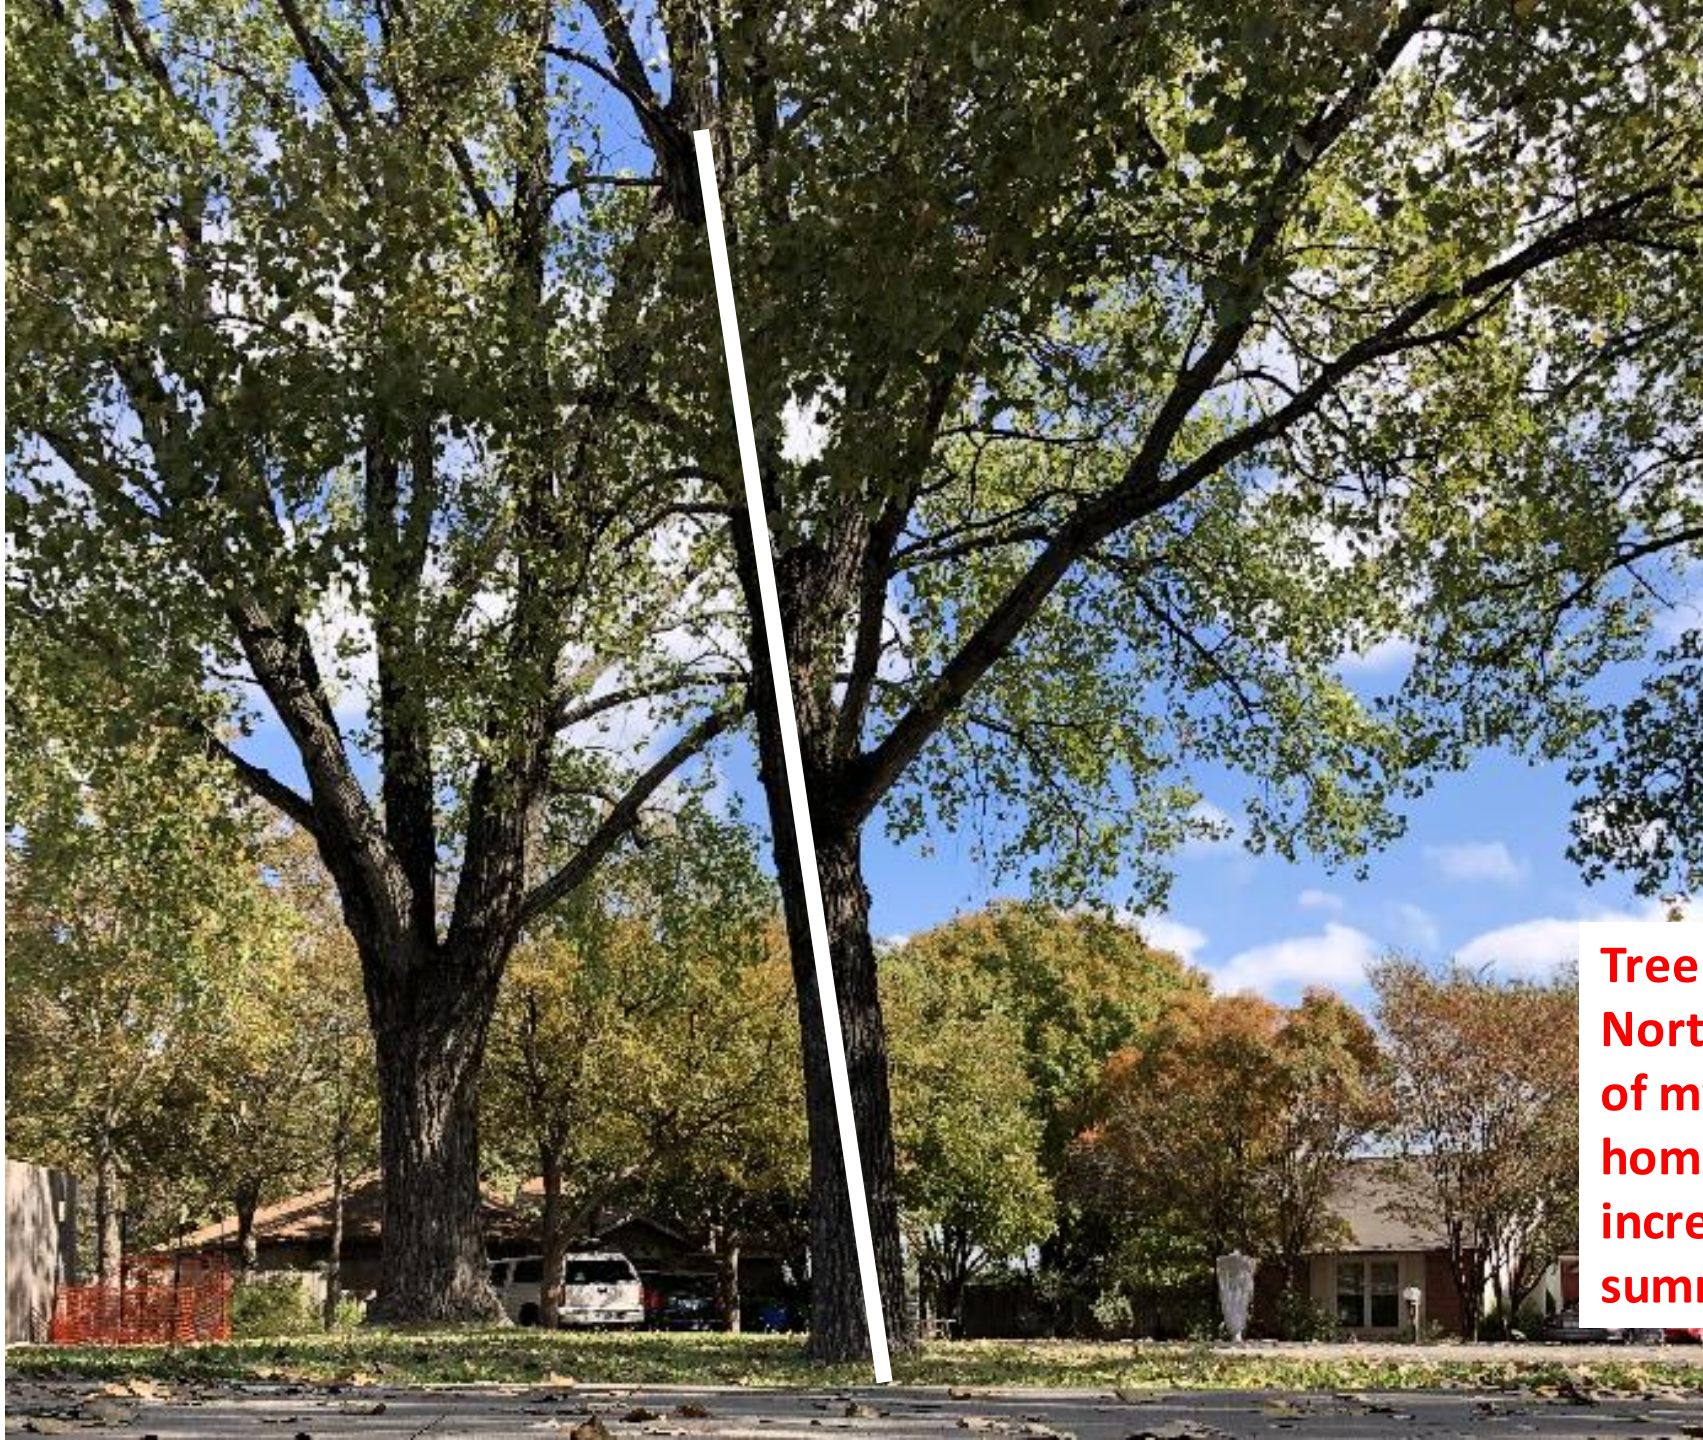
Tree leans to the North. In direct line of my driveway and home. The lean has increased this summer.

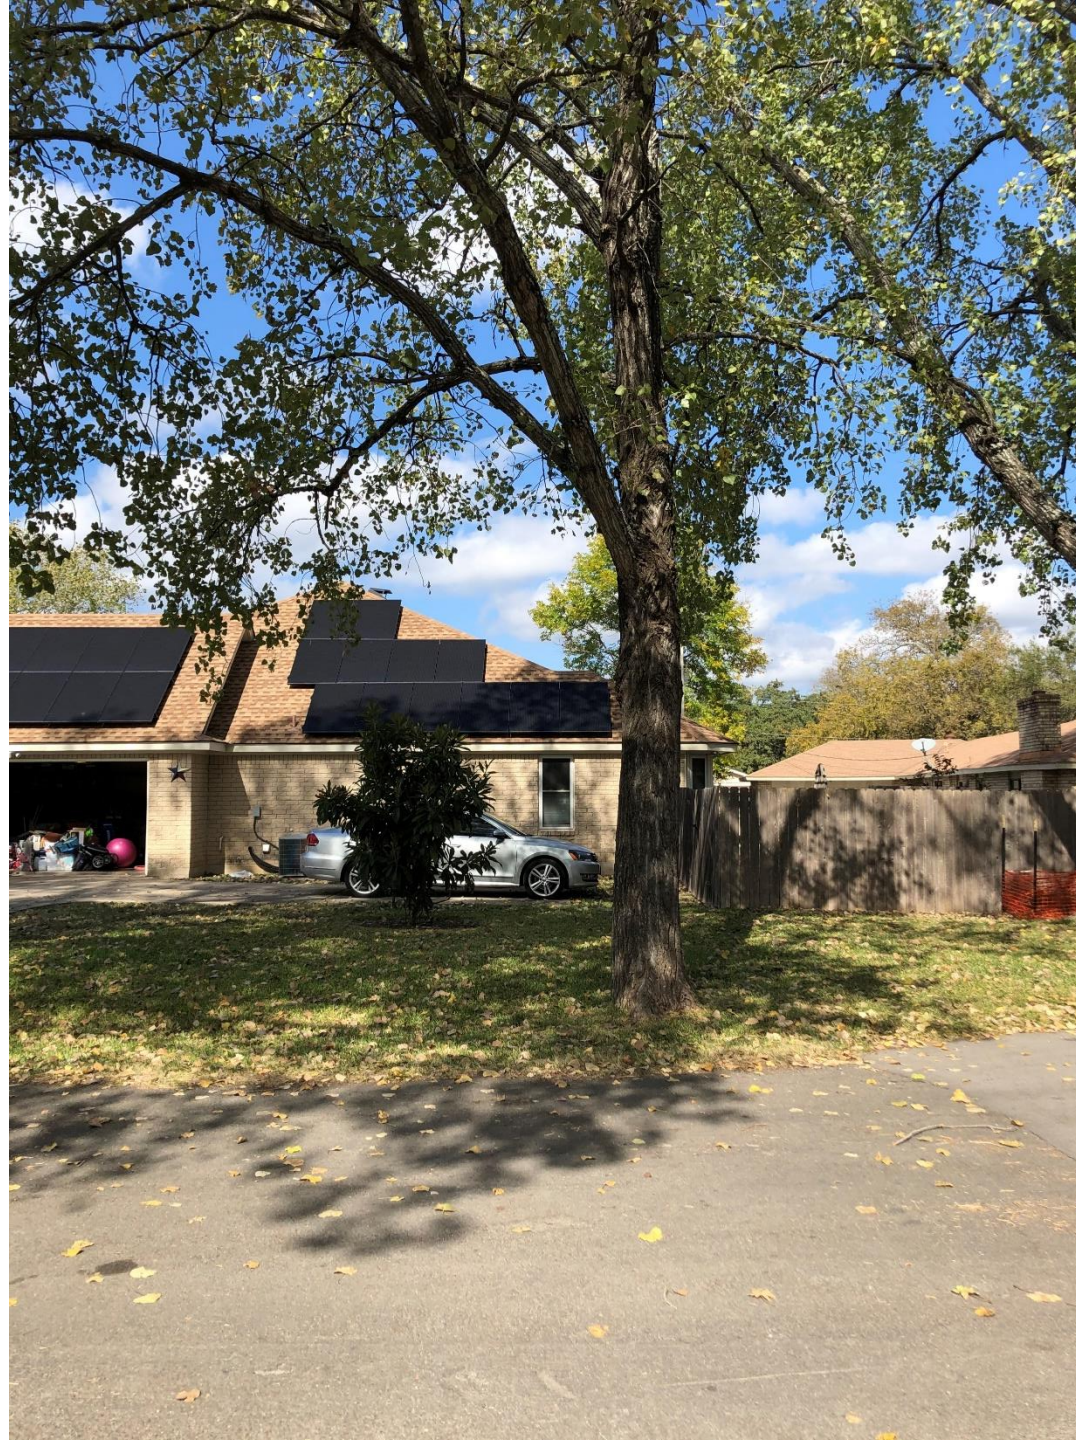
Trees are 90% likely to fall in the direction of their lean. This tree is in direct line of falling on my car and home. The impact of any fall would be significant.

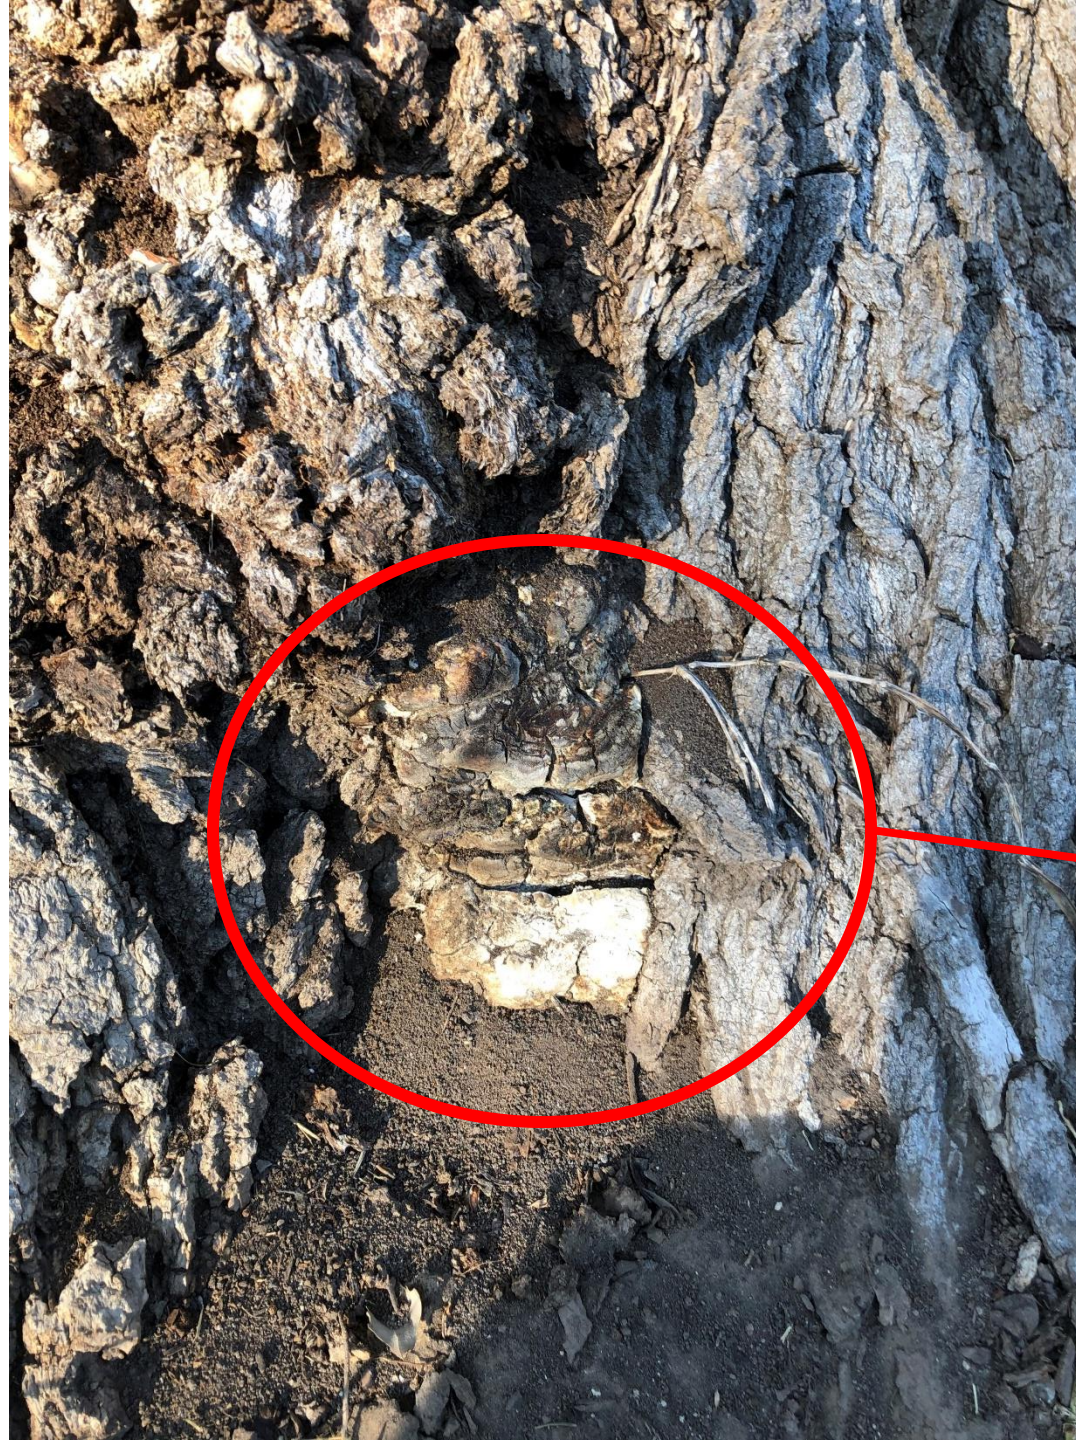
Fungus at the base of the tree. Indicates the tree is diseased and rotting from the inside.
