Appeal Regarding the Urban Forester's decision on two Cottonwood trees

42" and 20" Trees Located in the Right of Way
on Crown Ct, Austin TX

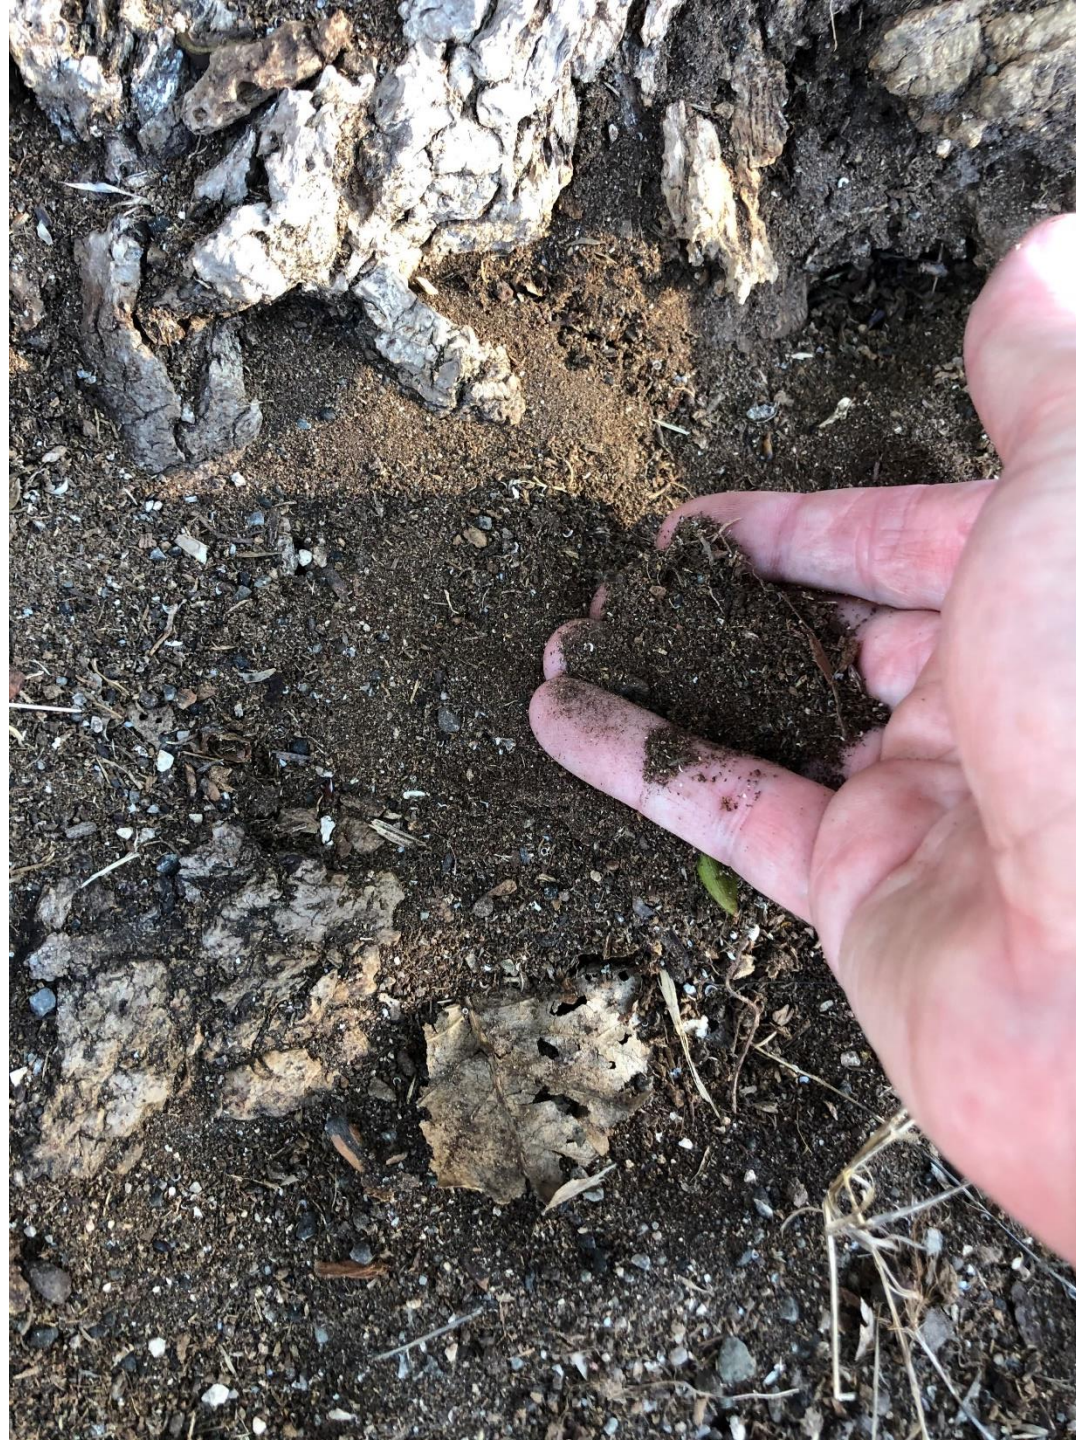
The rotted heartwood is being chewed up by carpenter ants and is visible all around the base of the tree.

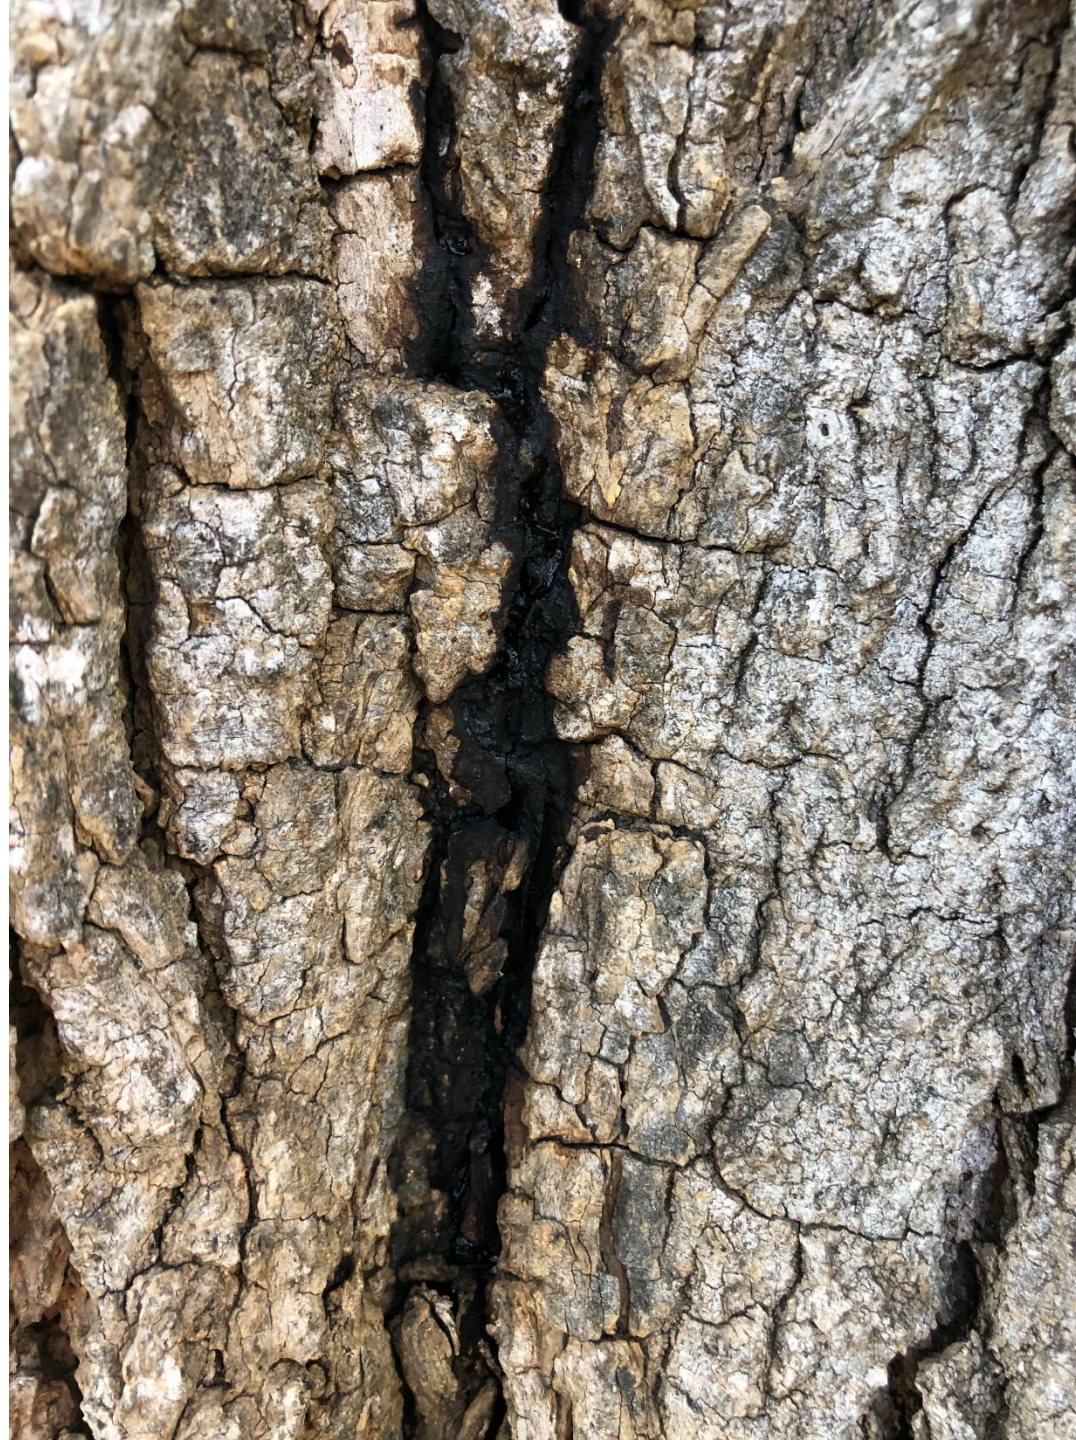
The black sap indicates a bacterial "wetwood" infection is also present. Further indicating that the tree is in poor shape and requires removal.

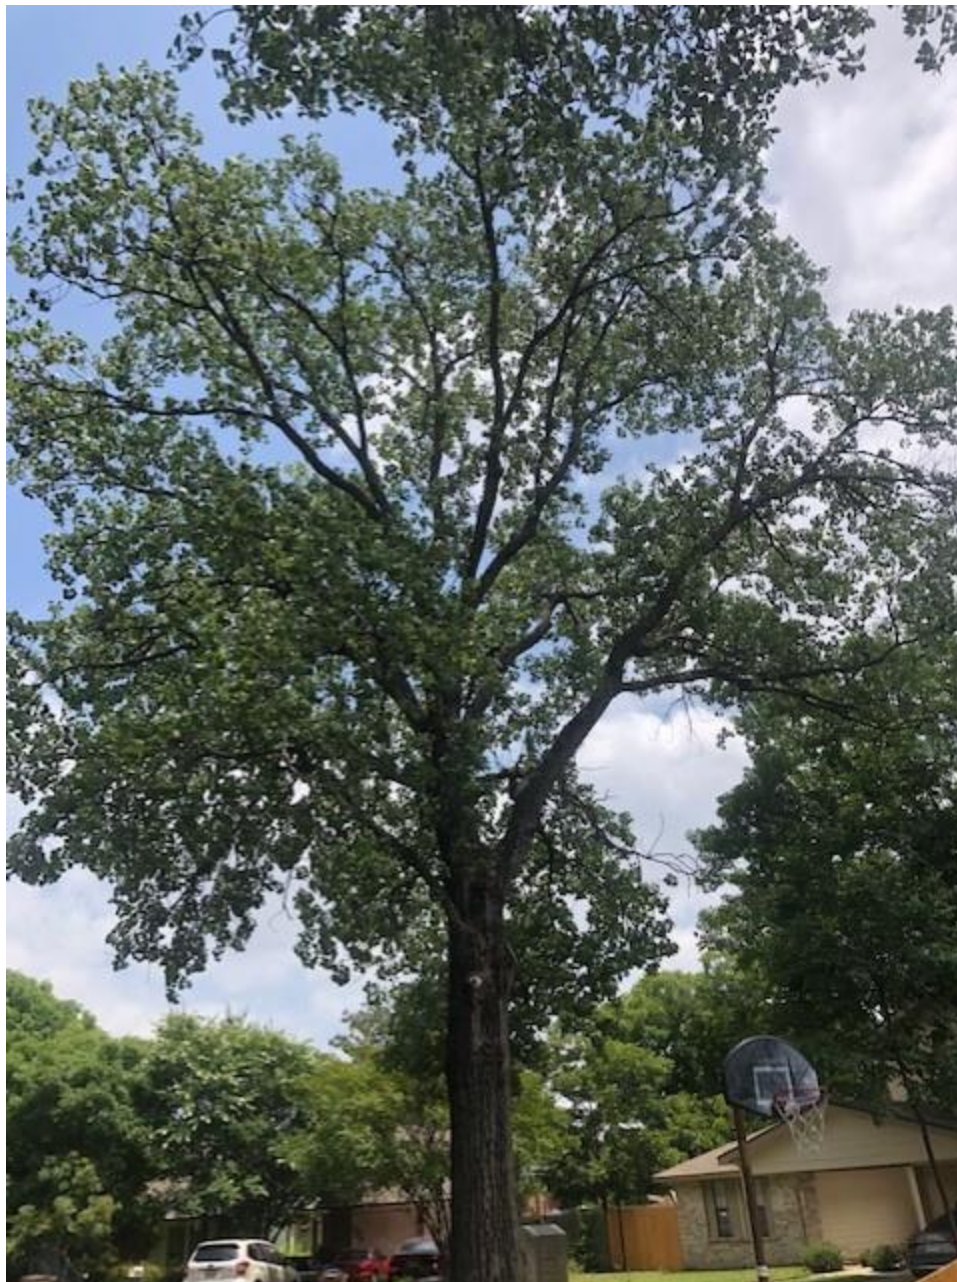
**The photo
attachment to Mr.
McMillan's report
is of the wrong
tree.**
