## **3003 E 18th Street Condition**

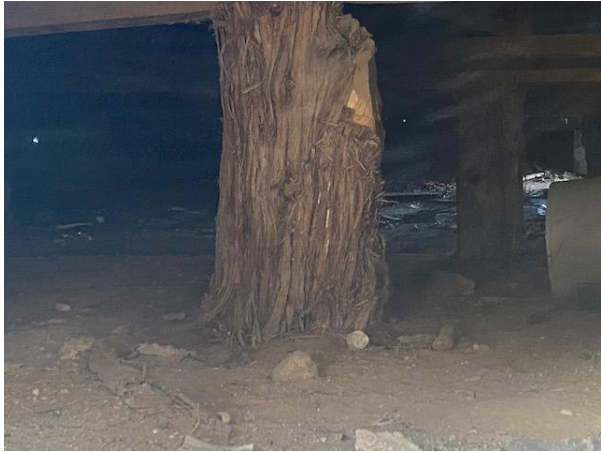
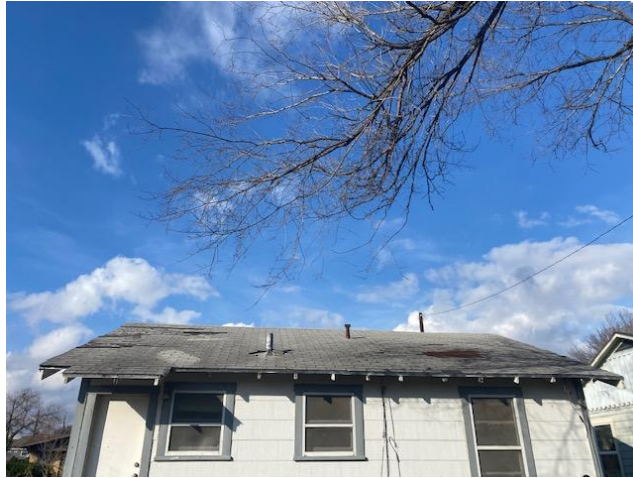
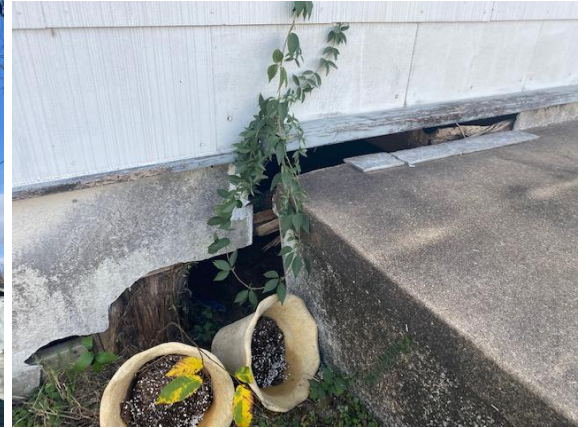
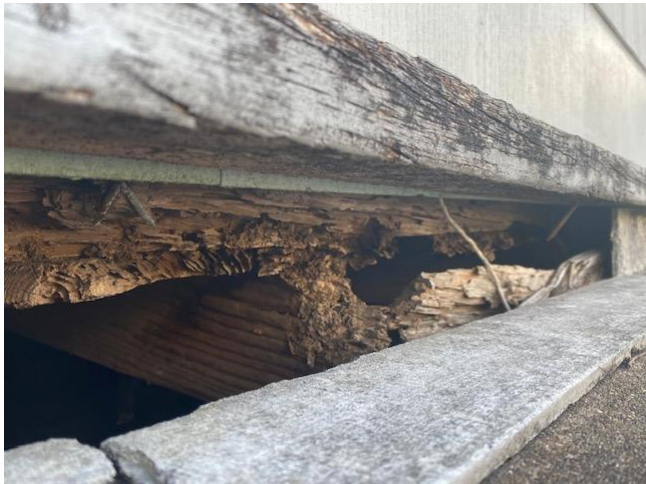
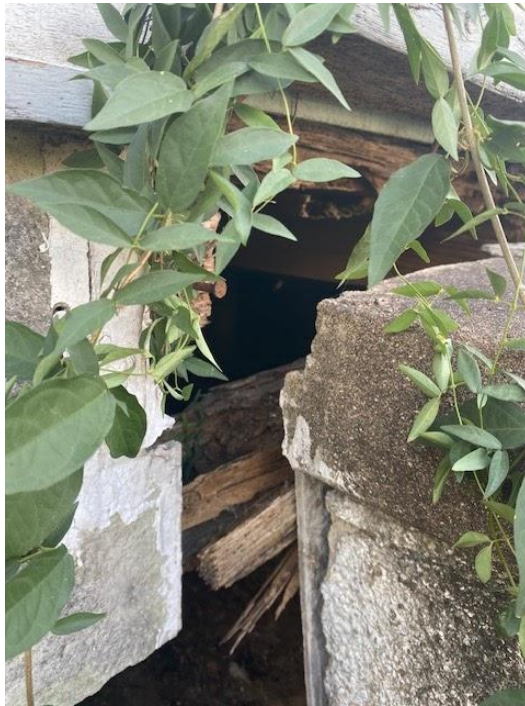
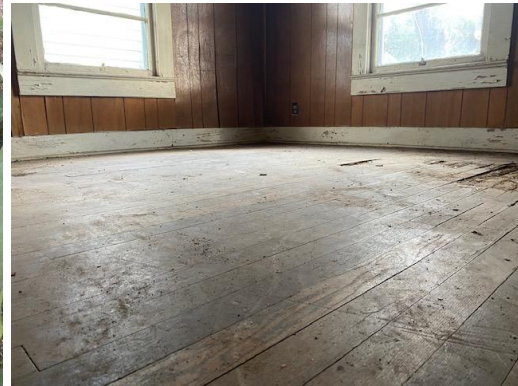
Roof deteriorated with water leaking through to the interior of the house

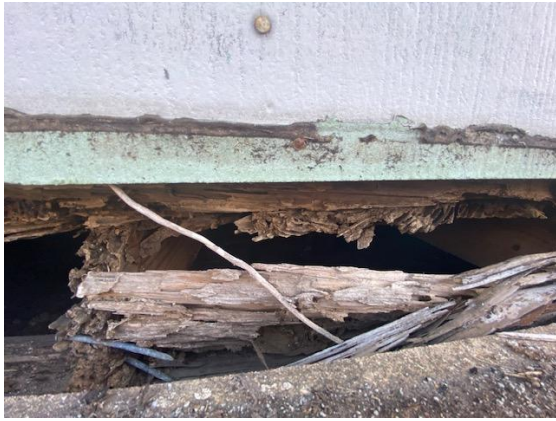
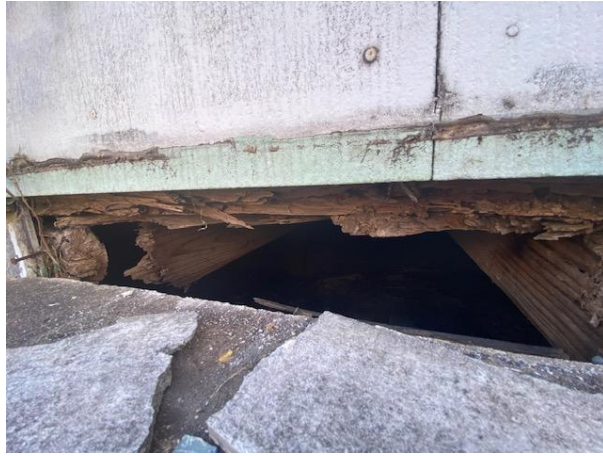
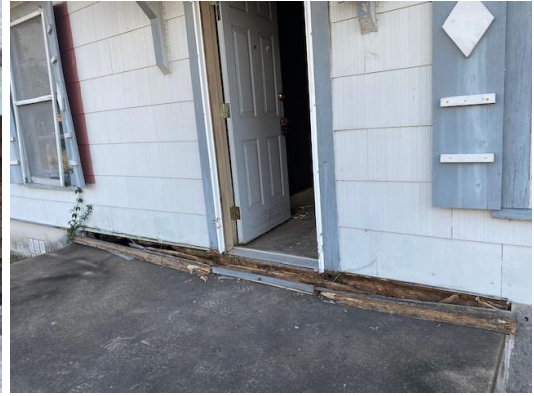
Uneven floors inside of house due to damaged beams
