1904 Mountain View Rd. Austin, TX 78703

# PROPERTY INSPECTION REPORT

**Concerning:** 1904 Mountain View Rd. Austin, TX 78703

**By:** Jeffrey Kent Prokaski TREC #9866

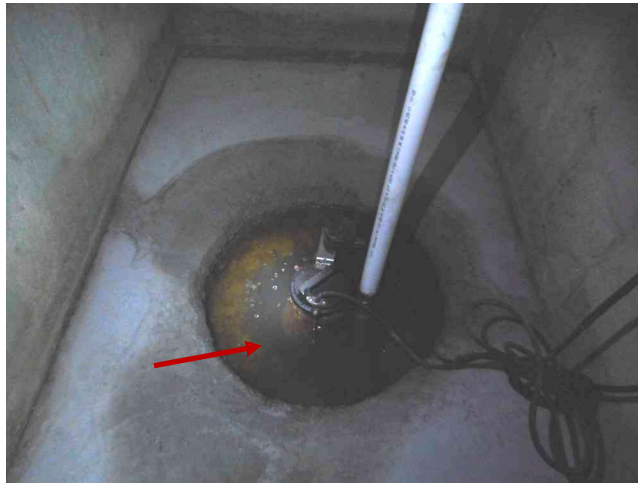
Sump pumps under the home were inoperative and should be repaired.

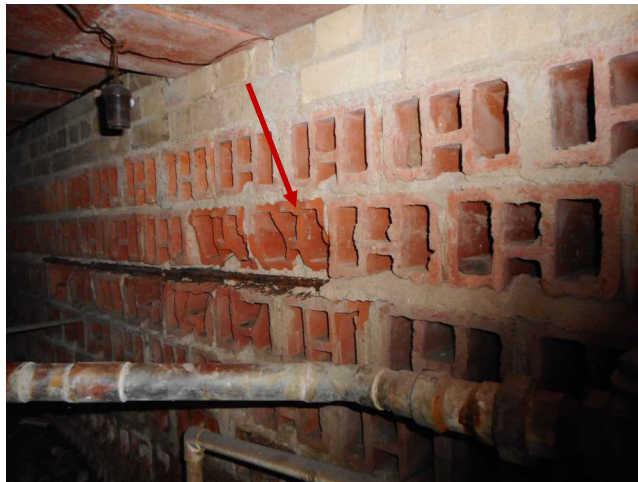
Improper pier were observed under the home. By today's standards, piers should be of solid block.

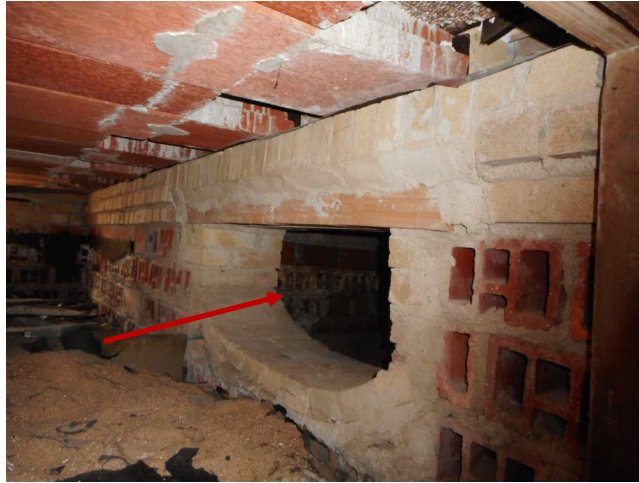
Altered piers under the home were observed. A structural engineer should be consulted on the integrity of the piers condition and the remedies available for correction..

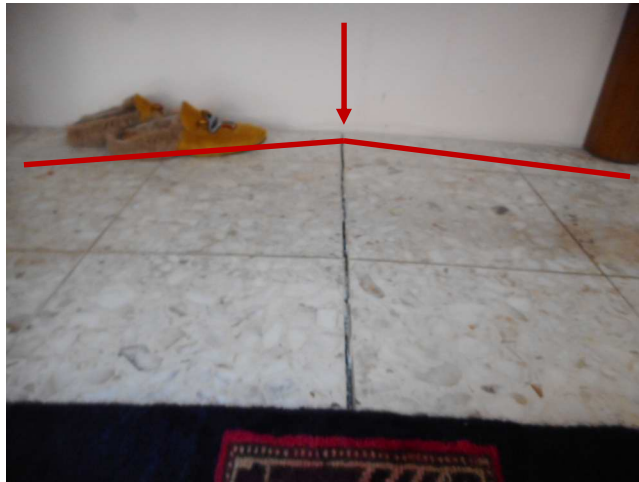
Substantial foundation cracking was observed in the front entry. This implies that structural movement of the building has occurred. The rate of movement cannot be predicted during a one-time inspection. A structural engineer should be consulted to further evaluate this condition and the remedies available for correction.

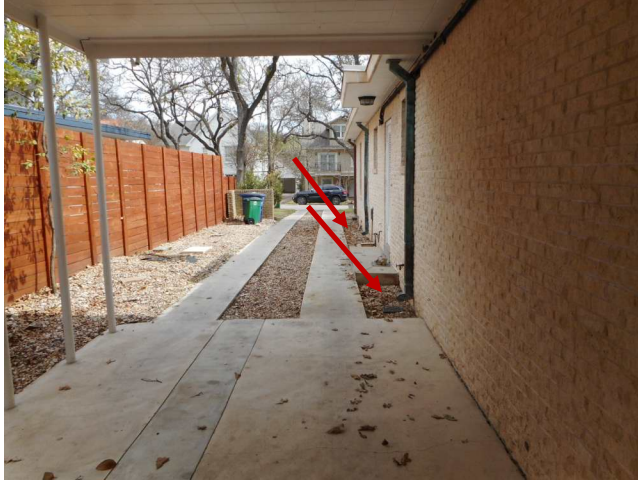
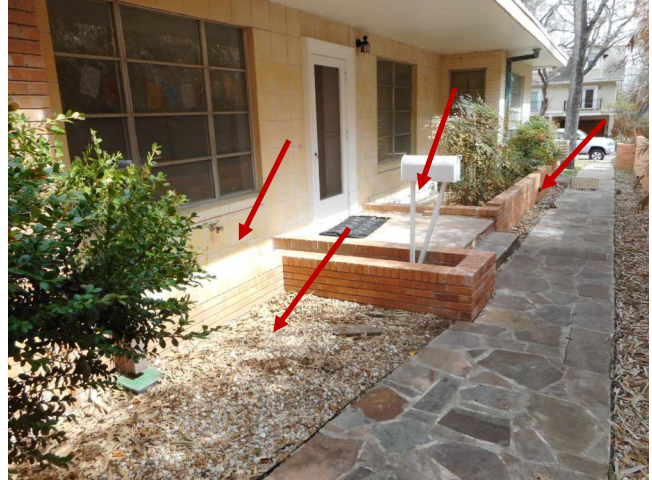
Poor and/or negative site drainage was observed. Proper drainage is needed on to help prevent water from standing and/or ponding next to the foundation area. Under today's building standards, the grade away from the foundation walls should fall a minimum of six-inches (6") within the first ten feet (10ft.). If adding soil to the perimeter to create positive drainage, remember to keep the soil level about four (4") inches BELOW the foundation edge. French drains may also be used to divert water accumulation.

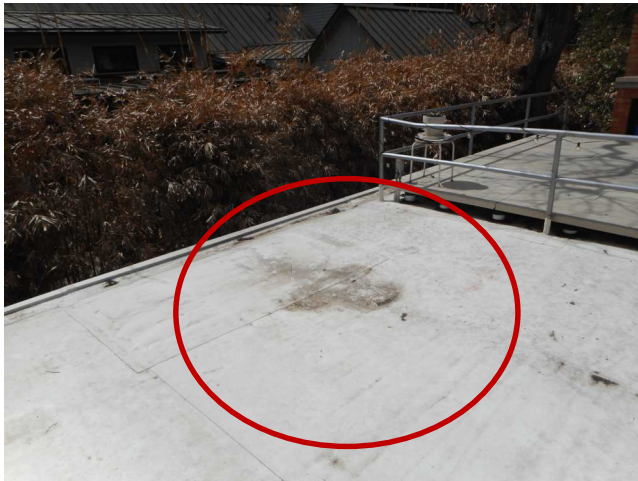
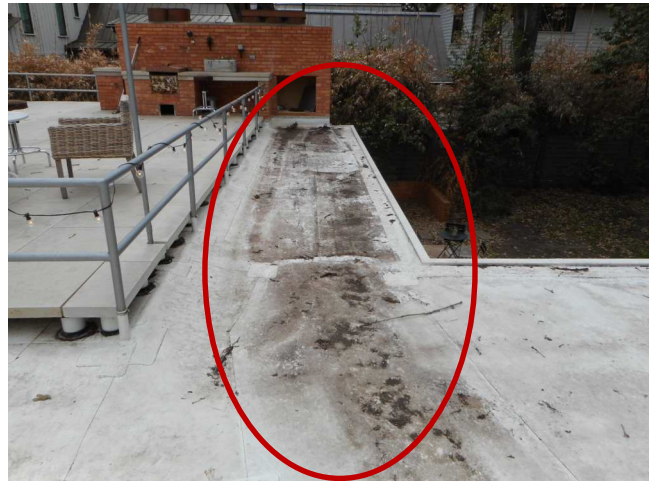
Water appears to pond on the membrane. This usually leads to a shortened life expectancy and increases the potential for damage if leakage occurs. Improvement is not usually practical until re-roofing is performed. At that time, the roof should be appropriately sloped, or drains should be provided as necessary.

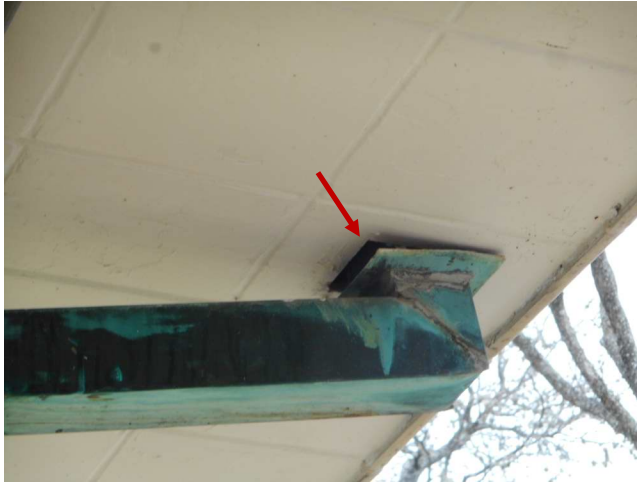
Damaged gutters should be repaired or replaced as necessary to avoid spilling roof runoff around the building – a potential source of water entry or water damage.

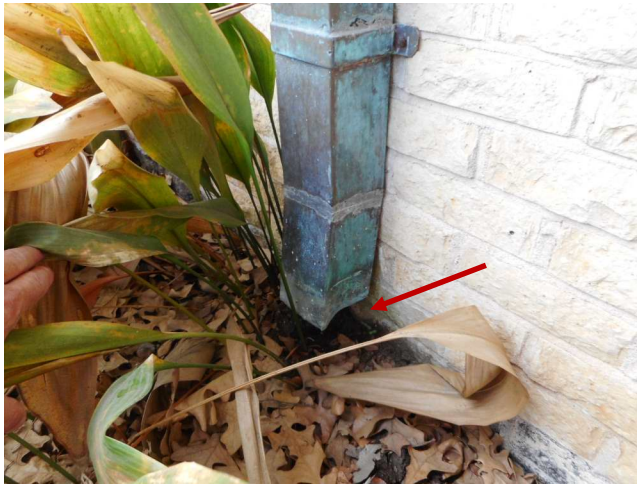
The downspout(s) should discharge water at least five (5) feet from the house. Storm water should be encouraged to flow away from the building at the point of discharge. Ramps or extension tubes are recommended.

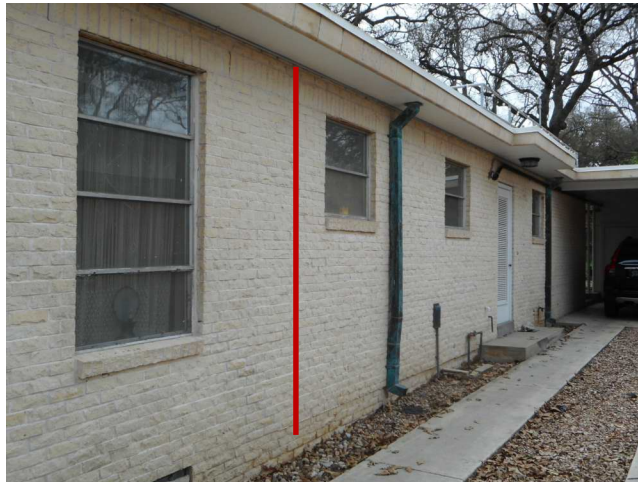
Under current building standards, masonry walls in excess of twenty five feet are required to have an expansion joint which was not present at the time of inspection.

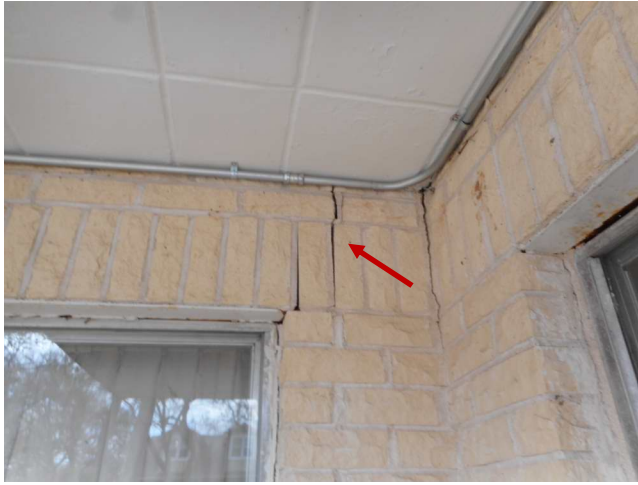
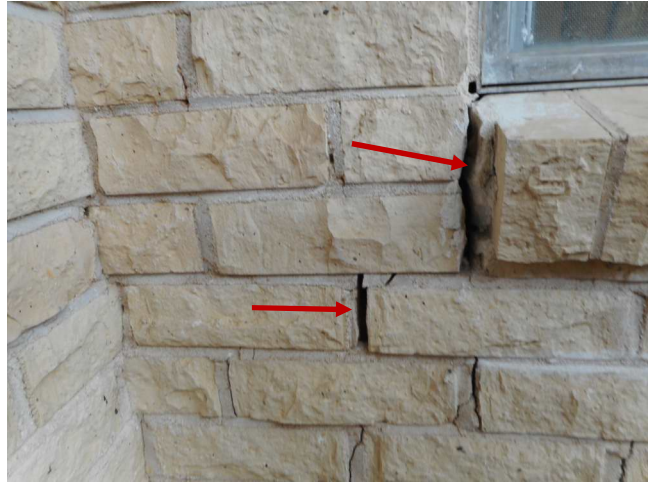
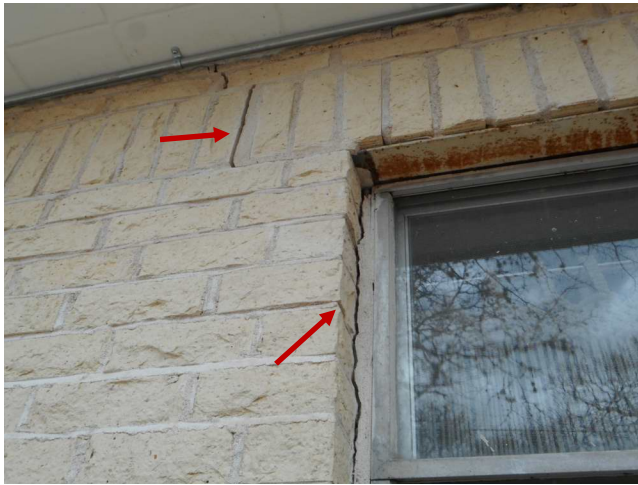
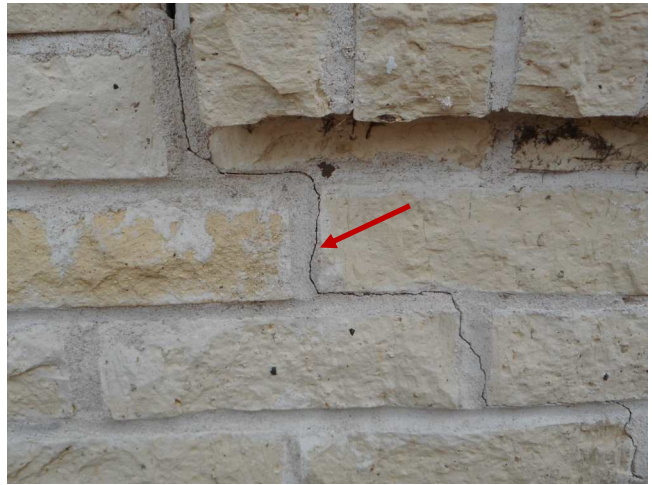
Pronounced exterior wall cracks were observed in various locations around the home. This implies that structural movement of the building has occurred. The rate of movement cannot be predicted during a one-time inspection. A structural engineer should be consulted to further evaluate this condition and the remedies available for correction.

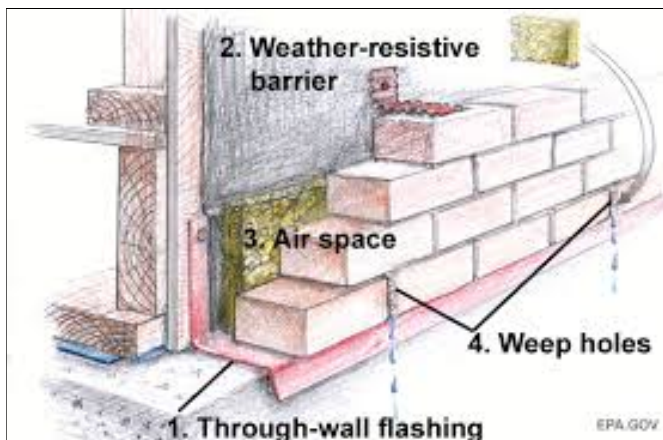
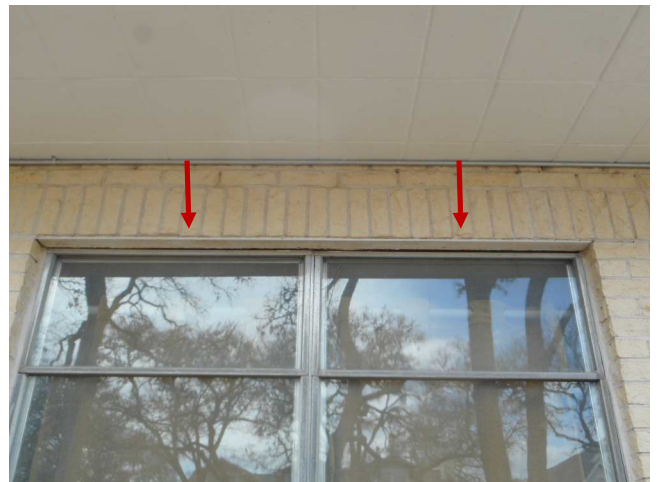
There were no weep holes found above the lintels. Weep holes allow moisture to drain from the wall cavity due to penetration or condensation. Drilling weep holes post construction can damage the flashing. Recommend improvement on an as needed basis only.

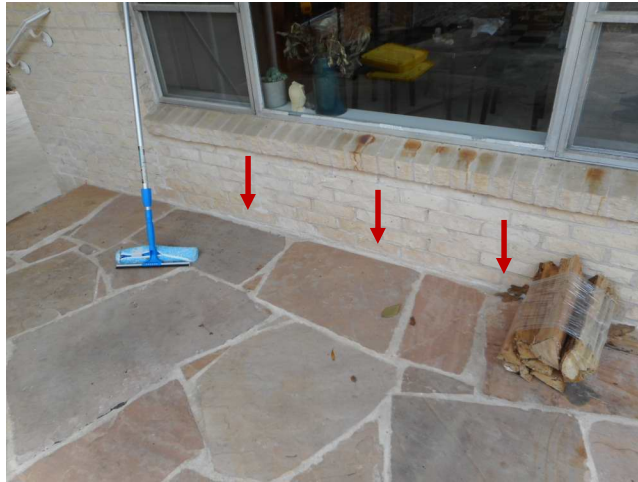
There were no weep holes found in the brick or stone veneer wall structure. Weep holes allow moisture to drain from the wall cavity due to penetration or condensation. Drilling weep holes post construction can damage the flashing. Recommend improvement on an as needed basis only.

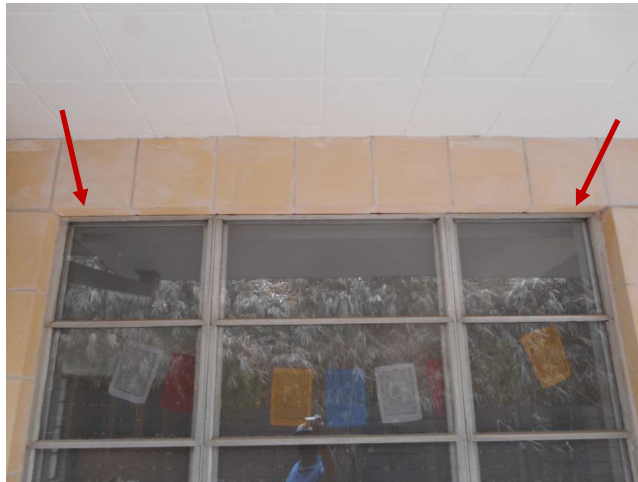
Steel lintels were not installed over some of the windows on the home. This does not comply with IRC code for home construction.

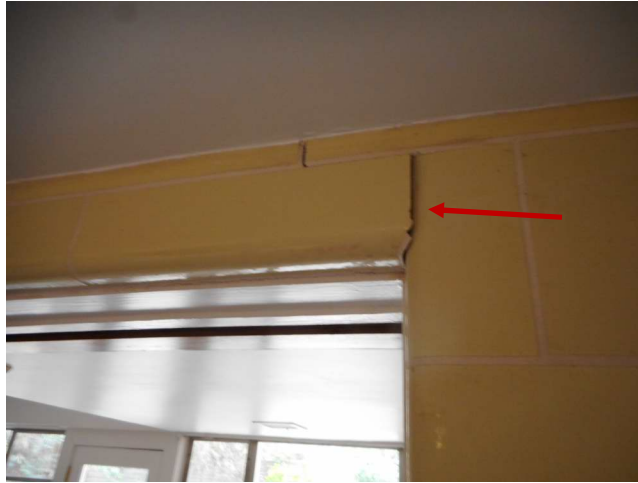
Larger than typical wall cracks were noted in the kitchen. This condition could indicate greater than normal movement within the structure and potential structural problems. Further investigation may be necessary.

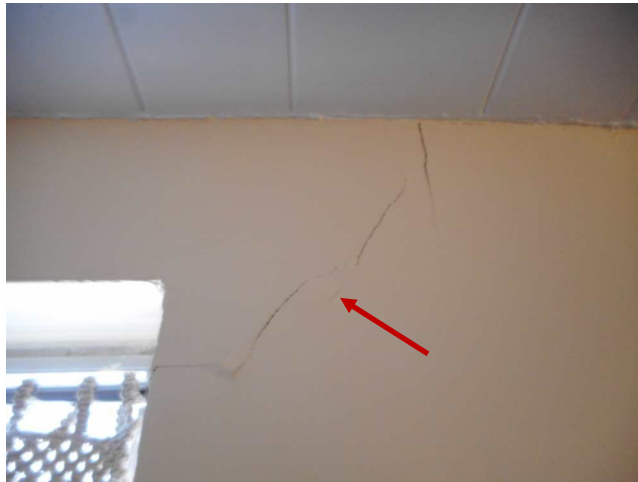
Larger than typical cracks were noted in the master bedroom. This condition could indicate greater than normal movement within the structure and potential structural problems. Further investigation may be necessary.

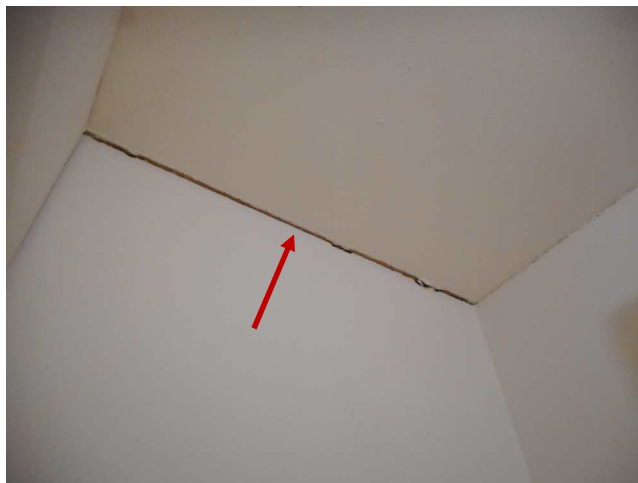
Larger than typical cracks were noted in the south east bedroom. This condition could indicate greater than normal movement within the structure and potential structural problems. Further investigation may be necessary.

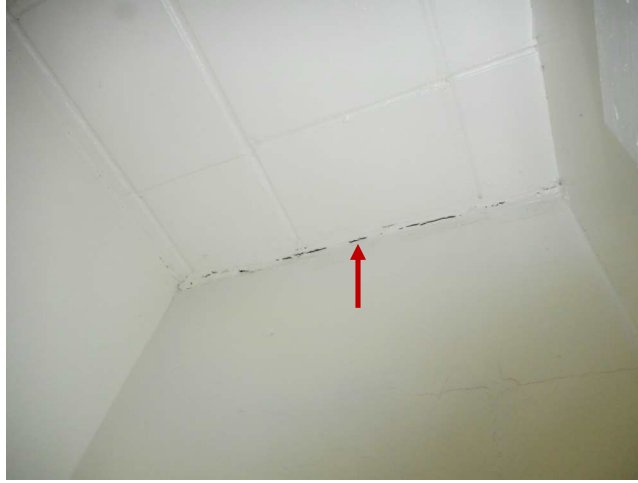
Larger than typical cracks were noted in the south bedroom. This condition could indicate greater than normal movement within the structure and potential structural problems. Further investigation may be necessary.

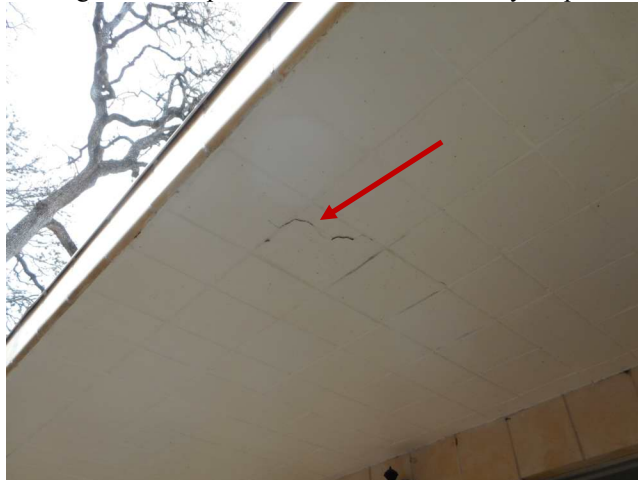
Water damage in the ceiling was noted on the south side of the home. This condition should be further investigated and repairs undertaken, if necessary, to prevent further damage to the structure.

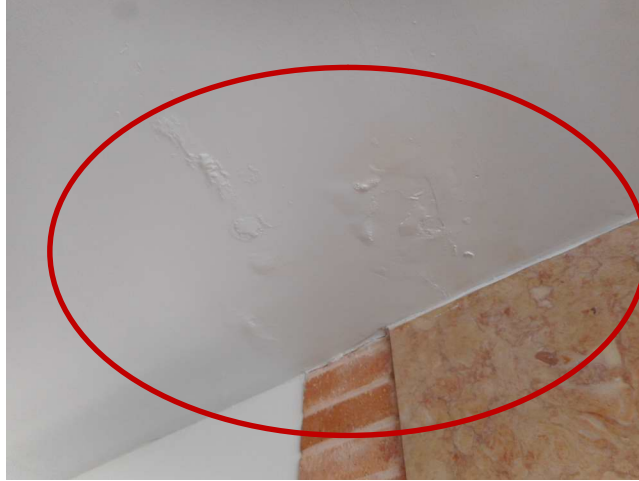
Water damage was noted in the living room ceiling. This condition should be further investigated and repairs undertaken, if necessary, to prevent further damage to the structure.

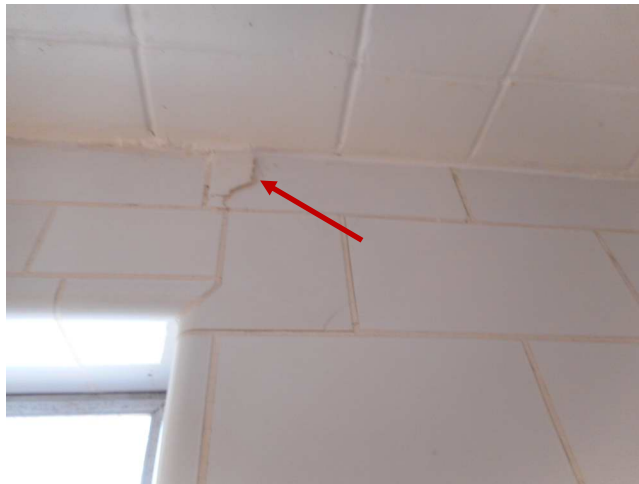
Larger than typical cracks were noted in the master bathroom. This condition could indicate greater than normal movement within the structure and potential structural problems. Further investigation may be necessary.

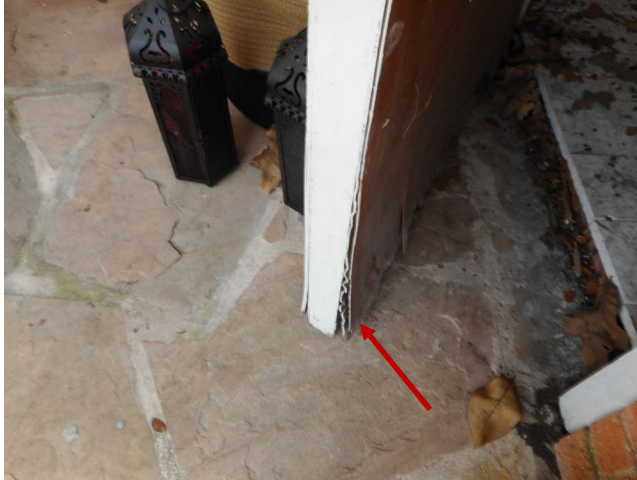
The damaged door to the outdoor storage should be repaired as needed.

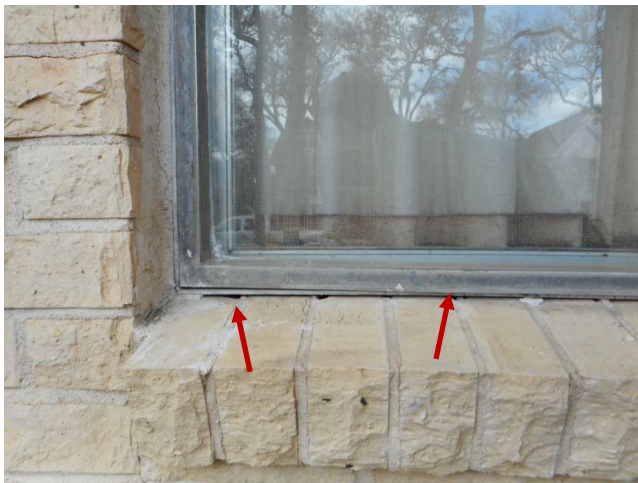
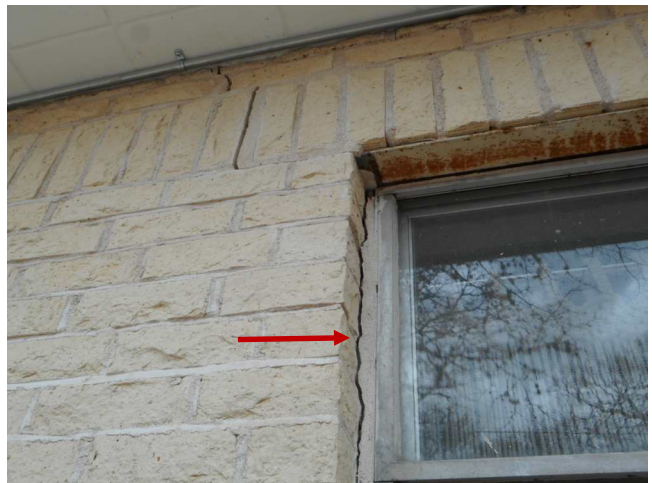
The windows and window sills on the exterior of the house are in need of re-caulking or re-pointing to avoid water penetration.

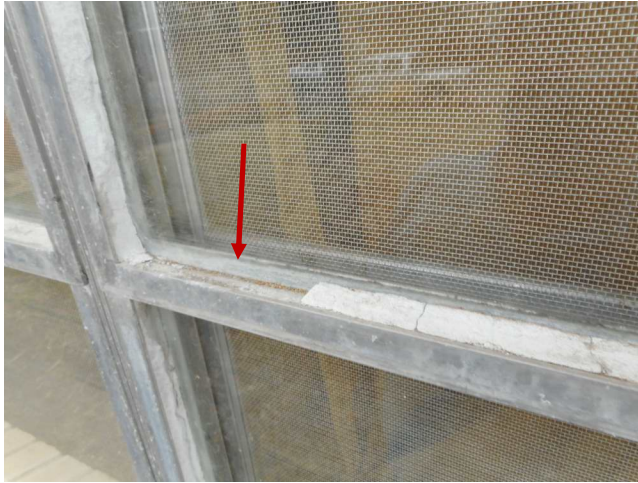
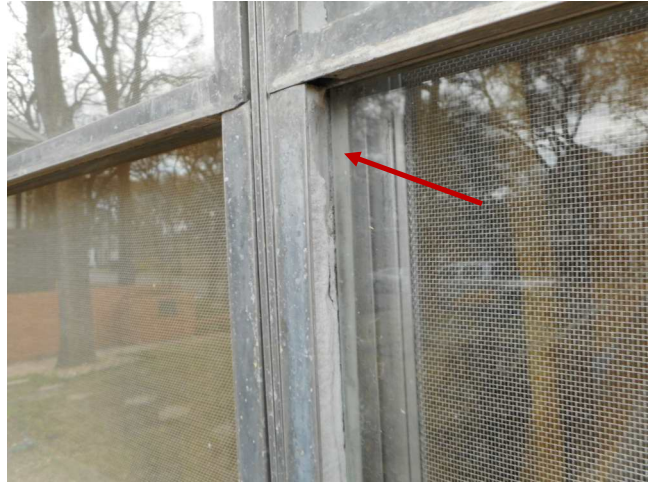
Missing and/or damaged window glazing was observed. This should be repaired to prevent water penetration.

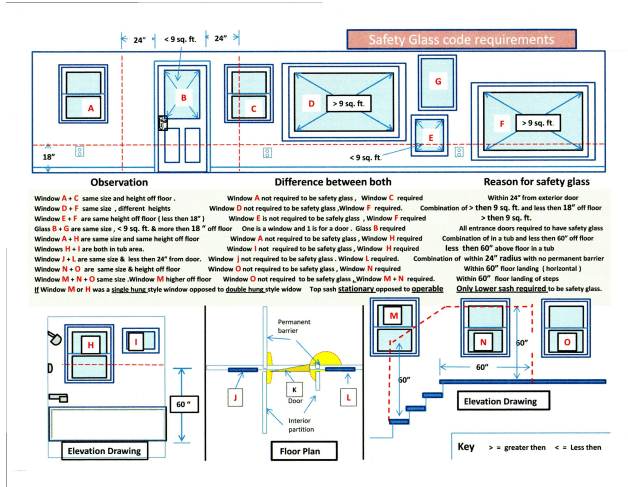
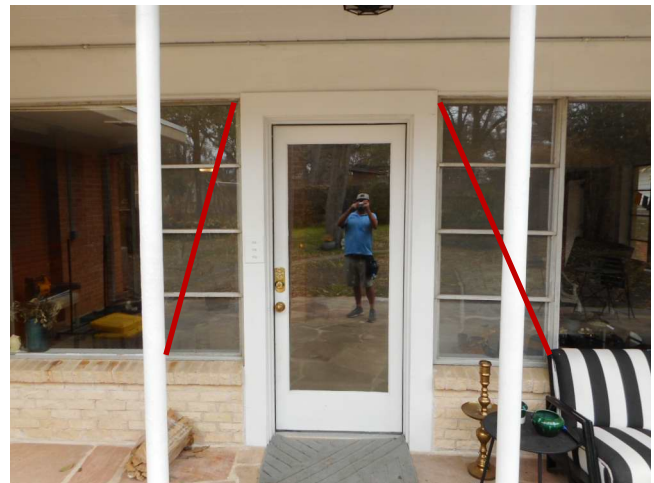
Safety glass etchings were not observed on the glass within the windows next to exterior doors. This glass is required for windows close to the floor or in hazardous locations and is generally identified by an etching in the corner of the glass pane.

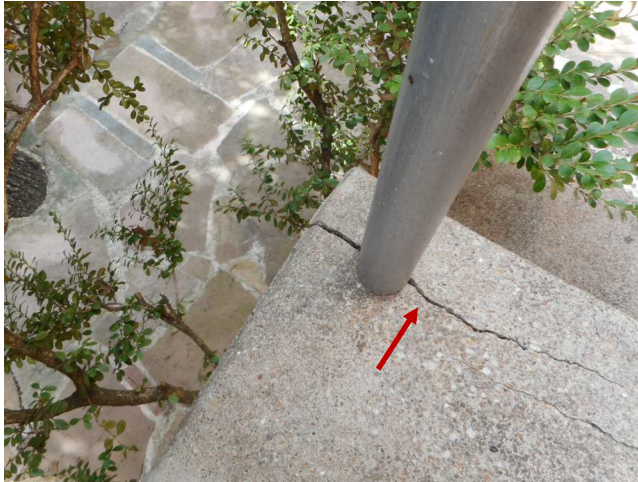
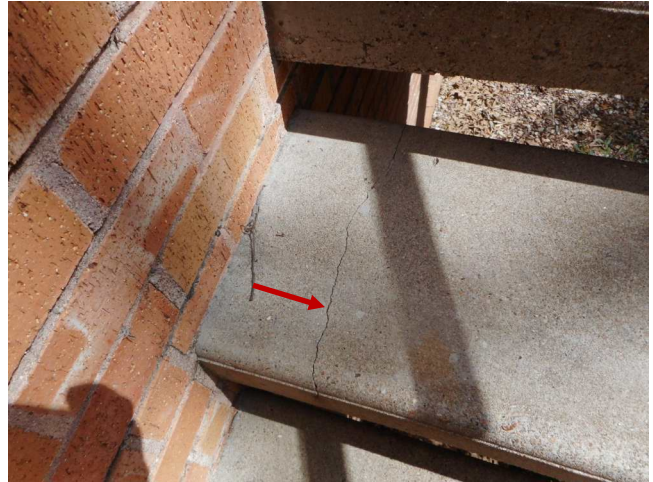
The stair treads to the rooftop deck were found to be damaged. This condition should be repaired for safety reasons.

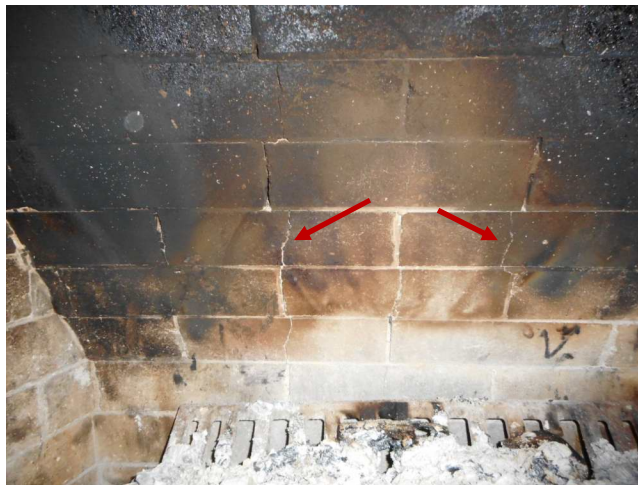
The rear wall of the fireplace firebox should be repaired for improved safety.

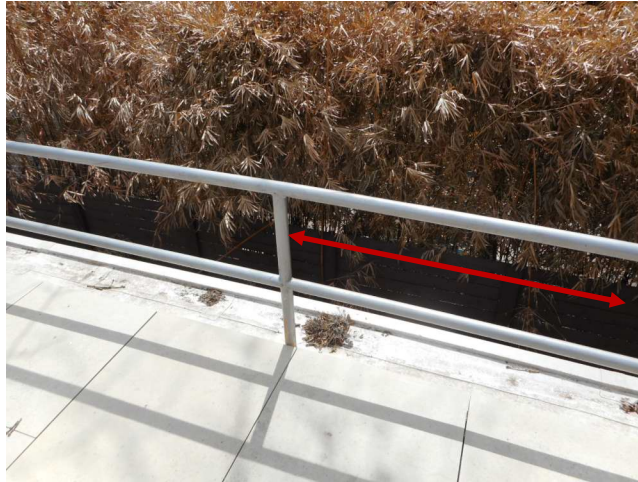
The openings in the deck railing are large enough to allow an object of four inches in diameter to fall through. It is recommended that this be repaired for improved safety.

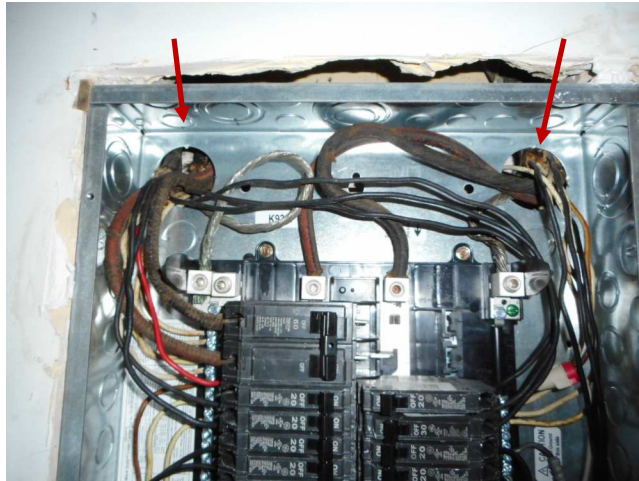
Cable clamps (sometimes referred to as bushings or grommets) are required where wiring passes into a distribution panel. Cable clamps serve to protect the wiring from the metal edges of the panel openings. Improvement is recommended.

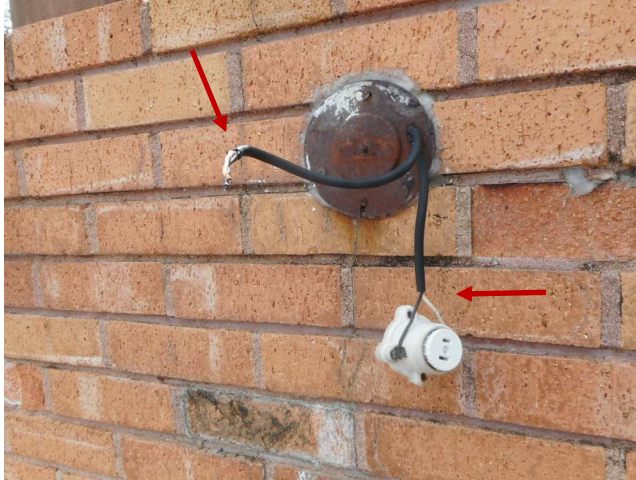
Exposed wiring on the roof should be enclosed for safety reasons.

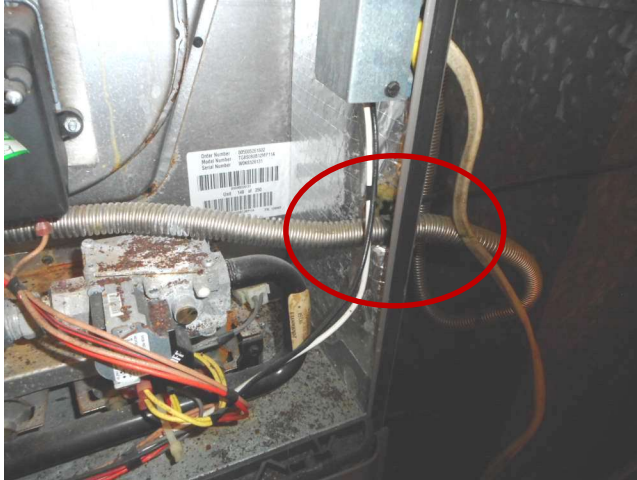
The gas supply flex connector was observed to be passing through the heating unit cabinet. Ridged piping should be extended to outside the housing and the flex line connected at that point. The soft metal line can come in contact with the sharp metal edge of the cabinet causing leaks in the line.

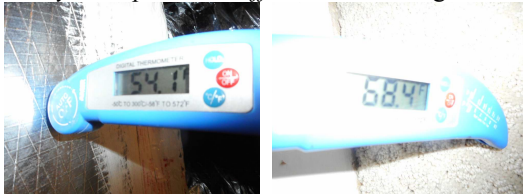
**B. Cooling Equipment***Comments:*Main Central Cooling System*Today's temperature differential:* 12 degrees Needs servicing

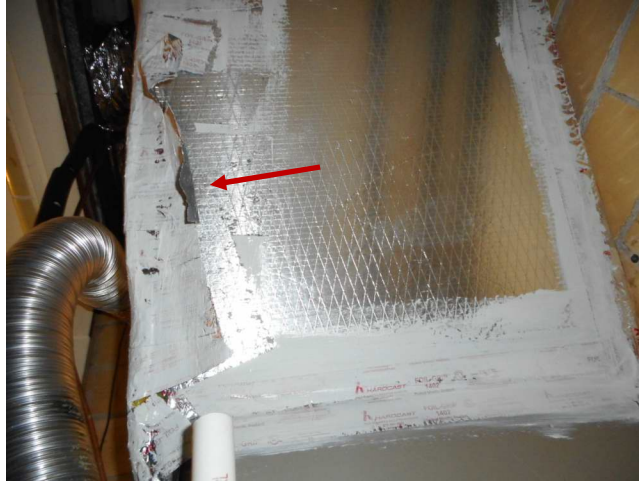
There is air leaking where the supply air plenum attaches to the air handler. This improvement is a minor repair and will reduce energy costs.

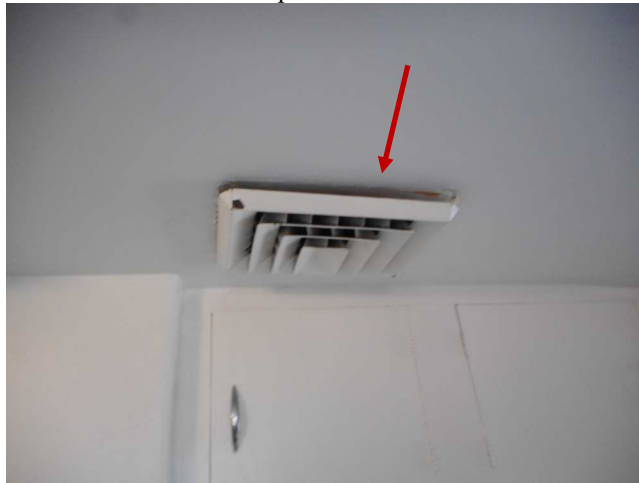
Loose vents should be improved in the kitchen.

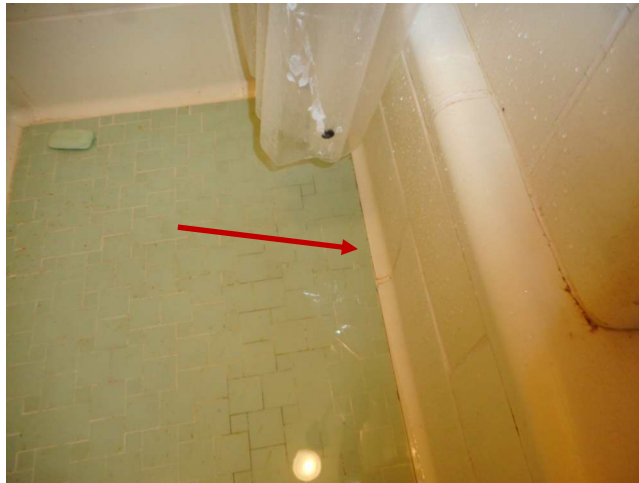
The tile shower stall requires repair in the hall bathroom. Loose or damaged tile, grout and caulk should be repaired or replaced as necessary. Any damage to the wall behind the tile should also be repaired (if necessary). Further investigation may reveal the need to rebuild a portion of the shower stall.

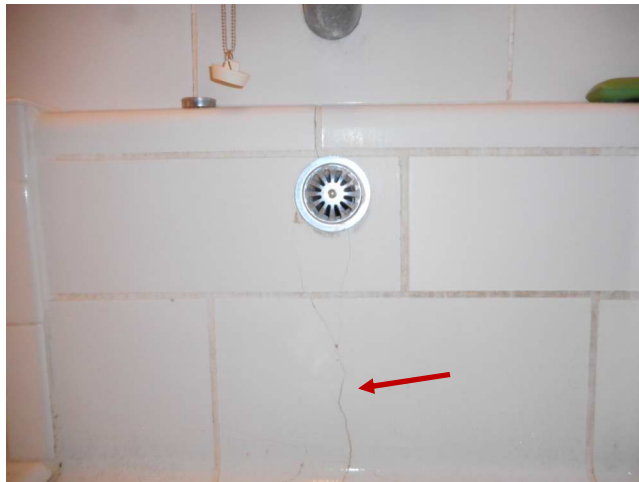
The tile shower stall requires repair in the master bathroom. Loose or damaged tile, grout and caulk should be repaired or replaced as necessary. Any damage to the wall behind the tile should also be repaired (if necessary). Further investigation may reveal the need to rebuild a portion of the shower stall.

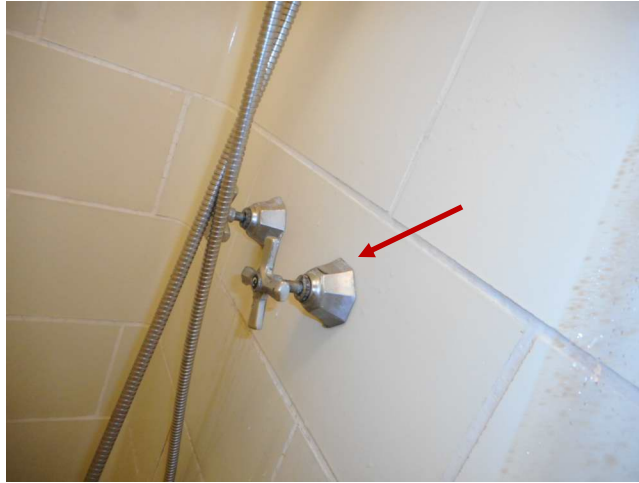
The shower hardware in the bathrooms should be sealed to the tile enclosure to prevent water penetration into the wall.

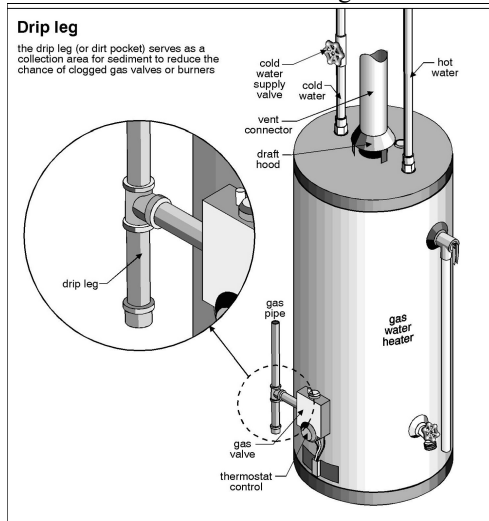
Drip legs were not present at the furnace connection. Under current building standards, drip legs should be installed downstream from the gas shut-off valve and as close to the equipment inlet as possible.
