On 02 March 2021, R. Derek Hammond of RDH C&E performed a site observation to view the existing single story residence located at 1904 Mountain View Drive in Austin, Texas. This report details what was encountered during the site visit, conclusions, and recommendations.

### **Existing Site Conditions**

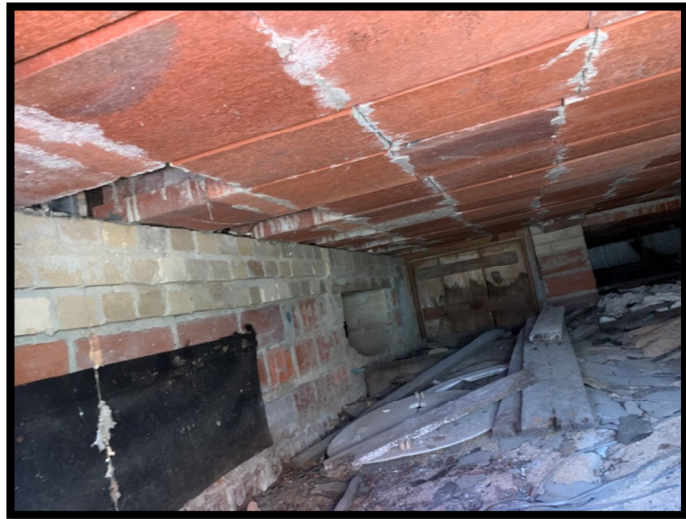
The existing structure was composed of a structural clay tile stem walls with shallow foundations below.

The floor was an elevated floor composed of structural clay tile, grout and steel mesh reinforcing. The exterior walls were composed of structural clay tile on the inner wythe and brick veneer on the outer face within, and a multi wythe brick veneer façade at the courses above grade. The roof was composed of cast in place concrete and structural clay tile.

Figure 1: Stem walls (taken in crawl space) supporting clay tile floor

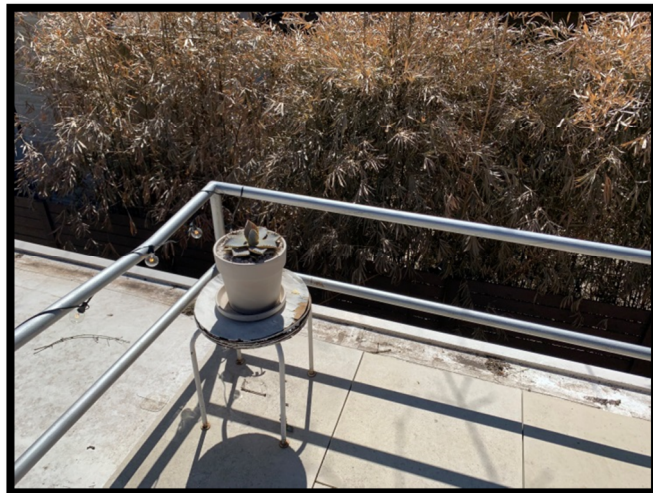
Figure 3: Hand railing on roof, approximately 24" tall, 42" required

Exterior stairs, composed of concrete, cantilevered from the house. Cracking was observed on multiple stair treads near the connection to the house. No handrails were present on the stairs. Handrails on the perimeter of the roof were approximately 24 inches tall. Below the front entryway landing, on the north side of the house, ponding water was observed. The landing was also cracked and showing signs of collapse into the space below.

Additional safety concerns noted were the cracking on the cantilevered stairs, and the lack of hand railing on the stair. The hand railing, per IRC 2015, is required to have a minimum height of 42". The cracking on the stair treads, if un-repaired, will continue to open over time, and will shear off. The hand railing around the roof is

also not in compliance with IRC 2015, and will need to be replaced with code approved hand railing.

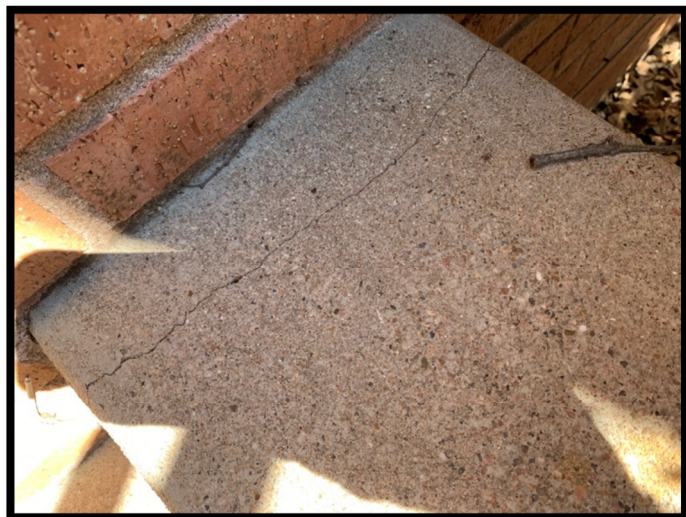
Figure 2: Cracked stair

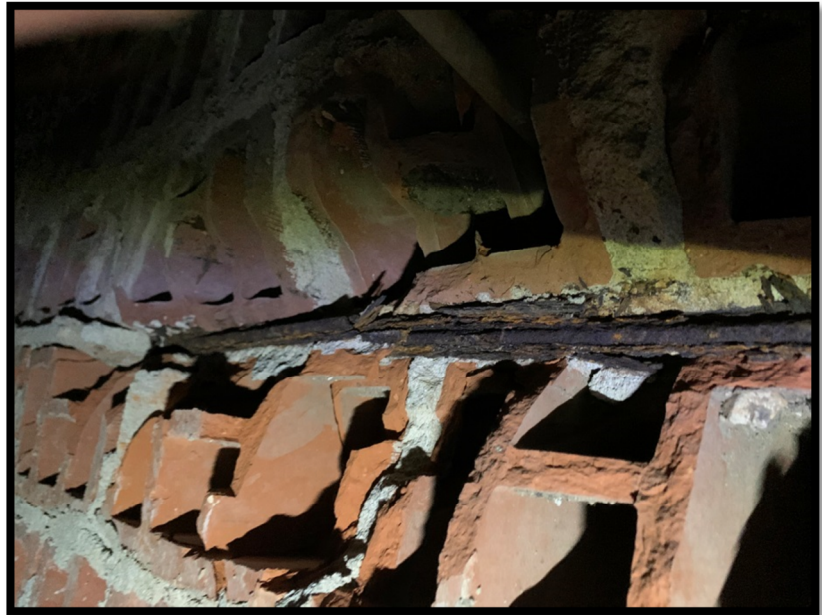
Rusting in the ladder joints was observed throughout the stem walls, and were blooming in more than 25% of the stem walls observed. Two sump pumps were located on the east and west sides, each appeared to be inoperable as water was present in each of the pits. The interior wall adjacent to the living room was heaving, and the floor adjacent to the wall was also buckling/ faulting. The crack was approximately over 1" and over 36" in length

Damage was encountered in multiple locations within the stem walls from the duct installation and from ladder joints blooming within the stem wall. The corrosion was likely accelerated from the sump pumps inoperability, and garden beds resting against the building. The stem walls support the floor, main walls within the residence, and effectively the roof as well. To remove, replace, and repair the damaged cells, the floor and roof would all be required to be shored. The clay tile material is brittle by nature, and would not be easily replaced or repaired. Caution should be taken if repairing as the weight of the floors, walls, etc. is high.

Figure 5: Rusty/blooming ladder joints within stem walls & damaged clay tiles.

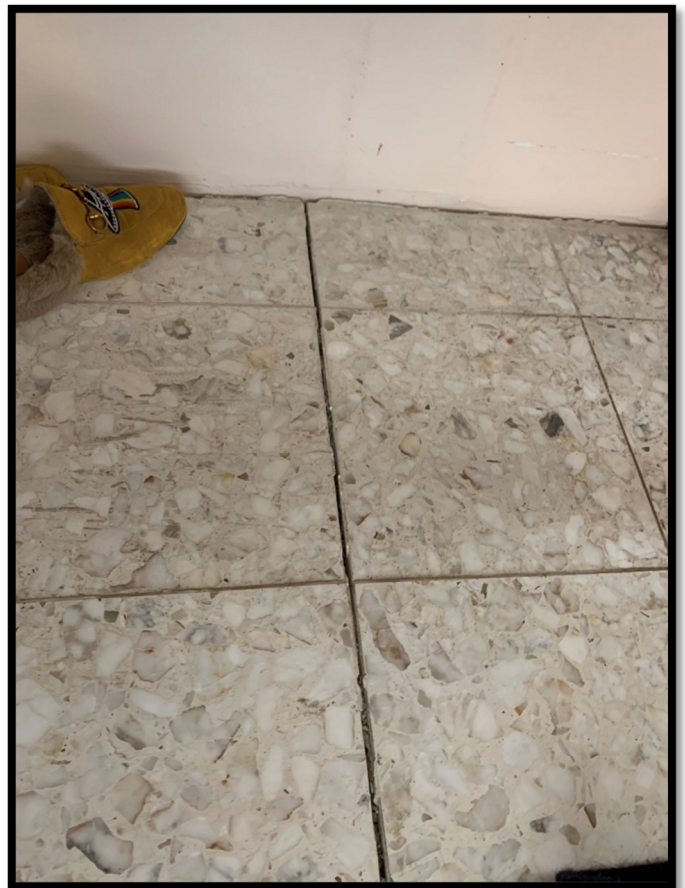
The heaving within the living room was noted to have worsened over the past month, specifically during the winter freeze in mid to late February 2021. The heaving suggests that water is able to rest against and beneath the soils and foundations on the interior walls. When soils with clay are introduced to moisture, they heave upward. This is likely what is causing the faulting in the floor, which

Figure 4: Faulting in living room floor

was accelerated by the amount of moisture from the storm. The flooring material is similarly brittle in nature to the walls, and would likely not support any additional loads as it appears the existing loads cannot be supported as constructed.

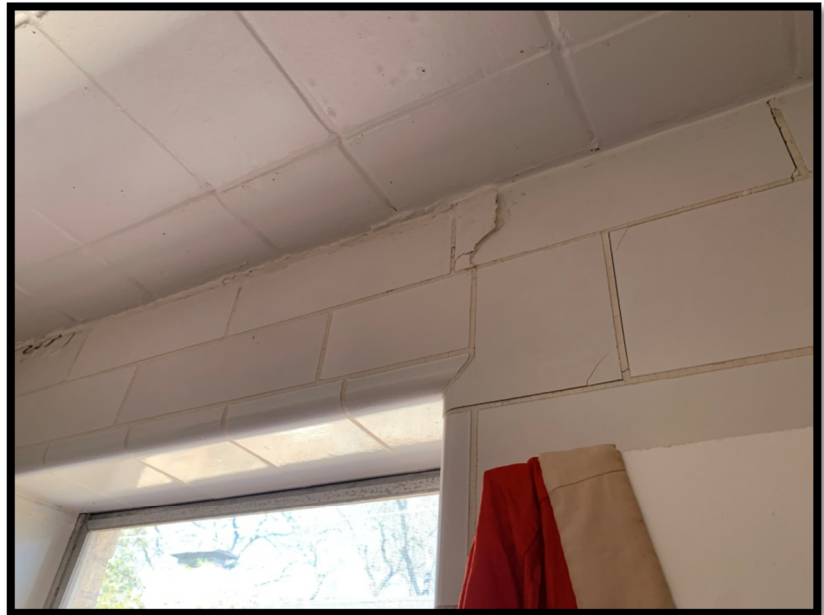
Figure 6: Cracking noted on stair header in bedroom

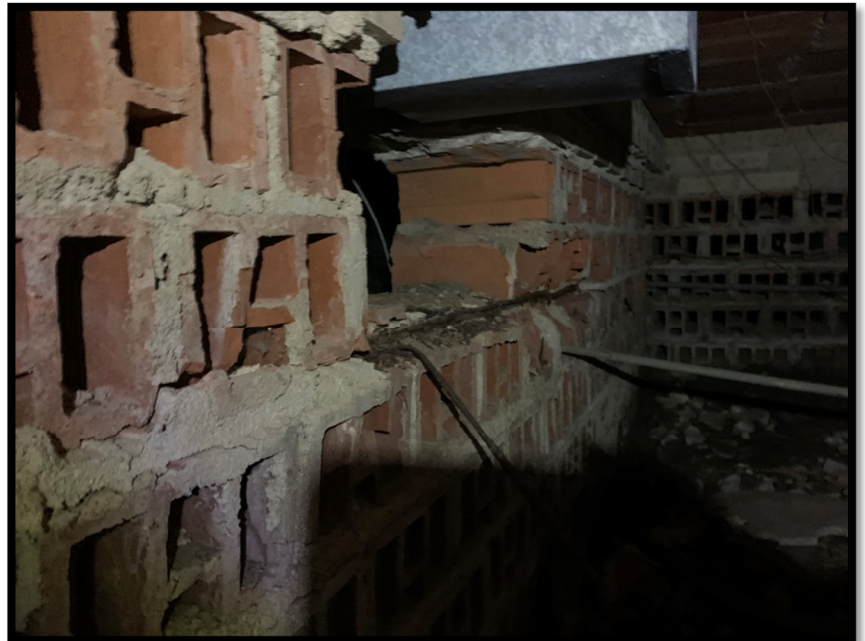
Multiple penetrations had been made through the stem walls and damage was noted on more than 25% of the walls. Some molding was noted on the stem walls adjacent to the garden beds on the east end of the home.

Figure 7: Damaged stem walls from duct penetrations, rusting and broken ladder joints

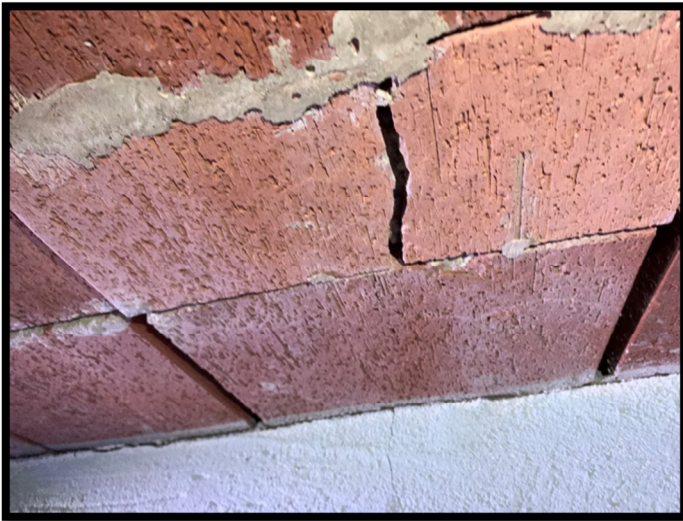
Figure 9: Cracking on floor clay tiles.

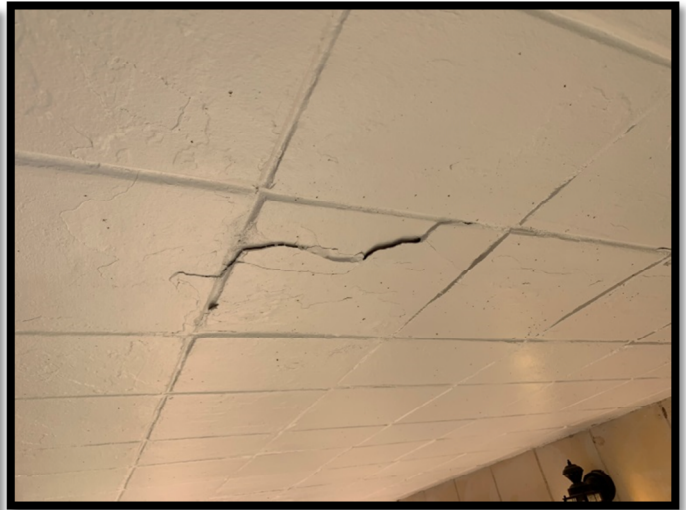
Figure 8: Cracking in ceiling

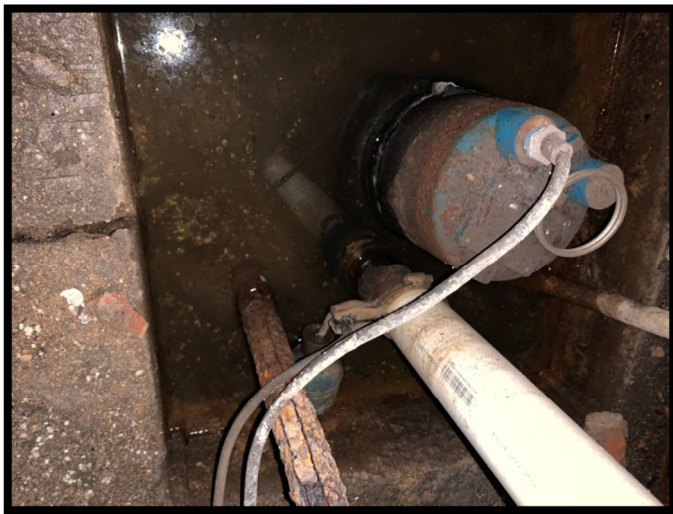
Figure 11: 1 of 2 inoperable sump pumps

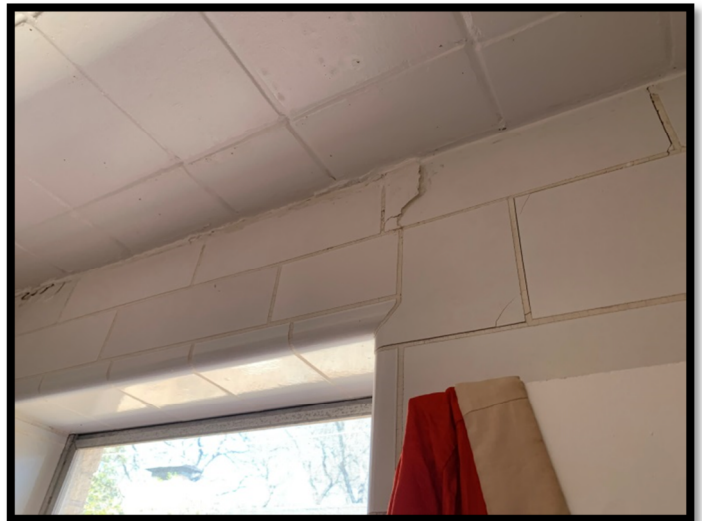
Figure 10: Cracking at window header

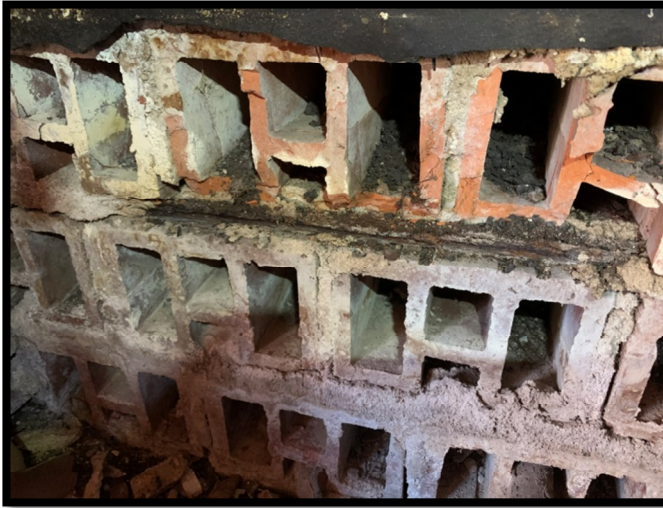
Figure 12: Rusting ladder joint in crawl space below bedroom

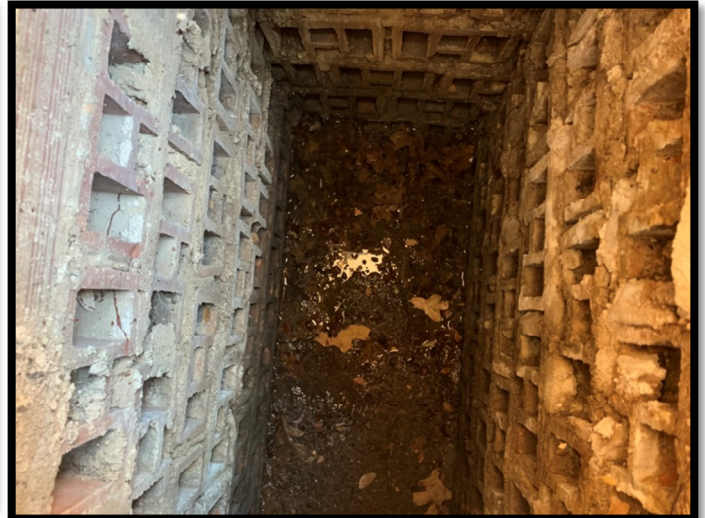
Figure 13: Water resting in space below side entry door
